**Long-Term Surveillance and
Maintenance Plan
for the
Boiling Nuclear Superheater
(BONUS) Reactor Facility,
Rincón, Puerto Rico**

August 2016

U.S. DEPARTMENT OF
ENERGY

Legacy
Management

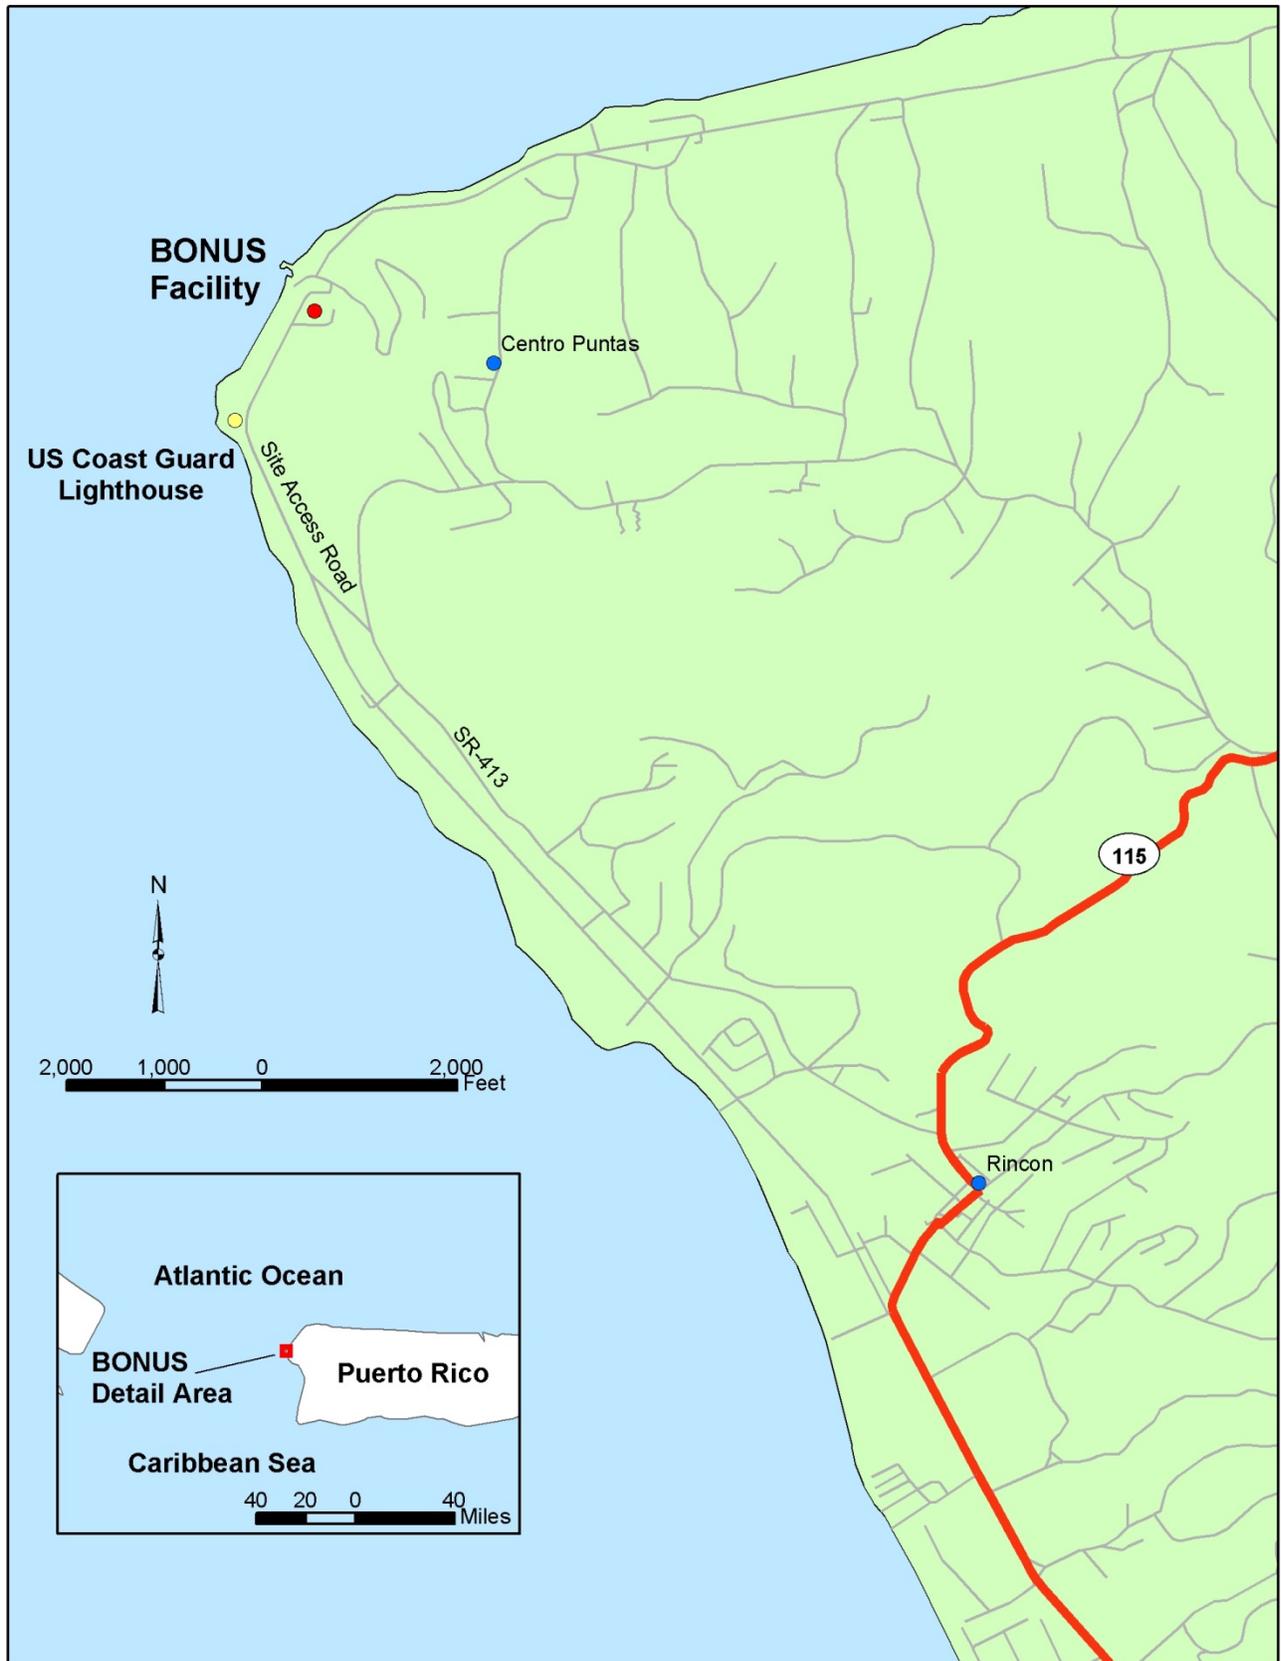
Figure 1. Location of the BONUS Facility, Rincón, Puerto Rico

The BONUS facility is located on the westernmost coastal point (Punta Higuera) of Puerto Rico near a U.S. Coast Guard lighthouse (Figure 1). The facility lies within a 5-acre (2-hectare) fenced area and is surrounded by 137 acres (55 hectares) of undeveloped land primarily vegetated with brush, native pasture, and woodland, formally known as the BONUS site (owned by PREPA) and which served primarily as a buffer zone when the plant was in operation. Warehouses, the chlorination plant, and water tanks were also located in this area. The 6-foot- (1.8-meters [m]-) high, chain-link security fence is topped with three strands of barbed wire.

Figure 1 shows the location of the site in relation to local features and roads. Access to the site is granted by PREPA. The primary contact for accessing the site is:
