**Monticello, Utah, National  
Priorities List Sites  
Federal Facility Agreement  
(FFA) Quarterly Report:  
October 1–December 31, 2015**

**January 2016**

Legacy  
Management

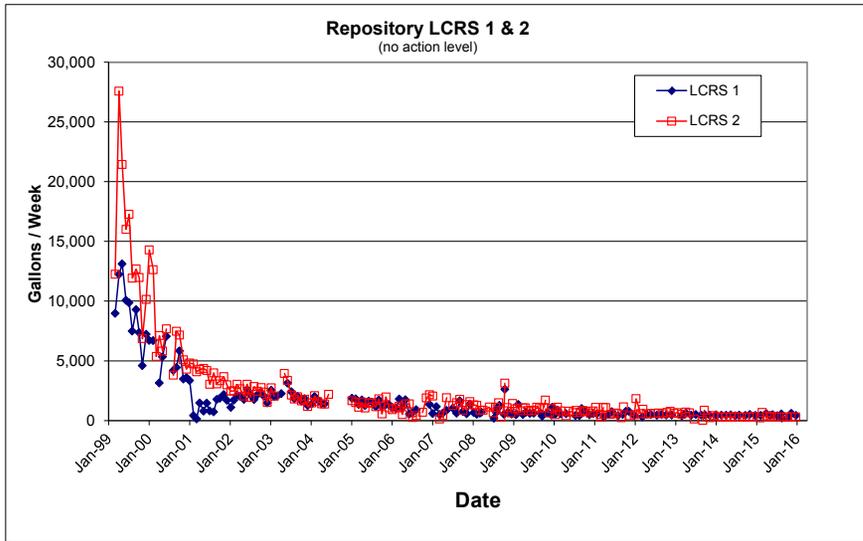
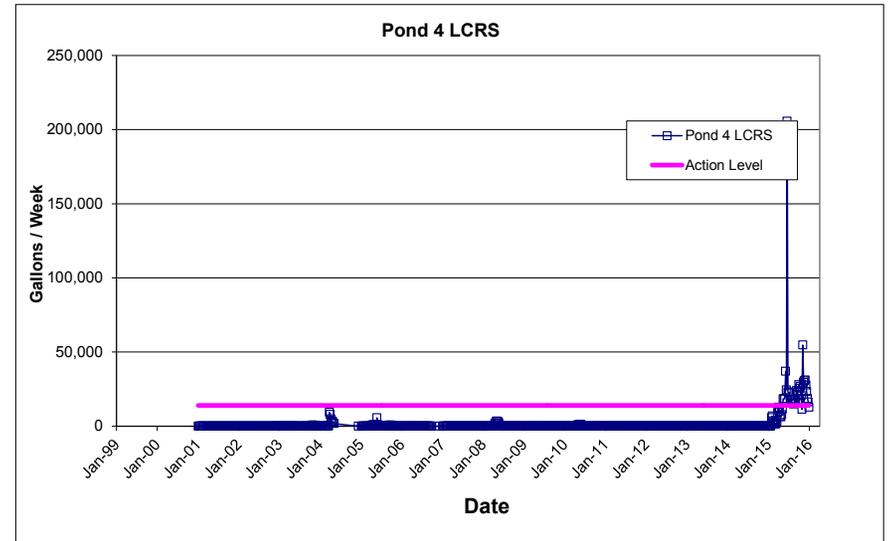
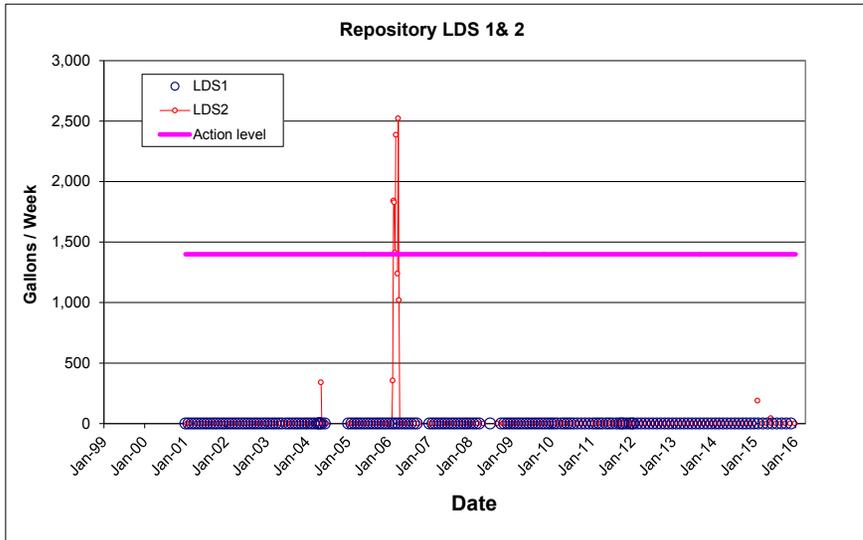
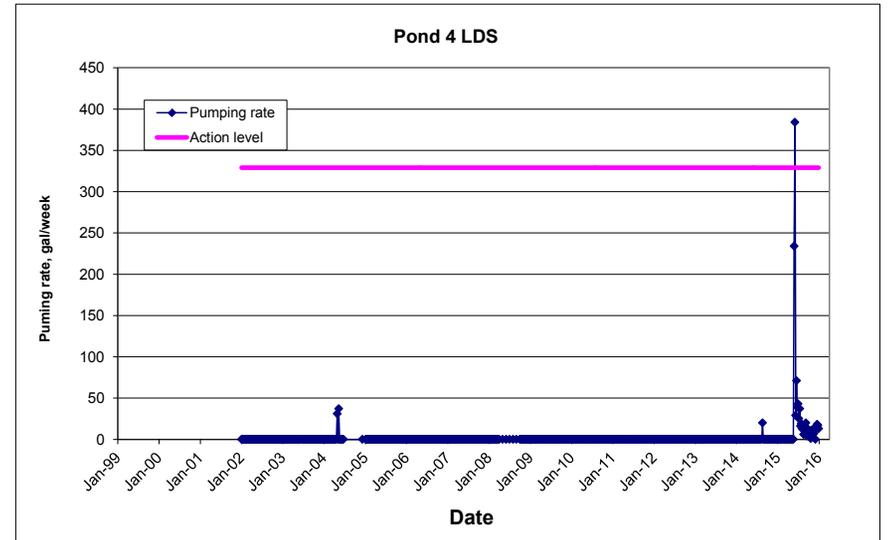
### Graphs Showing Performance History for Repository and Pond 4 Leachate Collection and Recovery System (LCRS) and Leak Detection System (LDS)

### **Graphs Showing Performance History for Repository and Pond 4 Leachate Collection and Removal Systems and Leak Detection Systems**
