MOUND PLANT Potential Release Site Package PRS # 410

PRS 410

PRS HISTORY:

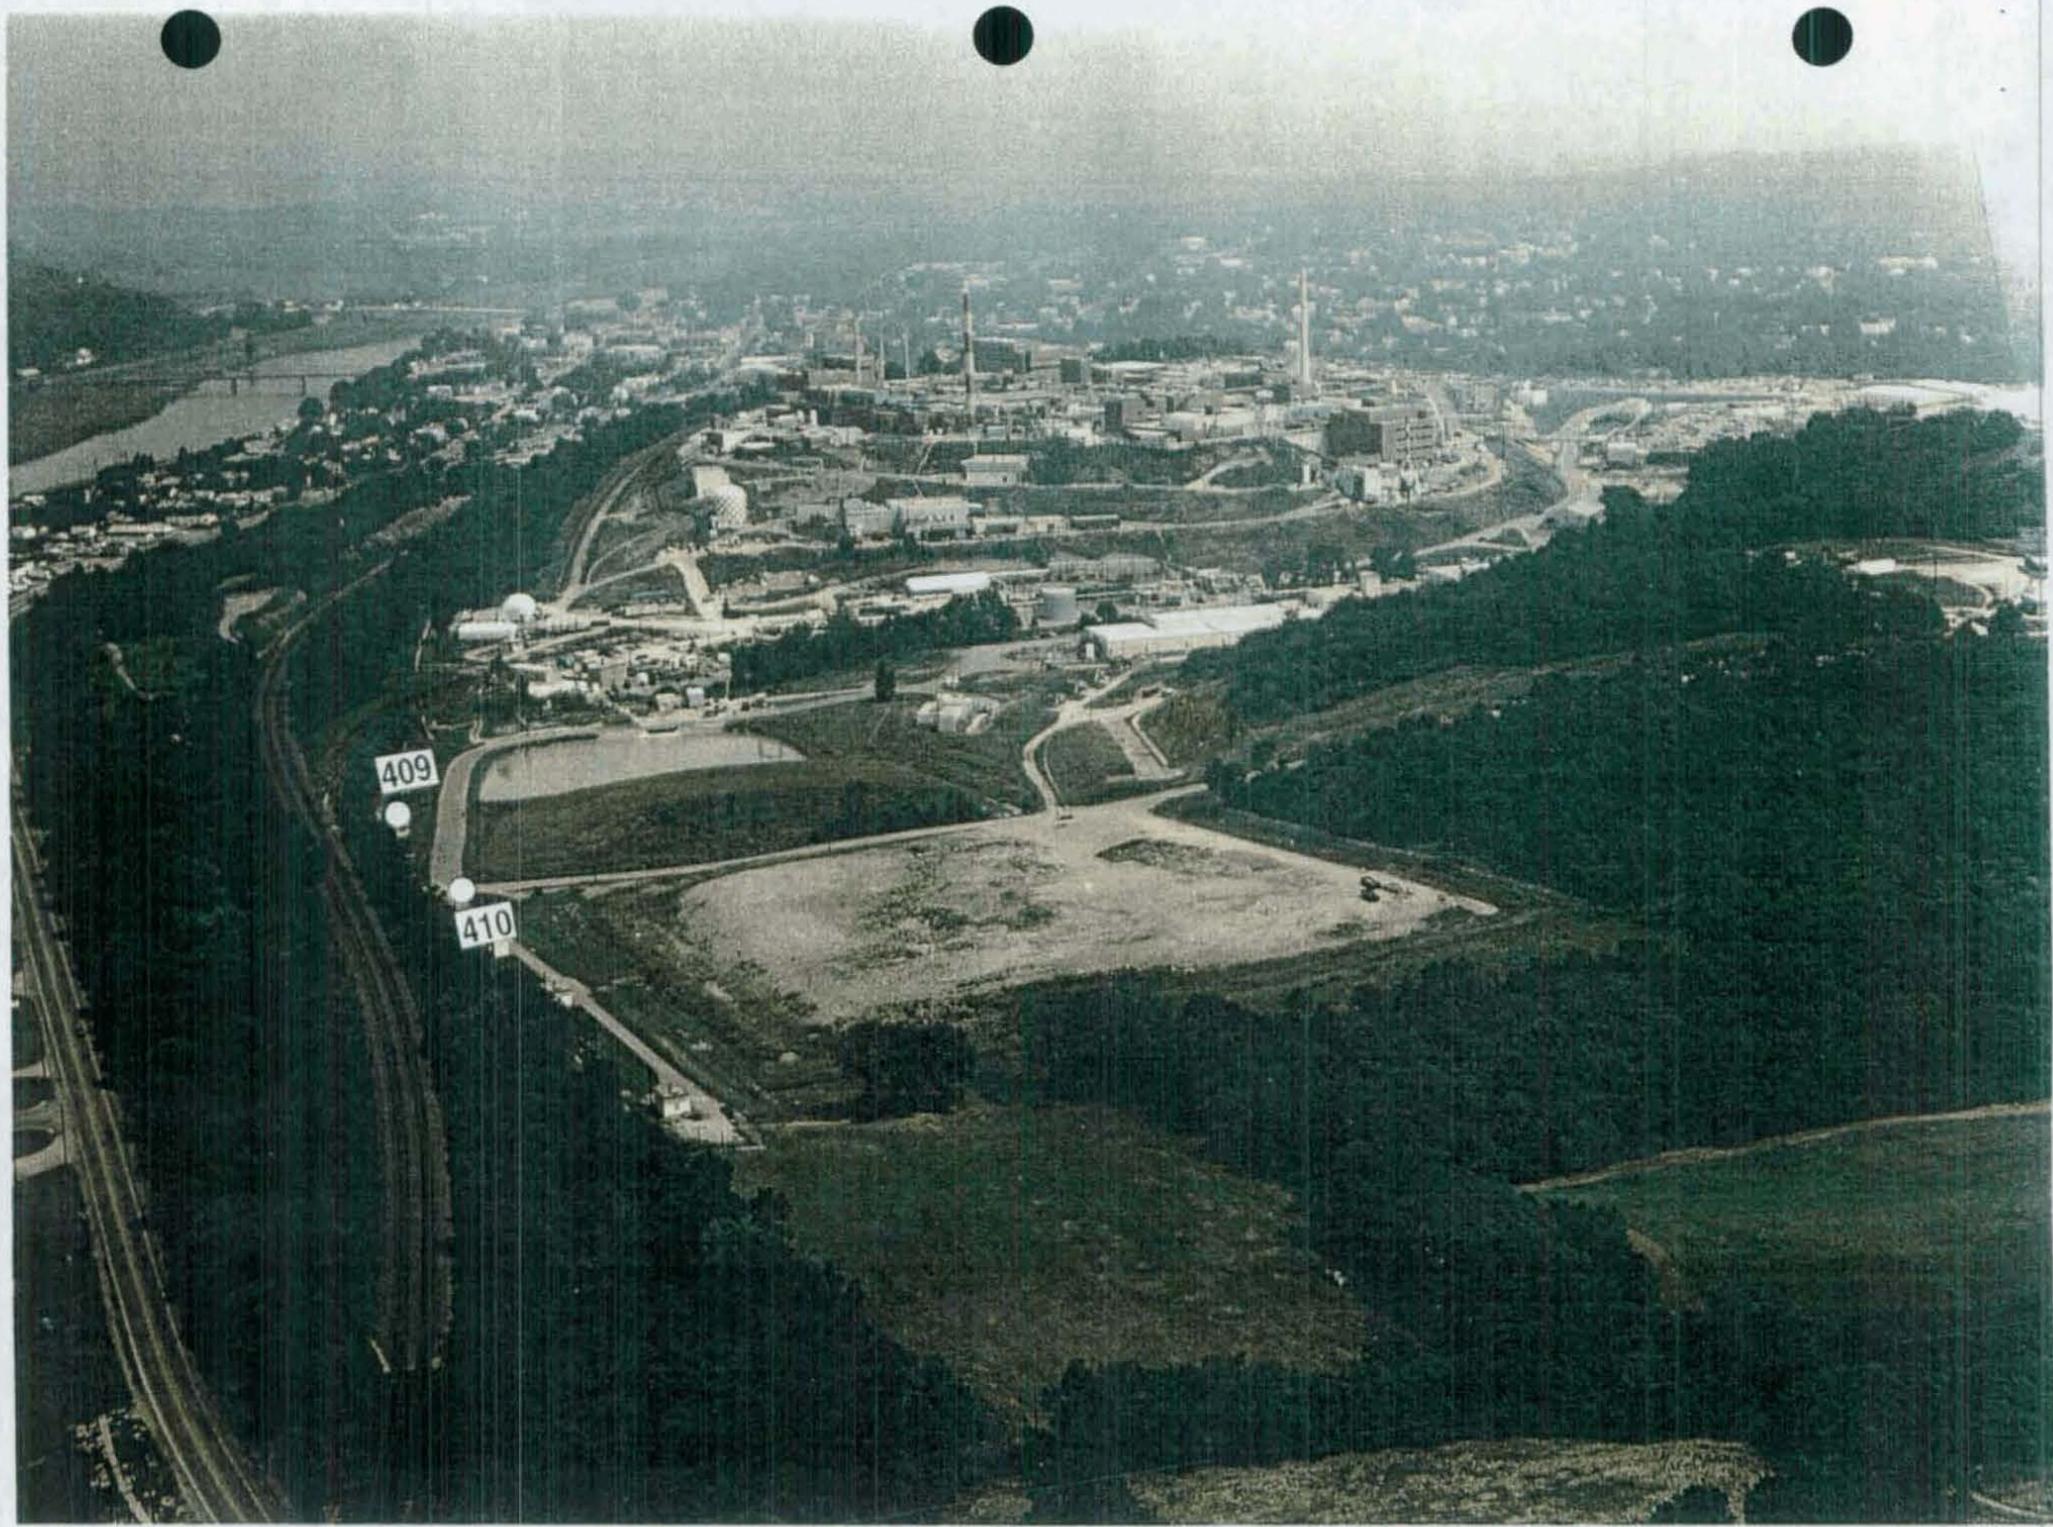
On the map below:

- PRS number and location shown in black
- Fencing shown in red
- Elevation contours shown in brown

PRS 410 is a gravel/soils area located in the vicinity of the road which runs east to west between the OU1 landfill and the Spoils Area.^{1,3} The contamination was discovered when an aroma of diesel fuel was encountered during the removal and replacement of an underground drainage pipe from beneath the road.^{1,3} The road is scheduled to be asphalt paved to its original condition in the spring of 1997.² Currently (February, 1997), PRS 410 has been filled with clean gravel.²
