Enclosed are the fact sheets developed for the top 20 Environmental Restoration (ER) sites identified during the ER Prioritization effort. These fact sheets were designed to be a quick reference for each of the top 20 sites' environmental risk, and any problems which may be associated with remediation.

**FACT SHEET FOR TOP 20 ENVIRONMENTAL SITES
IHSS 101, SOLAR PONDS**

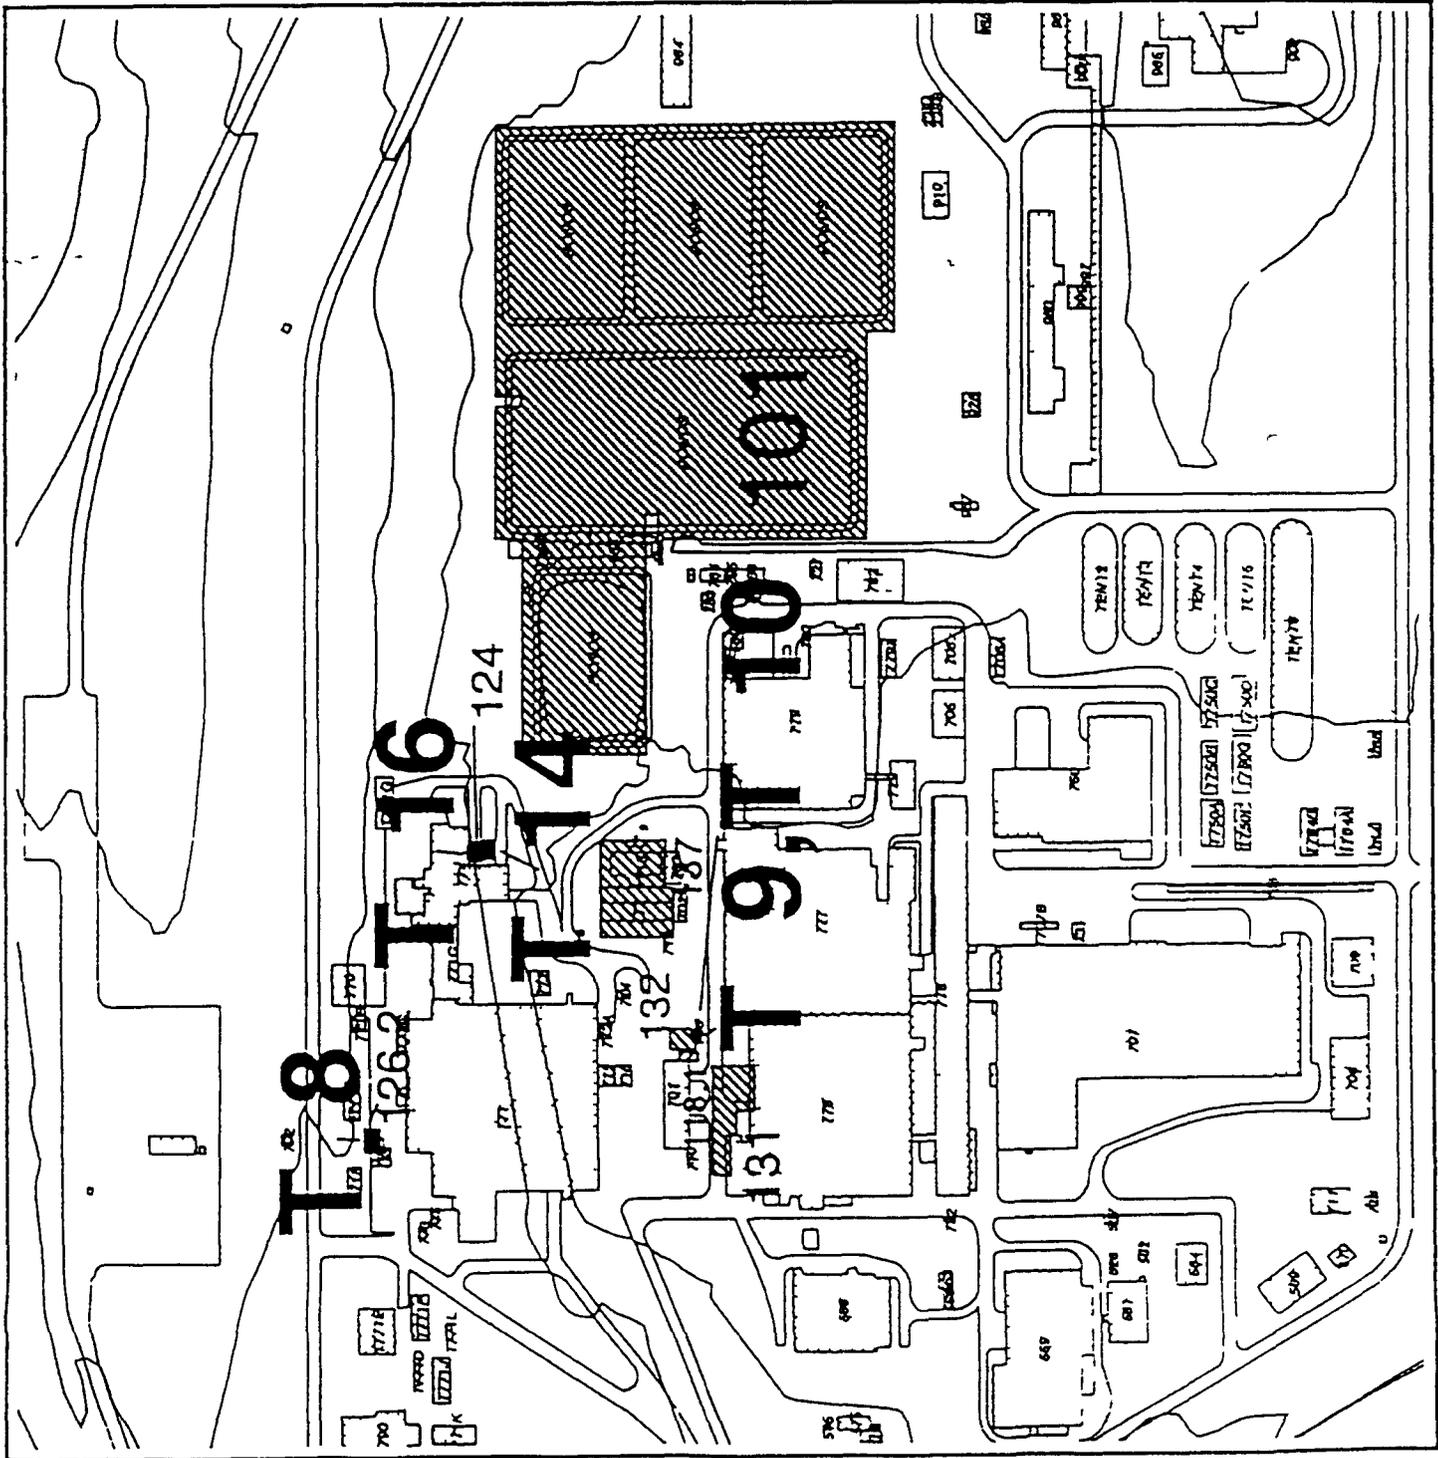
Location: The Solar Ponds are located in the northeast quadrant of the protected area, upslope of the Walnut Creek drainage, near Buildings 778, 964, and 910

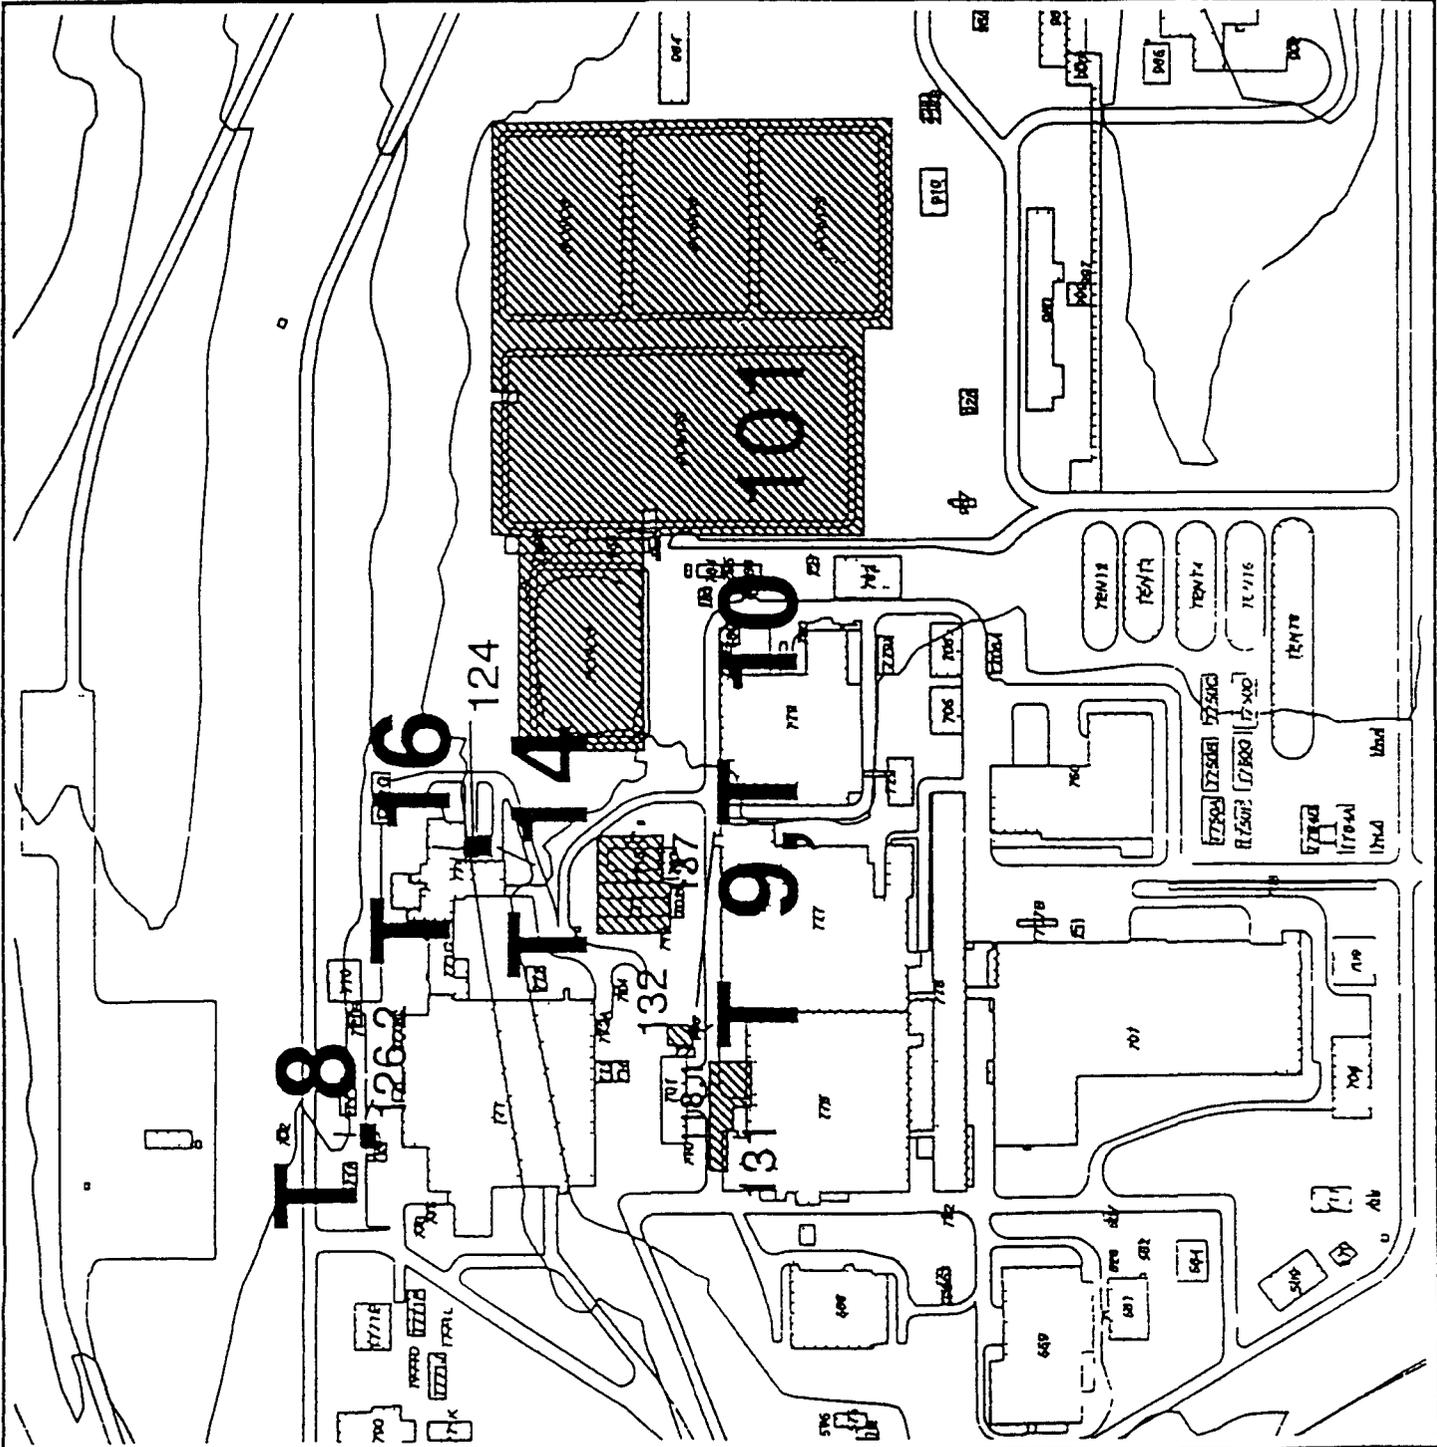
**FACT SHEET FOR TOP 20 ENVIRONMENTAL SITES
IHSS 131, RAD SITE #1 - 700 AREA**

Location: IHSS 131 is located on the north side of Building 776

Description: IHSS 131 consists of radioactive releases due to an explosion in Building 776 in 1964 and the associated fire fighting activities. Plutonium was released to the environment in an approximate 2,000 square foot area around the dock of Building 776. After the explosion, soil was removed and the area has been covered with asphalt. Volatile organic contamination may be present adjacent to IHSS 118 1, the carbon tetrachloride tank spill.

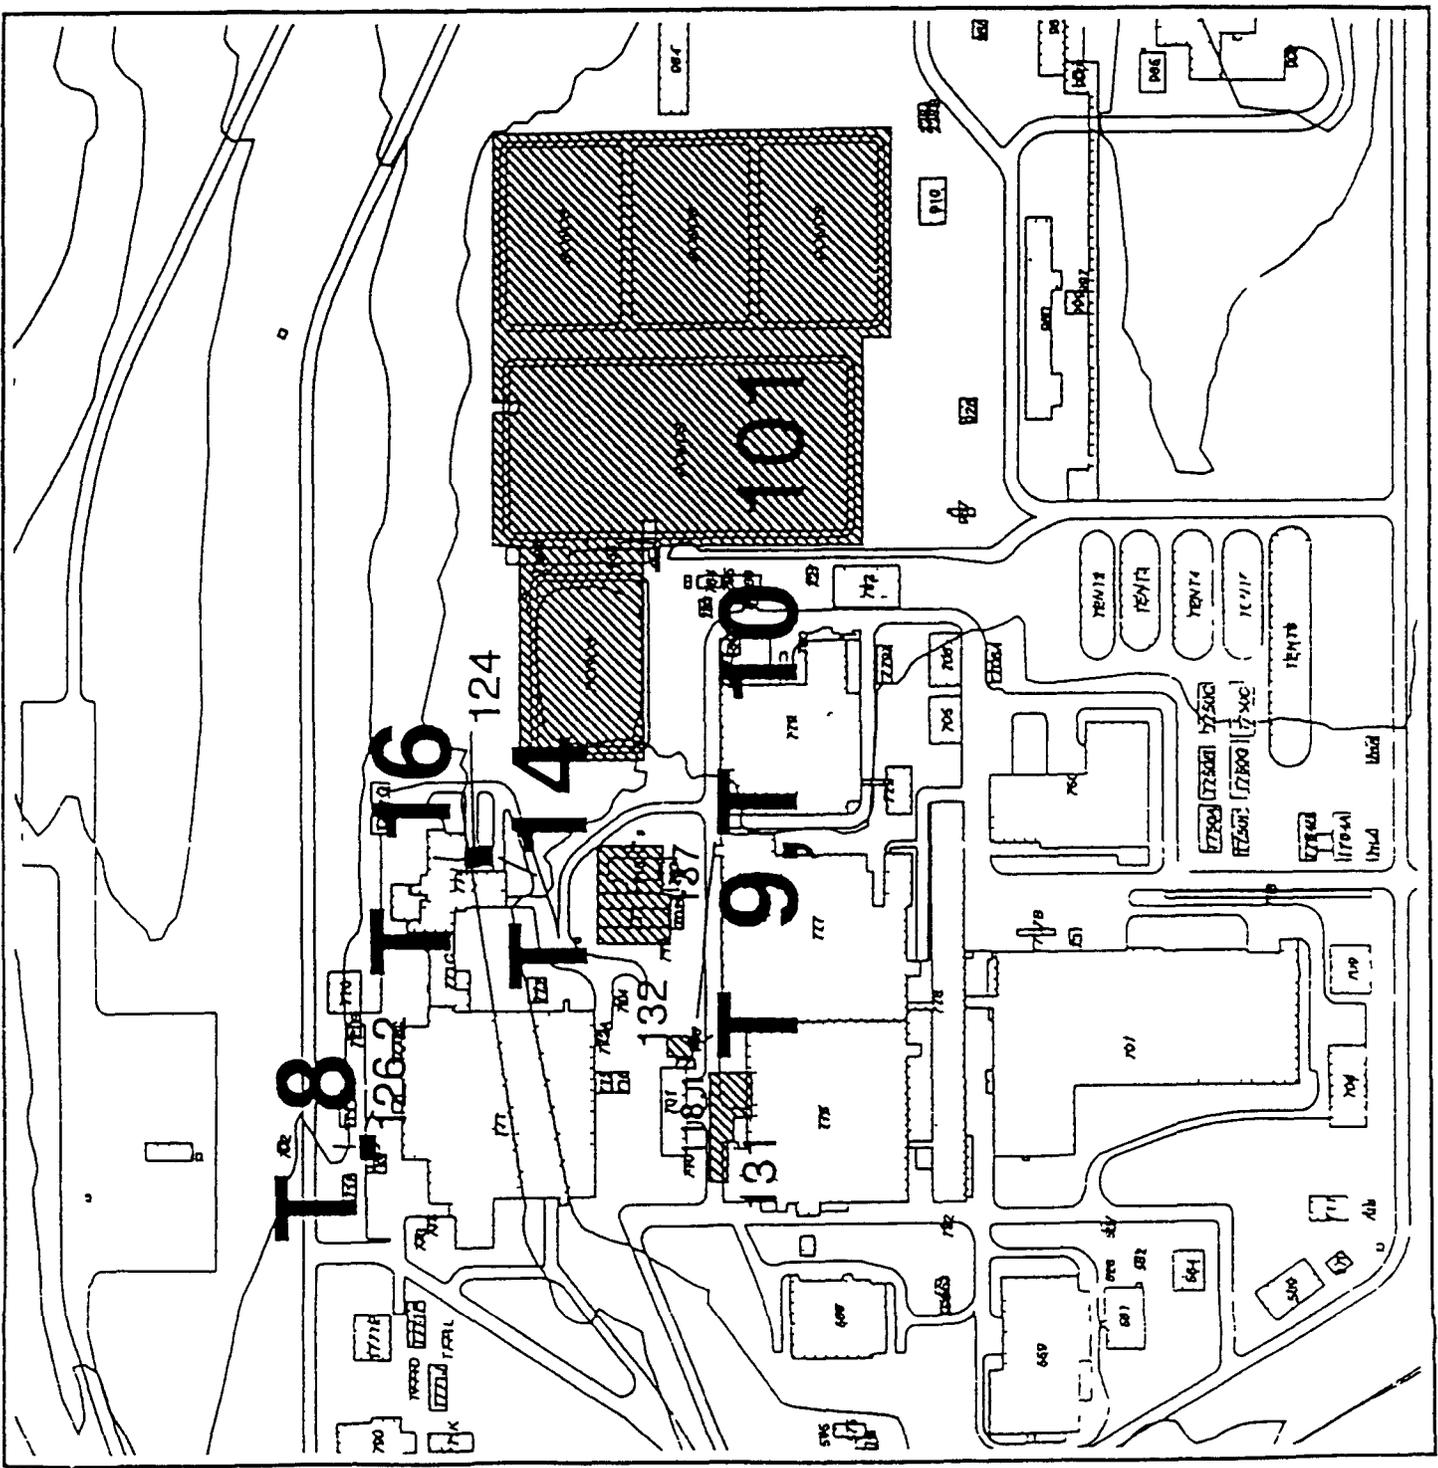
**FACT SHEET FOR TOP 20 ENVIRONMENTAL SITES
IHSS 118 1, 132, AND TANK UNITS 9 AND 10**

Location: Overlapping IHSSs in an approximately 1000 square foot area on the north and west side of building 730

- T 8 Tank Locations and Labels
- 118 1 IHSS Locations and Labels
- Buildings

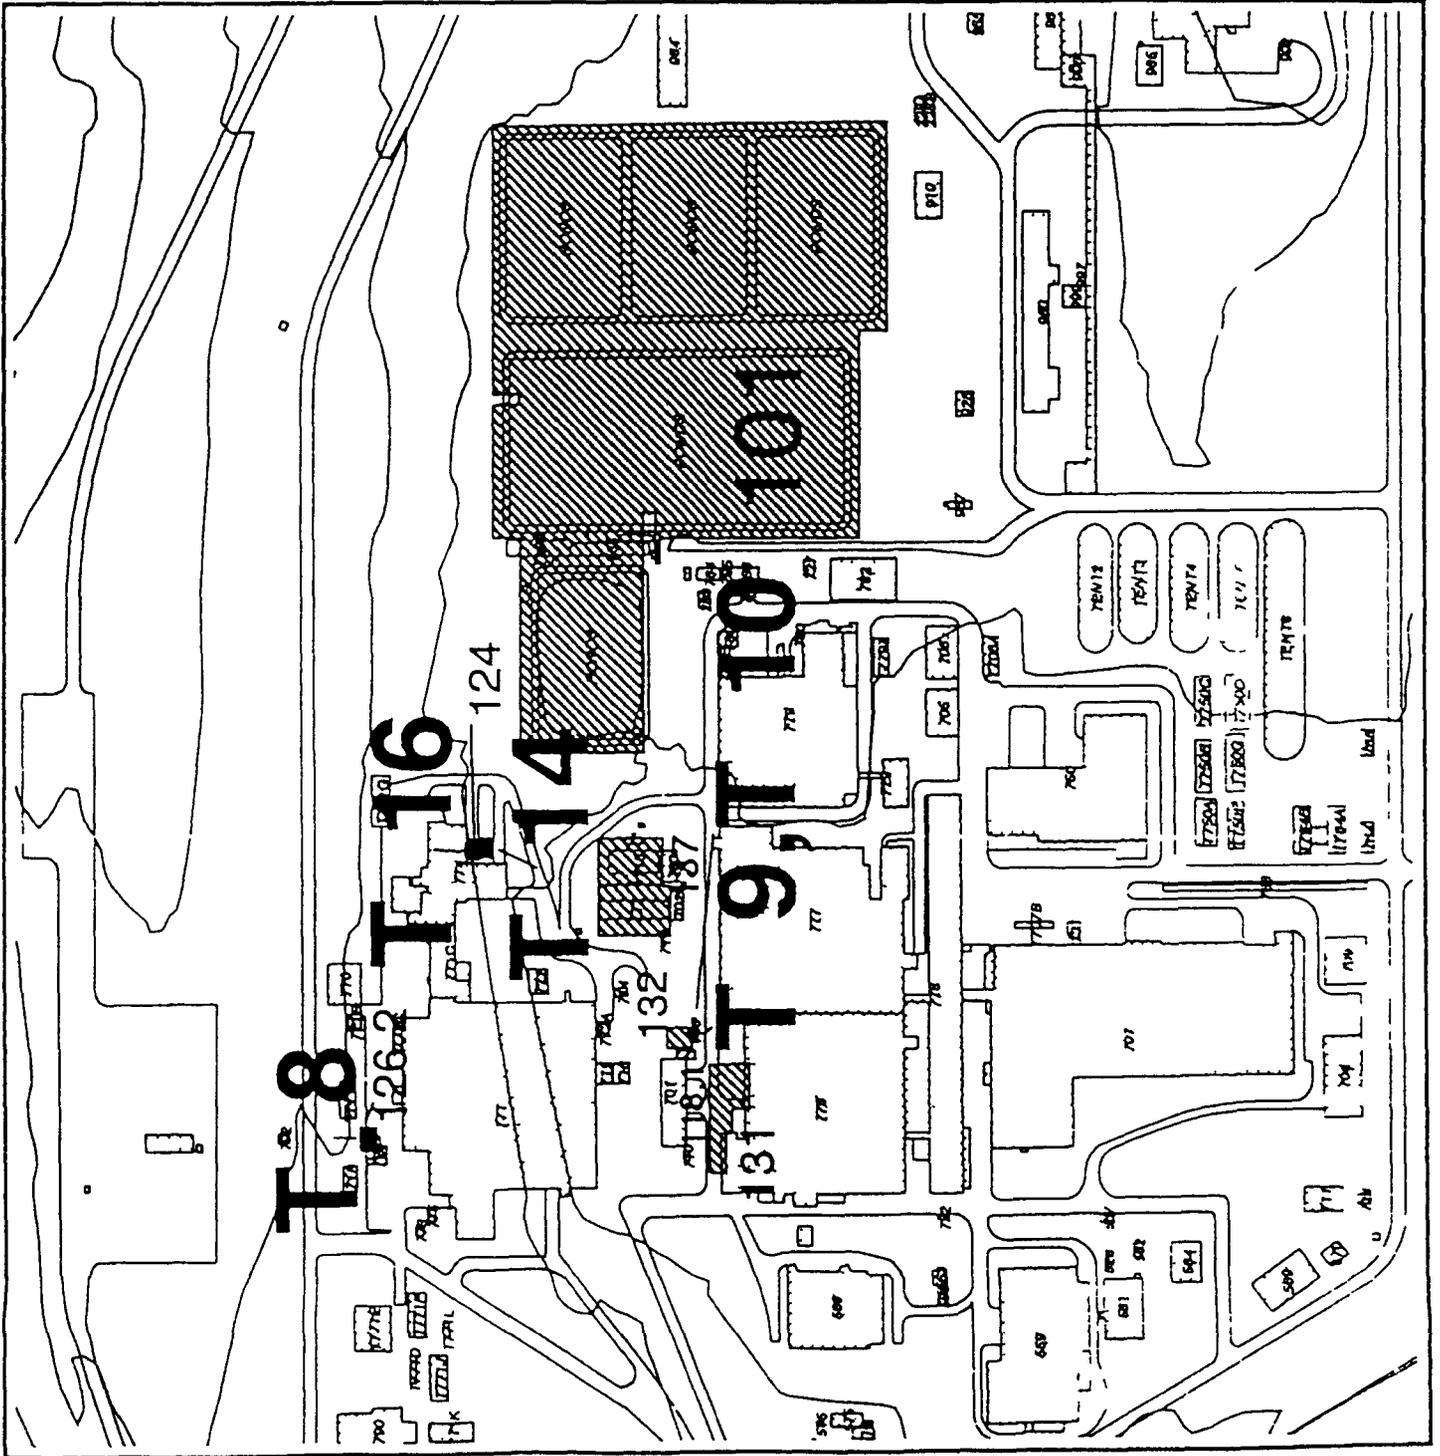
**FACT SHEET FOR TOP 20 ENVIRONMENTAL SITES
IHSS 137, BLDG. 712/713 COOLING TOWER BLOWDOWN**

Location: IHSS 137 is associated with cooling towers and Buildings 712 and 713, in the 700 Area. The cooling towers serve Buildings 776 and 777 and are adjacent to each other in the area south of Building 774 and north of Building 777.

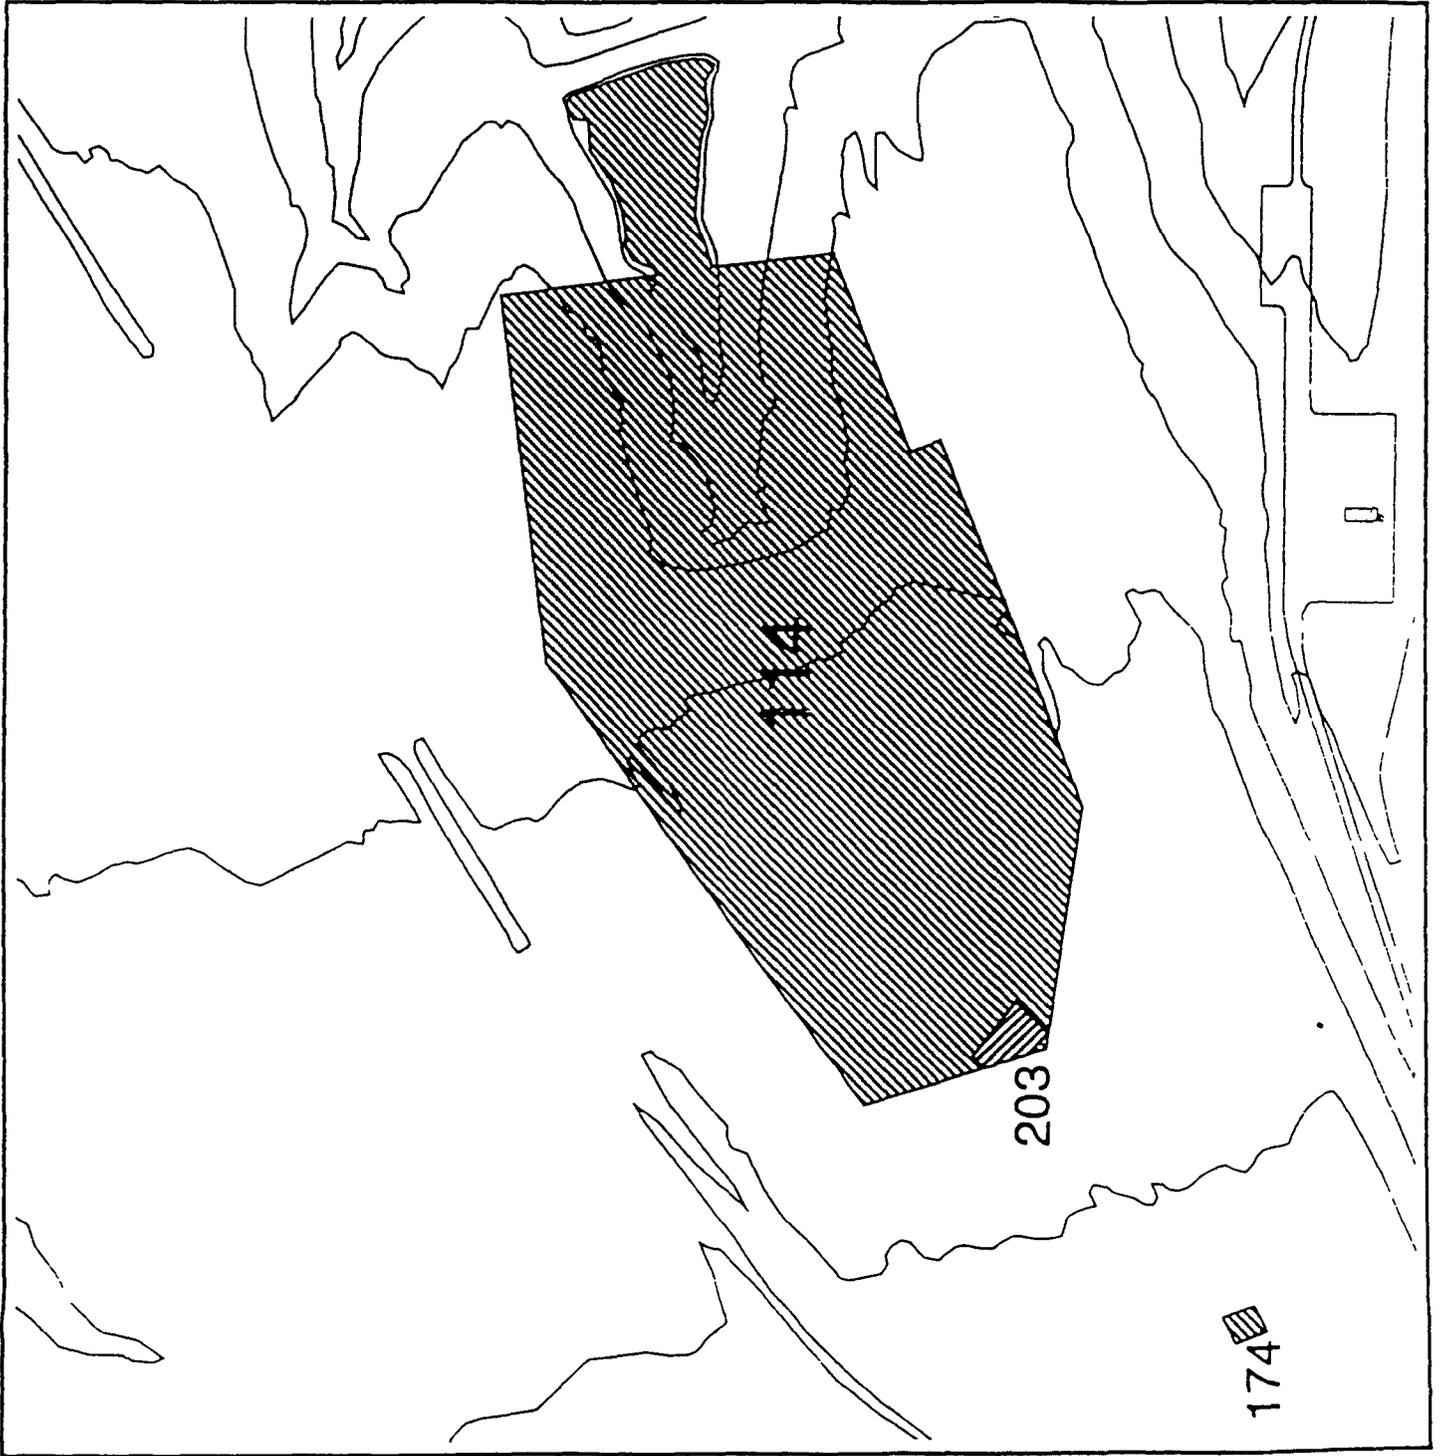
**FACT SHEET FOR TOP 20 ENVIRONMENTAL SITES
IHSS 174.1 (174a), DRUM STORAGE AREA**

Location: IHSS 174a is located within, and is a subset of, IHSS 170, Property Utilization and Disposal (PU&D) Yard. It is located northwest of the Protected Area in the Buffer Zone adjacent to the existing sanitary landfill.

Description: IHSS 174a is a subset of IHSS 170, PU&D storage yard, and is approximately 60 feet by 60 feet in area in the northeast portion of IHSS 170. Historically, this area was used to store drums containing waste oils, paints, and paint thinners. It is estimated that as many as 460 drums have been stored at this location. Leaks and spills occurred from these stored drums until 1985, when all of the waste oils and drums were removed for disposal.

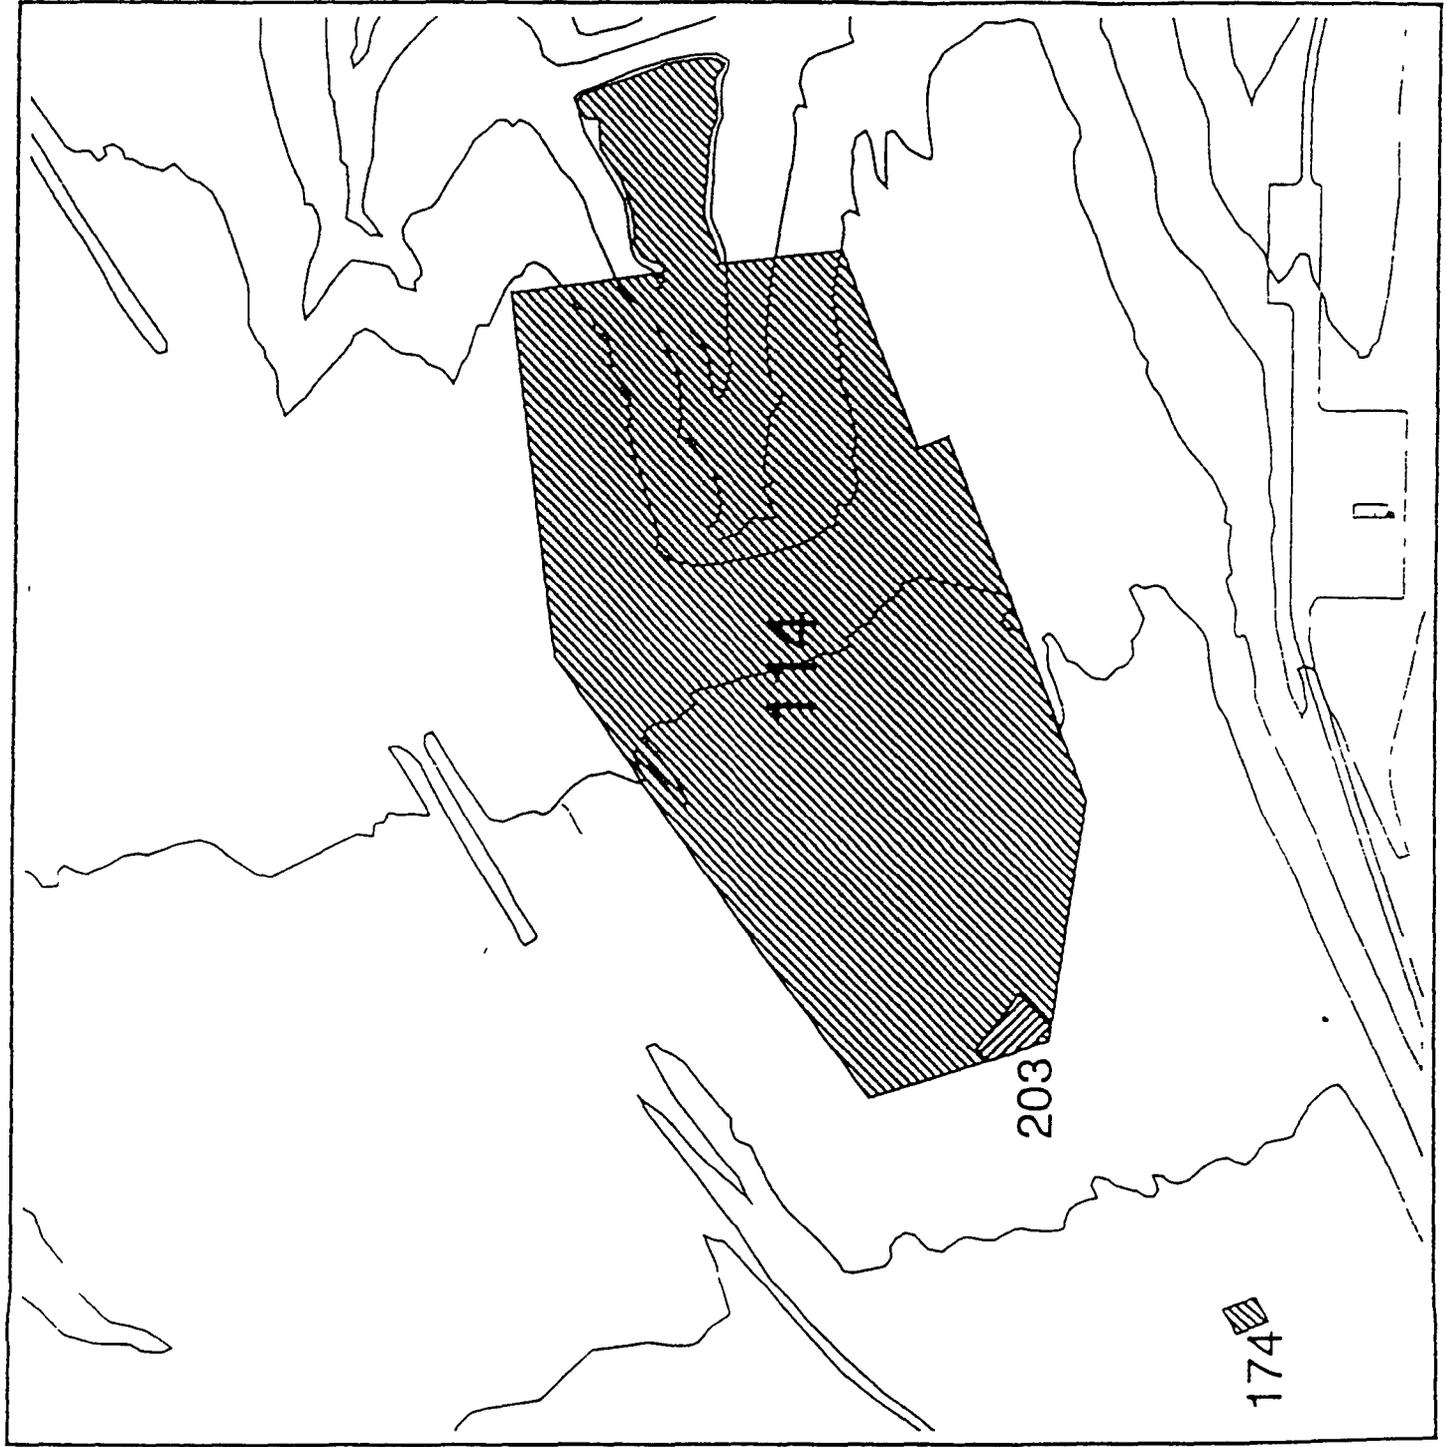
**FACT SHEET FOR TOP 20 ENVIRONMENTAL SITES
IHSS 114, PRESENT LANDFILL (INCLUDES IHSS 203)**

Location. The Present Landfill is located at the head of the No Name Creek Drainage, in the northwestern quadrant of the Site

- 203 ■ IHSS Locations and Labels
- Buildings

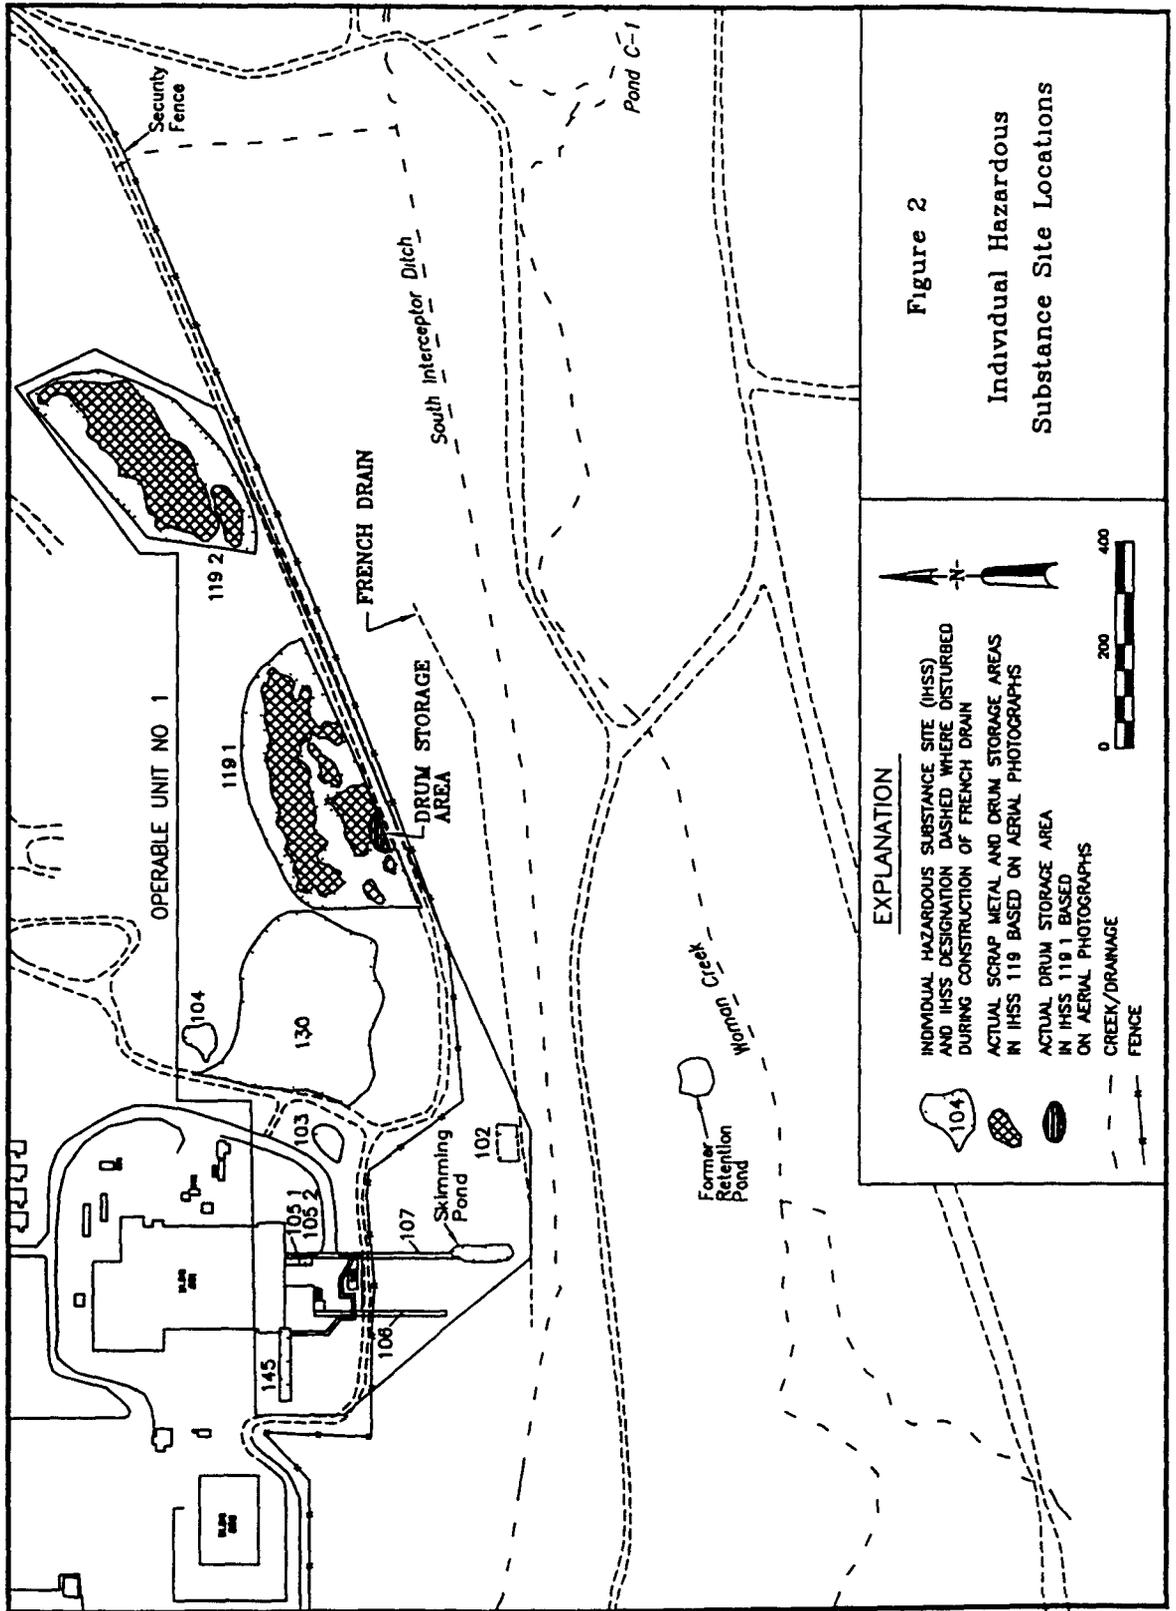
**FACT SHEET FOR TOP 20 ENVIRONMENTAL SITES
IHSS 119 1, FORMER DRUM STORAGE AREA**

Location: IHSS 119 1 is a former drum storage area located within Operable Unit 1, on the hillside southeast of Building 881, north of Woman Creek

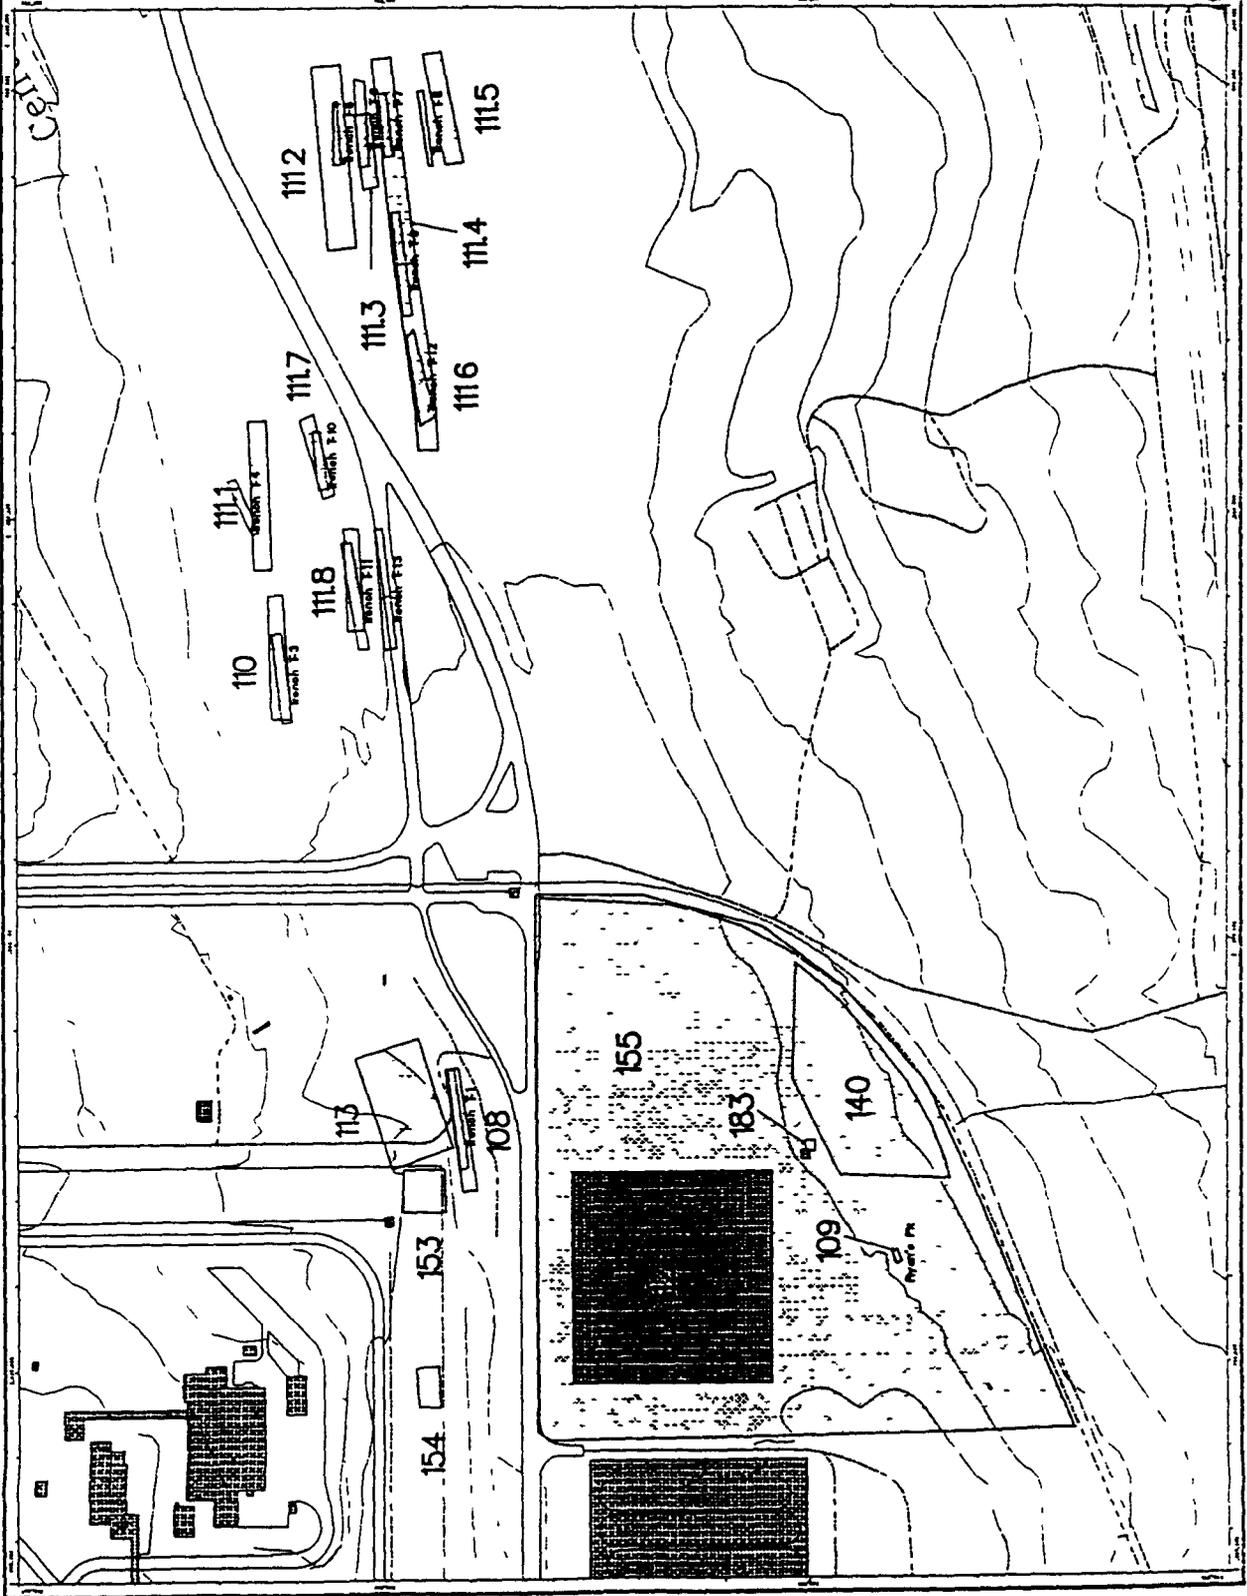
**FACT SHEET FOR TOP 20 ENVIRONMENTAL SITES
IHSS 109, RYAN'S PIT**

Location: IHSS 109 is a former waste disposal area located within Operable Unit 2 south of the 903 Pad. The IHSS is approximately 23 feet in length, 11 feet in width, and 6 feet in depth and contains approximately 57 cubic yards of contaminated soils and debris.

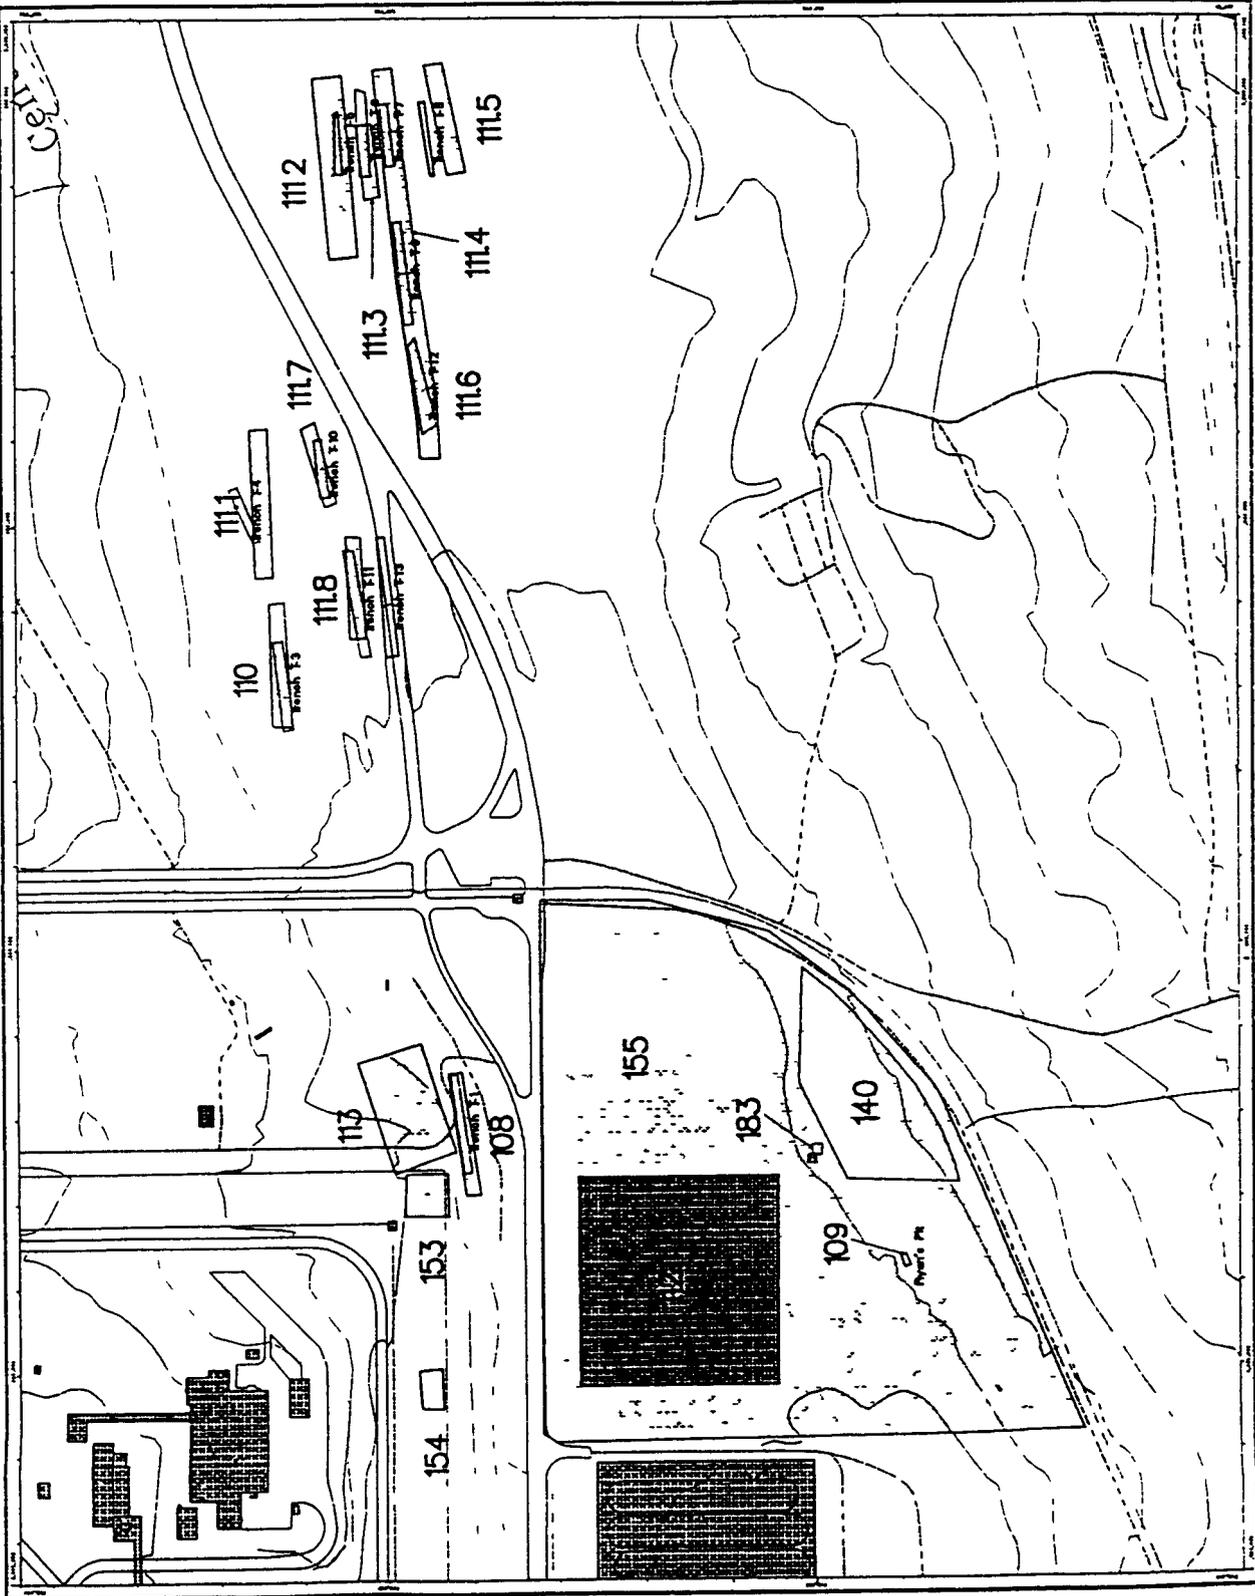
**FACT SHEET FOR TOP 20 ENVIRONMENTAL SITES
IHSS 110, TRENCH T-3**

Location: Trench T-3 is located in the east buffer zone, north of the East Access Road. It is approximately 180 feet in length, averages about 18 feet in width, and is approximately 10 feet deep.

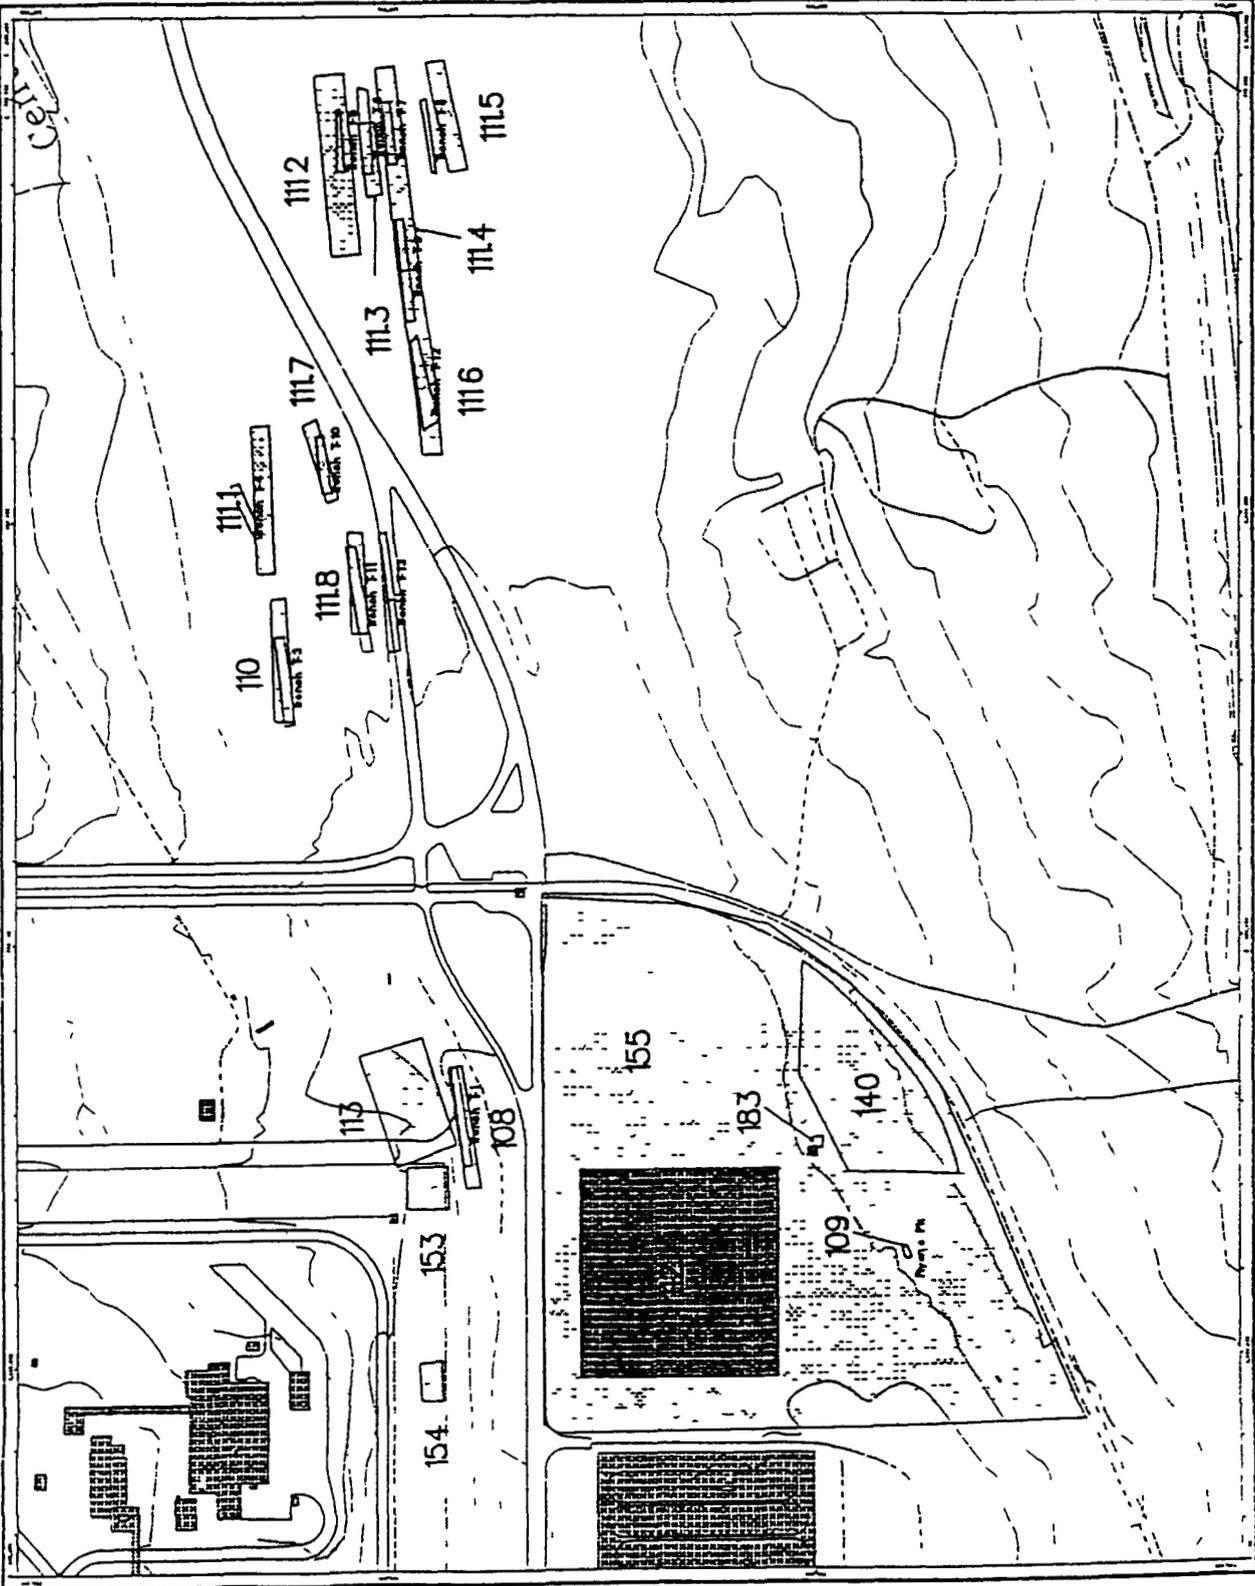
**FACT SHEET FOR TOP 20 ENVIRONMENTAL SITES
IHSS 108, TRENCH T-1**

Location: IHSS 108 is a former drum and waste disposal area located within Operable Unit 2, directly south of the Mound Area. The trench is approximately 200 feet in length, 20 feet in width, and 10 feet in depth and contains approximately 1,490 cubic yards of contaminated soils and debris.
