Enclosed are the fact sheets developed for the top 20 Environmental Restoration (ER) sites identified during the ER Prioritization effort. These fact sheets were designed to be a quick reference for each of the top 20 sites' environmental risk, and any problems which may be associated with remediation.

**FACT SHEET FOR TOP 20 ENVIRONMENTAL SITES
IHSS 101, SOLAR PONDS**

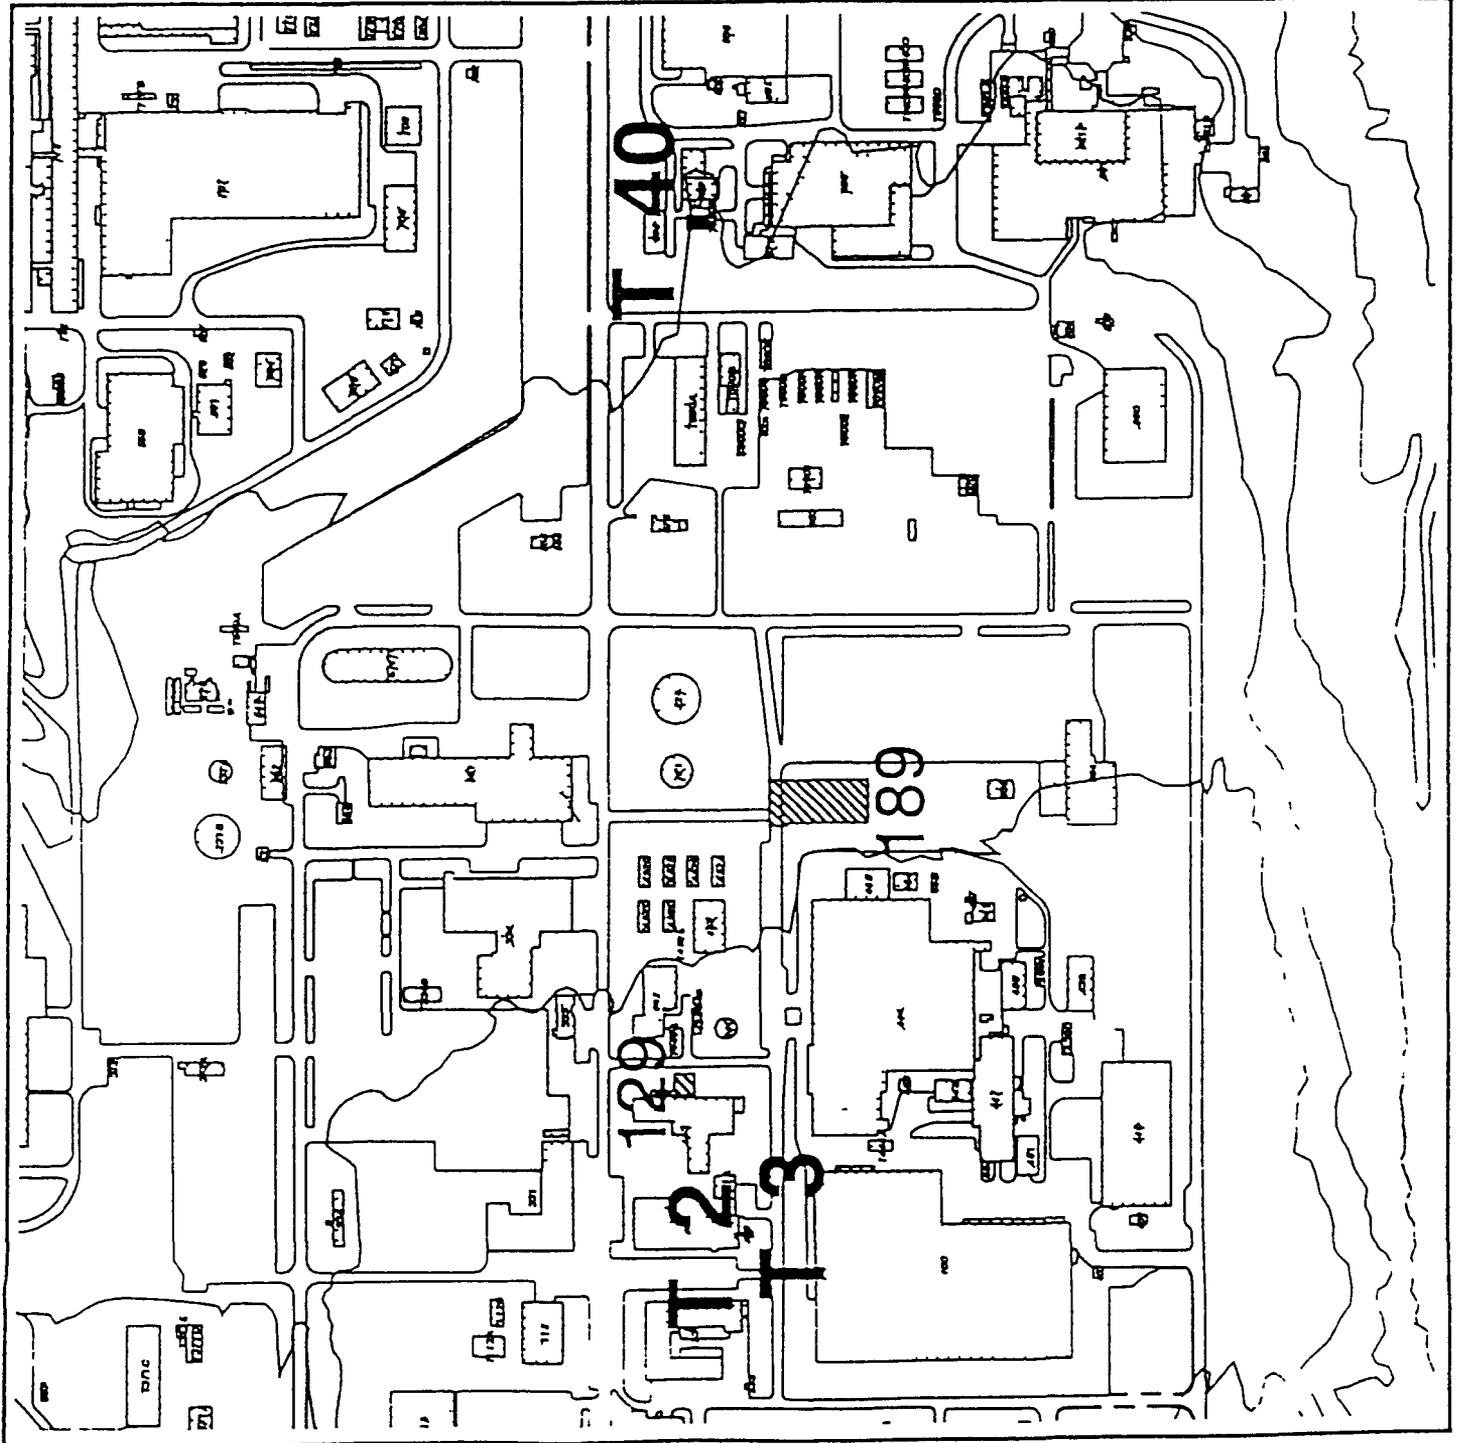
**FACT SHEET FOR TOP 20 ENVIRONMENTAL SITES
IHSS 121 TANKS T-2/T-3, IHSS 122, UNDERGROUND CONCRETE TANKS**

Location: Tank units T-2 and T-3 within IHSS 121 are located in the 400 area, along the south wall of Building 441. These tanks are also referred to as IHSS 122 - Underground Concrete Tanks.

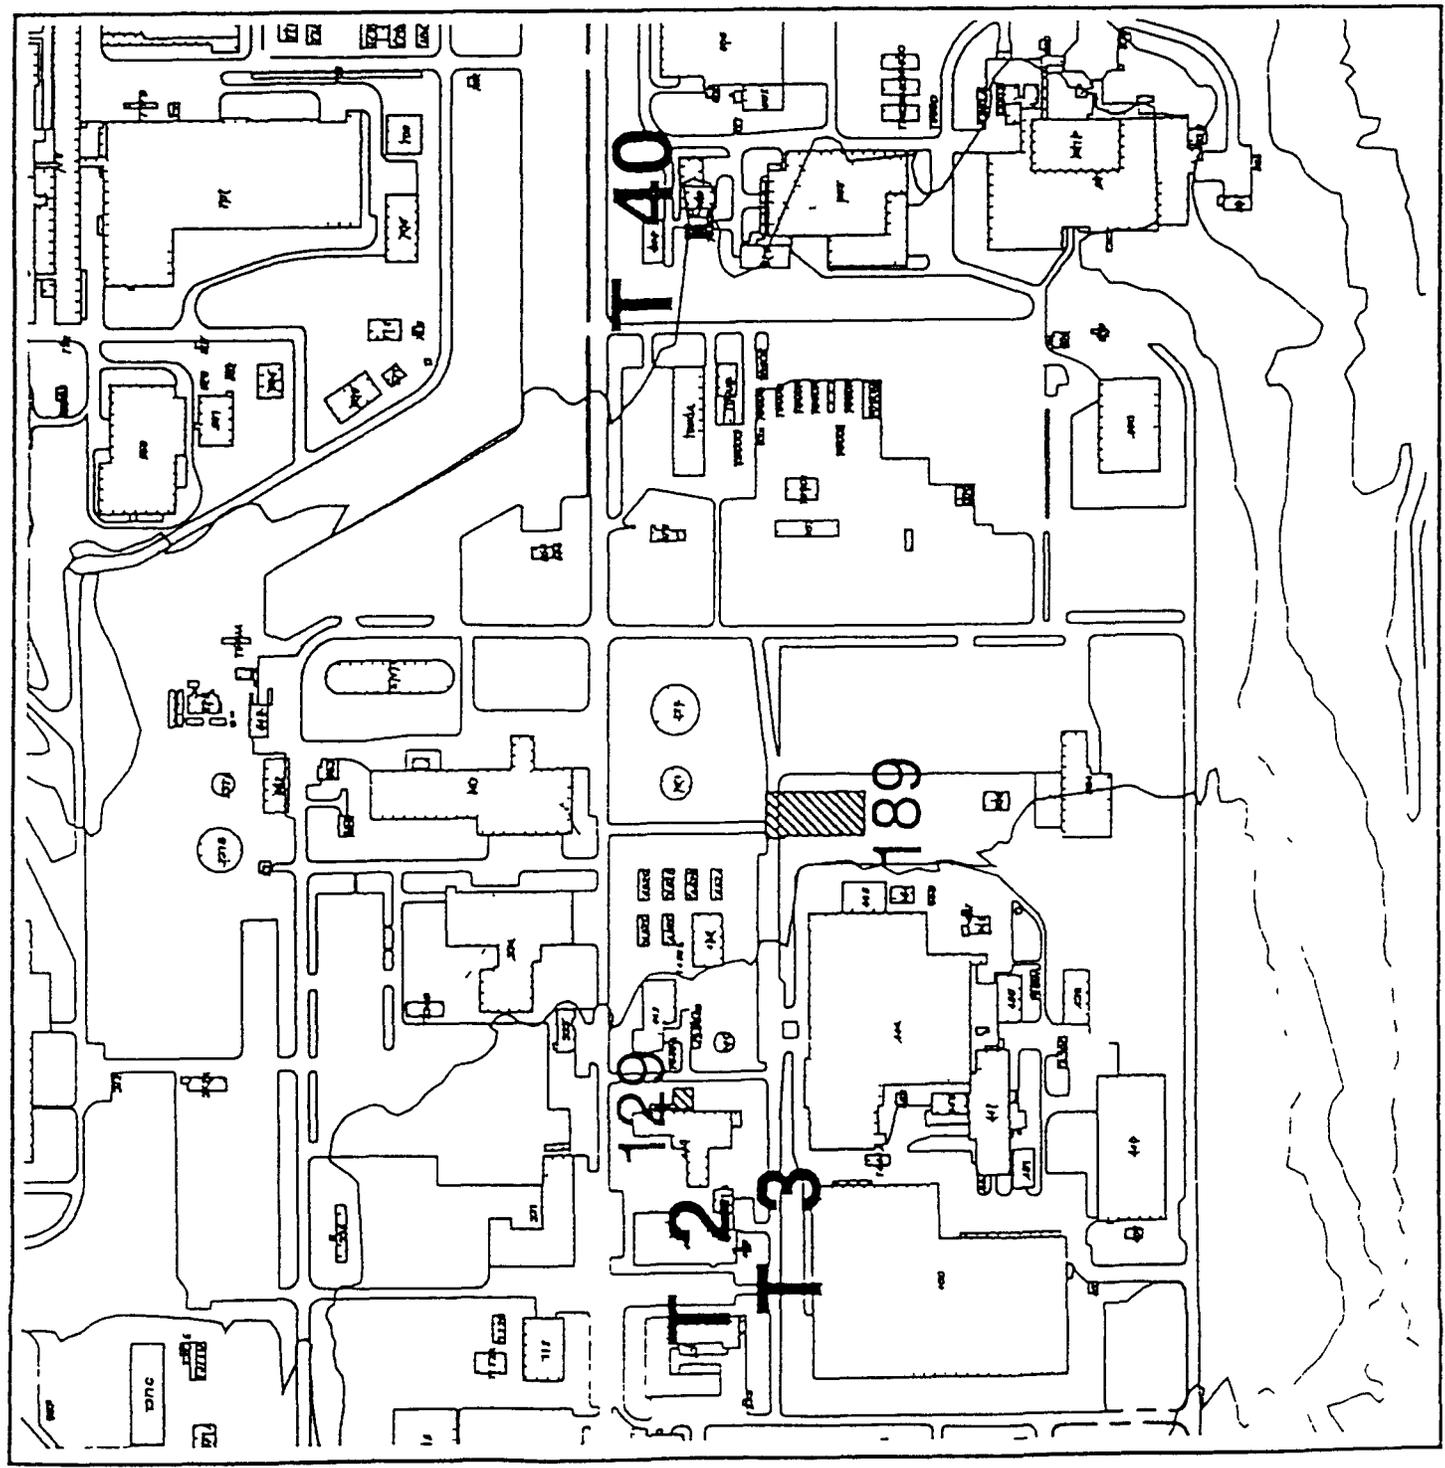
**FACT SHEET FOR TOP 20 ENVIRONMENTAL SITES
IHSS 121 TANK T-40**

Location: Tank unit T-40 is located in the 800 Area west of building 889

- T 2 Tank Locations and Labels
- 189 IHSS Locations and Labels
- Buildings

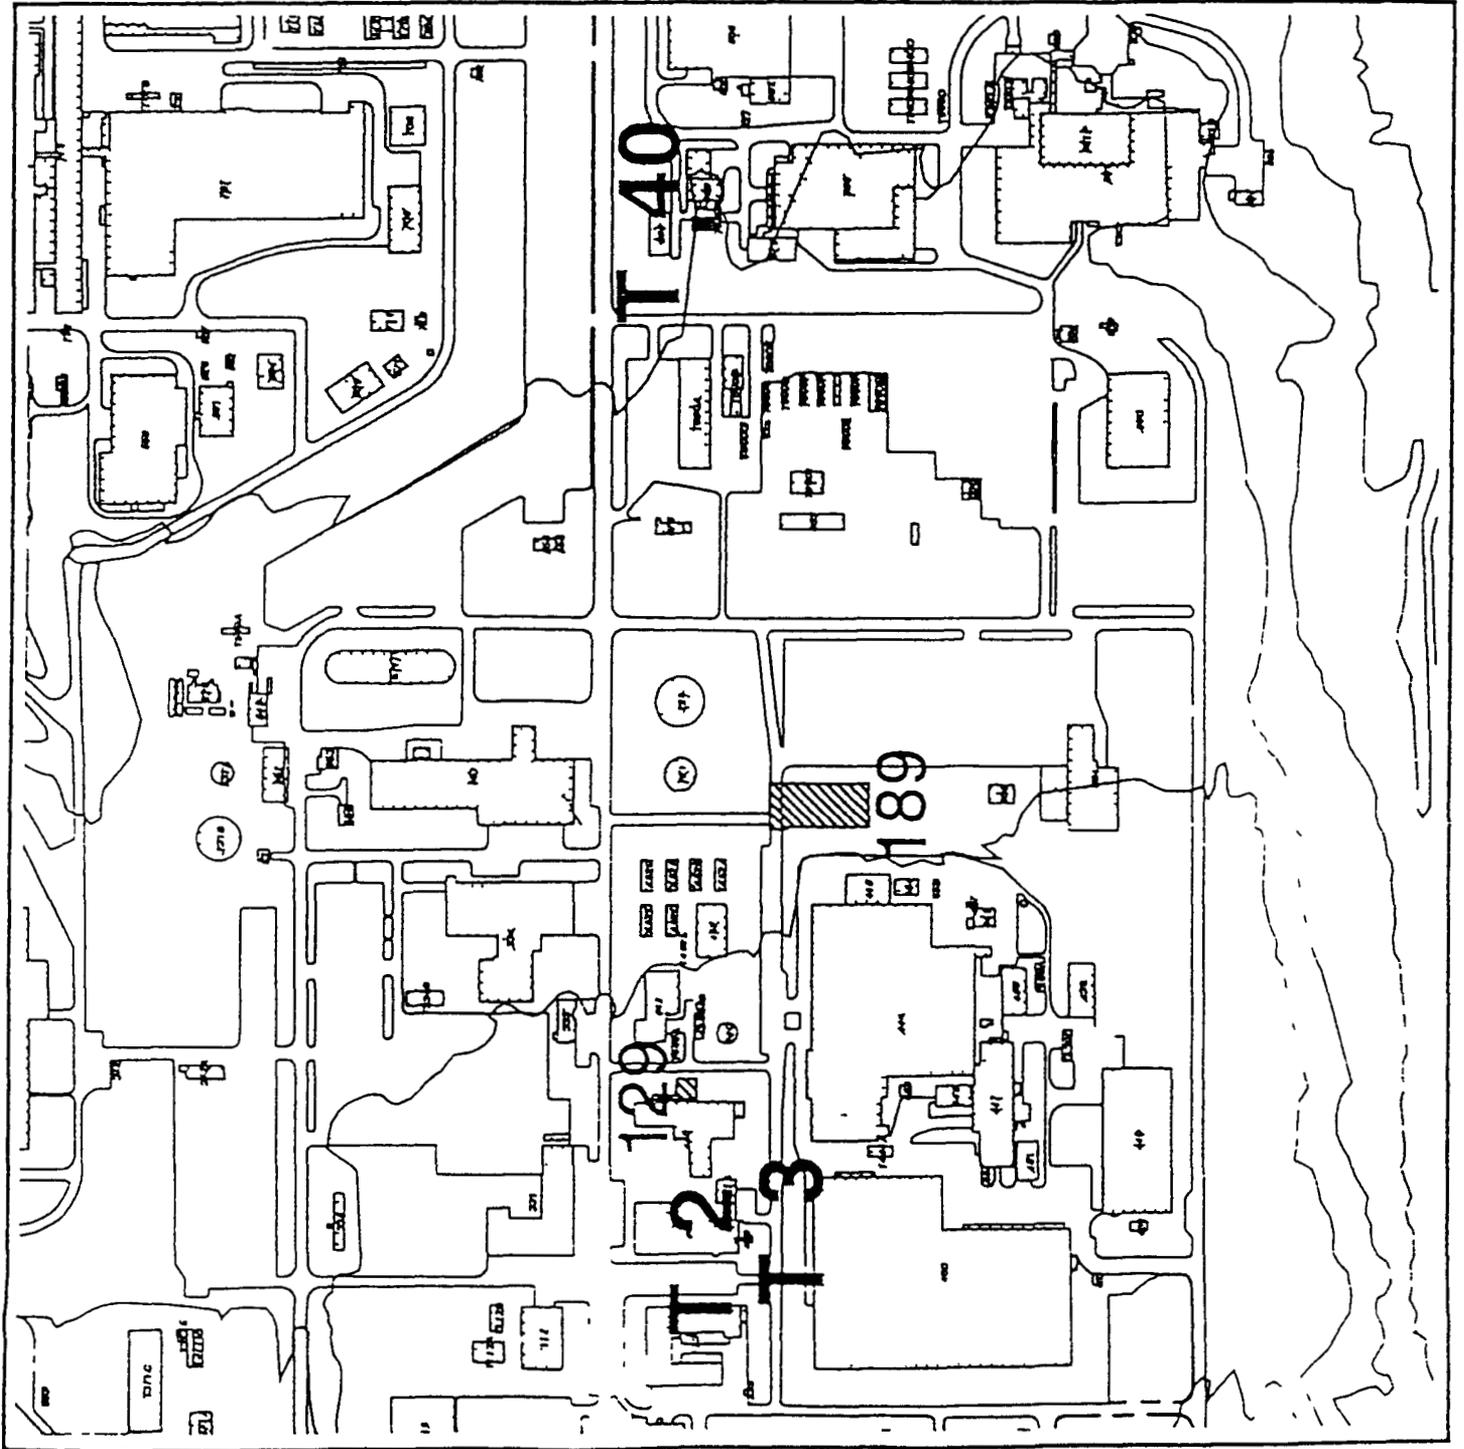
**FACT SHEET FOR TOP 20 ENVIRONMENTAL SITES
IHSS 189, NITRIC ACID TANKS**

Location: IHSS 189 Nitric Acid tanks are located to the northeast of Building 444. This area is also referred to as the acid receiving area.

Description: The acid tanks found in IHSS 189 consist of two, approximately 10,000-gallon storage tanks, adjacent to the railroad tracks east of Building 444, south of Cottonwood Avenue. The tanks have been used to store nitric acid since 1952, supplying acid to Buildings 771 and 883. The tanks are installed within concrete secondary containment structures. Over the years, numerous spills of unknown volumes occurred during filling and transfer of acid from these tanks.

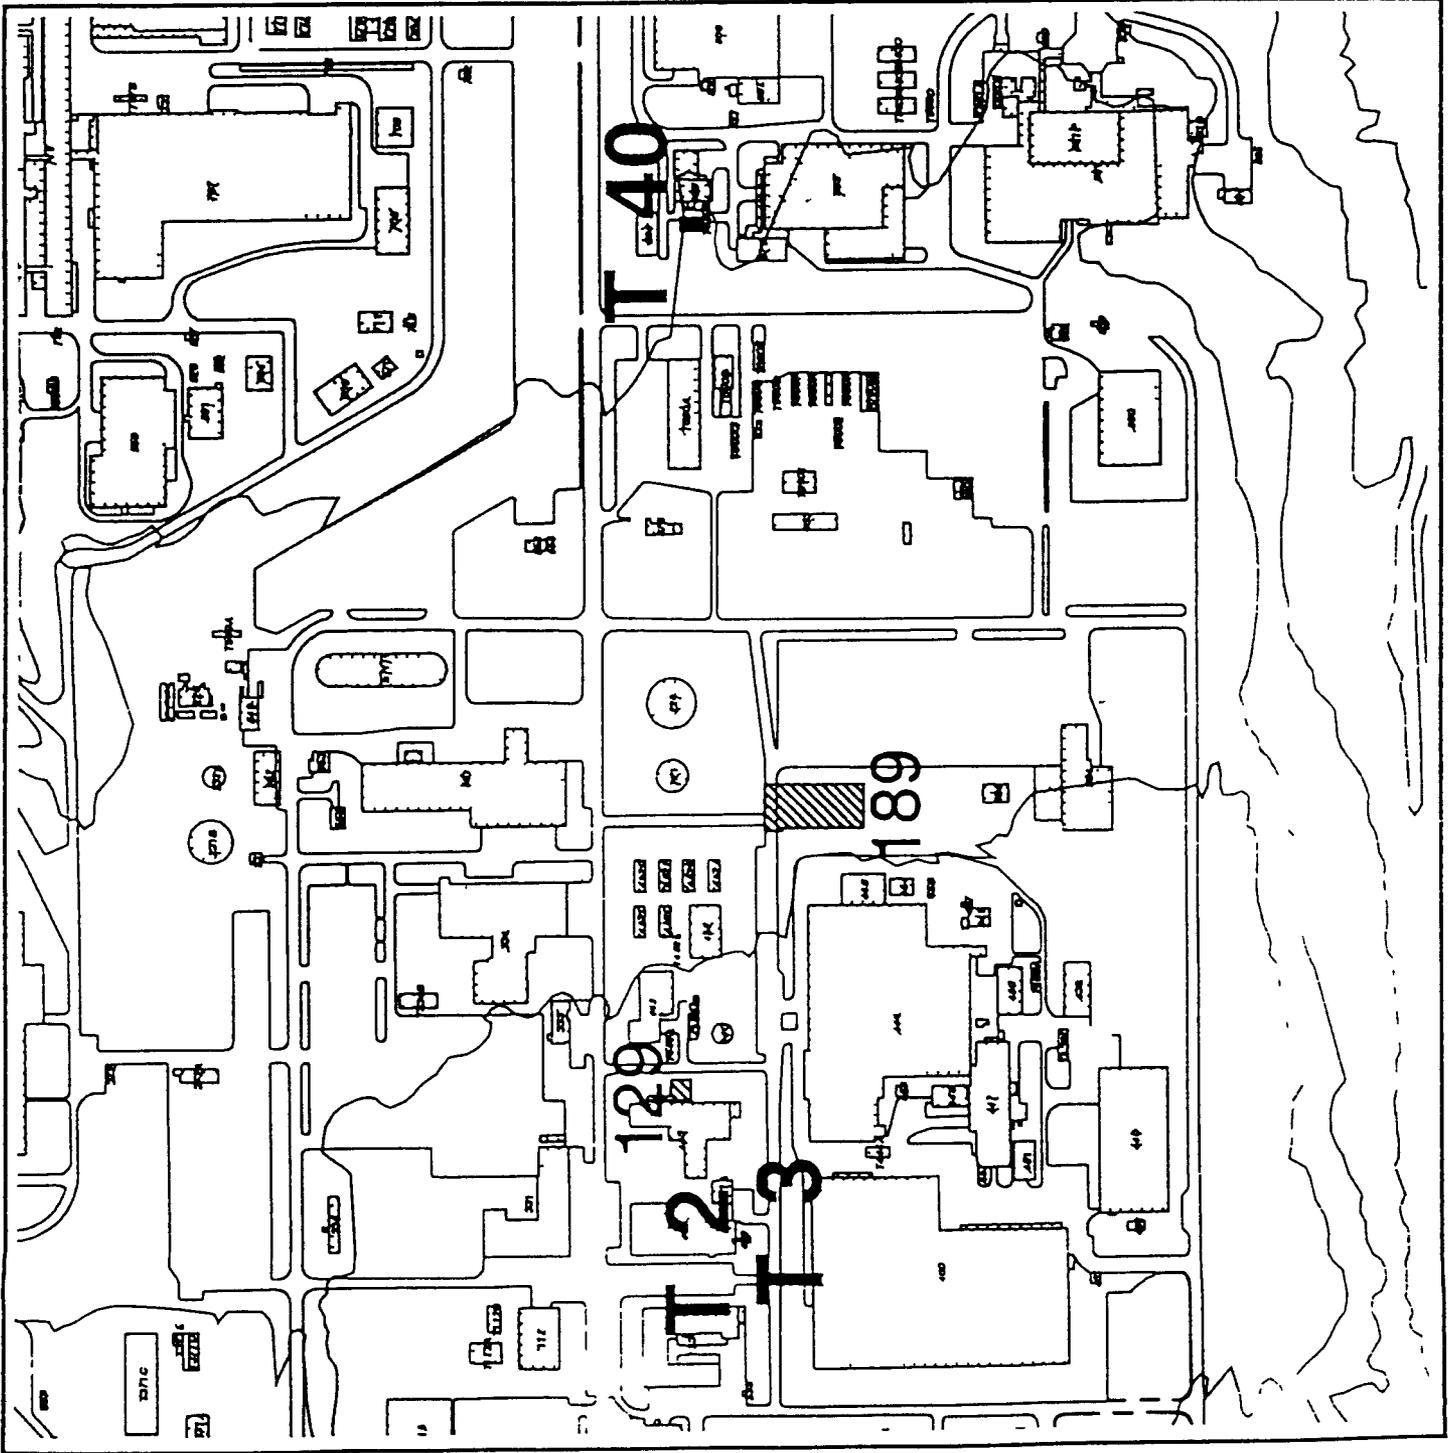
**FACT SHEET FOR TOP 20 ENVIRONMENTAL SITES
IHSS 129 - OIL LEAK**

Location: This IHSS is located on the east side of Building 443, Steam Plant

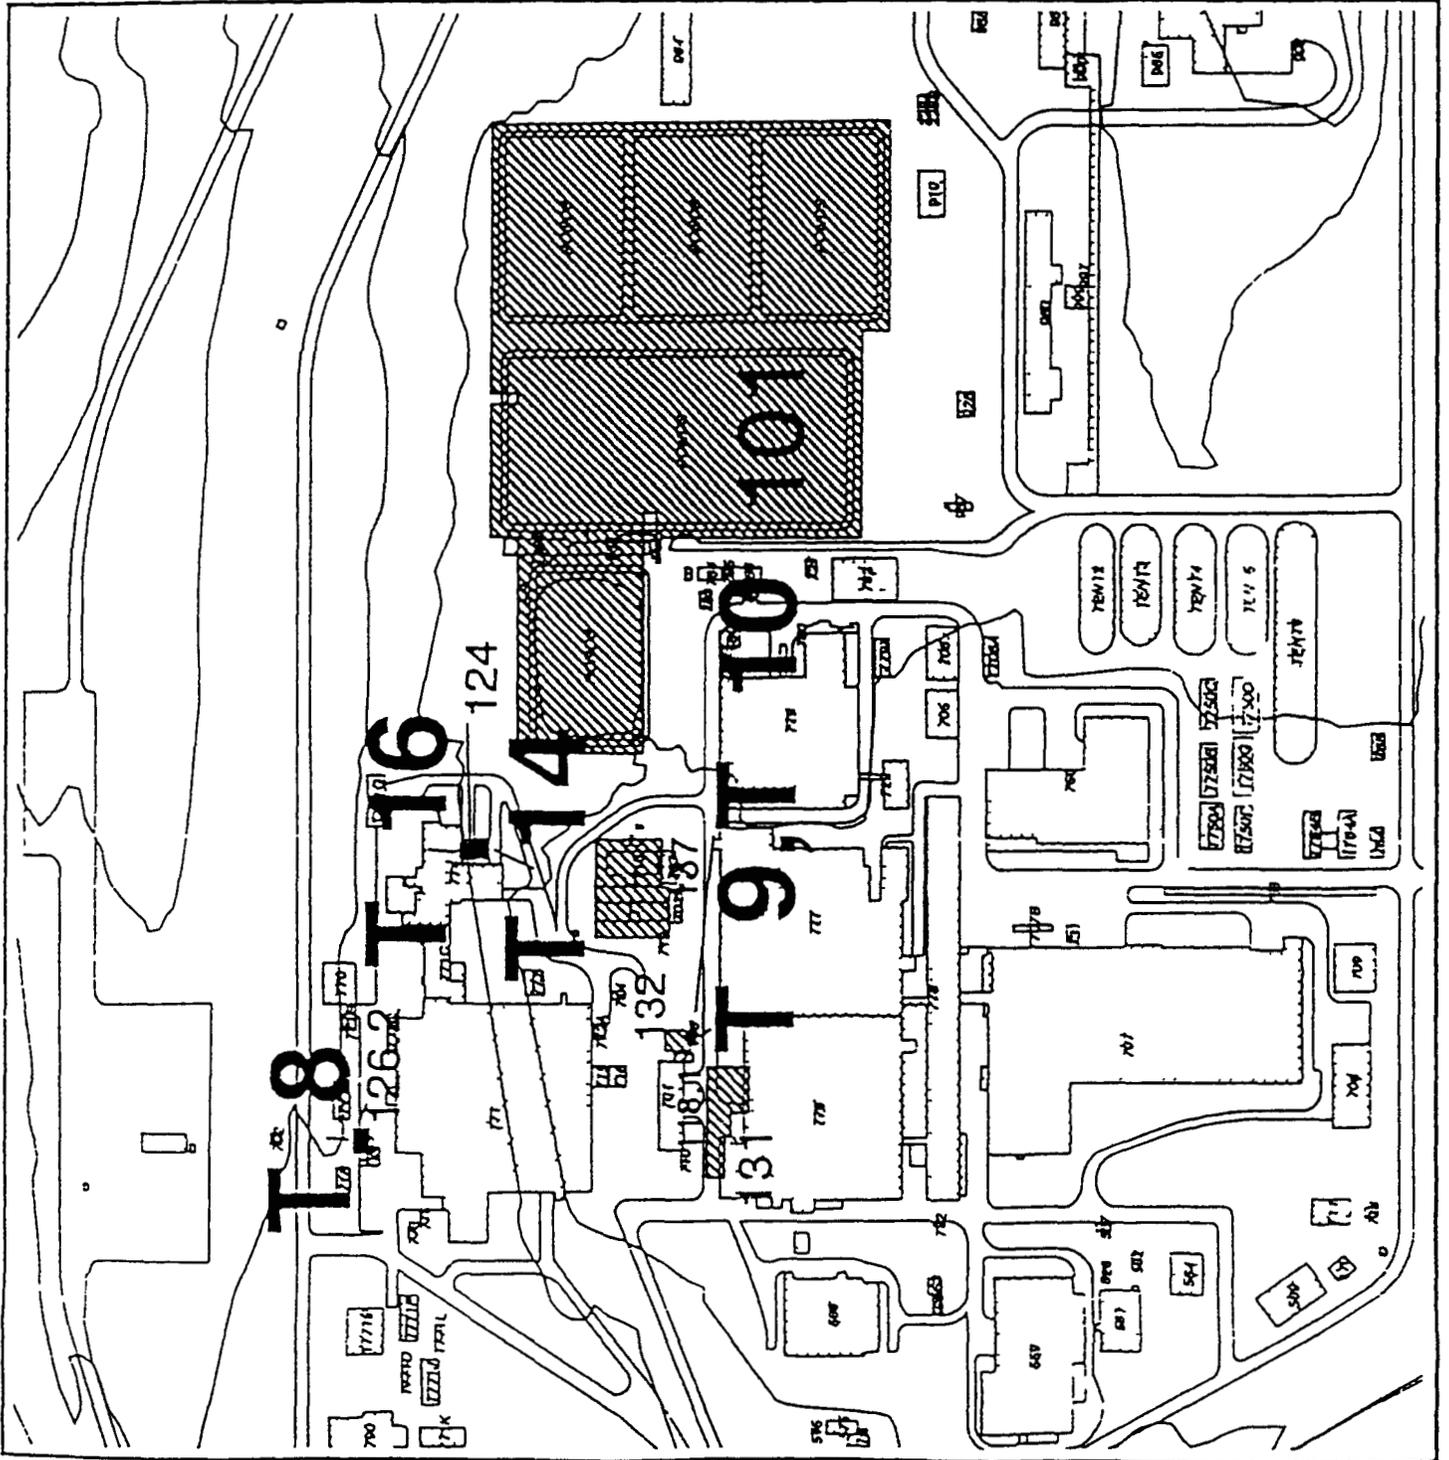
**FACT SHEET FOR TOP 20 ENVIRONMENTAL SITES
IHSS 121, 124.1, 125, PROCESS WASTE TANK T-16 N**

Location: Tank T-16 is in the 700 Area on the east side of Building 774 and underlies a chemical storage tank. It is physically connected to tank T-14 which should be remediated and closed at the same time.

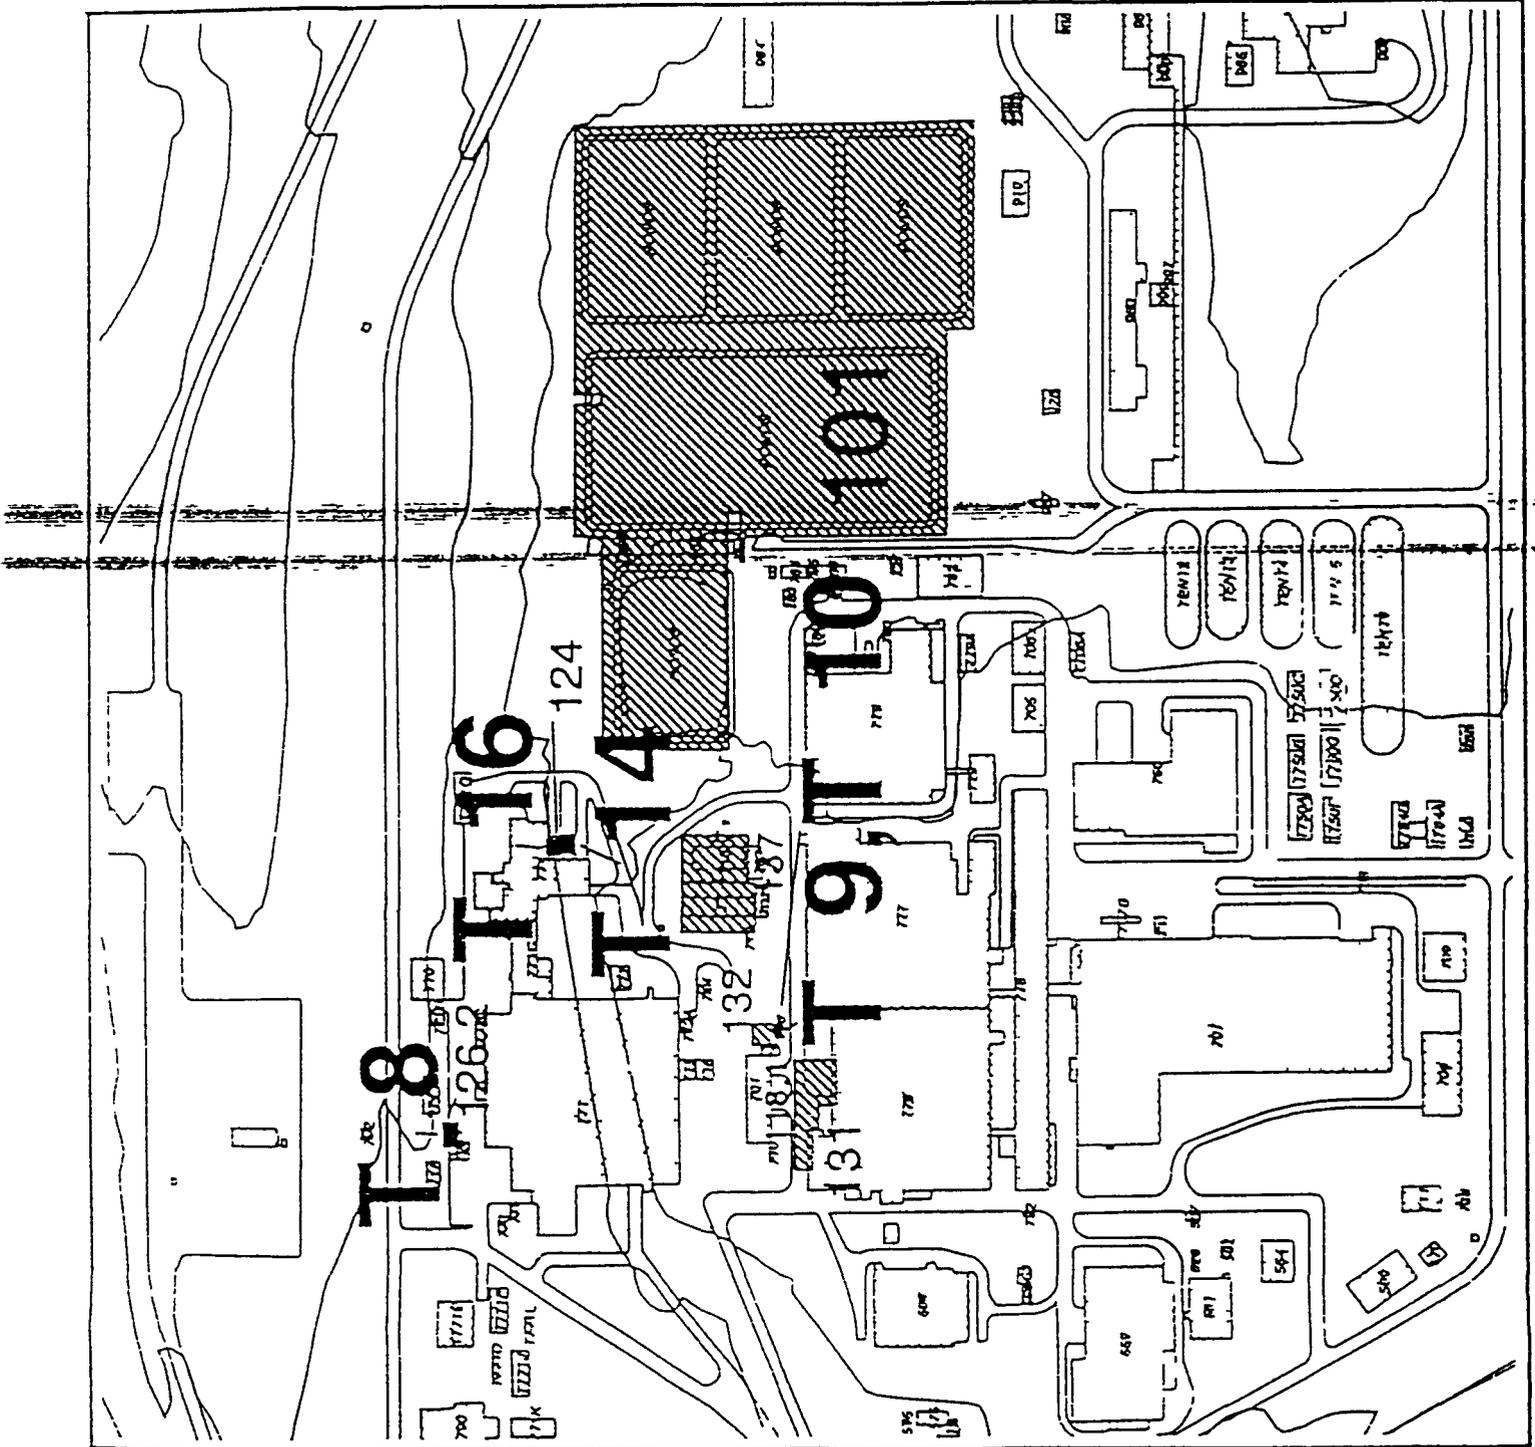
**FACT SHEET FOR TOP 20 ENVIRONMENTAL SITES
IHSS 121, 124.3, PROCESS WASTE TANK T-14**

Location: Tank T-14 is in the 700 Area on the east side of Building 774 and underlies a chemical storage tank. It is physically connected to tank T-16 which should be remediated and closed at the same time.
