2007 U. S. Fish and Wildlife Service Biological Opinion Annual Mitigation Monitoring Reports for the Rocky Flats Site

2007 Phytoremediation Project Report for the Rocky Flats Site

**Preble's Meadow Jumping Mouse Mitigation Monitoring Report for the
Phytoremediation Project at the Rocky Flats Site
2007 Annual Report
Biological Opinion: ES/LK-6-CO-05-F-014 (June 16, 2005)**

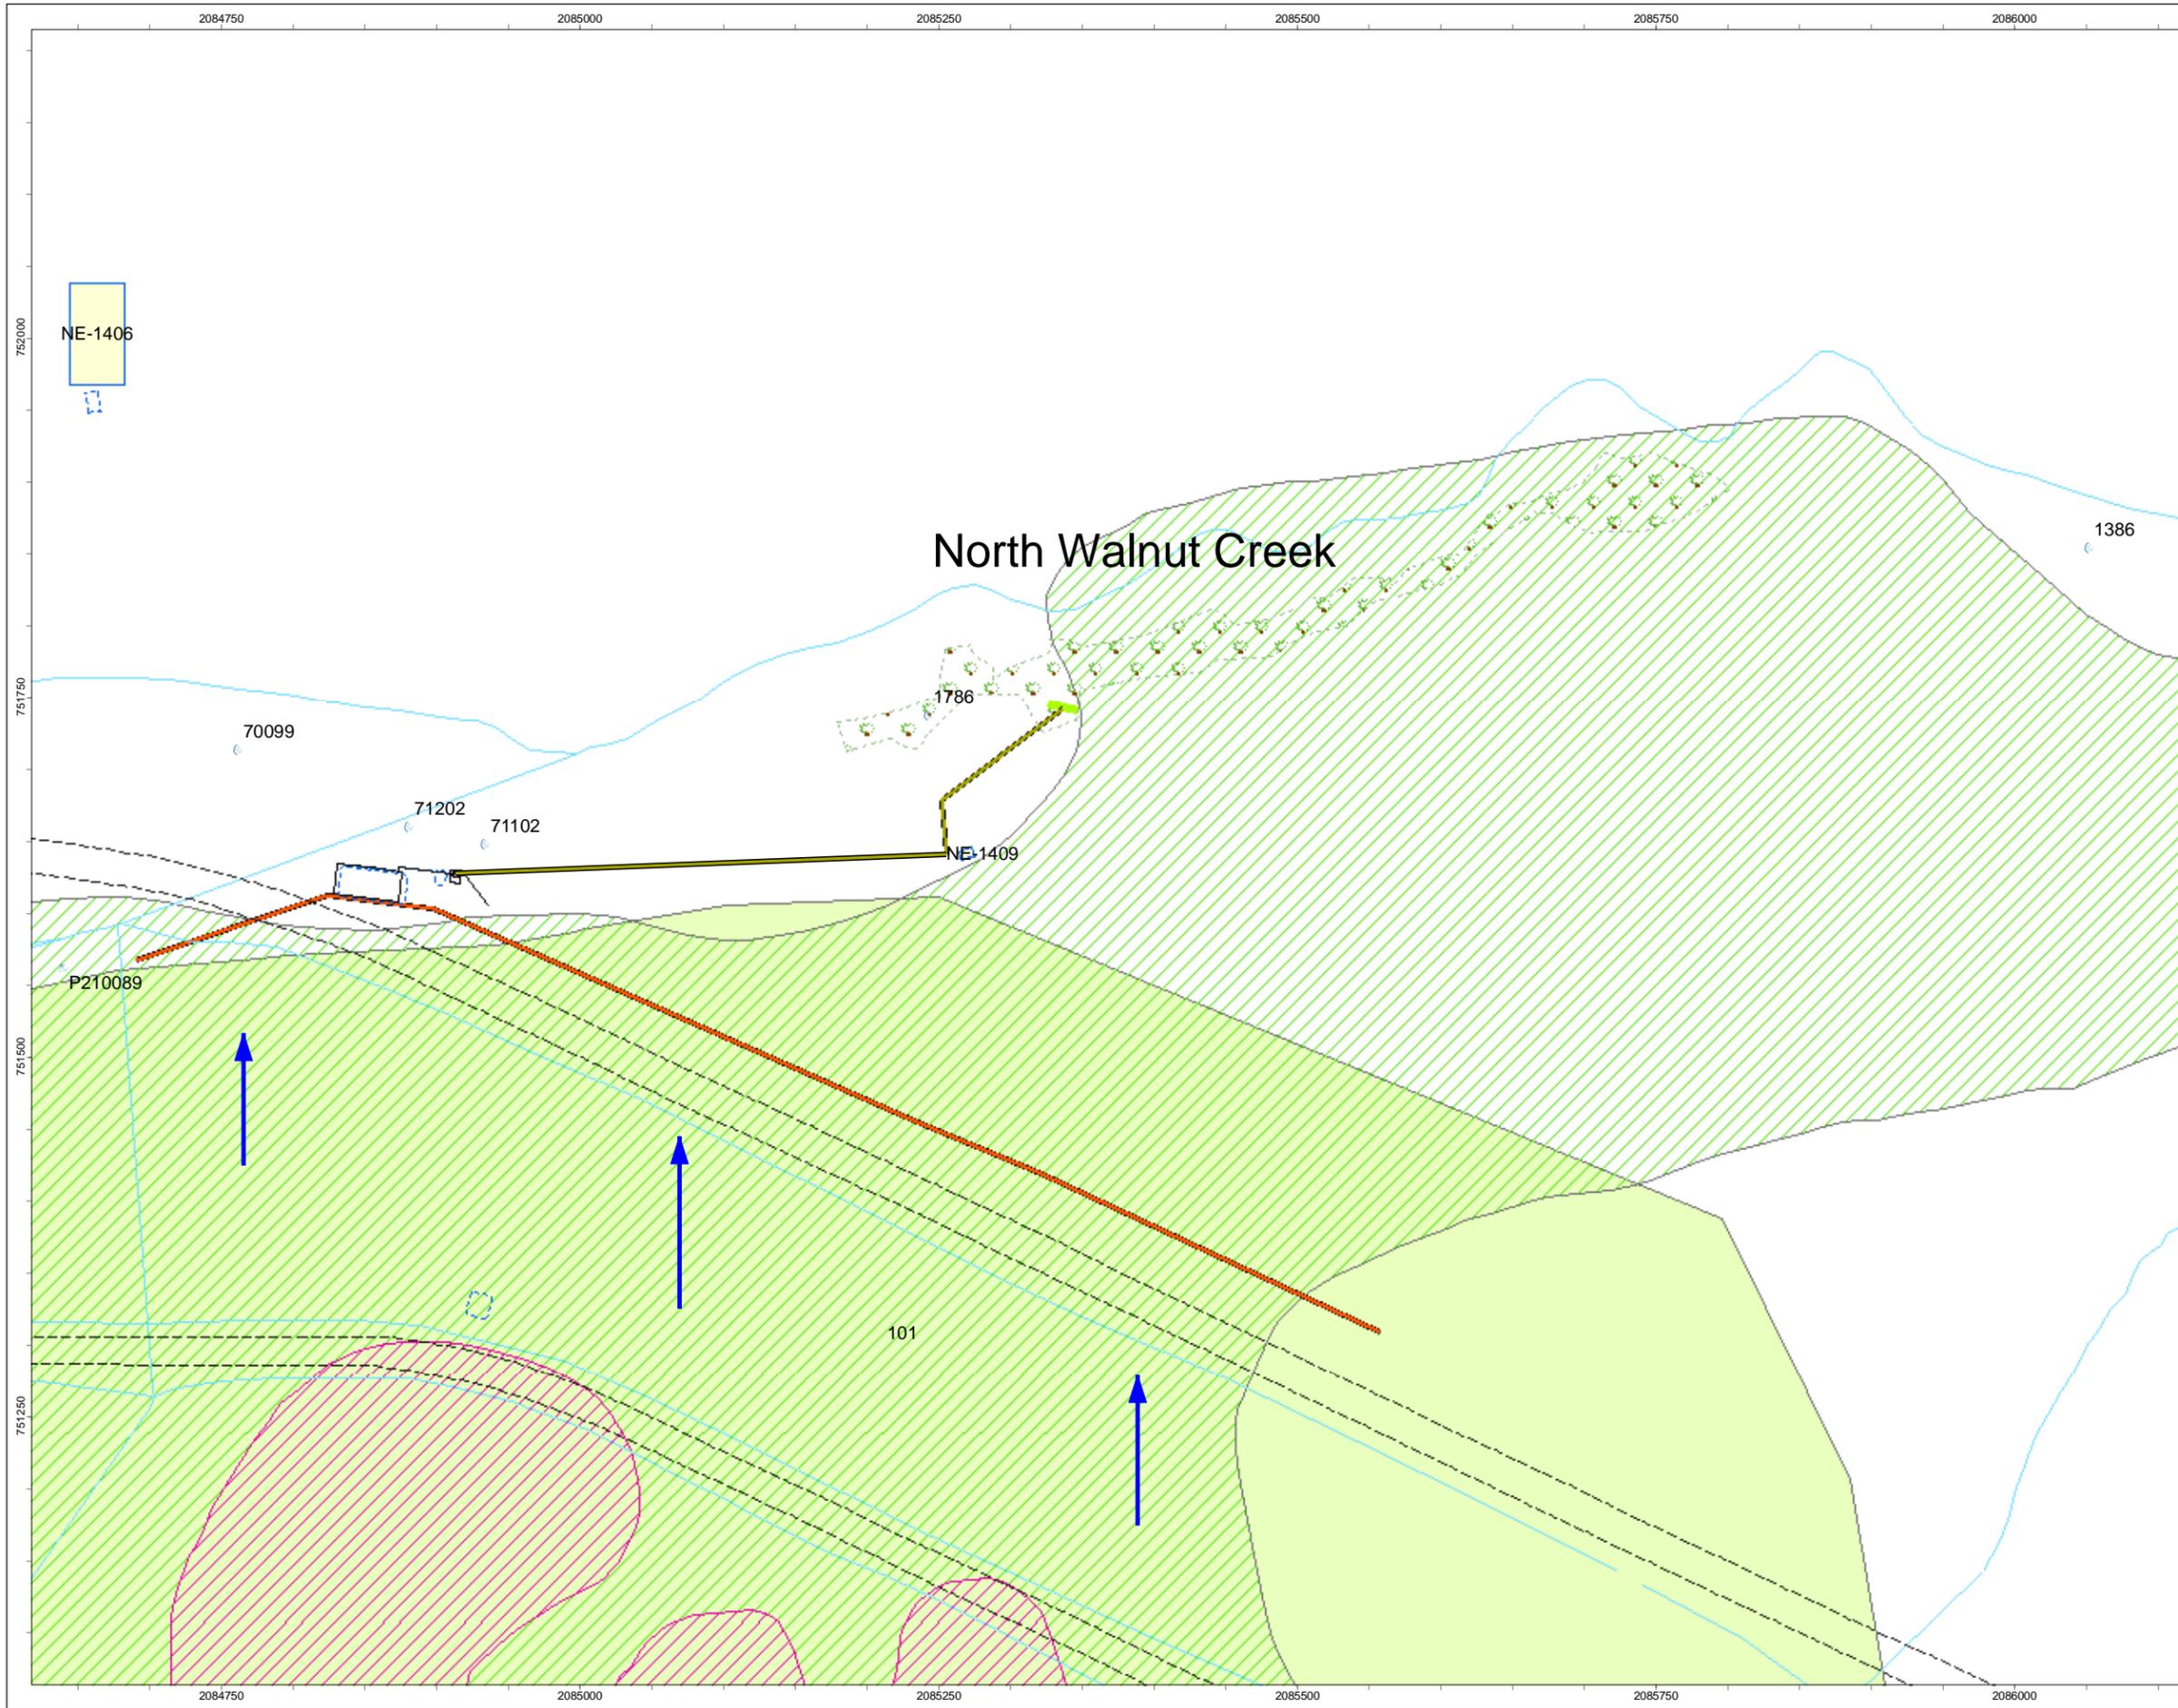
Figure 1

**Proposed
Phyto-remediation
Enhancement of
Groundwater Quality
at the Solar Ponds Plume**

- GW Flow Direction
- Groundwater Wells
- Discharge Gallery
- Transmission Pipe
- Treatment Cells
- Collection Trench
- Individual Hazardous Substance Site
- Potential Area of Concern
- No Further Action PACs in 1992
- Under Building Contamination
- Nitrate Plumes**
- >Tier I GW AL
- >SW Standard
- Proposed Phyto-remediation
- Standard Map Features**
- Road
- Facility
- Pond
- Stream or Drainage Feature

The locations of the Phytoremediation Project at the Solar Ponds Plume area and East Trenches Plume area are shown on Figures 1 and 2, respectively. At the Solar Ponds Plume area, the concept was to intercept groundwater flows from the south before they reached North Walnut Creek. At the East Trenches Plume area, the purpose was to intercept the groundwater flows along the south side of the B-Ponds before they reached the ponds (i.e., South Walnut Creek). Planting was conducted in early May 2005 and was completed within a week. Final application of a soil enhancement product was made in late May 2005. Plant materials came from nearby native sources in Jefferson and Boulder Counties. At the Solar Ponds Plume area in North Walnut Creek, a total of 770 plants (stakes) were installed: 435 coyote willows and 335 cottonwoods. All of the cuttings were soaked in a root dip product (described below) and inserted into a 12- to 18-inch deep hole punched into the ground with a long, pointed steel piercing implement. The planting hole was sealed by a footstep or another plunge with the implement to ensure proper planting. At the East Trenches Plume area along Ponds B-1, B-2, and B-3 in South Walnut Creek, a total of 760 plants were planted. At Ponds B-1 and B-2, a total of 475 plants were installed: 158 willows and 317 cottonwoods. At Pond B-3, 115 willows and 170 cottonwoods were planted for a total of 285 plants. Planting techniques at the East Trenches Plume area were the same as the Solar Ponds Plume area, however, some plantings were doubled up in their planting holes to ensure survival of at least one cutting and to gain extensive localized growth. Because the planting area along the B-Ponds was steeply sloped and located in a very short transition zone from wetter soils at the pond edges to the drier adjacent upland soils, the planting strategy was to install the cuttings closer together in wet areas, and space them farther apart in dry areas.

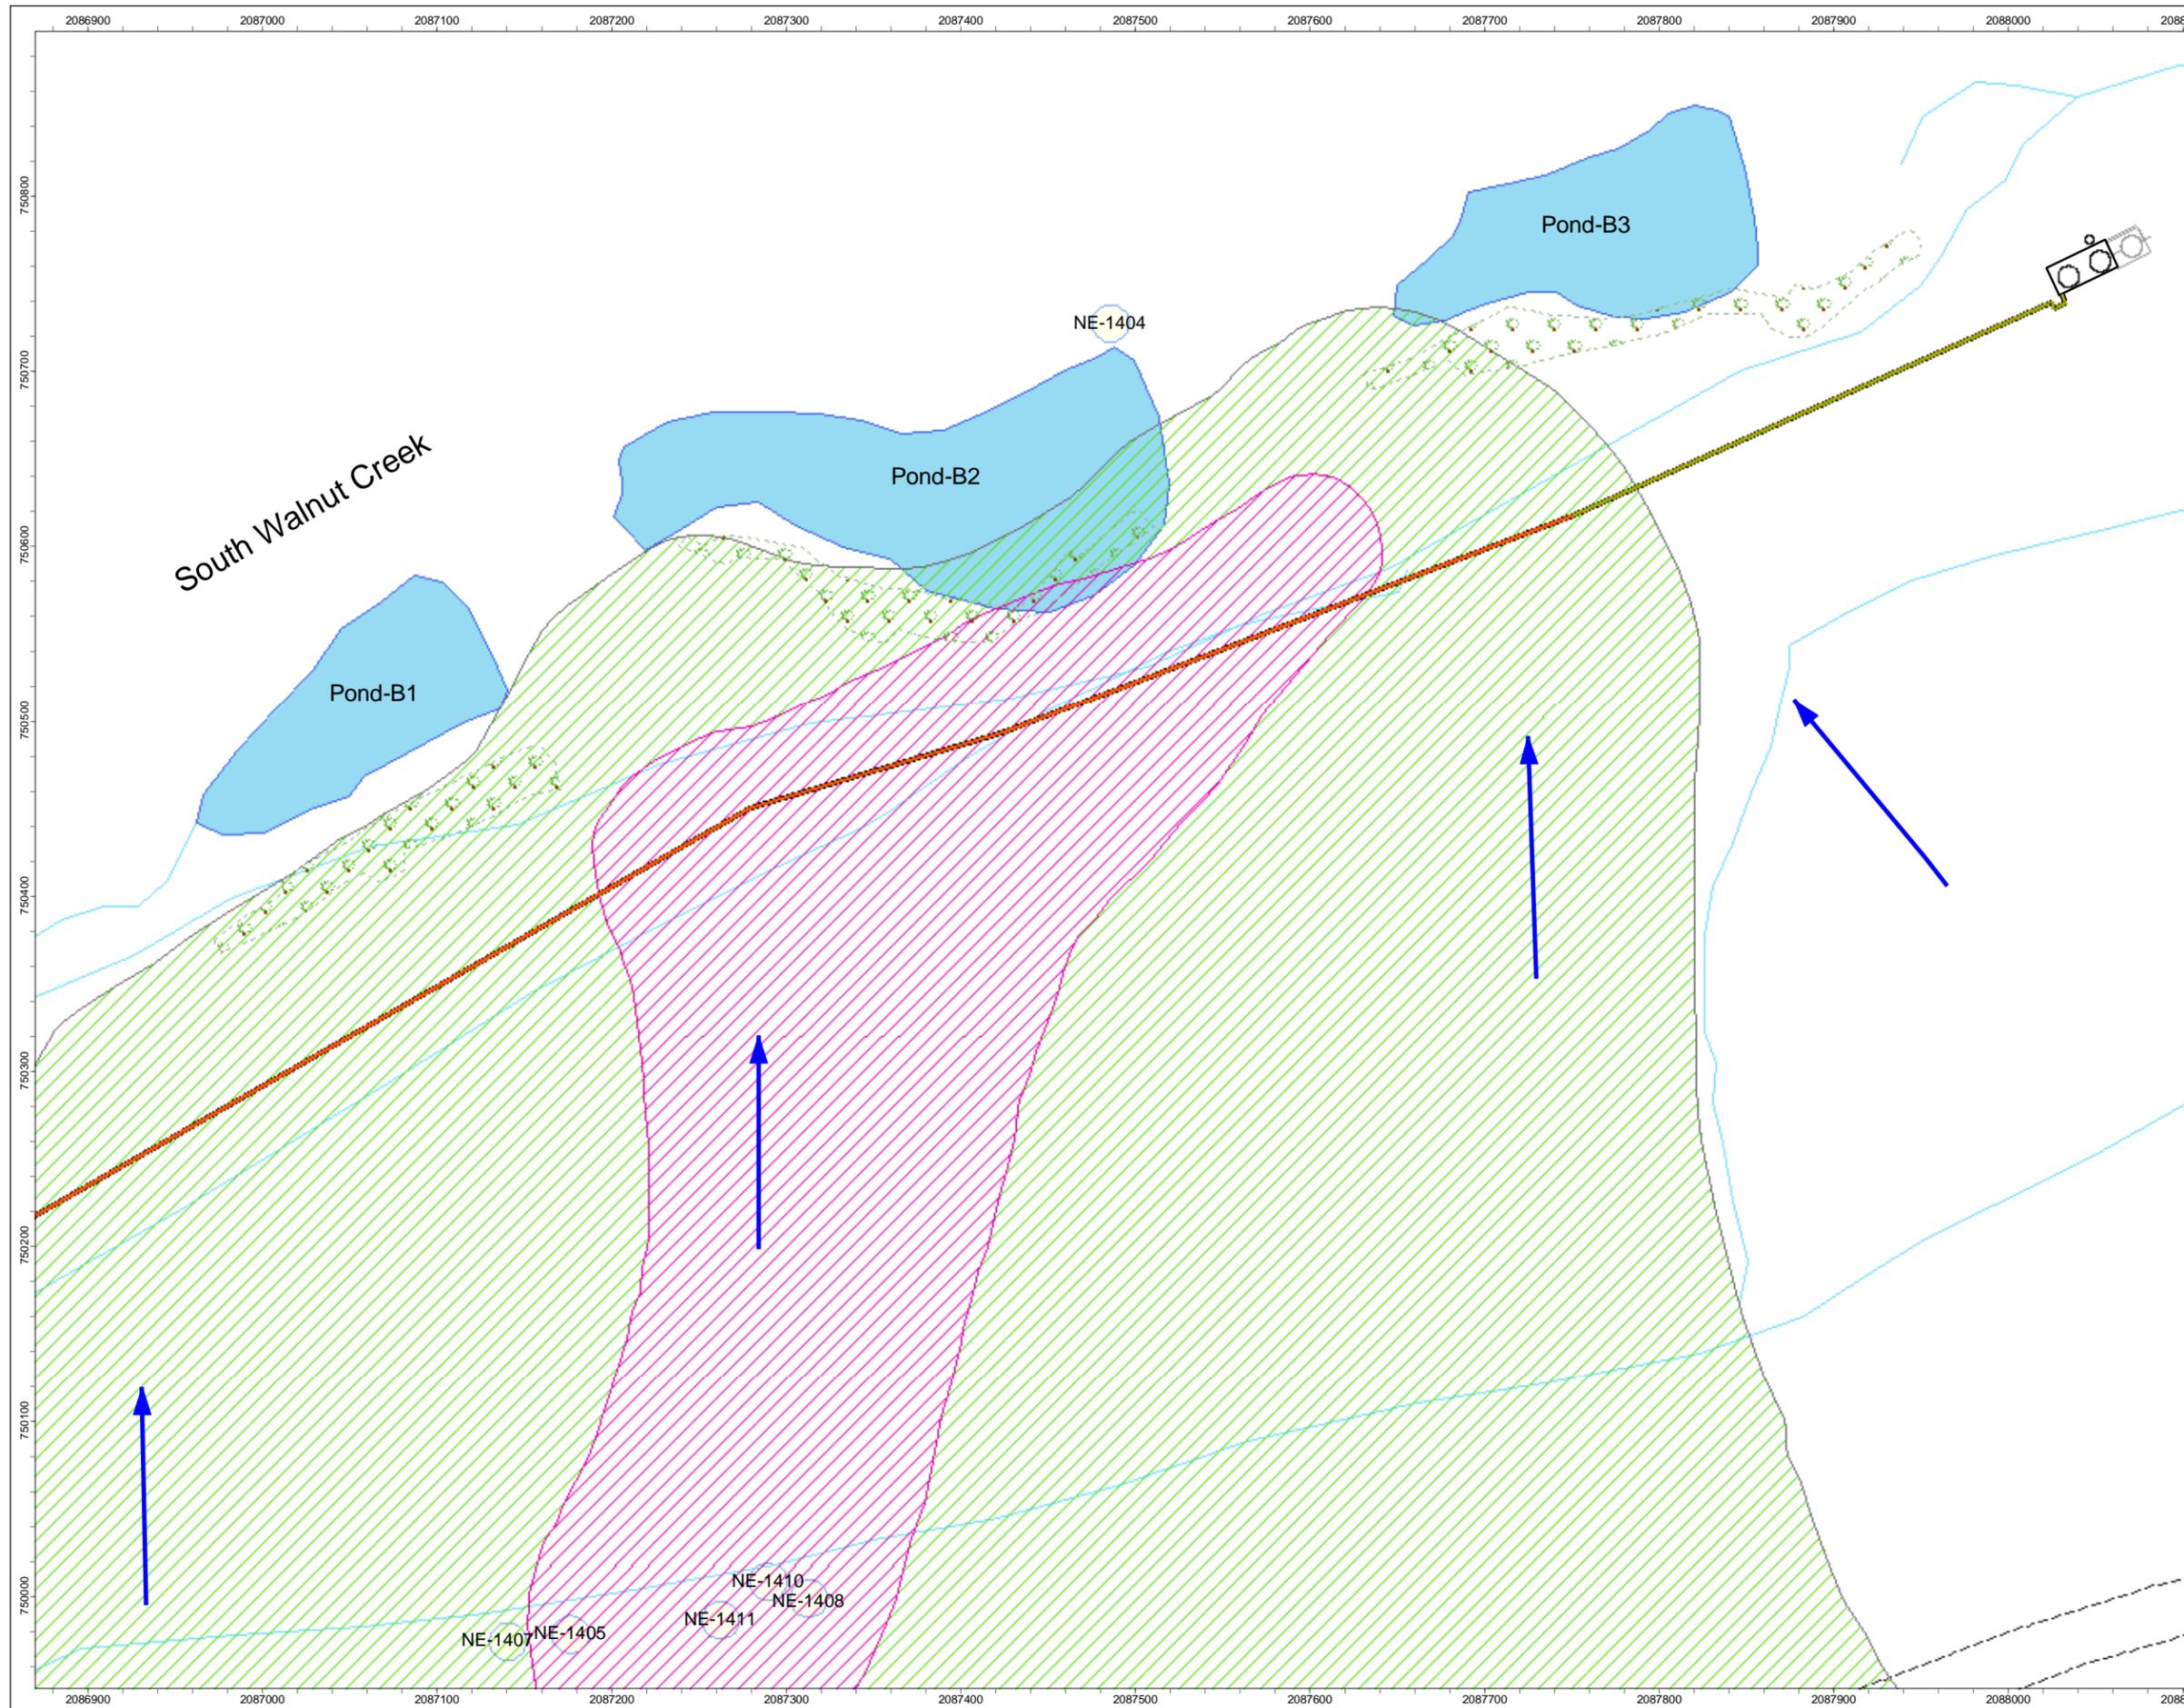
Figure 2

Proposed Phyto-remediation Enhancement of Groundwater Quality at the East Trenches Plume

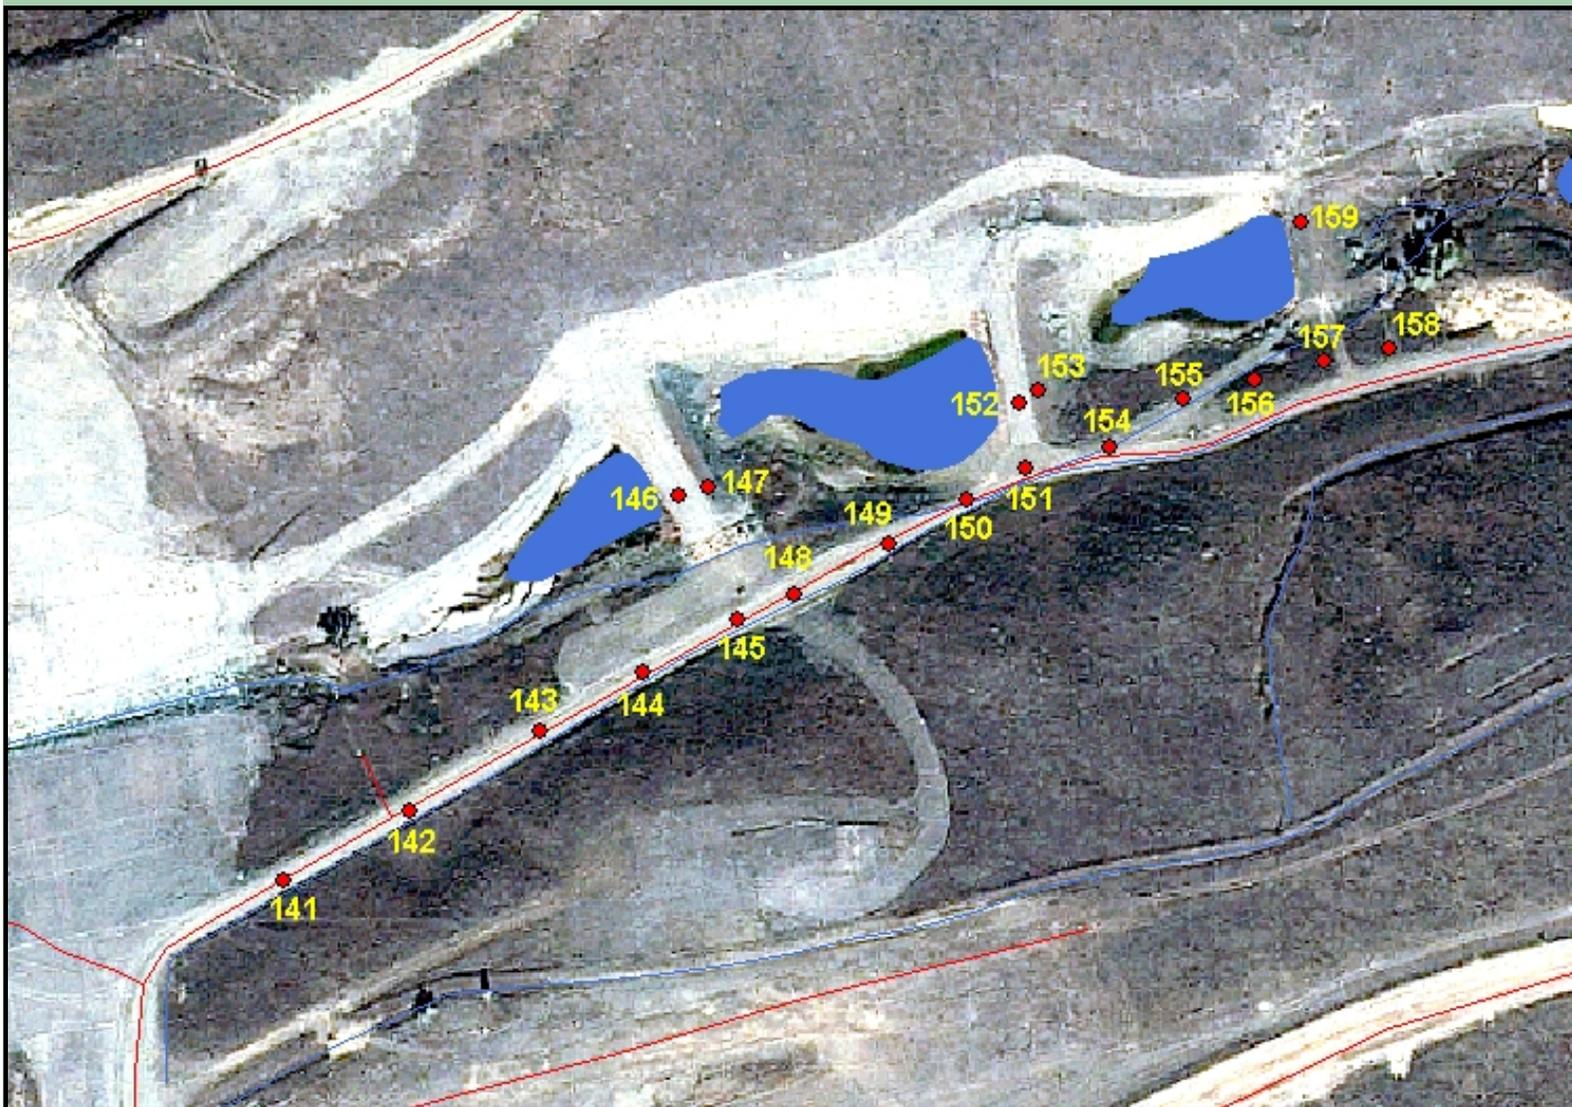
(Clicking on any photopoint on the maps will take you to the corresponding monitoring photos, then clicking on any photo will enlarge that photo)

East Trenches Plume Treatment Area

At the East Trenches Plume area, plants were originally installed in 2005 along the southern edges of Ponds B-1, B-2, and B-3 ponds after completion of the pond remediation activities. The success rate for survival of the coyote willow planted in 2005 at Pond B-1 was approximately 60% at the end of the first growing season, while none of the plains cottonwoods survived at this pond. By August 2006, none of the plantings installed in 2005 had survived at Pond B-1 due to the drought conditions; however, along the south edge of the pond where coyote willow was present prior to the cleanup activities, a large amount of regeneration from the rootstock had occurred. In spring 2006, an additional 110 coyote willow stakes were planted on the bottom of the Pond B-1 wetland area along the stream and oxbow areas on the southern side of the pond. By August 2006, only 30 coyote willow stakes planted earlier in spring 2006 were still surviving. The loss of 2006 planted materials was due primarily to the lack of water in the pond resulting from the drought. In 2007, the above-average precipitation received during winter and spring filled the pond completely. Water remained throughout much of the summer and hence drowned the plants that had survived on the bottom from 2006. No new plants were installed on the south side of Pond B-1 in 2007. The coyote willow stand that had originally been growing along the south side of Pond B-1 pond prior to the cleanup project has grown back completely and was 5–7 feet tall in 2007.

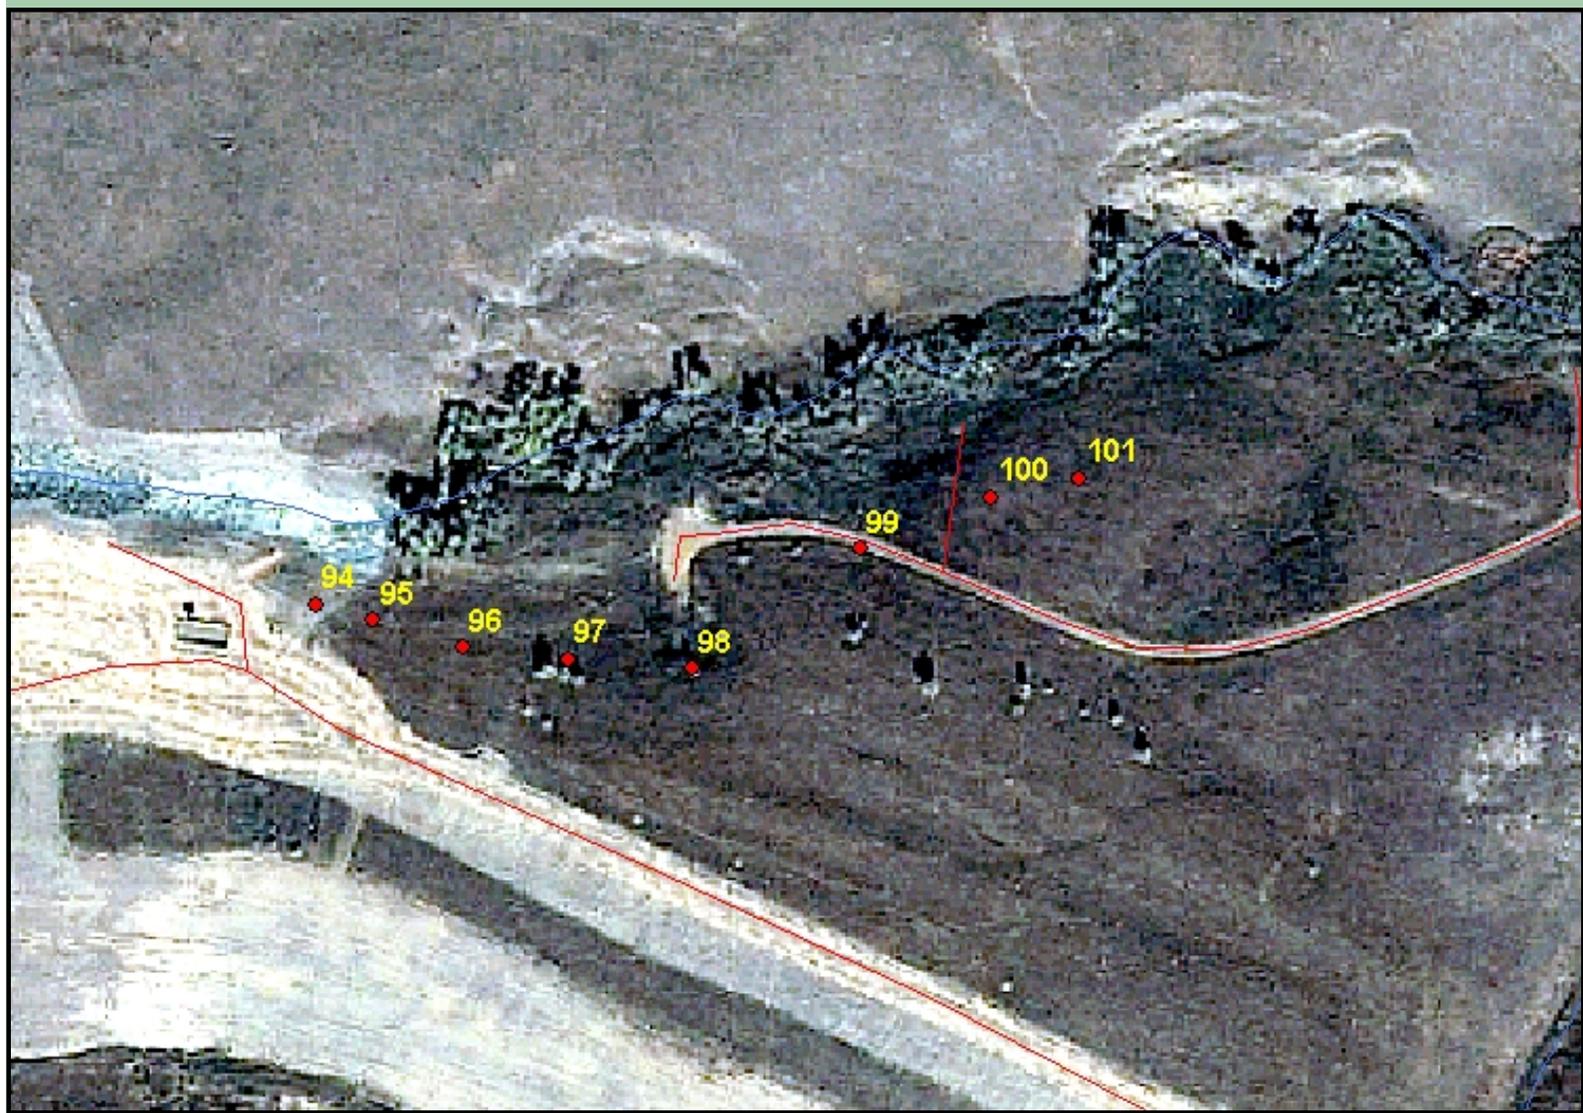
Solar Pond Plume Treatment Area

In 2007, abundant winter and spring moisture caused a large flush in the growth of the smooth brome grass around the Solar Ponds discharge gallery. The height of the smooth brome in the surrounding area made observation and counts of the planted willow difficult. There may have been some additional plants that were not observed and counted because they could not be found in the dense stand of smooth brome. The coyote willow planted in 2007 ranged from two to five feet tall in late August and seemed to be well established along the tire ruts where water was flowing. It is expected that these willow will continue to expand and fill in along tire ruts. Photomonitoring results are shown in Appendix A on the CD-ROM.
