Memorandum

Subject: **2009 Annual Survey**

MMG conducted the comprehensive annual survey at the Dr. Modesto Iriarte Technological Museum (former BONUS Facility) during the dates of 31 August – 3 September 2009 with support from PREPA personnel. Due to inclement weather, completion of the survey was delayed until PREPA personnel could return to the facility and perform masslin smears on 8 December 2009. This survey was conducted in accordance with the Sampling and Analysis Plan (SAP) for the BONUS Facility prepared by the U.S. Department of Energy (DOE) (or DOE contractor) as amended by a 16 January 2001 Memorandum from Webb to Alvarado. The survey was also altered, as presented below in this report, in consideration of the covering of contamination areas/surfaces by paint and/or concrete, the shielding (concrete floor) placed on the Basement Level, the verification survey performed in January 2005 (refer to 22 February 2005 Memorandum entitled: *2004 Annual Survey and Verification Survey for Basement Floor*), and subsequent annual surveys. This report is organized in accordance with Section 6.2 of the SAP. The sampling and inspection results are discussed below.

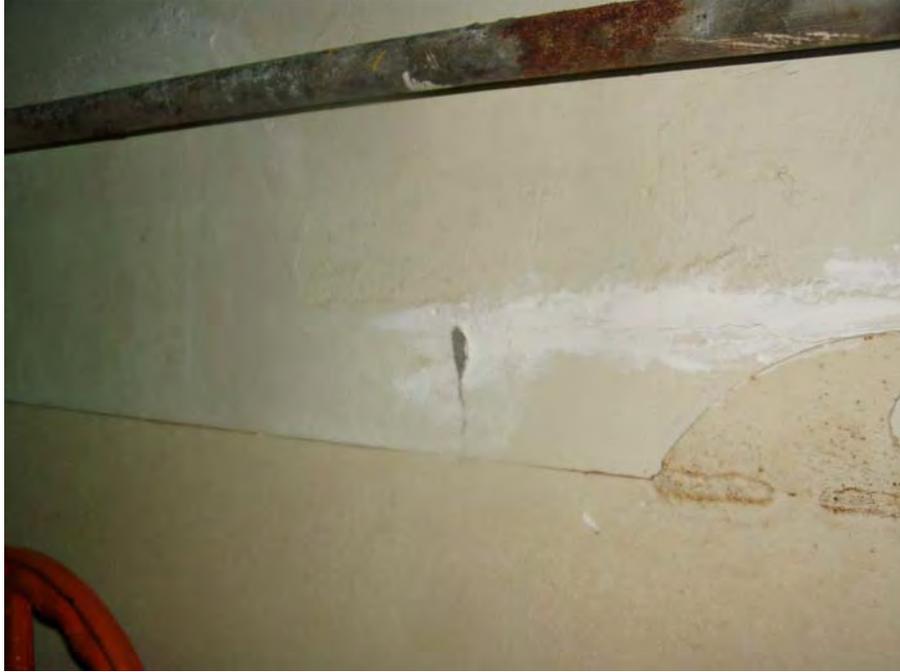
Figure 1. Entombment Top (North Side) – Surface Cracks (Typical)

Dome-Entombed Concrete Monolith and Monolith Penetrations: Inspection of the Concrete Monolith area revealed superficial cracks throughout the surface of the structure (same as in previous surveys - refer to Attachment 1 Photos, Figure 1). Superficial cracks are also present along the base of the “top plug” of the concrete monolith top (Attachment 1, Figure 2). All dose rate measurements taken around the structure were not significantly different from background measurements taken. No immediate action is necessary.

- Concrete Monolith: It is recommended that the Concrete Monolith Top be designated as a controlled area due to the presence of elevated fixed surface beta/gamma contamination levels. Marking/posting of this area is not required; however, administrative procedures should be in place to ensure that no intrusive (disturbing the Concrete Monolith surface) work is performed on this level without review and approval by the RCM. Job-specific RWPs may be required for any future intrusive work on the Concrete Monolith Top.

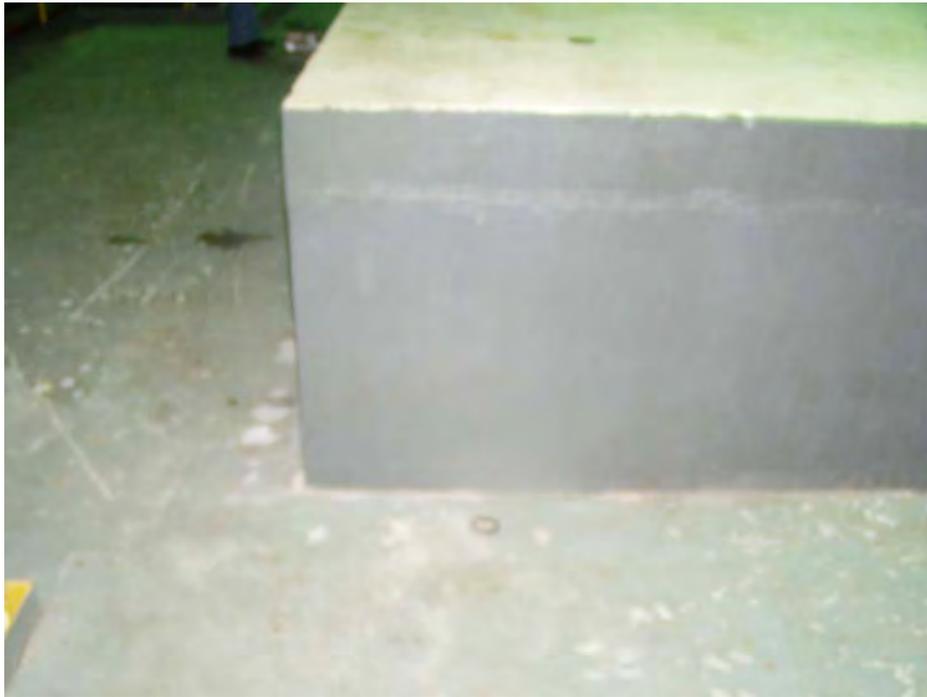
Figure 2. Entombment Top (Top Plug)

There are no radioactive Contamination Areas (as defined in 10 CFR 835) associated with the exterior of the Concrete Monolith structure. Smear samples were collected from the surface of the Concrete Monolith to assess transferable or removable surface beta/gamma contamination. None of the smear samples exhibited removable contamination above the minimum detectable activity (MDA). One survey location exhibited total surface contamination levels above the MDA. Survey location 9 had total surface beta/gamma contamination level of 1,084 disintegrations per minute (dpm)/100 cm². This value is well below the survey action level for total surface beta/gamma contamination (5,000 dpm/100 cm²). It is recommended that the Concrete Monolith Top be designated as a Controlled Area due to the presence of slightly elevated fixed surface beta/gamma contamination levels. Marking/posting of this area is not required; however, administrative procedures should be in place to ensure that no intrusive (disturbing the Concrete Monolith surface) work is performed on this level without review and approval by the RCM. Job-specific RWPs may be required for any future intrusive work on the Concrete Monolith Top.

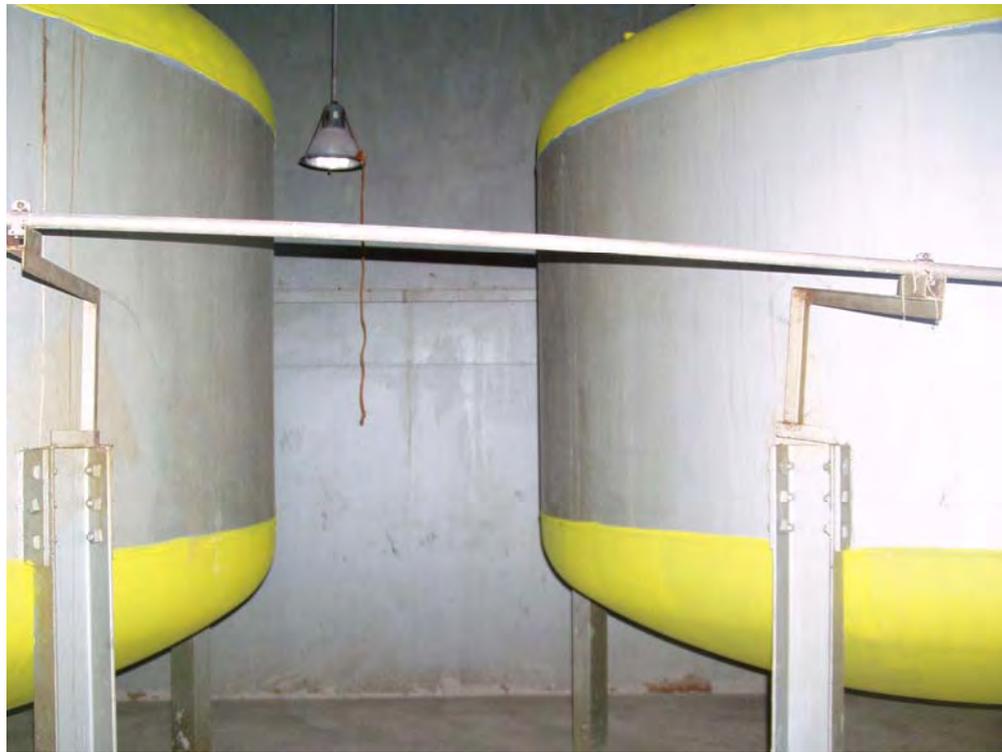
Figure 4. Basement Level – Retention Tanks 1 and 2

Dome-Basement Level: Corrosion is evident on all metal surfaces within approximately 6 in. of the floor, including contaminated surfaces. However, the concrete floor cover (installed in late 2004) covers all floor areas where surface contamination was present, which is preventing contact with previously accessible contaminated and corroding surfaces. Only surface fissures/cracks were noted in the concrete floor covering (refer to Attachment 1 Photos, Figure 8). Control measures (fixed with paint and thin concrete layer in some places), which were previously implemented, were inspected and do not require maintenance at this time. Ongoing and routine assessment of accessible surfaces in the basement is recommended to evaluate the continued effectiveness of the new flooring and control measures (e.g., paint) emplaced on previous contamination areas. Access to areas with historical removable contamination is being effectively controlled. No immediate action is necessary.

- Proposed non-public access area in the Basement Level – Despite the fact that elevated removable surface contamination levels have been fixed through control measures (examples found in Attachment 1, Figures 4 and 5), it is recommended that the proposed non-public access areas in the Basement Level be designated as a controlled area and be marked/posted in accordance with Section 6.7 of SOP PBR-11.1.4 (modify posting to avoid alarming visitors). The non-public access areas are those portions of the Liquid Waste Pump Room/F.W. Heater Room and Retention Tank Room that will be partitioned off as “no public access”. Those portions of these rooms that will allow public access will be controlled as stated in the previous bullet. Administrative procedures should be in place to ensure that no intrusive (disturbing the floor or wall surfaces) work is performed on this level without review and approval by the RCM. Job-specific RWPs may be required for any future intrusive work in this area.

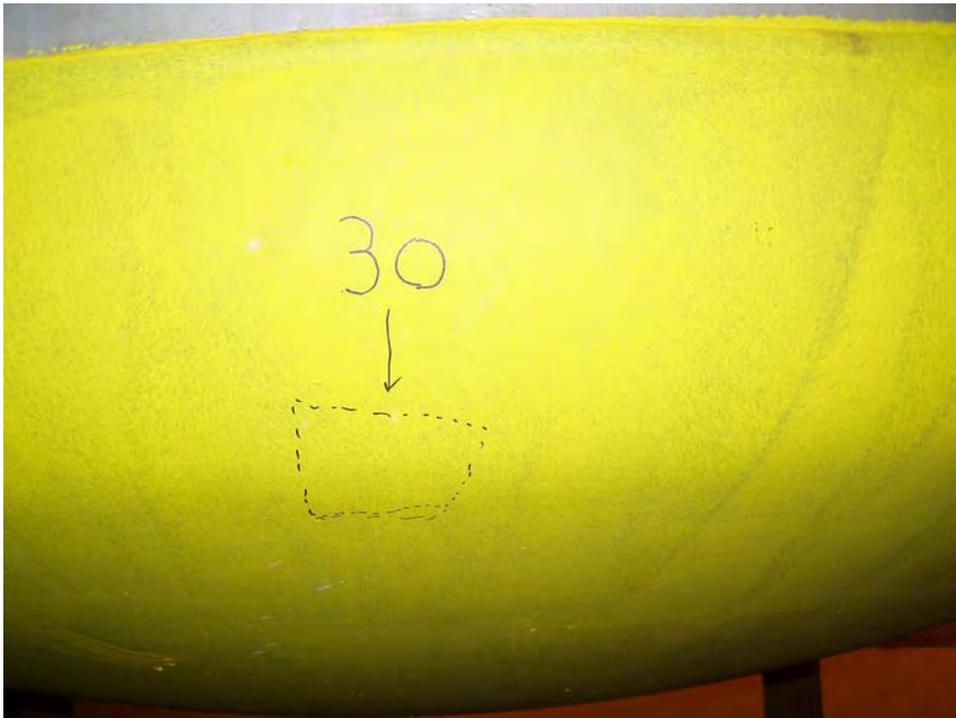
Figure 6. Basement Level – Survey Location 30 on Retention Tank 1

above the 5,000 dpm/100 cm² action level (8,129 dpm/100 cm²). Two additional survey locations, 30 and 31, exhibited a total surface contamination level above MDA, but well below the 5,000 dpm/100 cm² action level. Based on these results, there are no radioactive Contamination Areas associated with the Basement Level.

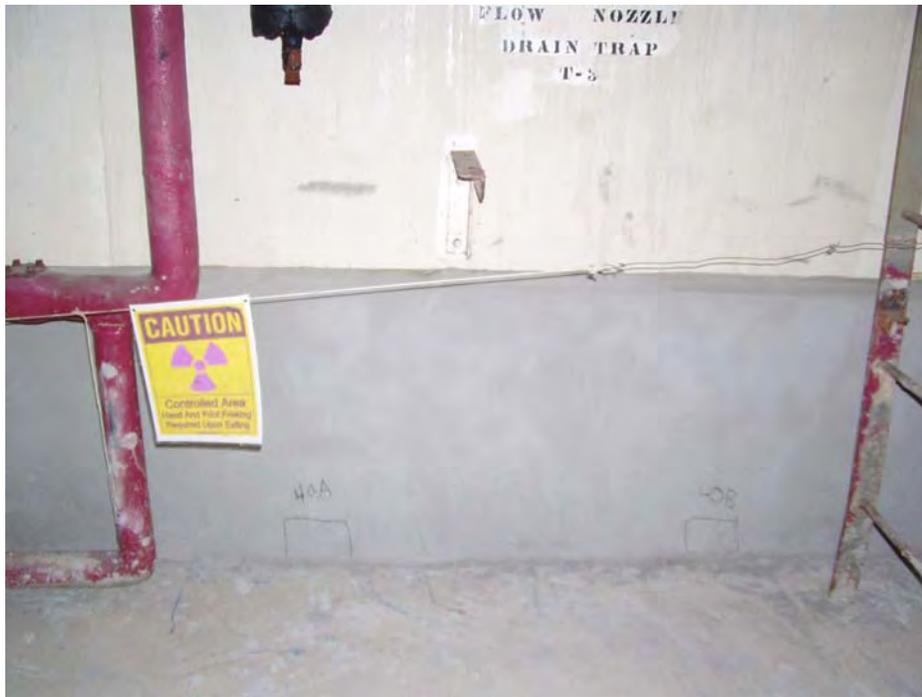
Figure 9. Basement Level – Survey Locations 40A and 40B

Since the Basement Level floor has been covered with approximately 4-in of concrete, all floor sampling locations on this level were evaluated for transferable/removable surface contamination only (i.e., only smear samples/masslin were performed). Masslin samples (survey locations 70, 71, 81, and 89-103) were collected from the floor surface of the Basement Level to assess transferable or removable surface beta/gamma contamination. Masslin smear samples exhibited no removable contamination above MDA or 1,000dpm/100cm². In addition to the masslin samples performed on the floor throughout the level, total and removable contamination was assessed on other surfaces (other than floor) that have been covered with paint and/or concrete due to historical removable contamination (survey locations 30, 31, 40A, 40B, 50A, and 50B). Attachment 1, Figures 6, 7, 9, and 11 depict these six Basement Level survey locations. None of the smear samples from these locations exhibited removable contamination above MDA. However, one of these survey locations, 40A (refer to Attachment 1), had total surface beta/gamma contamination levels

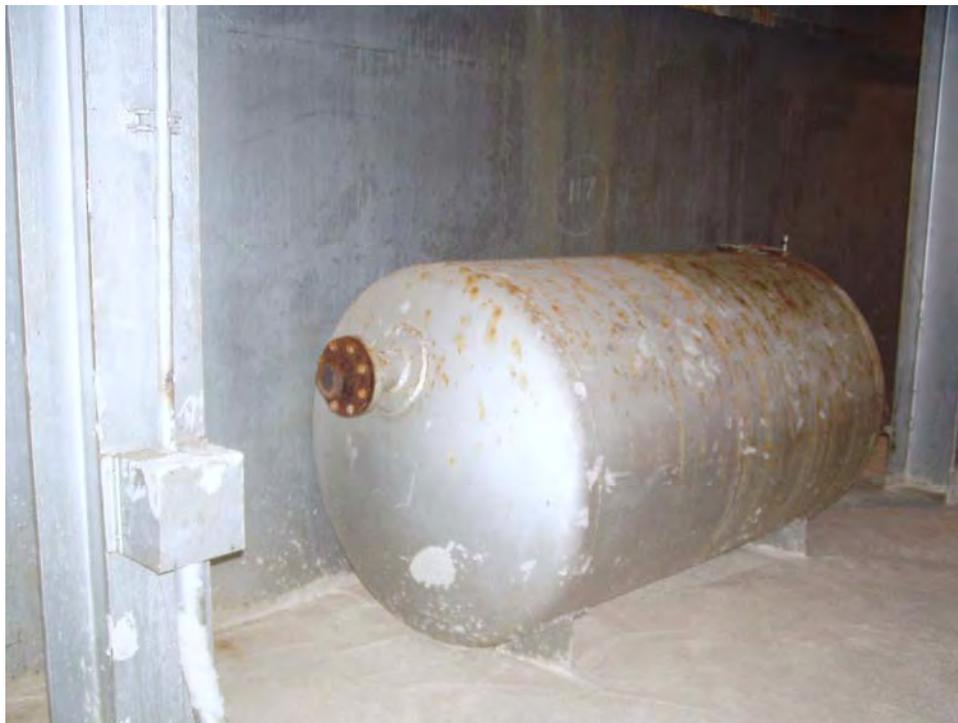
Figure 10. Basement Level – Tank Formerly Labeled as Radioactive Material/Waste Storage Tank

Two additional survey locations (42 and 43) were evaluated in the Vapor Sphere Room where a tank (Attachment 1, Figure 10) was historically used for radioactive waste/material storage (a sign indicating radioactive material storage was also present on the door). These survey locations (repeated from last year's annual survey) were taken from on top of the newer concrete floor. Both removable and total surface readings at these two locations were below MDA.

- There is no need for special marking/posting of the Vapor Sphere Room or the tank in this room that was historically used for storage of radiological waste/material. Survey locations 42 and 43 may be removed from subsequent surveys. However, the Vapor Sphere Room will continue to be assessed through the masslin floor surveys performed annually on the Basement Level.
