**Long-Term Surveillance Plan
for the U.S. Department of
Energy Canonsburg Uranium Mill
Tailings Disposal Site
Canonsburg, Pennsylvania**

March 2013

**U.S. DEPARTMENT OF
ENERGY**

Legacy
Management

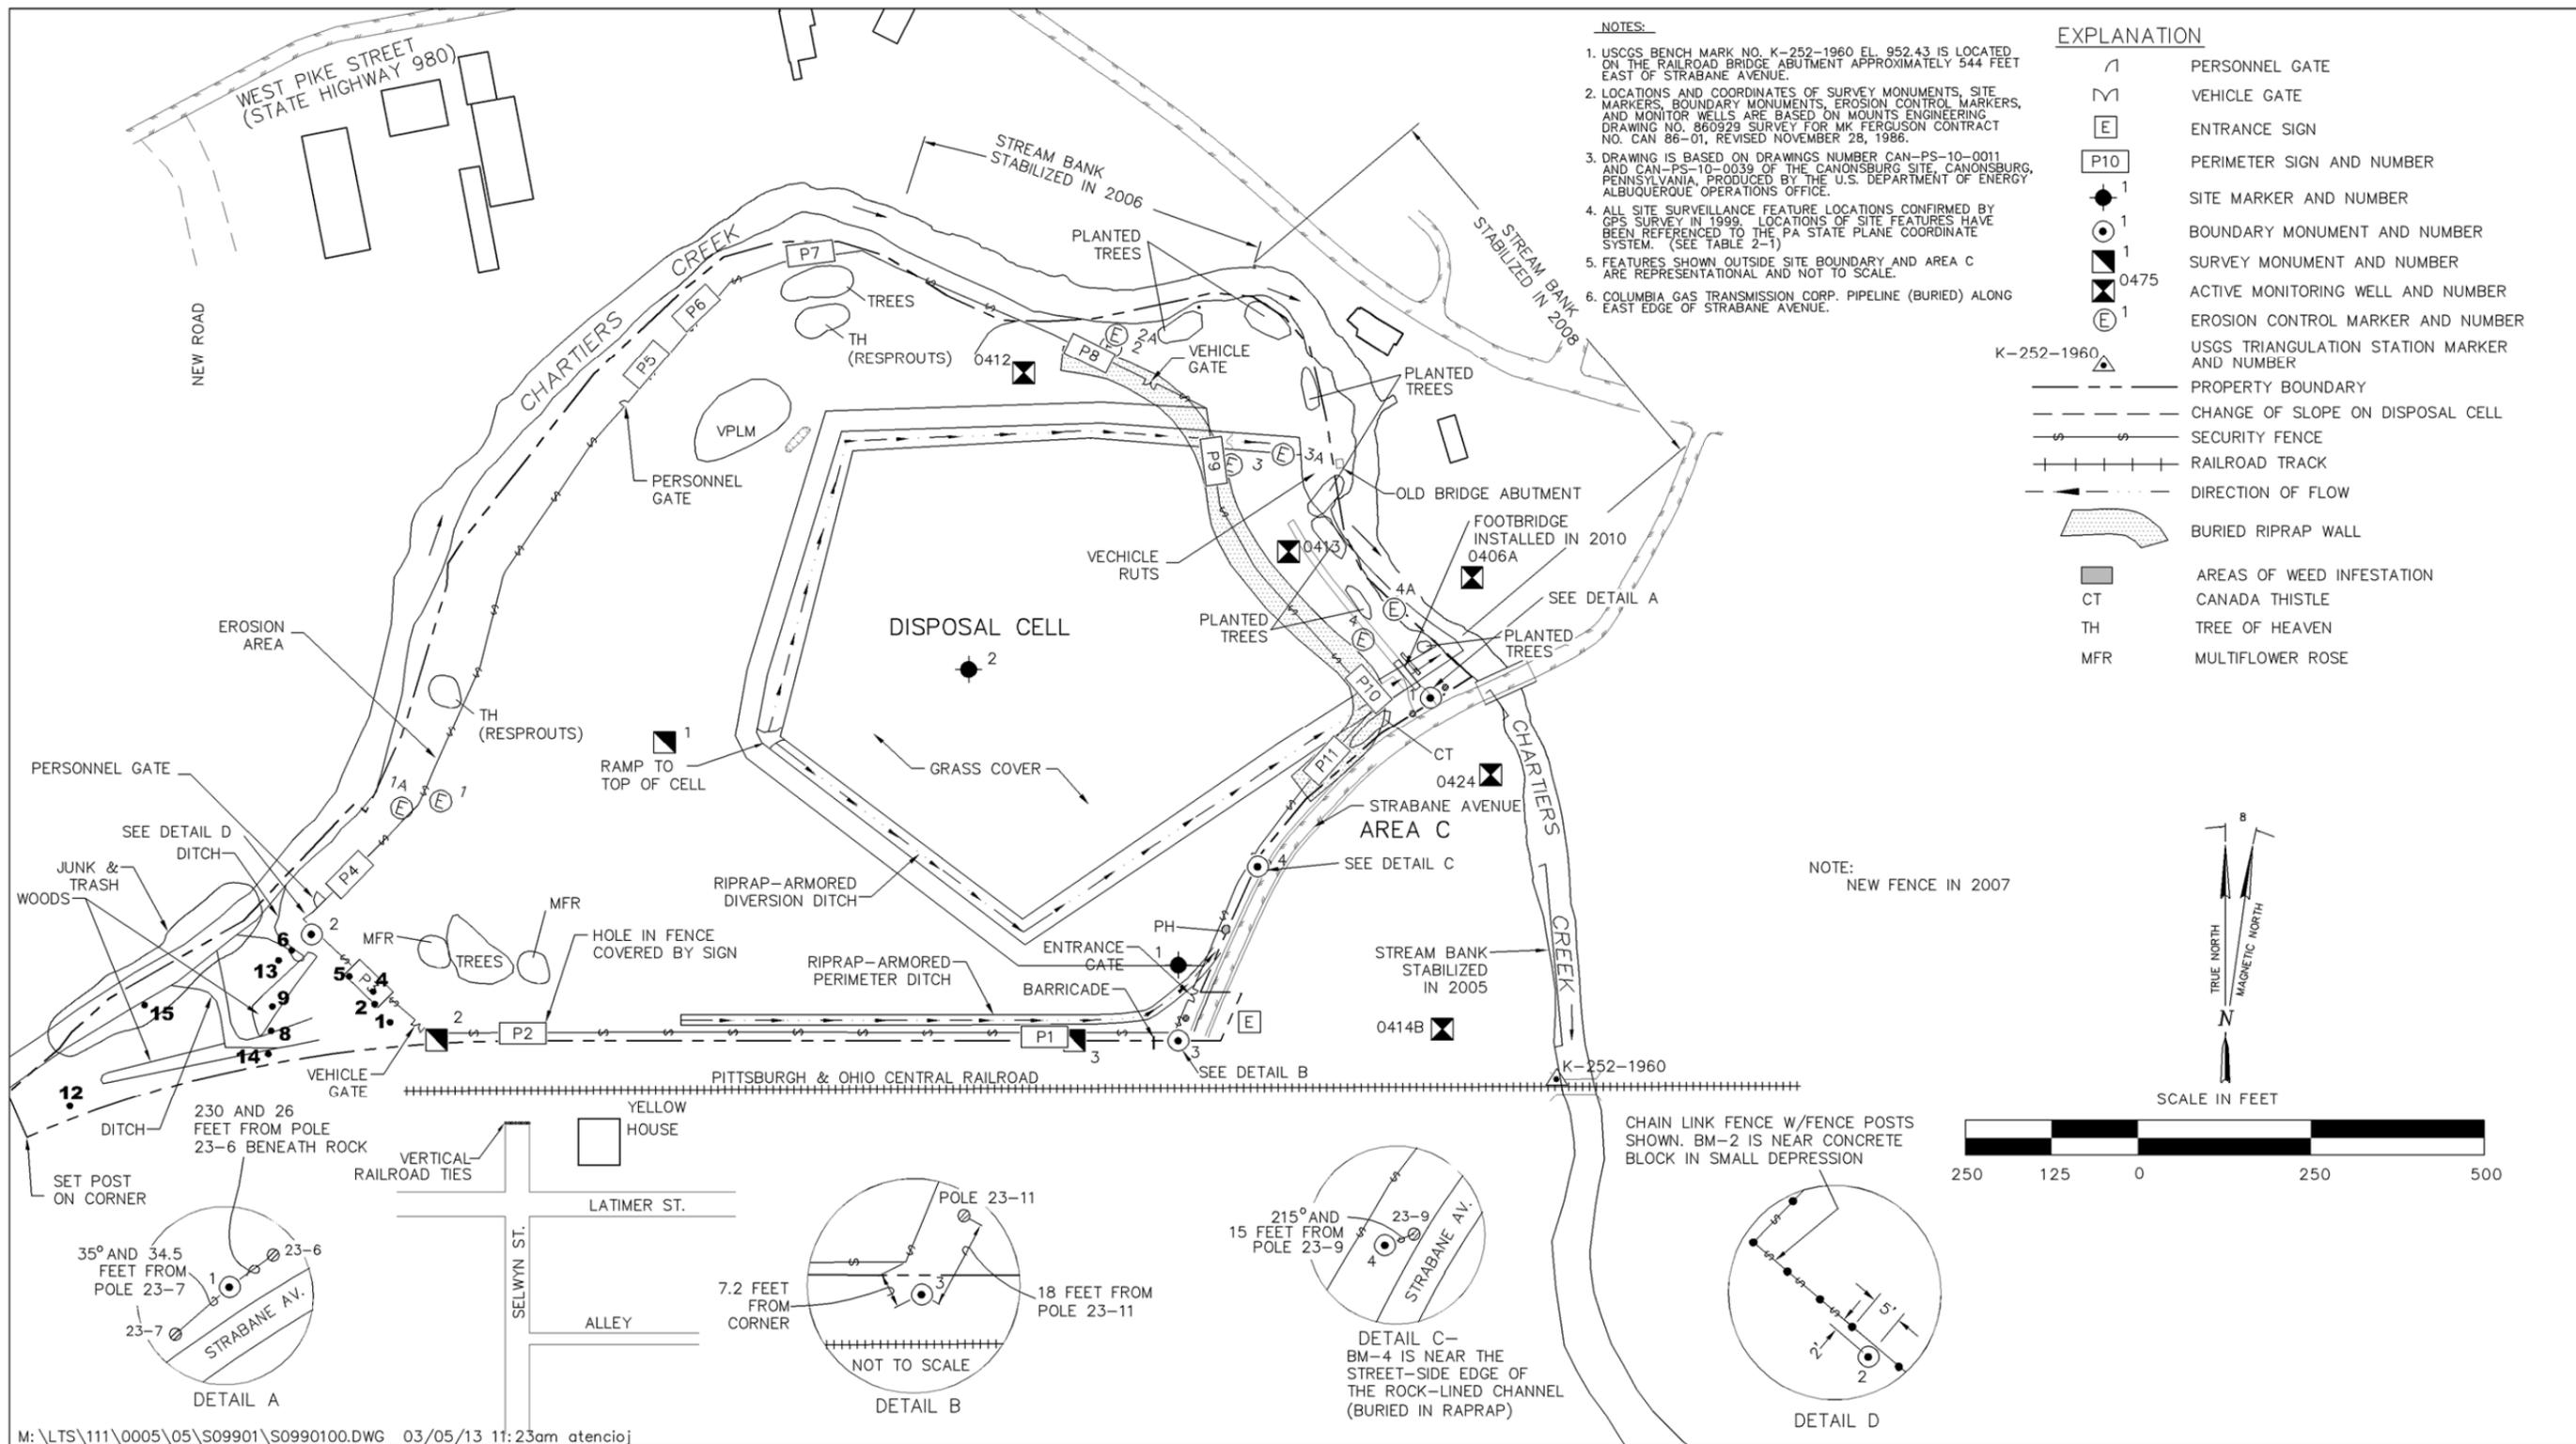
Figure 2. Canonsburg, Pennsylvania, Disposal Site

Drainage Structures: A rock-lined diversion ditch surrounds the disposal cell. This ditch intercepts runoff and conveys it to Chartiers Creek via two outflow channels. Another rock-lined channel, the perimeter drainage ditch, protects the railroad grade on the south and Strabane Avenue on the east from runoff and erosion. The D_{50} of the rock in the rock-lined diversion ditch is 16 inches. In the perimeter ditch, the D_{50} is 6 inches.

Vicinity Property Low Mound: A feature labeled “VP [vicinity property] low mound” on some early drawings (hereafter, VPLM), immediately northwest of the disposal cell contains 943 cubic yards of waste materials from vicinity properties. This material includes low-level contaminated materials received too late for inclusion in the disposal cell. The VPLM is approximately 70 feet by 90 feet and 2 to 3 feet deep. One foot of soil and well-established grass vegetative cover (grasses, weeds, and crown vetch) covers the VPLM disposal area. Despite the term “mound,” the surface expression of the VPLM is only about 1 foot above surrounding grade. In 2006, a small amount of soil material from a stream bank stabilization project was placed between the cell and the VPLM.

Security Fence: Most of the Canonsburg site is enclosed by 7-foot-high chain-link fence (Figure 2). The previous 6-foot-high chain-link fence topped with three strands of barbed wire was replaced in 2007. The new fence was realigned along a portion of the west side of the site by moving it back from the steep slope that drops down to Chartiers Creek. The fence is considered to be the de facto erosion control marker (ECM). There are three large vehicle gates in this fence: an entrance gate at the southeast corner of the site along Strabane Avenue, a vehicle access gate at the southwest corner, and a vehicle access gate north of the disposal cell between perimeter signs P8 and P9. There is also a personnel access gate northwest of the disposal cell between perimeter signs P5 and P6. All gates are secured by padlocks.

Inspectors also will carry site inspection maps. The base map, represented by Figure 2, will be annotated to reflect recent observations, issues, and photograph locations. Inspectors will annotate the map, sign and date it, and submit it to the inspection case file. Map information will be processed for inclusion in the inspection report and will constitute the basis for the following year's inspection map.

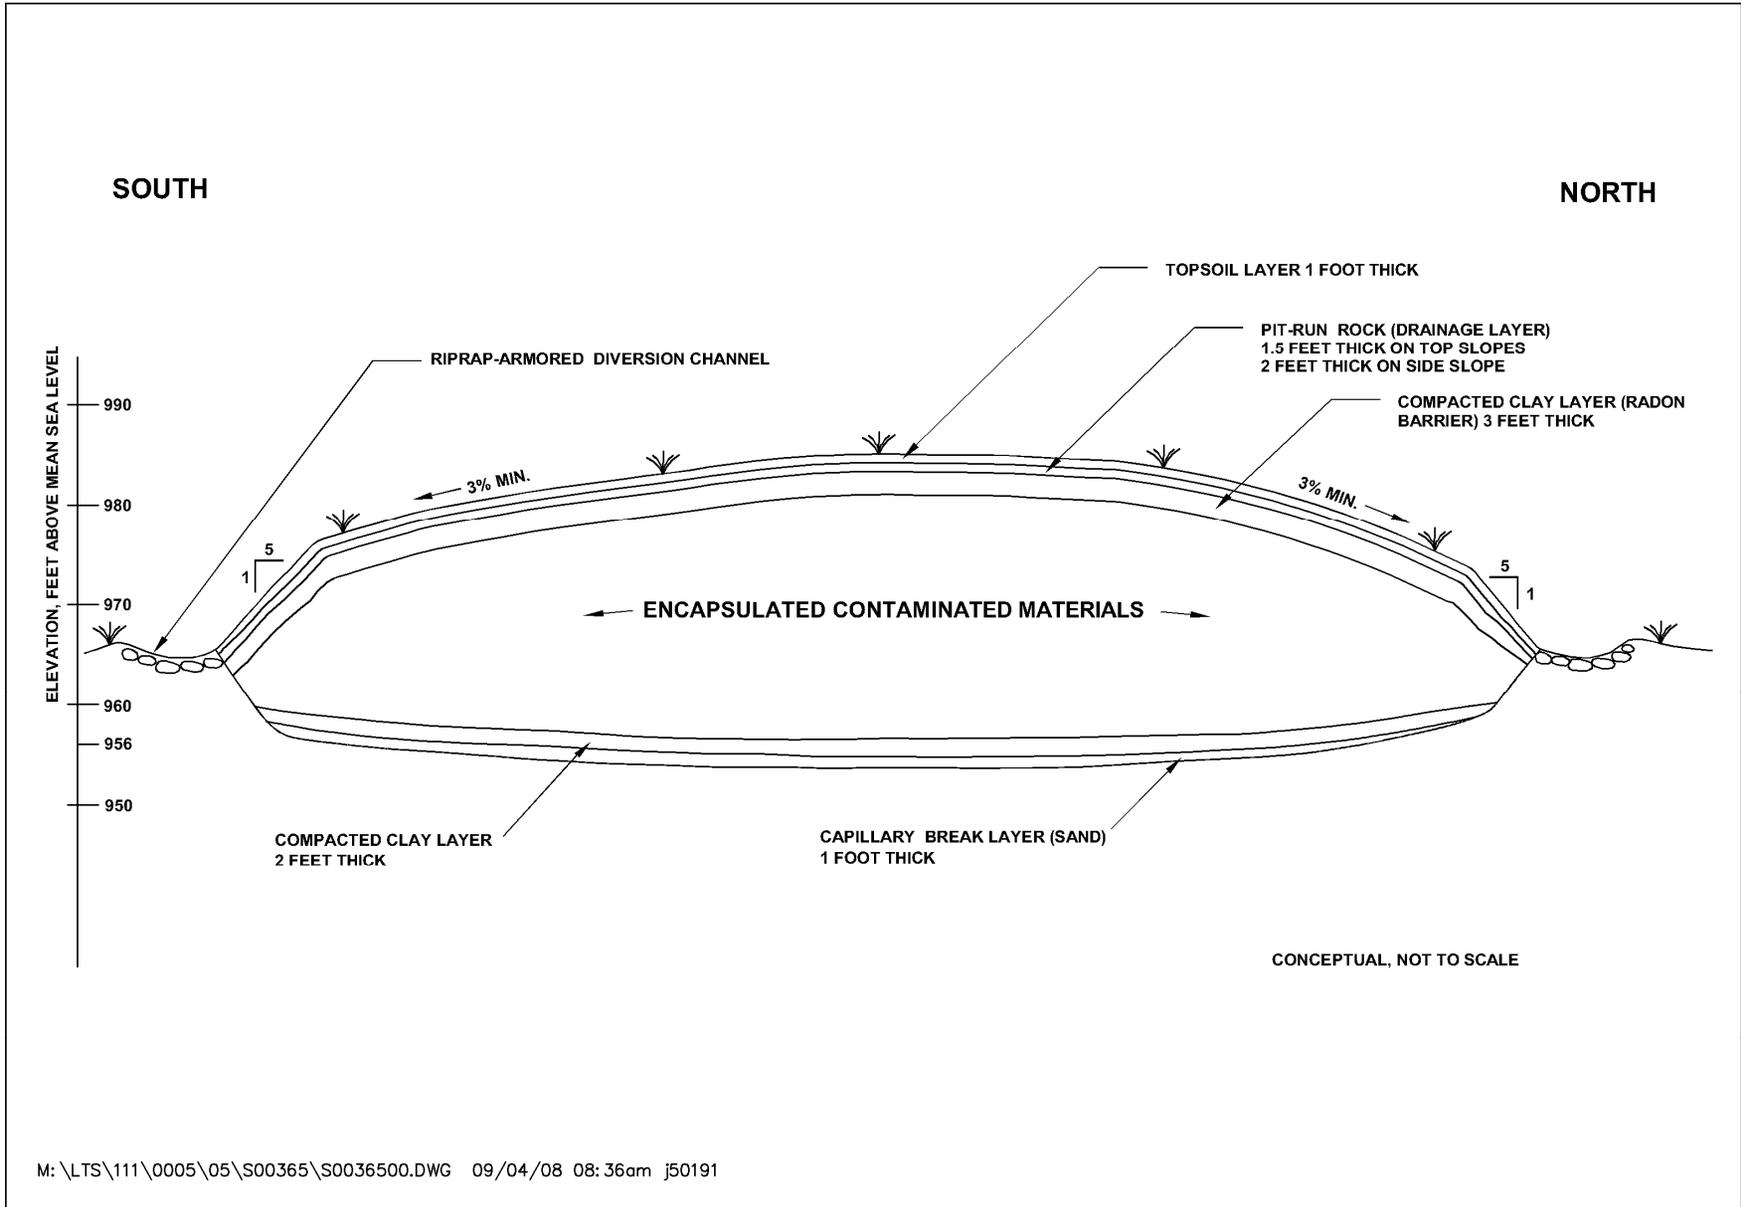
Figure 3. North-South Cross Section of the Canonsburg, Pennsylvania, Disposal Site

Flood Plane and Buried Riprap Wall: The site is on the south bank of Chartiers Creek. On the west and north, the site is protected from flooding by a high, stable, natural stream bank supported by undisturbed bedrock and mature hardwood forest. On the northeast, along the creek and between erosion control markers ECM-2 and ECM-2A (Section 2.3.5) and the Strabane Avenue bridge, the site is bordered by a narrow floodplain.

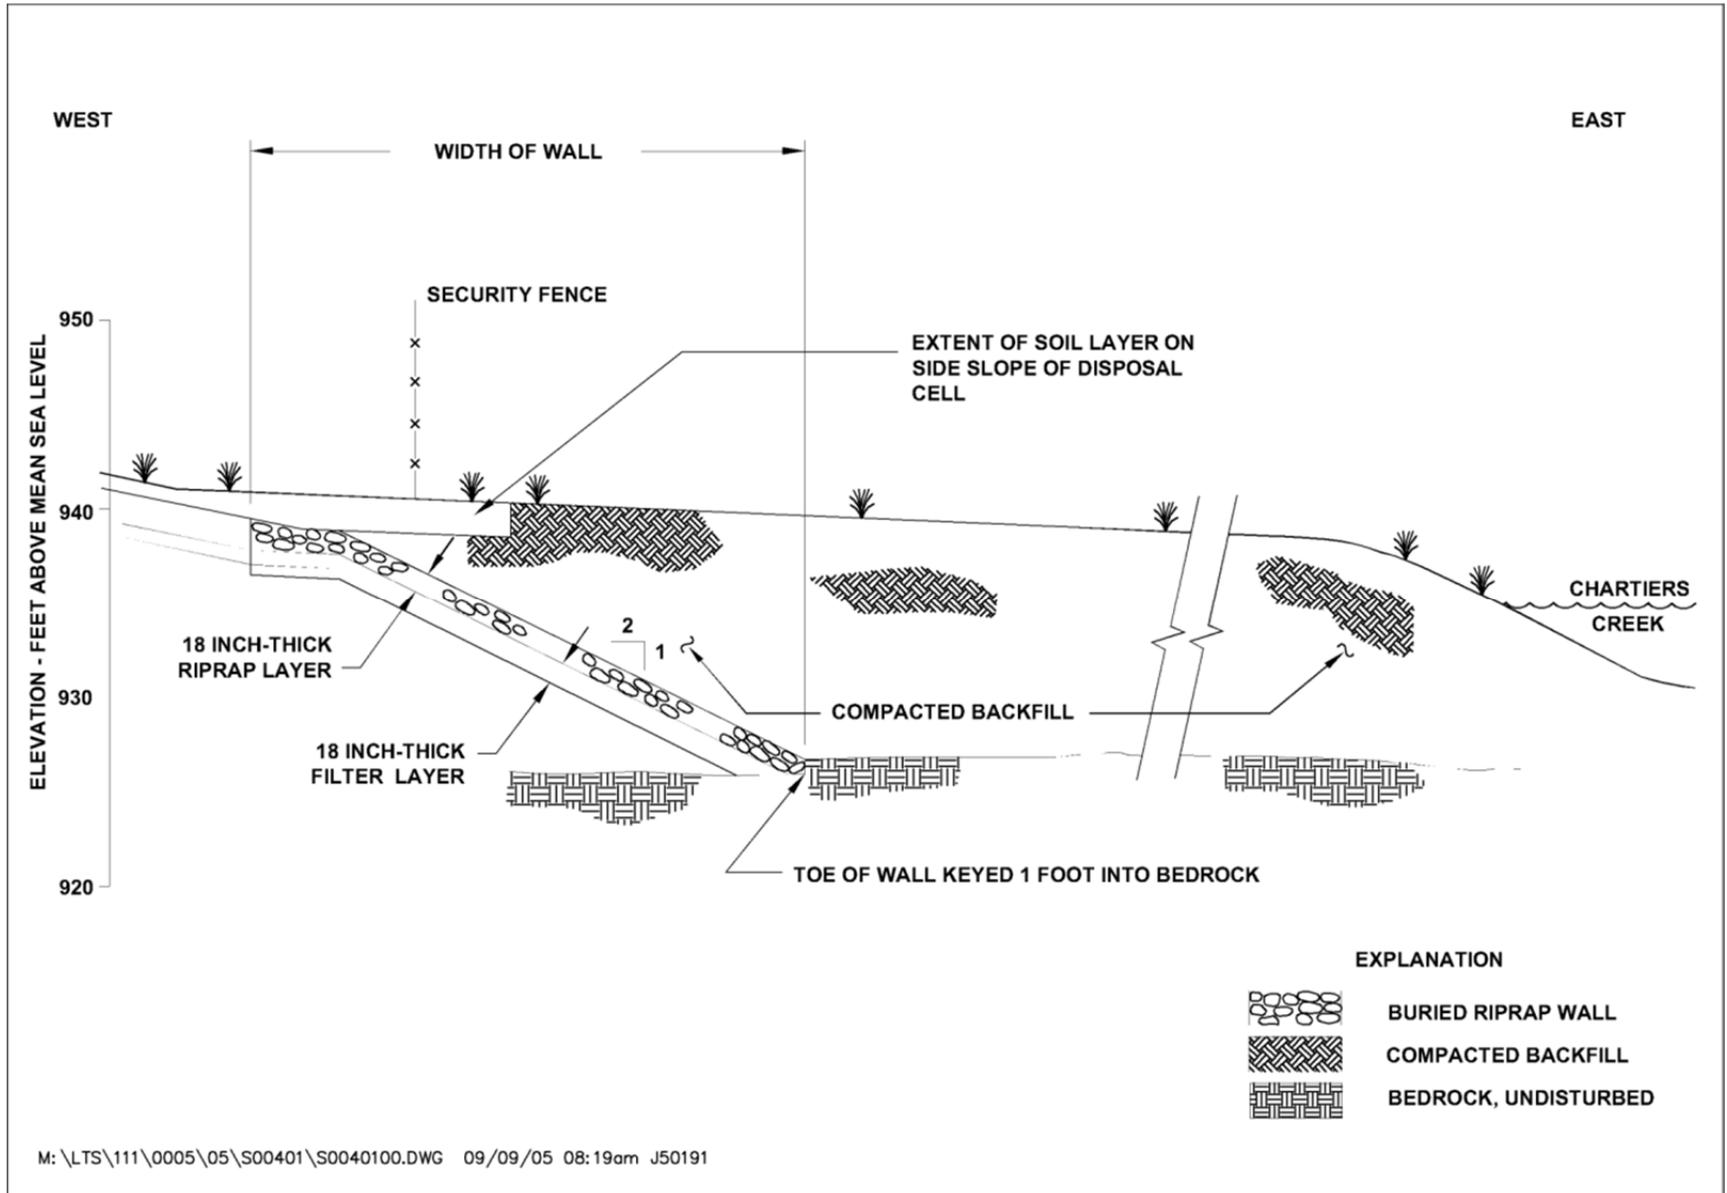
Figure 4. East-West Cross Section Through Buried Riprap Wall, Canonsburg, Pennsylvania, Disposal Site

Under PMP conditions, water may overtop the high bank west of the disposal cell and VPLM, but the shallow depth and low velocity of the water are considered insufficient to threaten either feature, both of which are protected by well-established turf and, in the case of the disposal cell itself, an engineered cover designed to prevent erosion from overland flows. Flooding from a 1,000-year storm event would only reach an elevation of 955 feet msl, 13 feet below the VPLM at its deepest point. The risk of flood damage to the VPLM disposal area, including the possibility that floodwater could erode and expose buried materials, is therefore not credible.

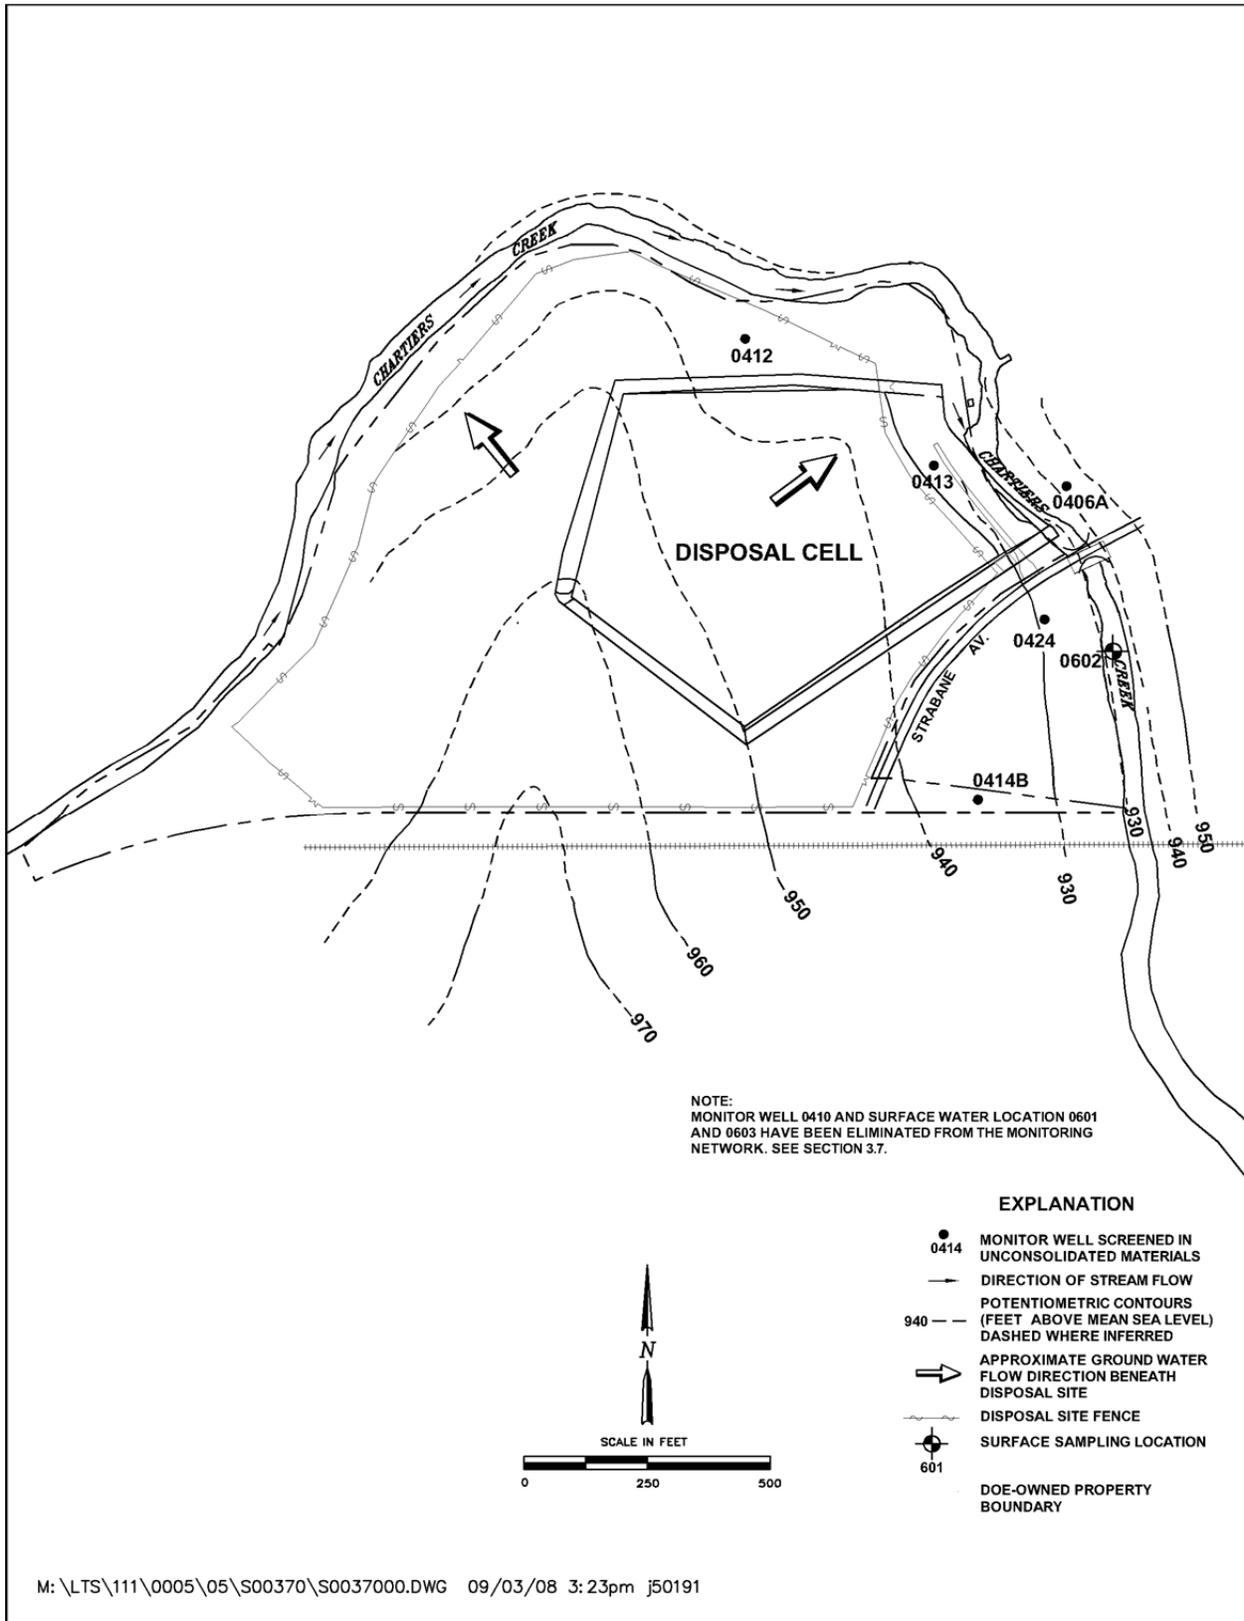
Figure 5. Potentiometric Surface, Monitor Wells, and Surface Water Sampling Locations, Canonsburg Disposal Site

Gradient in the unconsolidated materials is toward Chartiers Creek, the normal discharge zone for the shallow groundwater (Figure 5). Flow in the shallow bedrock is downward and then through zones of secondary porosity along joints, fractures, and bedding planes. A low-permeability rock formation separates groundwater in the shallow bedrock from higher-quality water in deeper aquifers.

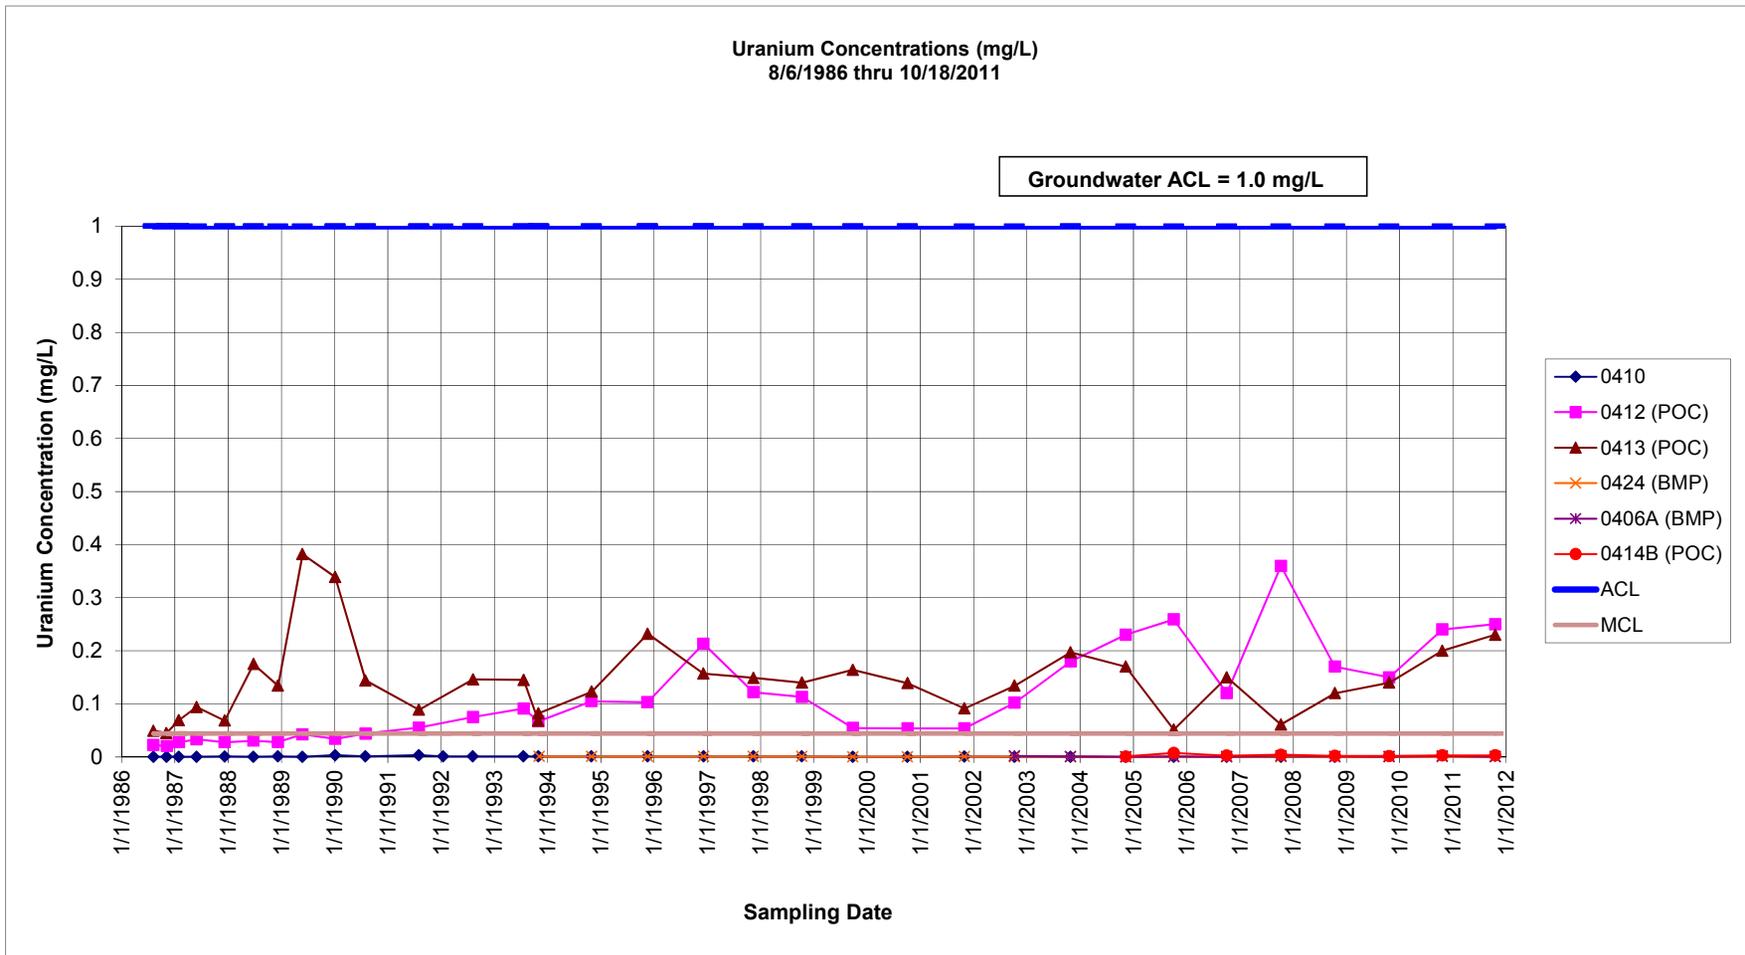
Figure 6. Uranium Concentration Trends in Groundwater at the Canonsburg, Pennsylvania, Disposal Site, 1995–2011

Concentrations of uranium in groundwater in POC wells 0412 and 0413, adjacent to the disposal cell, are still above the MCL of 0.044 milligrams per liter (mg/L), but are considerably lower than the ACL of 1.0 mg/L. Although uranium concentrations have fluctuated since 1995, they have remained close to the range historically observed at the site (Figure 6). Background (upgradient) levels in groundwater in monitor well 0410 have been consistently at or below the laboratory detection limit (approximately 0.001 mg/L). Concentrations of uranium in groundwater in monitor well 0414B, in Area C, have decreased below the MCL. Concentrations in monitor well 0406A, across Chartiers Creek, are also very low.

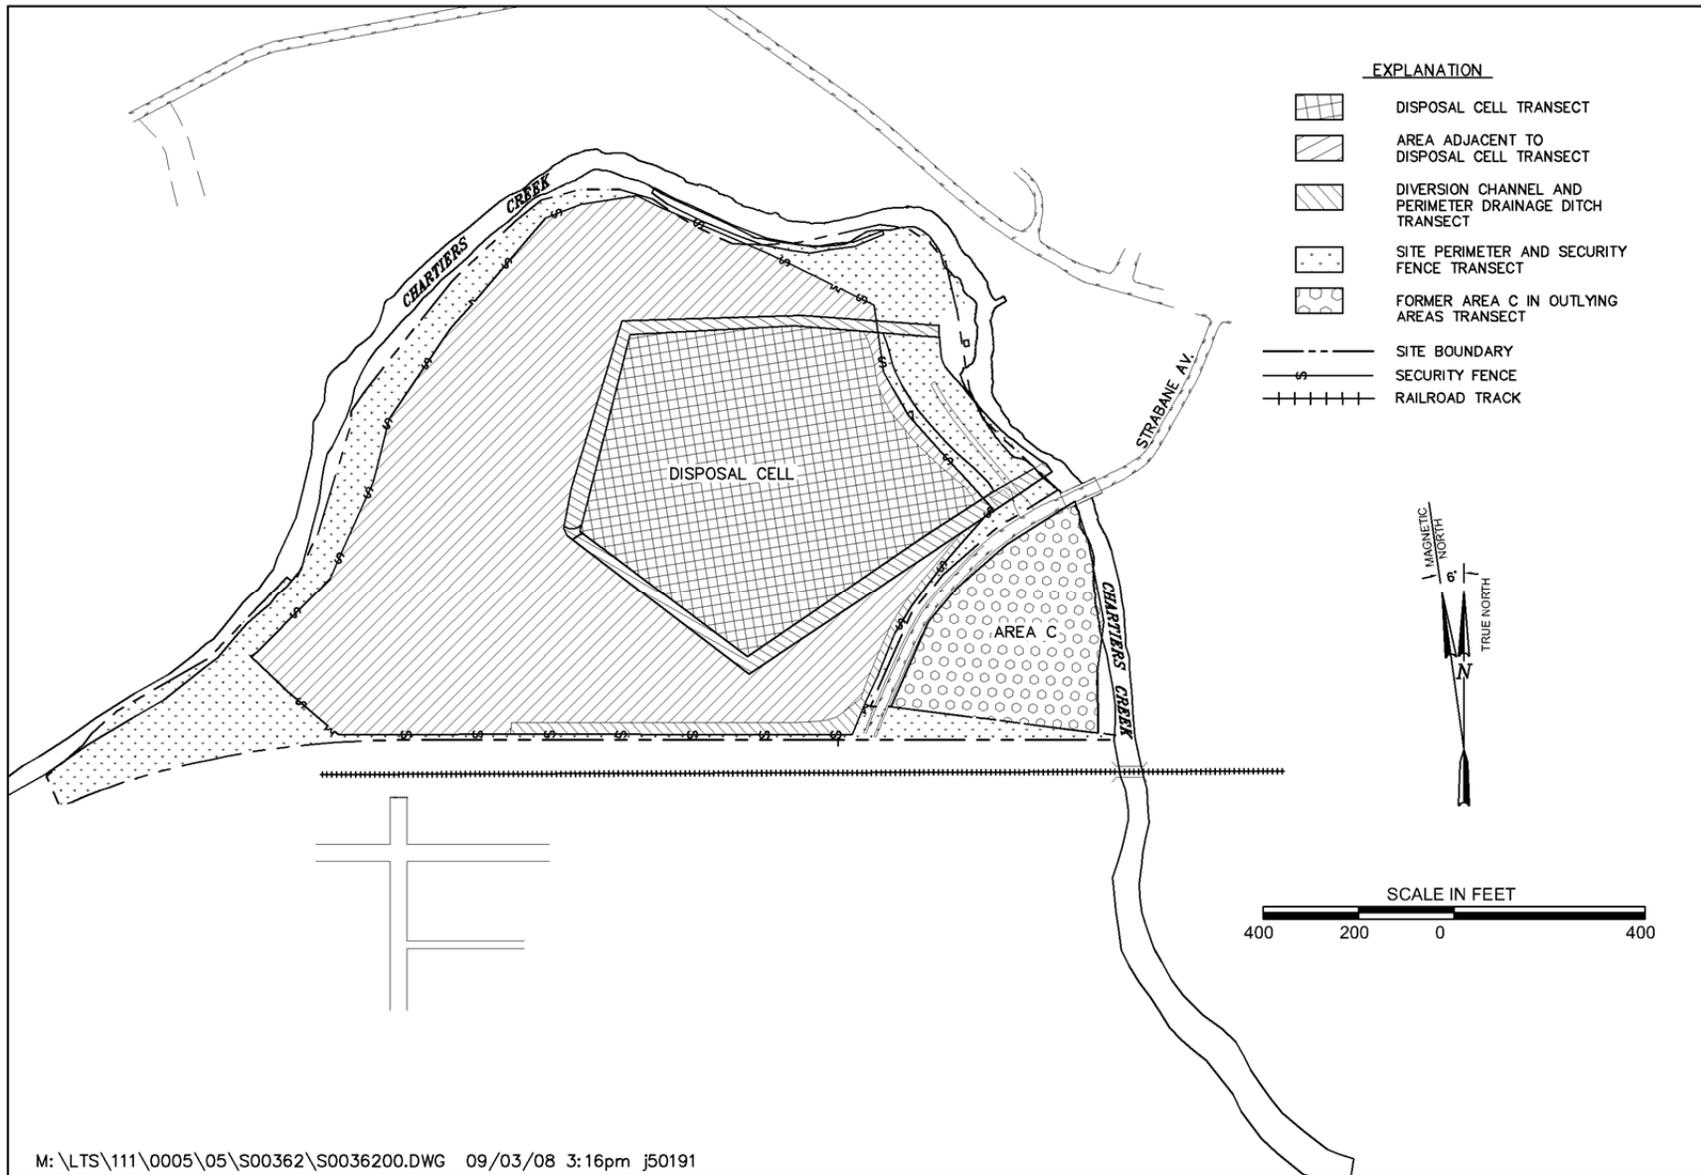
Figure 7. Canonsburg, Pennsylvania, Disposal Site, Inspection Transects

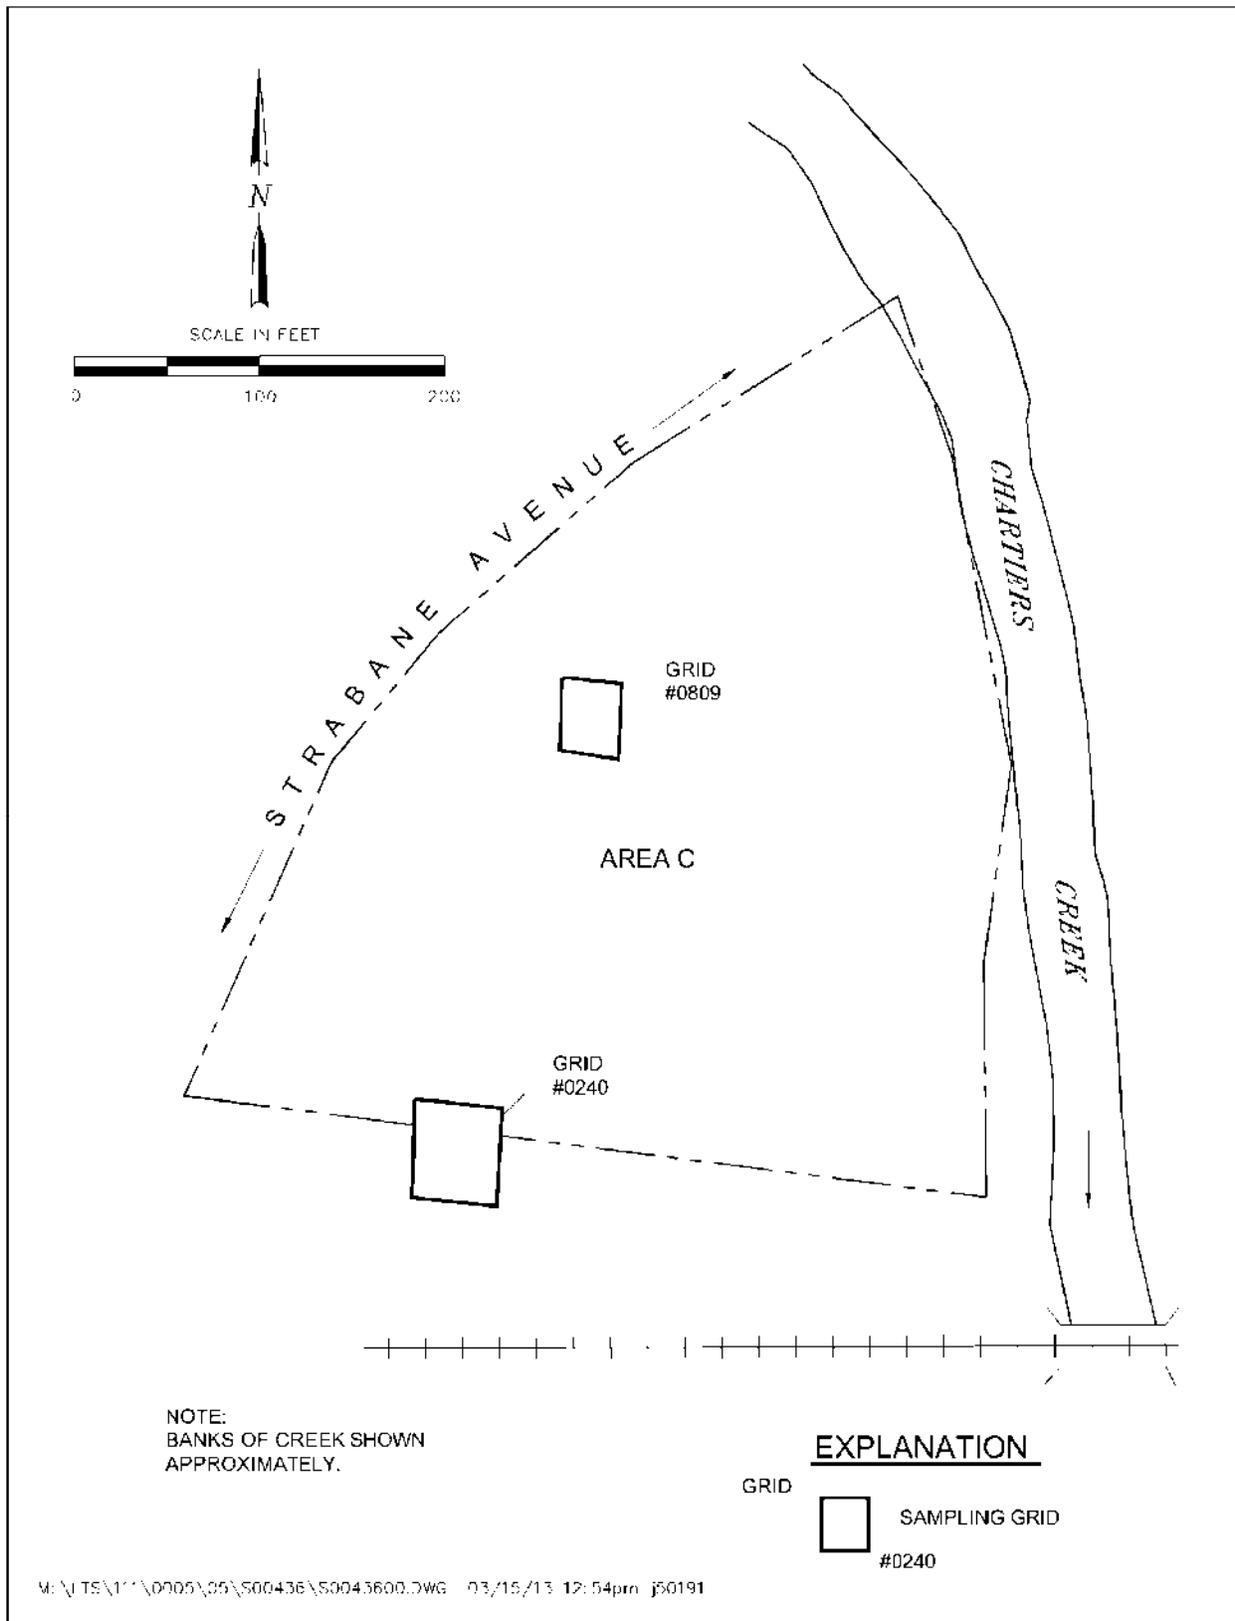
Figure 8. Location of Thorium-230 Anomalies, Area C, Canonsburg, Pennsylvania, Disposal Site

Area C: In 1992 inspectors began to observe progressive loss of stream bank along the eastern edge of Area C. The loss was attributed to loss of cohesion in the bank materials due to seepage and erosion from occasional high water in the creek. Erosion at Area C is no threat to the disposal site, but perhaps a concern because of two thorium anomalies in Area C (Figure 8).

During remedial action verification, two thorium anomalies were discovered beneath clean fill at depths of 6 to 8 feet (Appendix D). Ingrowth from thorium was not a consideration at the time the Canonsburg site was remediated, so the thorium anomalies were left in place. However, radium-226 ingrowth will result in concentrations slightly exceeding the standard in 40 CFR 192 within 1,000 years. DOE does not consider erosion along the stream bank to be a threat to these anomalies because the closer of the anomalies is 220 feet from the bank where slumping has occurred. However, in 2000–2001, DOE intervened to stabilize the stream bank to preserve the value of the property, prevent exposure of the thorium anomalies, and prevent sedimentation in the creek.

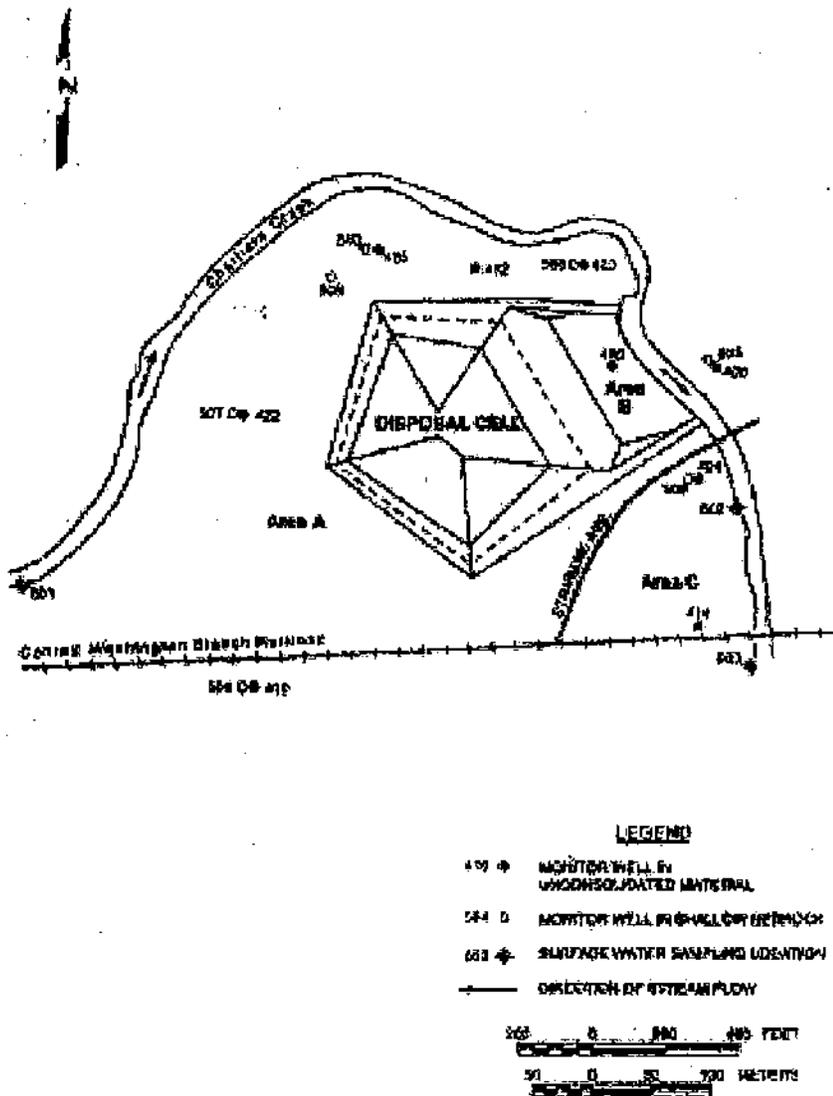
Figure 2
Locations of Monitoring Wells and Surface Water Sampling Points
Canonsburg Site (from DOE, 2008)

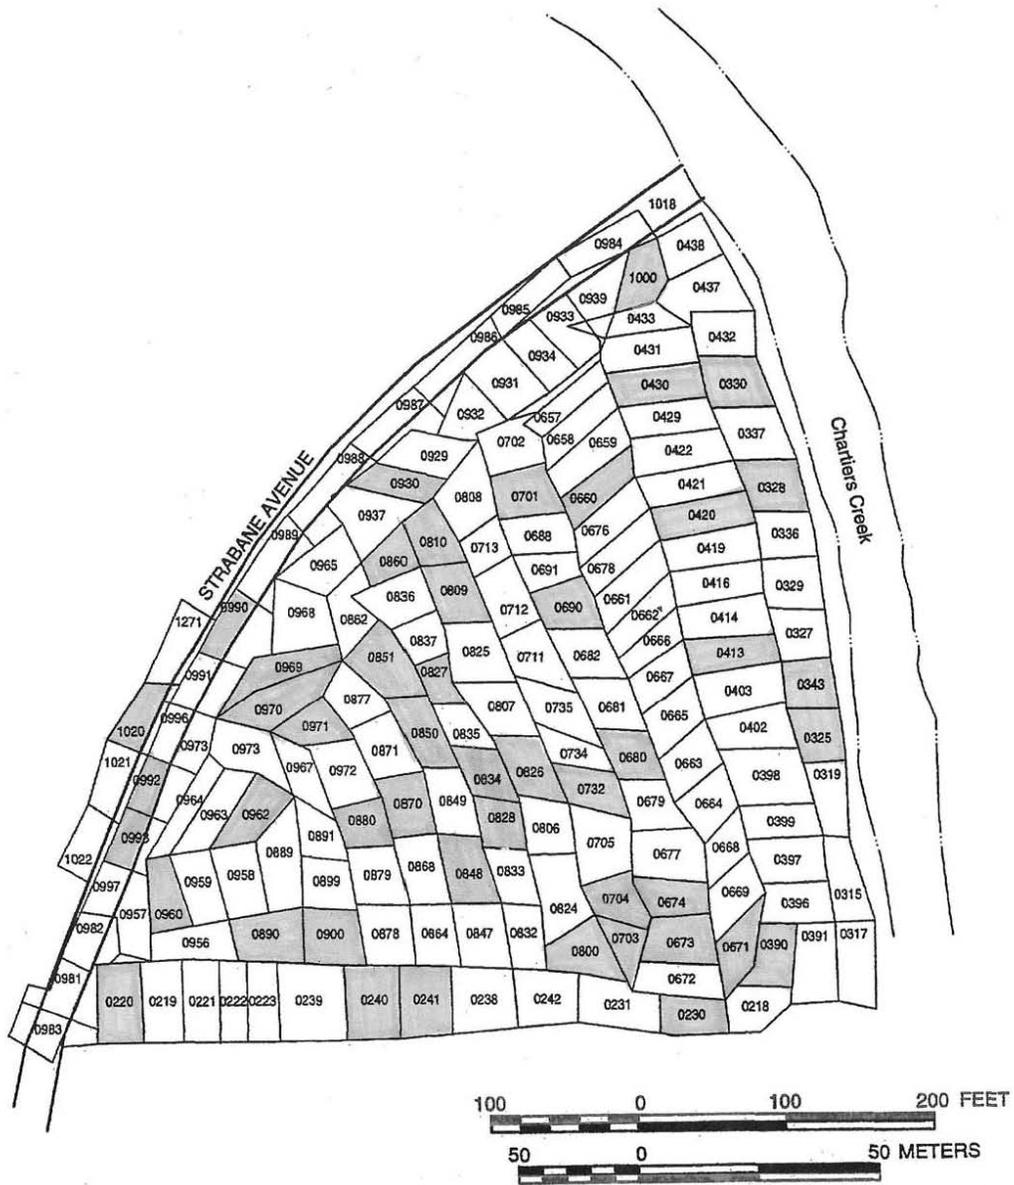
Area C Available Thorium Soil Sampling Results
