# FERNALD PRESERVE

## 2013 Site Environmental Report

**U.S. Department of Energy**  
**Office of Legacy Management**  
Issued May 2014

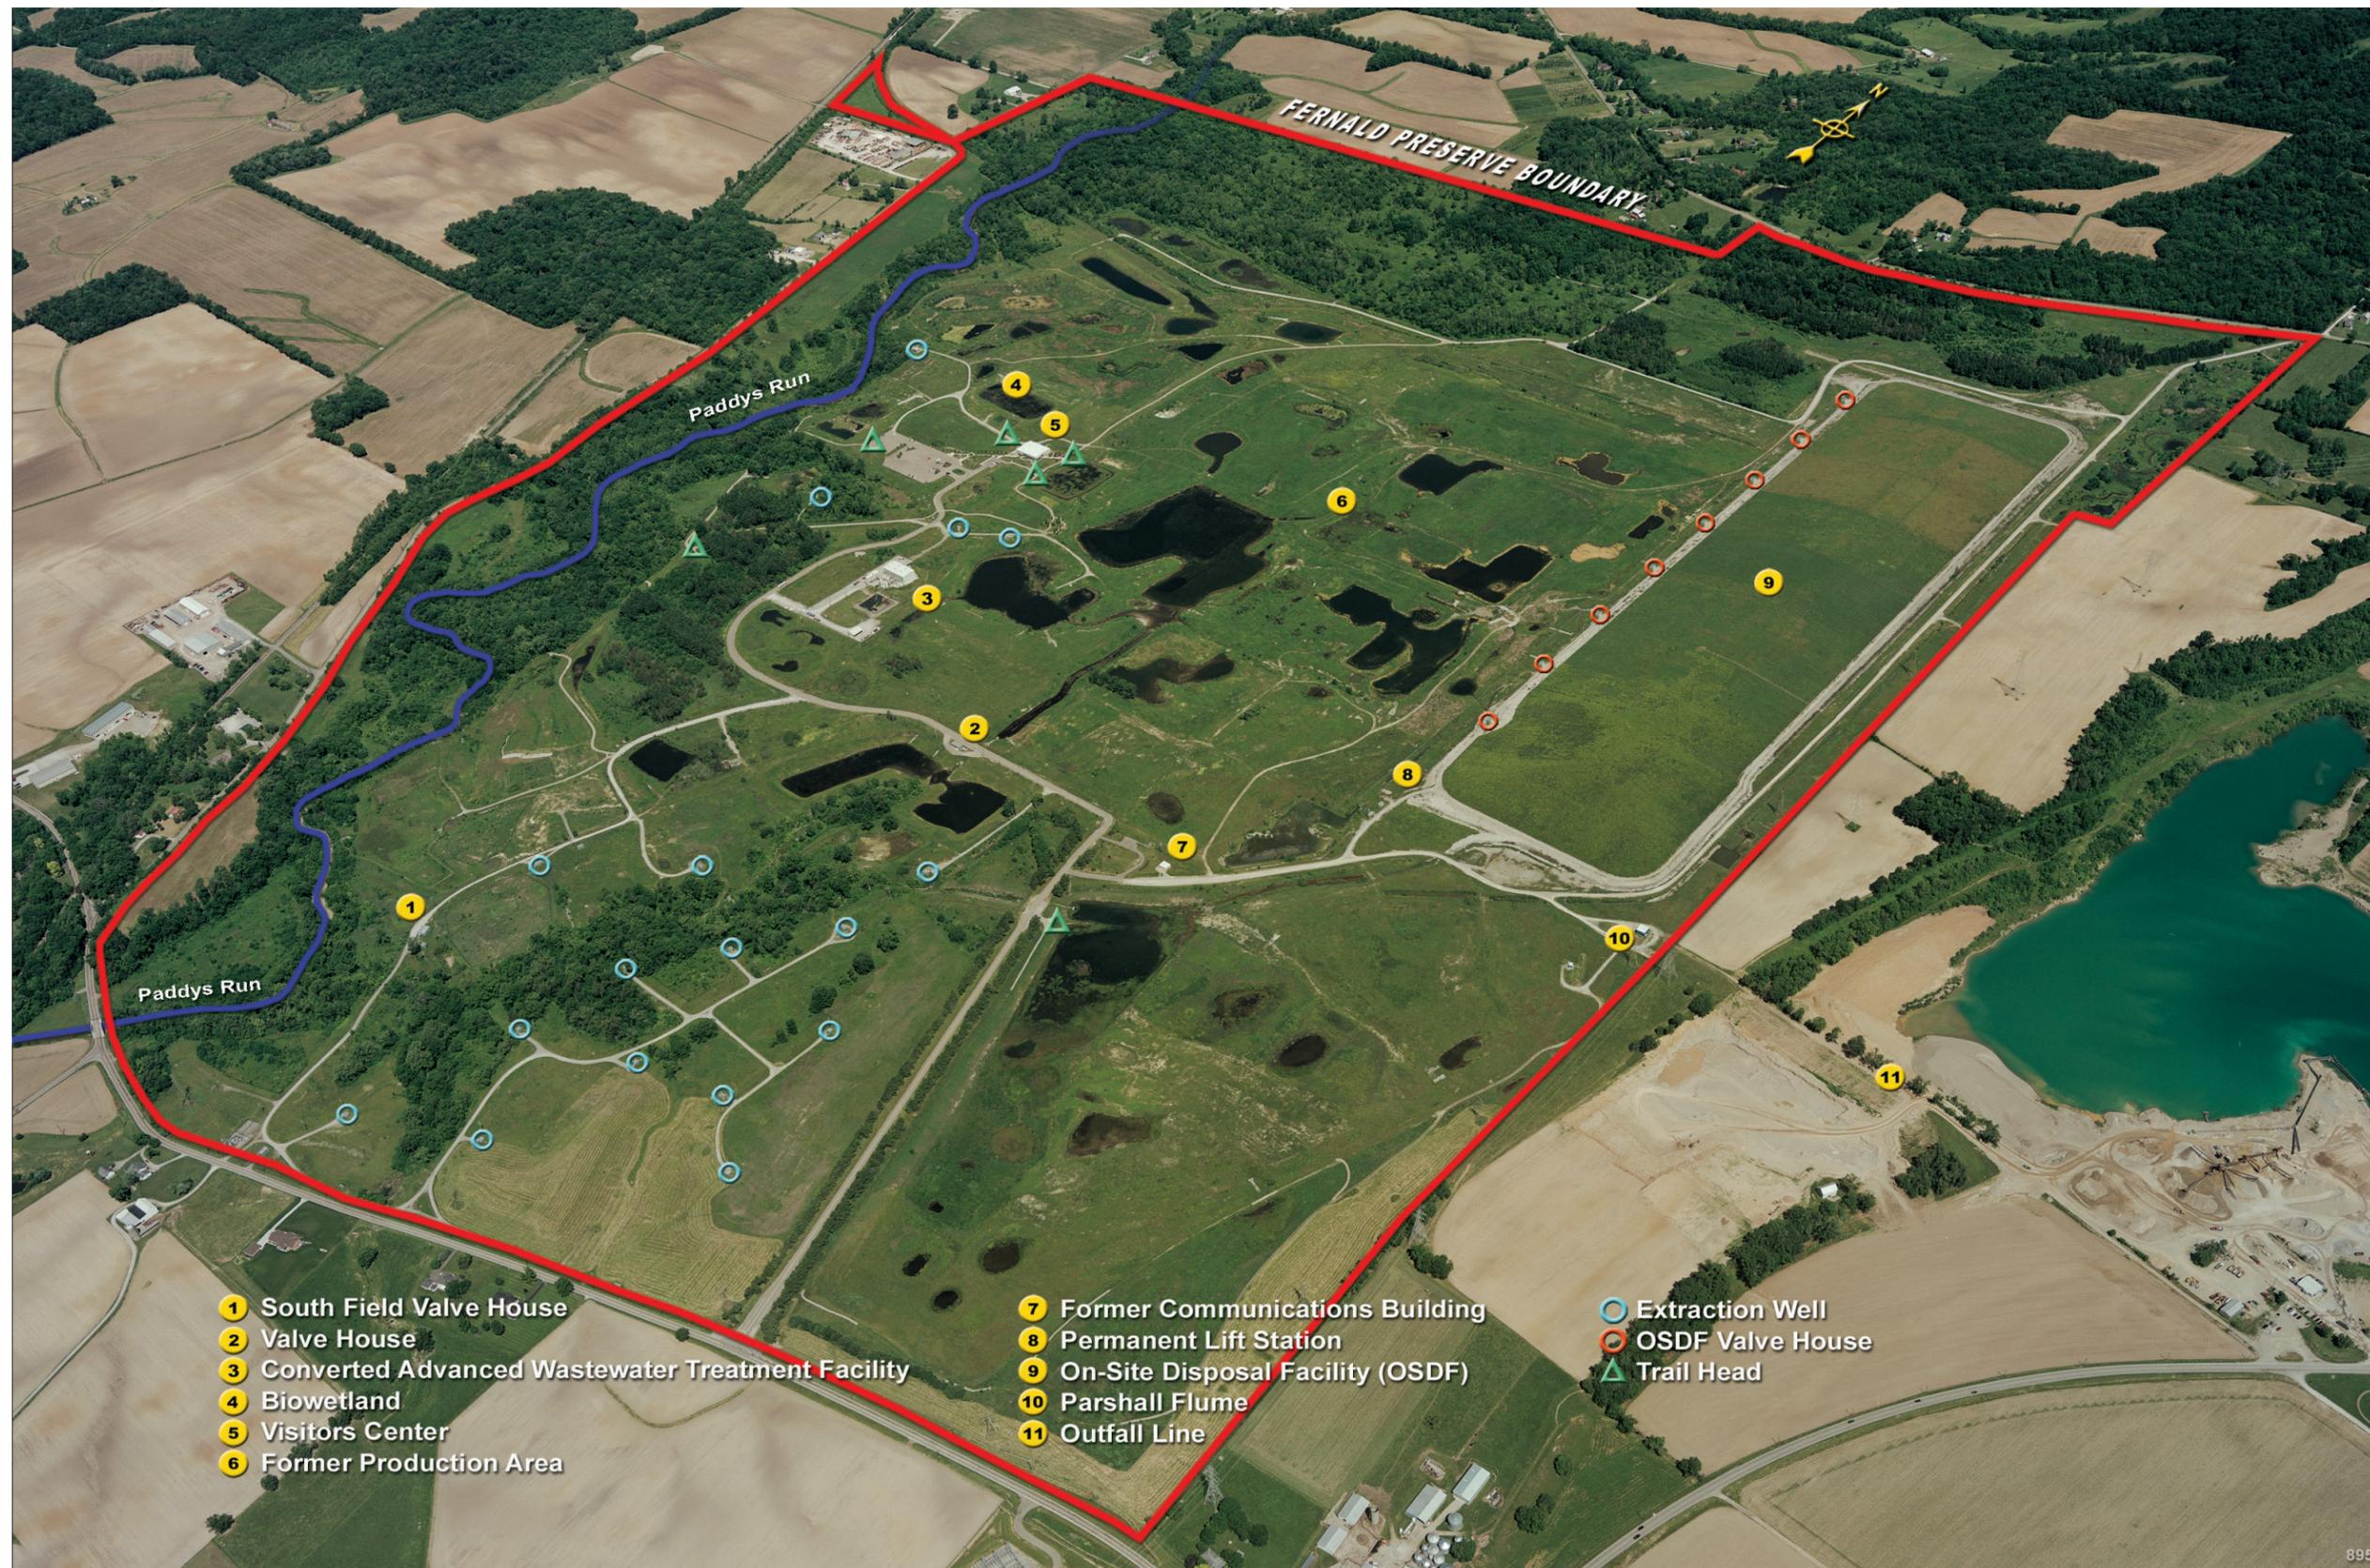
Figure 3. Fernald Preserve Perspective

Figure 3 depicts the location of the major physical features of the site, such as the buildings and supporting infrastructure. The Former Production Area and the OSDF dominate this view. The Former Production Area occupies approximately 136 acres (55 hectares) in the center of the site, and the OSDF occupies approximately 120 acres (48.6 hectares). The Great Miami River cuts a terraced valley to the east of the site, and Paddys Run (an intermittent stream) flows from north to south along the site's western boundary. In general, the site lies on a terrace that slopes gently among vegetated bedrock outcrops to the north, southeast, and southwest.

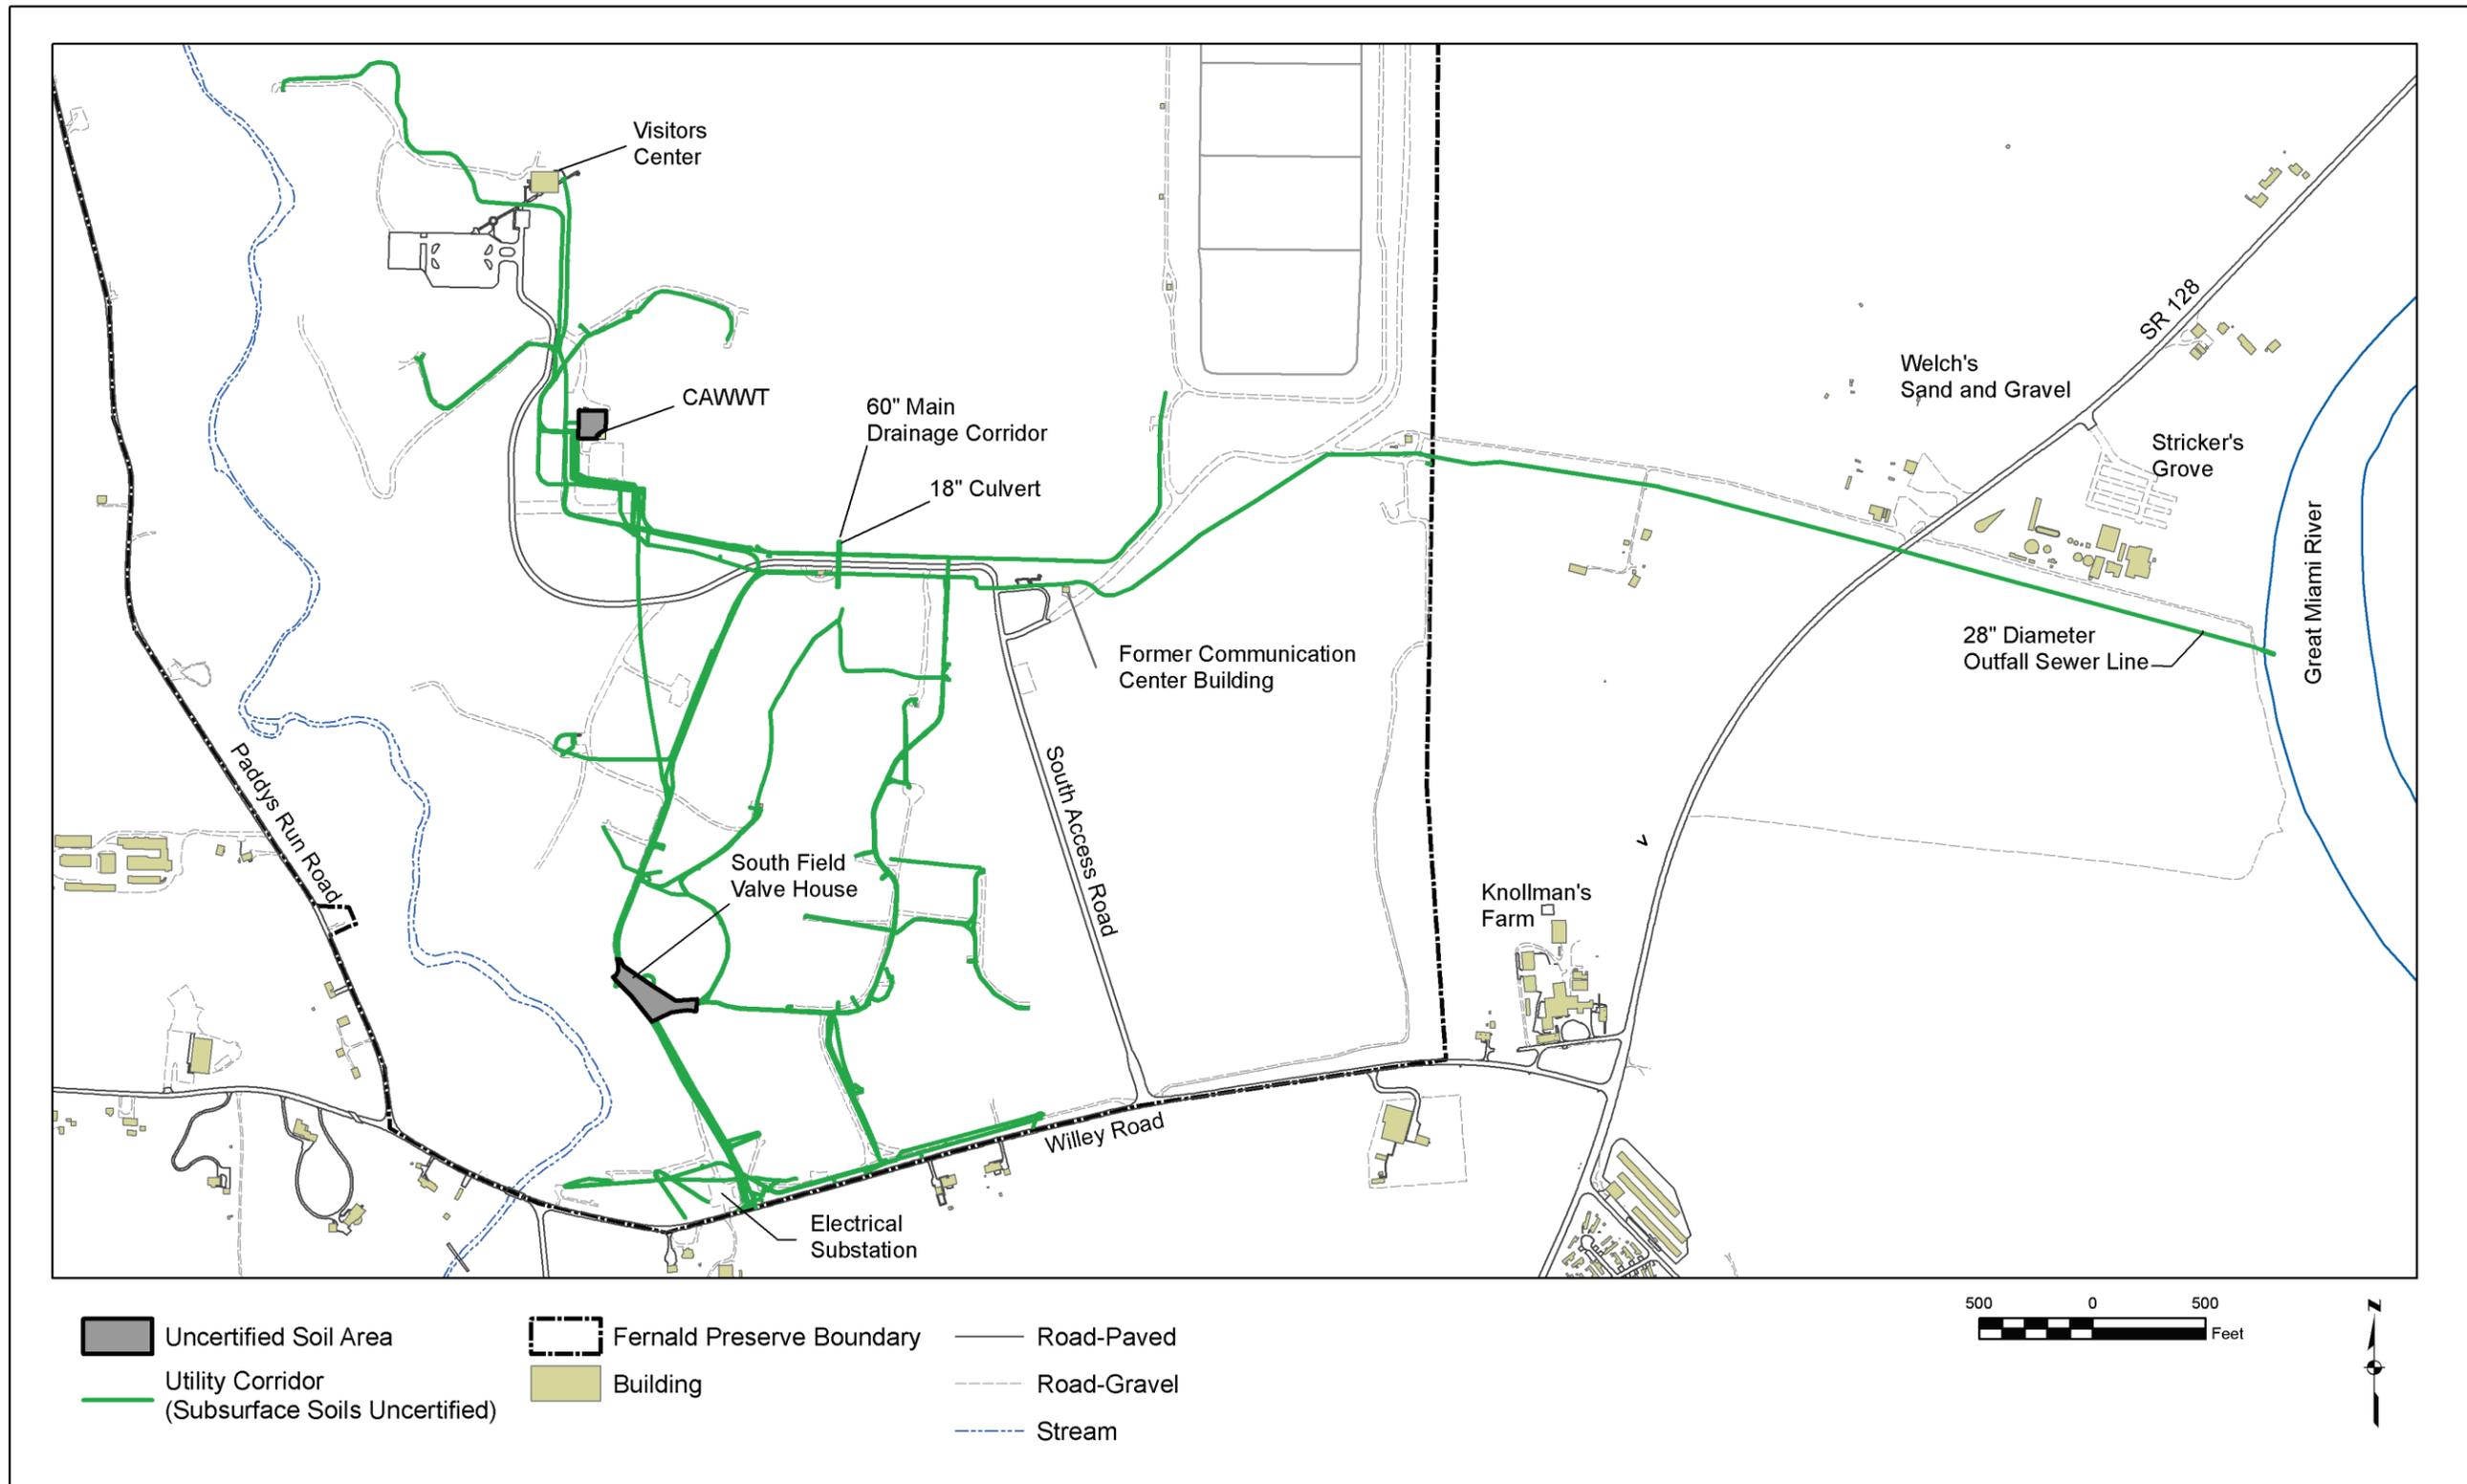
Figure 9. Uncertified Areas and Subgrade Utility Corridors

- Figure 9 indicates soil areas that remain uncertified pending the end of the groundwater remedy and the decontamination and decommissioning of the related facilities and the associated utilities. Elevated uranium concentrations persist in surface water in an area adjacent to former Waste Pit 3. No specific actions other than continued monitoring were conducted in 2013. This issue is further discussed in Section 4.

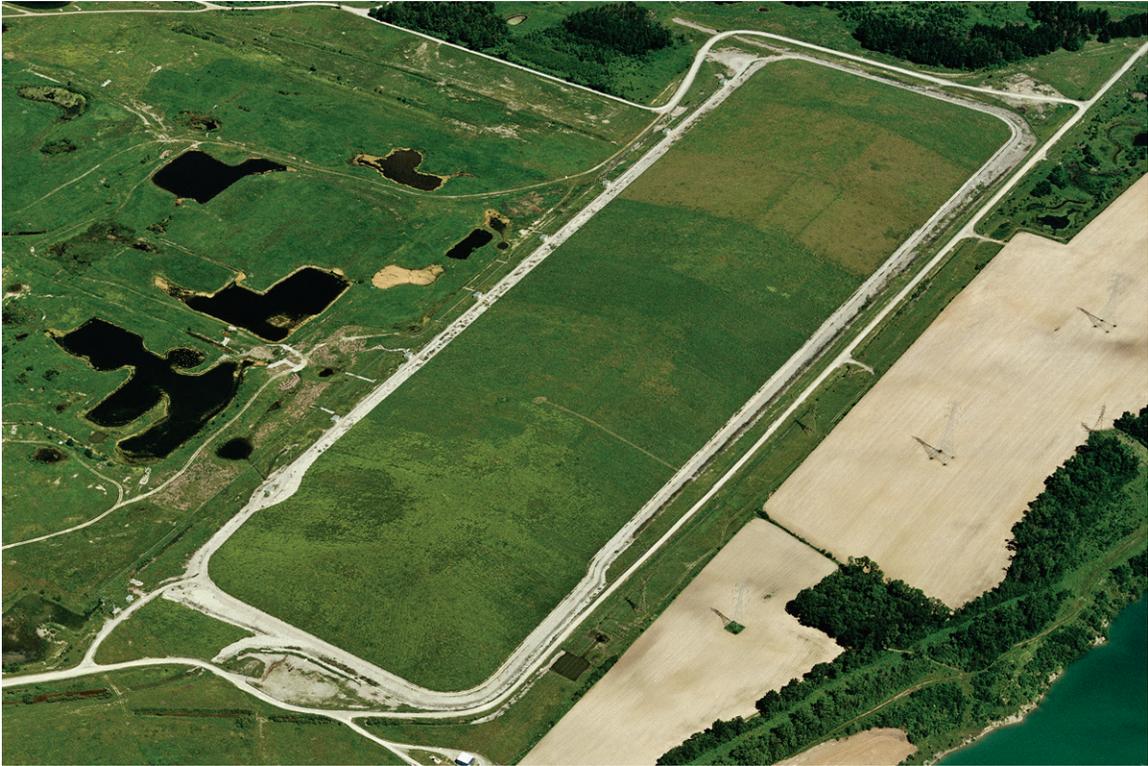
*Aerial Photograph of OSDF, June 2013*

Engineered features within the OSDF continue to perform as designed, indicating that a leak from the facility is not occurring. Leachate flow continues to diminish as expected, and leak detection system flow volumes indicate that the cell liners are performing well within design specifications.
