Monticello National Priorities List Sites Federal Facilities Agreement (FFA) Quarterly Report: July 1–September 30, 2009

This report summarizes project status and activities implemented July through September 2009, and provides a schedule of near-term activities for the Monticello Mill Tailings Site (MMTS) and the Monticello Vicinity Properties (MVP) sites. This report also includes disposal cell and Pond 4 leachate collection data, quarterly site inspection reports, site meteorological data, and a performance summary for the ex situ groundwater treatment system.

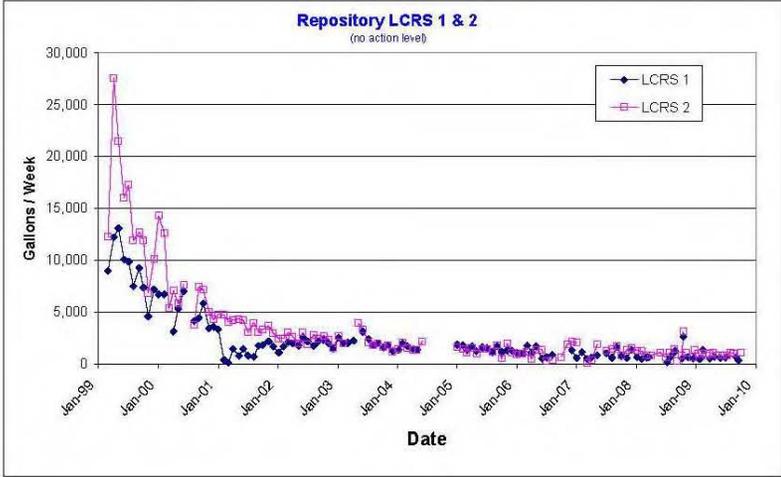
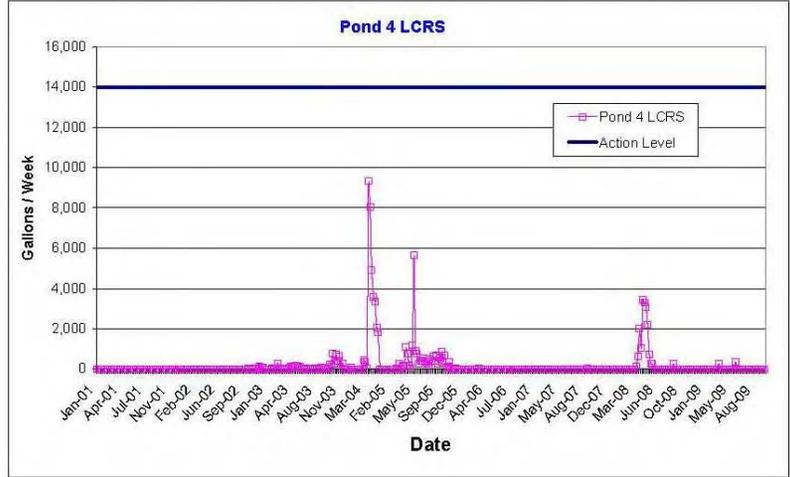
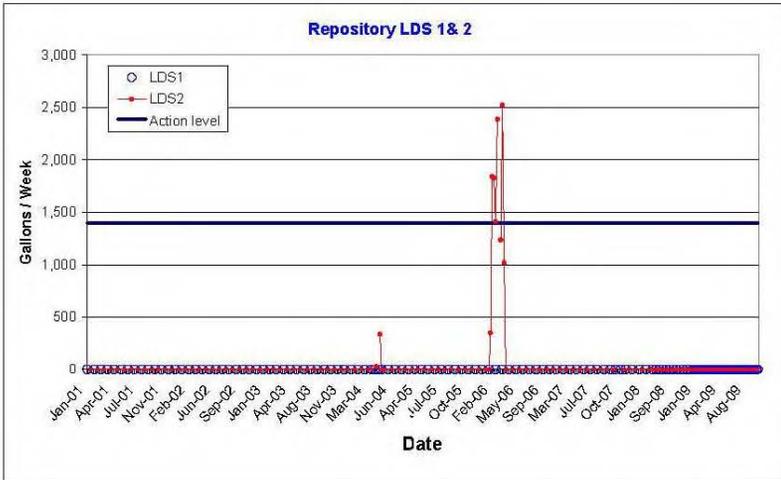
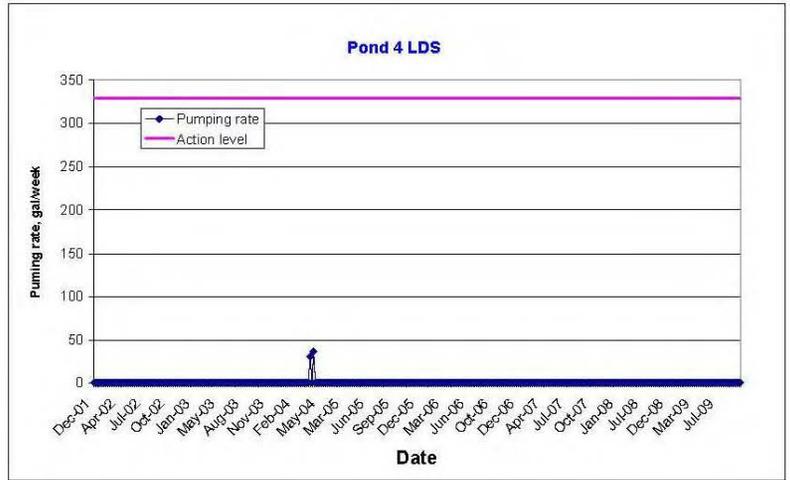
Graphs Showing Performance History for Repository and Pond 4 Leachate Collection and Recovery System (LCRS) and Leak Detection System (LDS)

- Repository leachate collection in the upper sumps (Leachate Collection and Recovery System [LCRS]) was normal for the quarter. Leachate continues to decrease in quantity from approximately 30,000 gallons per week in 2000 to current values of about 1,000 gallons per week per sump (see attached graph).

- Pond 4 LCRS operation was normal (no water collected during the quarter).
- Disposal cell and Pond 4 leachate collection in the lower sumps (Leachate Detection System [LDS]) remains at zero (see attached graphs).
