Monticello National Priorities List Sites Federal Facilities Agreement (FFA) Quarterly Report: October 1–December 31, 2009

This report summarizes project status and activities implemented October through December 2009, and provides a schedule of near-term activities for the Monticello Mill Tailings Site (MMTS) and the Monticello Vicinity Properties (MVP) sites. This report also includes disposal cell and Pond 4 leachate collection data, quarterly site inspection reports, site meteorological data, and a performance summary for the ex situ groundwater treatment system.

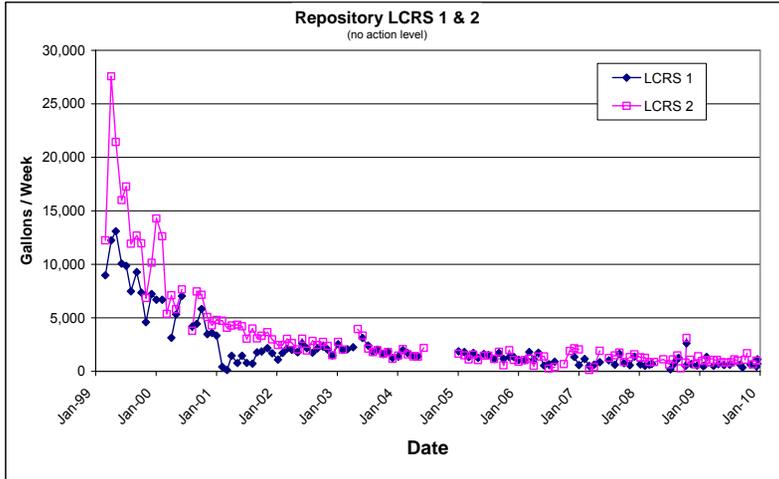
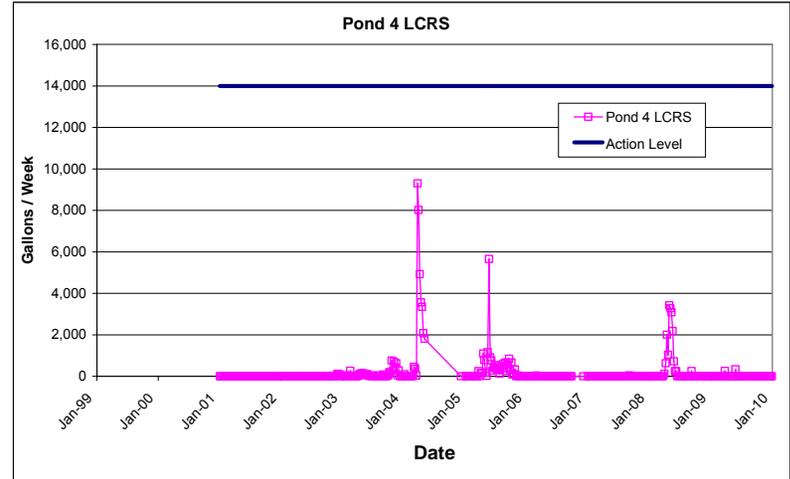
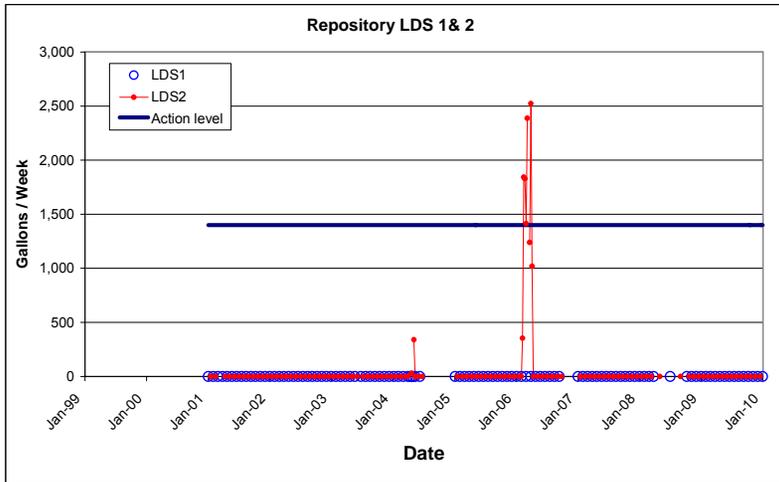
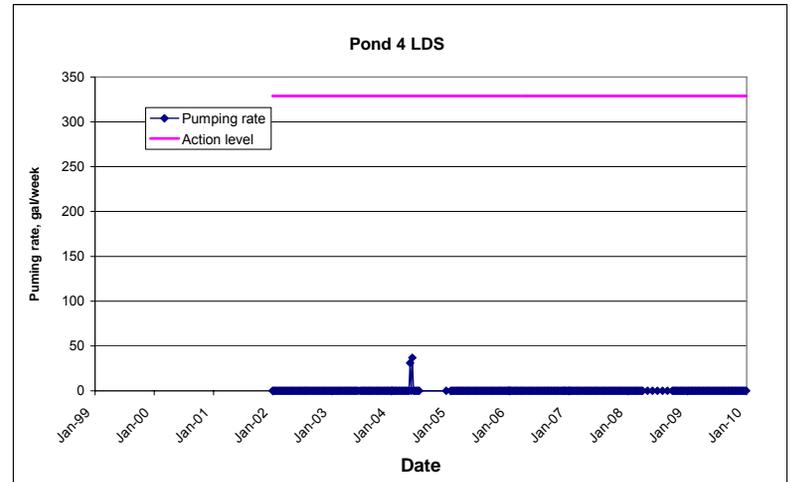
Graphs Showing Performance History for Repository and Pond 4 Leachate Collection and Recovery System (LCRS) and Leak Detection System (LDS) and Leak Detection System (LDS)

- Leachate Detection System [LDS]
 - Disposal cell and Pond 4 leachate collection in the lower sumps remains at zero (see attached graphs).
- Leachate Collection and Recovery System [LCRS]

- Repository leachate collection in the upper sumps was normal for the quarter. Leachate production has decreased in quantity from approximately 30,000 gallons per week following final waste encapsulation in 1999 to current values of about 1,000 gallons per week or less for each of the two sumps (LCRS 1 and LCRS2; see attached graph).

- Pond 4 LCRS operation was normal (no water collected during the quarter).

- LCRS 1 requires replacement of the water level transducer since July 2009. The transducer activates the sump pump at a specified water level in the sump. Health and safety evaluations were not completed in time for replacing the transducer in fall 2009. Health and safety evaluations have since been completed; however, heavy snow cover now prevents replacing the transducer. The LCRS 1 pump is operated manually each month until the transducer is replaced. All remaining repository and Pond 4 telemetry components are functional.
