**Final Remedial Action Report  
for Operable Unit 2 –  
Other Waste Units**

20000-RP-0003

**1.0: INTRODUCTION**

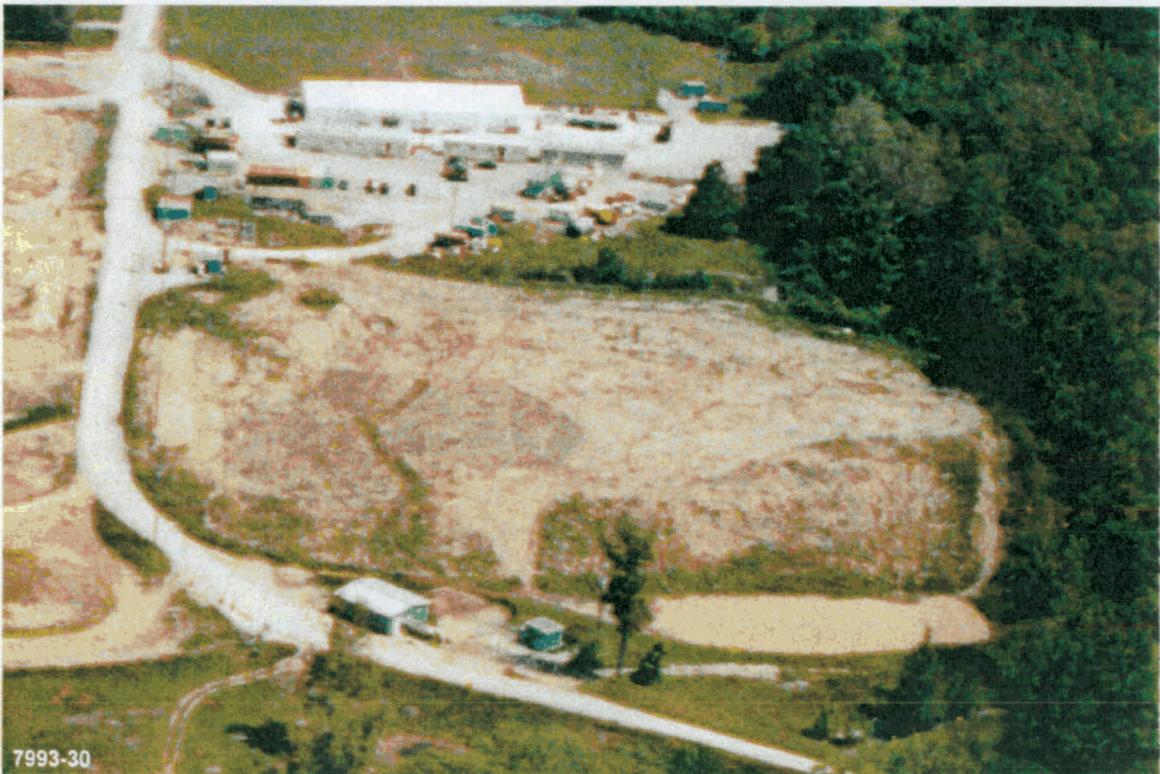
Operable Unit 2 Active Flyash Pile

After Excavation – Circa May 2003

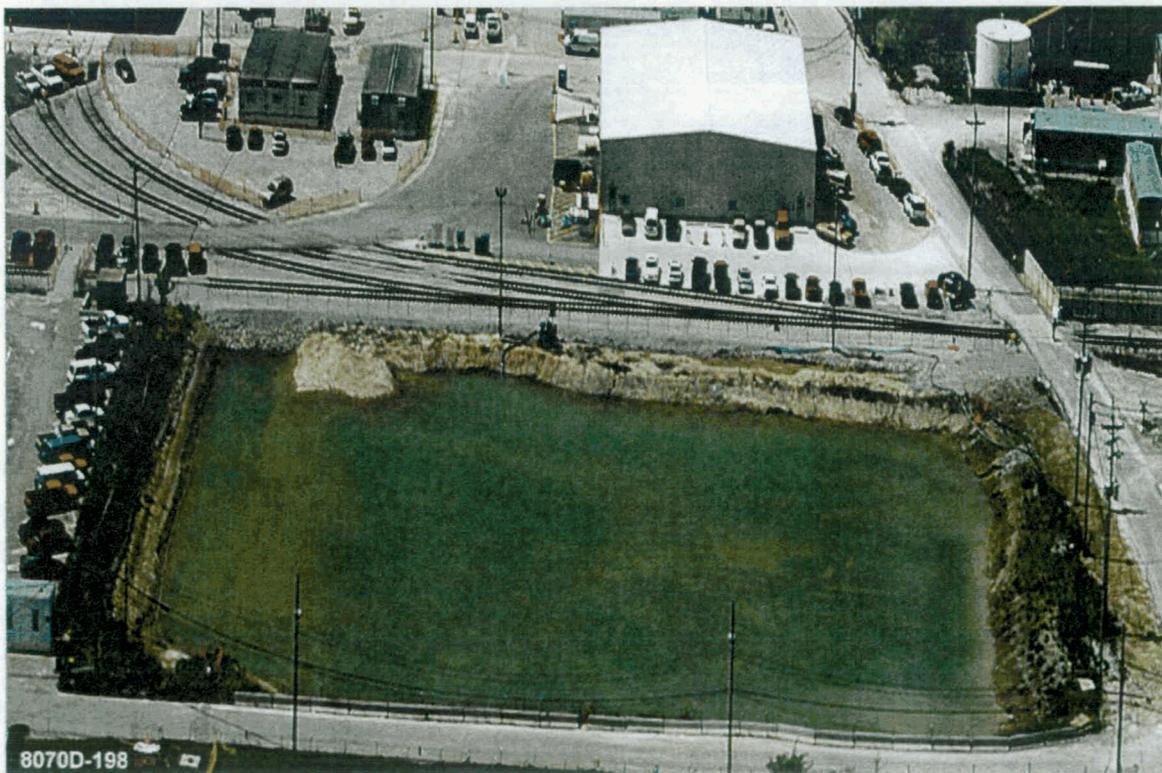
Operable Unit 2 Lime Sludge Ponds

After Excavation – Circa May 2004

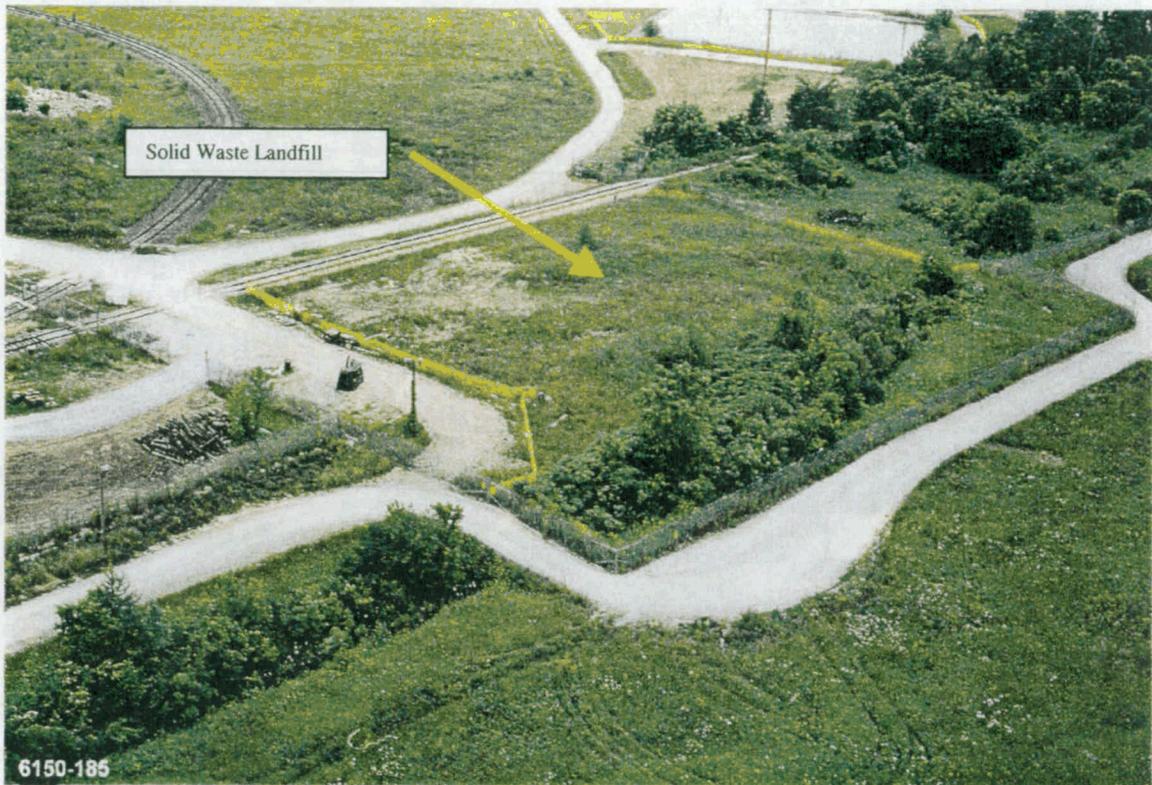
6150-185

Operable Unit 2 Solid Waste Landfill

Before Excavation – Circa June 2002

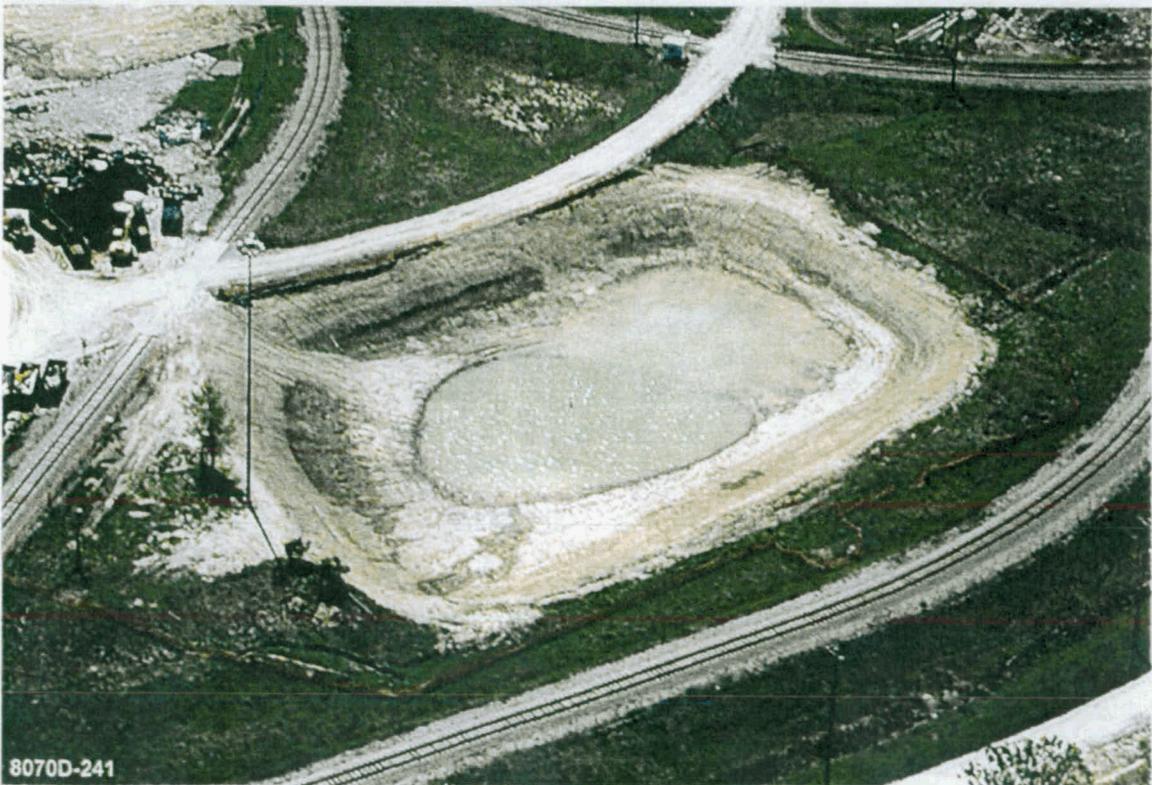
8070D-241

Operable Unit 2 Solid Waste Landfill

After Excavation – Circa May 2004

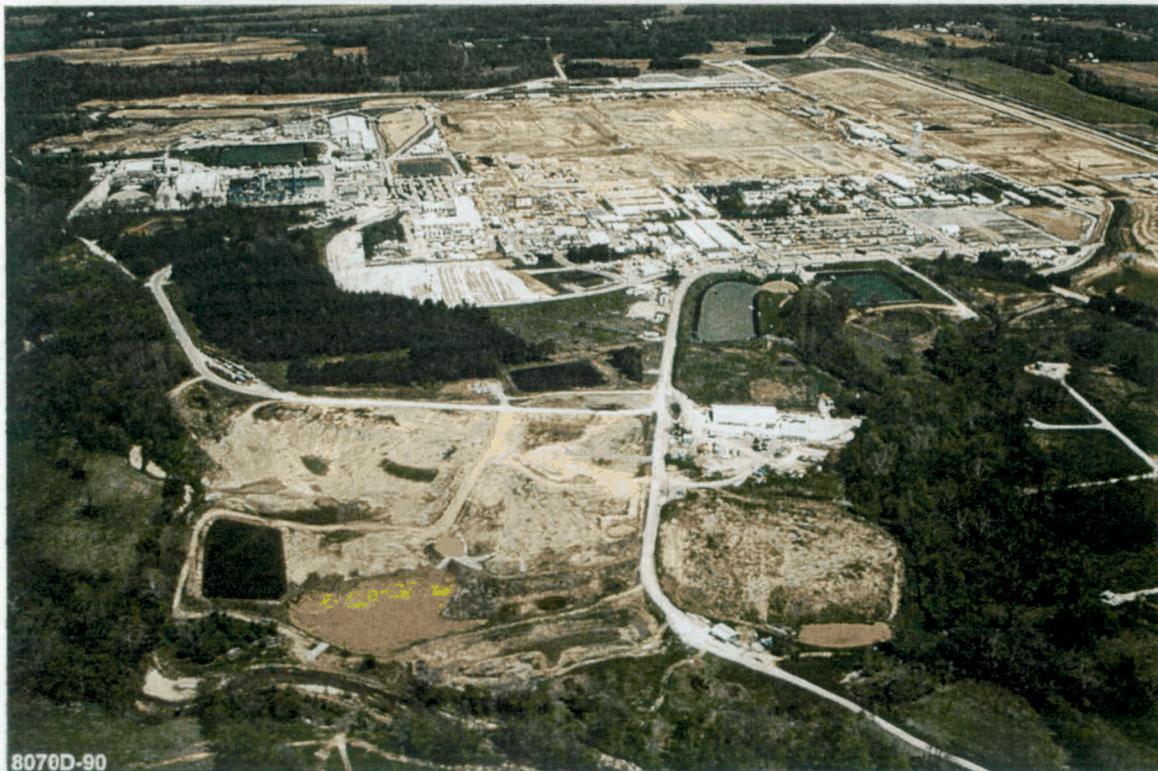
8070D-90

Operable Unit 2 Southern Waste Units
