# Annual Assessment of the Effectiveness of Site-Wide Institutional Controls Applied to the Former DOE Mound Site Property

June 2008

## Office of Legacy Management

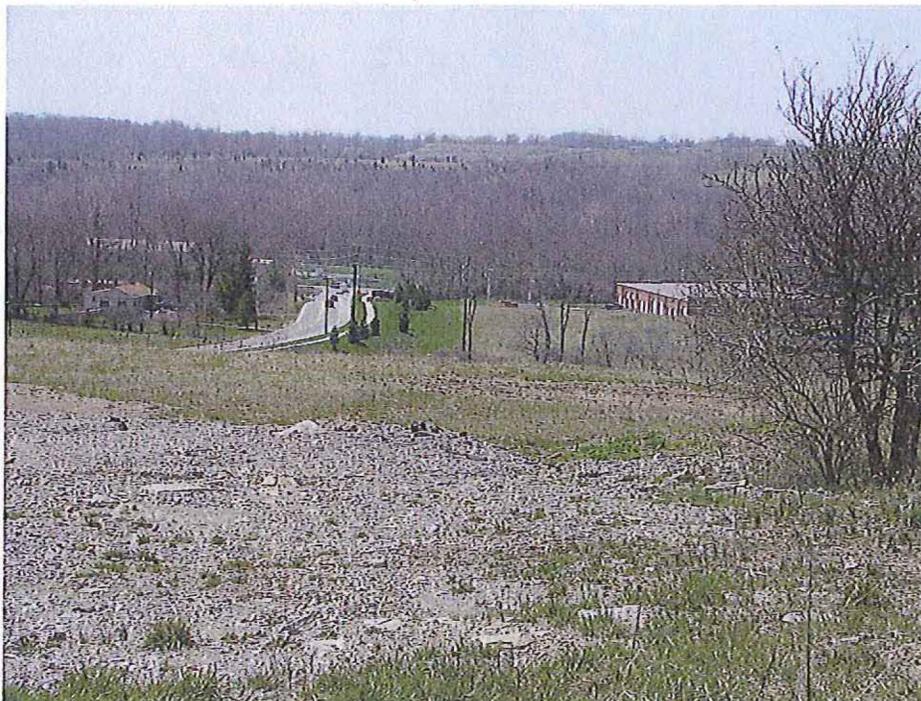
The Flex Building in the southwest corner of Parcel 4 is leased to a single tenant. The tenant's line of business is consistent with the City of Miamisburg's I-2 General Industrial District Zoning ordinance (Figure 9).

*Figure 9. Parcel 4 MMCIC Flex Building in Southwest Corner of Parcel 4  
(Near Benner Road and Old 25)*

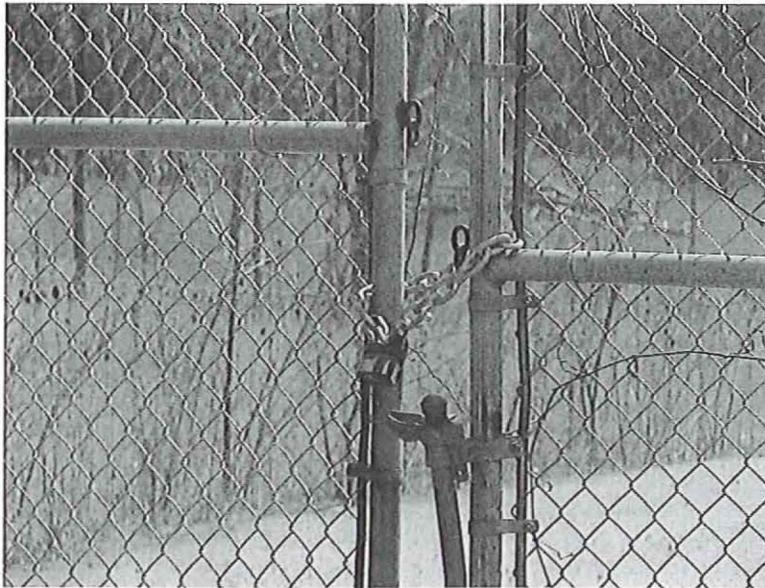
Unauthorized vehicular access to the old southeast construction road is still prohibited by a sidewalk installed along Benner Road. The northern entrance to this road is blocked by fencing and a locked gate (Figure 11).

*Figure 11. Parcel 4 Locked Gate, Facing South on Old Construction Road*

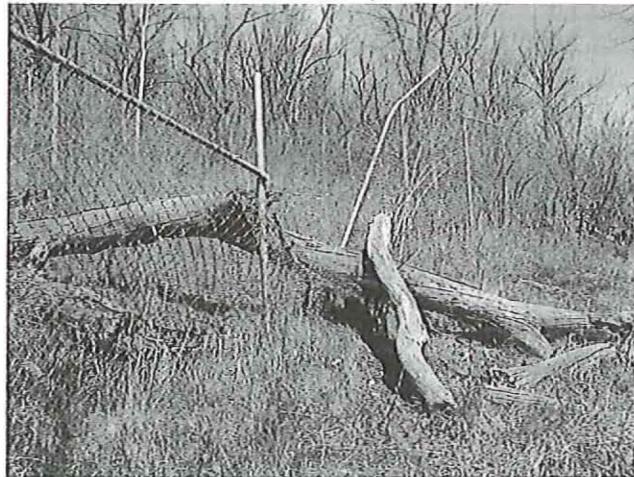
Figure 15. Parcel 4 Fallen Log Lying across Fence

As noted last year, the log was still lying across a damaged fence along the northern boundary of Parcel 4 near well 0444. The fencing is not part of the IC for that parcel (Figure 15).

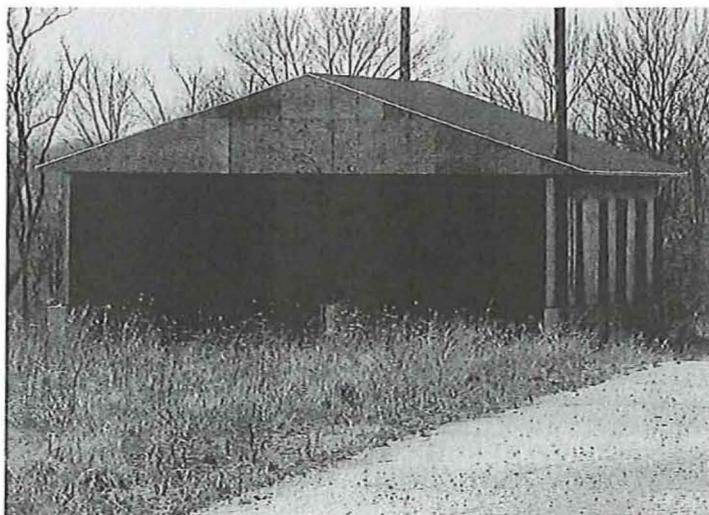
The salt storage shed and concrete pad in Parcel 1B remain empty, as shown in Figure 20.

*Figure 20. Phase 1B Empty Salt Storage Shed*

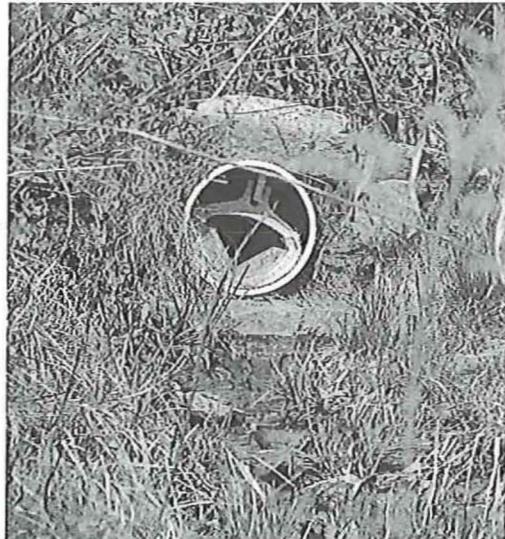
Wells 0411, 0442, and 0443 were locked, labeled, and in good repair, and Seep 0617 was in good condition (Figure 21, Figure 22, Figure 23, and Figure 24).

*Figure 24. Parcel IB Groundwater Seep 0617 in Good Repair*

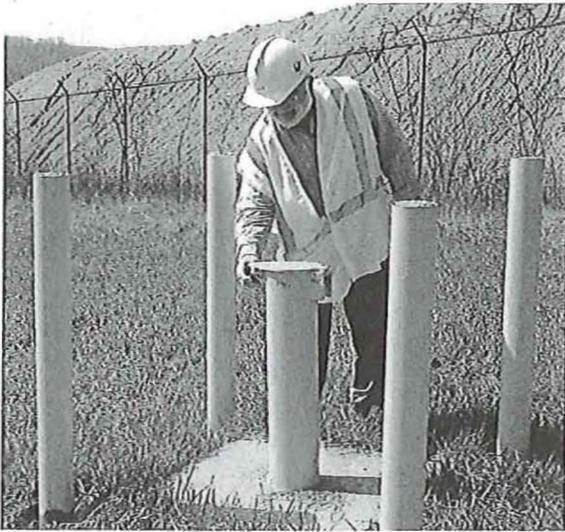
*Figure 25. Parcel IC Well 0445, Locked, Labeled, and in Good Repair. Art Kleinrath in photo*

Well 0445 was locked, labeled, and in good repair (Figure 25).
