MOUND PLANT

Potential Release Site Package

PRS # 17

**MOUND PLANT
PRS 17
OIL BURN STRUCTURE**

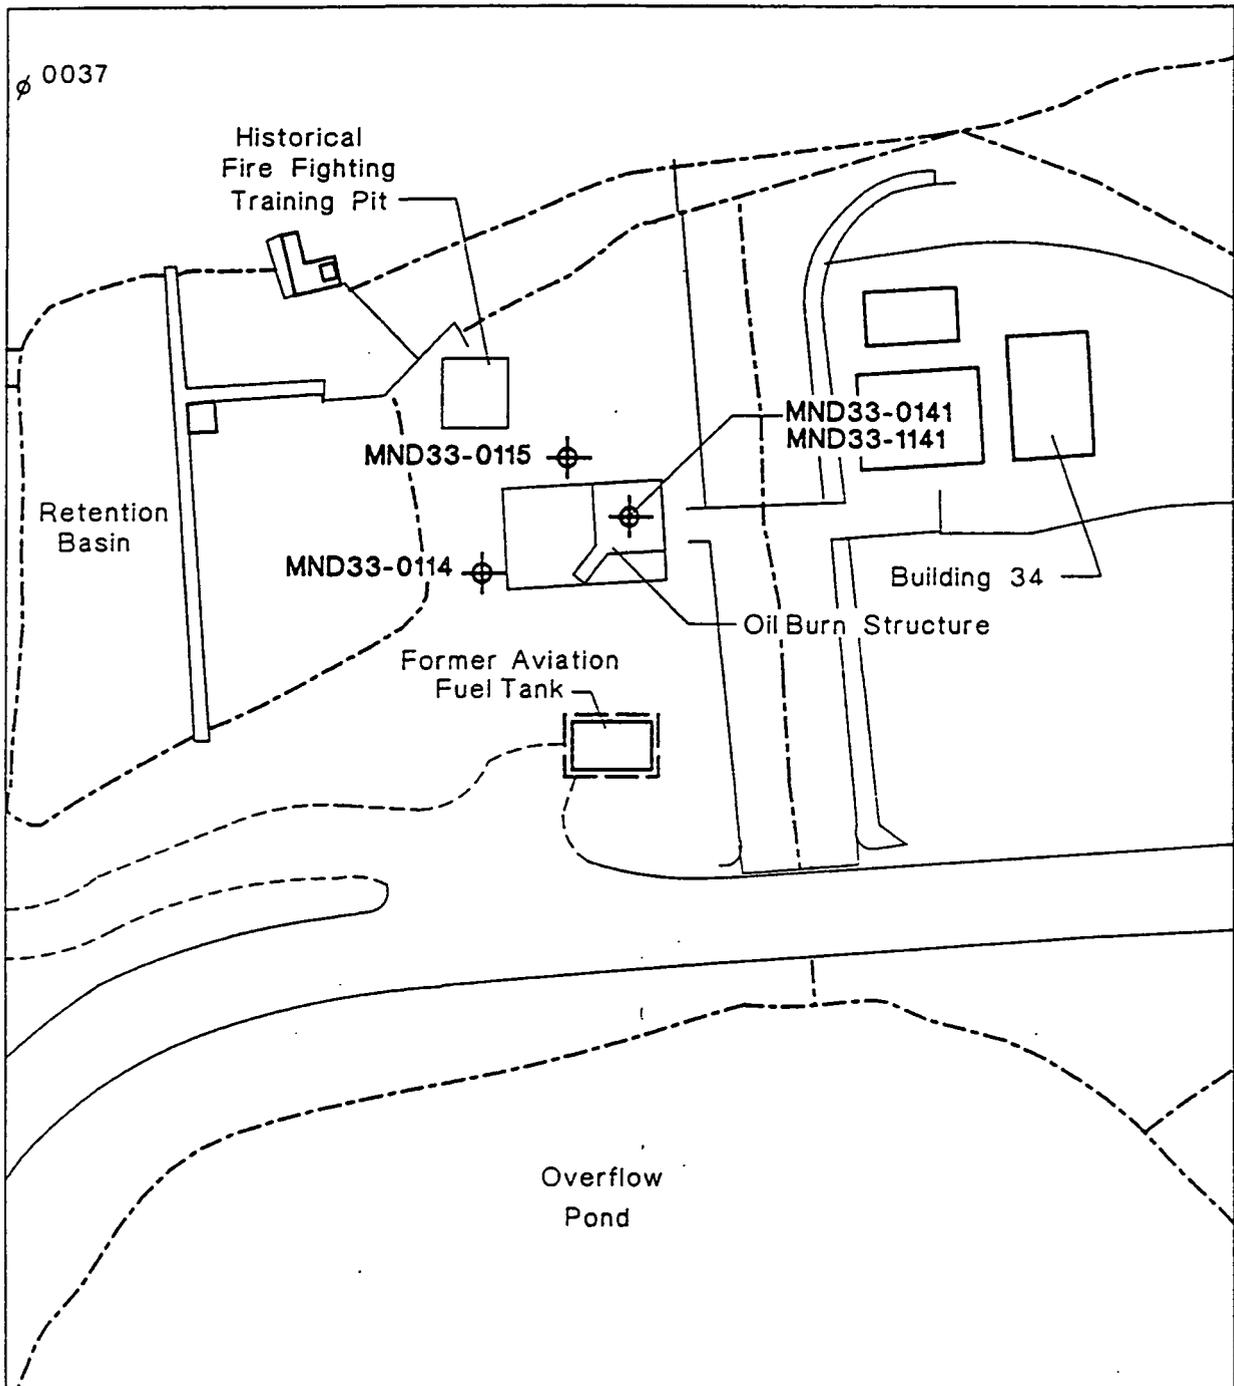
Figure 2.12(b). Building 34 Oil Burn Structure soil sample locations.

The objective of sampling at the Building 34 Oil Burn Structure was to assess whether the site is or has been a source of hazardous contaminant releases to the environment. The Building 34 Oil Burn Structure sampling activities were conducted by hollow stem auger drilling techniques and surface sampling with a stainless steel scoop. Surface water was also collected for laboratory analyses from inside the oil burn structure. Soil sample collection from two boreholes at the Building 34 site was conducted by WESTON representatives on 27 and 28 January 1992. Soil boring locations are shown in Figure 2.12(b). The soils in the vicinity of the Building 34 Oil Burn Structure are generally composed of a gravelly, silty, sandy clay to a gravelly silty clay to a depth of 11.0 ft BGS. Groundwater was not encountered in the soil borings during sampling. Groundwater was encountered nearby at the Building 34 Fire-Fighting Training Pits soil boring MND33-0112 at a depth of approximately 12.0 ft BGS. Sampling of surface water and sediment at the oil burn structure was conducted on 20 February 1992. All samples were shipped to IT Laboratories for analysis. A summary of samples collected at each location listing the sample identification number, sampling depth interval, date sampled, and requested analytical parameters is presented in Table II.12.

Two soil borings (five samples, one duplicate), one sediment sample, and one surface water sample was collected at the oil burn structure to assess potential environmental releases of contaminants during previous site activities. All soil samples from the oil burn structure were analyzed for TCL VOCs, SVOCs, P/PCBs; TAL inorganics; dioxin/furans; lithium; and EPH. In addition, soil samples MND33-0114-0001 and -0002; and MND33-0115-0001 and 0002 were analyzed for radionuclides using gamma spectroscopy, and soil sample MND33-0115-0002 was analyzed for nitrite/nitrate. The sediment sample collected from within the oil burn structure was analyzed for TCL VOCs, SVOCs, P/PCBs; TAL inorganics; dioxin/furans; lithium; EPH; and gamma spectroscopy. The surface water sample collected from within the oil burn structure was analyzed for TCL VOCs, SVOCs, P/PCBs; TAL inorganics; dioxin/furans; lithium; and EPH. The validated analytical results for all analytes detected above laboratory reporting limits for each sample analyzed are presented in Table III.16.

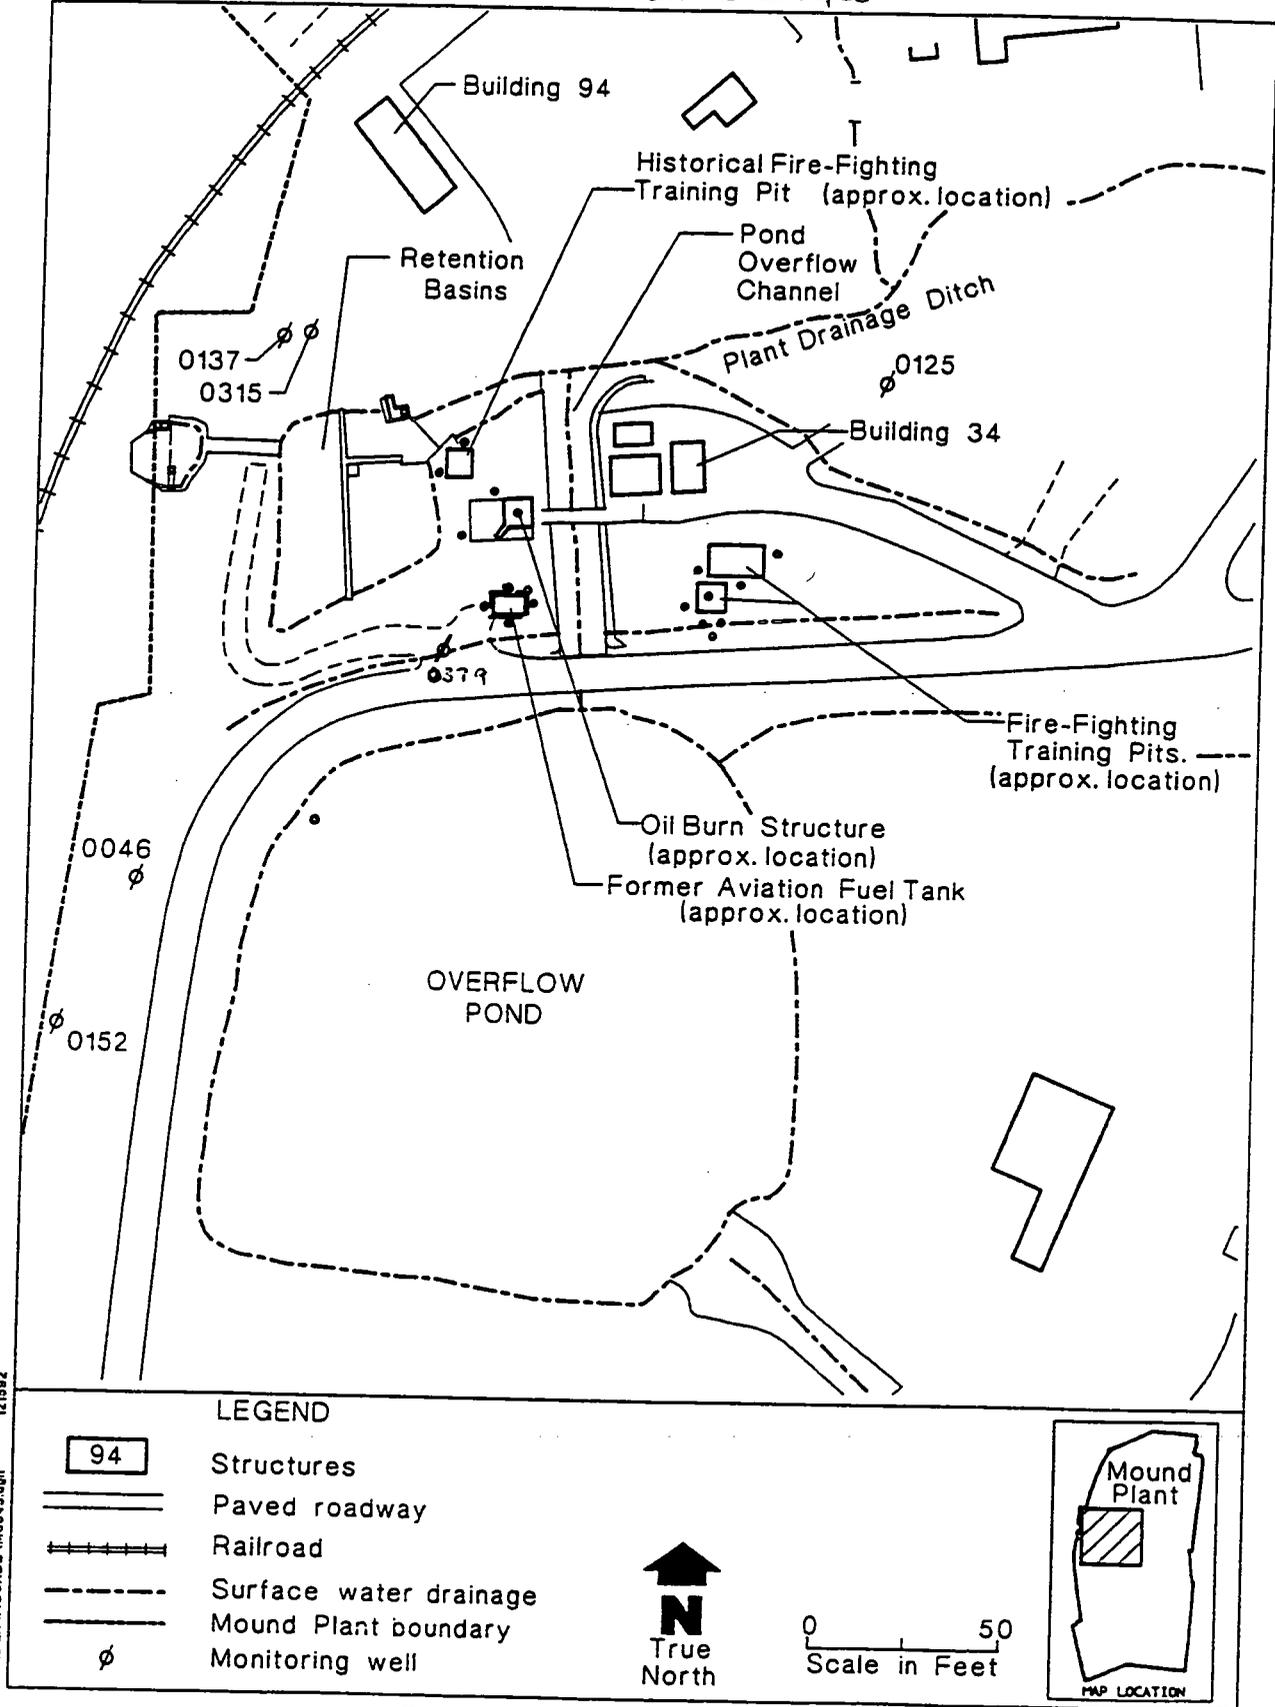
Figure 2.12(a). Building 34 sites.

The Building 34 Oil Burn Structure is located west of Building 34, east of the retention basin, and north of the Building 34 Former Aviation Fuel Tank (Figure 2.12(a)). The Building 34 former Aviation Fuel Tank, which was located approximately 50 ft from the oil burn structure, supplied aviation fuel through underground lines to the oil burn structure. The underground lines were located on the west side of the channel to the overflow pond. As part of the removal activities for the Building 34 former Aviation Fuel Tank, an assessment of the underground line was conducted by Bowser-Morner (Bowser-Morner 1991). Elevated PID readings up to 160 units were reported by Bowser-Morner at a location east of the tank near the values for the test fire units. The oil burn structure was used to test barrels against shipping requirements by burning with a fuel fire for 15 minutes.

Building 34 is located in the lower valley area of the Mound Plant Site (Figure 2.12(a)). Building 34 was constructed in 1965 near the container testing facility to serve as a center for training emergency personnel. There are four sites associated with Building 34; the oil burn structure, the fire-fighting training pits, the

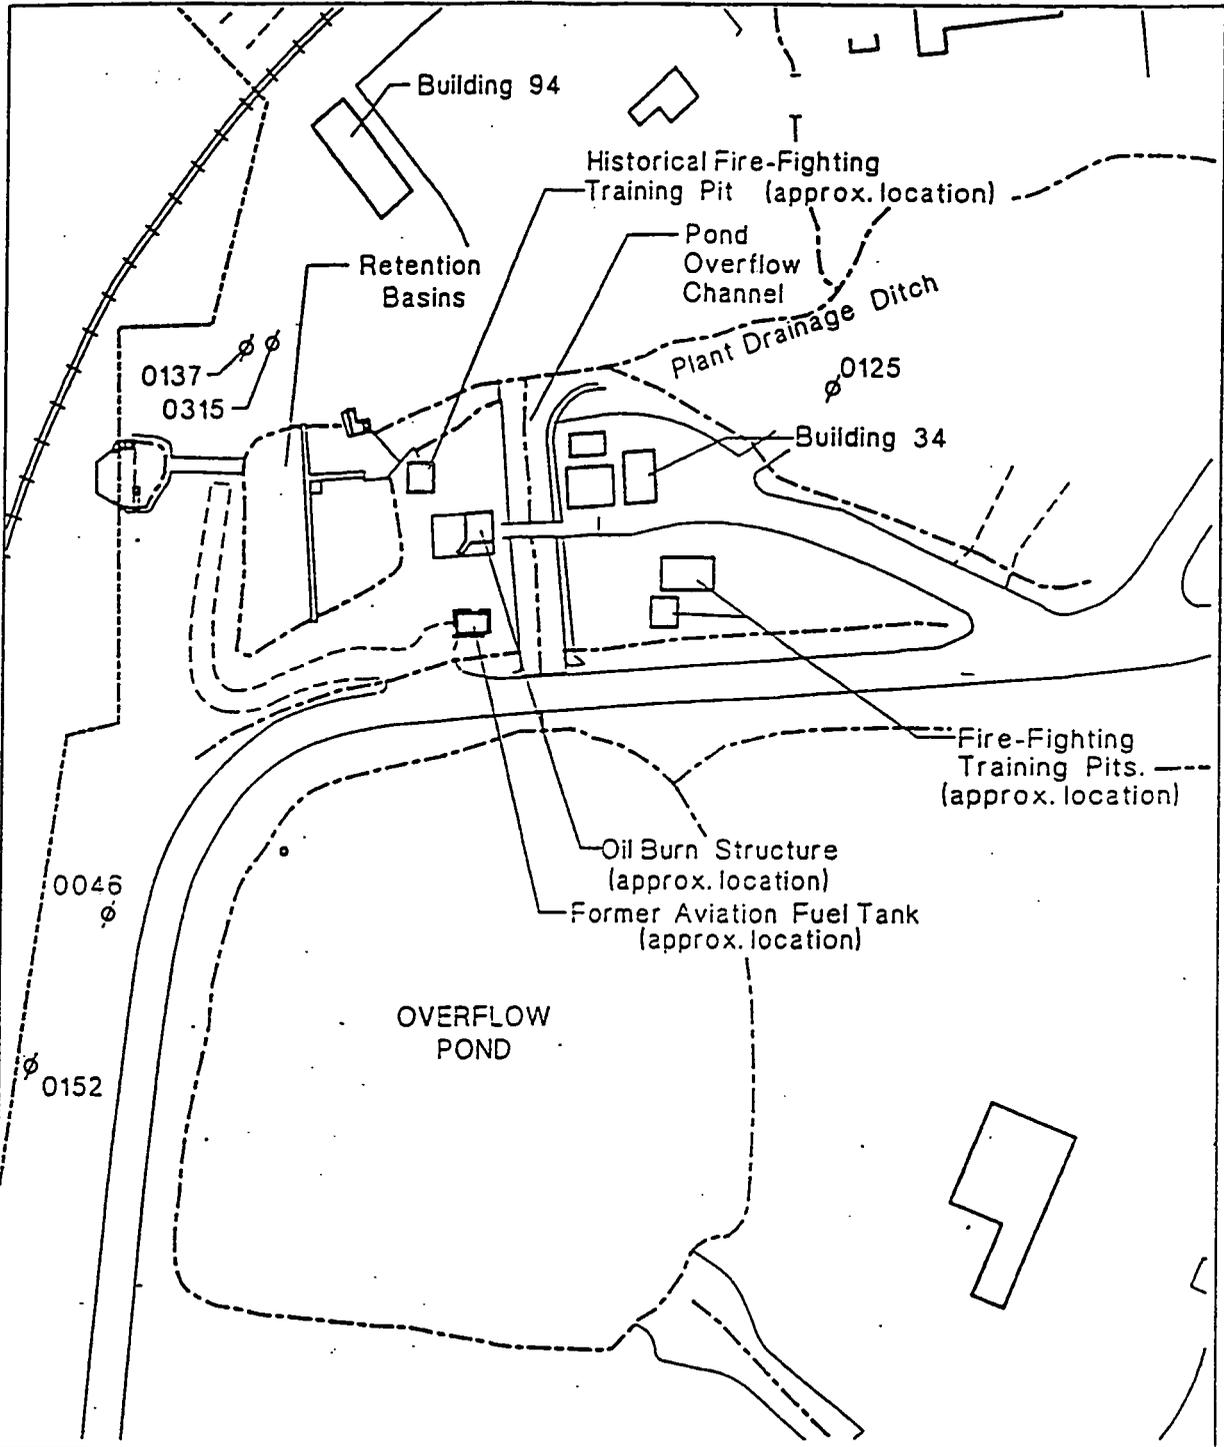
Figure 1 Building 34 sites.

Soil, sediment, and surface water sampling for dioxin/furan analyses was conducted at the Building 34 Oil Burn Structure, the Building 34 Fire-Fighting Training Pits, and the Building 34 Historical Fire-Fighting Training Pit (OU3 Limited Field Investigation Report) as requested by the U.S. EPA. Dioxin/furan analyses were requested at sites where the burning of solvents and oils may have occurred (Figure 1). Soil samples from boreholes in OU1 were also analyzed for dioxin and furans (OU1 Remedial Investigation Report).

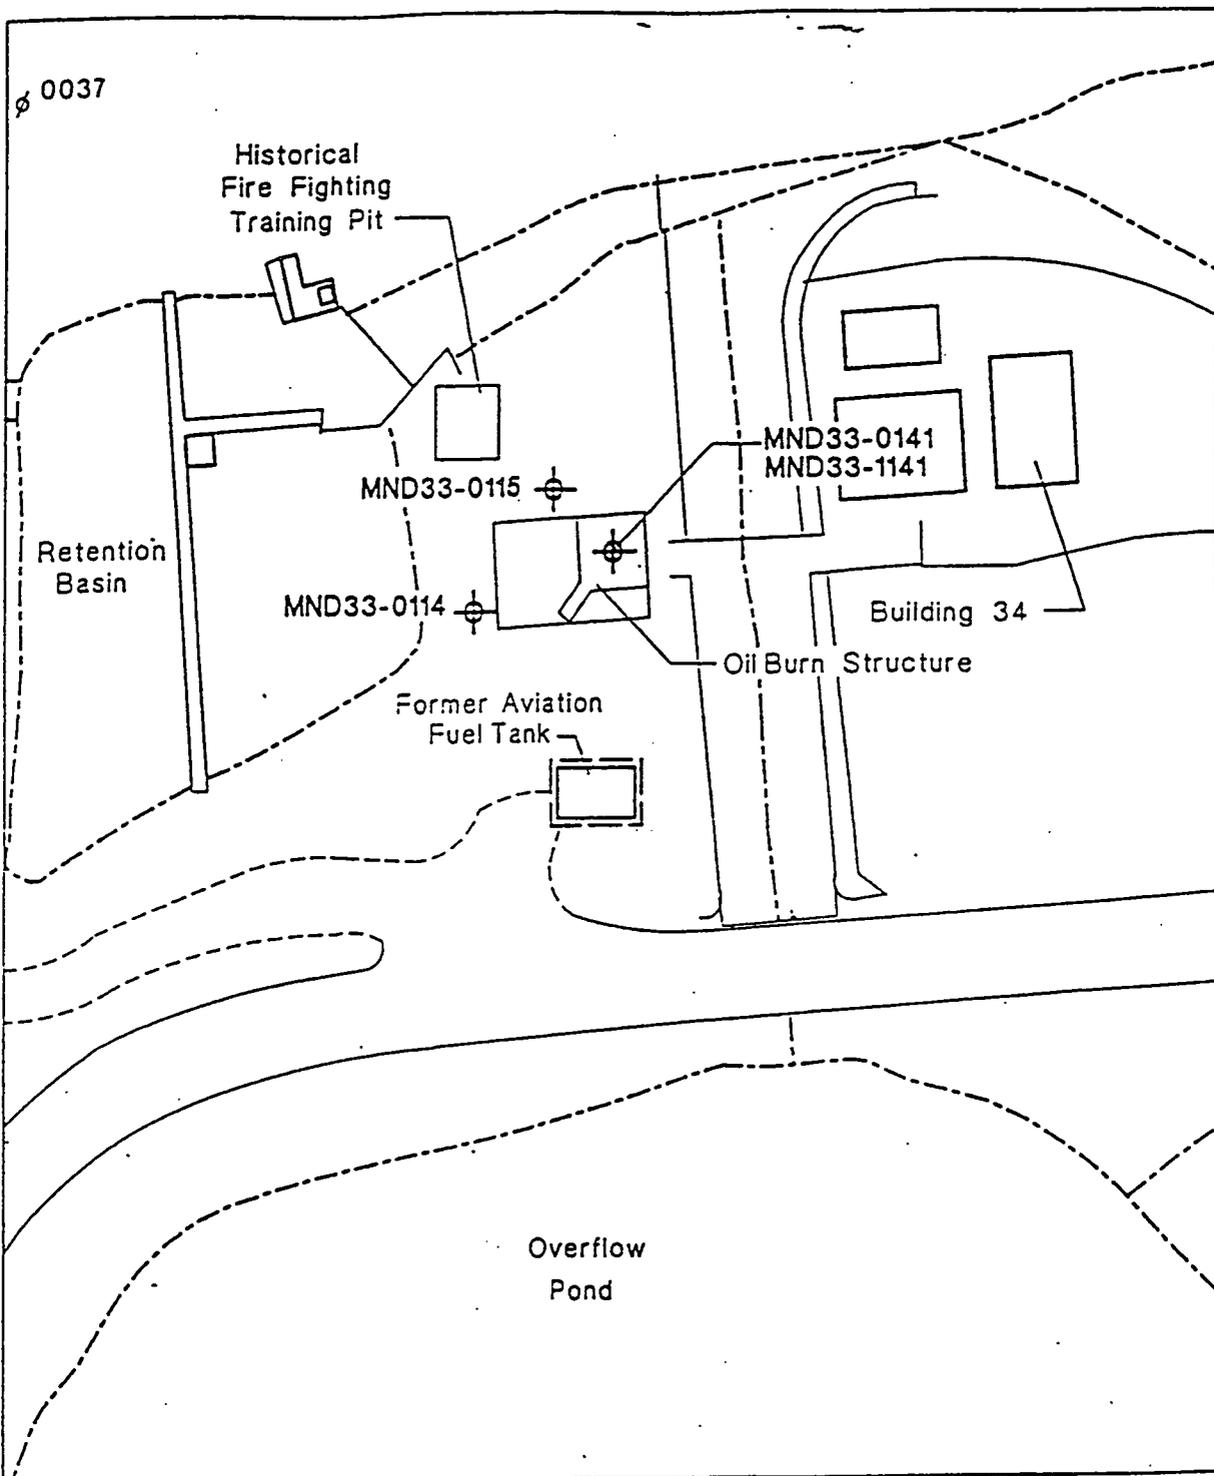
Figure 2 Building 34 Oil Burn Structure soil sample locations.

Dioxins and furans were not detected in any of the 7 surface water and groundwater samples analyzed under OU3 investigations. Out of the 31 soil and sediment samples collected (Appendix I), only 4 samples had detectable dioxin/furan concentrations (Table 1). The TEF adjusted concentration values (EPA 1989) are all well below the typically proposed (CDC guidelines, Paustenbach *et al*, 1986) action levels of 1 ppb (1000pg/g) for surface soils (within 1 ft of the ground surface). Proposed action levels are typically 20-25 ppb for contaminants deeper than 1 ft. The locations of all samples are shown in figures 2, 3, 4.
