MOUND PLANT Potential Release Site Package PRS # 345

PRS 345 is the Former Equipment Storage Area. Prior to the 1960s there were two farm buildings located in the area described as PRS 345.² These buildings were demolished in the early 1960s. This location became a PRS in 1980s when the grassy field was used as a contractor's equipment yard and staging area for nonhazardous material, such as semi-trailers and rebar. Storage of contractor's equipment was discontinued in the 1990s.³ It remained an undeveloped grassy area until the Environmental Restoration Group constructed a Bioremediation Facility on the area in 1995.

**MOUND PLANT
PRS 345
FORMER EQUIPMENT STORAGE SITE
NEAR AREA C**

**OPERABLE UNIT 9 SITE SCOPING REPORT:
VOLUME 12 – SITE SUMMARY REPORT**

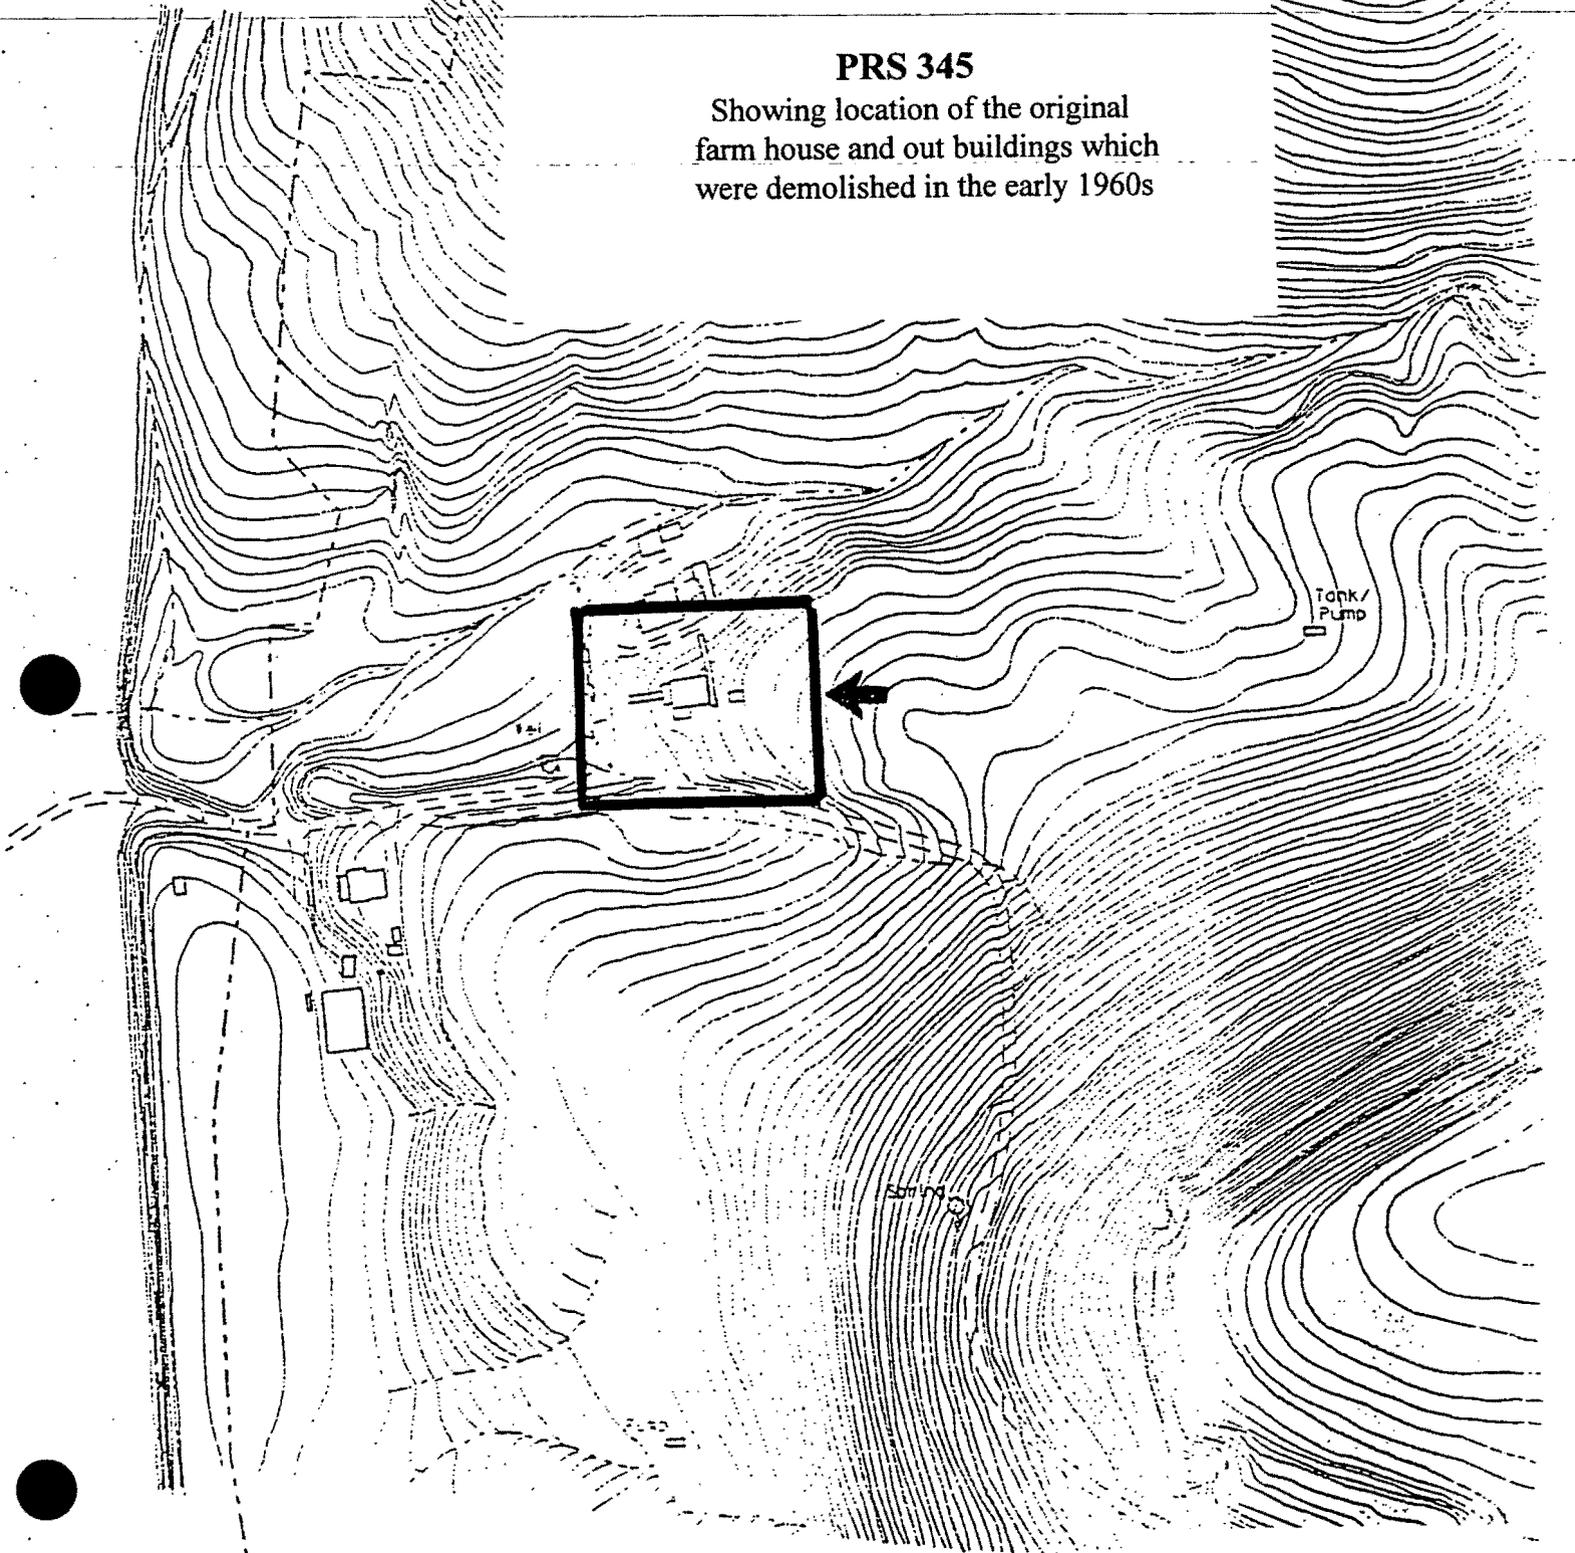
PLATE 3

Historic Topographic Map
of Main Hill, 1946

PRS 345

Showing location of the original
farm house and out buildings which
were demolished in the early 1960s

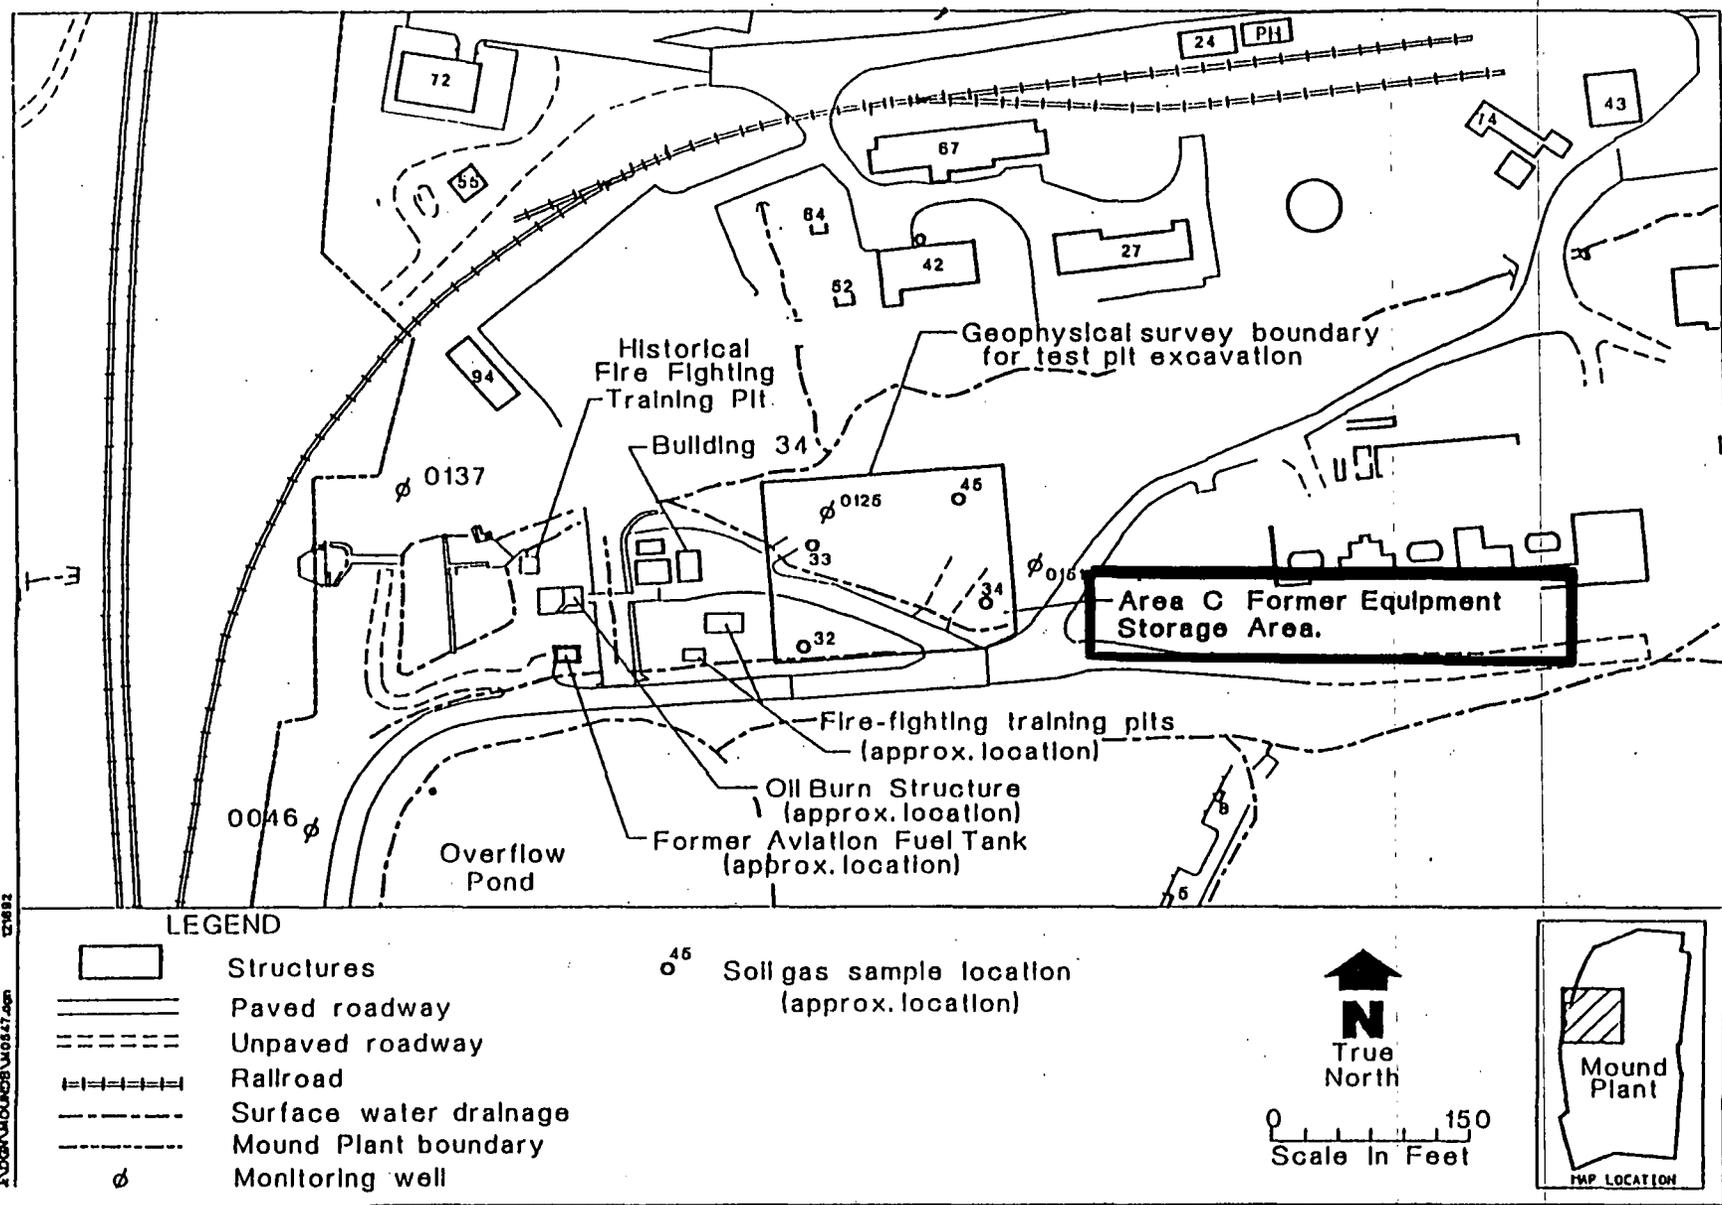
Figure 2.16(a). Area C Former Equipment Storage area.

Area C is located in the Mound Plant lower central valley (Figure 2.16(a)). "Area C" is the name given to a site where lithium carbonate containers were treated and disposed of. From its identification by the CEARP Program in 1986 through mid 1991, this area was believed to be in the location described in the OU 3 Work Plan, east of Building 34, as shown in Figure 2.16(a). However, in 1991 it was determined that the disposal area was more nearly centered around the current location of Building 34. In this subsection, the investigation of the erroneously located "Area C" is described. This area was investigated despite new information about its correct location, because geophysical surveys had identified subsurface anomalies in the area.

In the 1980s, Area C was a grassy field that was used as a contractors' equipment yard and staging area for nonhazardous material, such as semi-trailers and rebar. Storage of contractors' equipment was discontinued in the area in the 1990s and the area currently is an undeveloped grassy field. Structures west of Area C include Building 34, a drop tank, a submergence tank, and a test burn facility. The Building 34 Oil Burn Structure, Former Aviation Fuel Tank, Fire-Fighting Training Pits, and retention basins are also located to the west of Area C.

Located within Area C is monitor well 0125. Located to the east of Area C and southwest of the former location of Old Building 72 is monitor well 0151 as shown in Figure 2.16(a).

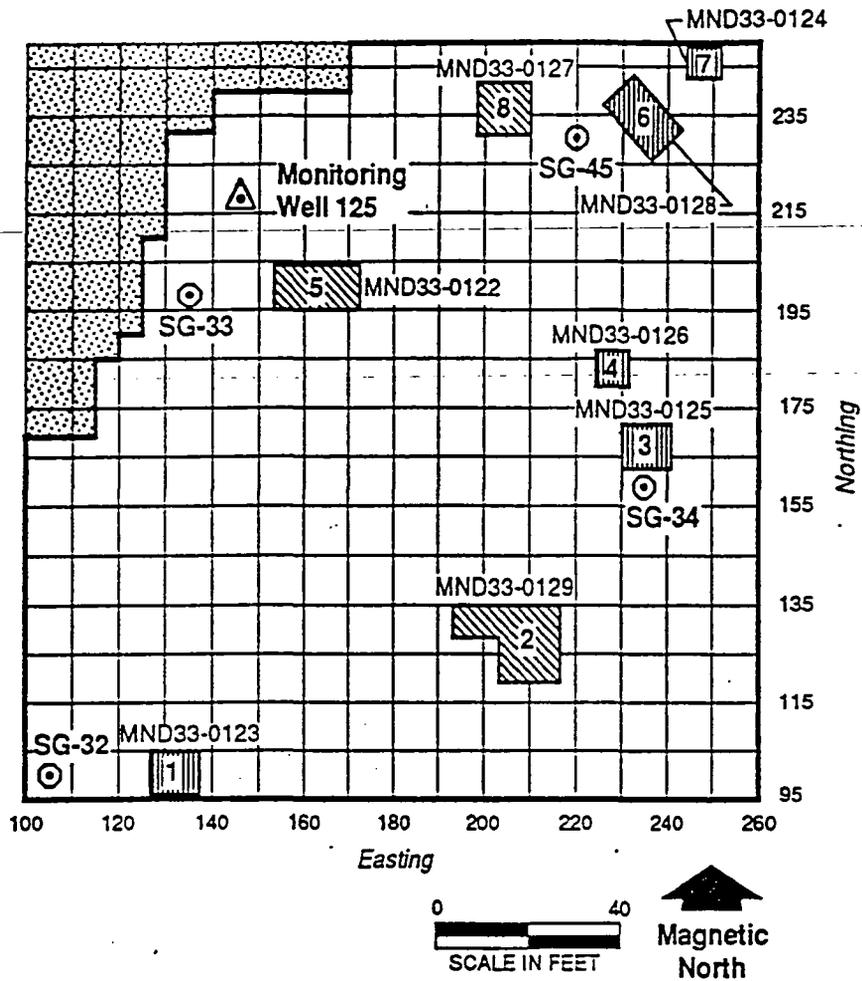
Figure 2.16(b). Area C Former Equipment Storage Area test pit locati

A geophysical investigation was performed in Area C using two techniques, ground penetrating radar (GPR) and magnetic measurement. The objective of the geophysical investigation was to identify locations in Area C where ferrous metal objects were buried. Magnetic anomalies were detected at eight locations in Area C as shown in Figure 2.16(b). Only three of the anomalies were associated with the objects detected on the GPR records. Five of the magnetic anomalies presented in Figure 2.16(b) were located in close proximity to the four soil gas sample stations.

excavations using a backhoe. The test pit areas were marked according to coordinates as stipulated in the Work Plan and are shown on Figure 2.16(b). Excavation work was conducted by WESTON representatives from 31 January to 4 February 1992. Test pit excavations were performed according to Work Plan guidelines. Three of the test pits (nos. 2, 5, and 8) were associated with anomalies found using GPR techniques. The remaining test pits (nos. 1, 3, 4, 6, and 7) were associated with the anomalies found during the magnetic survey.

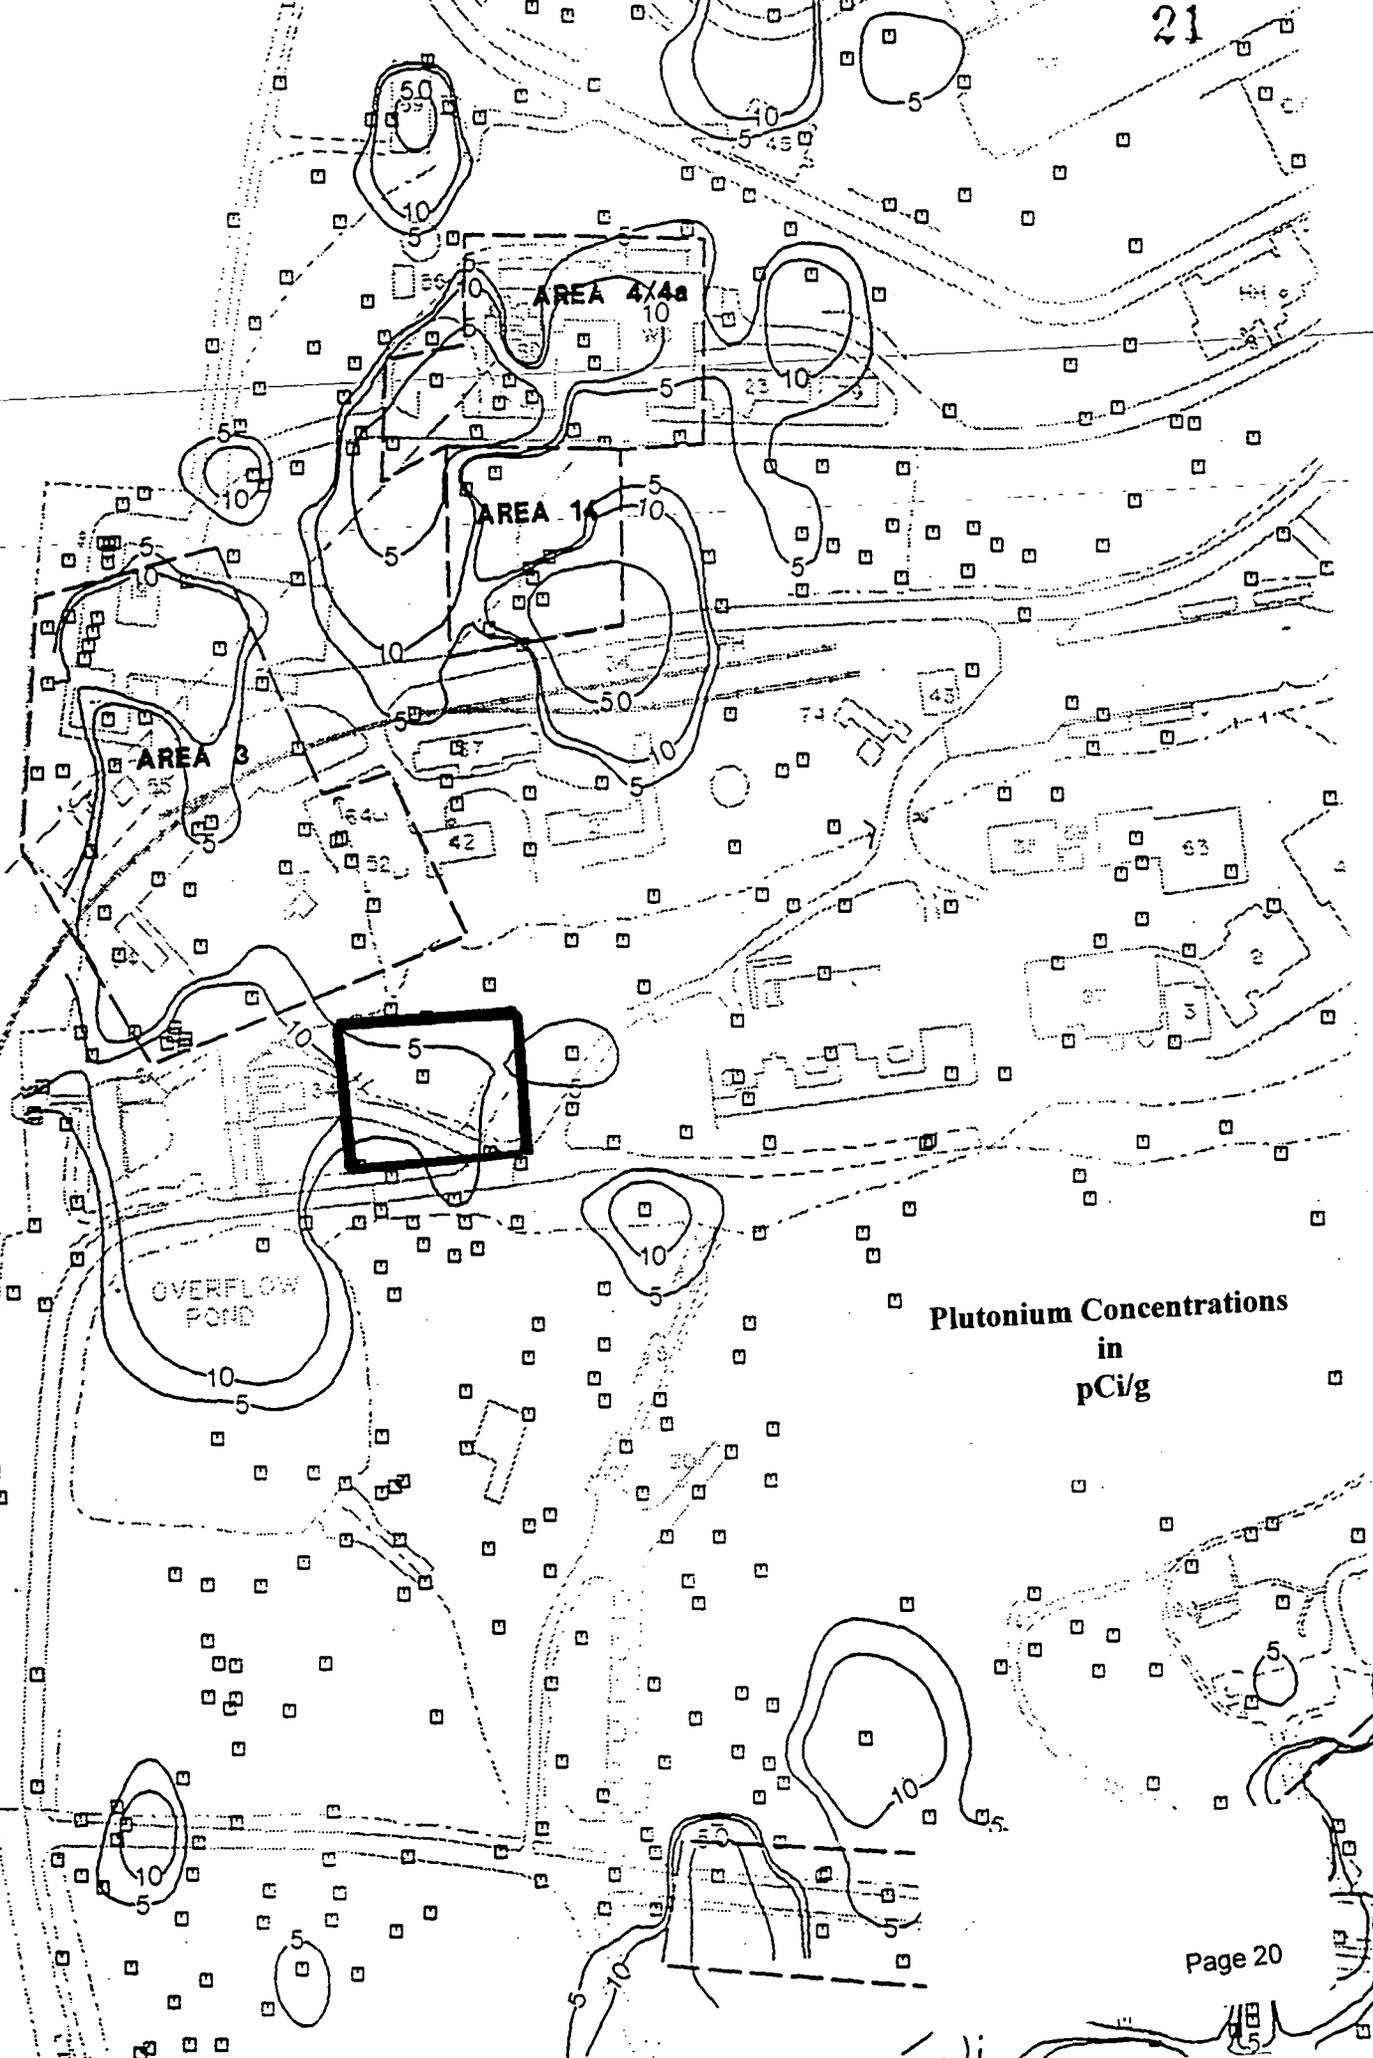
PLATE 4
Site Survey Project
Plutonium Concentrations

Plutonium Concentrations
in
pCi/g

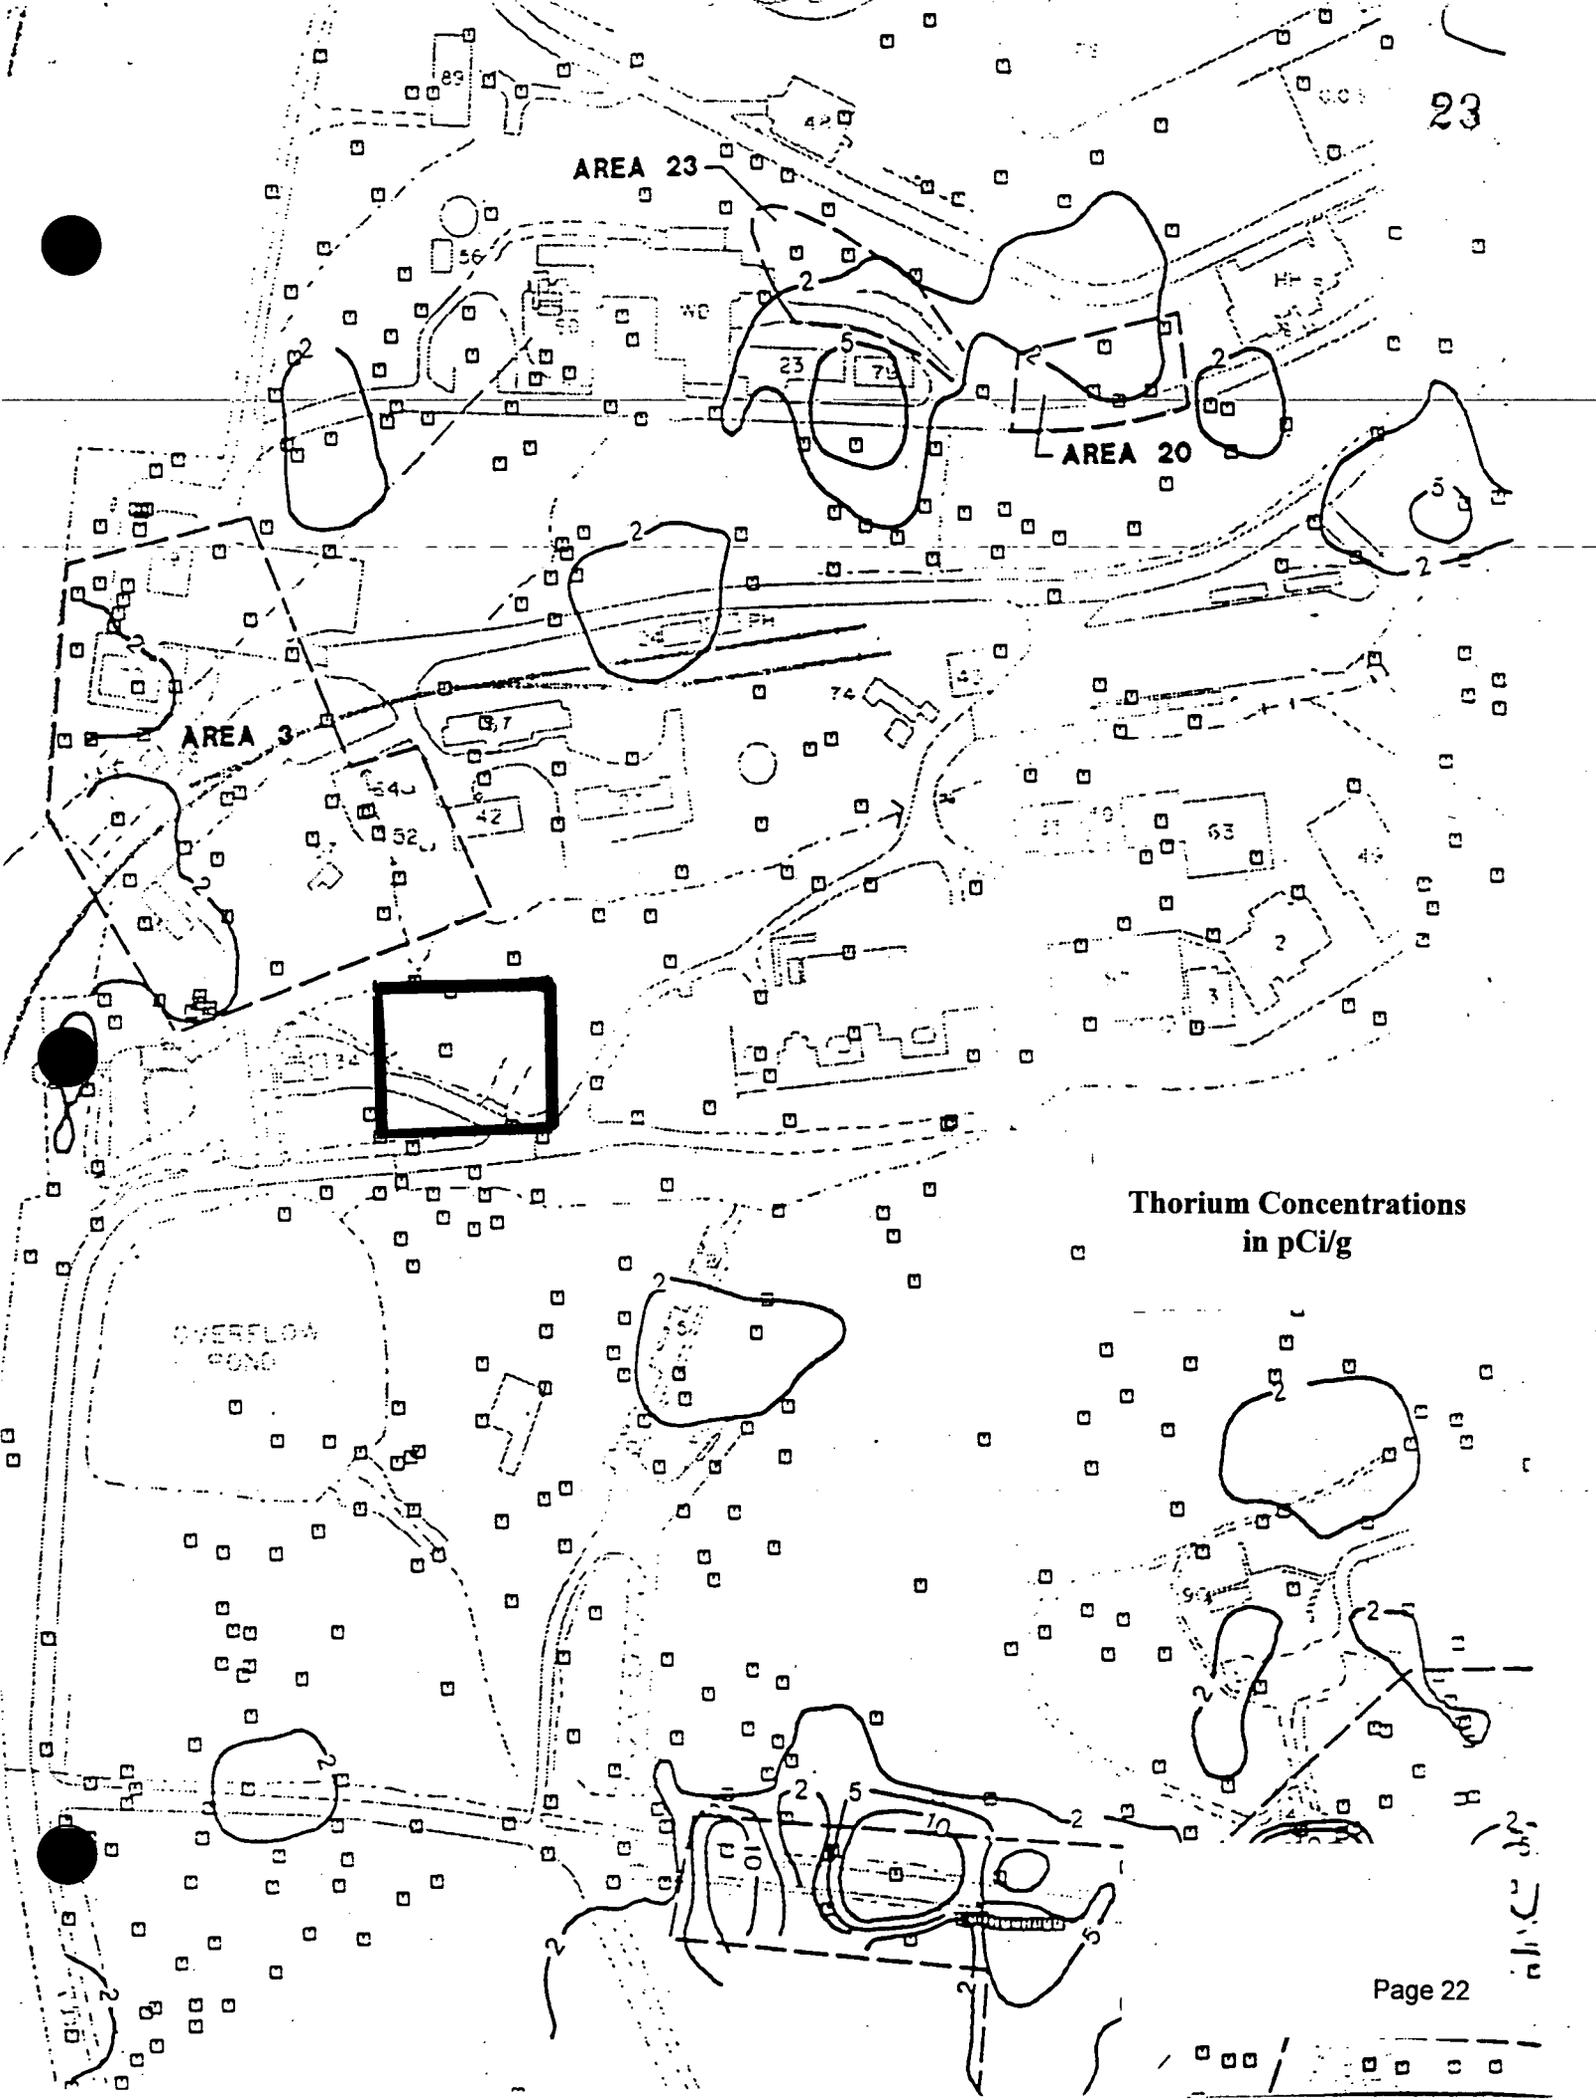
PLATE 5
Site Survey Project
Thorium Concentrations

Thorium Concentrations
in pCi/g
