## Potential Release Site Package

### PRS # 272

PRS 272

**MOUND PLANT  
PRS 272  
CONCRETE DEBRIS DISPOSAL SITE  
AREA 10 (SM/PP HILLSIDE)**

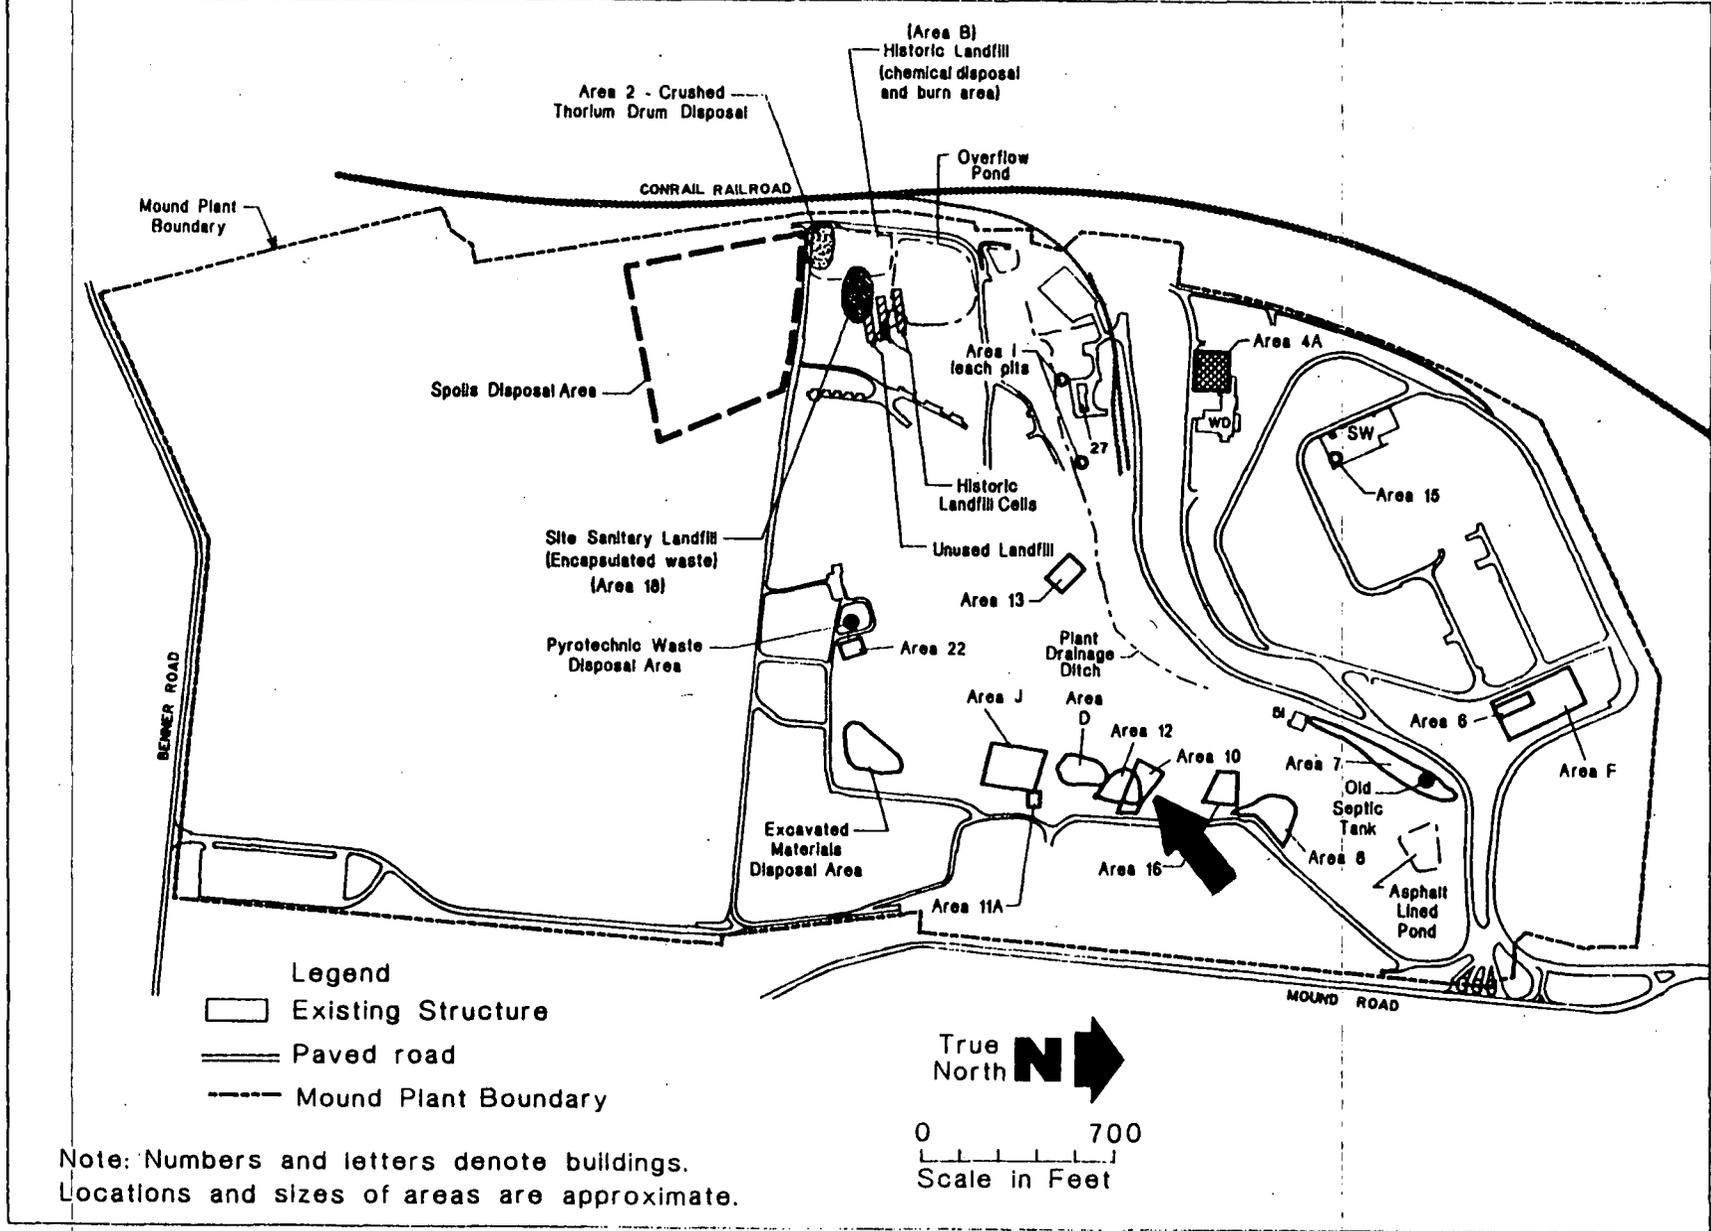
Figure 6.1 On-plant waste disposal areas.

Area 10 is west of Building 30, on the slope of the SM/PP Hill, in the east-central portion of Mound (Figure 6.1) (DOE 1991c). It was used for the disposal of concrete contaminated with polonium-210 from the Dayton operations. The concrete was deposited in 1950 and, because of the short half-life of polonium-210 (138.4 days), is no longer radioactive (DOE 1992g). One hundred and sixty truckloads of debris were brought to Mound from Dayton Unit IV (Halbach 1950), and 100 truckloads were brought from Unit III. It is unknown how much of this was stored in Warehouse 10, the tropical huts, or dumped in Area 10. Many of the temporary buildings at Unit III were also razed and brought to Mound when that facility was decommissioned. Some more recent concrete disposal may also have occurred, but nothing is known for certain. The area is estimated to be approximately 150 ft by 100 ft. The single surface soil sample collected from Area 10 during the 1982 to 1985 Radiological Site Survey had a plutonium-238 concentration of 11.8 pCi/g and a thorium concentration of less than 2 pCi/g (DOE 1991c).

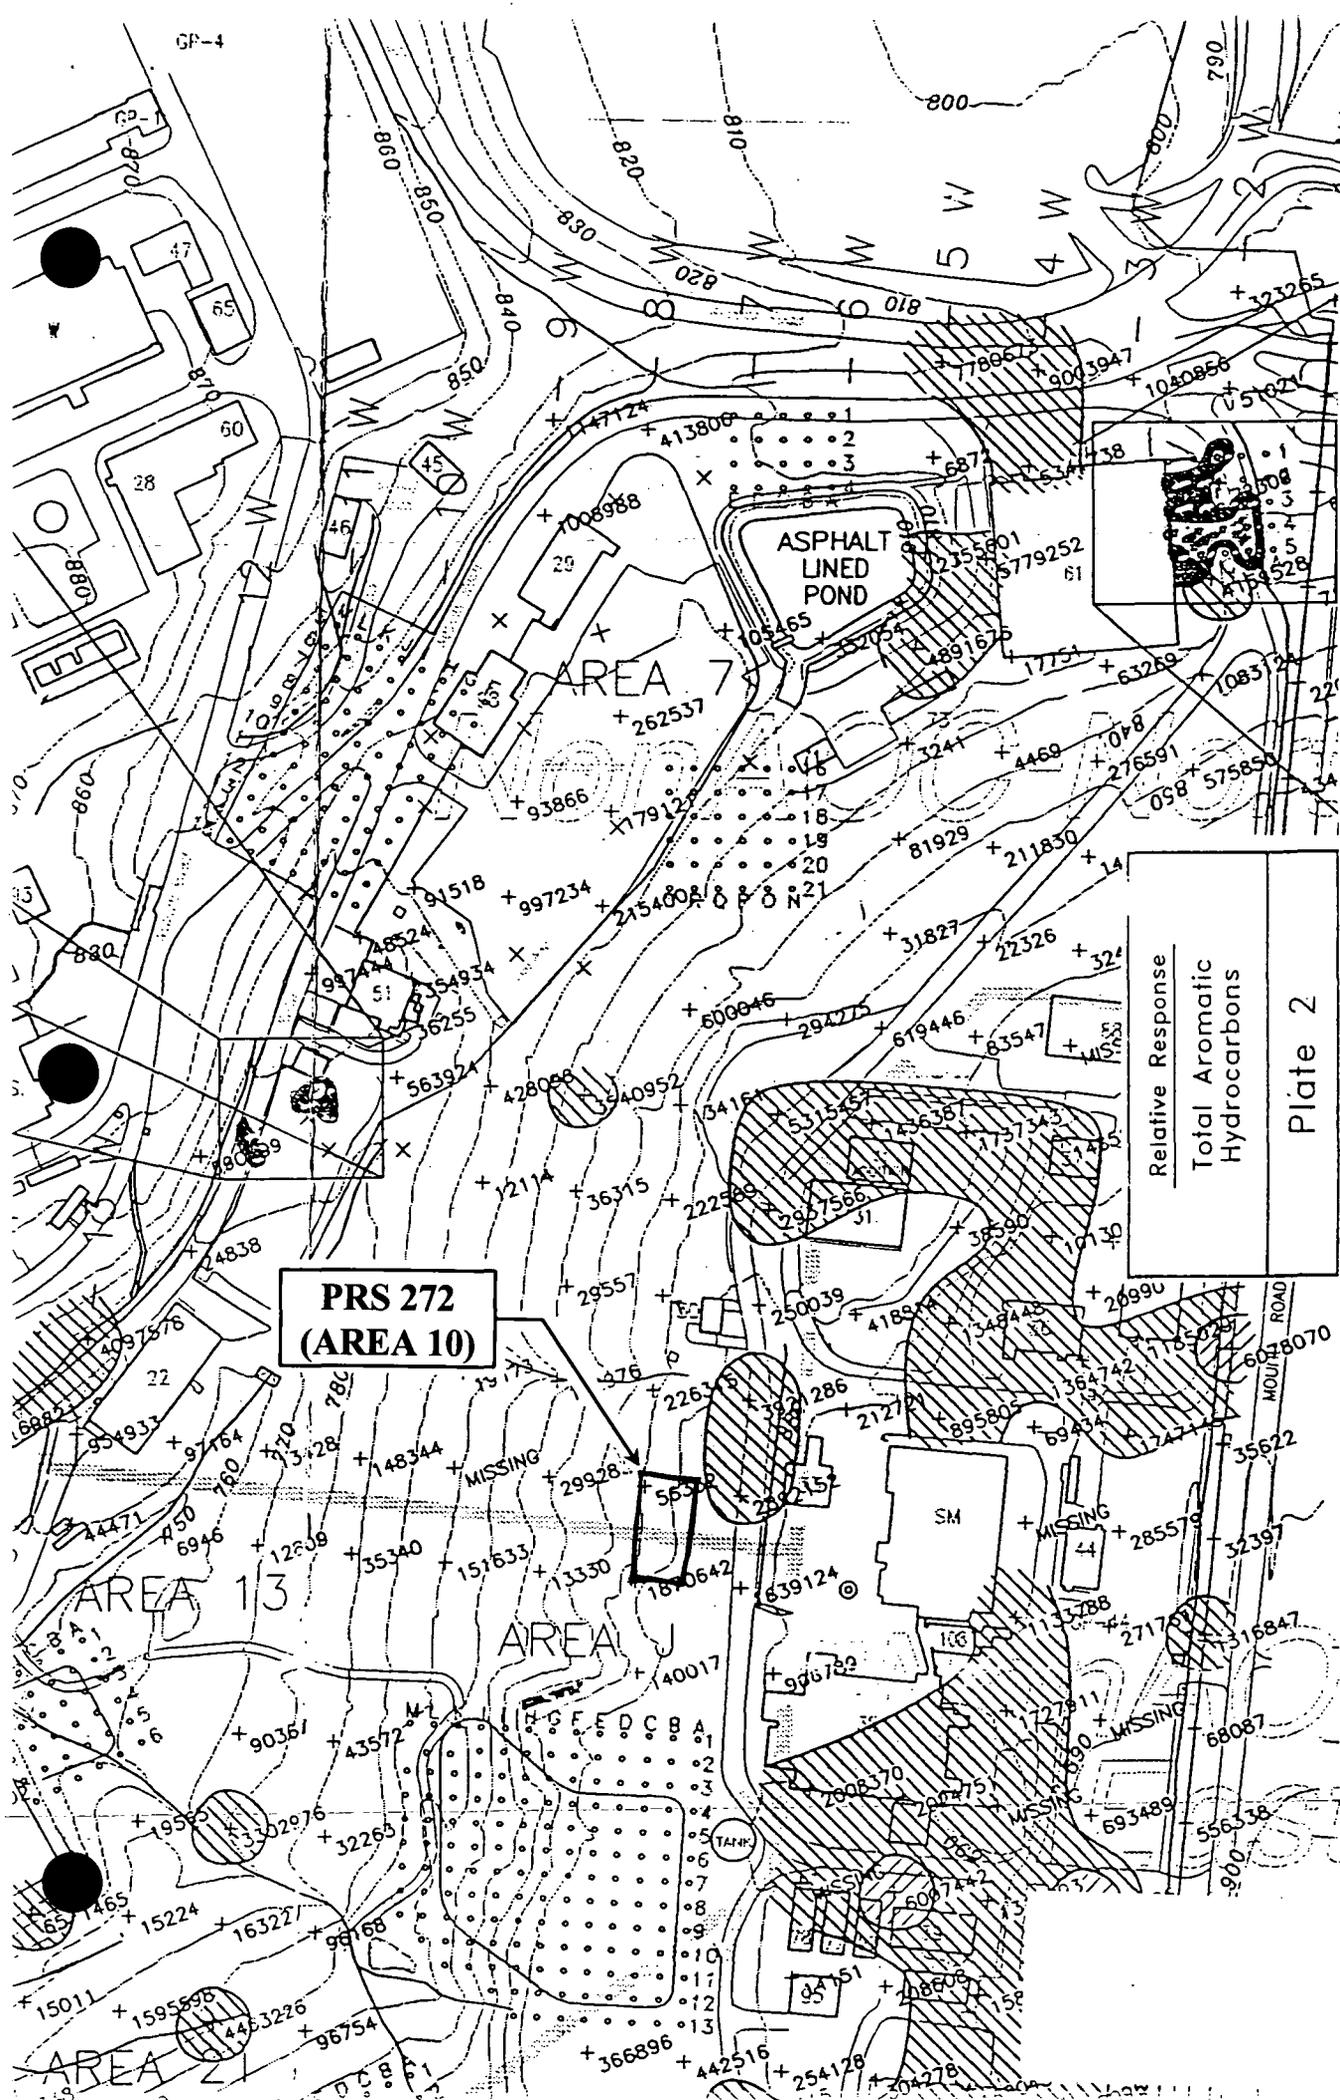
Relative Response  
Total Aromatic  
Hydrocarbons  
**Plate 2**

In 1994, a PETREX soil gas survey was conducted at PRS 272.<sup>6</sup> No relative elevated readings were detected.

**PR5 272  
(AREA 10)**

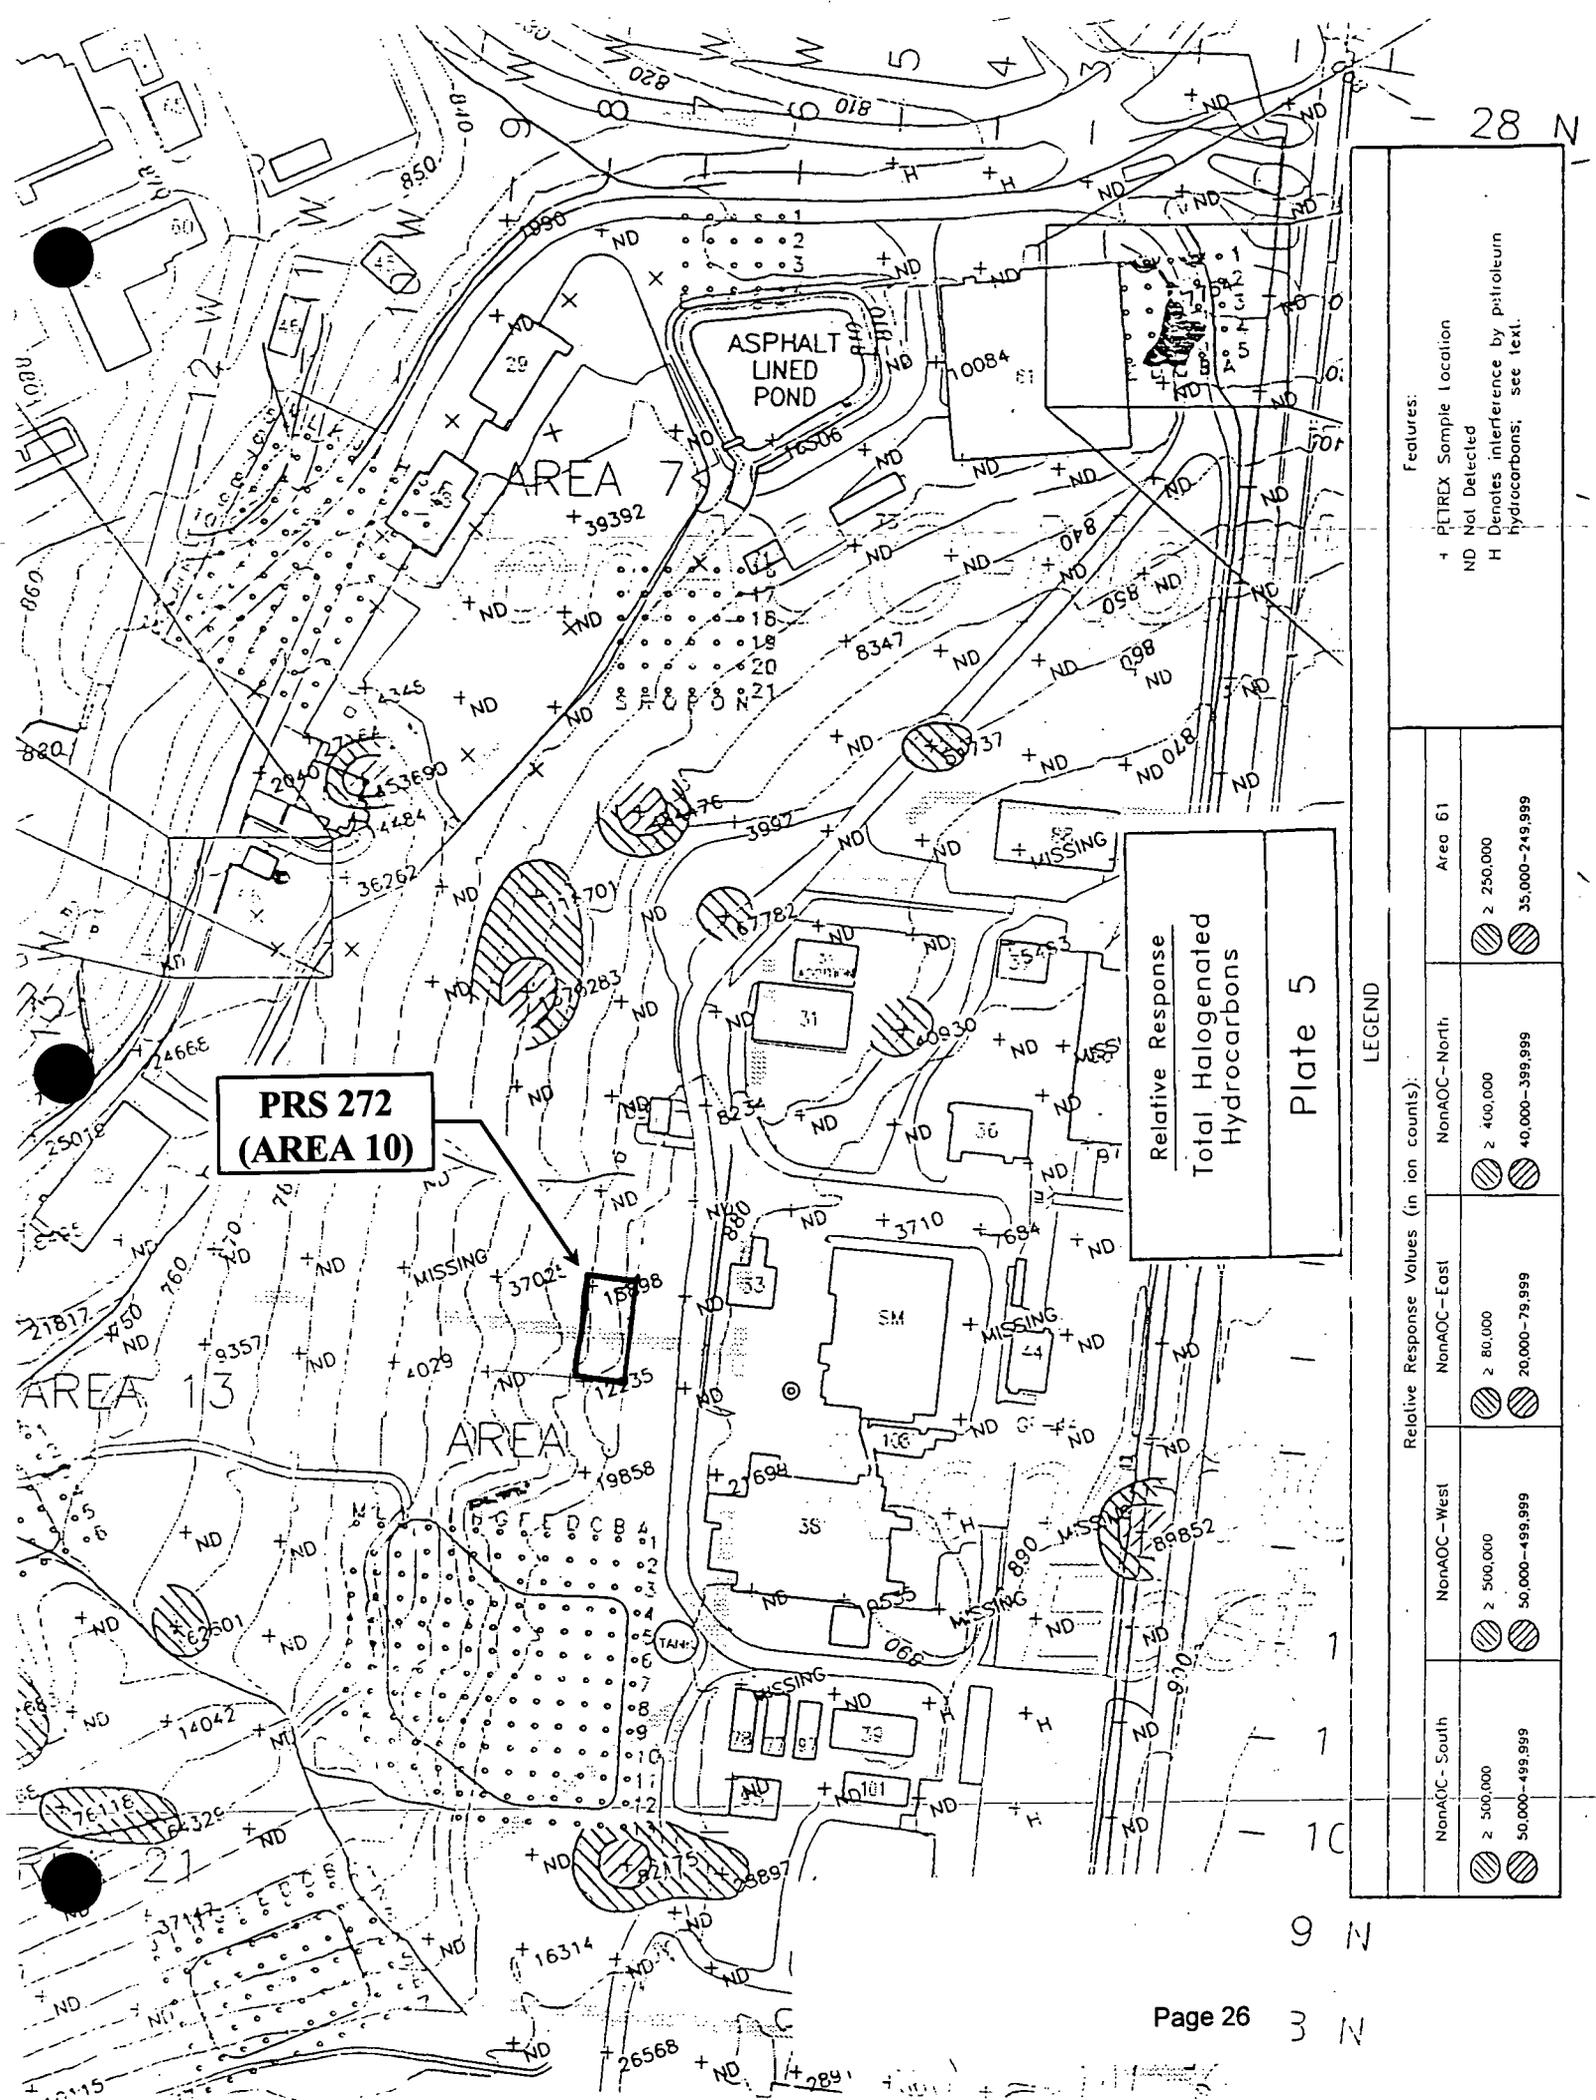
Relative Response  
Total Halogenated  
Hydrocarbons  
**Plate 5**

**PRS 272  
(AREA 10)**

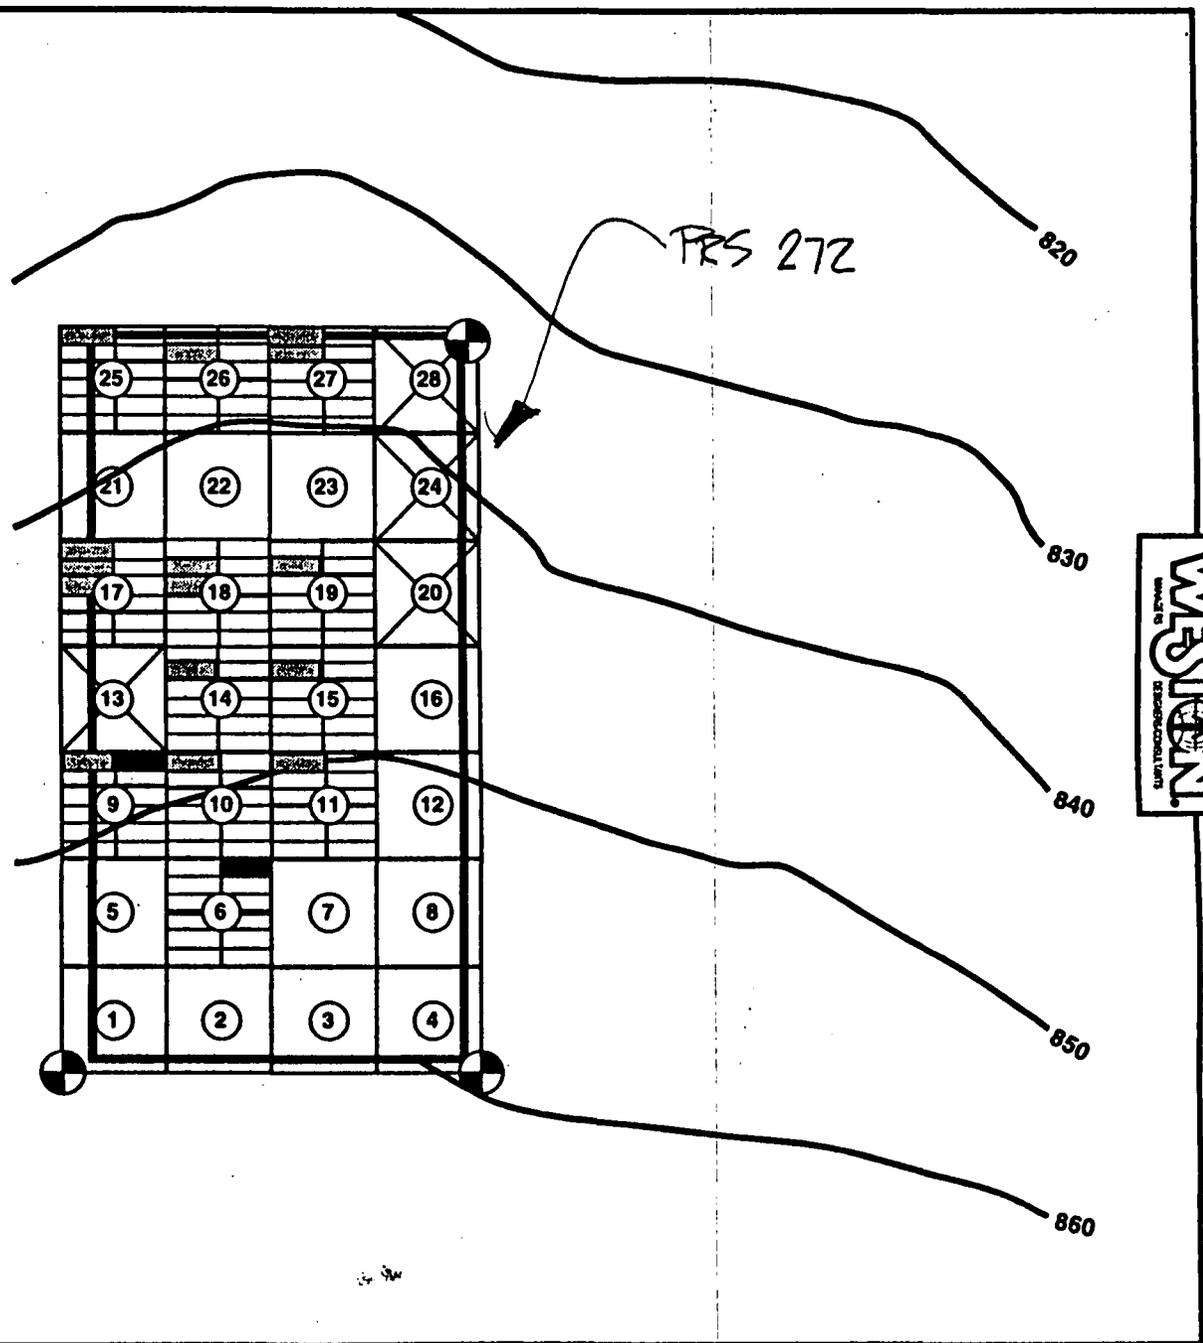
**FIGURE 5-6 AREA 10**

No organic vapors were detected in soil samples at the site. Elevated concentrations of chromium and lead were detected by the PXRF. Pu238 was found in excess of 41 pCi/g in soil samples collected from the site.

Table 5.7 shows Area 10 field results exceeding action levels. Figure 5.6 graphically represents Area 10 field sampling results.

Principal Hazardous Compounds Identified:  
(Maximum Concentration)  
CrLo (285.07mg/Kg)  
Pb (535.39mg/Kg)

Organics  
None Detected

Approximate Grid Size = 15ft x 15 ft
