ACTION MEMORANDUM

ENGINEERING EVALUATION/COST ANALYSIS

BUILDING 124 (CWPF)

DECEMBER 2004

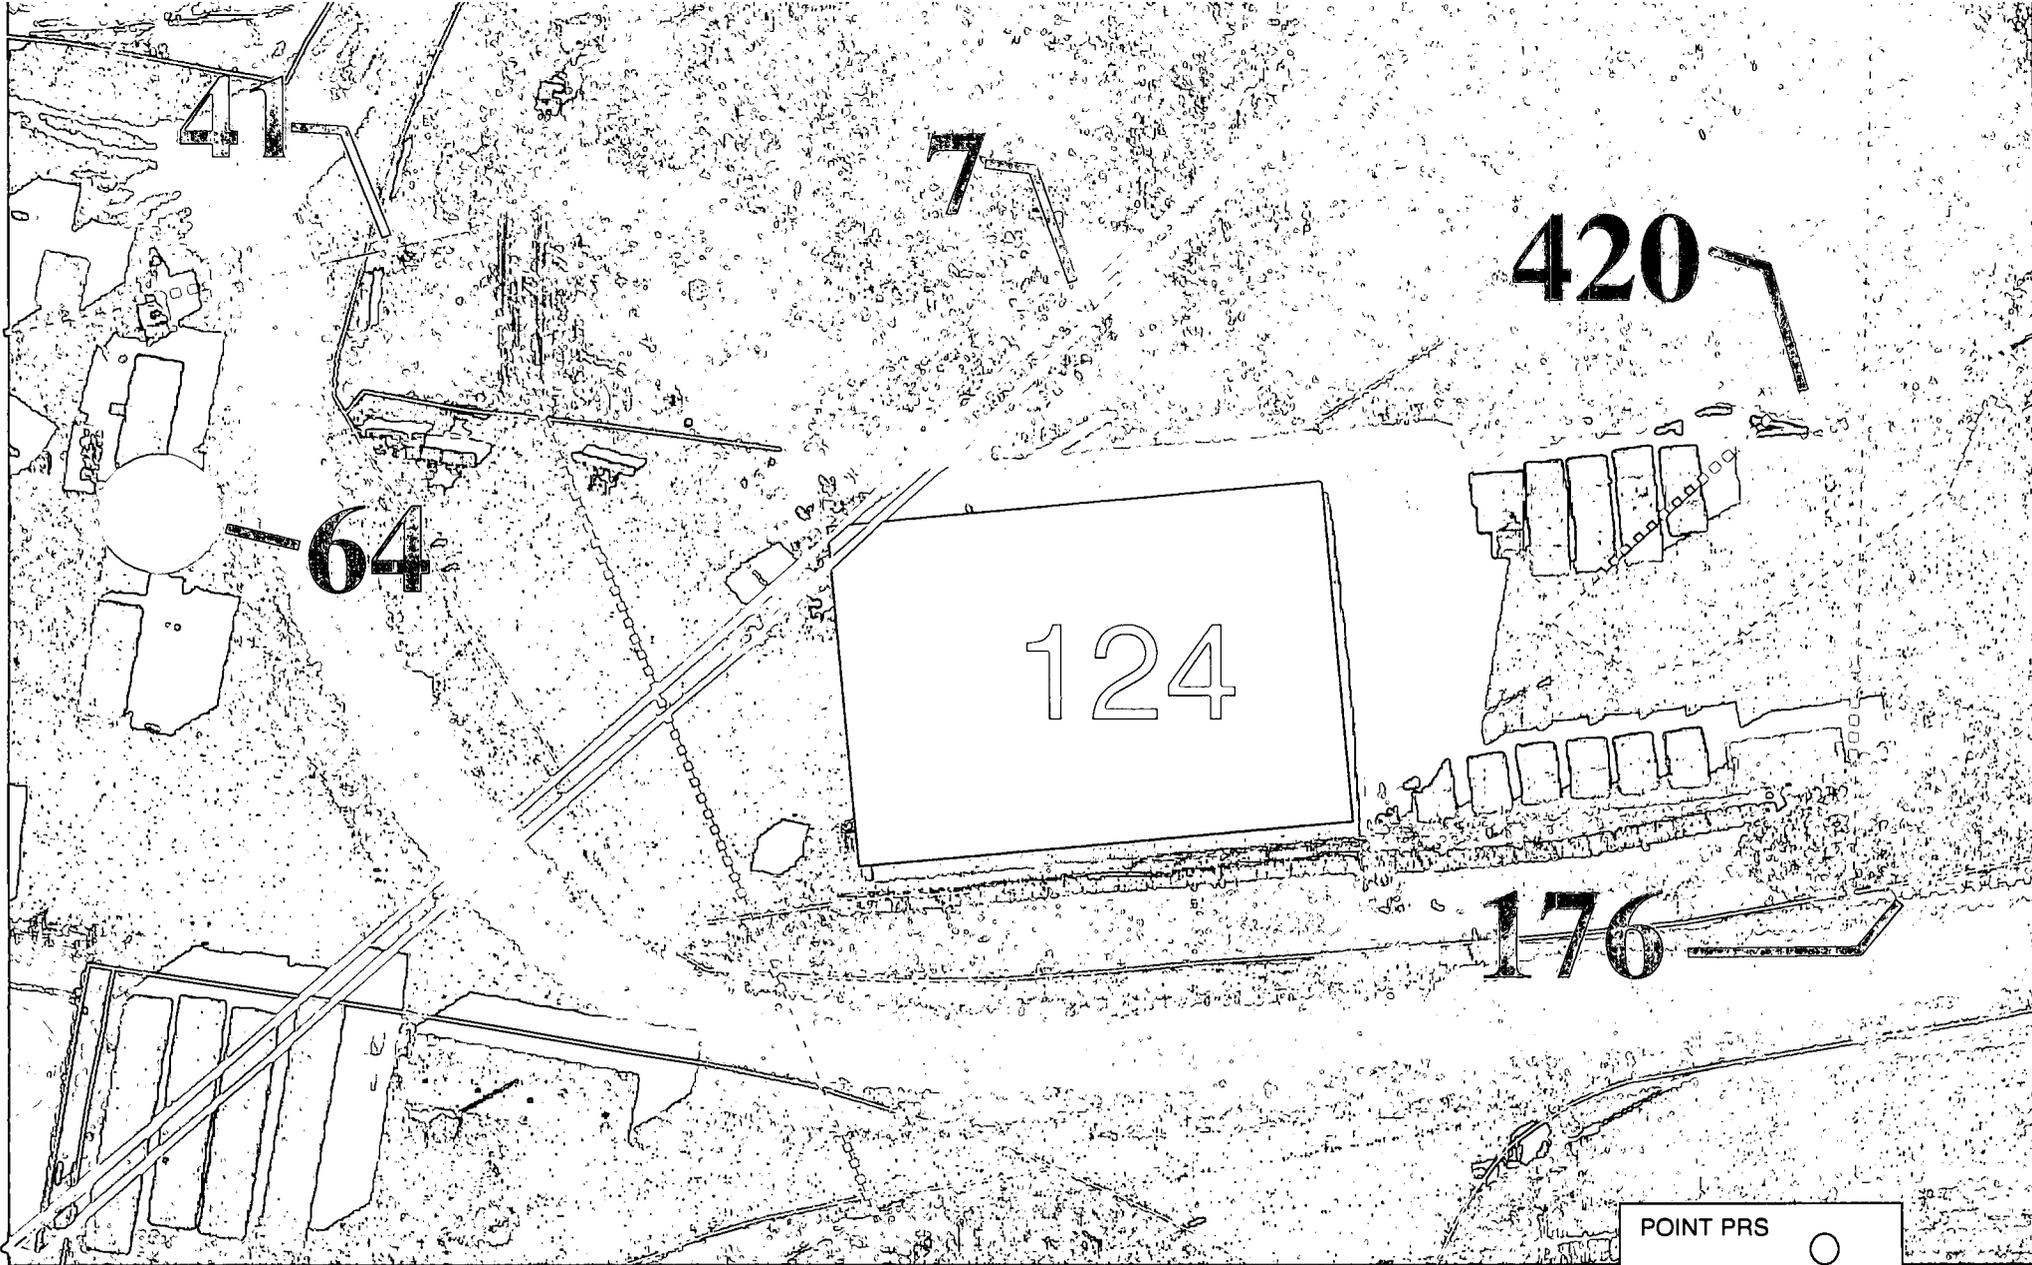
FIGURE 2: PRSs IN VICINITY OF BUILDING 124

- POINT PRS ○
- AREA PRS (dotted line)
- LINEAR PRS — (solid line)

As a result of the investigations and documentation accomplished to comply with the CERCLA cleanup process via the Federal Facilities Agreement (FFA), DOE and the site contractor tabulated all the PRSs identified under the various regulatory programs in effect at the site. Of the site PRSs identified, five are in the vicinity of Building 124 (Appendix B, Table 1). Their locations are shown on Figure 2, and additional information is included in Appendix D.

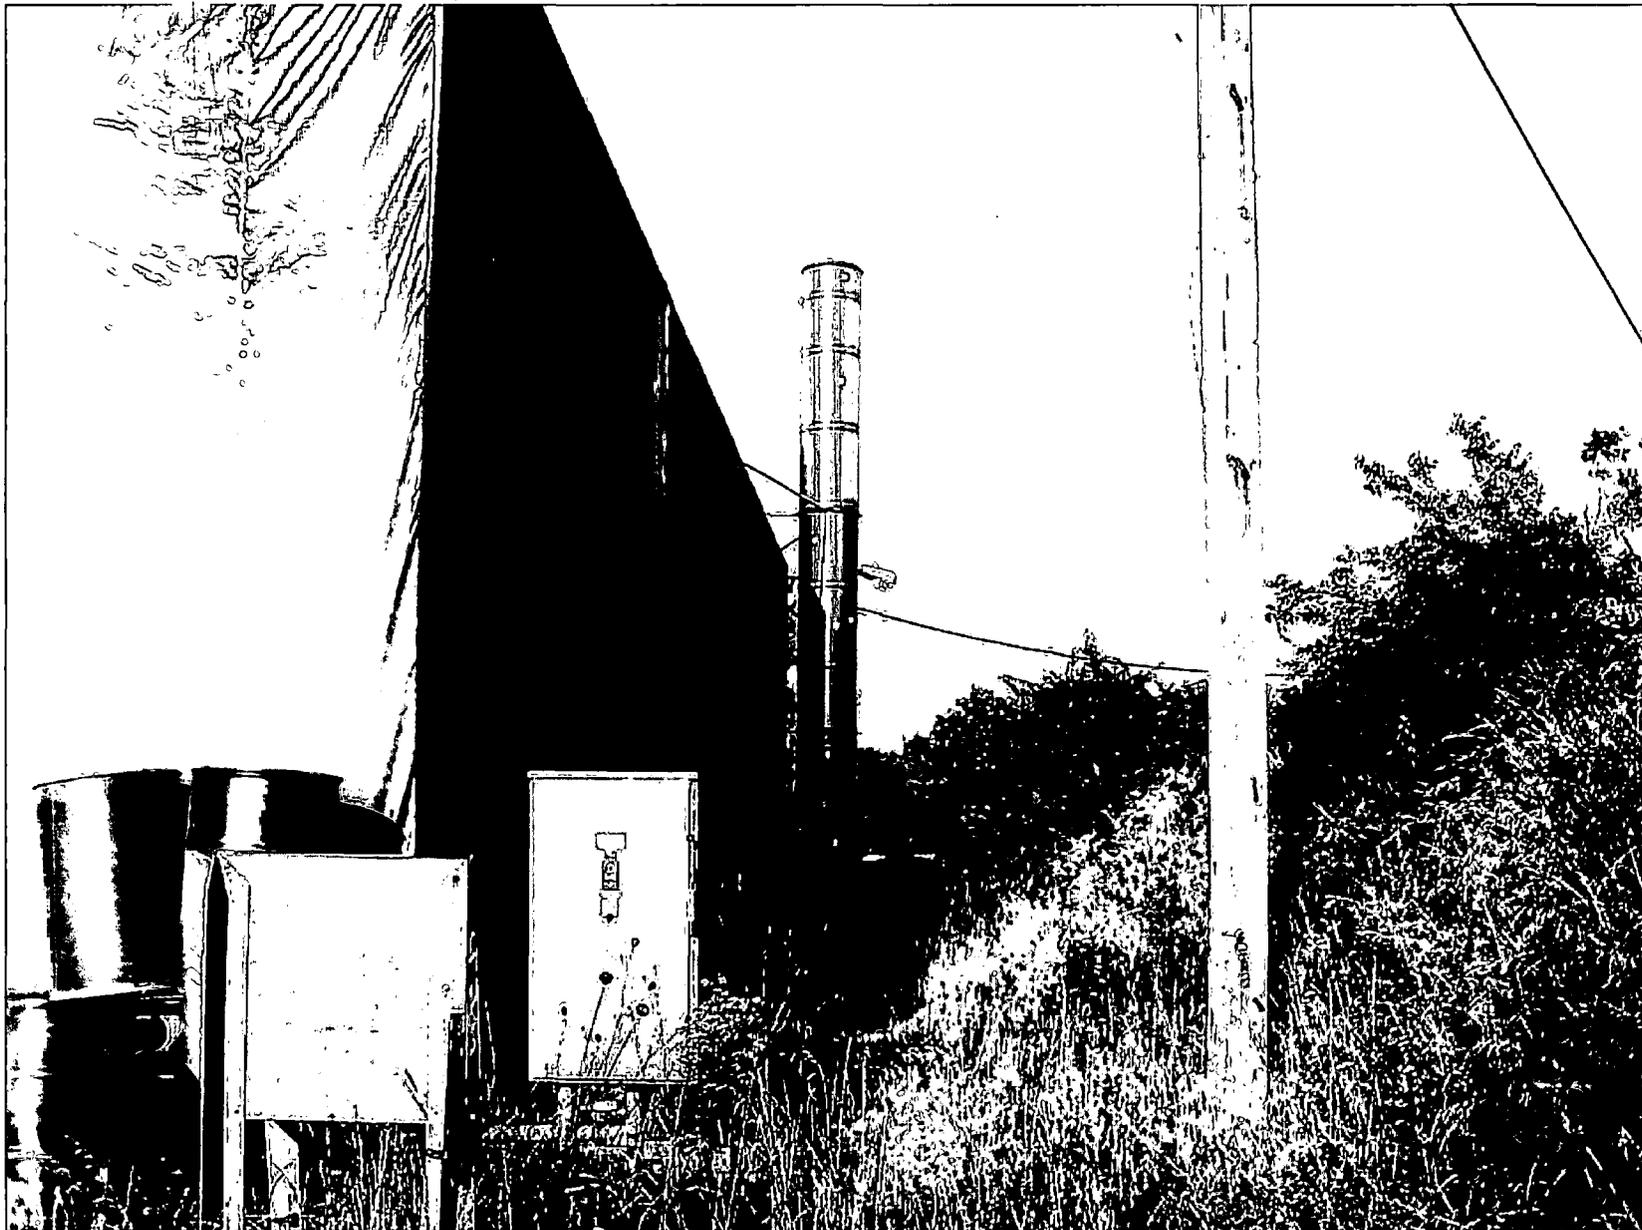
Building 124 – RUBB Building HEPA Ventilation Stack

The Rubb building main area (excluding the Perma-Con® unit) is not heated or cooled. A split heating and air conditioning unit recirculation system serviced the Perma-Con® structure. This system provided the heating/cooling for the Perma-Con® from makeup air from outside and exhausted approximately 15% through the HEPA filter into the Rubb building. Two window units provided additional heating/cooling for the Perma-Con® structure: one for the observation room and the other on the east end of the Perma-Con® structure. The Perma-Con® air recirculation system is equipped with a HEPA filter.

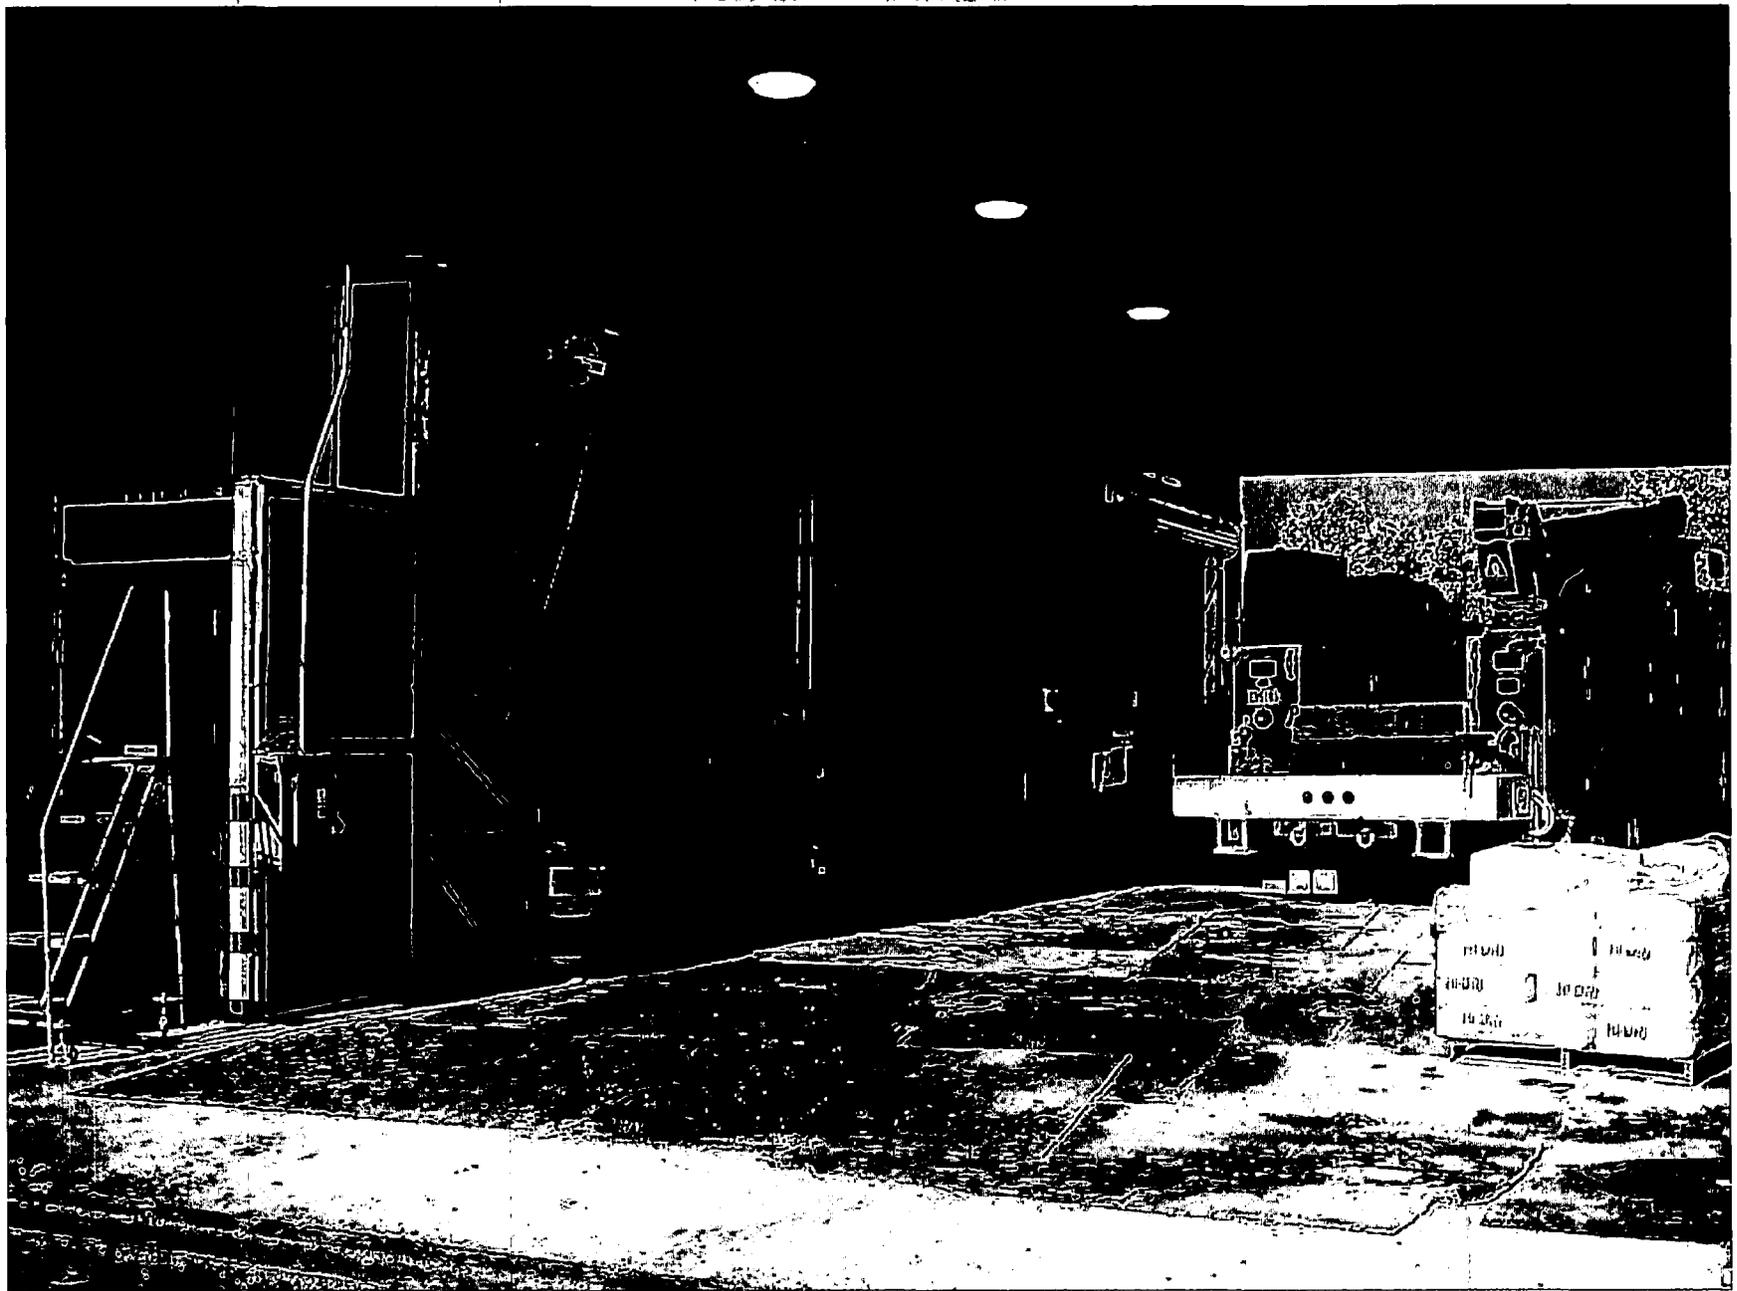
View of Fixed Contamination Area (FCA) – Painted and Covered With Sheeting

Appendix E. The soil blending tent enclosure adjoining the Perma-Con® structure was removed (Circa 2003) as part of the decommissioning process. The floor slab area where the soil blending tent enclosure stood is a Fixed Contamination Area (FCA). Decontamination of the floor area failed to remove radiological constituents to a level below Cleanup Objective. The floor area was painted to seal the floor surface and protective covering was placed over the painted area. Additional characterization is underway and is expected to be completed in October 2004.

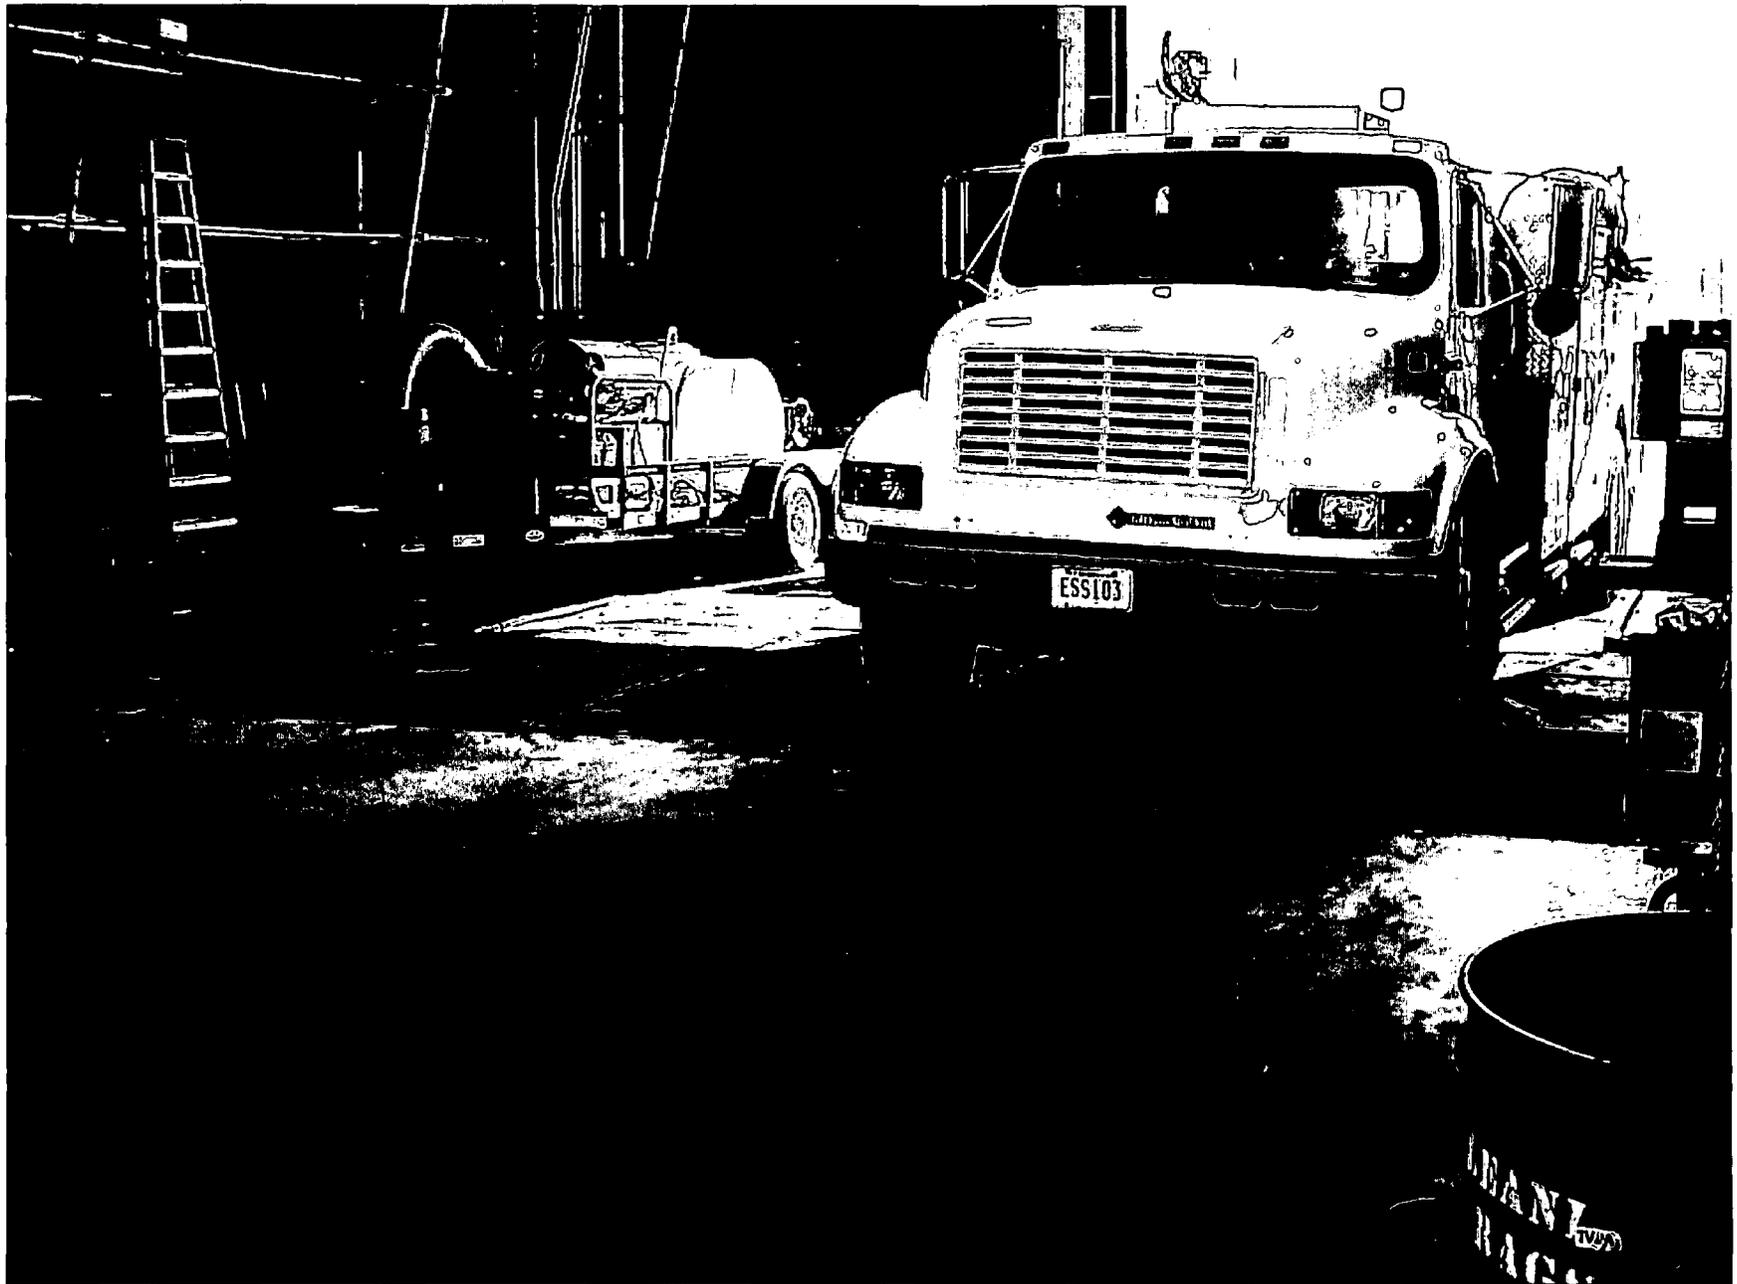
View From West Side of Fixed Contamination Area (FCA)

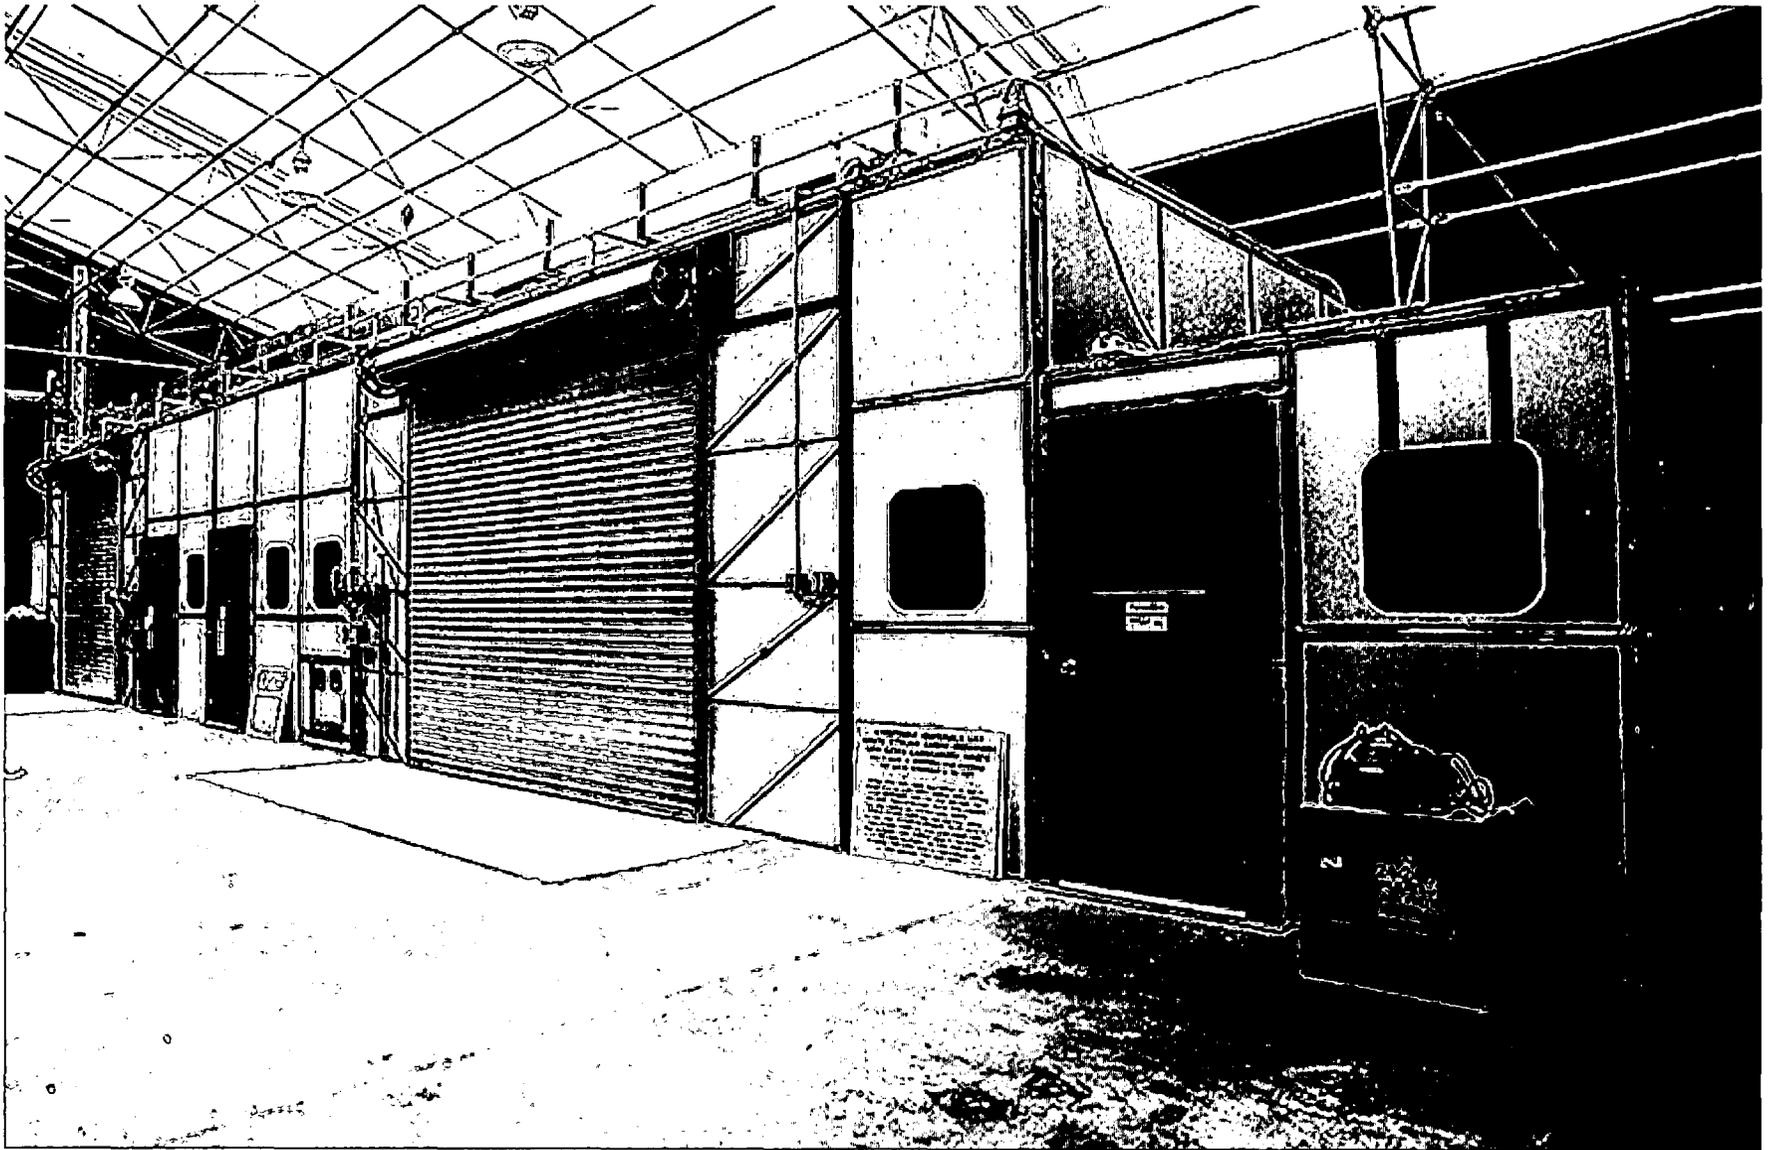
Interior of Building 124 – PermaCon Structure

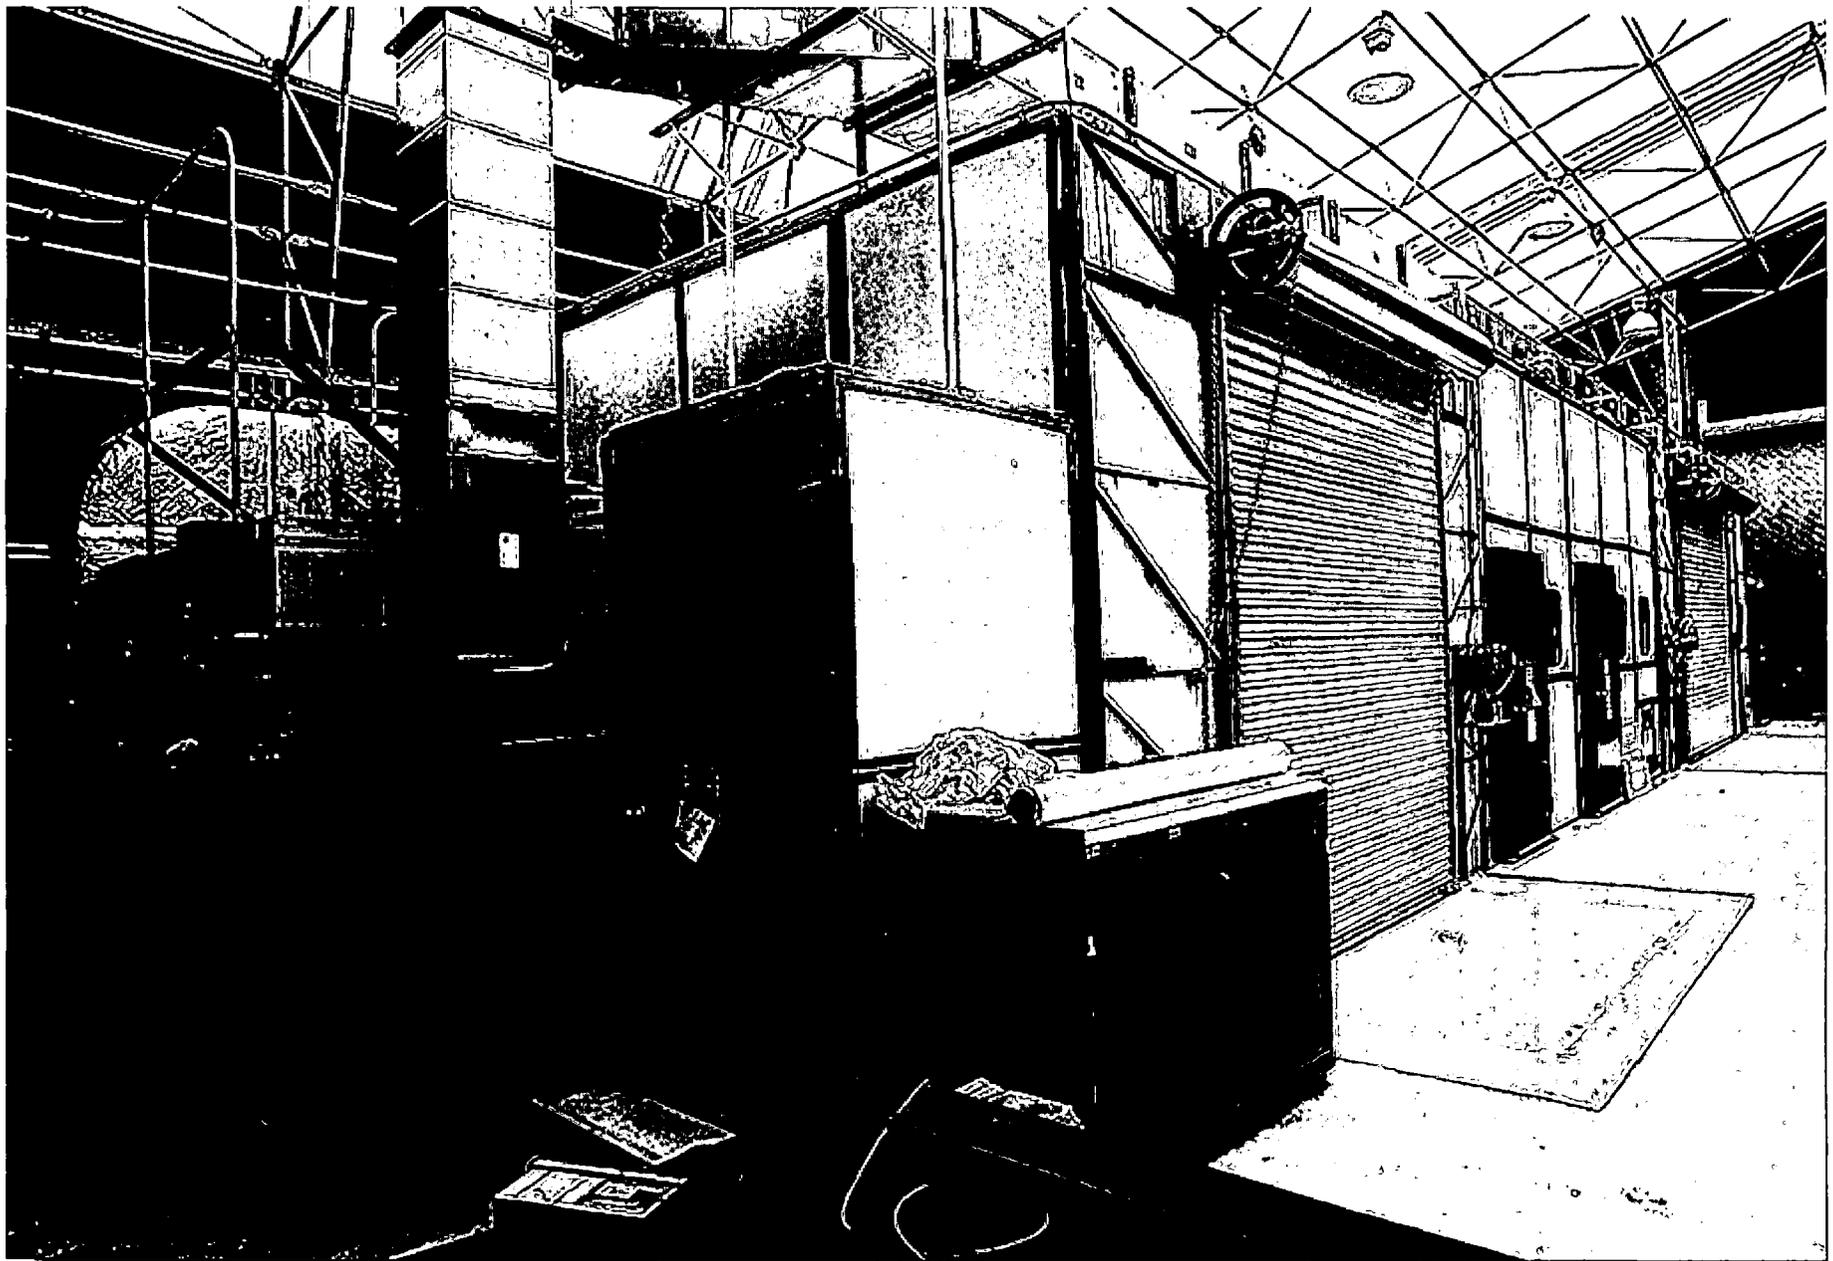
View of Air Handling Unit at East End of PermaCon Unit

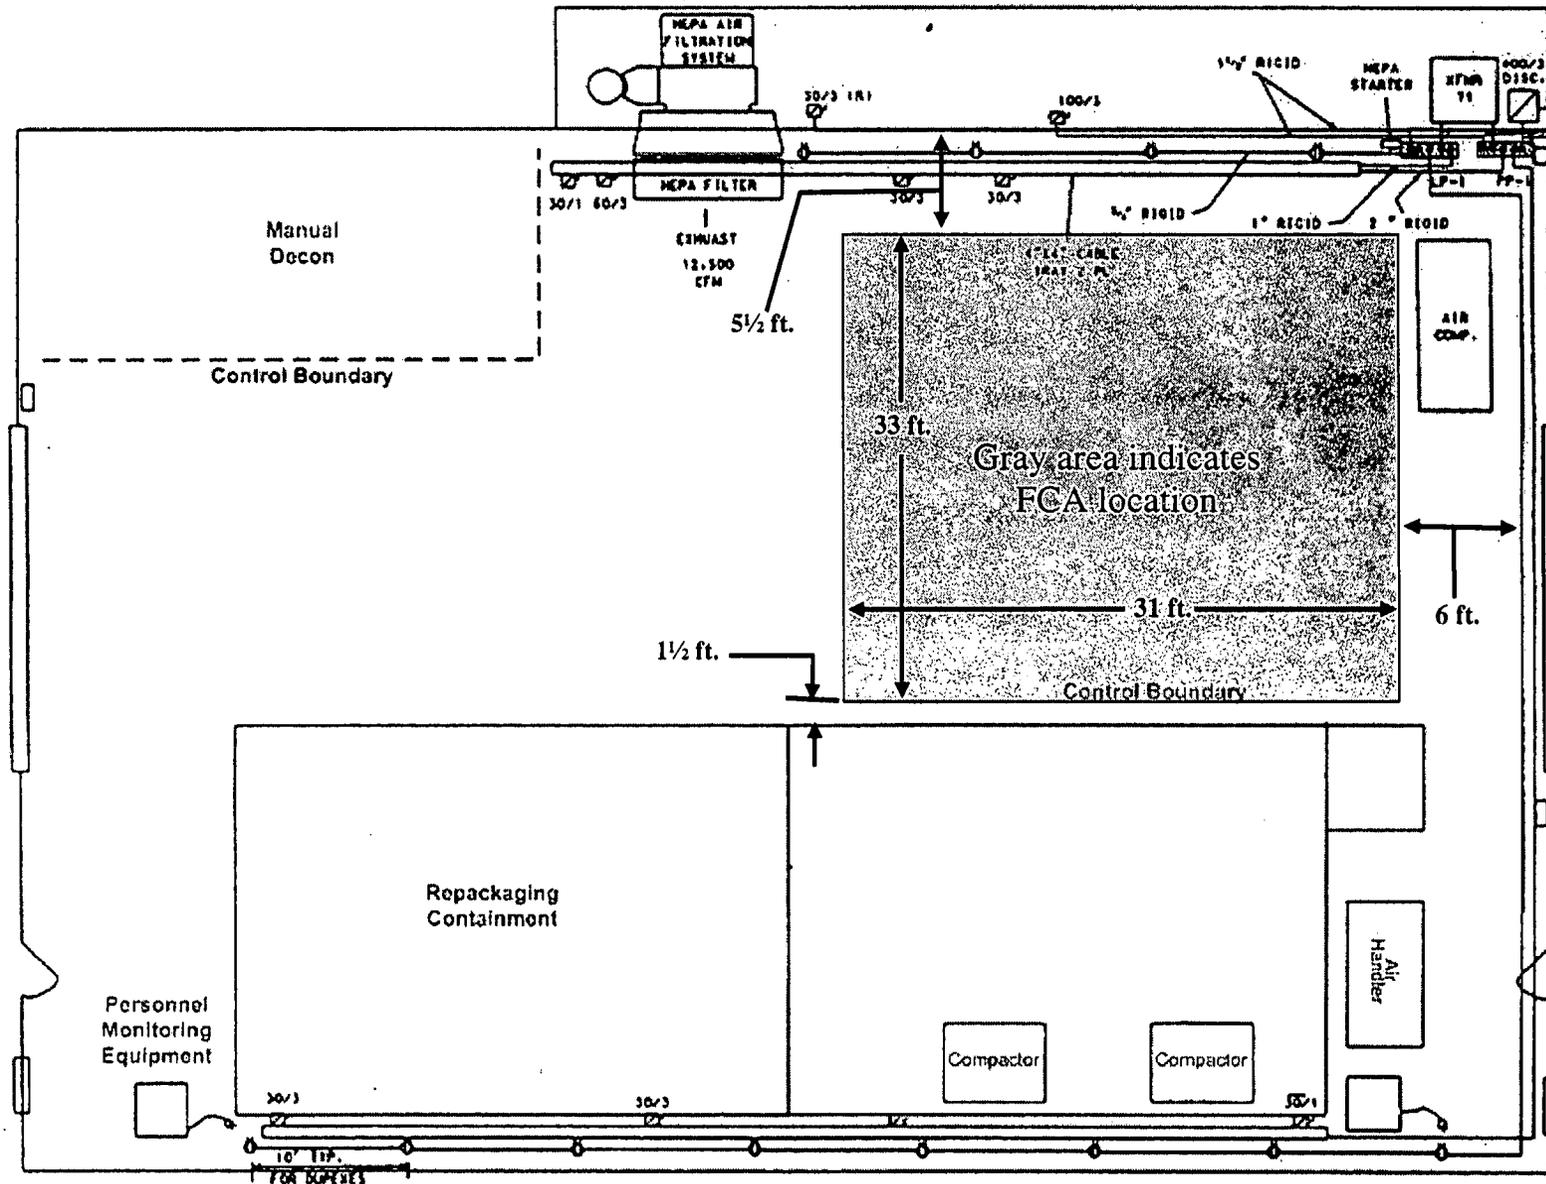
GENERAL LAYOUT OF BUILDING 124 (CWPF)

FCA dimension/location measurements are approximations

Building 124 underwent radiological characterization in 2003 to prepare for decommissioning. The characterization identified several areas of fixed contamination. The existing floor plan of Building 124 along with the Perma-Con® unit is depicted in
