**MOUND PLANT**  
**Building Data Package**  
**Building 105**  
**Located within Release Block D**

# Mound Plant Recommendation Building 105

# Mound Plant Building 105

## Parts Machining

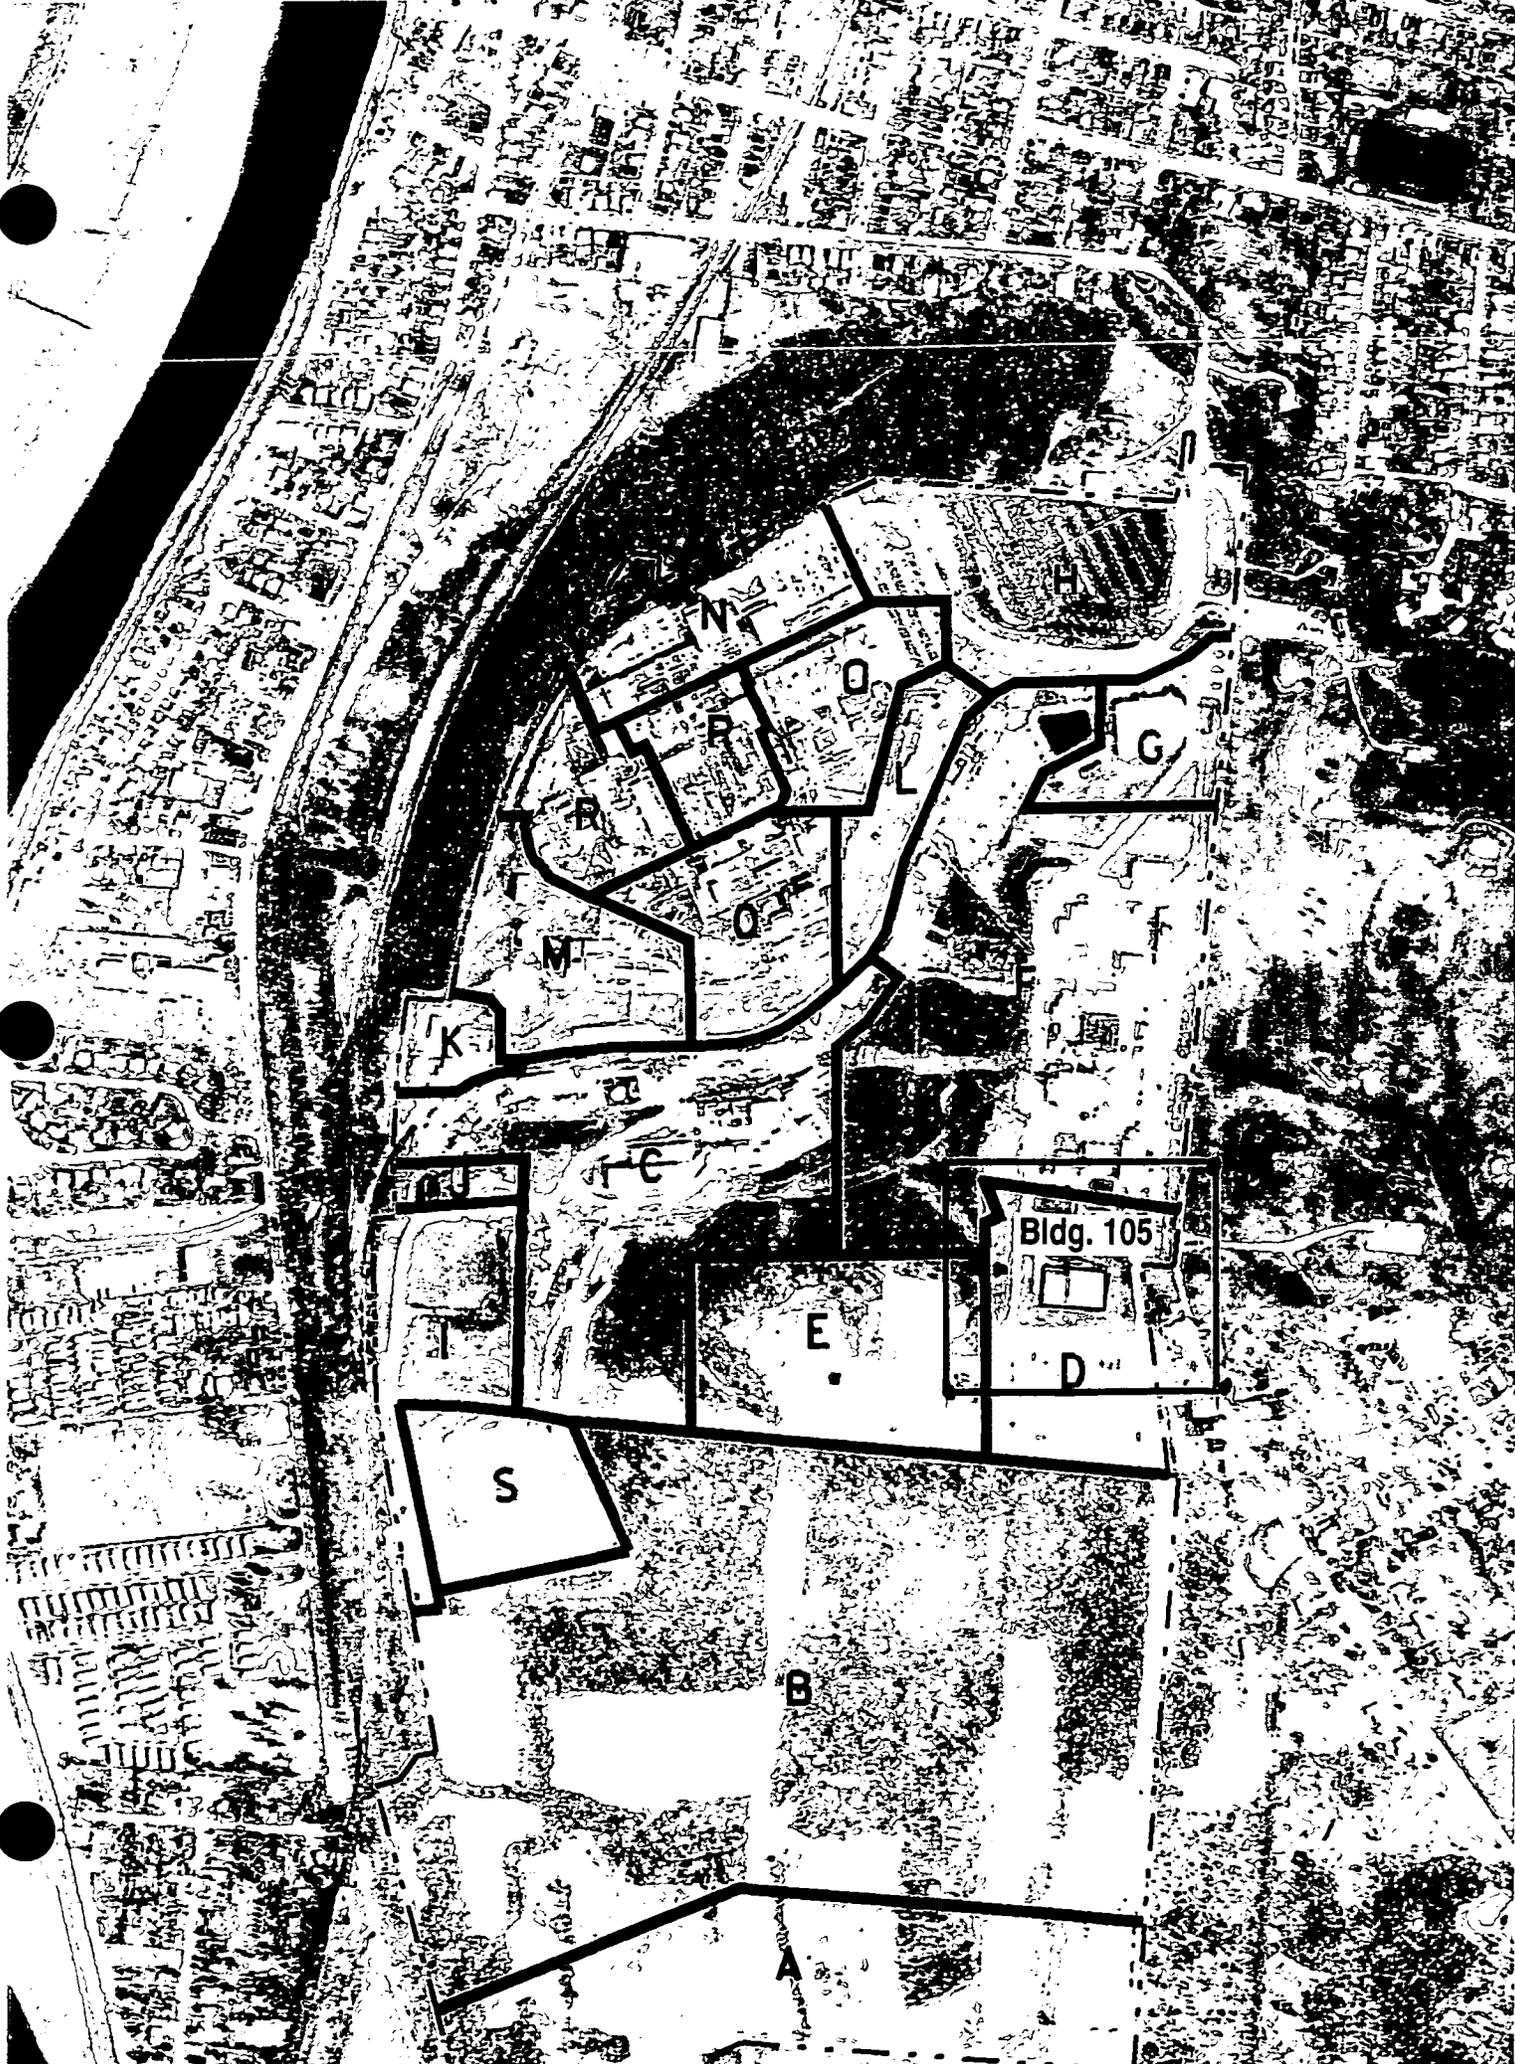
- Building number and location shown in black
- PRS locations and numbers shown in blue
- Surrounding buildings shown in green
- Fencing shown in red
- Elevation contours shown in brown
