Miamisburg Closure Project Potential Release Site Package

PRS 211/212

Final
January 2005

**MIAMISBURG CLOSURE PROJECT
PRS 211/212**

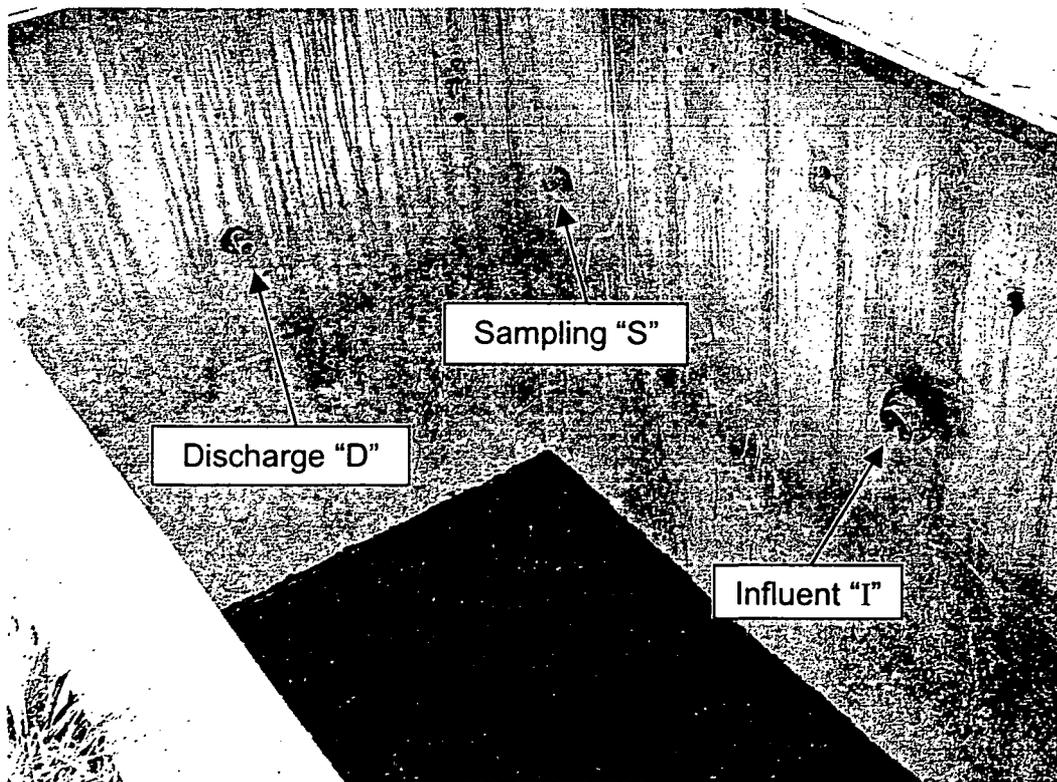
FIGURE 7: September 2004 view of open pit (looking southwest), showing discharge, sampling, and influent line stubs

Surveys were taken of the remaining stubs of the discharge (D) and sampling (S) lines, where they exit the pit (see Figure 7 and RSDS 04-TF-0292, Attachment 6). Results from swipe and direct surveys were well below DOE 5400.5 criteria. No residual solids were observed in pipelines D or S during the survey.

Contamination levels observed in the pipelines and soils associated with PRS 211/212 are below surface release and soil cleanup criteria. No further action is warranted for the four remaining portions of associated pipelines or their soils. These portions have previously been plugged at the sanitary manhole and under the A building footprint, and they will be further plugged at the pit wall prior to pit demolition. This will prevent infiltration of debris into the sanitary system and will prevent migration of subsurface materials. The pipelines will be abandoned in place.

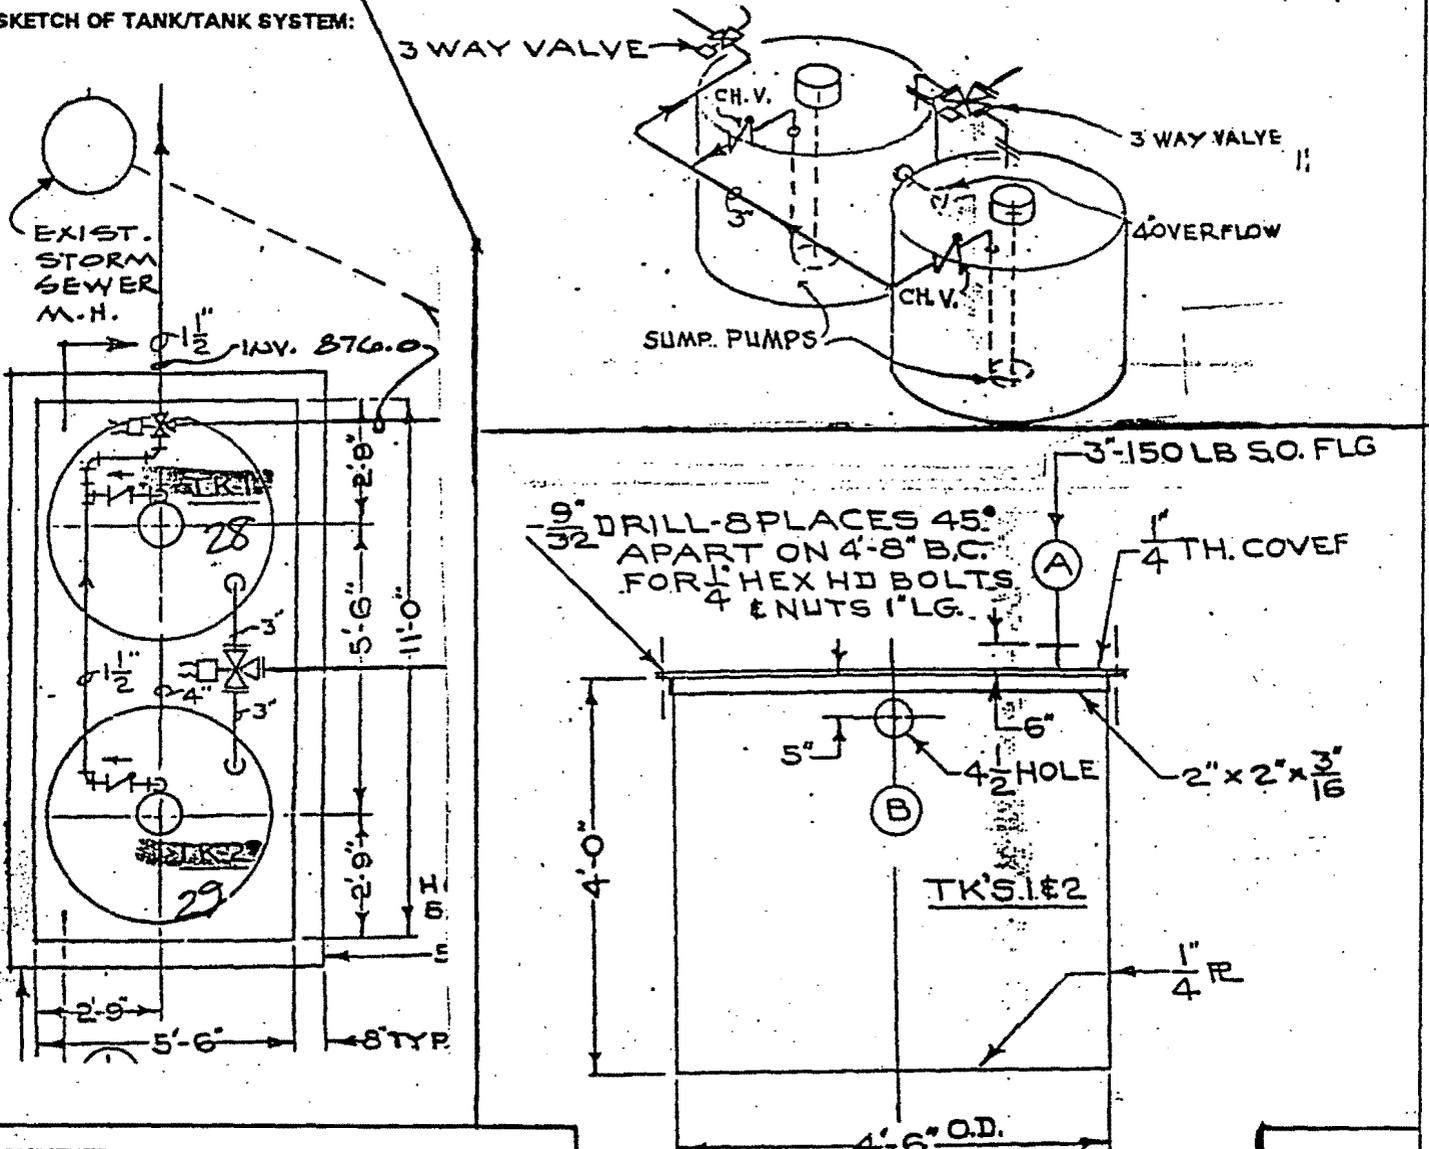
SKETCH OF TANK/TANK SYSTEM:

Sketch Taken from: Drawing No: -M-1 Rev 1 Job 6064 ³⁵⁰⁰⁰⁹ _{Dwr 11 Addn 9}
 Project Title: Decontamination Facility, Admin Bldg
 Drawing Title: Plumbing Plan & Details
 Tanks are located near OSE back entrance.

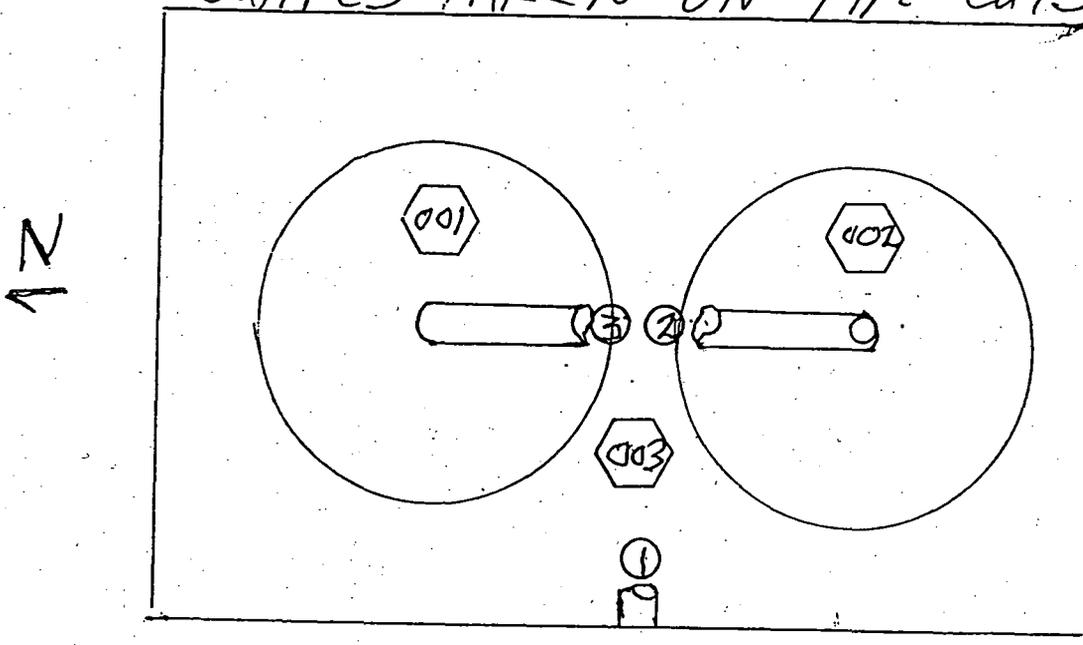
MAP / DRAWING

SEE ATTACHED RESULTS
SWIPES TAKEN ON PIPE CUTS

SLUDGE SAMPLE TAKEN FROM
PIPE CUTS. SEE ATTACHED RESULTS.

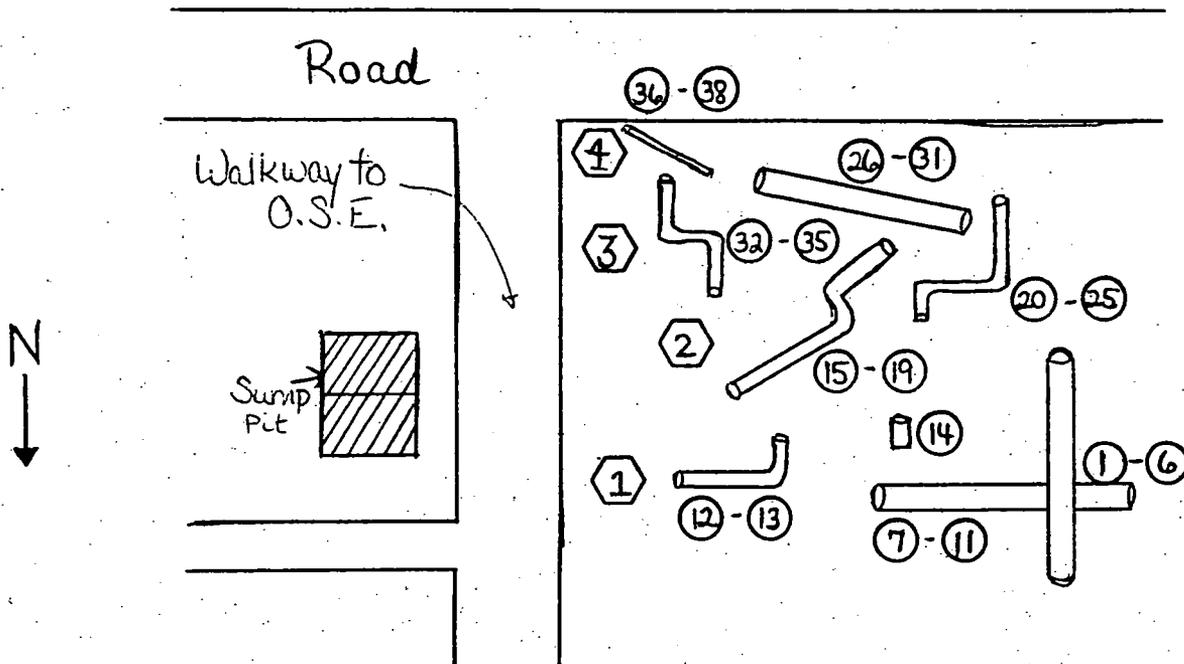
MAP / DRAWING

*Direct scan and pause survey conducted
No clicks in required time
Integrated not required*

** Initial analysis by gamma spec
Additional analysis performed by alpha spec to verify Thorium levels.
See attached results*

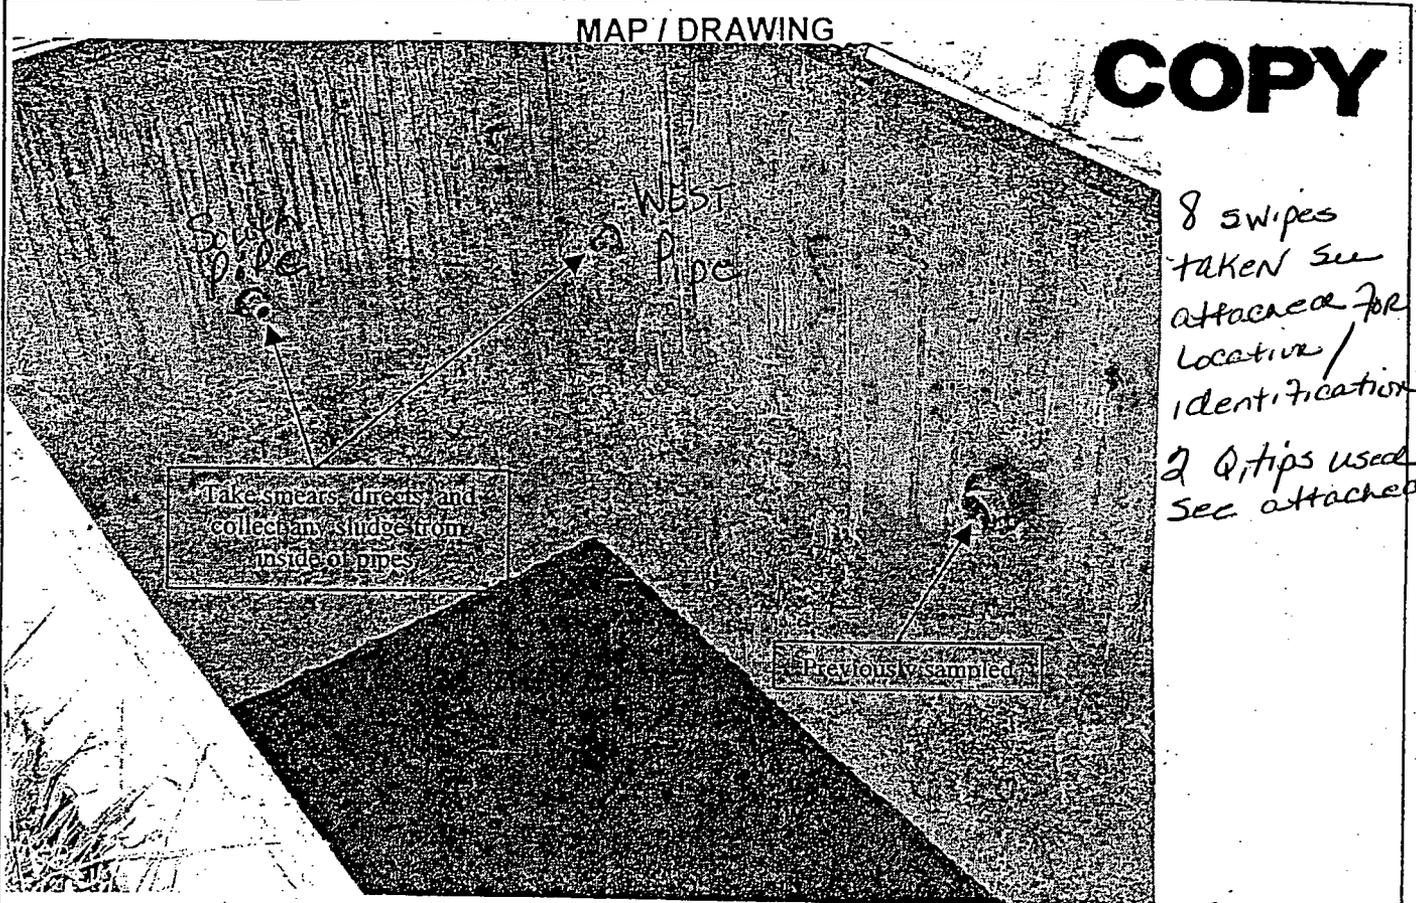
LOCATION: (BLDG./AREA/ROOM)	<u>A-building Shower Collectors Pit</u>	SURVEY NO.	<u>04-TF-0292</u>
PURPOSE:	<u>Characterization Survey Internal and External, Piping.</u>	RWP NO.	<u>N/A</u>
		DATE:	<u>9-22-04</u>
		TIME:	<u>11:00</u>

Direct Scan and Pause Survey
 No Clicks in Required Time
 Intergrated Not Required

Pipes Internals CLEAN
 No SLUDGE
