MODIFICATION #8 TO THE BUILDING 776/777 DECOMMISSIONING OPERATIONS PLAN
MSF-016-02

RCRA Unit Specific Closure Information Sheets

**Appendix H
B776/777 Closure Project
RCRA Unit Closure Information Sheet**

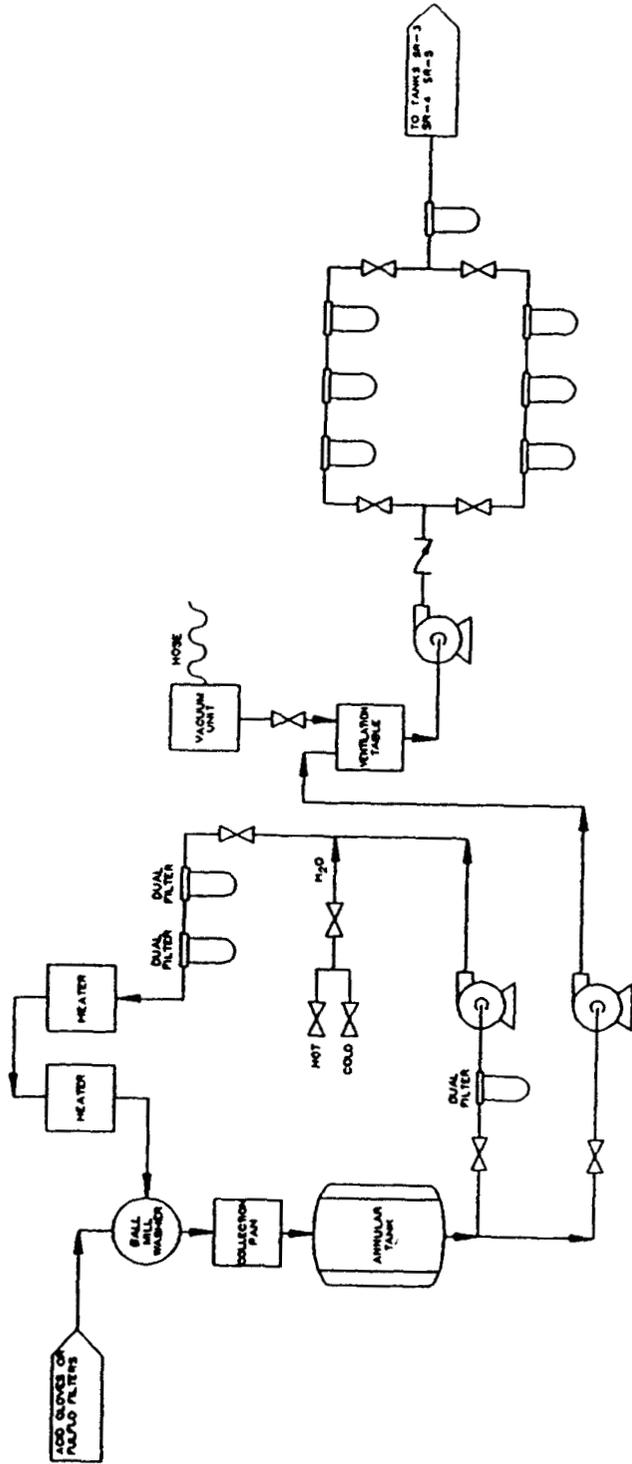
B776/777, SEF 60
Size Reduction Vault Ball Mill Tank System
Building 776, Room 146

Unit Description	<p>The Size Reduction Vault (SRV) is located in Room 146 and is a High Contamination Area (HCA). The SRV was an interim status treatment/storage unit used to repack containers, crush empty drums and HEPA filters in a drum crusher and consolidate drummed waste into crates.</p> <p>The SRV also contains a ball mill washer used to wash acid-contaminated leaded gloves and metal tooling. Liquid from the ball mill was collected in an open pan beneath the ball mill then drained into a 12-gallon annular tank. The liquid was then pumped through a bank of cartridge (Ful-Flo) filters in the SRV and into the SRV tanks in Room 134 (Set 55).</p> <p>The concrete floor in room 146 provided secondary containment for the tank system and the repack operations.</p>
Unit Boundaries and Interfaces	<p>The ball mill washer tank system includes the washer pan, annular tank, pumps, and filters located in the SRV and the outlet piping leading to Tanks SR-3, SR-4, and SR-5 in Room 134 (Set 55). A drawing is attached showing the tanks and ancillary equipment.</p> <p>The concrete secondary containment for the SRV will be addressed with SET 82 (building structure).</p>

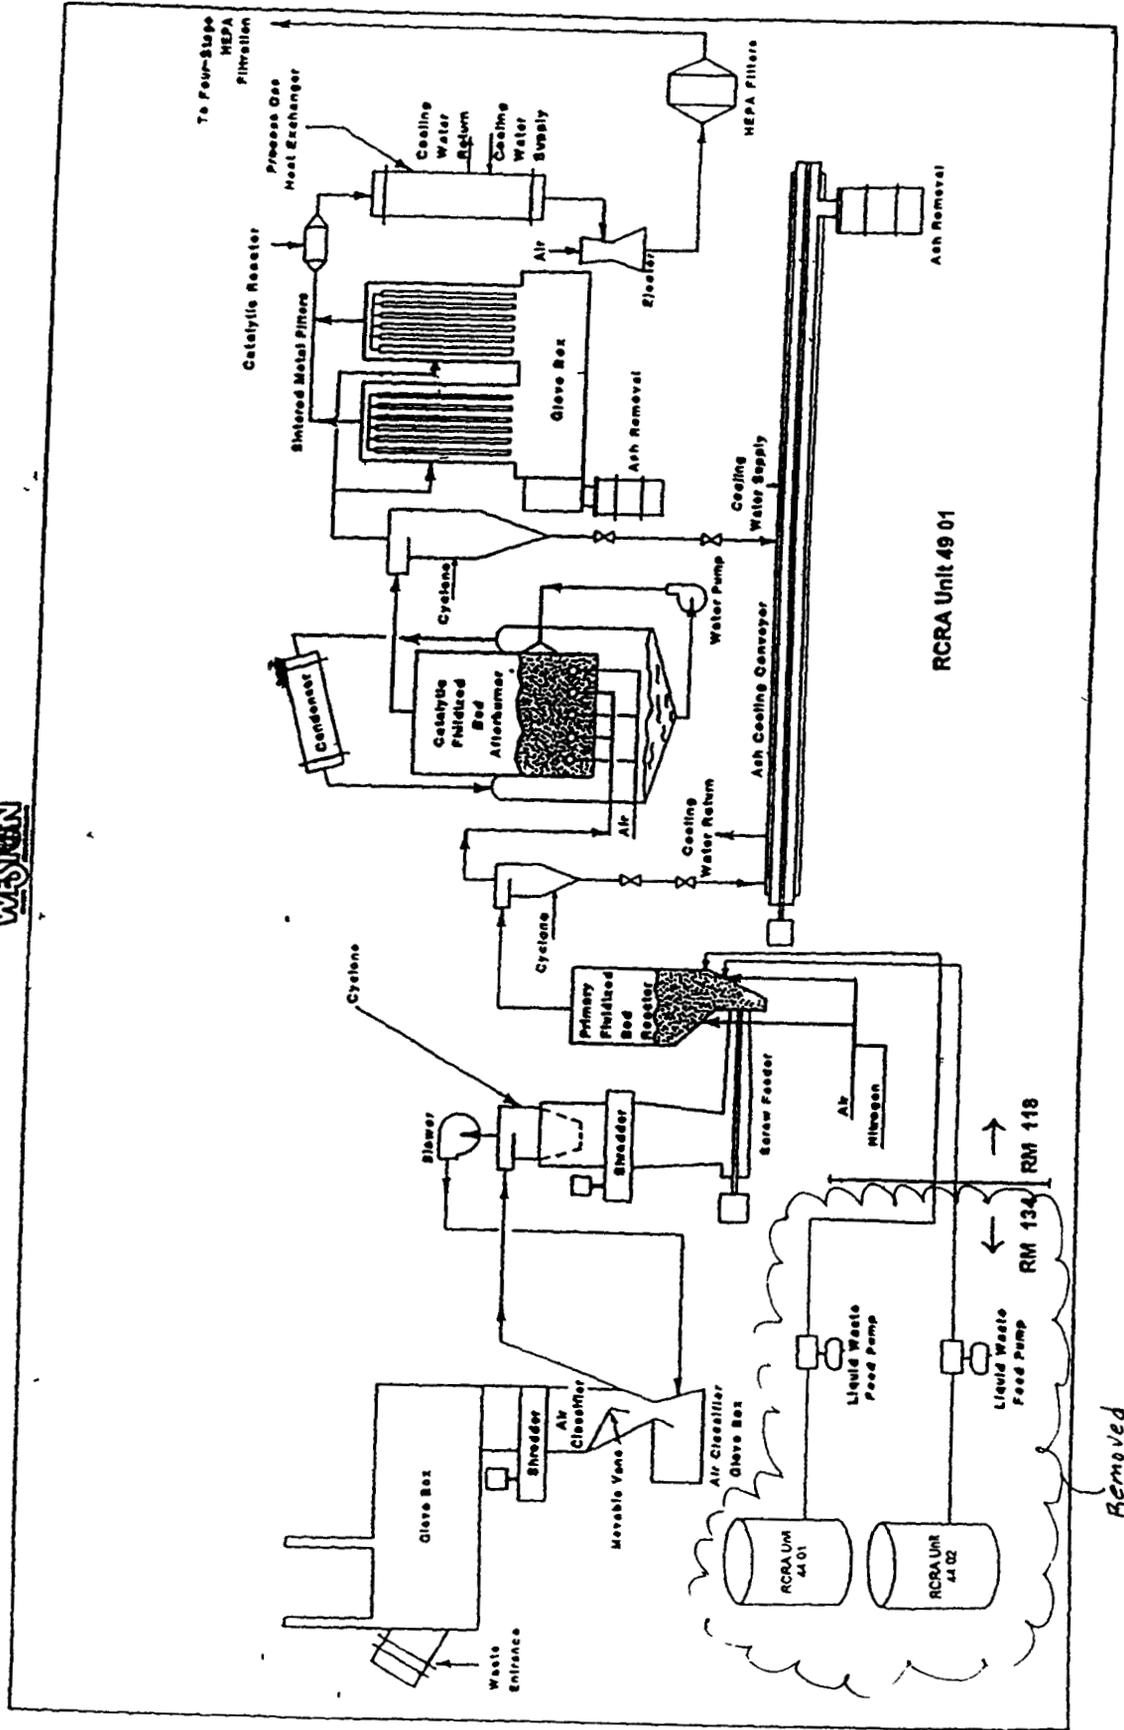
B776/777, SET 61
Pilot Fluidized Bed Incinerator
Building 776, Room 135

Unit Description	<p>The Pilot Fluidized Bed Incinerator (PFI) is located in Building 776 Room 135. The pilot PFI was built as a scaled up version of a laboratory scale incinerator with a feed rate of 9 kg/hr. The incinerator could burn both liquid and solid wastes. The wastes were fed into the primary incineration reactor containing a fluidized bed of sodium carbonate and chromic oxide on alumina oxidation catalyst. The off gas from the primary reactor passed through a cyclone separator and entered the afterburner reactor which also contained a fluidized bed of chromic oxide on alumina oxidation catalyst. The off gas from the afterburner reactor passed through another cyclone separator and through a bank of sintered metal filters that removed the remaining particulate from the air stream. The exhaust then passed through HEPA filters prior to exiting through the building plenum system HEPA filters.</p> <p>The pilot PFI was built in 1973. The unit was tested using new solid feed materials from June 1973 – July 1974. The unit was then modified to accommodate liquid feed in 1974. From February 1975 – July 1980 the unit burned paint thinner from the B333 paint shop miscellaneous solid wastes such as wipes, plastic and general building trash. HEPA filters, ion exchange resin, sewage sludge from the Rocky Flats sewage plant, a new tributyl phosphate/kerosene mixture and wastes such as naphtha, methylene chloride, paint stripper, ultrasonic cleaner and misc #6 fuel oil sludge, spent kerosene, benzene, xylene and color indicators. (Ref: PFI Trial Burn Plan 1/14/88)</p> <p>A PCB trial burn was conducted in May 1981. The test burn feed was prepared by mixing 25 weight percent pyranol and 75 weight percent kerosene. The pilot PFI demonstrated a 99.9999 percent destruction efficiency for PCBs.</p>

Unit Boundaries and Interfaces	<p>The pilot PFI unit boundary includes all equipment and gloveboxes within Room 135. A drawing showing the pilot PFI system is attached. The feed tanks (pencil tanks 1-1 and 1-2) in Room 134 were removed in March 2000.</p>
EPA Waste Codes/ Waste Characterization	<p>Ash from the pilot PFI has been characterized with EPA waste codes D007 and T005. D007 is assigned to the ash based on the chromium oxide in the fluid bed catalyst. The liquid feed was characterized with EPA waste codes of D001, D007, D035, and T005. (Ref: Backlog Waste Reassessment Baseline Book, Subpopulation 1D). There is no evidence to suggest the solid feed was hazardous.</p> <p>The pilot PFI ceased burning solvent wastes in July 1980, prior to the November 1980 effective date of the RCRA Subtitle C regulations. The wastes removed from the incinerator (liquid and ash) are considered retroactively F-listed, but the incinerator itself is not.</p> <p>The ash is not FSCA regulated because the incinerator has a high destruction efficiency for PCBs. The liquid feed system will be tested to determine if it is contaminated with PCBs.</p>

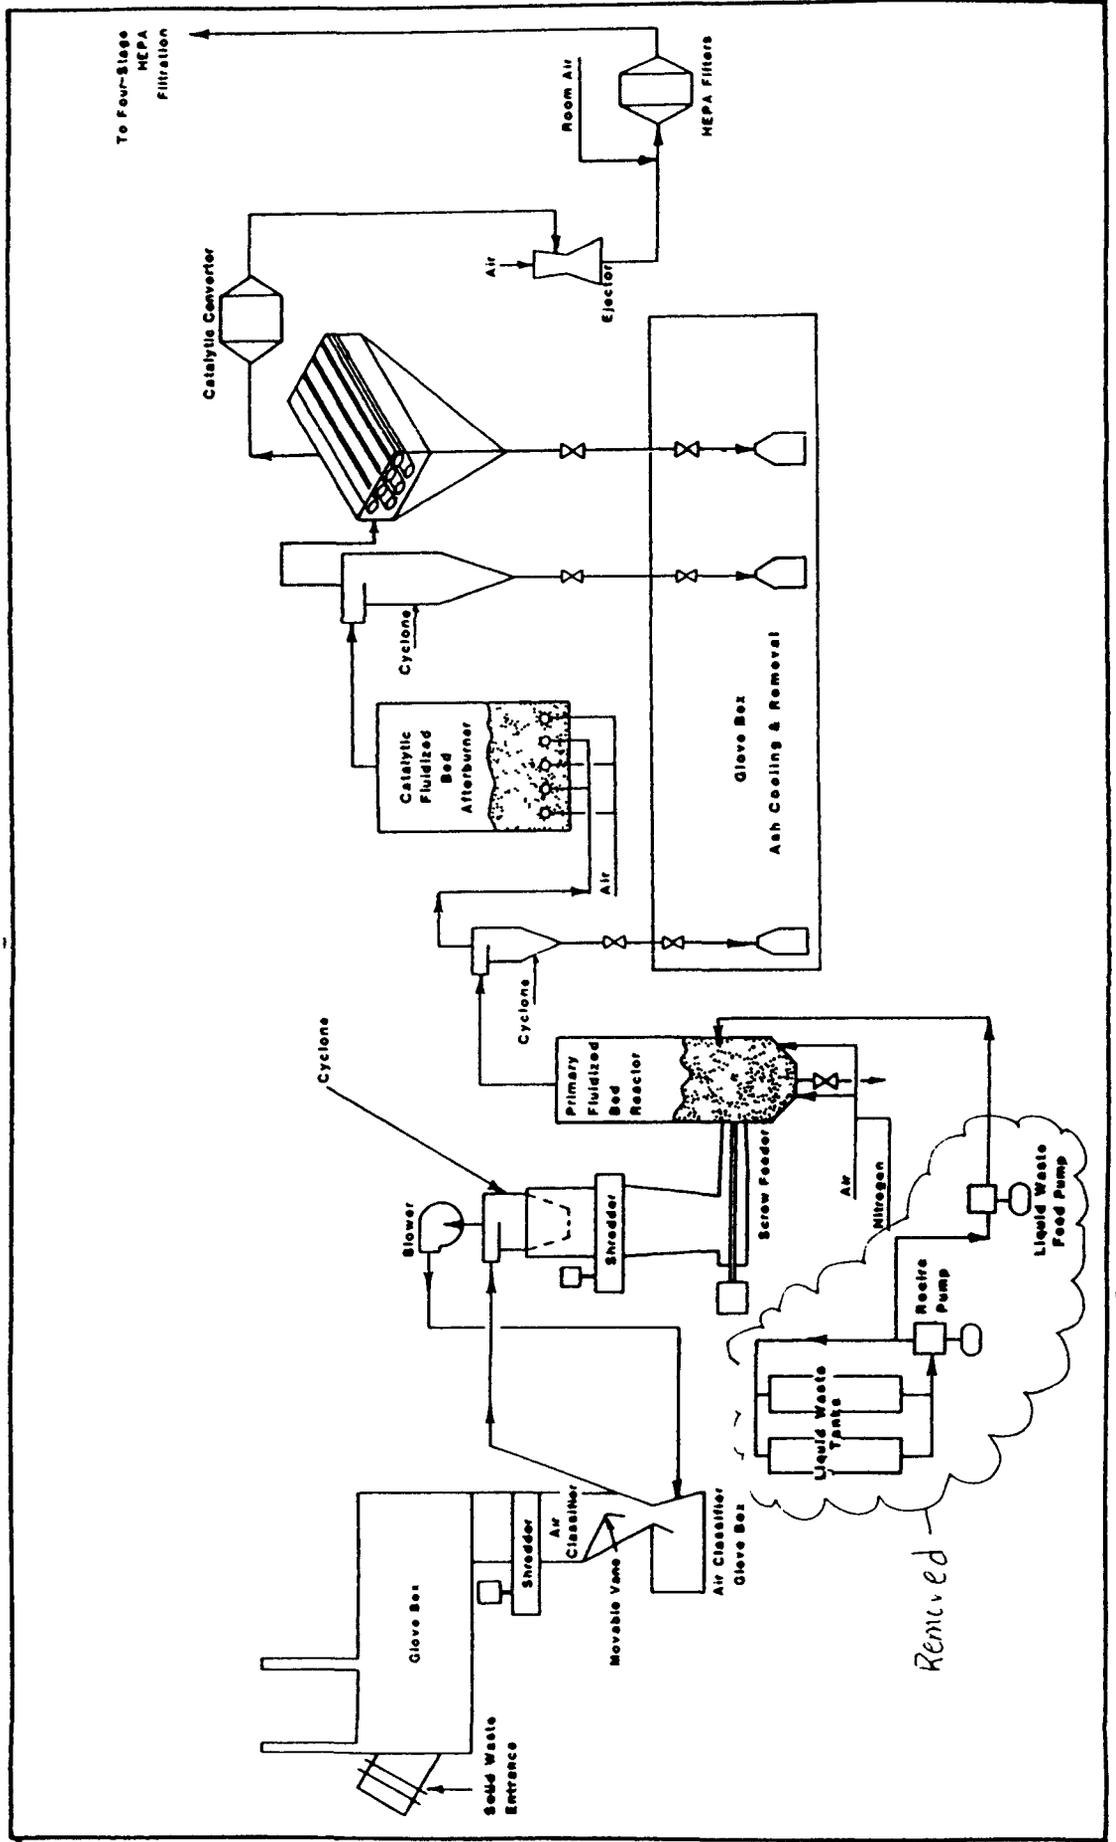
B776/777, SET 63
Production Fluidized Bed Incinerator
Building 776, Room 118

Unit Description	<p>The Production Fluidized Bed Incinerator (FBI) is located in Building 776, Room 118. The production FBI was built as a 9 to 1 scaled up version of the pilot FBI. The incinerator could burn both liquid and solid wastes. The wastes were fed into the primary incineration reactor containing a fluidized bed of sodium carbonate and chromic oxide on alumina oxidation catalyst. The off gas from the primary reactor passed through a cyclone separator and entered the afterburner reactor which also contained a fluidized bed of chromic oxide on alumina oxidation catalyst. The off gas from the afterburner reactor passed through another cyclone separator and through a bank of sintered metal filters that removed the remaining particulate from the air stream. The exhaust then passed through HEPA filters prior to exiting through the building plenum system HEPA filters.</p> <p>The production FBI was built in 1978. The first runs (1978-1981) used non-contaminated office trash, B776 low-level combustible waste, and compressor oil as test materials. Further testing was conducted from 1985-1988 using methanol, diesel products, and nonradioactive surrogate combustibles (shredded coveralls, leather gloves, rolls of PVC plastic, wood, and paper). (Ref: Backlog Waste Reassessment Baseline Book and FBI Trial Burn Plan 1/14/88)</p>

Unit Boundaries and Interfaces	The Set 63 boundary includes all equipment within the incinerator canyon, room 118, and associated gloveboxes and control equipment in rooms 118A, 118B, 118C, 118D, 118E, 118F, 118G, and 118H. A drawing showing the production FBI system is attached. The feed tanks (taschig ring tanks T-1 and T-2) in Room 134 were removed in January 2000 with Set 62.
EPA Waste Codes/Waste Characterization	Ash from the production FBI has been characterized with EPA waste code D007 based on the chromium oxide in the fluid bed catalyst. The solids and liquids burned in this unit were not known to contain any EPA-listed wastes. (Ref: Backlog Waste Reassessment Baseline Book, Subpopulation IC)
Selected Closure Option	Unit removal without onsite treatment
Closure Activities	Closure activities include draining any residual liquids, removing any residual catalyst material and ash, size reduction (if necessary), and packaging of the equipment. As the equipment is dismantled, the interior surfaces will be visually inspected to determine if they are free from significant quantities of residual wastes. If so, the component will be closed by removal and managed as non-hazardous waste. If significant residual material remains that cannot be readily removed, the component will be closed by removal and managed as mixed waste with waste code D007.

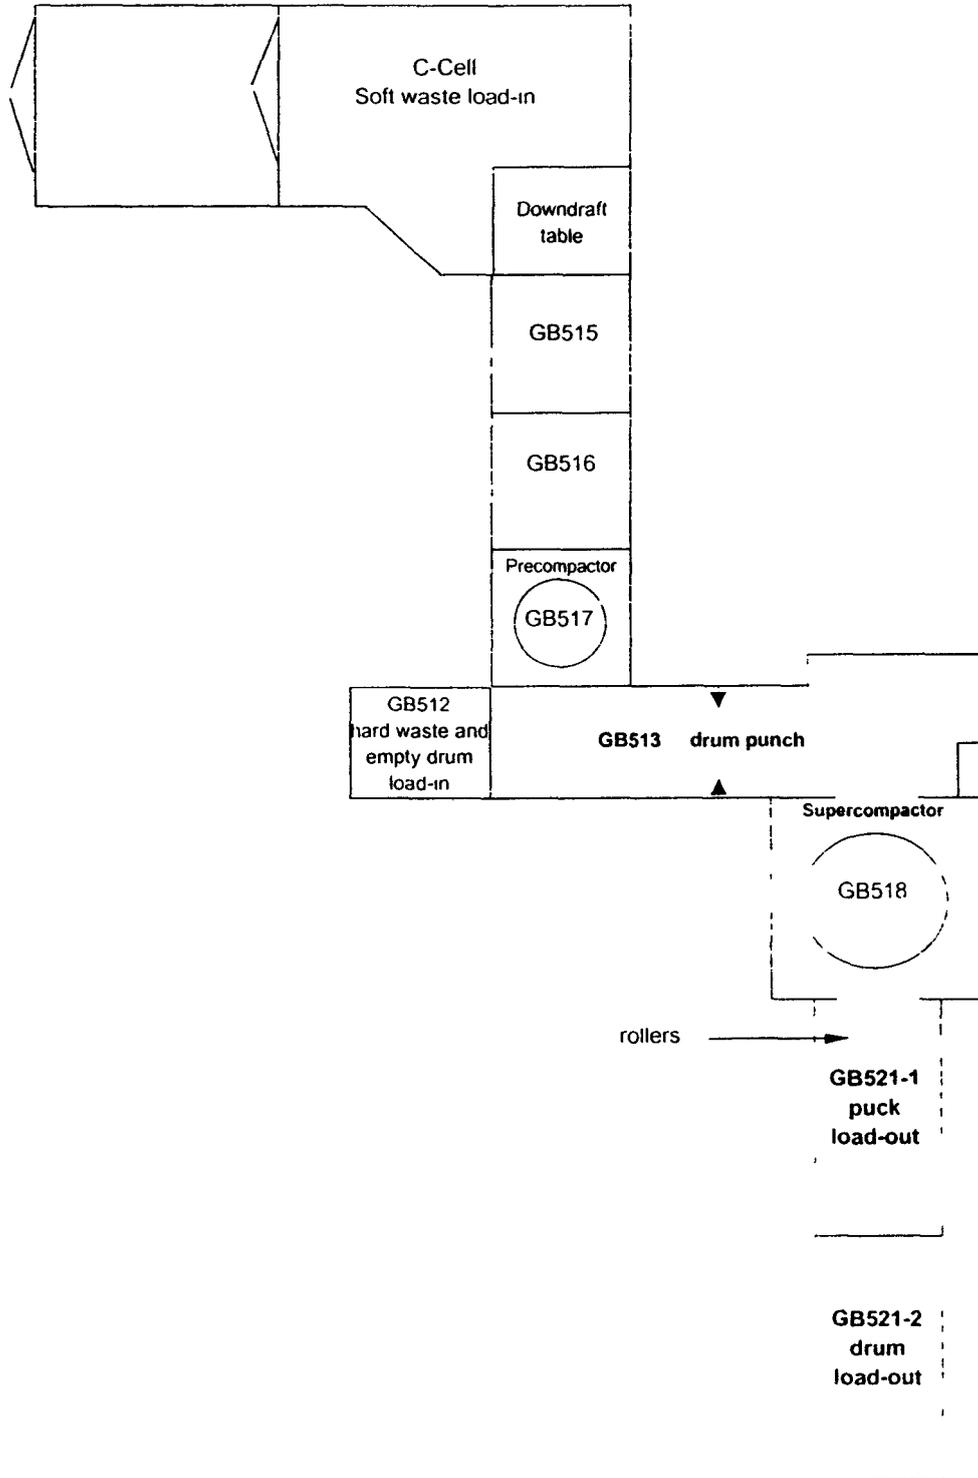
B776/777, SET 64
Supercompactor and Repackaging Facility (SARF)
Building 776, Room 134

Unit Description	<p>The Supercompactor and Repackaging Facility (SARF) is located in Building 776 Room 134. The SARF was installed in the early 1990's and operated briefly in 1993-1994. The largest pieces of equipment are a 2000 ton (force) supercompactor, 30 ton pre-compactor and associated hydraulic systems.</p> <p>Much of the SARF equipment is located inside of gloveboxes including GBs 512, 513, 515, 516, 517, 518, and 521. A c-cell was constructed on the north end of GB515 to provide containment for drum load-in. Drums of soft waste (paper, plastic) were unloaded in the c-cell on a downdraft table. The inner waste bags were transferred into GB516 where they were opened and sorted to remove non-conforming items. The waste was then placed into 35-gallon drums in GB517 for precompaction. The precompactor ram compressed soft waste within the 35-gallon drum. Filled drums were transferred via motorized rollers into GB513 for piercing. 35-gallon drums of hard waste (metal, glass) were loaded into GB512 for direct transfer into GB513 for piercing and did not go through the precompactor. The drums were pierced to allow air to escape from the 35-gallon drum during supercompaction, which occurred in GB518. Supercompaction involved crushing the entire 35-gallon drum plus contents into a puck. There was a collection ring at the base of the supercompactor to collect any liquids, but no liquid was ever encountered. The compressed pucks were loaded out into 55-gallon drums from GB521.</p> <p>The hydraulic systems were located outside the gloveboxes and did not come in contact with hazardous waste.</p> <p>Secondary containment for the SARF is provided by the gloveboxes.</p>

Unit Boundaries and Interfaces	The SARF unit boundary includes the glovebox system and the attached c-cell. A drawing showing the SARF layout is attached. The SARF was a stand-alone system and did not connect to any other gloveboxes or piping systems.
EPA Waste Codes/Waste Characterization	<p>A WEMS query identified only 11 drums of mixed waste generated by the SARF. Ten drums carry EPA waste codes of F001 and F002, and one drum has F005, D007, and D008 in addition to F001 and F002.</p> <p>The glovebox floors and rollers and the precompactor and supercompactor rams will be cleaned using debris rule technology and managed as FIW or FRU waste.</p>
Selected Closure Option	Unit removal in conjunction with debris rule treatment.
Closure Activities	The SARF components and containment that directly contacted listed waste include the floors of GBs 516, 517, 513, 518, and 521; the rollers in GBs 513 and 521; and the precompactor and supercompactor rams. Closure activities for these gloveboxes and components will include cleaning using an approved decon solution. After cleaning, the surfaces will be visually inspected to determine if they meet the standard for a clean debris surface. If they meet the standard, the component will be closed by removal and managed as non-hazardous waste. Otherwise, they will be closed by removal and managed as

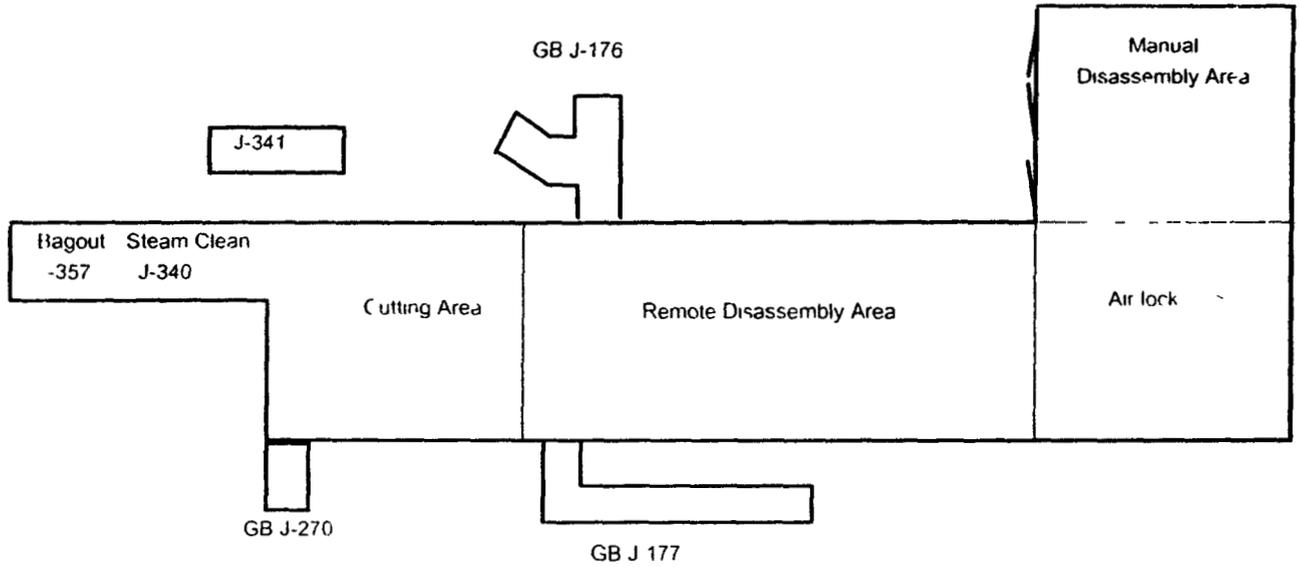
B776/777, S1 F 66
Advanced Size Reduction Facility
Building 776, Room 134

Unit Description	<p>The Advanced Size Reduction Facility (ASRF) is located in Room 134. The ASRF is a large stainless steel containment canyon that extends from ground level on the first floor through the 2nd floor (Room 209). There are five gloveboxes (J-176, -177, -270, -340 and -357) attached to the ASRF. Another free-standing glovebox (J-341) is located north of GB J-340.</p> <p>The ASRF was installed and operated in the 1980s for remote size reduction of equipment and gloveboxes. The ASRF has four major areas which are the Manual Disassembly Area (MDA), Transfer Area, Remote Disassembly Area (RDA) and Cutting Area. The MDA is currently used for waste treatment and repackaging. Once the cutting was completed, the pieces were passed through GB J-340 into T-357. GB J-340 was designed with a steam cleaner.</p> <p>Steam condensate was collected in pencil tank T-345 below GB J-340 and filtered in GB J-341. The condensate was then either cooled in heat exchangers and collected in Pencil Tank T-344 for recycle to the steam guns in the ASRF or transferred to Annular Tanks T-360 and T-370 (Set 52). Because the condensate was recycled through the system for reuse, the pencil tanks and filter system in GB J-341 are not regulated. The waste line exiting GB J-341 is the start of the regulated system.</p> <p>Glovebox J-176 has a drum drop and was originally designed as a waste sorting area. This glovebox has been used for leaded glove washing, LLC O cuttable repackaging, and other repack and sampling operations. Gloveboxes J-177 and 270 have been used for the storage of RCRA-regulated liquids.</p> <p>Secondary containment for the ASRF is provided by a stainless steel floor in the ASRF and all associated gloveboxes.</p>

Unit Boundaries and Interfaces	<p>The ASRF unit boundary includes the entire canyon area and all attached gloveboxes. A drawing showing the ASRF layout is attached.</p> <p>A drawing is attached showing the T-344/T-345 tank system. Shading indicates the portion of this system that is not regulated. Regulated piping beneath approximately eight feet will be removed as part of Set 66, and the ends of the piping leading into the overhead will be capped or plugged. The remaining line in the overhead in Room 134 will be removed as part of Set 78 (miscellaneous piping over eight feet).</p>
FPA Waste Codes/ Waste Characterization	<p>The tanks were drained to a physically empty condition in June 2000. Analytical results show that the liquid waste contains low levels of listed solvents (111 trichloroethane at up to 1100 ug/l and carbon tetrachloride at up to 570 ug/l) and levels of RCRA metals below ICIP.</p> <p>FPA waste codes of 1001 and 1002 will be applied to the regulated ancillary equipment upon removal. The waste is below FDR levels for these waste codes.</p>

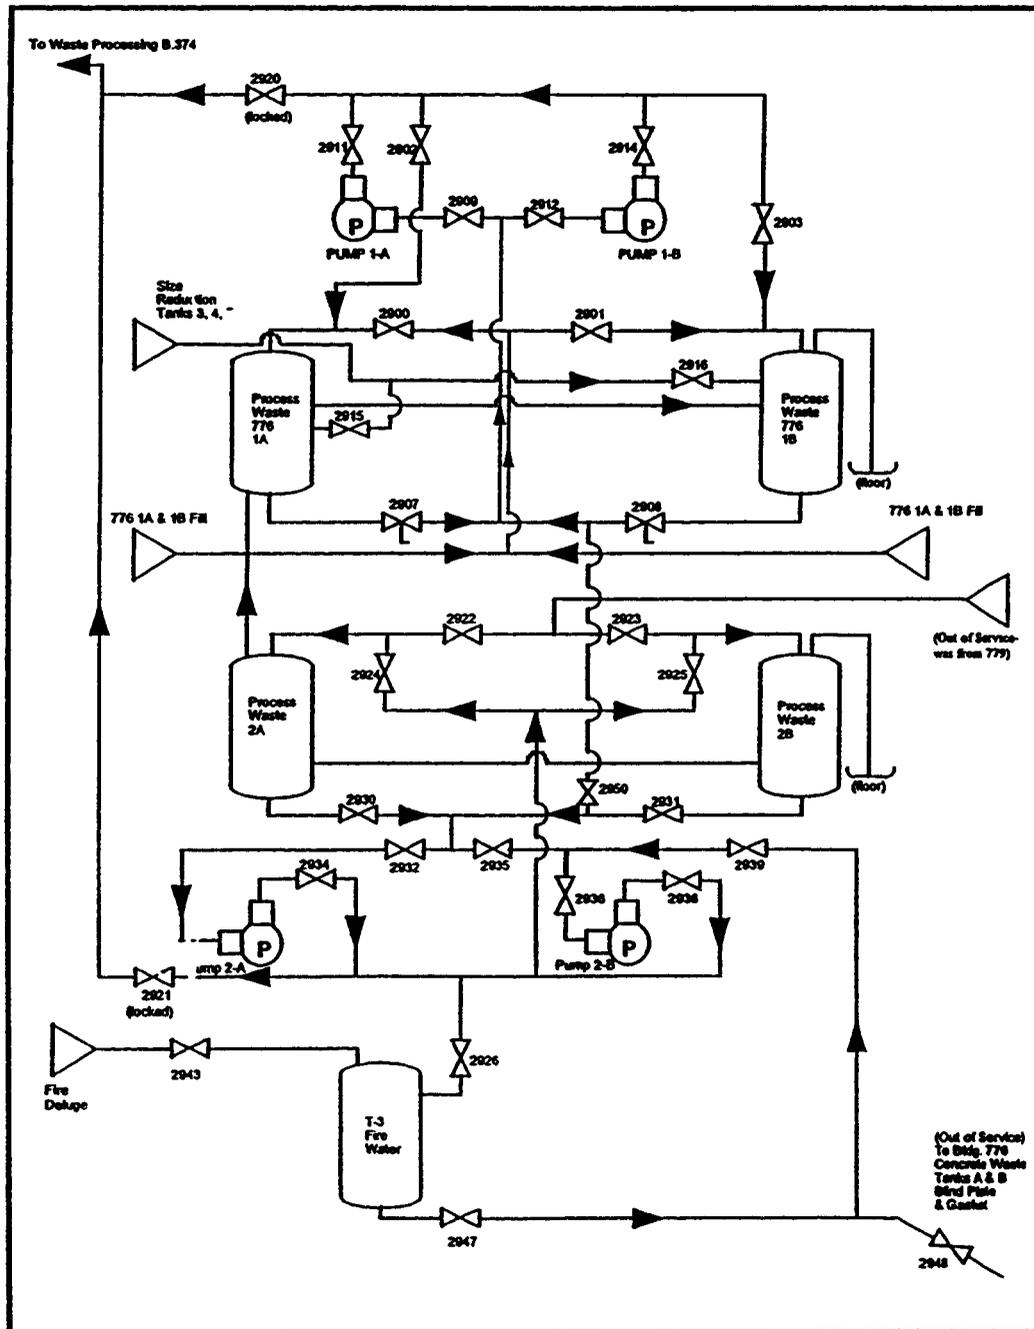
B776/777, SET 69
Process Waste Tank System Diagram
Building 776, Room 127

Unit Description	<p>SET 69 includes five fiberglass tanks within a bermed area in Room 127. Four of the tanks are RCRA-permitted process waste tanks. The fifth tank, T3, is a raschig ring filled tank for the collection of plenum deluge water, and is not RCRA regulated.</p> <p>The process waste tanks have been in use since 1977. The tanks have historically collected hazardous and non-hazardous process wastes from Buildings 776, 777, and 779. The tanks currently collect hazardous and non-hazardous remediation wastes from Buildings 776 and 777.</p> <p>The liquids from the tanks are pumped through the process waste lines to Building 374 via valve vault 9. When Building 374 closes, the waste will be collected by tanker truck for transfer to a treatment facility.</p> <p>A hypalon-lined bermed area provides secondary containment for the tanks. The concrete floor of the building provides secondary containment for the ancillary piping.</p>

Unit Boundaries and Interfaces	<p>The T-tank system includes the four tanks and ancillary equipment in the bermed area, and the outlet piping leading to valve vault 9. All ancillary piping beneath approximately eight feet will be removed as part of Set 69, and the ends of the piping leading into the overhead will be capped or plugged. The remaining lines in the overhead will be removed as part of Set 78 (miscellaneous piping over eight feet). A drawing is attached showing the tanks and ancillary equipment.</p> <p>The hypalon liner and concrete berm will be removed as part of Set 69. The concrete floor will be addressed with Set 82, Building Structure.</p>
EPA Waste Codes/Waste Characterization	<p>The T-tanks have stored process waste that was characteristically hazardous for RCRA metals such as cadmium, chromium, and lead (D006, D007, and D008). The tanks also stored low-concentration F-listed wastes (F001 F002) received from ASRF condensate tanks T-360 and T-370.</p> <p>The 776 Closure Project may elect to demonstrate that the F-listed wastes are no longer contained in the T-tank system in conjunction with characterization efforts for the site-wide process waste system (e.g. B374 sludge de-listing petition).</p>

Note Tank T-3 is not part of the RCRA-regulated system
