BUILDING 995/SANITARY SEWER CLOSEOUT REPORT RESPONSE -- DWF-068-05

Instructions for Completion of Type 1 Facility Closeout Report

Facility Descriptions, Operation and Closure of the Sanitary Collection and Treatment Systems at RFETS

SANITARY WASTE LINES
CLOSEOUT REPORT DWG-1

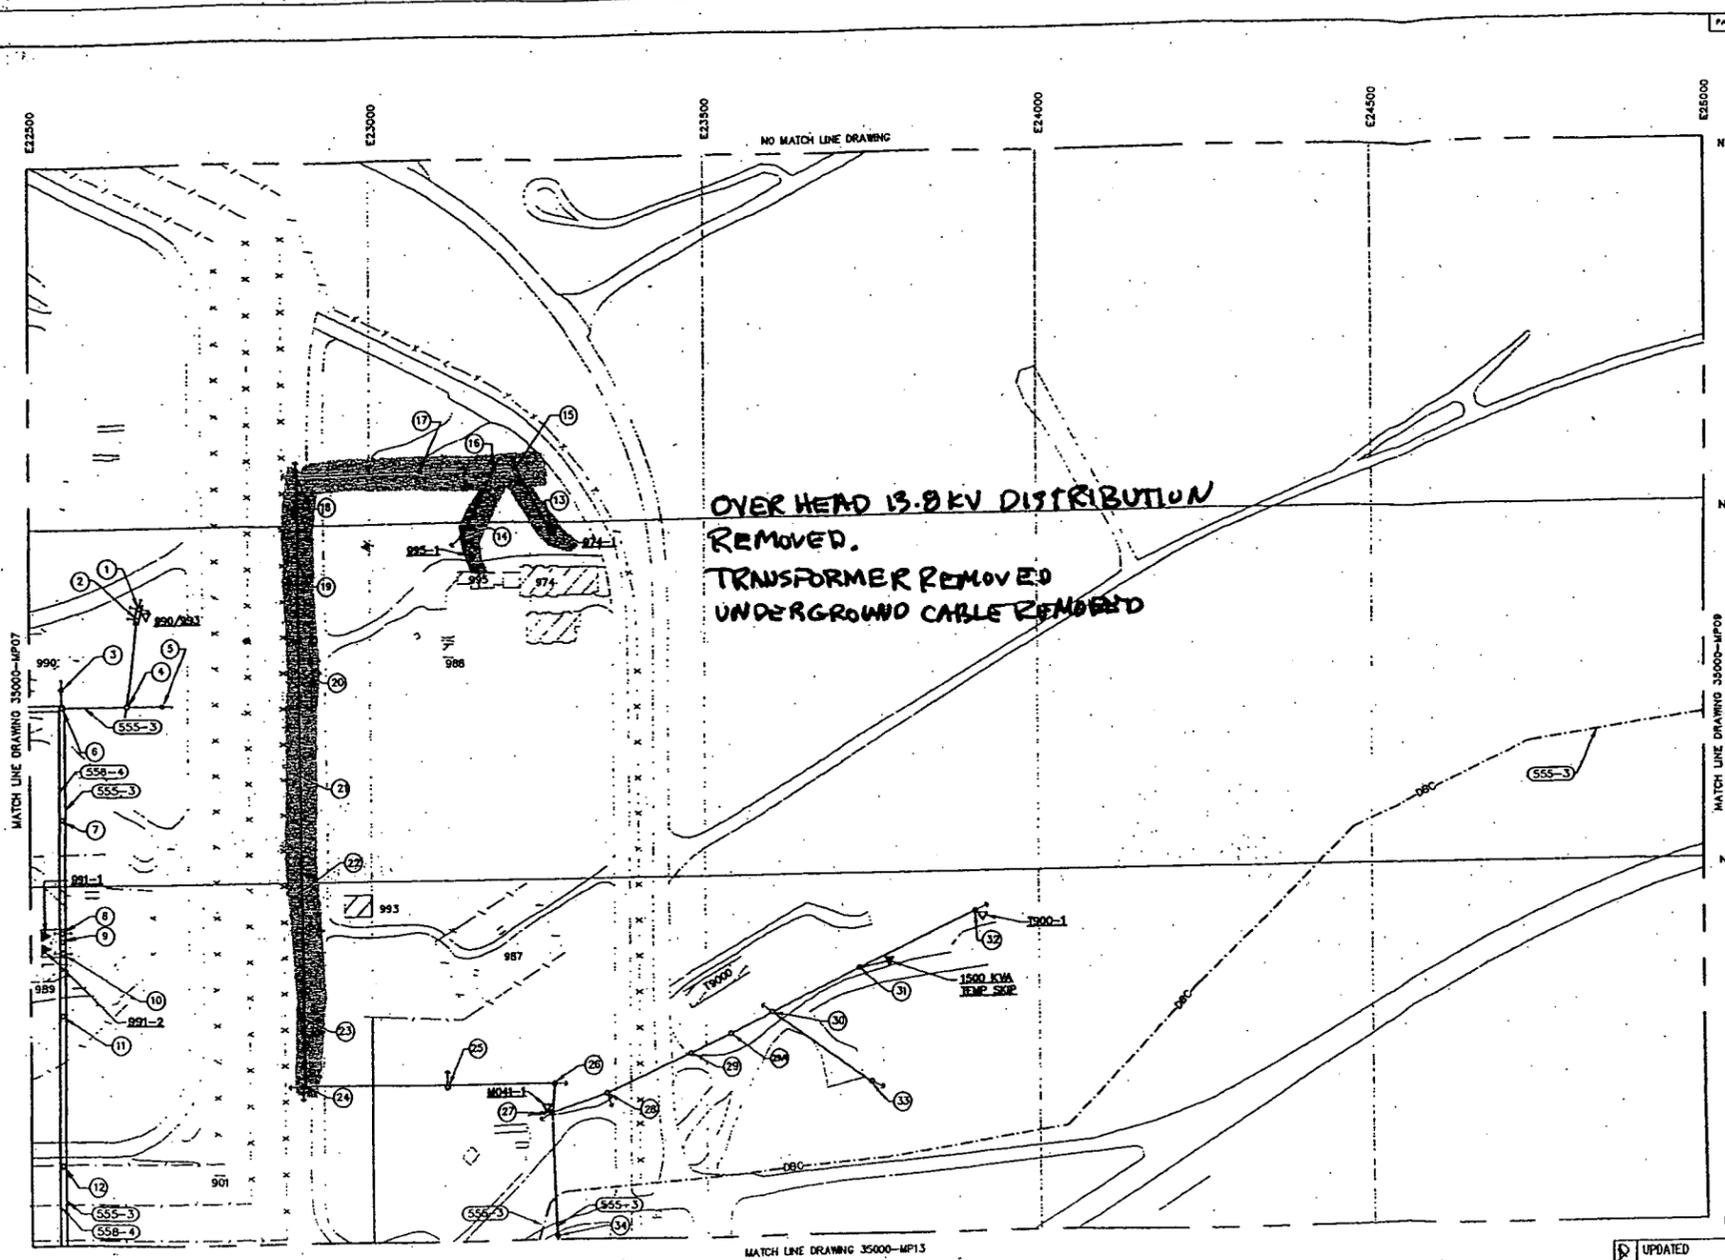
Attached to this report are Figures A, B C and D which show the utility removals and facility disposition. Buildings in the 990 area were removed as was the junction box identified as Manhole 146. The equalization basins were removed to 4 feet below final grade, then filled with clean fill. All of the structures in the 995 area were removed, including the sludge drying beds, the influent and effluent storage tanks, the digesters, all manholes and similar structures, and in ground lines. Some structural components of the buildings were left in place at least 4 feet below final grade, and are identified on Figure D. The main concrete structures left in place include partial walls of B995 and influent storage tanks 2 and 3 plus the foundations of the tertiary clarifier (C-5), one of the chlorine contact chambers (CCC-2), B988, and one effluent cell (EC-3). The PVC pipe foundation drain at the base of EC-3 was also left in place.

CONCRETE LEFT IN PLACE AT LEAST 3 FEET BELOW FINAL GRADE

FOUNDATION DRAIN LEFT IN PLACE AT LEAST 3 FEET BELOW FINAL GRADE

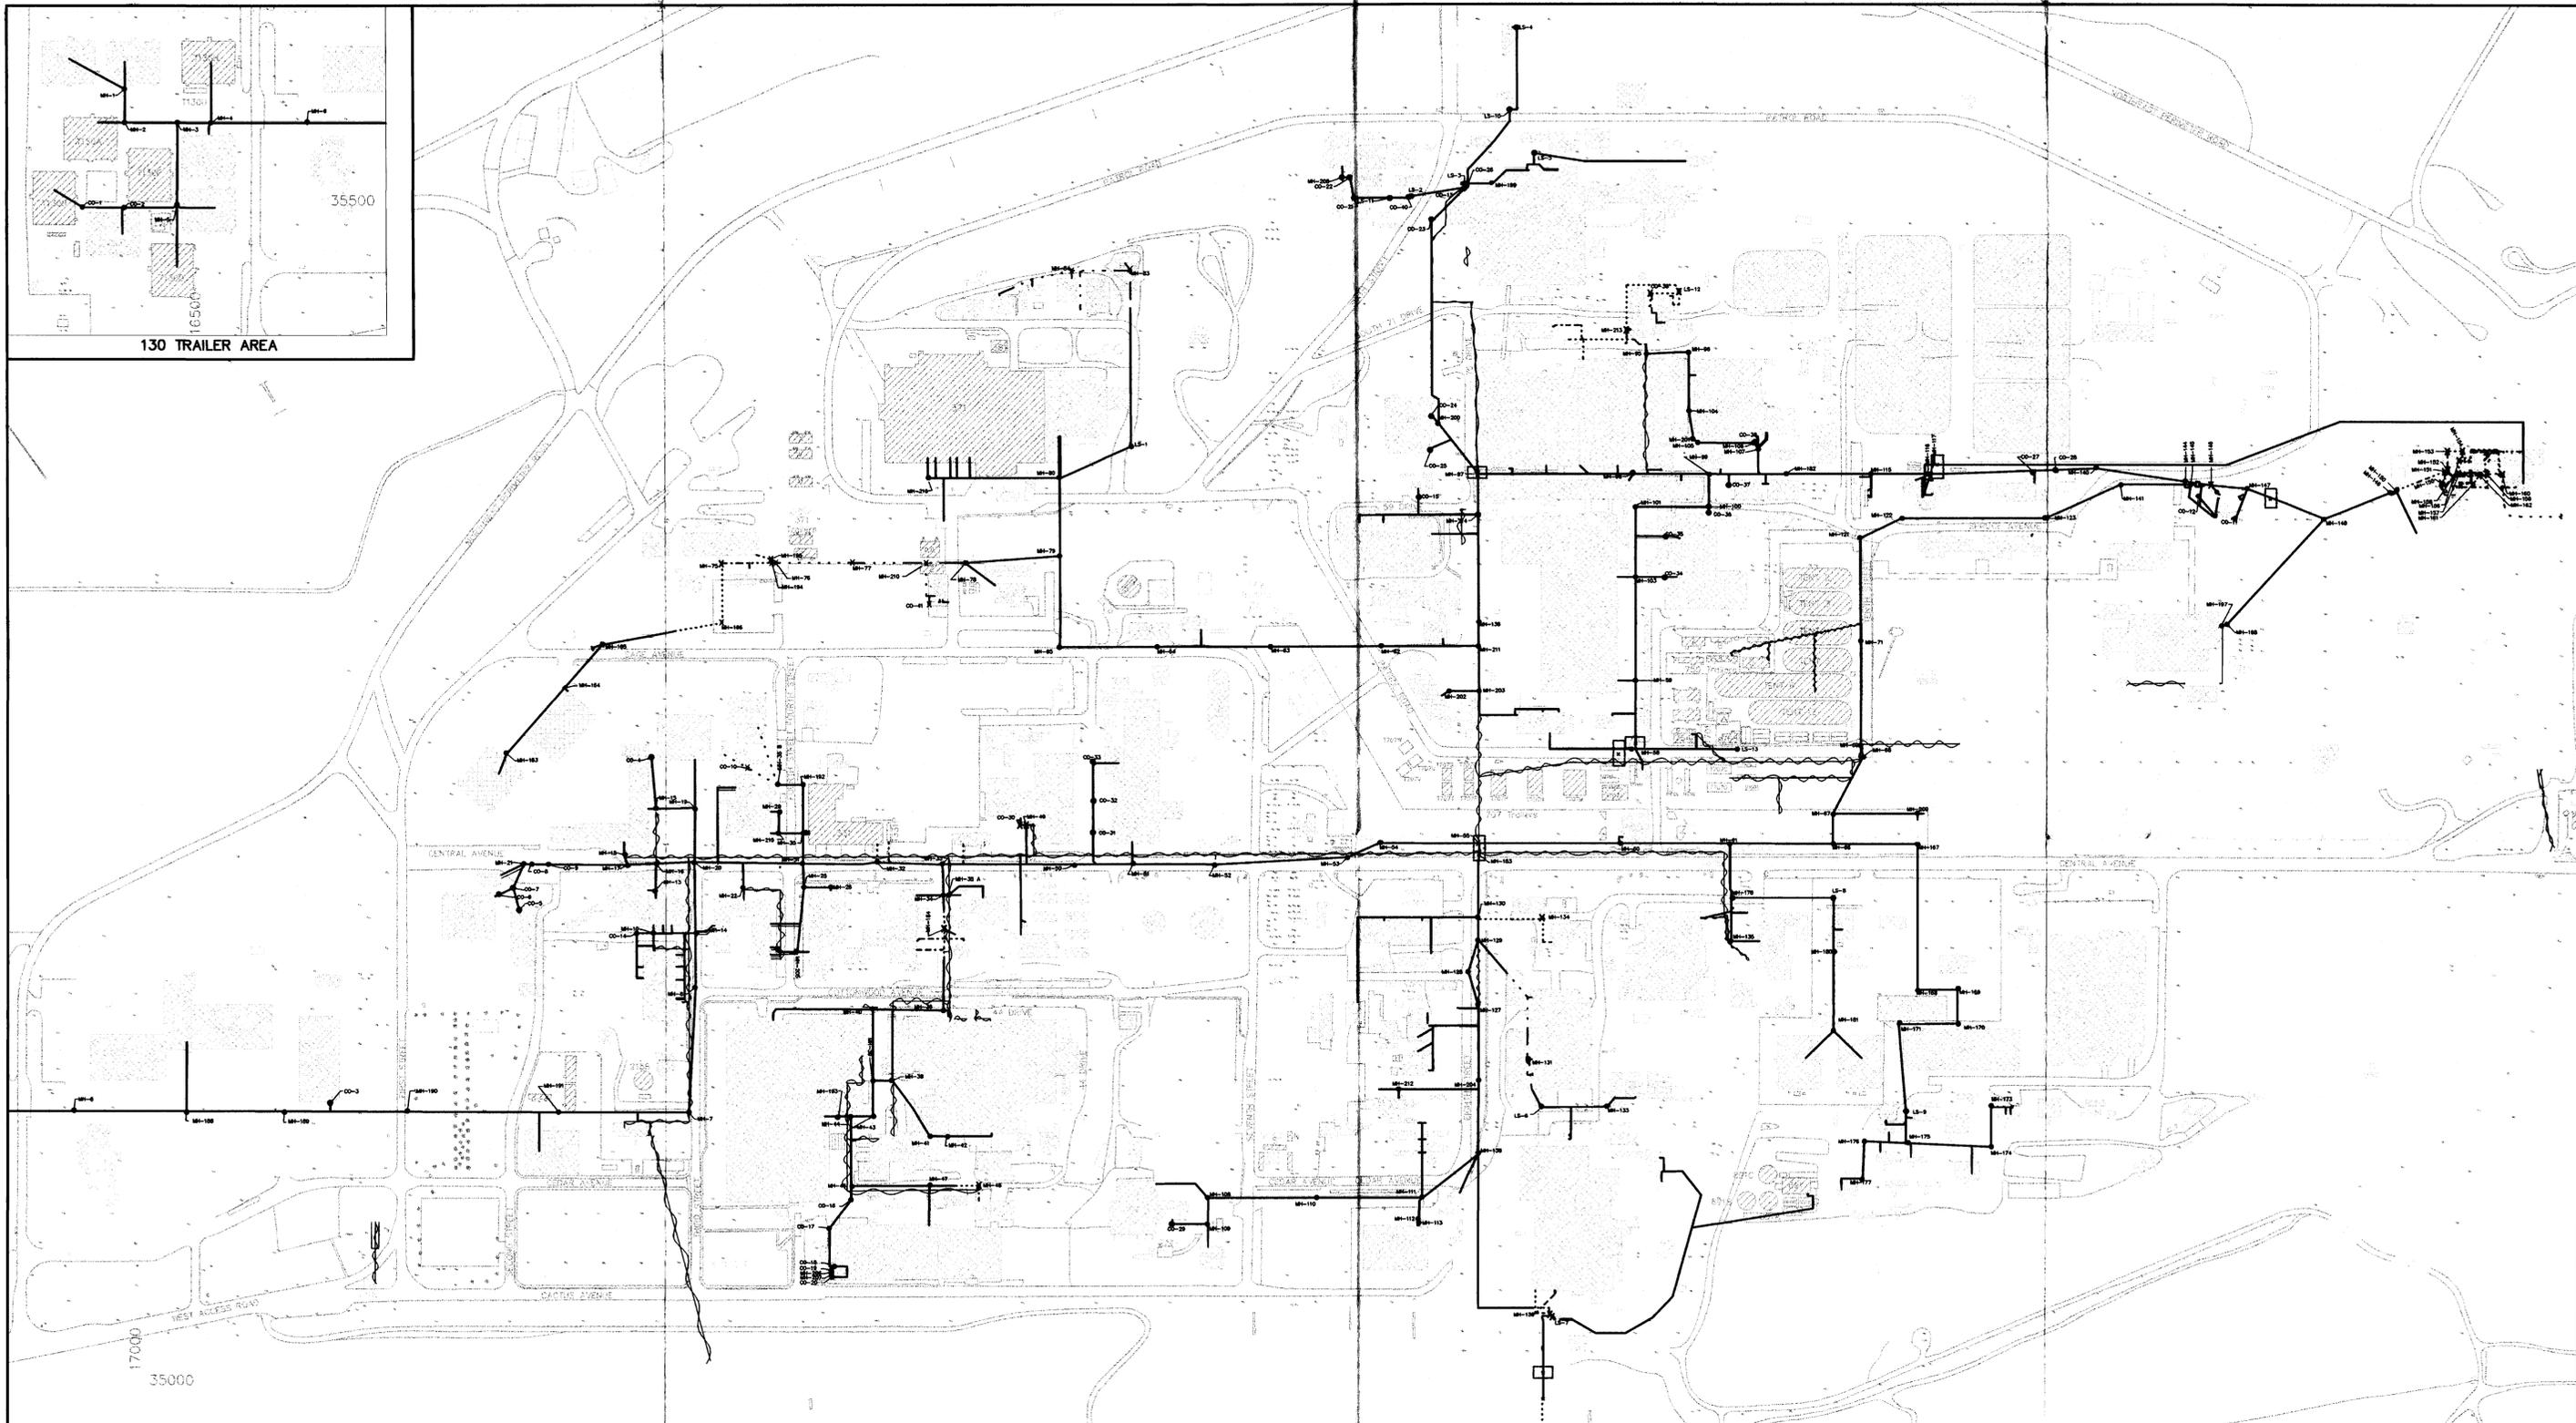
- 10) Drawing #1 - a) Please provide the disposition of MH-201, b) Please indicate if the N-S interruption of the line next to

MH-58 and at MH-55 included the abandoned lines and utility trenches as well, c) Please provide the disposition of LS-13, d) Please indicate if MH-55, MH-58, MH-117, MH-147, and MH 183 were removed during the interruption of the lines at these locations, e) Please show the disposition of the sanitary sewer line shown to continue to the east of the B995 complex on figure C, f) Please discuss the sanitary system, or lack of such a system, that may have been associated with the East and West Gates, g) please show the locations and disposition of the MHs associated with the abandoned system as included in Table 2.

- 11) Please include a discussion of the remaining infrastructure, such as manholes, lines, and septic tanks, associated with the abandoned sections of the sewer system shown in green on the Drawing.

As noted above, some manholes were removed as part of a building demolition before the closure strategy described in the Tech Memo was finalized; those cases are identified in Table 2. The attached drawing "Rocky Flats Sanitary Waste Lines Closeout Report Dwg 1" shows the status of the entire sanitary collection system, including which lines were removed and which remain, and the parts of the system (manholes, lift stations and cleanouts) that were "completely removed" as well as those "removed to 4 feet below grade". As described in the Technical Memorandum, known abandoned sanitary lines will be removed to a depth of at least 3 feet below final grade (bfg). The Technical Memorandum also describes abandoned lines for which no reliable information is available, citing erroneous reports, maps showing existing lines in the wrong direction, and indications that some designed installations were never implemented. Some portions of the original collection system had been abandoned prior to 1990; these lines were identified in the Technical Memorandum. Some parts of the active system had been abandoned after 1990, about the time a major portion of the collection system had been sliplined. In accordance with the Technical Memorandum, known abandoned lines were removed to below 3 feet and exposed ends grouted. Sewer lines discovered in the course of building demolition were also treated in a similar manner.
