Final East Trenches Plume Project Closeout Report Fiscal Year 1999

RF/RMRS-99-443.UN

Rocky Flats Environmental Technology Site

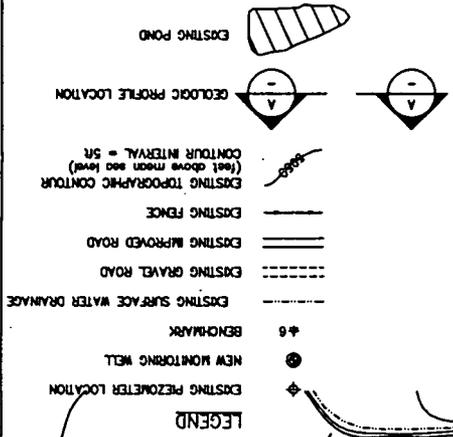
Figure 1
East Trenches Plume System

The groundwater collection system extends approximately 1,200 feet in an east-west direction (Figure 1) and captures the majority of the contaminated groundwater plume. To install the collection system, an excavation was dug at a variable depth of approximately 16 to 26 feet below ground surface, at least 6 inches, and on average, 3 feet into claystone. An impermeable barrier was installed that consists of 80-mil high-density polyethylene (HDPE) panels fitted with an interlocking strip on each side. A hydrophilic cord was threaded through the entire length of the interlock. This cord swells when wet, further sealing the panels together. These panels are 15 feet wide and of a variable height depending on the installation depth.

Four downgradient monitoring wells monitor the performance of the system. One existing well is being used along with three additional wells installed as part of the system (Figure 1).

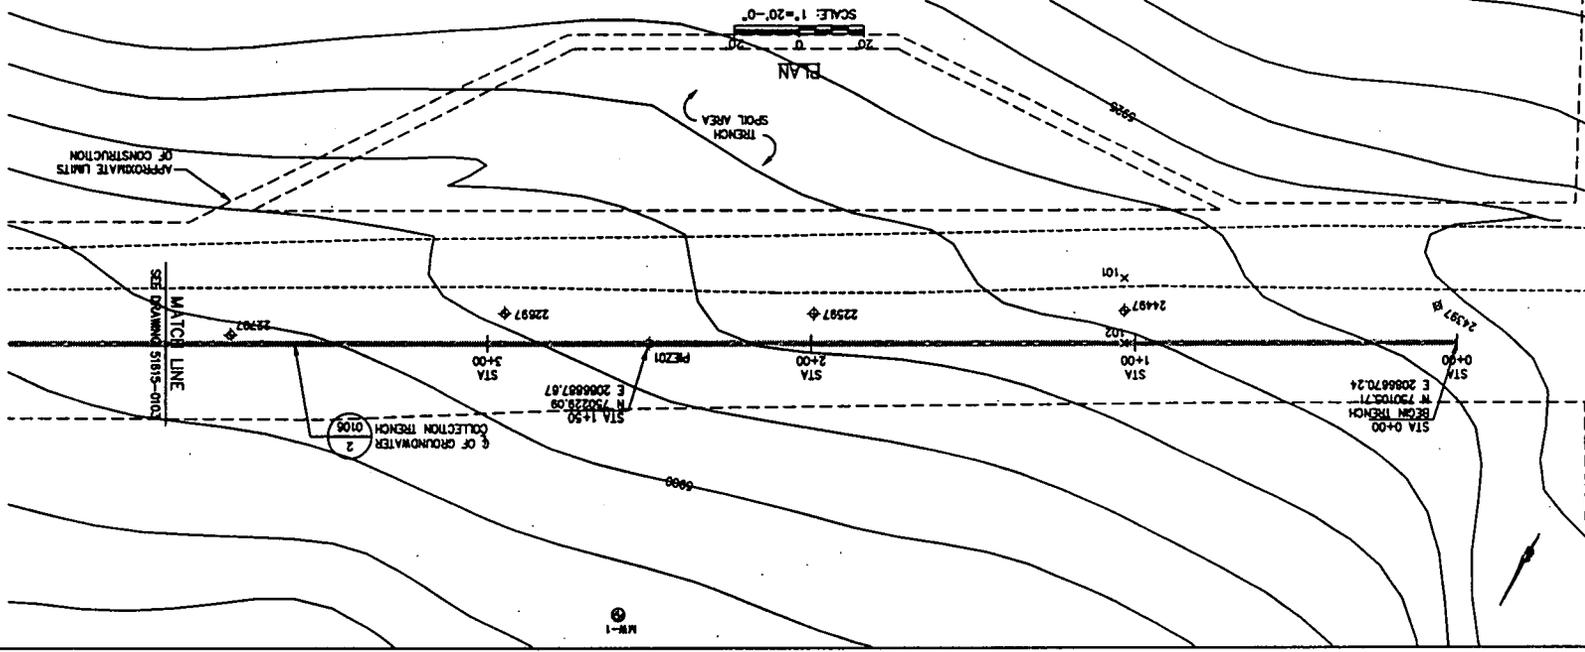
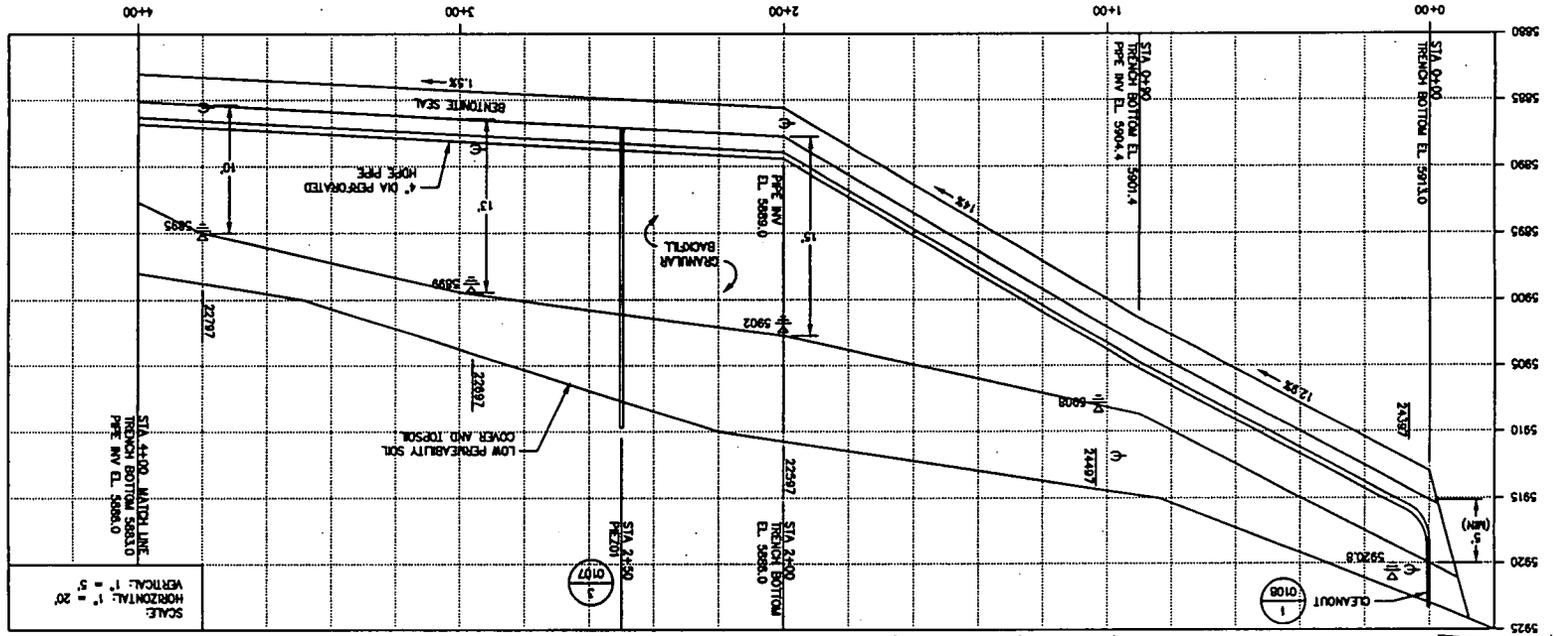
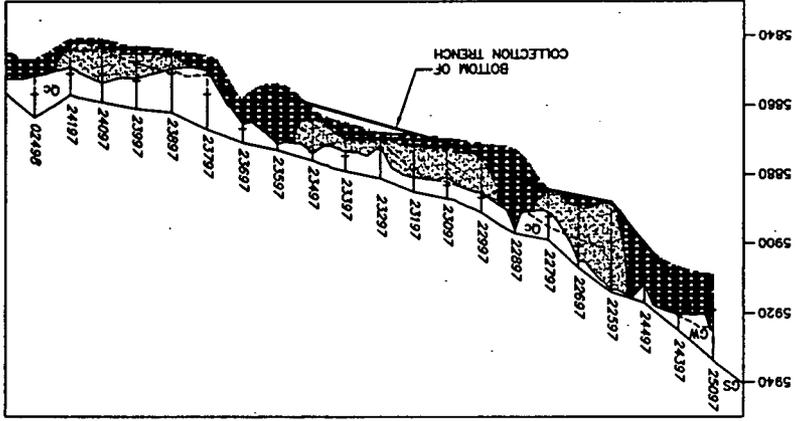
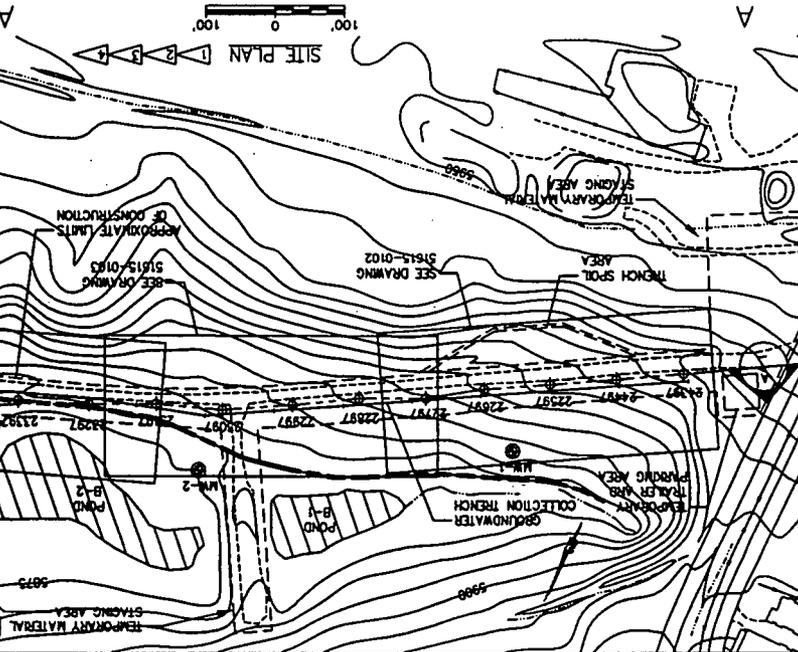
Figure 2
 East Trenches Plume
 Collection Trench Details

The bottom of the collection trench was filled with bentonite pellets to limit bypass or leakage. On the upgradient side of the barrier, approximately one foot of sand was placed over the bentonite to bed the collection line. The four-inch perforated HDPE groundwater collection line was placed on the sand, and piped to a central collection sump. Sand was then placed around and several feet above the horizontal collection line. The trench was then backfilled. Three piezometers were installed in the collection trench for monitoring of water levels within the collection system. Figure 2 shows the details of the trench construction.

In addition, Figure 9 of the Proposed Action Memorandum (RMRS 1999) shows geotextile around the filter pack in the collection trench. The geotextile was removed when it was determined that it was not necessary.

Where the two portions of the collection trench met, it was not possible to interlock the panels due to the conditions. Therefore, a panel from the western leg of the collection trench was installed that overlaps the eastern leg of the collection trench by approximately 4 feet. The area between the two panels was filled with bentonite. The area behind the overlap in the panels was filled with bentonite to the top of the panels. In all, 5.5 supersacks of bentonite, each containing approximately 3,500 pounds, were utilized to seal the area where the two panels overlap.

The perforated collection pipe was broken in several places during installation. The pipe could not be repaired because the excavation could not be entered due to highly unstable conditions. A new section of pipe was placed adjacent to and overlapping the severed section, with both sections bedded in sand. Field observations during installation of the western leg of the collection trench indicated that this method worked very well for transporting the collected groundwater.

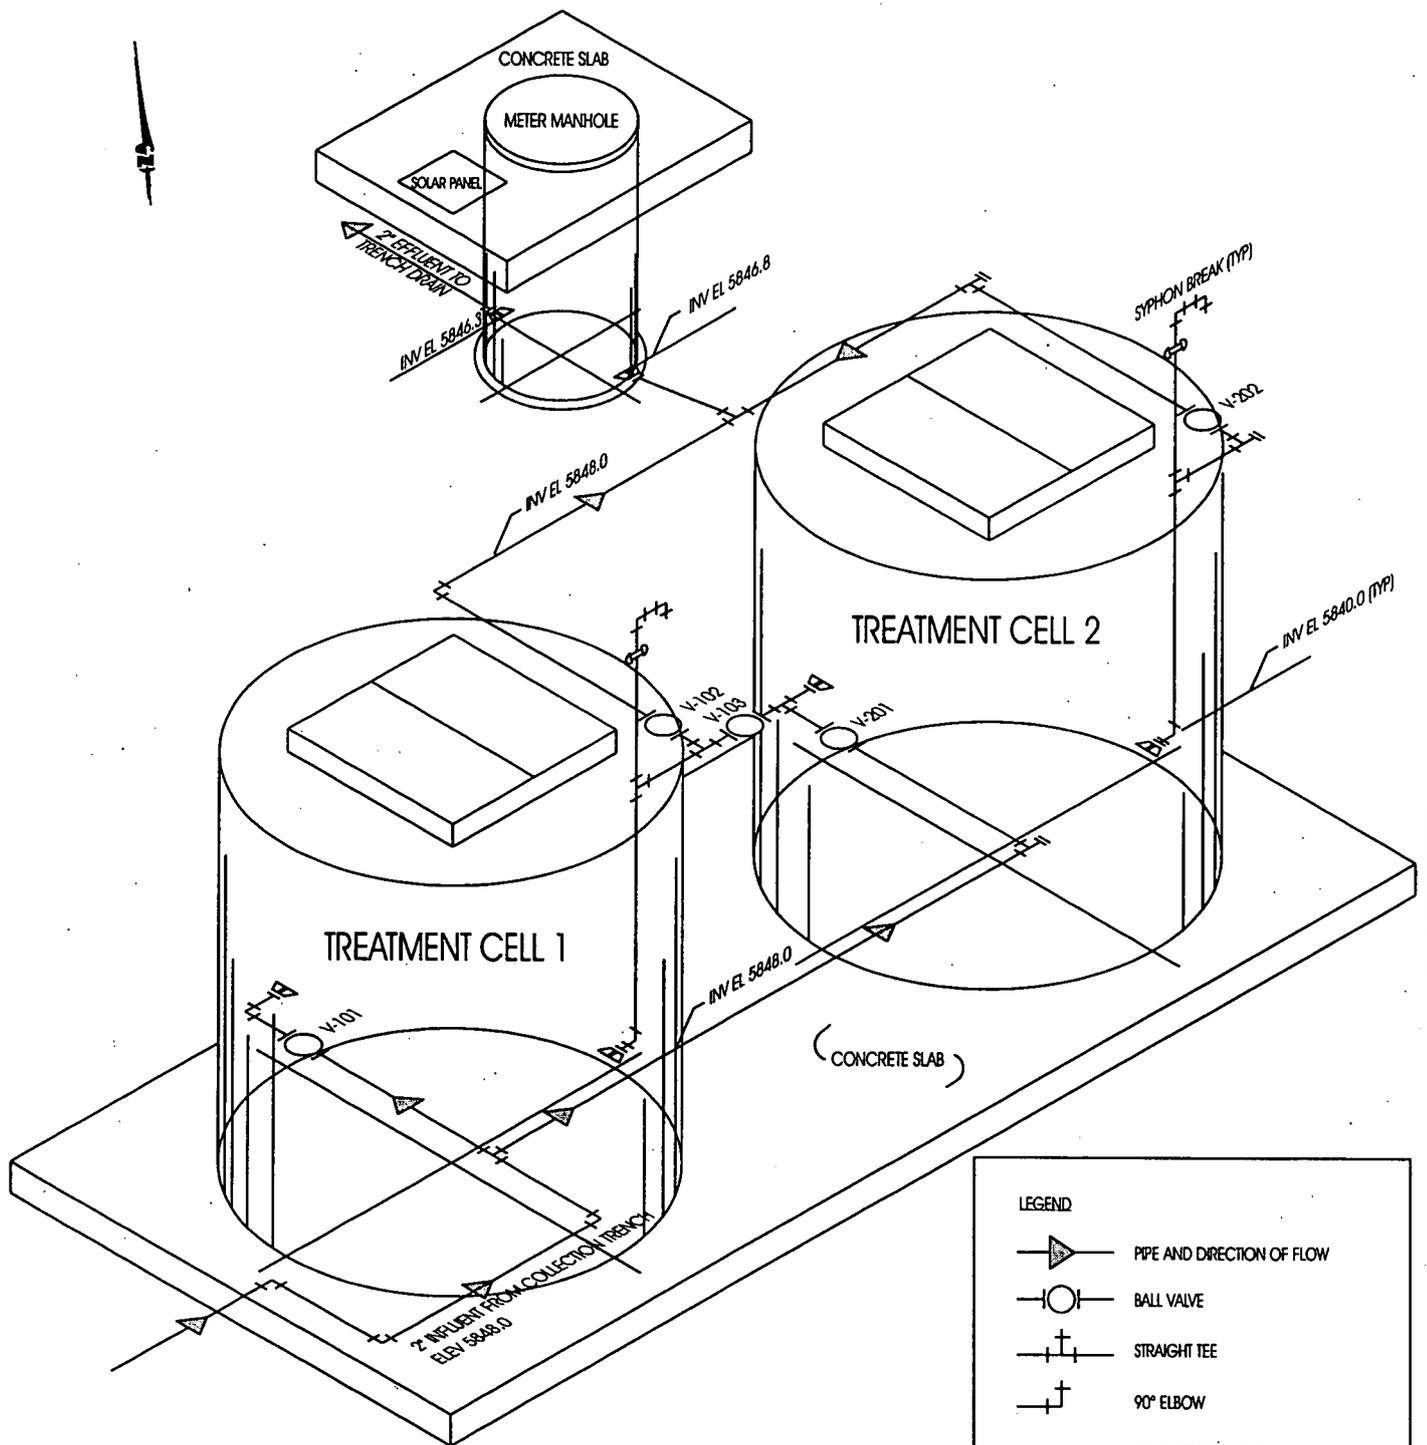
Figure 3 East trenches Plume Treatment System Isometric

The treatment cells are piped so that they can be run in serial or parallel (Figure 3). Water discharges from the base of the treatment cell to the next cell or to the metering manhole. The metering manhole contains a water-flow meter to determine the volume of water treated, and is the effluent sample location. From the metering manhole, the treated water then discharges to groundwater through an infiltration gallery located adjacent to South Walnut Creek. However, for additional flexibility, the system allows discharge directly to surface water in South Walnut Creek, if needed. Reclamation of the disturbed areas and restoration of the B-Series Pond road took place after installation of the collection and treatment system.

The treatment system consists of two high-density polyethylene tanks containing reactive iron, which degrades the dissolved VOCs in the groundwater. The system utilizes iron to induce conditions where hydrogen is substituted for chlorine in the chlorinated VOCs. The end products of the process are completely dehalogenated hydrocarbons and non-toxic salts. The treatment cells are approximately 12 feet in diameter and 13 feet tall. Groundwater enters the cells at the top and percolates through the 6.5 feet of iron. There is one foot of granular material on the bottom of each treatment cell to disperse the

groundwater. The upper foot of each cell is a 50/50 mixture of iron and pea gravel to simplify mechanical break-up of the expected crust formation.

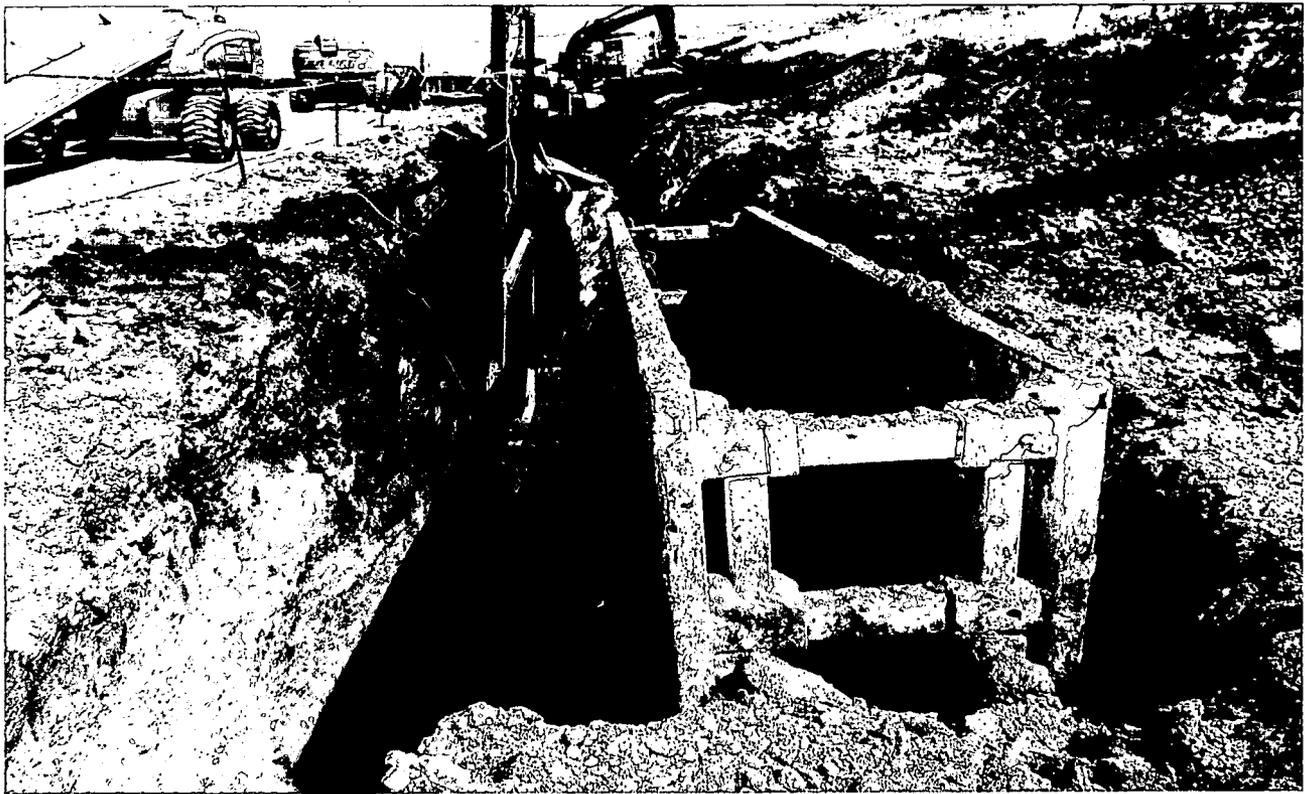
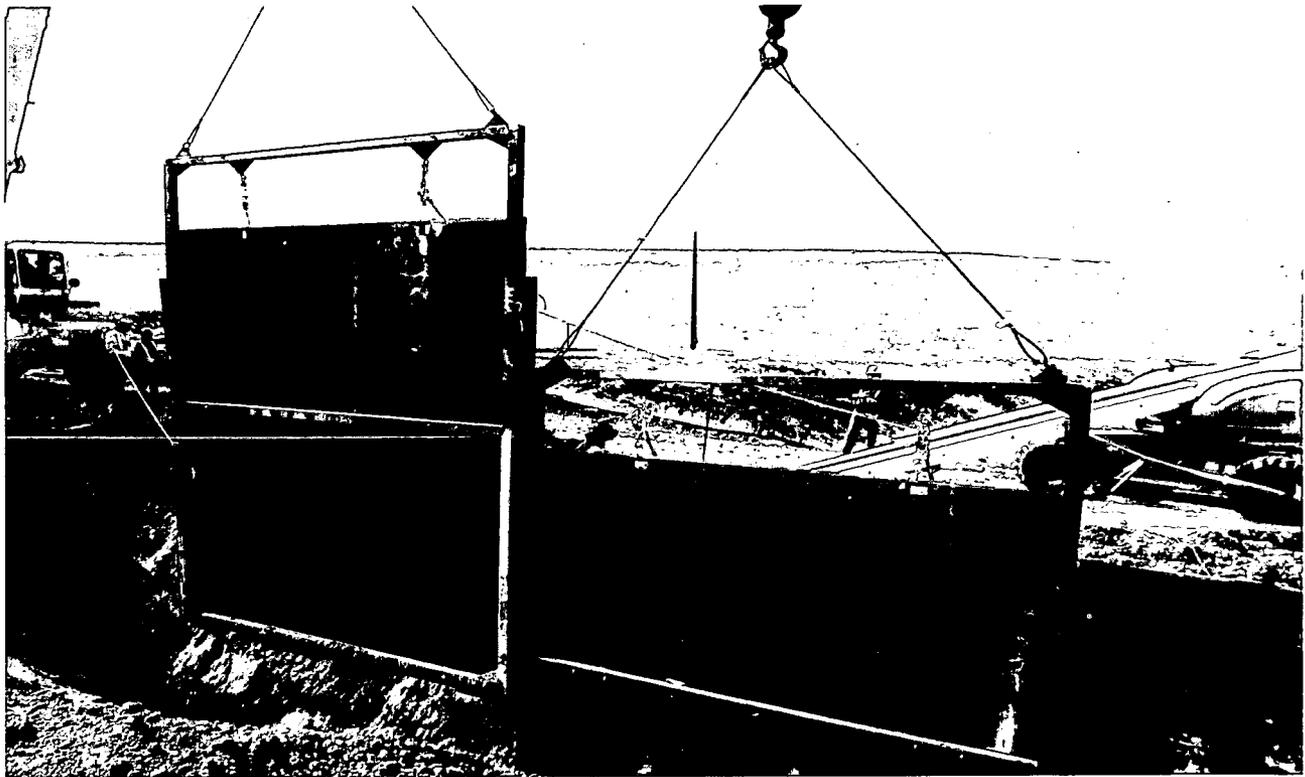
Installation of Panels at East Trenches

Significant failure of the excavation occurred during installation of the collection system. This failure was due in part to well above average precipitation during installation of the collection system, which saturated and destabilized the excavation, and to a previously unidentified fault zone in the collection system area. Failure of the excavation resulted in damage and removal of several barrier panels. When continued installation of the collection system was not possible under existing conditions, a sand trench was installed along the planned location of the western half of the collection trench to drain the area. After the sand trench was completed, the barrier panels were installed starting at the western end of the collection trench. Solid steel plates were used to support the panels during installation instead of the previously used hollow frames. These solid plates were additionally braced by I-beams and, along with a modified trench box, limited excavation collapse.

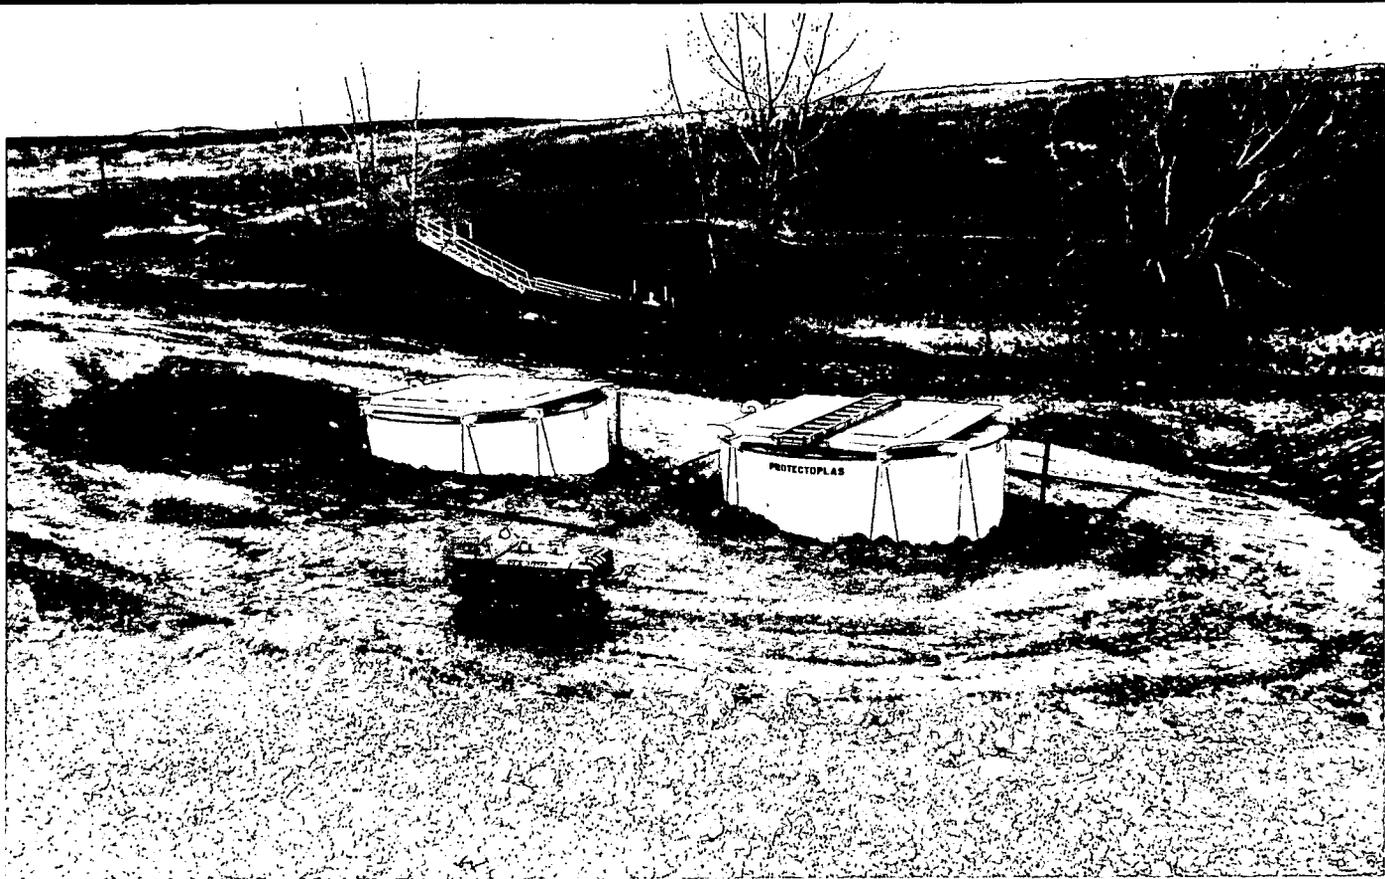
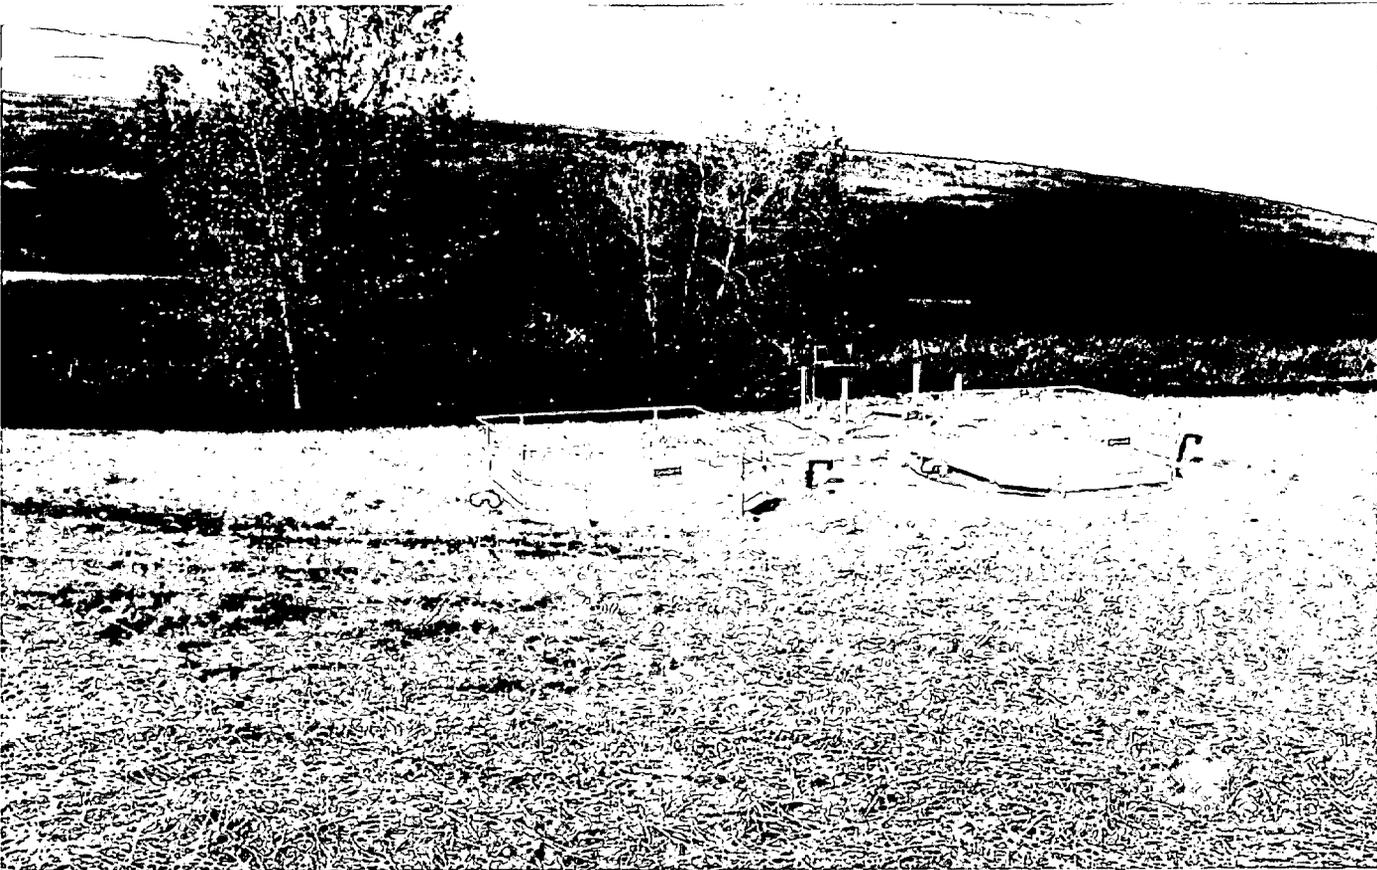
East Trenches Treatment Cells
