TRANSMITTAL OF THE "DRAFT CLOSEOUT REPORT FOR THE SOURCE REMOVAL AT THE TRENCH 1 SITE, IHSS 108, REVISION C, RF/RMRS-99-302.UN - JEL-057-99

Draft Closeout Report for the Source Removal at the Trench 1 Site IHSS 108

RF/RMRS-99-302.UN

June 1999
Revision C

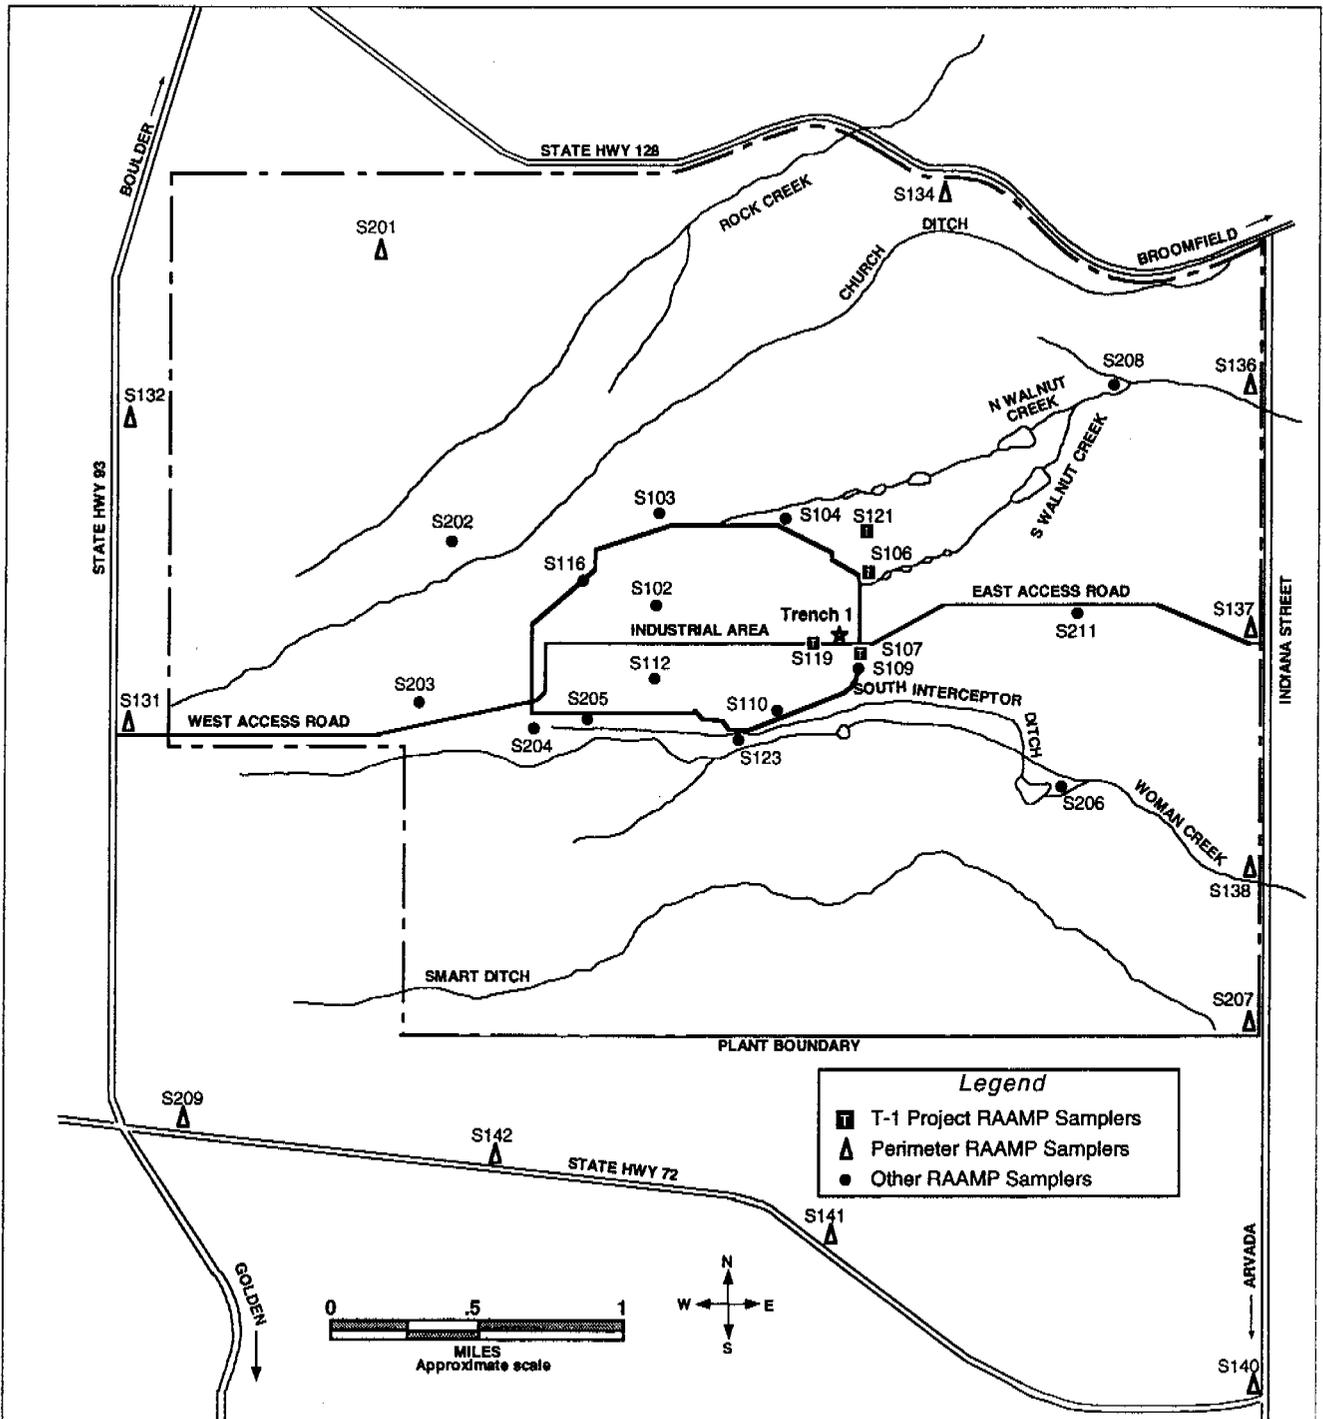
Figure 1. RAAMP Sampler Location Map

RAAMP Samplers Located Around T-1 Site
(Alpha Screens)

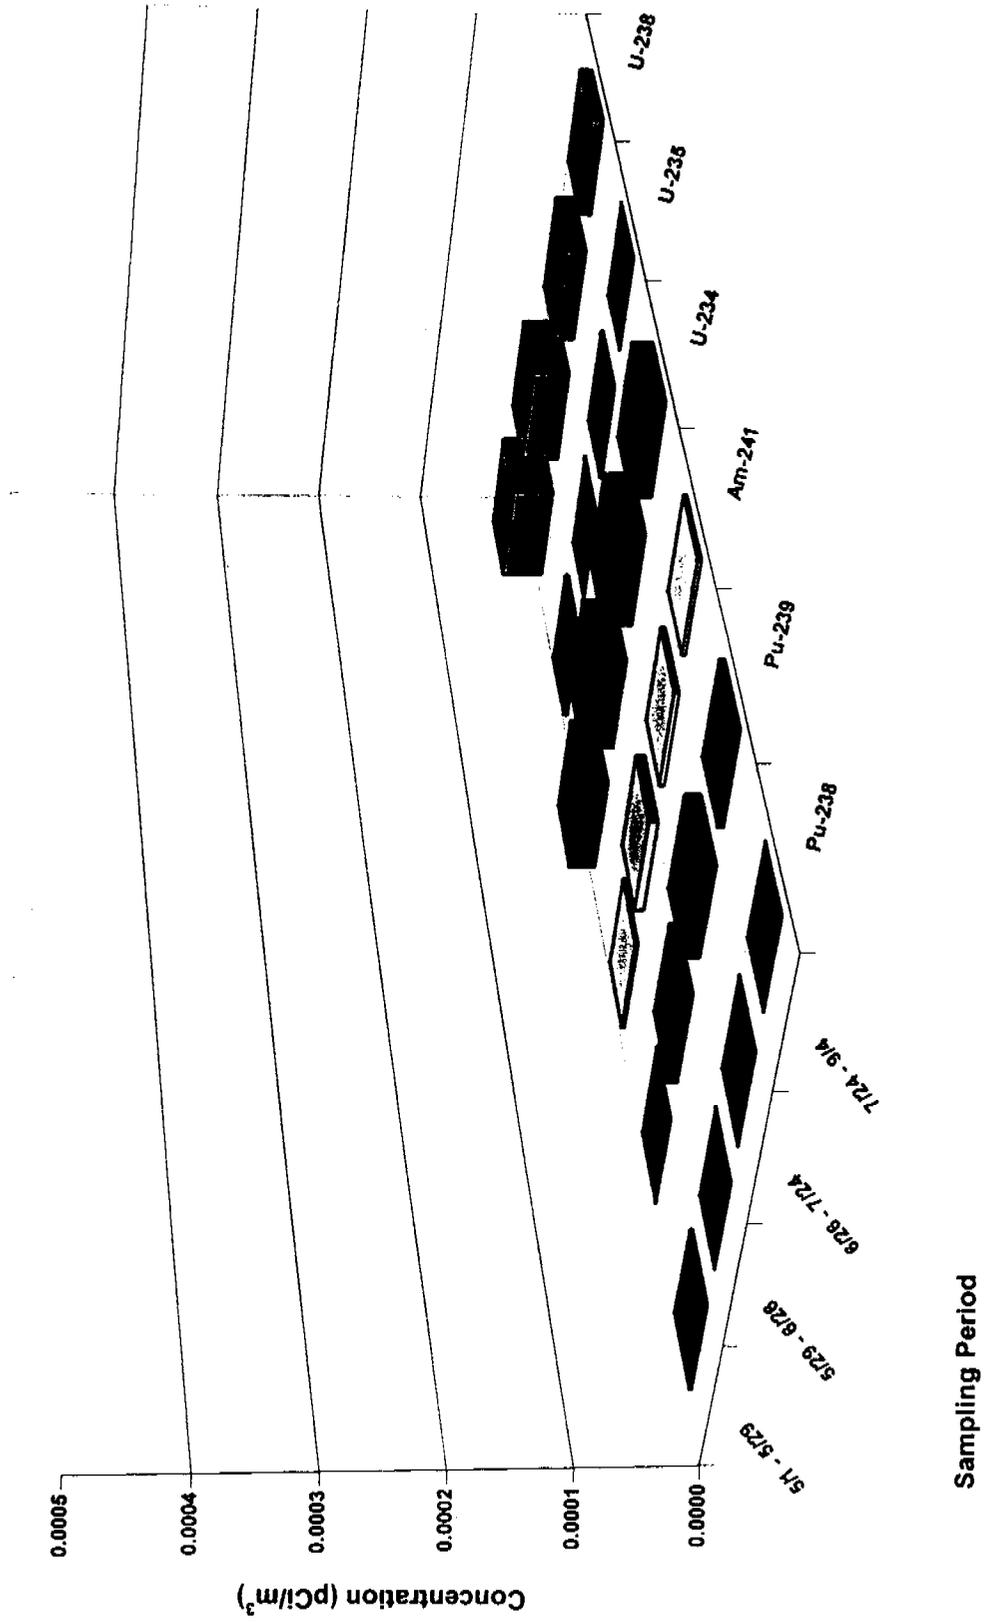
Figure 4

Isotopic Results
Sampler S-107 (East of 903 Pad)

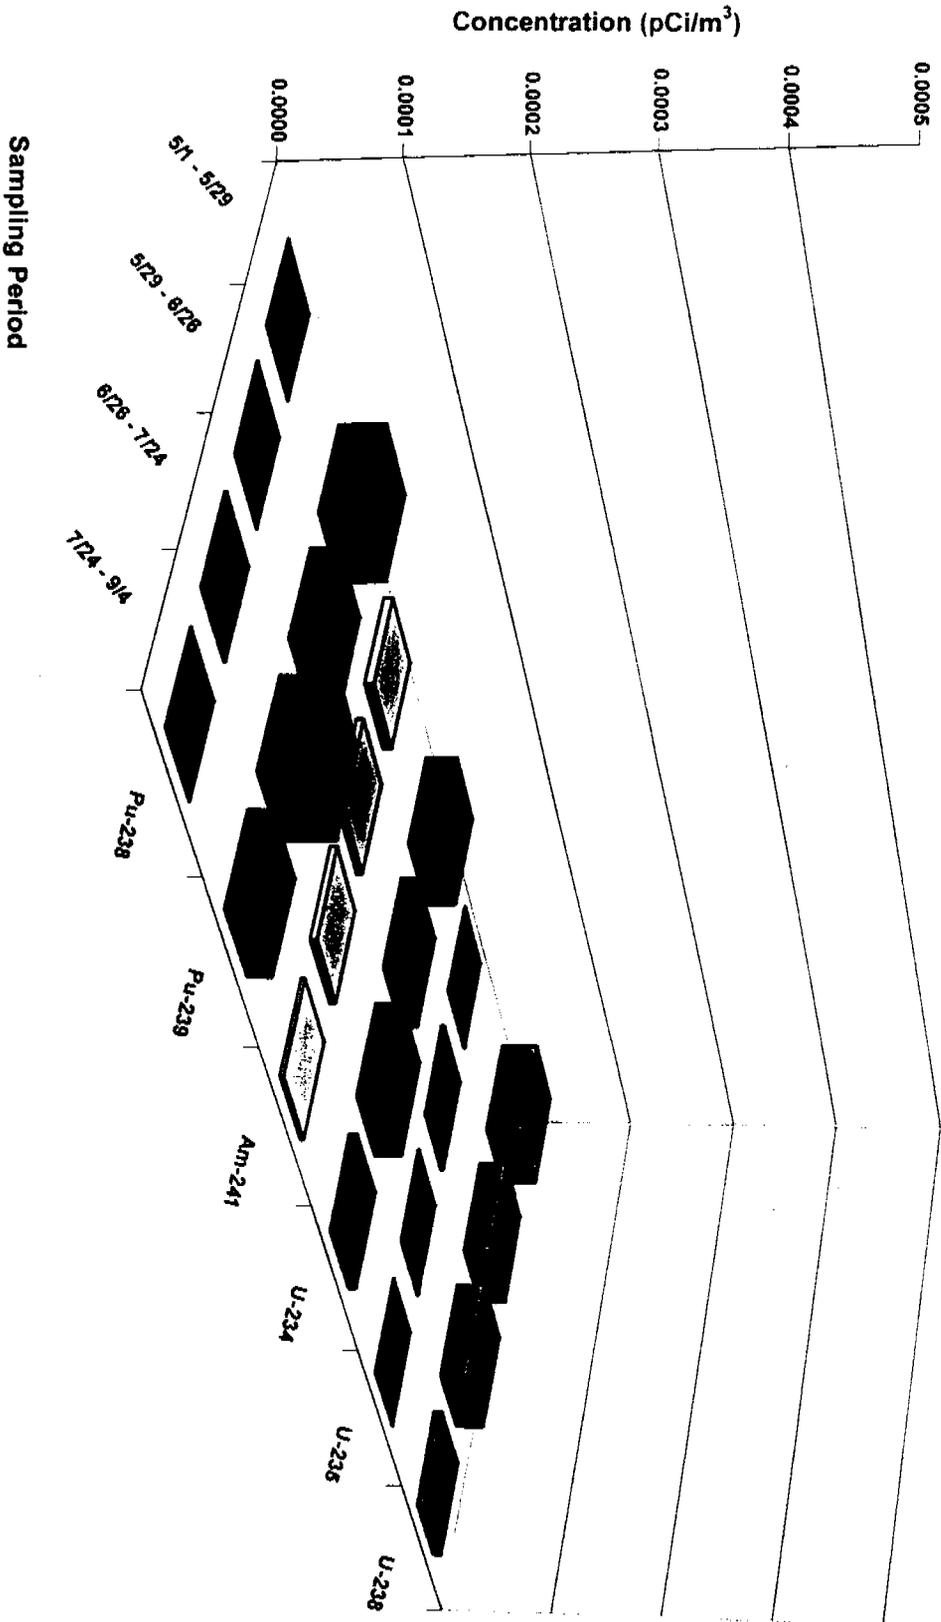
Figure 5

Isotopic Results Sampler S-119

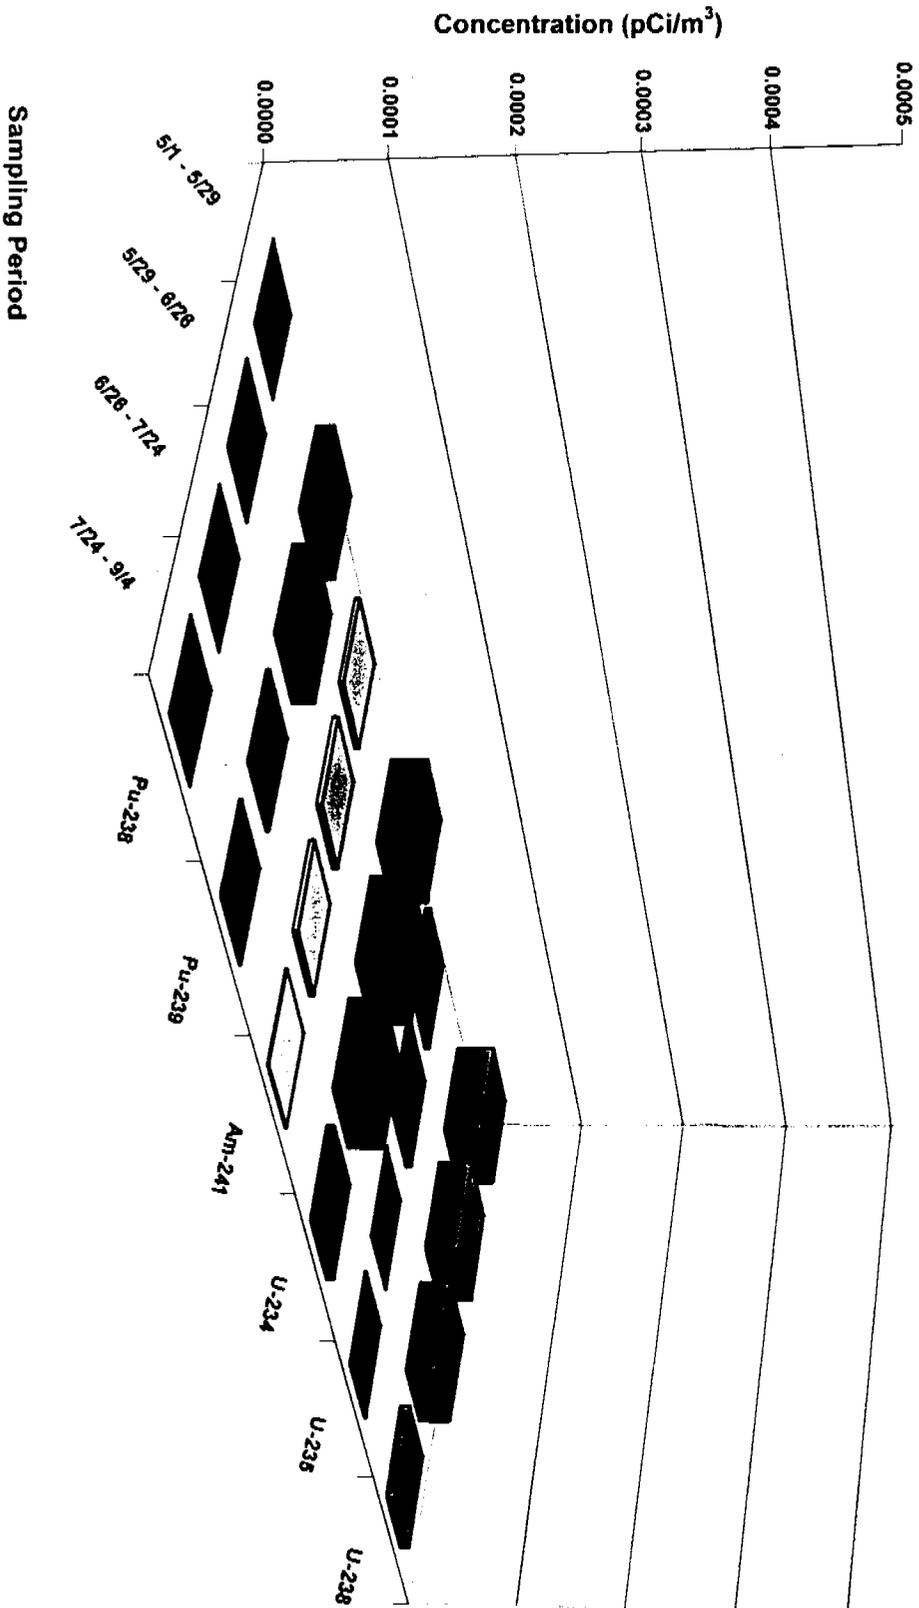
Figure 6

**Isotopic Results
Sampler S-121**

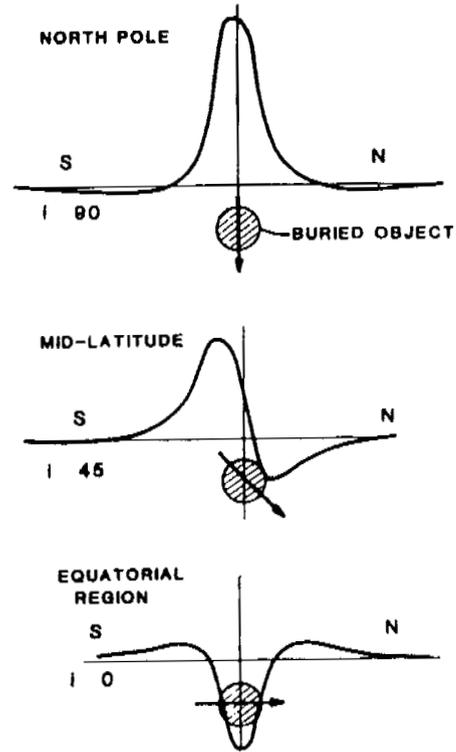
Figure 2 Shape of local perturbations (anomalies) in total magnetic field change with latitude.

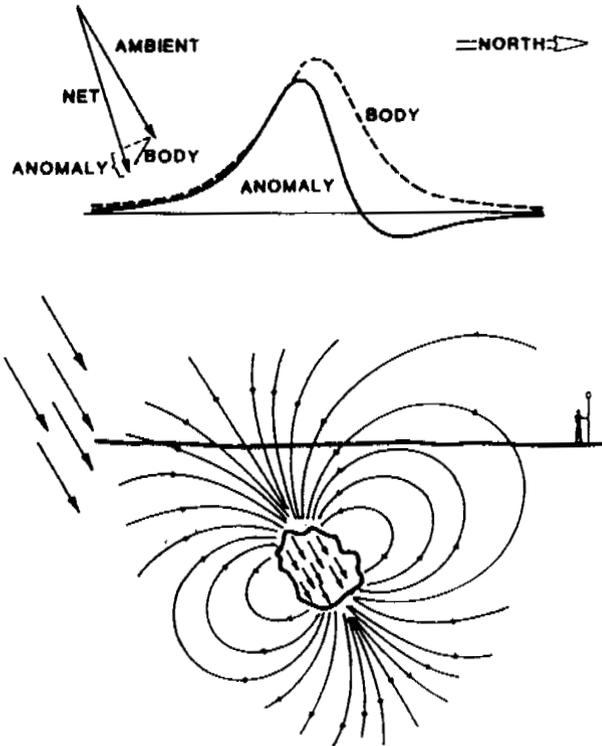
Figure 1 The earth's magnetic field induces a magnetic moment per unit volume in buried ferromagnetic debris (bottom). This causes a local perturbation (anomaly) in total magnetic field (top).

Buried ferromagnetic objects cause local perturbations in the Earth's magnetic field (Fig. 1). The Earth's magnetic field induces a magnetic moment per unit volume in ferromagnetic material, and this induced magnetization is parallel with and proportional to the local Earth's magnetic field. Therefore, the intensity and shape of perturbations caused by a buried drum varies with the latitude across the Earth (Fig. 2). The total magnetic field measured is the vector sum of the ambient Earth's magnetic field, plus local perturbations caused by buried objects.

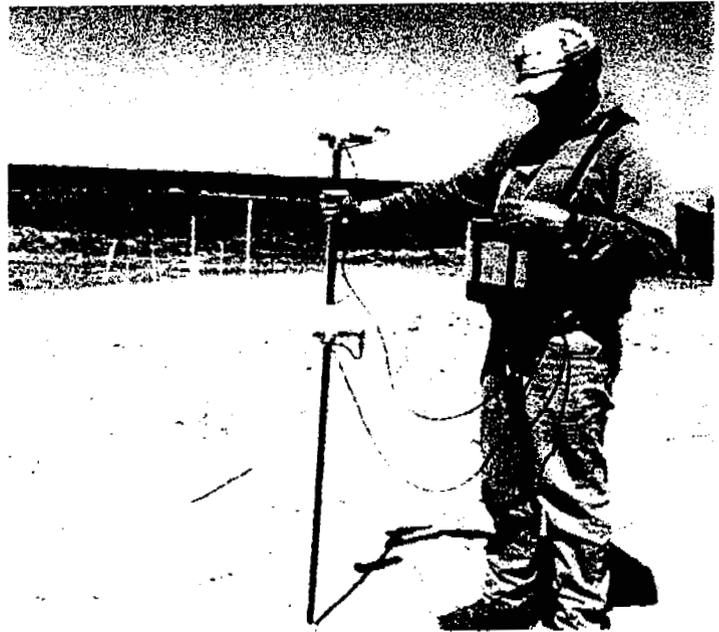
Figure 3 Proton Precession Magnetometer

Magnetic field measurements are typically made with proton precession magnetometers (Fig. 3), and both total magnetic field and the vertical gradient of the magnetic field can be measured simultaneously.

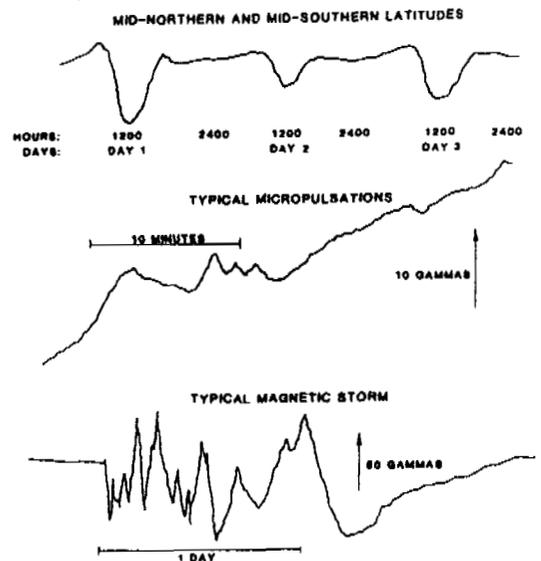
Figure 4 Variations in Earth's magnetic field over time

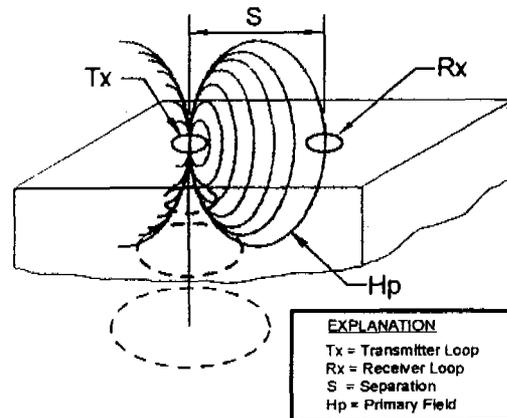
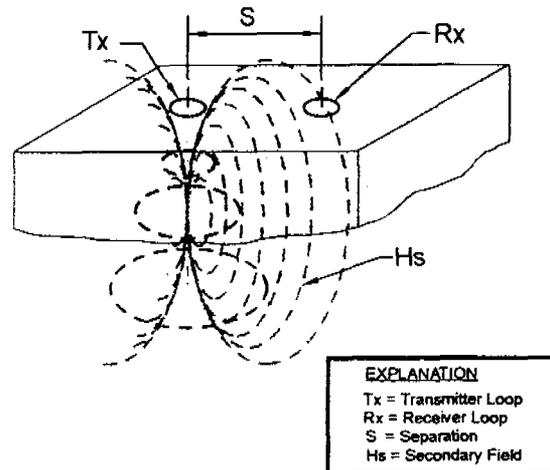
Figure 5 Schematic illustration of eddy currents in subsurface caused by primary magnetic field of Tx.

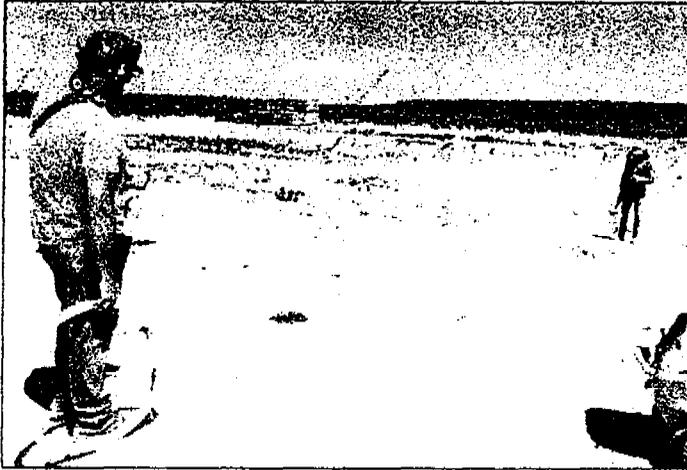
Figure 7 Geonics EM-34. Effective search depth depends on Tx-Rx separations and Coil orientation

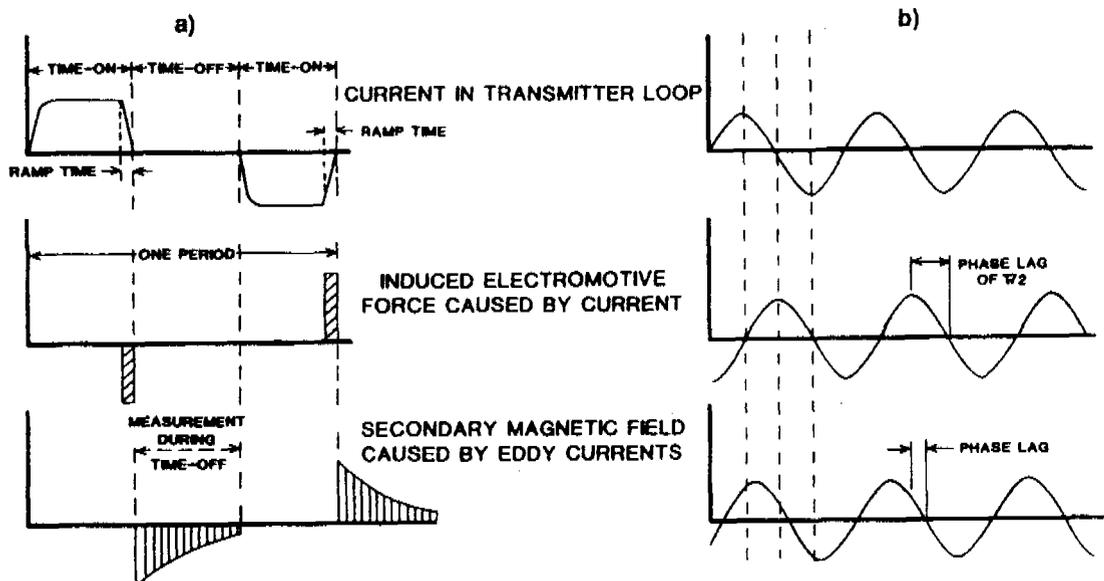
Figure 8 System waveforms used in time domain a) and frequency domain b) systems

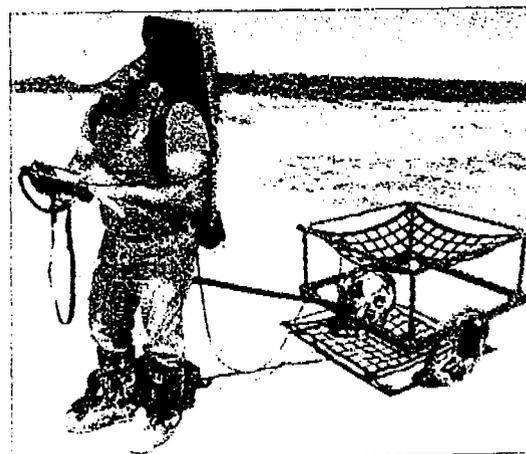
Figure 9 Photograph of EM-61 and operator

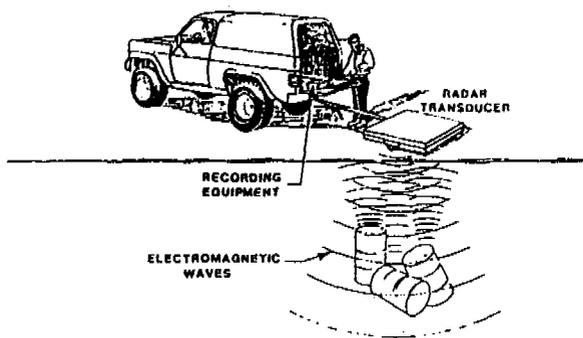
Figure 10 Schematic survey layout for GPR system

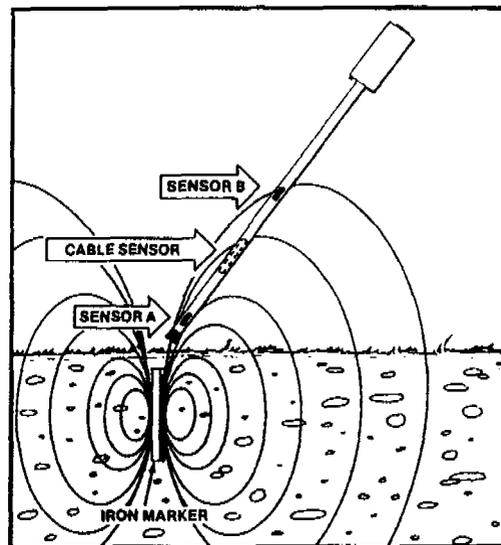
Figure 12 Schematic of principle of operation of metal detector using gradient in magnetic field.

- Sensing changes in the gradient of the magnetic field caused by local perturbations due to ferromagnetic objects (Fig. 12),
- Sensing the secondary EM fields due to a cable or metallic pipes (Fig. 13).

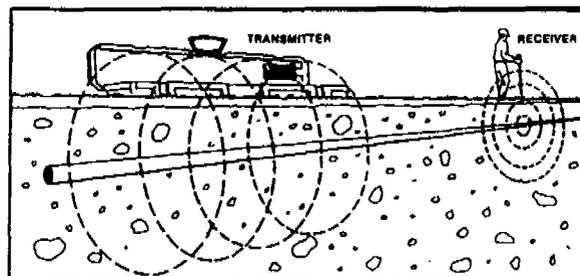
Figure 13 Schematic of principles of operation of pipe locator using anomalies in EM field caused by current flow induced in pipe.

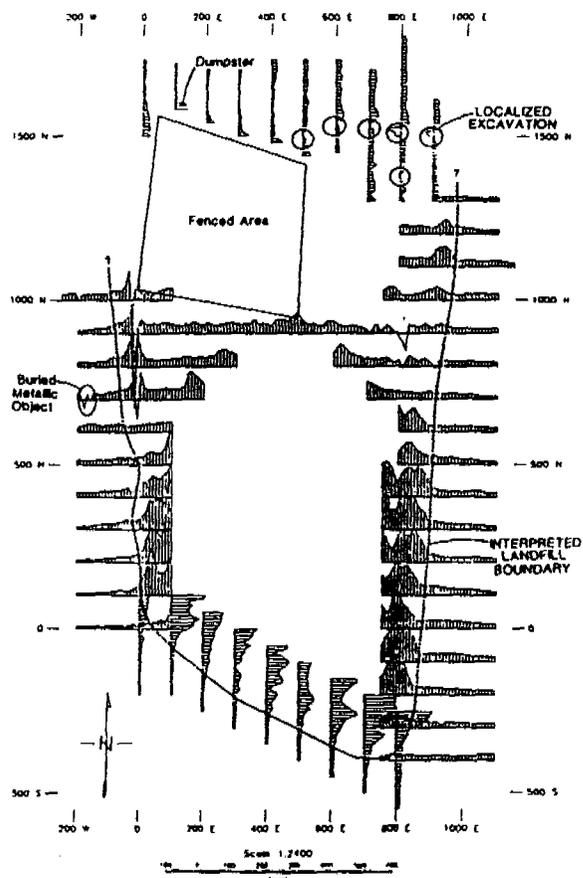
Figure 14 Stacked EM-31 apparent conductivity plots to locate landfill boundaries

An increase in apparent conductivity occurs along each profile from background onto the landfill, and the edges of the landfill are readily determined. Isolated anomalies are also observed outside the landfill boundary.

The survey outlined on Figure 14 was completed in 1 1/2 days of field work, and a framework for further investigation was established quickly. Stacked profile plots appear to be an optimum mode for data display here.

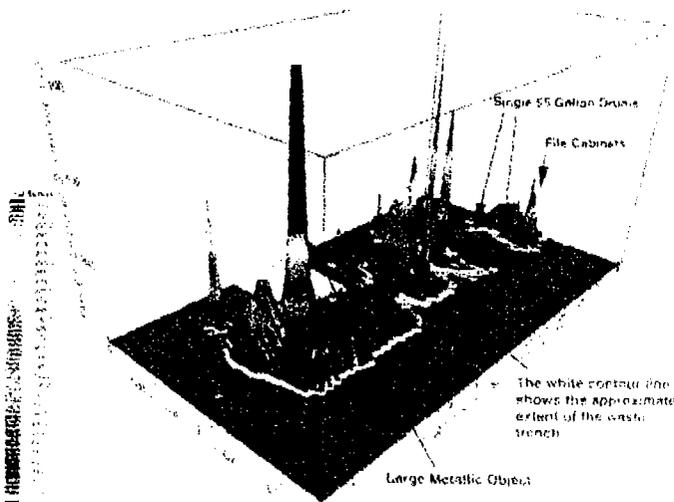
Figure 16 EM-61 3-D Perspective Plot

At INEL a trench has been constructed for the purpose of testing, detection and characterization of buried wastes by geophysical methods, and various retrieval technologies. Different objects, such as drums, wooden crates, and plastic vessels have been placed in the trench. Over this trench, data were acquired with a number of sensors, such as a EM-31, a proton precision magnetometer, EM-61 (time domain metal detector) and GPR. Measurements were made on a 2.5 ft. Grid. Results obtained with the EM-61 are given in Figure 15 in contour form and in Figure 16 as a 3-D perspective plot.

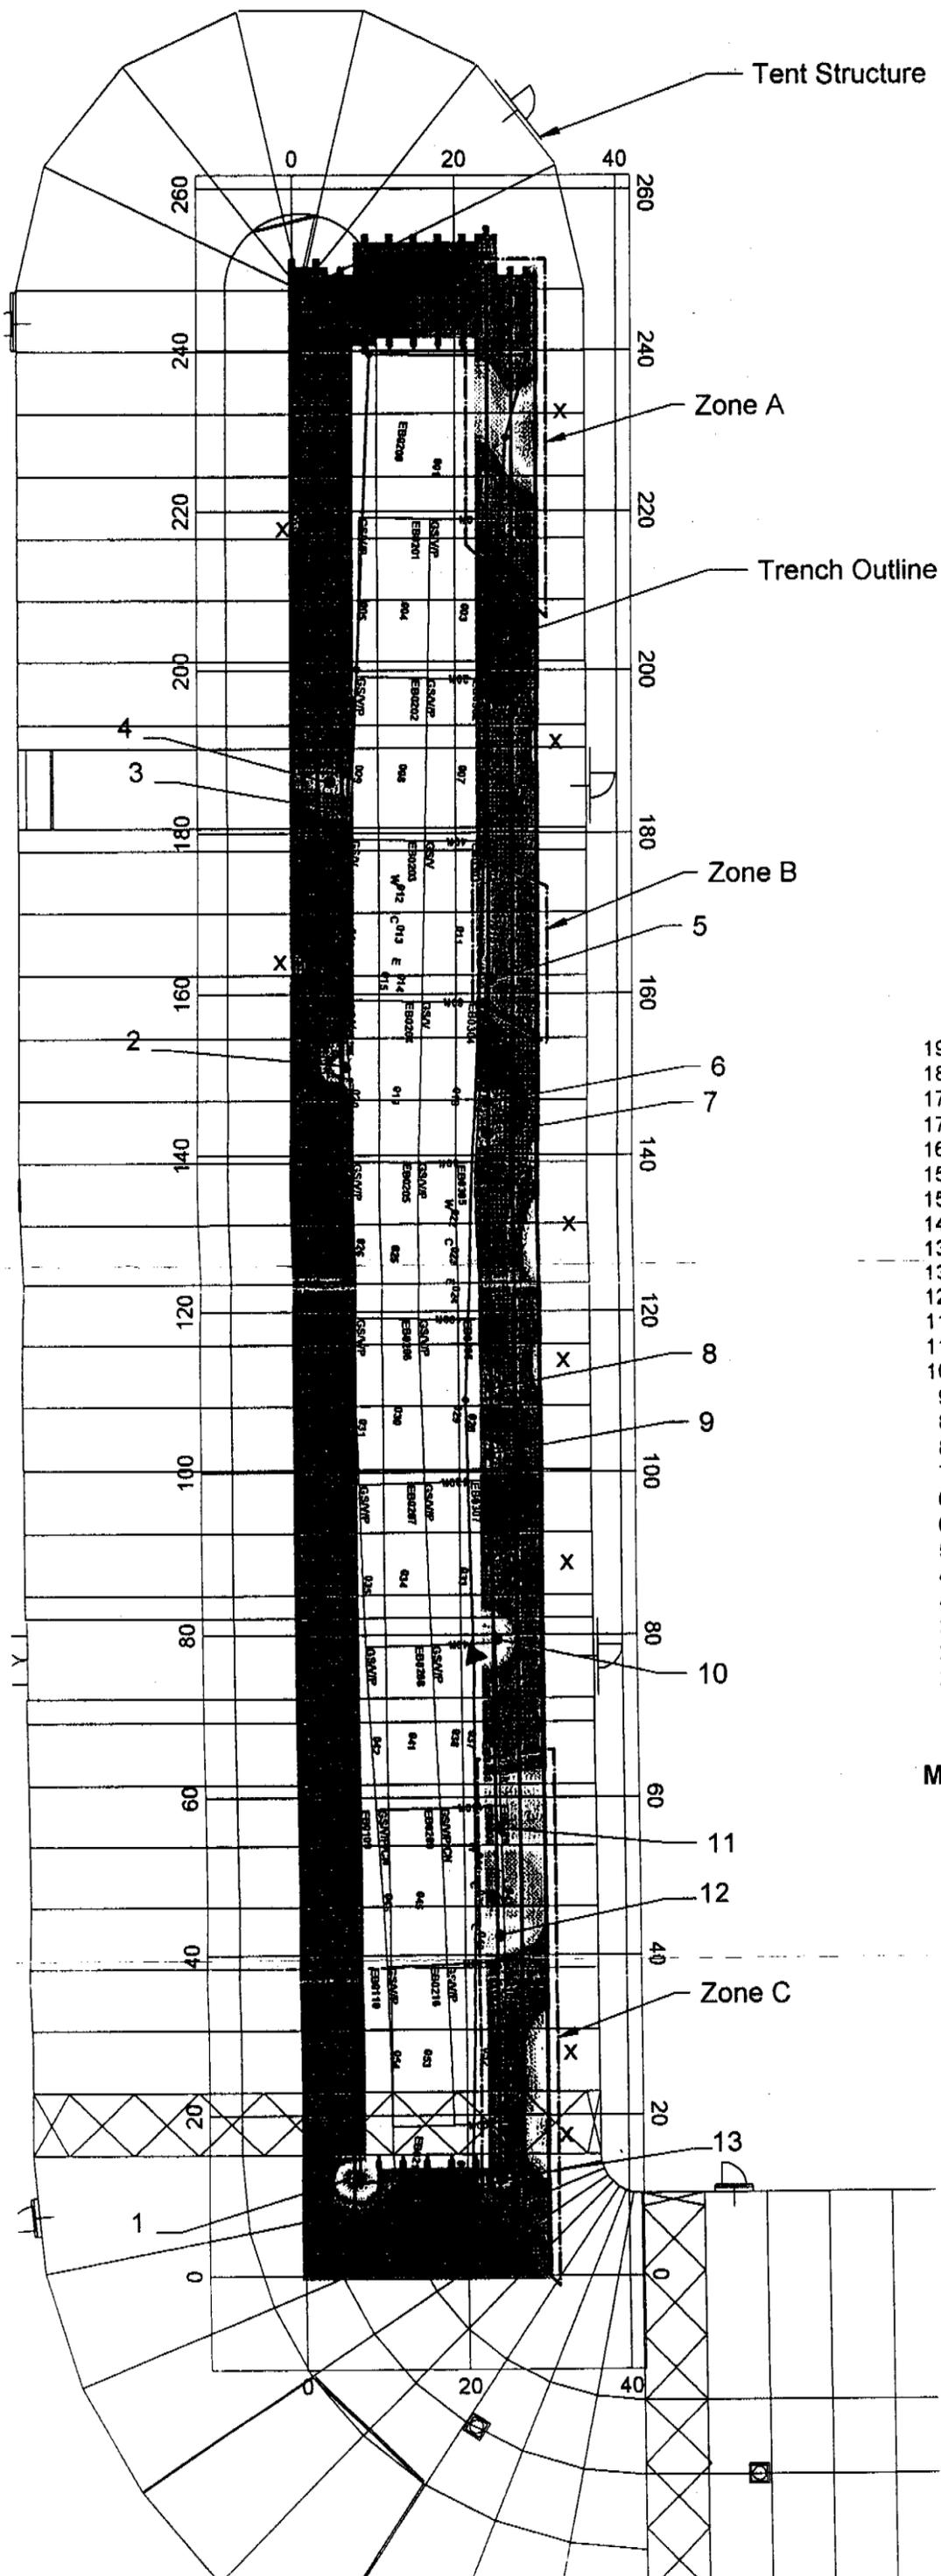
Figure No. 3-1
Project No. 9914RMR
File No. IProjects9914rmr RFT161.map
Date: 1/99

- Explanation**
- x Source of Anomaly Off Grid
 - Individual Anomaly
 - Zone of Anomalies
 - ▲ Buried Drum
 - Survey Lines

Blackhawk Geometrics Golden, Colorado
	Trench 1 Site EM61 Channel 2 Data
	U.S. Department of Energy Rocky Flats Environmental Technology Site
	RMRS

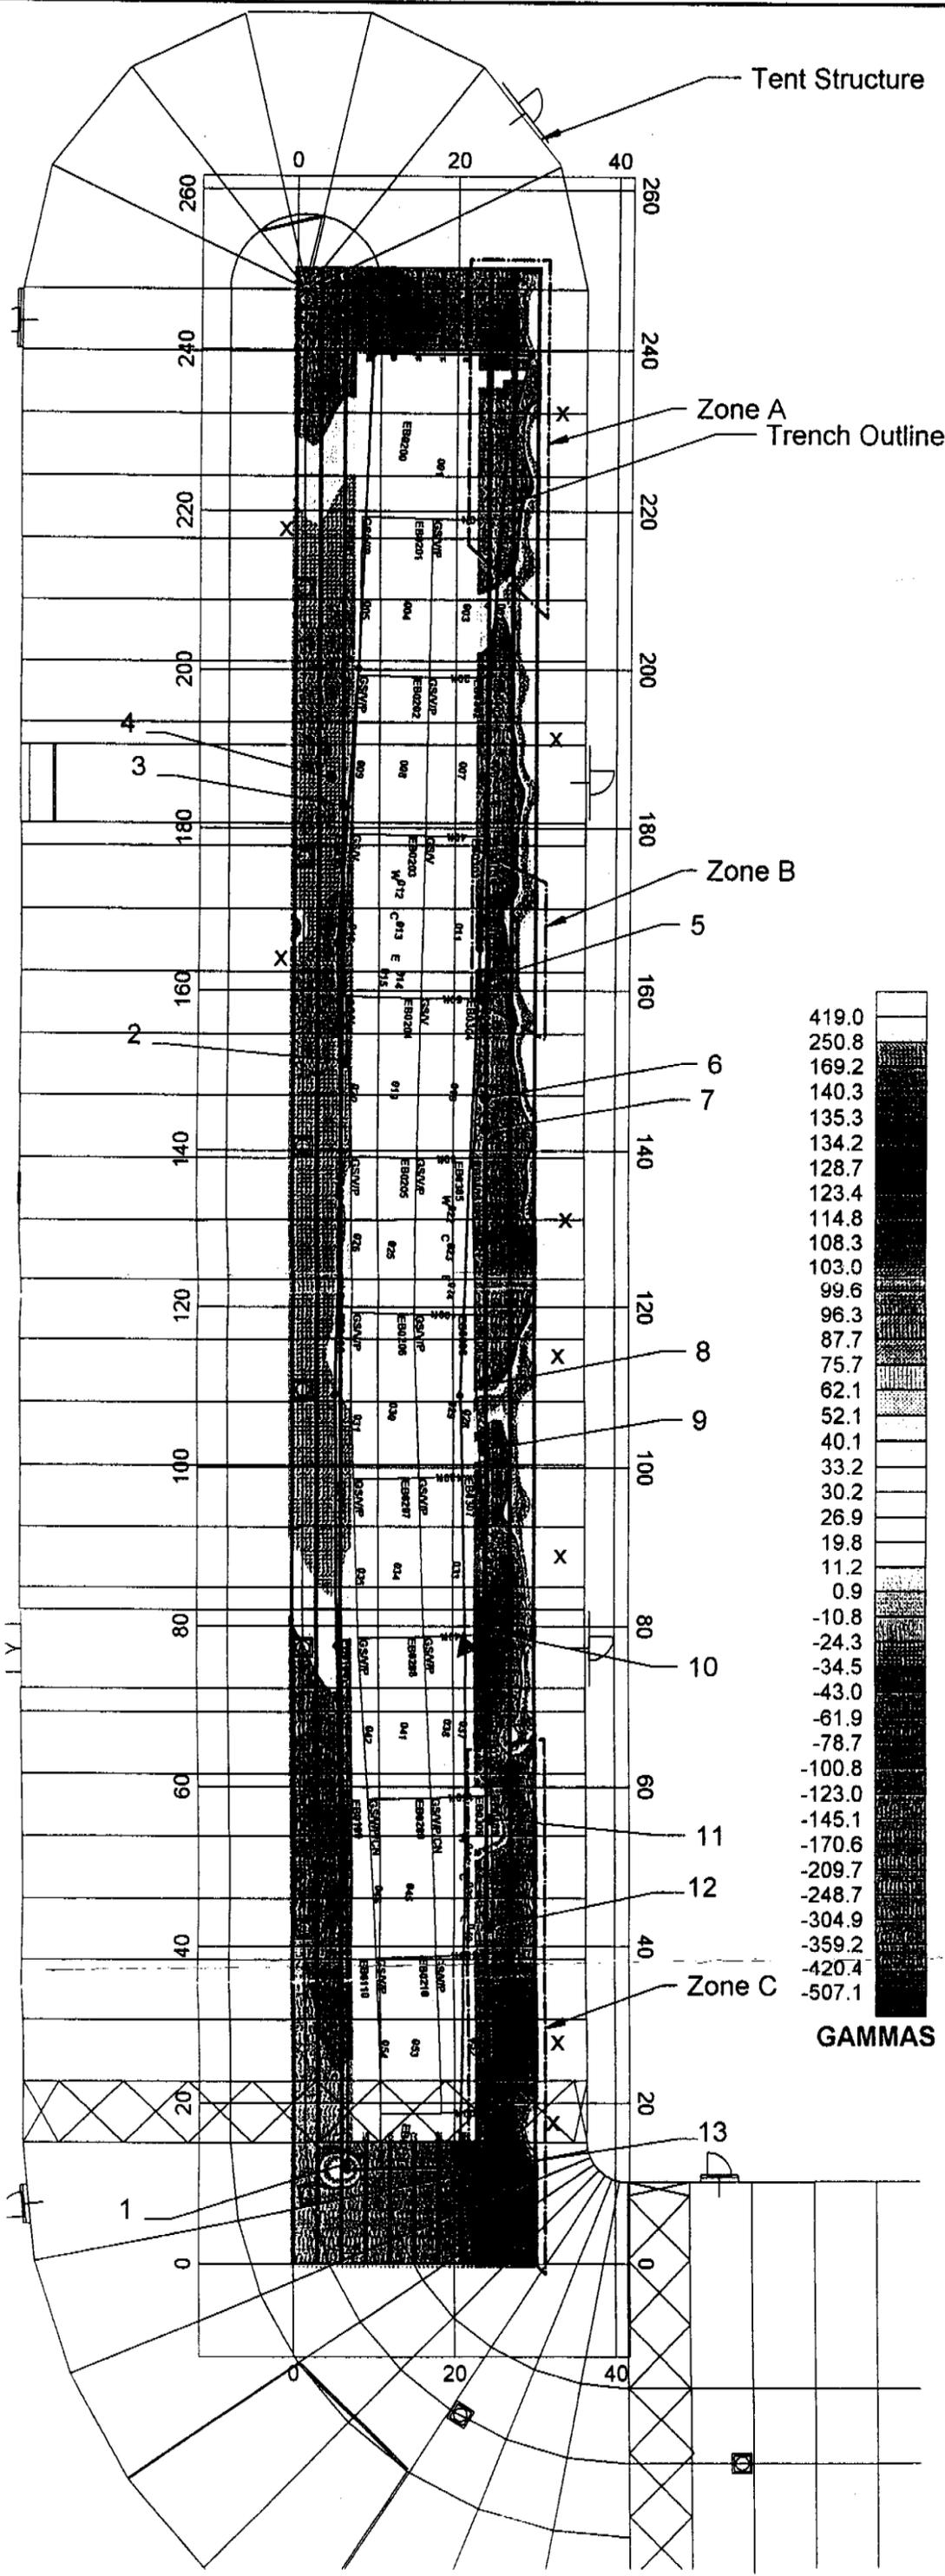
- Explanation**
- x Source of Anomaly Off Grid
 - Individual Anomaly
 - - - Zone of Anomalies
 - ▲ Buried Drum
 - - - Survey Lines

Blackhawk Geometrics Golden, Colorado
	<p style="text-align: center;">Trench 1 Site Total Field Magnetic Data</p> <p style="text-align: center;"><i>U.S. Department of Energy</i> <i>Rocky Flats</i> <i>Environmental Technology Site</i></p>
Figure No. 3-2	
Project No. 9914RMR	
File No. IProjects\9914rmr VRF1Mag.map	
Date: 1/99	RMRS
