**Draft Closeout Report
for IHSS Group 400-8**

UBC 441, IHSS 400-122,
and Portions of IHSS 000-121,
including Tanks T-2 and T-3

March 2004

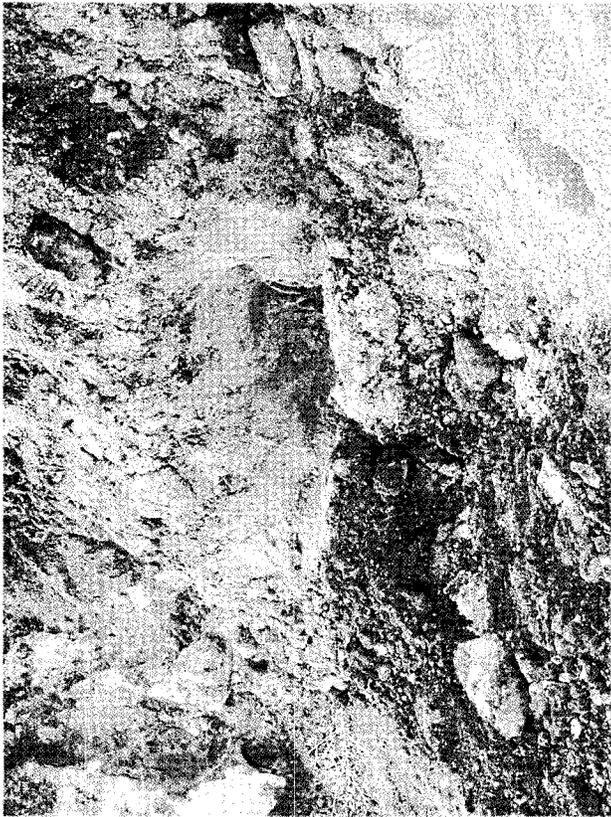
Exposed ends of clay pipe that extended north of the southern OPWL manhole. Manhole was west of Building 441.

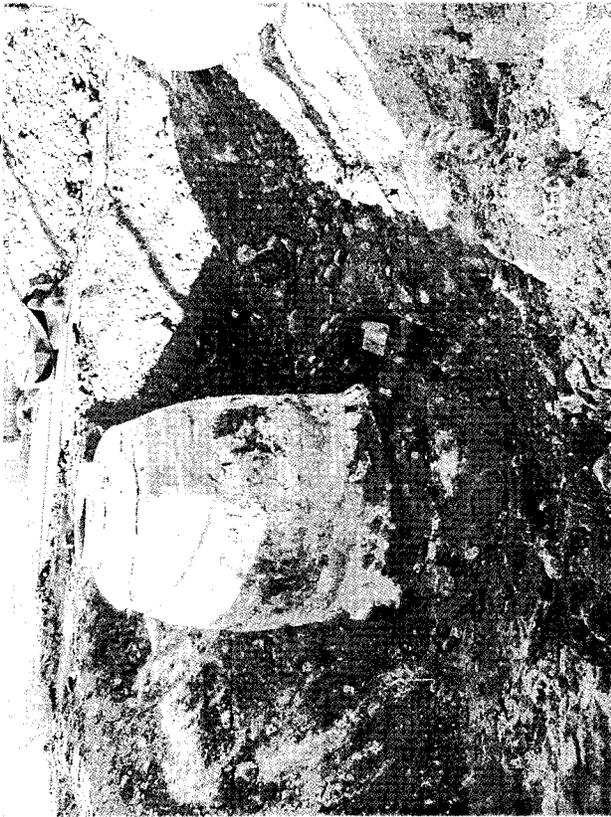
Northern manhole west of Building 441 with pipe and copper sleeve.

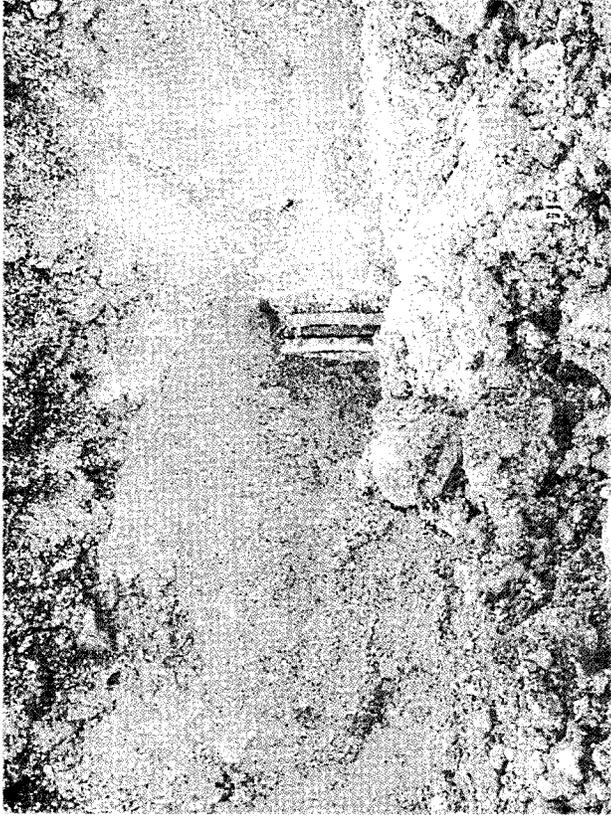
Open end of clay pipe extending north of southern OPWL manhole. Manhole was west of Building 441.

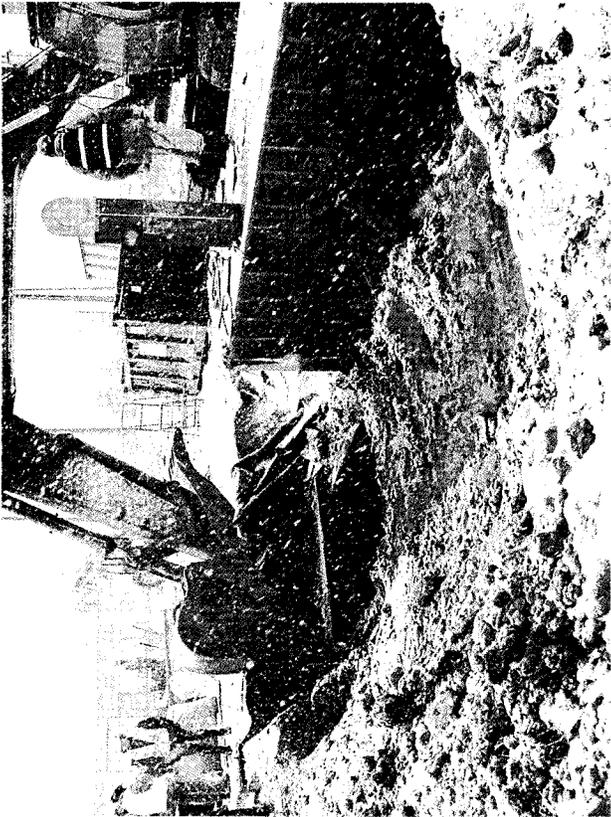
Open limestone bed of Tank T-2 below backhoe bucket. West half (underground) of Tank T-3 in foreground, covered east half of Tank T-3 with access covers to right.

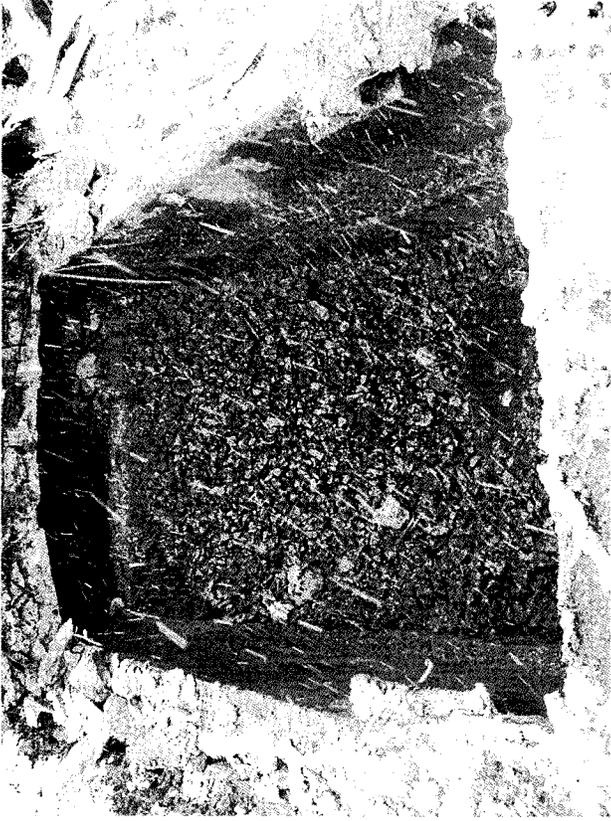
Crushed limestone gravel in Tank T-2.

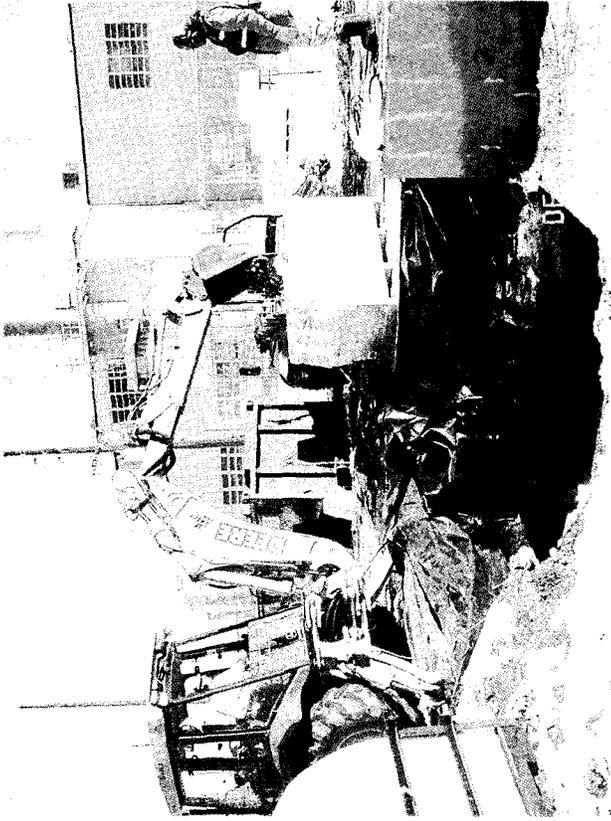
Limestone gravel from Tank T-2 being placed in IP-1 waste container.

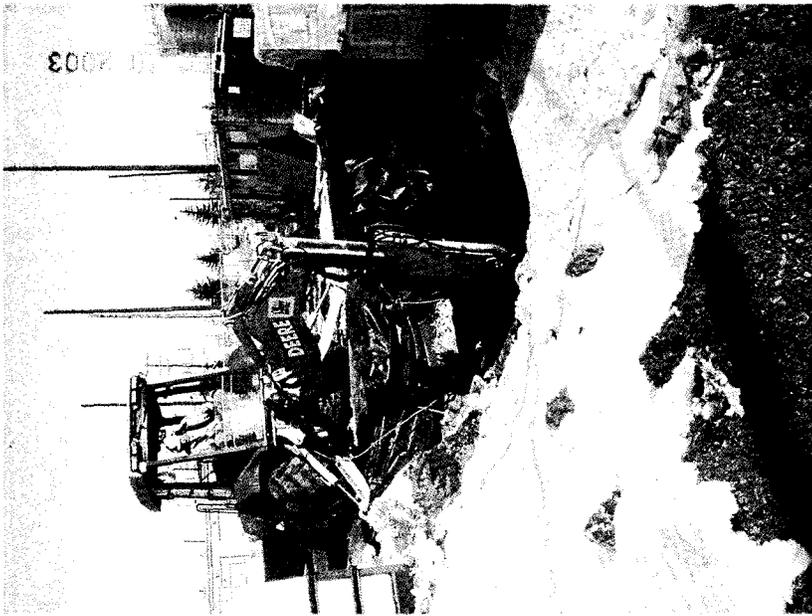
Limestone gravel being removed from Tank T-2.

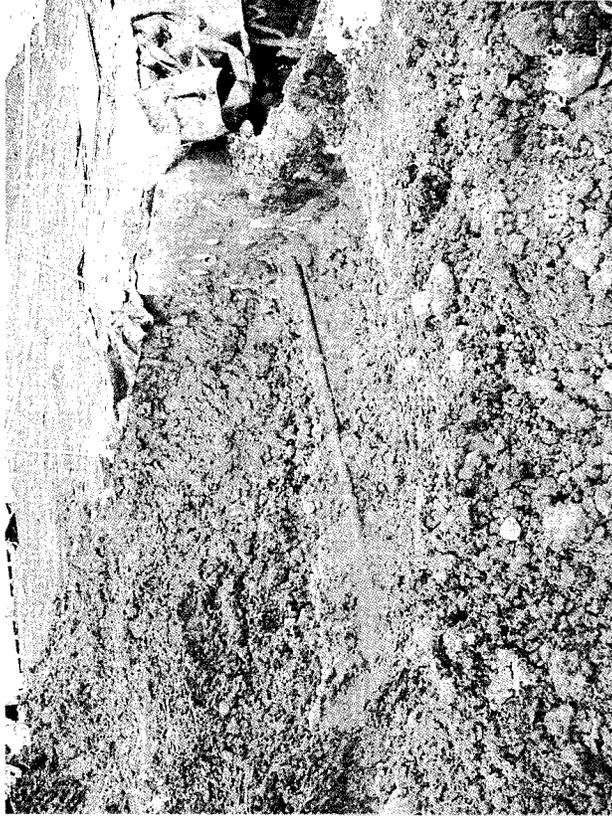
OPWL line (P3) entering wet well of Tank T-2 from the west.
Open limestone bed of Tank T-2 visible to right.

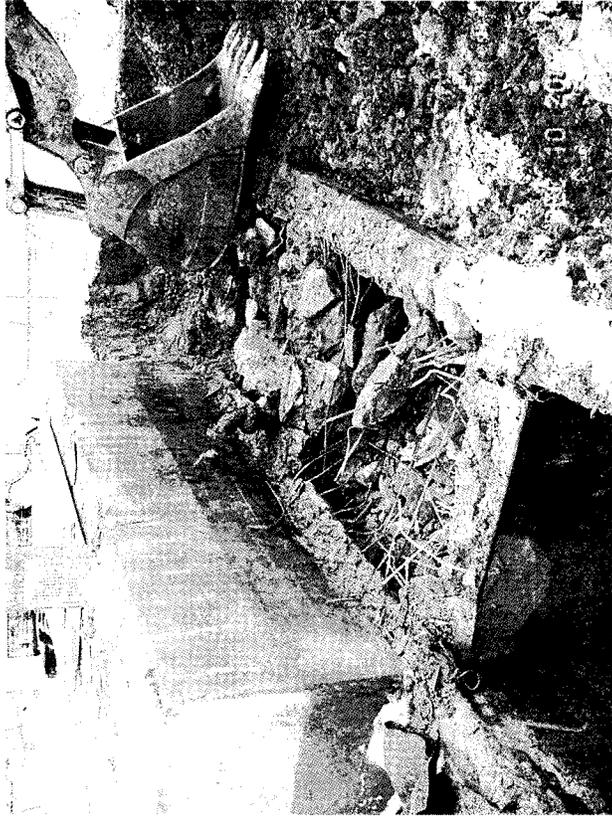
Top half (western side) of Tank T-3 (holding tank) broken open.
This part of T-3 was underground. Above ground eastern half
with cover and three access chambers to left.

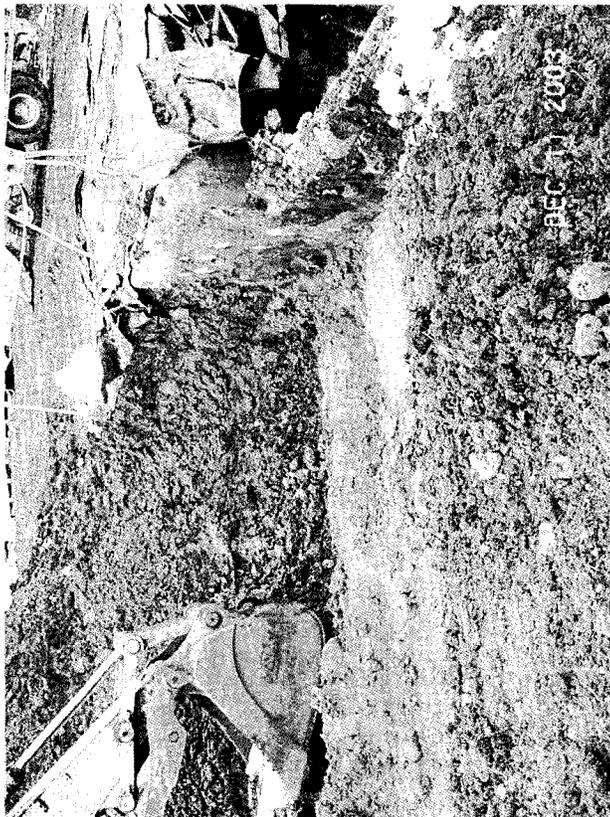
OPWL pipe (P3) west of wet well of Tank T-2 removed.

OPWL under the Building 441 slab and exiting the southern addition (from Tanks T-2 and T-3) were exposed, tapped and drained, and removed. Most of the lines were cast iron. The extent of the line removals is shown on Figure 7. Line P3, west of Tank T-2, between Buildings 123 and 441 remains largely intact as it passes under Fourth Street. It was removed in the vicinity of the northern manhole west of Building 441 (as discussed below) and east of the foundation wall of 441 up to Tank T-2. Line P4, east of Building 441, remains intact from 12 feet east of Tank T-3. The section of P4 that was removed was cut, bagged, and removed between 3 and 12 feet east of Tank T-3. The 3-foot section of P4 attached to Tank T-3 was removed with the tank.

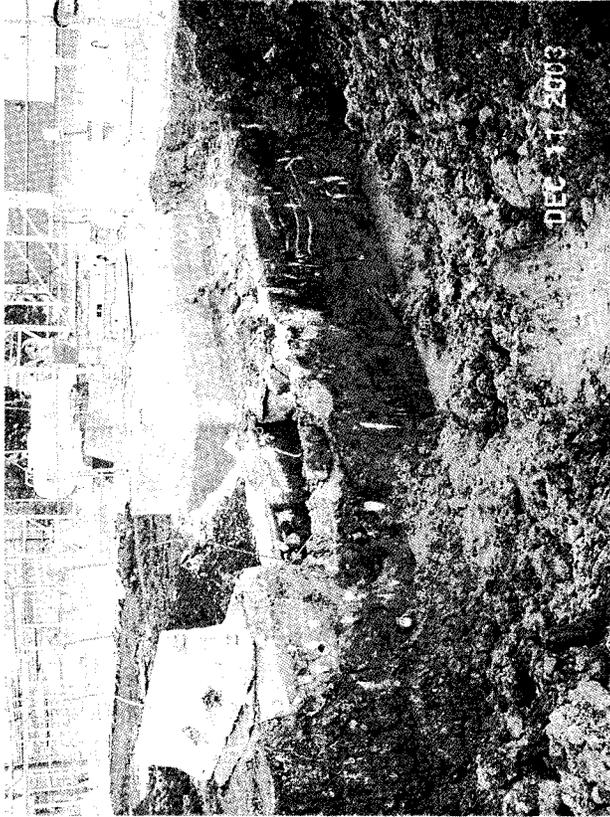
Wet well of Tank T-2 under Jersey barrier (left), open limestone bed of Tank T-2 (middle), and two components of Tank T-3, underground half with top crushed and covered half (right-background).

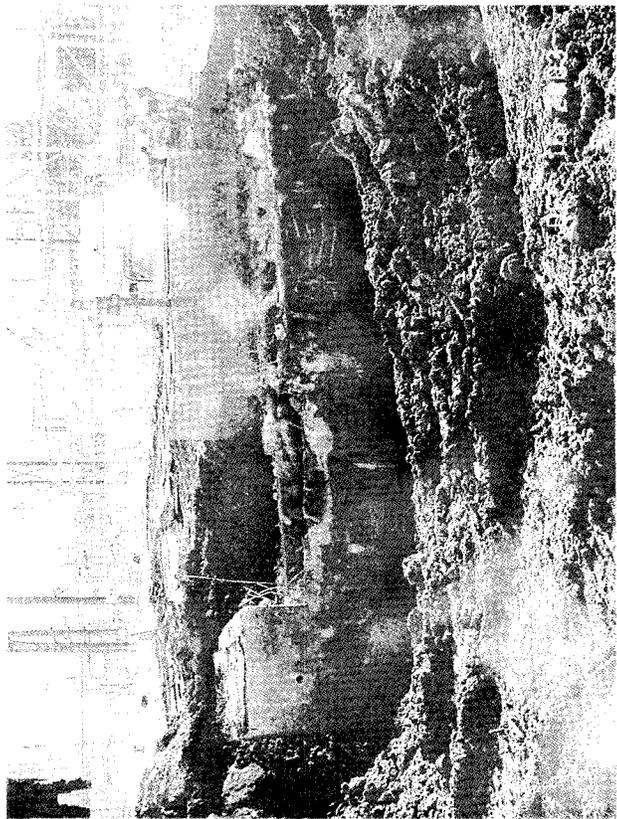
Wet well of Tank T-2 (left), open limestone bed of Tank T-2 (middle), and two components of Tank T-3, underground half with top crushed (right) and covered half (right-background).

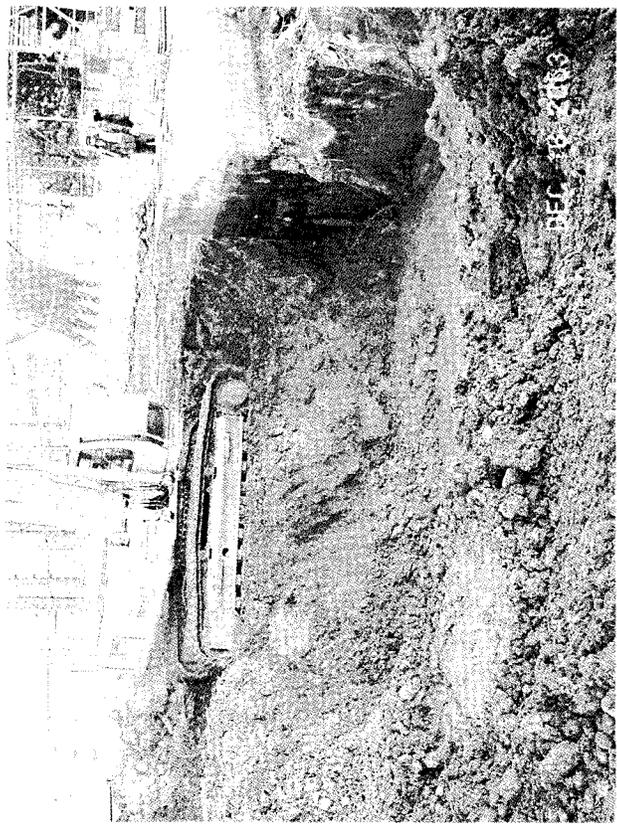
Tank T-2 removed including wet well and limestone bed. Tank T-3 still in place to right.

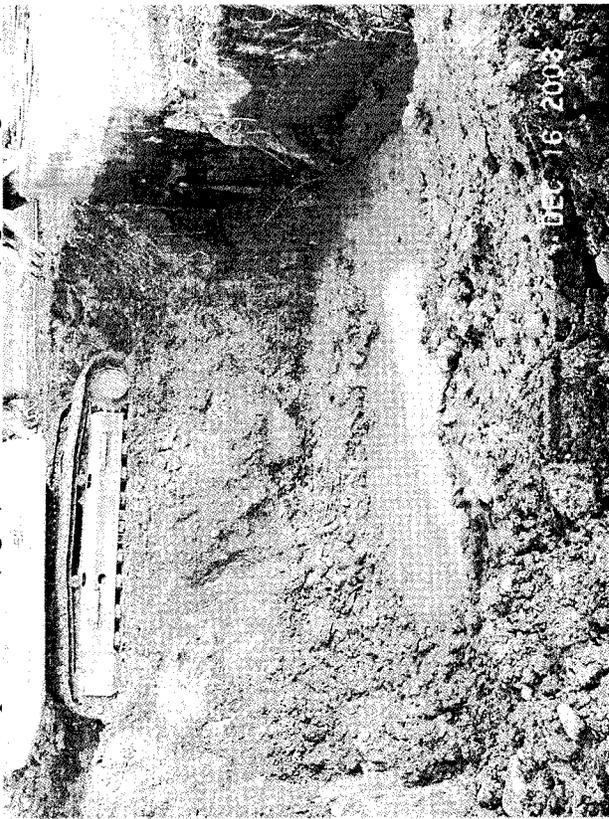
Heavily reinforced bottom part of Tank T-3 (holding tank) being broken up.

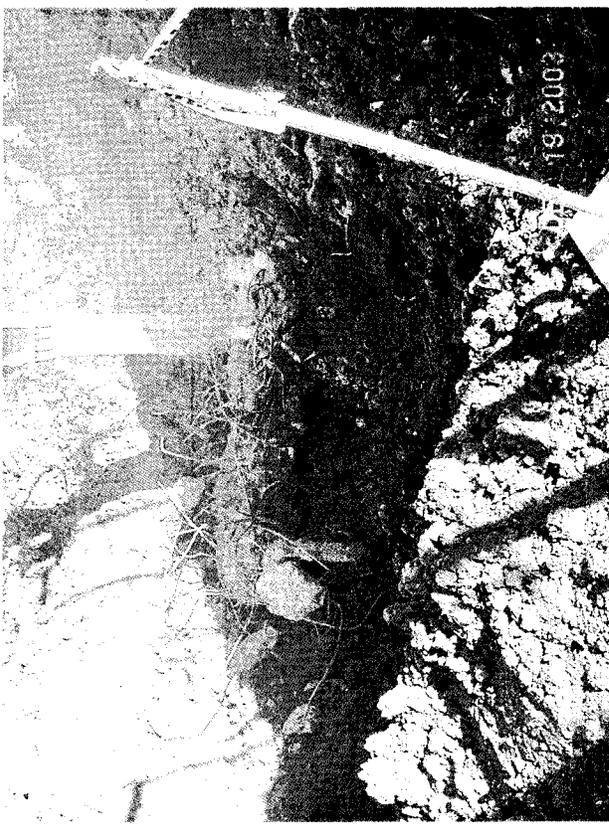
021

Heavily reinforced bottom part of Tank T-3 (holding tank) being broken up.

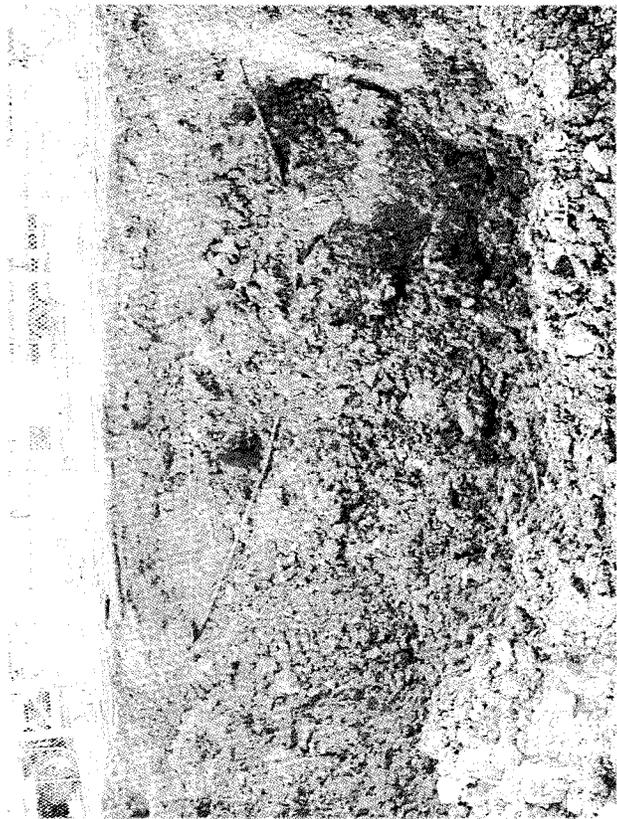
Excavation after the removal of Tank T-3 (holding tank). Note out of service alarm cable draped across side of excavation.

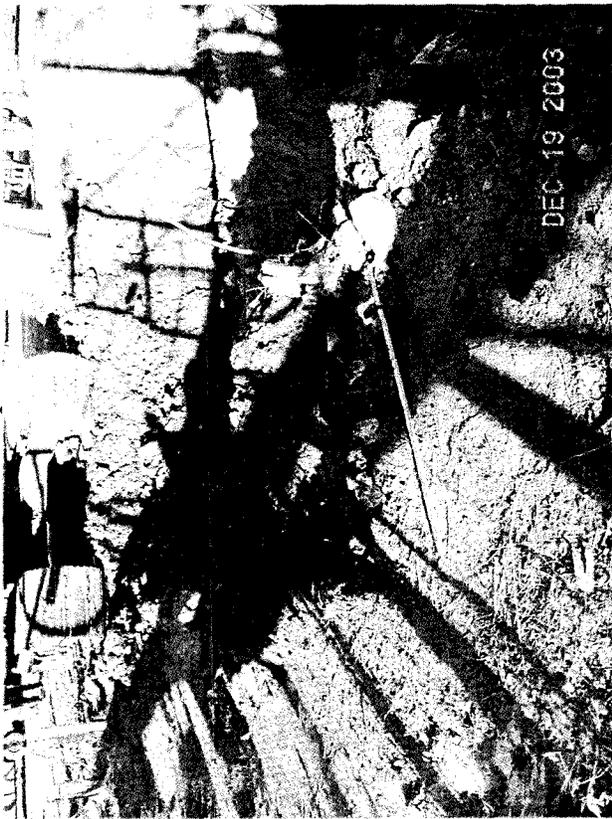
Lead contaminated soil removed with excavator bucket (marks from bucket teeth can be seen just above the wooden stake. Hole dimensions were approximately 4x4x2 ft.

Surface soil from a section 4 feet by 4 feet by 2 feet deep, approximately 8 feet south of Tanks T-2 and T-3, was removed. Based on existing characterization data, the soil had lead concentrations greater than the WRW AL. No additional soil was removed based on confirmation results (Figure 6 and Table 4). Post-remediation conditions are discussed in Section 9.0, and sampling locations considered NLR are discussed in Section 12.0.

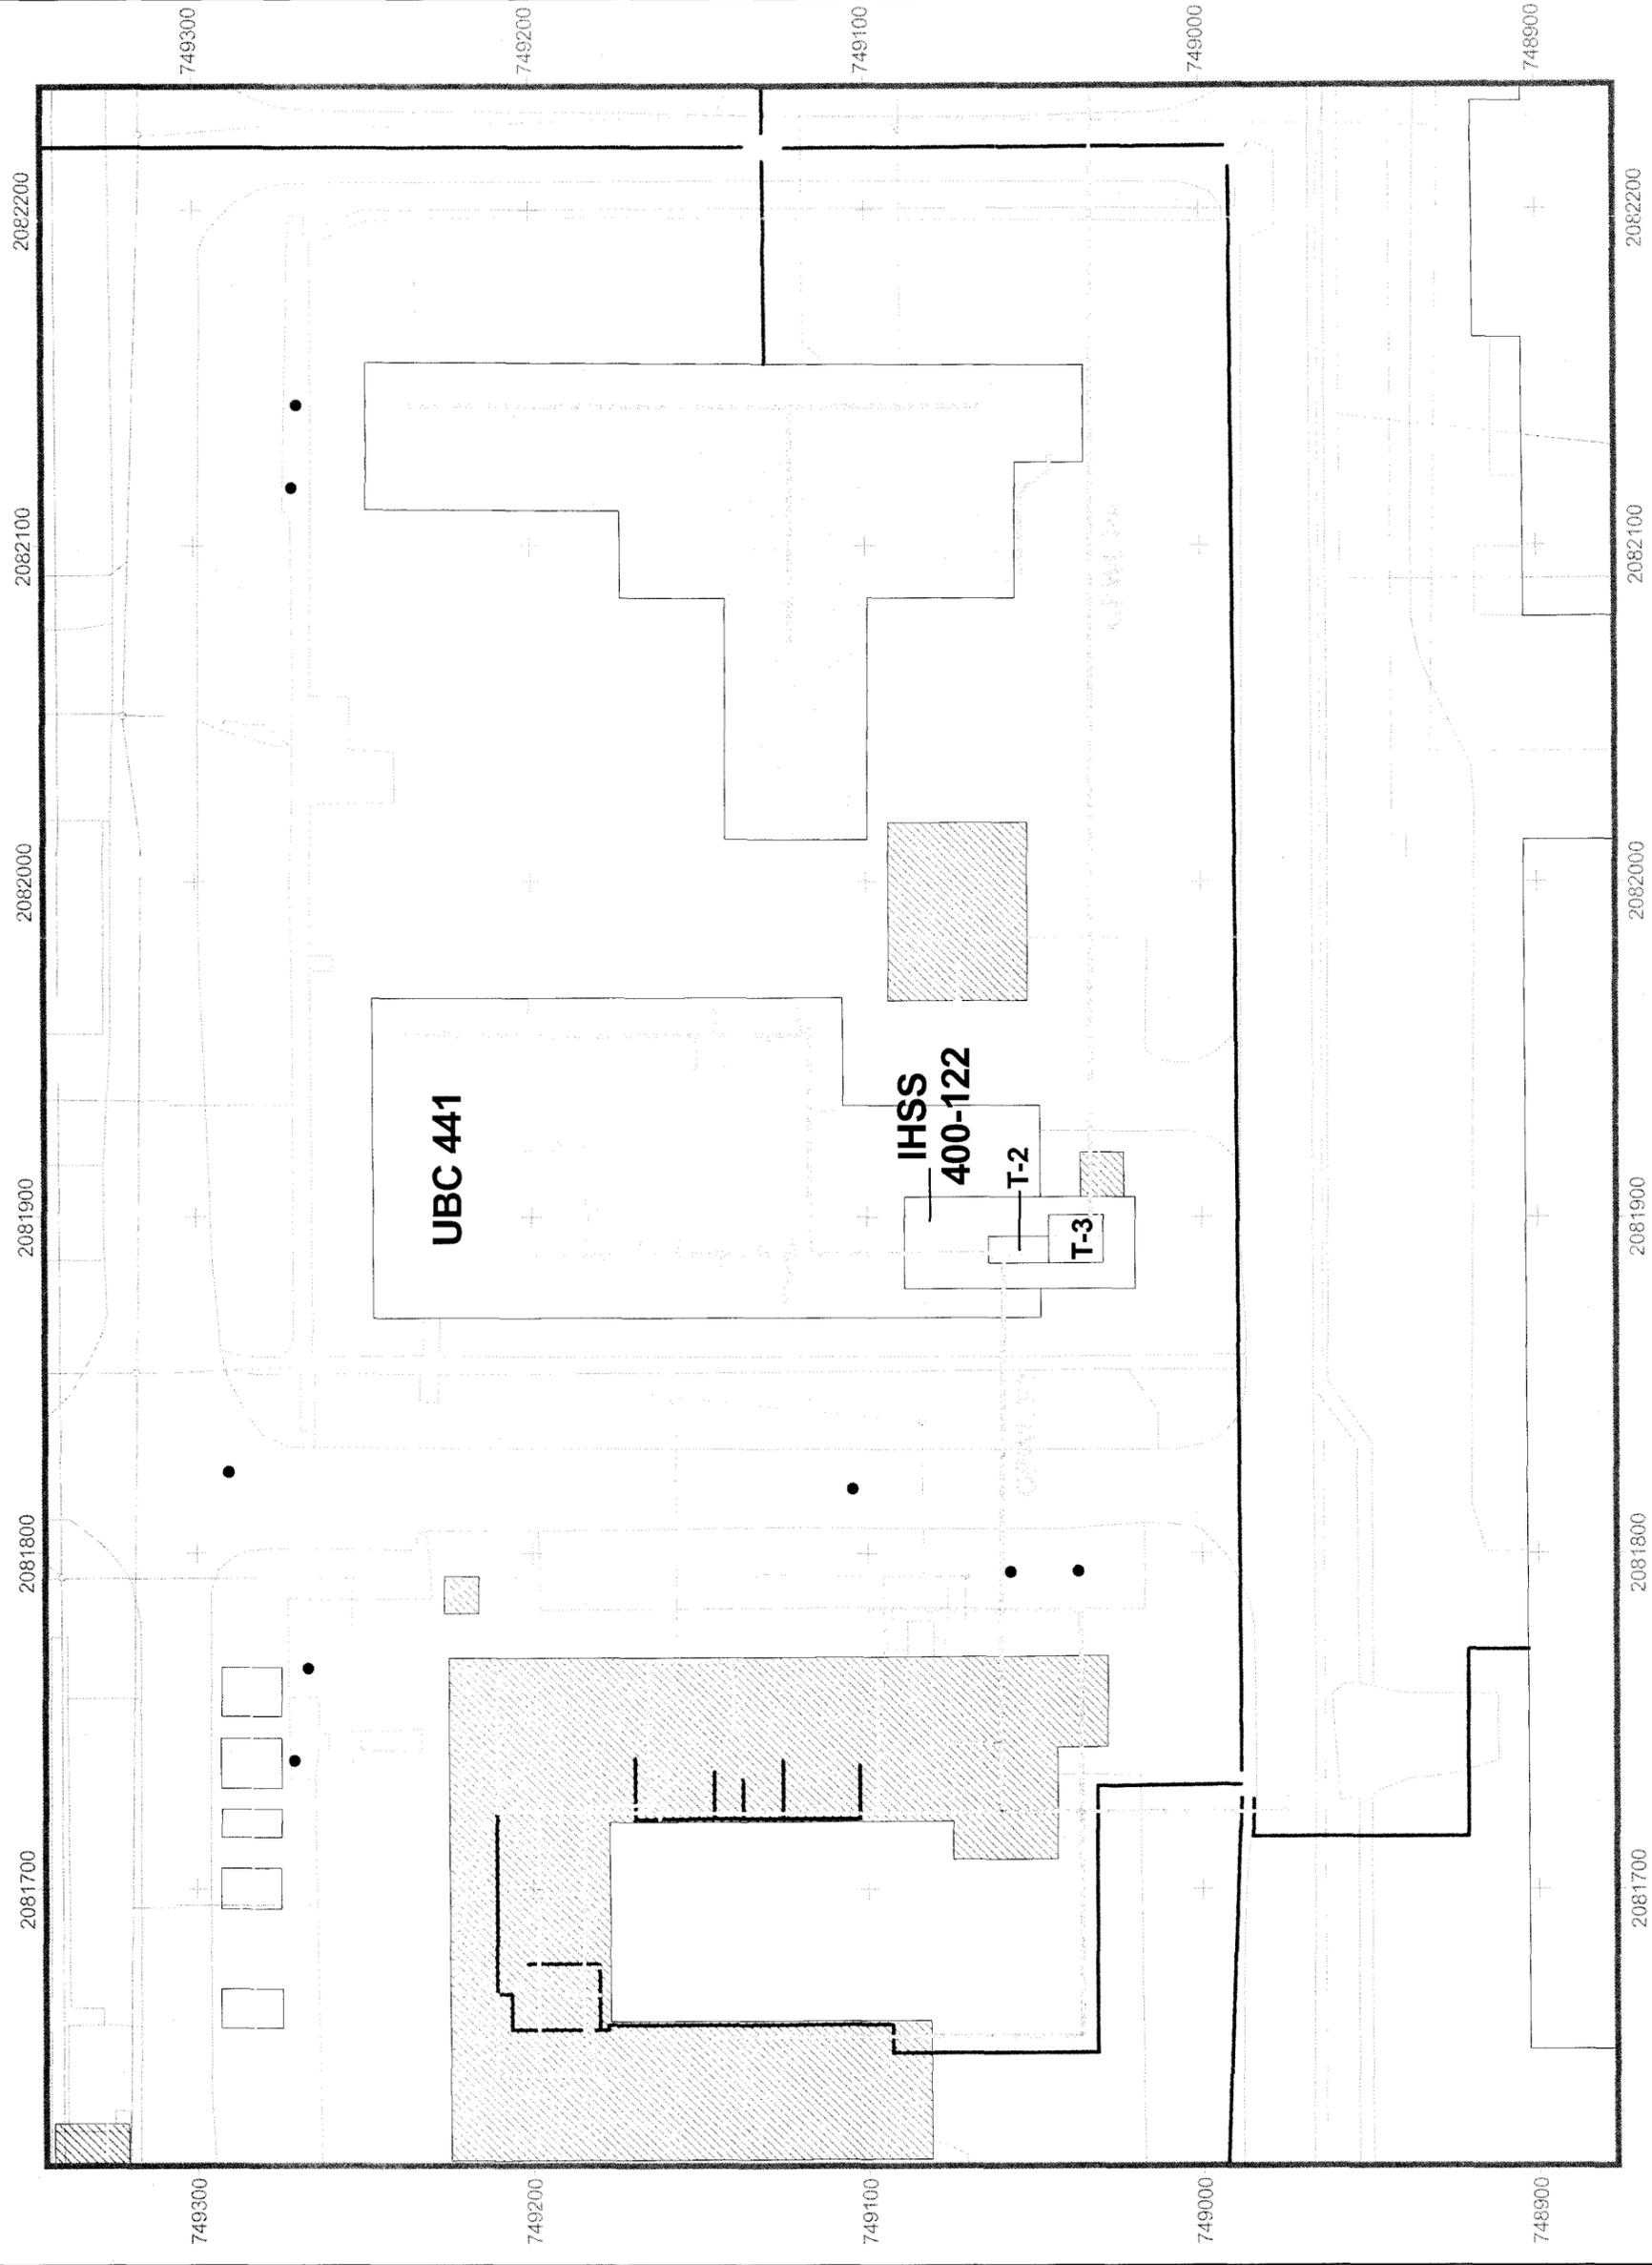
FIGURE 3 IHSS Group 400-8 Existing Characterization Data Plus Two Standard Deviations or Method Detection Limits

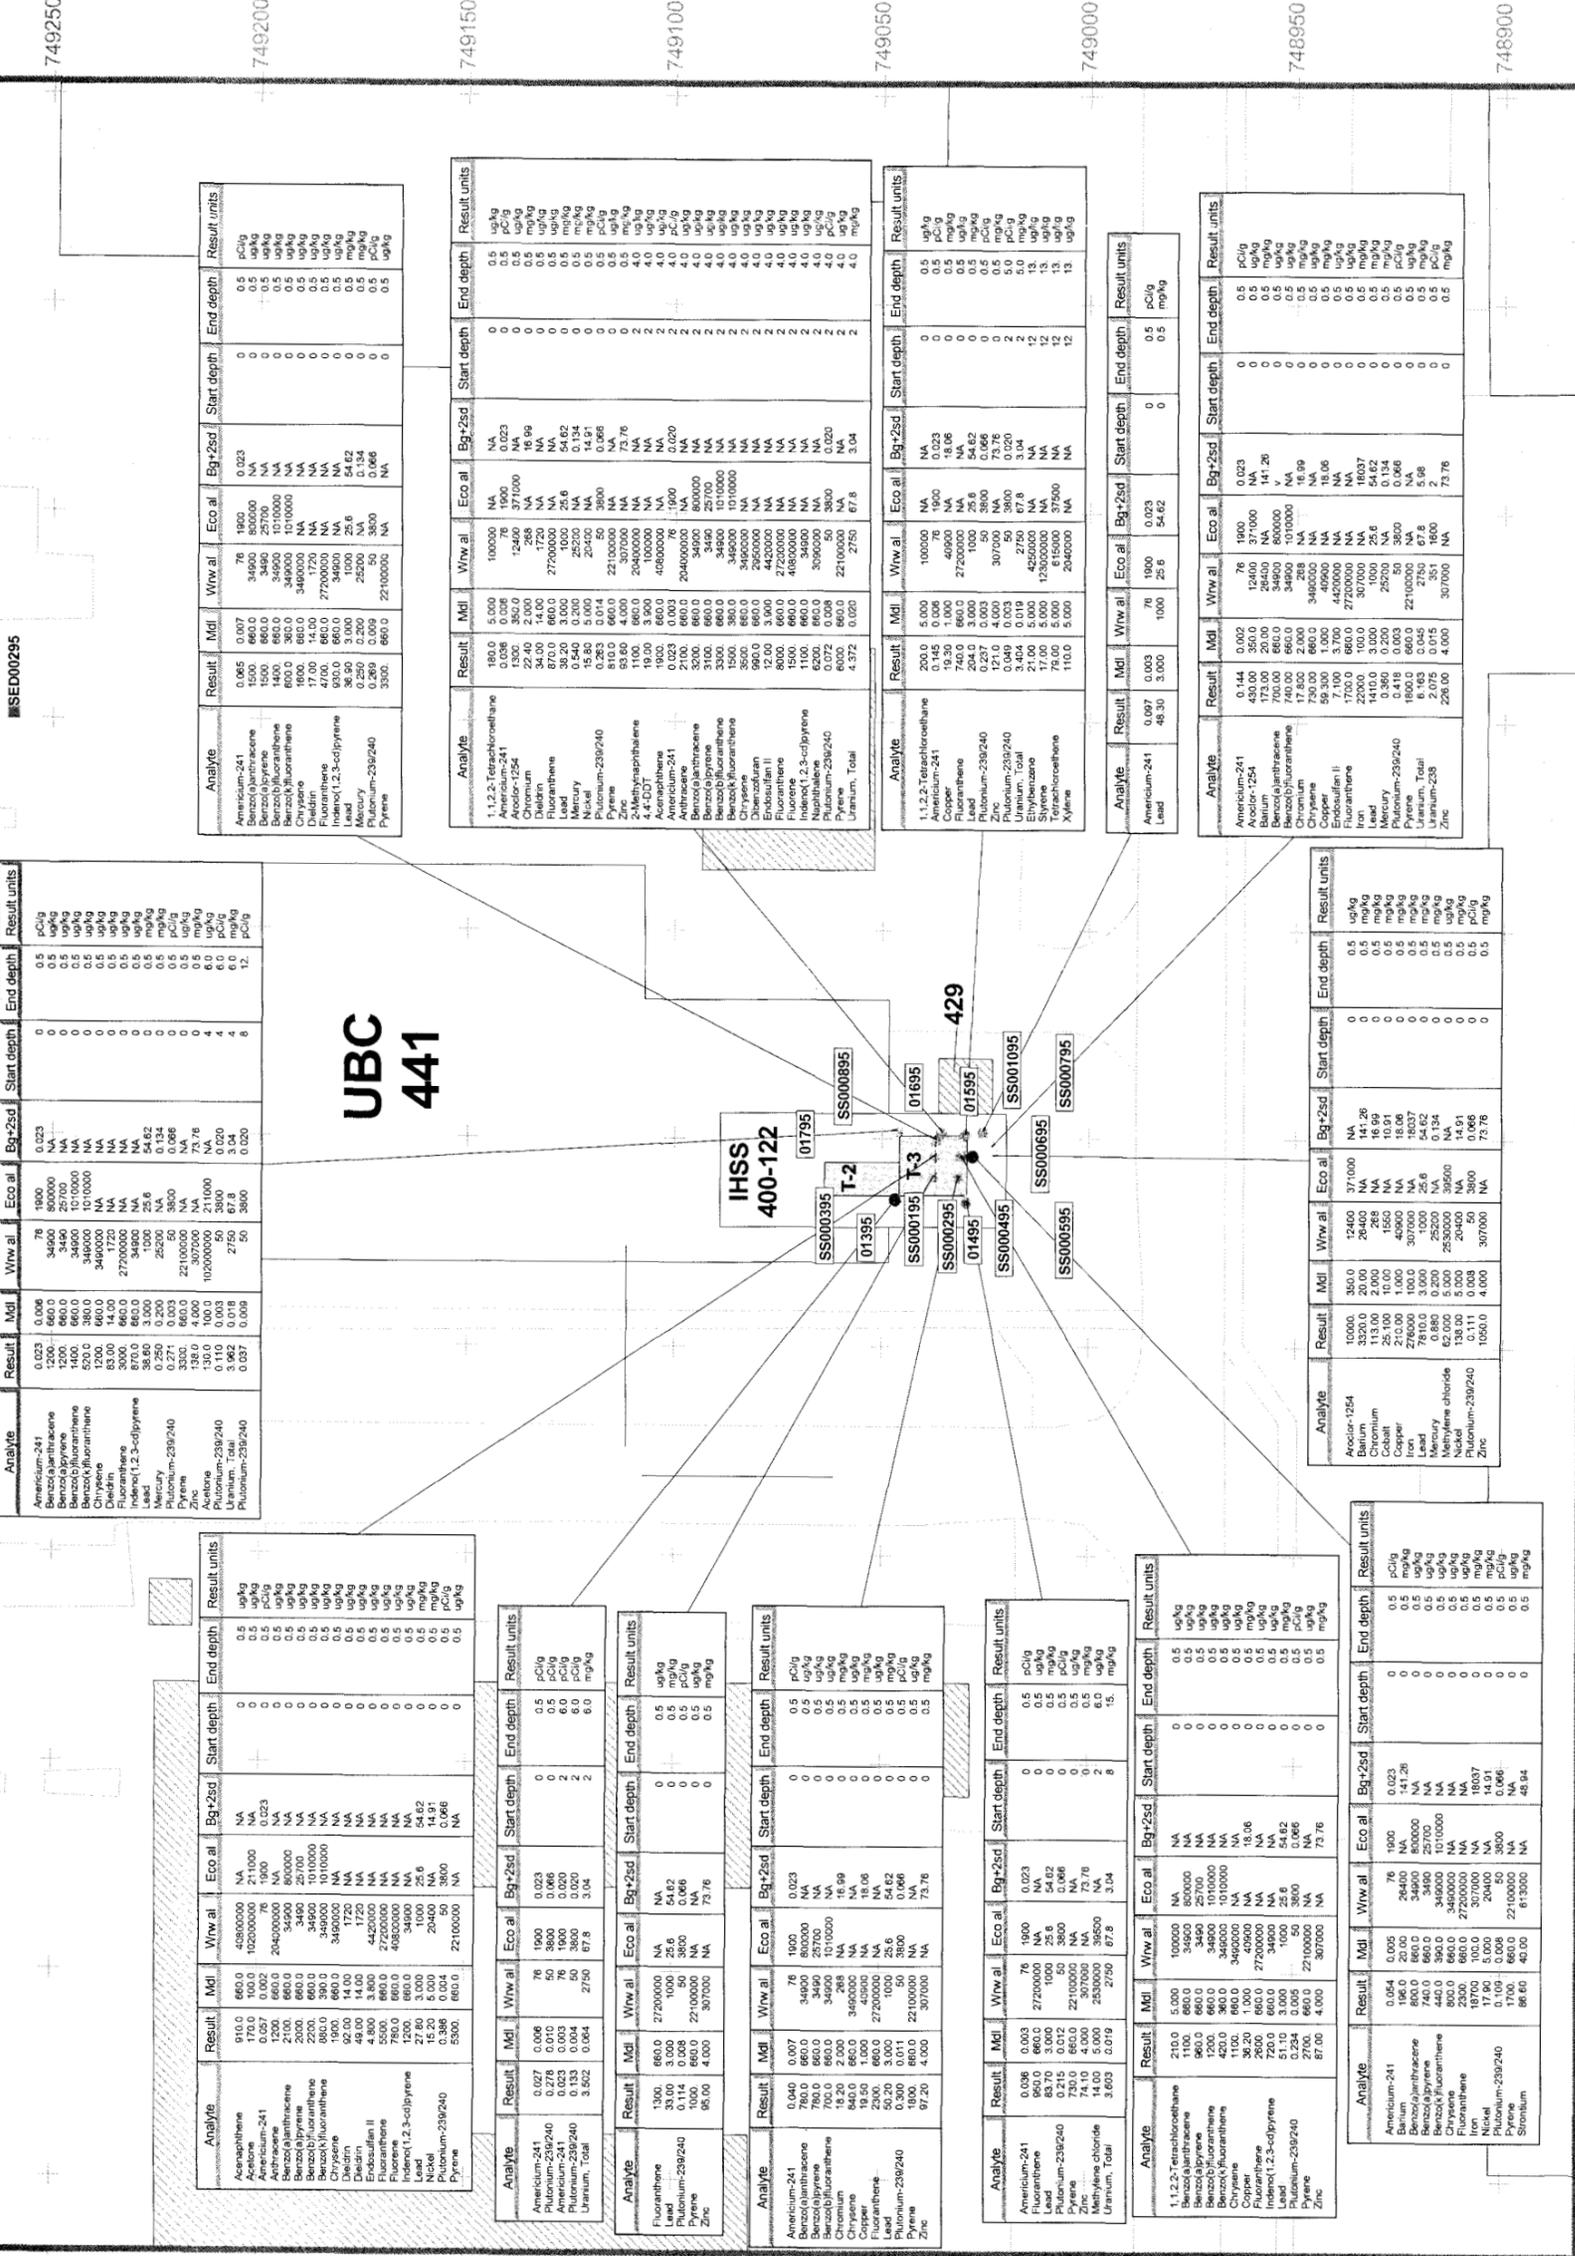
**IHSS Group 400-8
Accelerated Action Surface
Sampling Locations and Results
Greater Than Background
Means Plus Two Standard
Deviations or Reporting Limits**
