**Data Summary Report  
for IHSS Group 700-10**

**PAC 700-1101  
Laundry Tank Overflow  
Building 732**

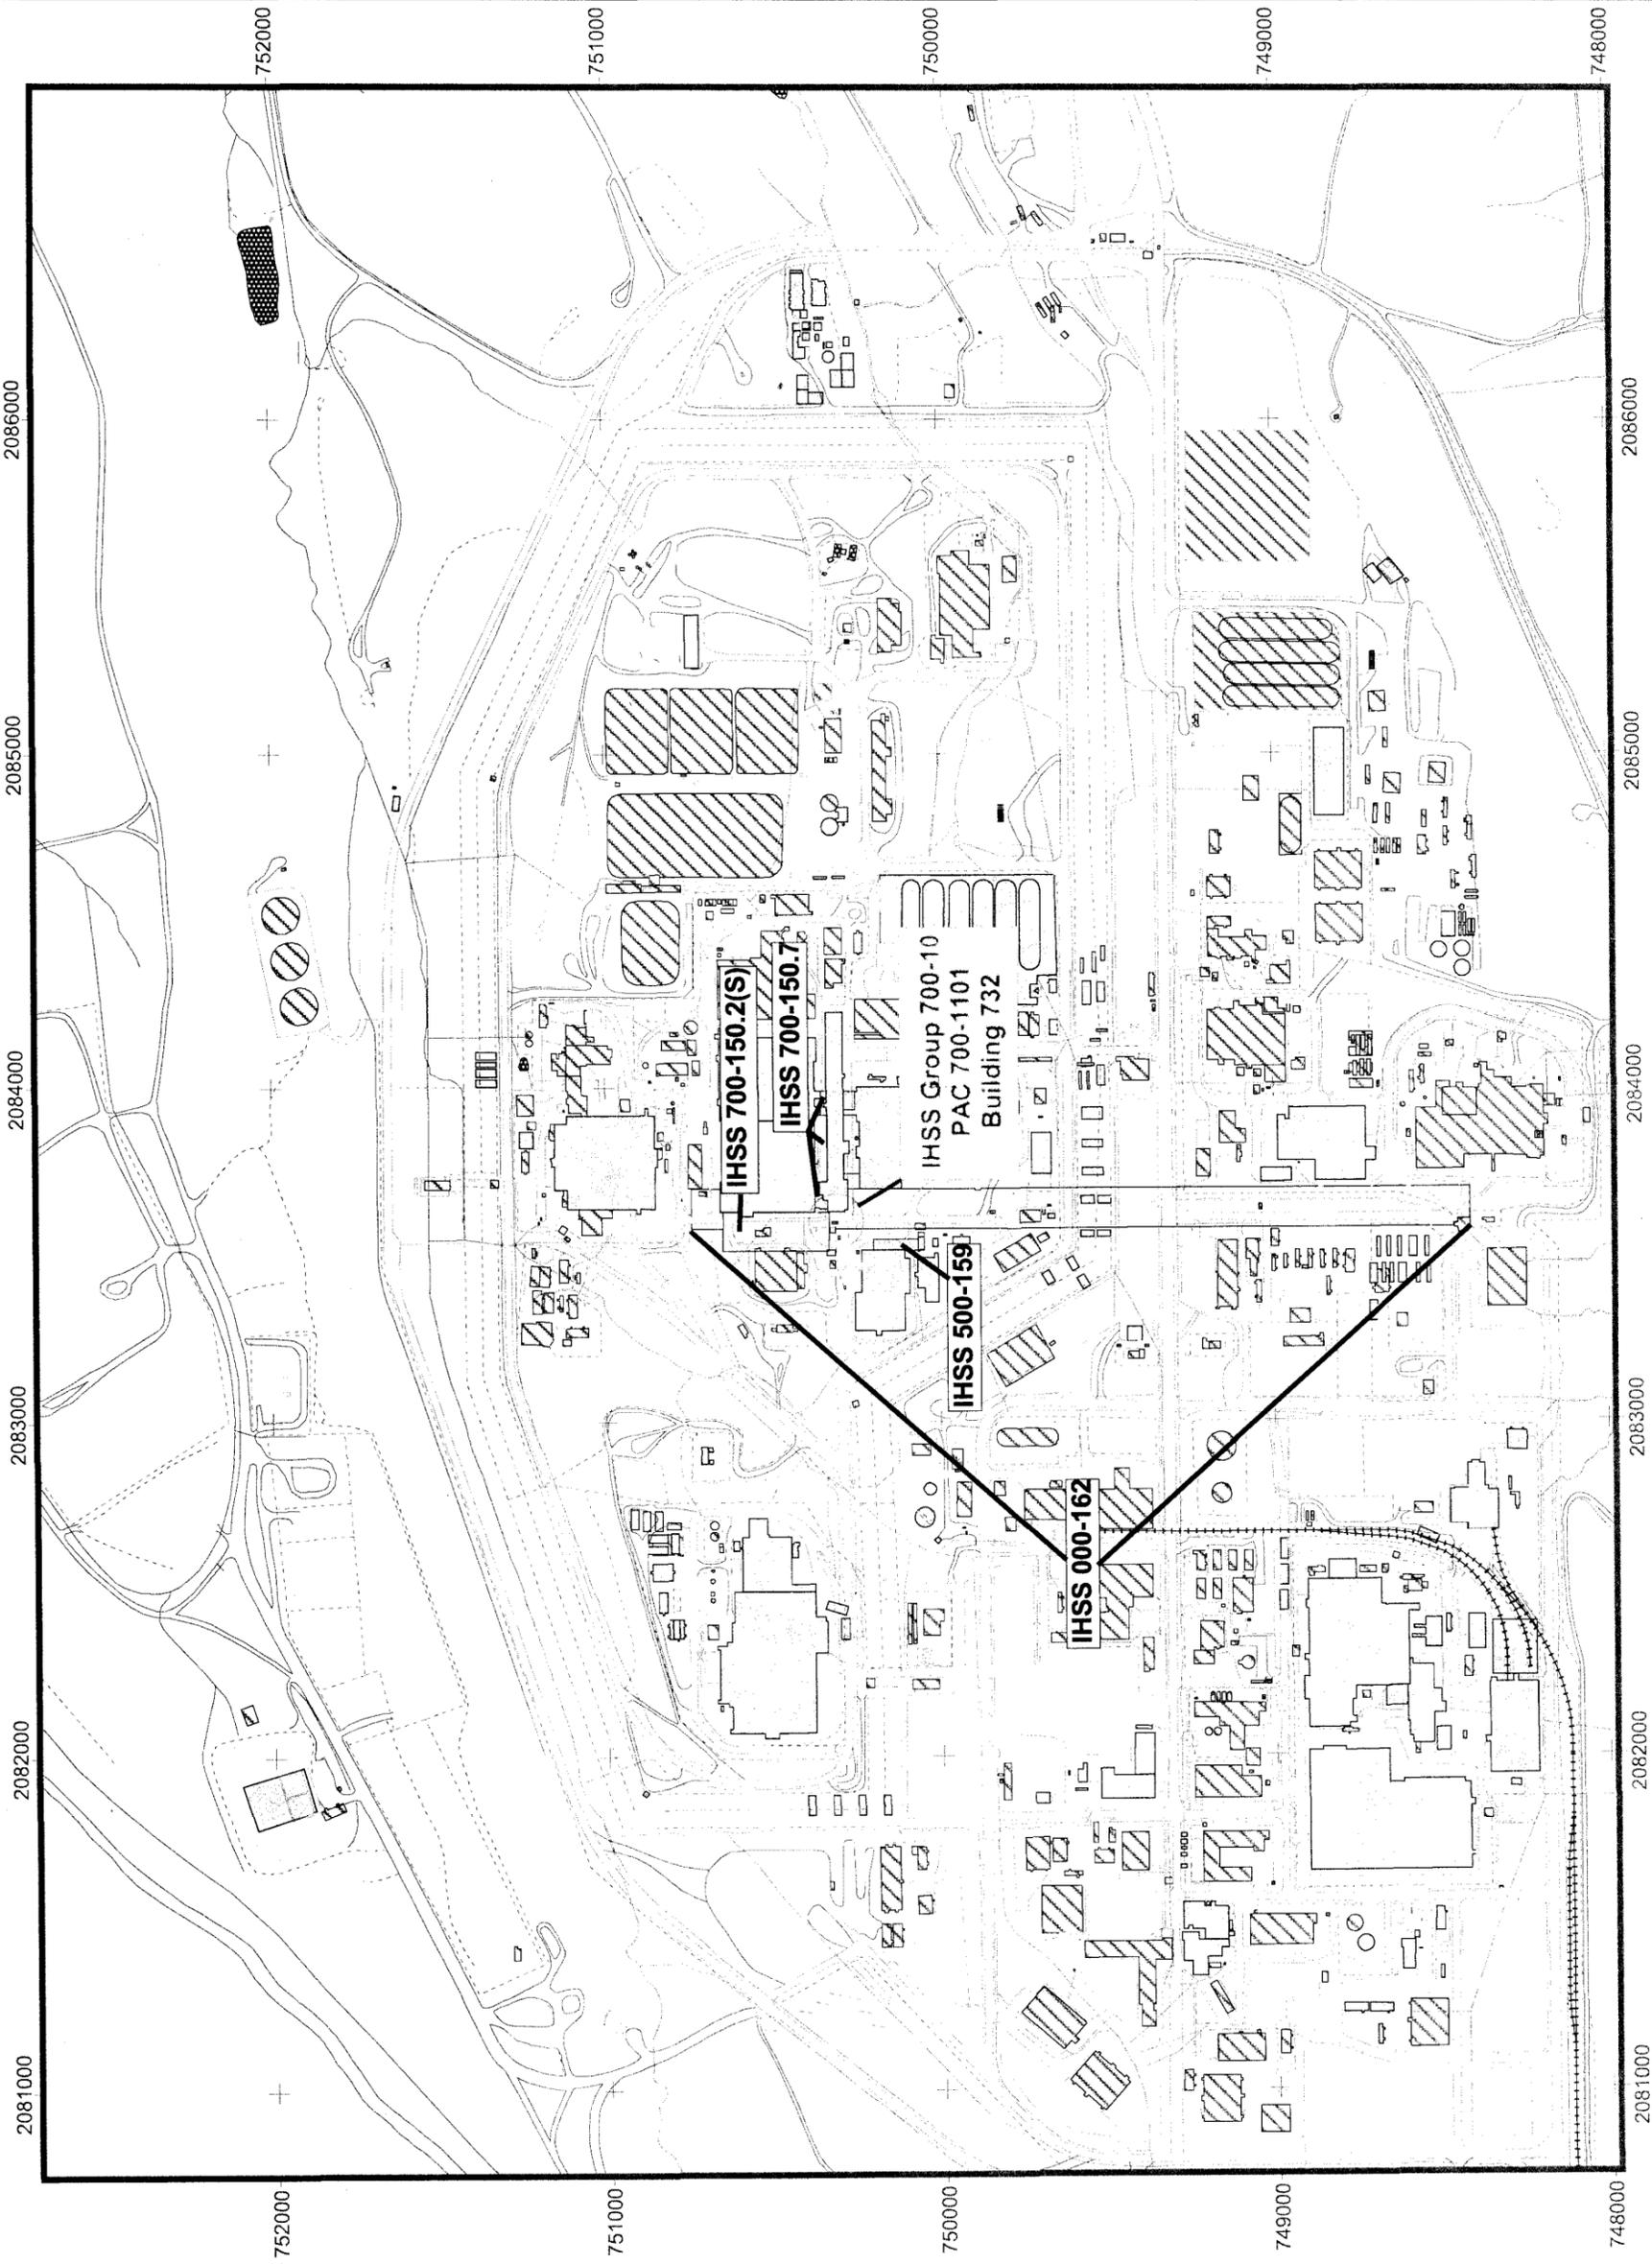
**FIGURE 2**

Groundwater in the vicinity of IHSS Group 700-10 is monitored at well locations 60299 and 60399 (Figure 2). From the beginning of 2000 through the end of 2003 trichloroethene concentrations increased to levels above Tier II ALs in groundwater at well 60299. The 2001 RFCA Annual Groundwater Monitoring Report (DOE 2002b) concluded that the VOC contamination in the PAC 700-1101 area is part of the IA Plume and that well 60299 is located on the eastern edge of the plume. Small amounts of trichloroethene detected in soil samples, as well as the presence of water above the floor within Building 732, suggest that PAC 700-1101 is not a source of VOCs.

**IHSS Group 700-10  
PAC 700-1101  
Detailed Location**

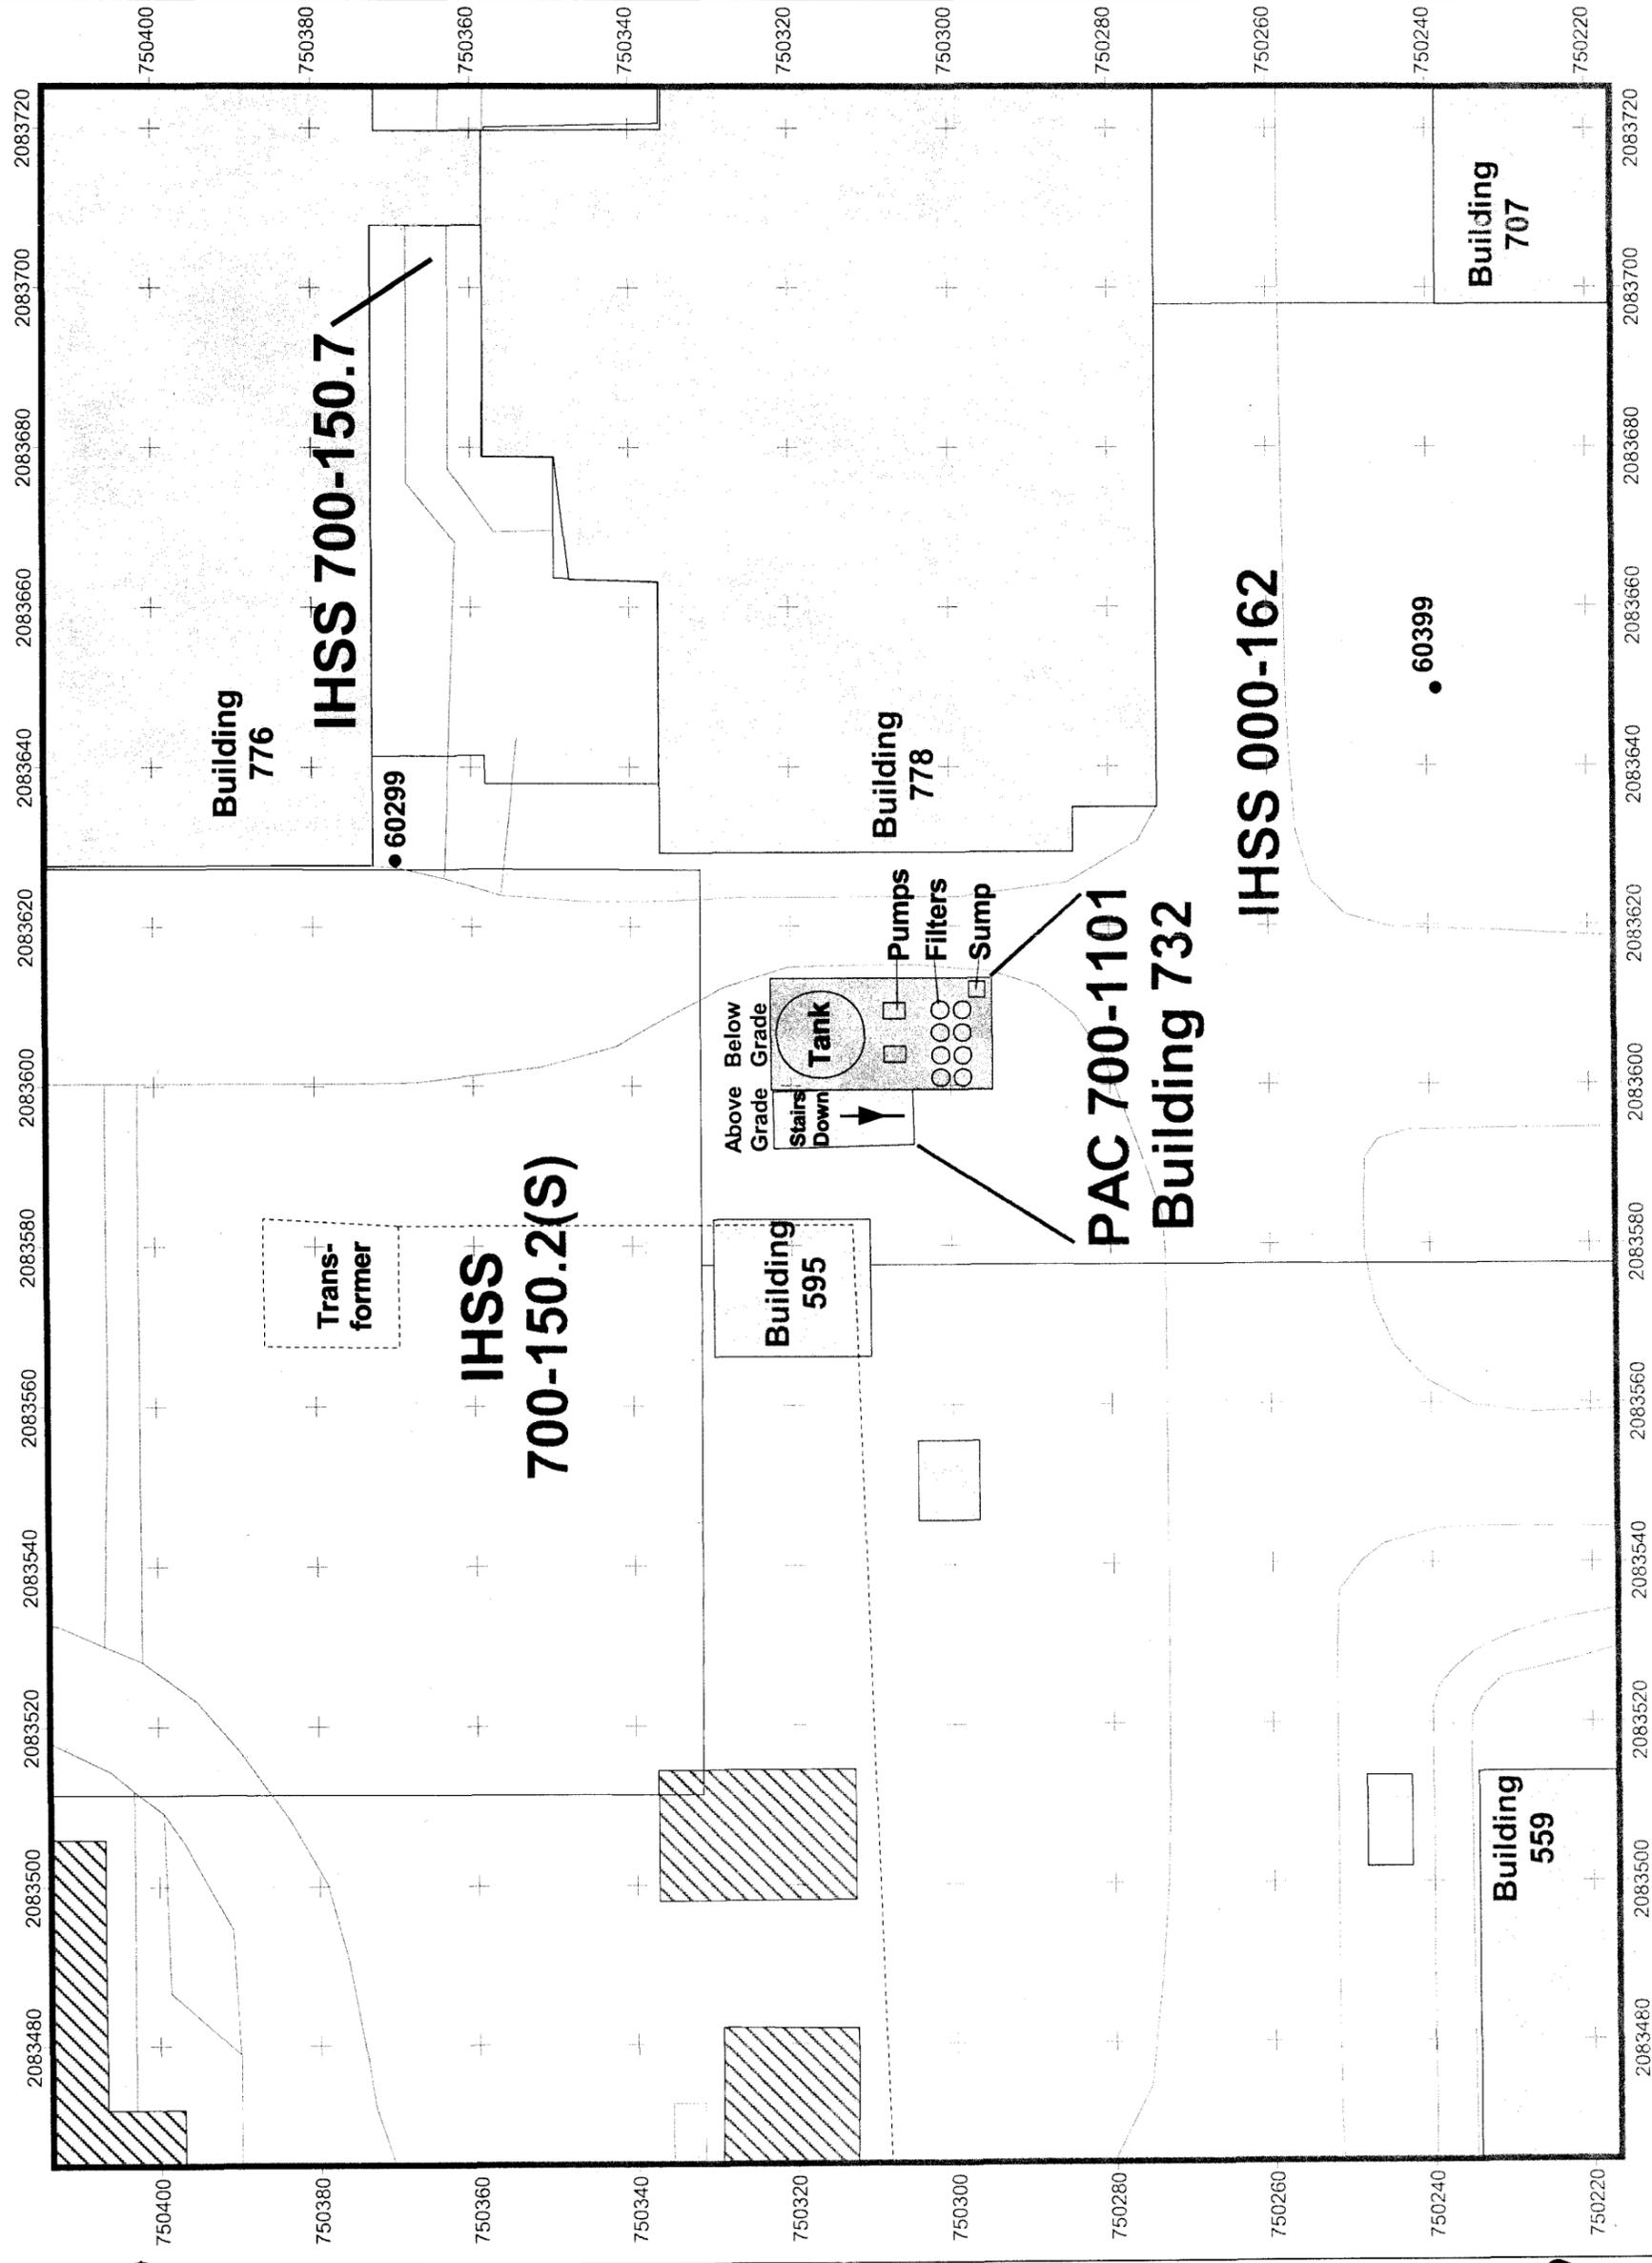
**FIGURE 3**

Accelerated action analytical data for IHSS Group 700-10 were collected in accordance with IASAP Addendum #IA-04-07 (DOE 2004). Sampling specifications, including PCOCs, are presented in Table 1. Deviations from the IASAP Addendum are also presented and explained in Table 1. Table 2 presents a summary of accelerated action sampling and analyses. The sampling locations with analytical results greater than background means plus two standard deviations or reporting limits (RLs), including wildlife refuge worker (WRW) action level (AL) exceedances, are listed in Table 3 and shown on Figure 3.

**IHSS Group 700-10 Accelerated Action Subsurface Soil Sampling Results Greater Than Background Means Plus Two Standard Deviations or Reporting Limits**
