**TRANSMITTAL OF CLOSE OUT REPORT FOR BUILDINGS 120, 120A, S120 (BUS STOP),
920 AND 920A -- DWF-074-05**

Type 1 Facility Closeout Report

Section A. Facility Data	
Facility No.	Buildings 120, 120A, S120 (Bus Stop), 920 and 920A
Facility Descriptor:	East and West Access Posts, Vehicle Search Facilities
Project:	RISS - Area 5 Group 15 D&D
Date of Demolition:	6/29/05 (120) and 4/27/05 (920)
Additional Information:	Guard posts and portable shelters demolished and disposed of as sanitary waste.
<i>(Must include information on environmental releases and conditions of site at turnover to Environmental Restoration)</i>

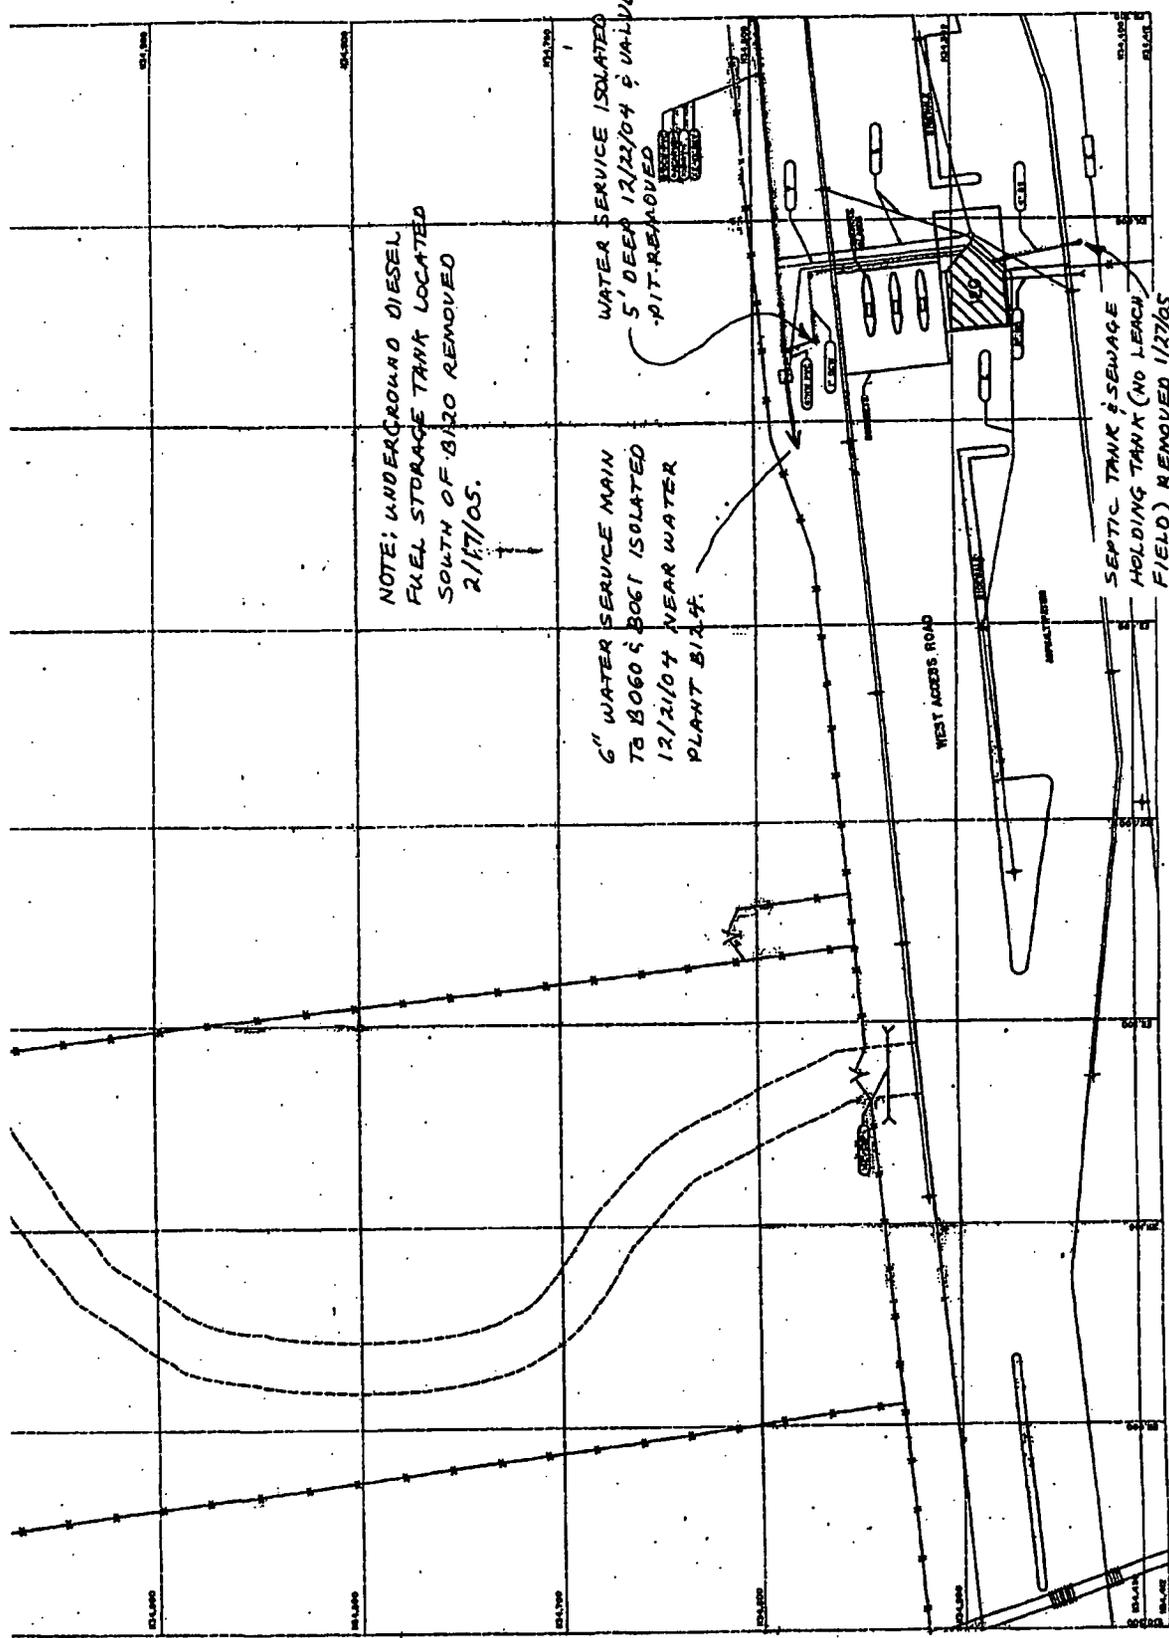
NOTE; UNDERGROUND DIESEL
FUEL STORAGE TANK LOCATED
SOUTH OF BAZO REMOVED
2/17/05.

6" WATER SERVICE MAIN
TO B060 & B061 ISOLATED
12/21/04 NEAR WATER
PLANT Bldg.

WATER SERVICE ISOLATED
5' DEEP 12/22/04 @ VALVE
-PIT-REMOVED

SEPTIC TANK & SEWAGE
HOLDING TANK (NO LEACH
FIELD) REMOVED 1/27/05

Buildings 120, 120A, 920 and 920A were removed during D&D activities, and sent offsite for disposal. The utilities were disconnected and removed to at least three feet below final grade as indicated on the attached map. There are no remaining structural components, utility lines, or parts of the foundation. The buildings are not in an IHSS or PAC therefore no soil sampling is required.

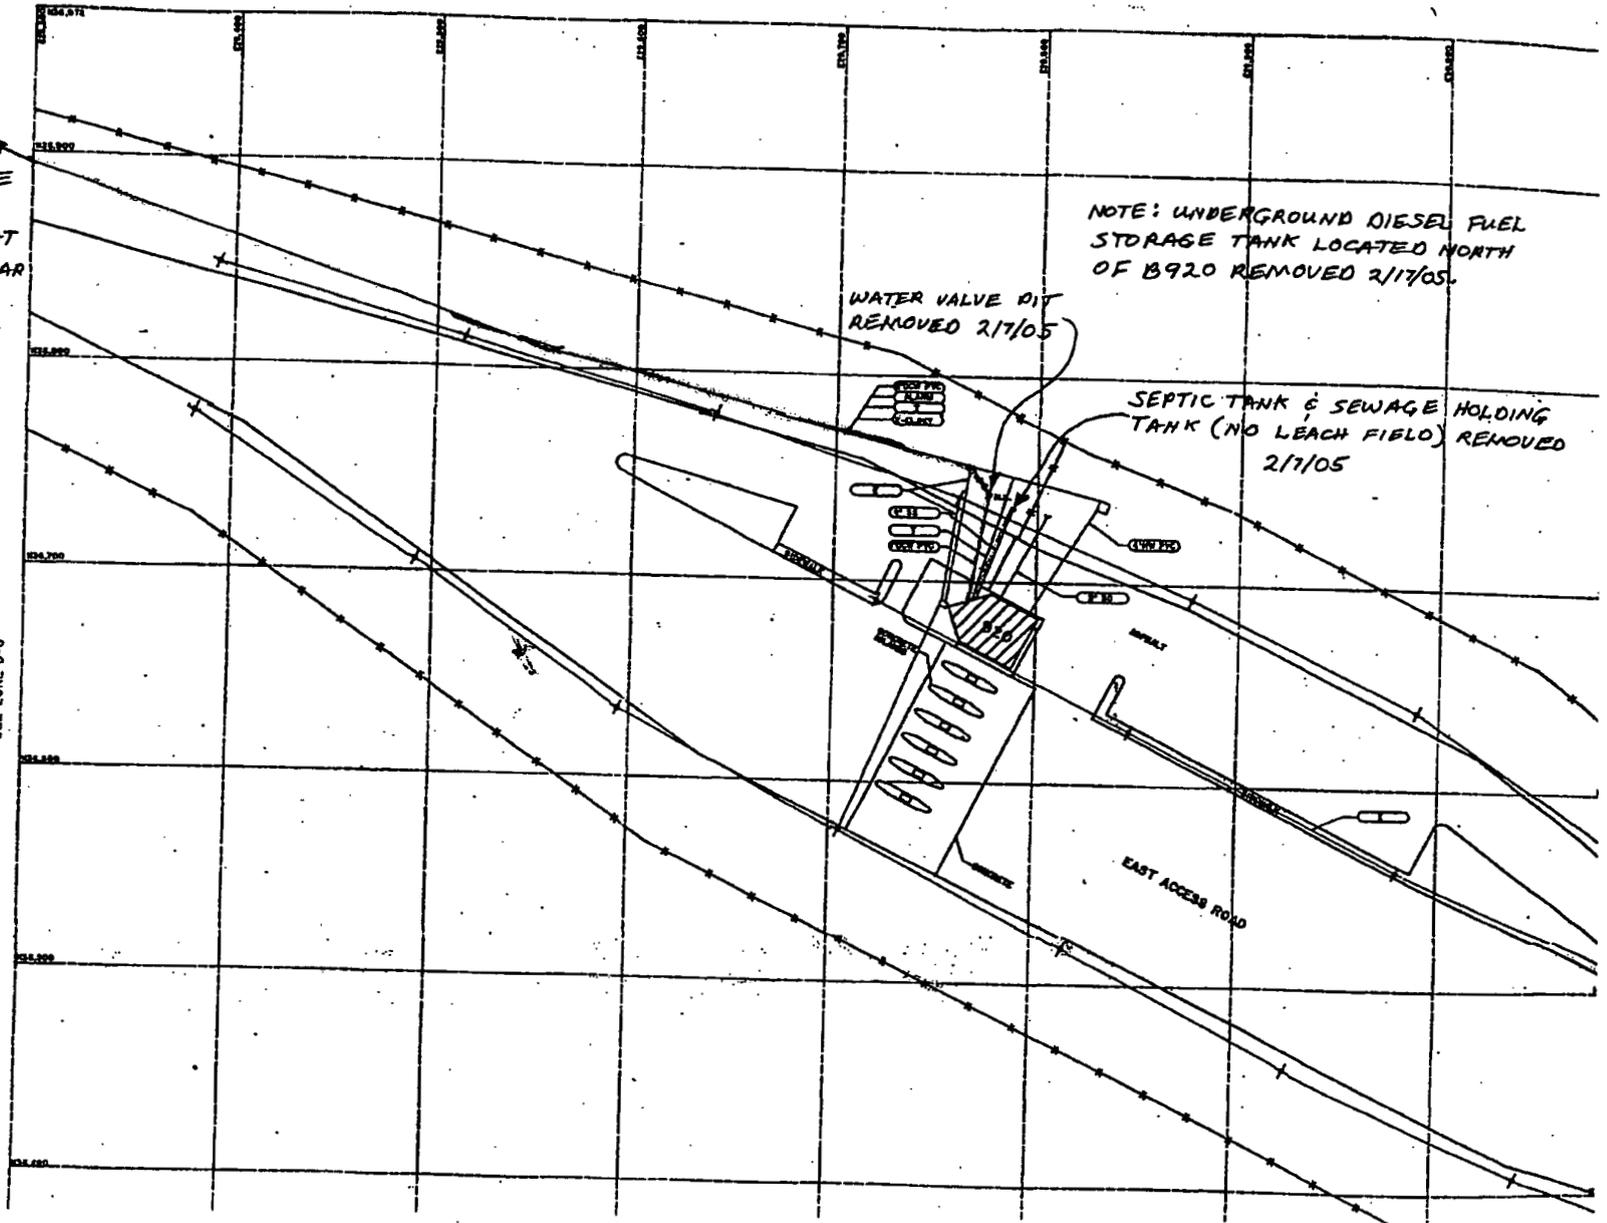
WATER SERVICE
ISOLATED 5 1/2'
DEEP 2/2/05 AT
VALVE PIT NEAR
INNER EAST
GATE B900

NOTE: UNDERGROUND DIESEL FUEL
STORAGE TANK LOCATED NORTH
OF B920 REMOVED 2/17/05.

WATER VALVE PIT
REMOVED 2/17/05

SEPTIC TANK & SEWAGE HOLDING
TANK (NO LEACH FIELD) REMOVED
2/17/05
