TRANSMITTAL OF CLOSE OUT REPORT FOR TRAILERS 707C, D, E, AND 701
-- DWF-077-05

Type 1 Facility Closeout Report

Section A. Facility Data	
Facility No.	707C, D, and E Trailers and 701
Facility Descriptor:	Officer Trailers and storage shed (701)
Project:	RISS
Date of Demolition:	July 7, 2005
Additional Information:	701 was a storage shed that was released using a WRE (attached).
<i>(Must include information on environmental releases and conditions of site at turnover to Environmental Restoration)</i>

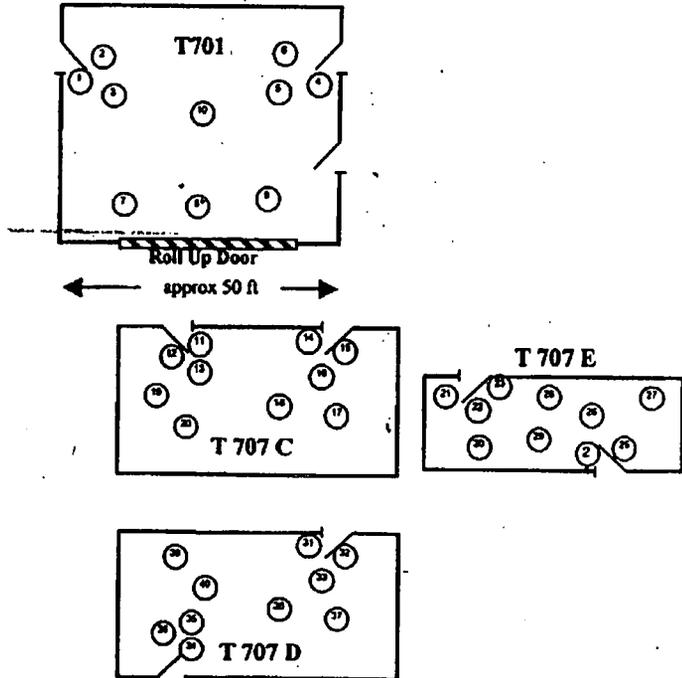
Drawing Showing Survey Points

Comments: Nuclide of concern is Pu. Survey points emphasized entryways and walkways.

1	See Map	<10	<48
2		<10	<48
3		<10	<48
4		<10	<48
5		<10	<48
6		<10	<48
7		<10	<48
8		<10	<48
9		<10	<48
10		<10	<48
11		<10	<48
12		<10	<48
13		<10	<48
14		<10	<48
15		<10	<48
16		<10	<48
17		<10	<48
18		<10	<48
19		<10	<48
20	See Map	<10	<48

Swipe Loc#	Location/Description Results in dpm/100cm ²	Removable	Direct
		α	β
21	See Map	<10	<48
22		<10	<48
23		<10	<48
24		<10	<48
25		<10	<48
26		<10	<48
27		<10	<48
28		<10	<48
29		<10	<48
30		<10	<48
31		<10	<48
32		<10	<48
33		<10	<48
34		<10	<48
35		<10	<48
36		<10	<48
37		<10	<48
38		<10	<48
39	▼	<10	<48
40	See Map	<10	<48
