**Final Technical Memorandum No. 7  
Soil Boring Sampling Plan  
Ash Pits 1-4, Incinerator and  
Concrete Wash Pad  
Operable Unit No.5**

**FINAL  
TECHNICAL MEMORANDUM NO. 7**

**ADDENDUM TO FINAL PHASE I  
RFI/RI WORK PLAN**

**Rocky Flats Plant  
Woman Creek Priority Drainage**

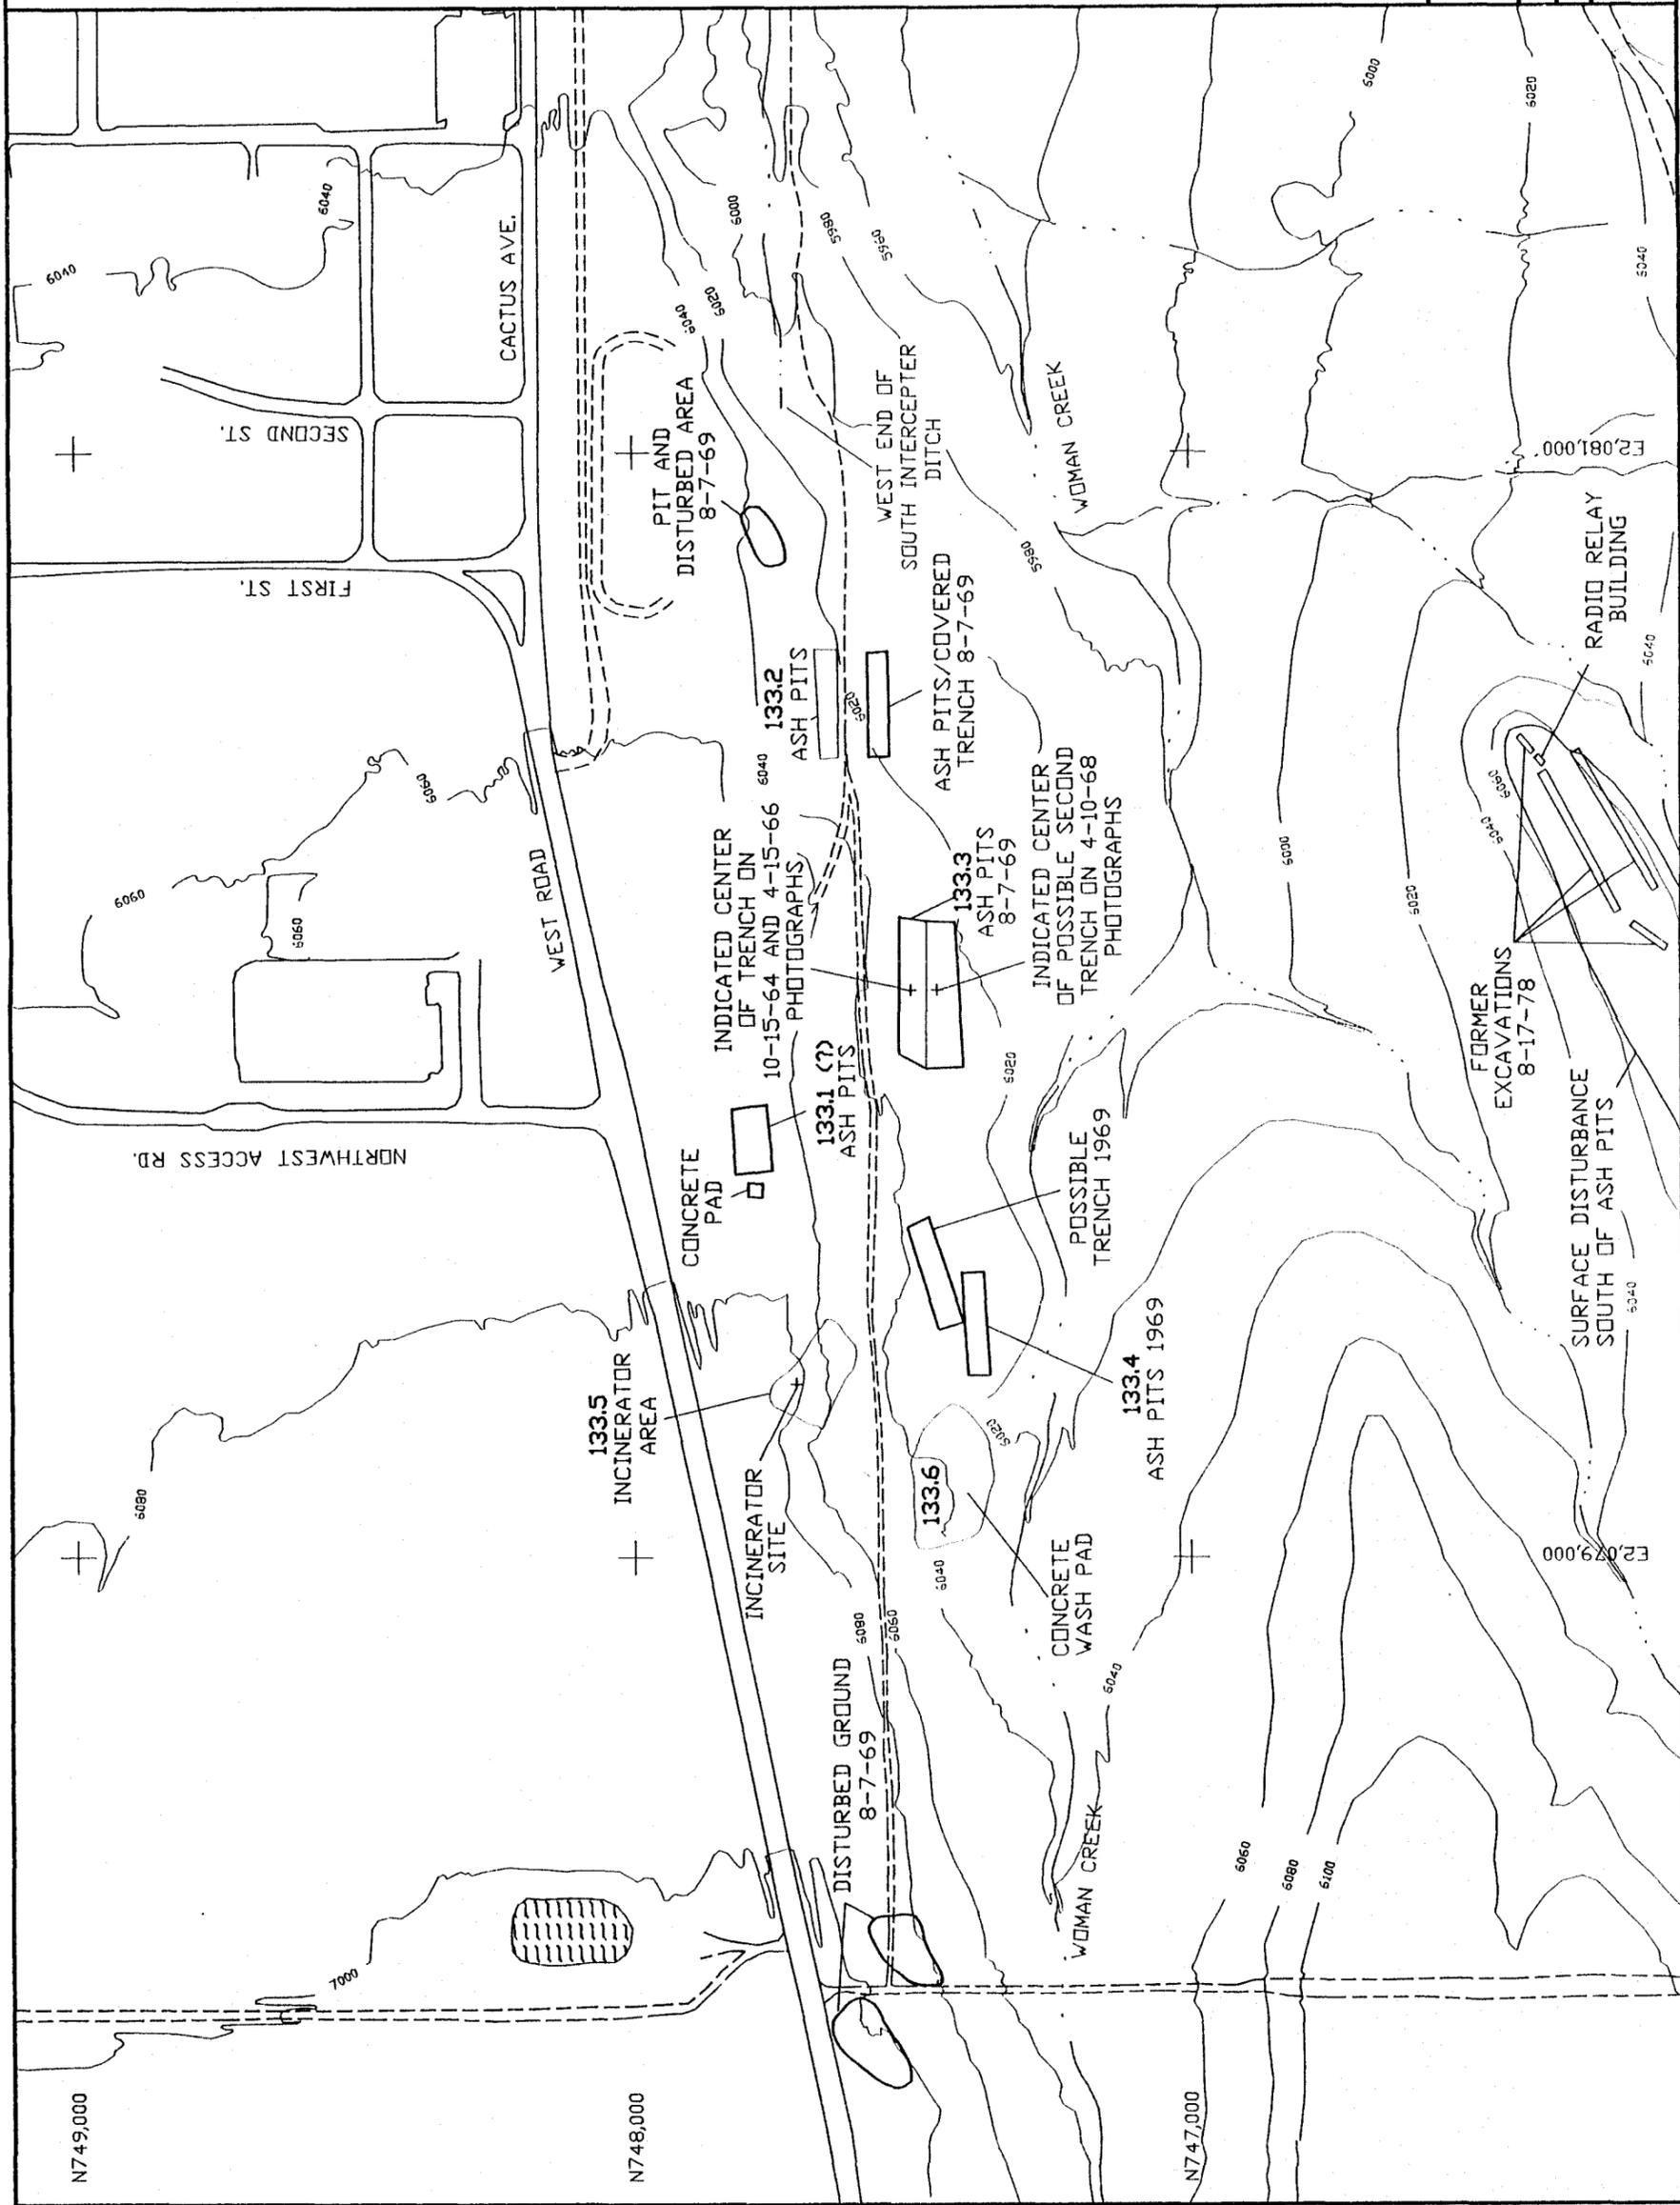
FIGURE 2

The locations of IHSSs 133.1 through 133.6 are shown on Figure 2. IHSSs 133.5 (incinerator) and 133.6 (concrete wash pad) are easily identifiable in both the photographs and the field, and essentially agree with the locations shown in the Work Plan. IHSS 133.1 is approximately located as shown in the Work Plan but consists of a concrete dump with no visible indications an ash pit ever existed at this site unless it was covered by the concrete. IHSSs 133.2, 133.3, and 133.4 were easily identified on the oblique photographs and their locations correlate well with sites that were visible on corresponding vertical photographs. These sites are shown on Figure 2 and do not agree with the sites shown on Figure 7-3 of the Work Plan.

The Surface Features Location Map (Figure 5), which is based on the survey traverse, provides information that has been incorporated into the map shown on Figure 2. Because the traverse was tied to land surveyed base lines, landmarks such as the concrete pad located just to the west of IHSS 133.1 have been more accurately located on Figure 2. Since most of the features shown on the west half of the map were located from this pad and other landmarks that could be easily identified on the vertical aerial photographs, adjustments were subsequently made to some of the IHSSs and other prominent features located on the west side of the map. These changes have resulted in improved correlations of some surface features with anomalies occurring on the EM and magnetic contour maps. It should be noted that a mylar overlay, drafted to the same scale as the geophysical survey maps, was used to identify the anomalies associated with the IHSSs

IHSS 133.4, a buried trench, as shown on Figure 2, has been expanded to include a possible disturbed area extending to the northeast from the trench area. The size of each area was determined from vertical aerial photographs and are estimated to be 180 ft. x 40 ft. and 190 ft. x 40 ft., respectively. There are no photographs documenting the presence or sizes of trenches in the area while they were in use.

and Woman Creek (Figure 8). An additional disturbed area was identified in the aerial photograph review (Figure 2). Two borings are proposed for investigation of the "pit and disturbed area" east of the Ash Pits.

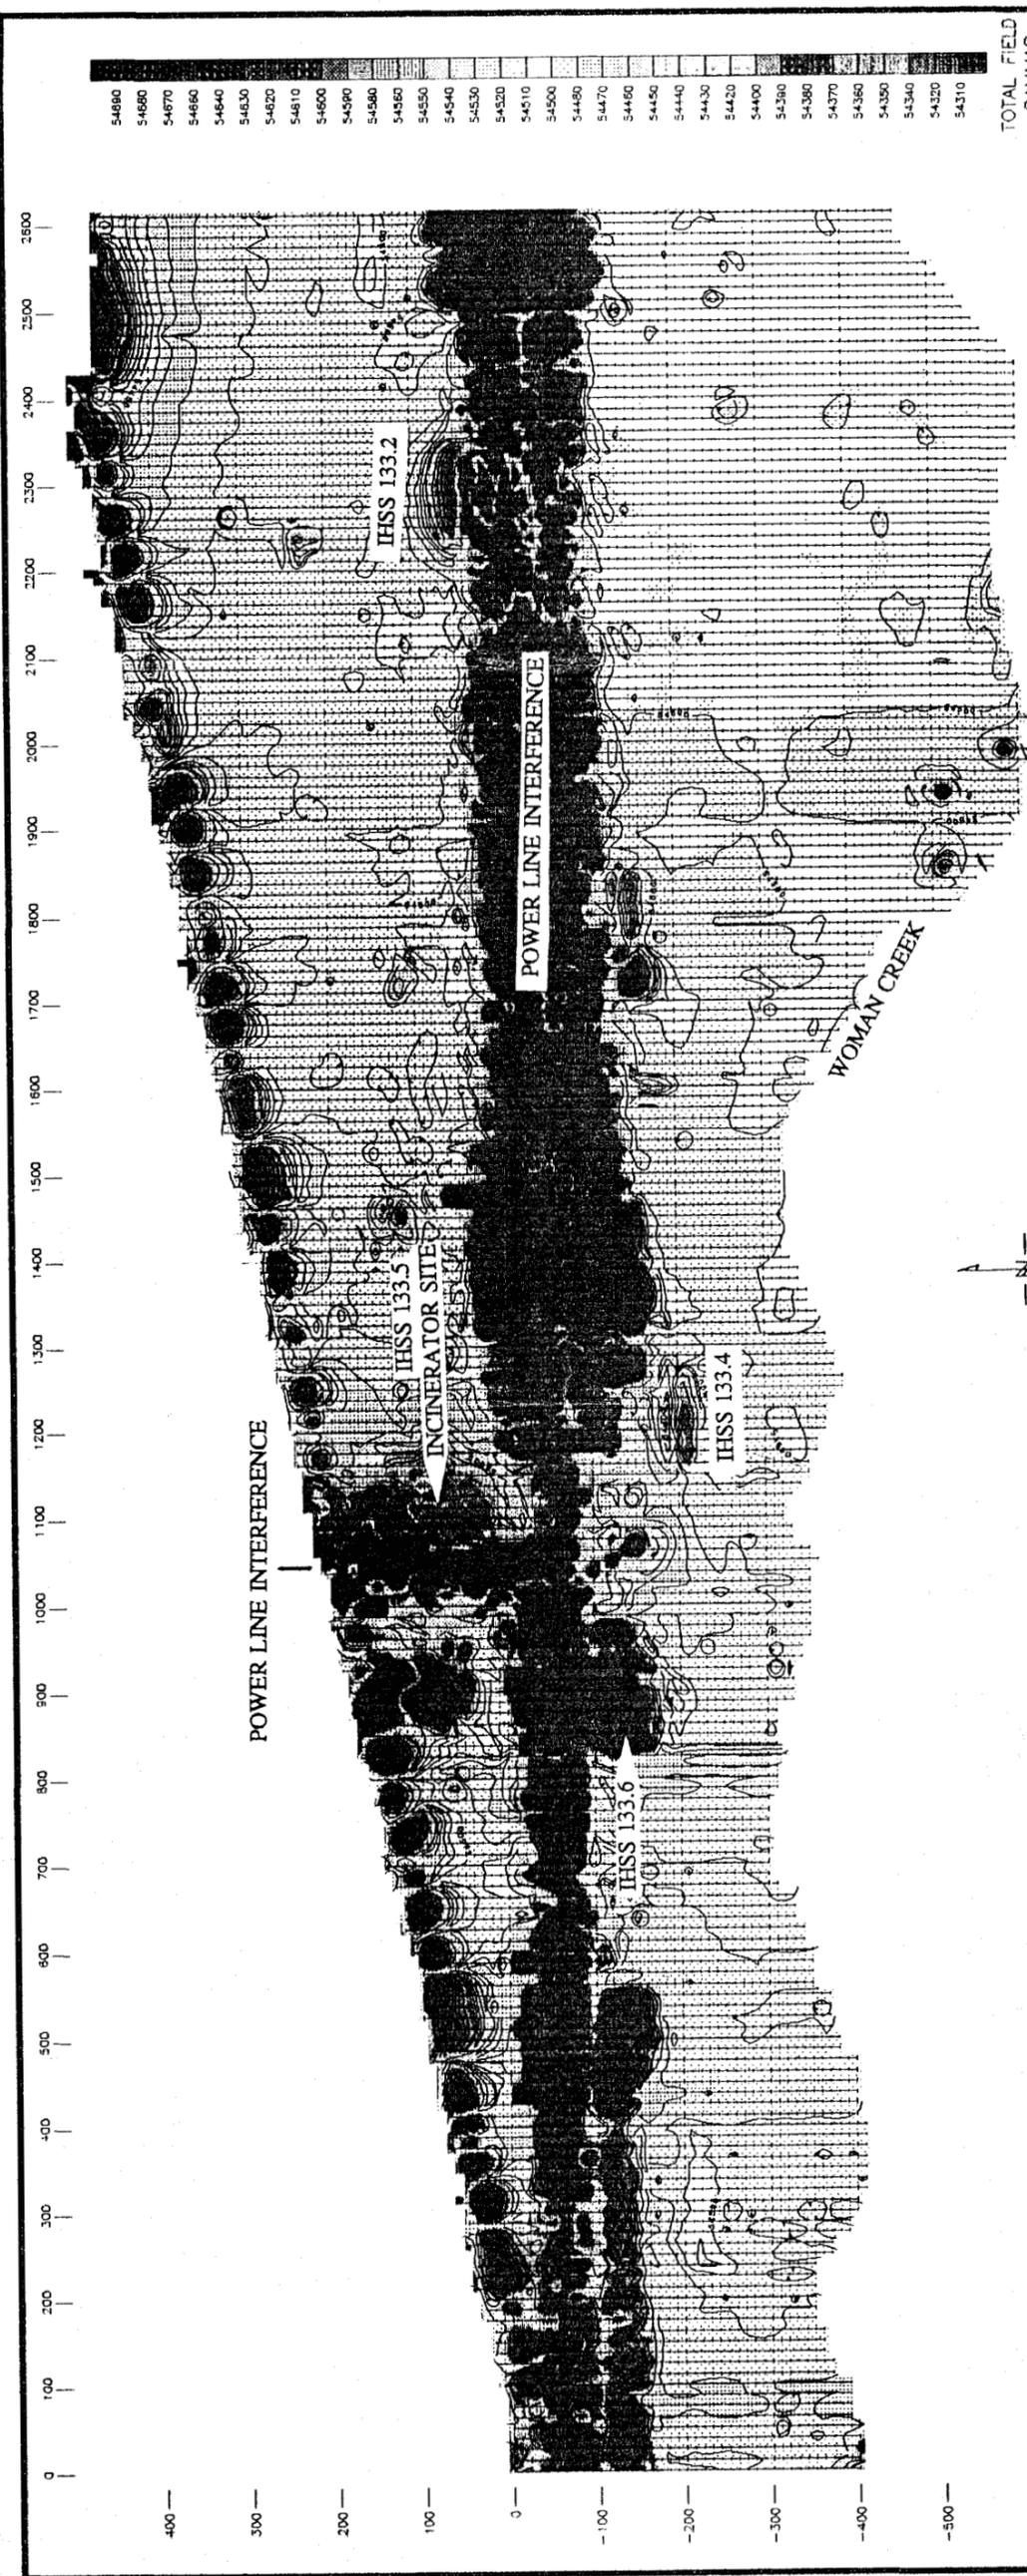
IHSS 133  
TOTAL MAGNETIC FIELD  
CONTOUR MAP

The total magnetic field map (Figure 3) shows well defined magnetic anomalies that correspond to the location of the southern-most pit shown on Figure 2. The configuration and sizes of the anomalies indicates that metallic debris was not uniformly distributed throughout the trench. Data over the indicated north pit was again distorted by power line interference.

The data shown on Figures 3, 4, 6, and 7, are essentially from direct field readings except where a minimal magnetic drift correction was applied to the magnetometer data. All data was acquired using a 12.5 foot line spacing and 10 foot station intervals. Only the contour interval was changed, as applicable, to enhance the definition of possible anomalous events.

A strong magnetic anomaly occurs along the north side of the area that generally appears to be outside of the interference from the power lines (Figure 3). Continuing to the south, this anomaly grades into a band showing lower magnetic intensities. The perimeter of the site was then mapped at background levels with no significant anomalies. Based upon the above configuration, it can be assumed that some magnetic metallic debris was buried or dumped along the north half of the site.

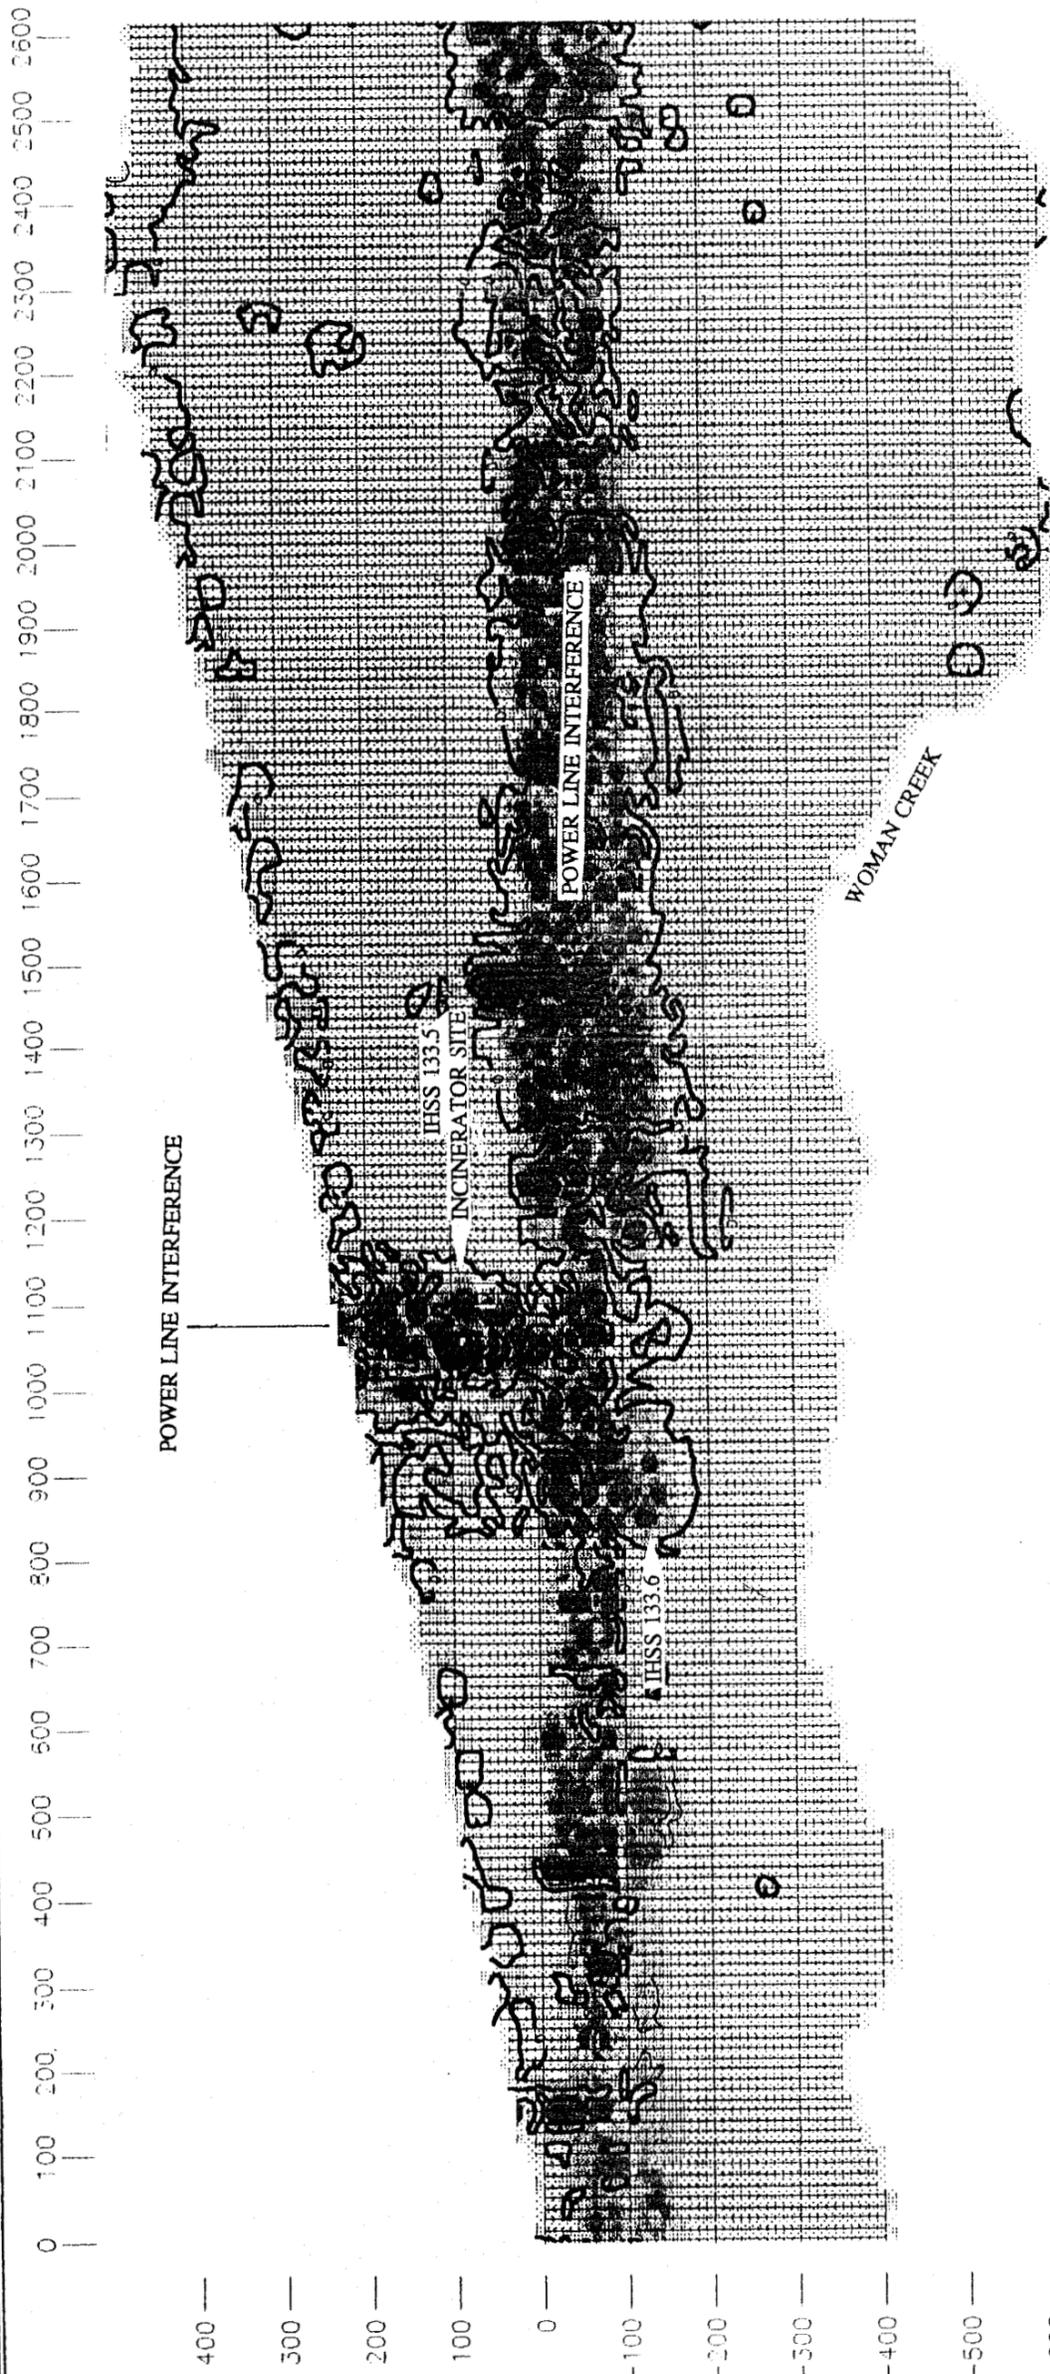
IHSS 133 MAGNETIC GRADIENT CONTOUR MAP	
TAT - SOIL BORING SAMPLING PLAN	
OUG PHASE I RFI/RI IMPLEMENTATION	
	8208.15.01.17
	FIGURE 4
FEBRUARY 93

The effective penetration depth of the magnetometer depends on the size and depth of the buried object(s). Because the pits were estimated to be a maximum of 10 to 12 feet in depth, the survey was expected to detect single drums or similar ferromagnetic objects. Because the powerlines

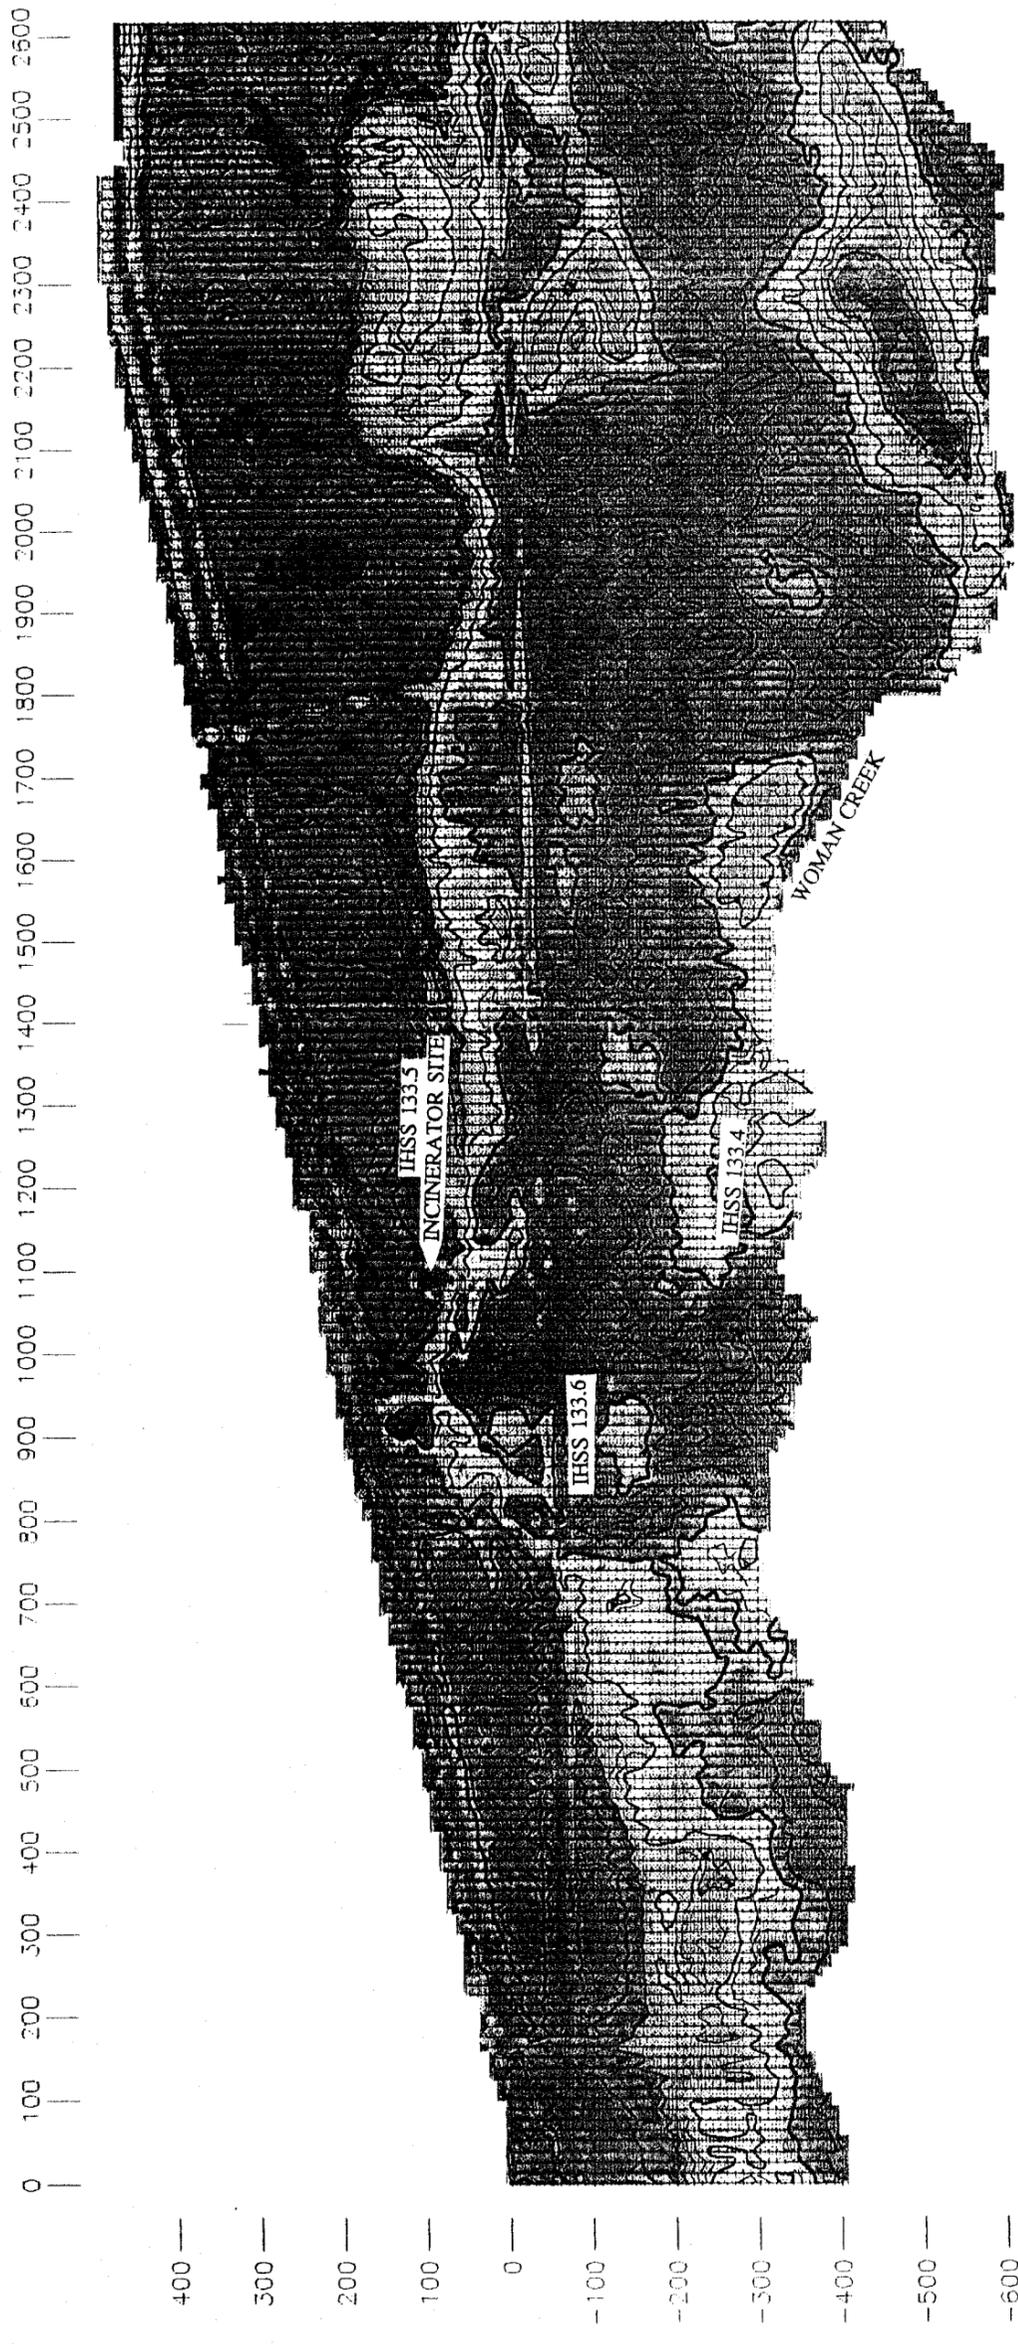
9208.15-01.17	FIGURE 6
	FEBRUARY 93	
IHSS 133 EM31 CONDUCTIVITY CONTOUR MAP ( VERTICAL DIPOLE )		
TMT - SOIL BORING SAMPLING PLAN		
OUS PHASE I RFI/RI IMPLEMENTATION

The EM survey data, which is shown on Figure 6, defines an area of relative high conductivity which is interpreted to be related to the varying saturation of alluvial sediments, which can vary from clay to gravel within the general area. The conductivity data does not delineate the trenches identified on the aerial photographs because the material filling the trenches, and the sediments surrounding the trenches are probably similar and equally saturated. Although the data failed to delineate the trenches, the overall disturbed area can be readily identified on the ground.

The EM data was successful in delineating the disturbed areas (Figure 6) and appears to be reliable enough that a slight site location adjustment was incorporated into Figure 2. A well defined elongated magnetic anomaly was recorded over IHSS 133.4 (Figure 3) and indicates the presence of magnetic debris within the east-west pit. The configuration of the anomaly also indicates a moderately uniform distribution of metallic debris through out the trench. No significant anomalies were detected over the northeast area which is subject to EMF interference from the power lines.

Topography within the IHSS 133 series area can be interpreted from the EM conductivity map (Figure 6) since the topographic highs are shown as low conductive areas (presumably due to a greater thickness of coarser unsaturated alluvial material) and the drainage ways and topographic lows are shown as higher conductive areas (composed of mixed, possibly more saturated alluvial sediments). The EM vertical dipole conductivity map (Figure 6) clearly defines the topography of the area and the previously existing road that was located below the incinerator. The floor and foundation of the incinerator occur as a rectangular shaped low conductivity anomaly surrounded by a high conductivity halo on both the EM conductivity and in phase maps (Figures 6 and 7).

The site is partially delineated by the EM survey. The vertical dipole conductivity map (Figure 6) shows an area of low conductivity that probably coincides with the area of thick concrete cover. The map then grades into a larger area showing a higher conductivity that is most likely indicative of more conductive or partially saturated alluvial sediments that underlie the dump area.

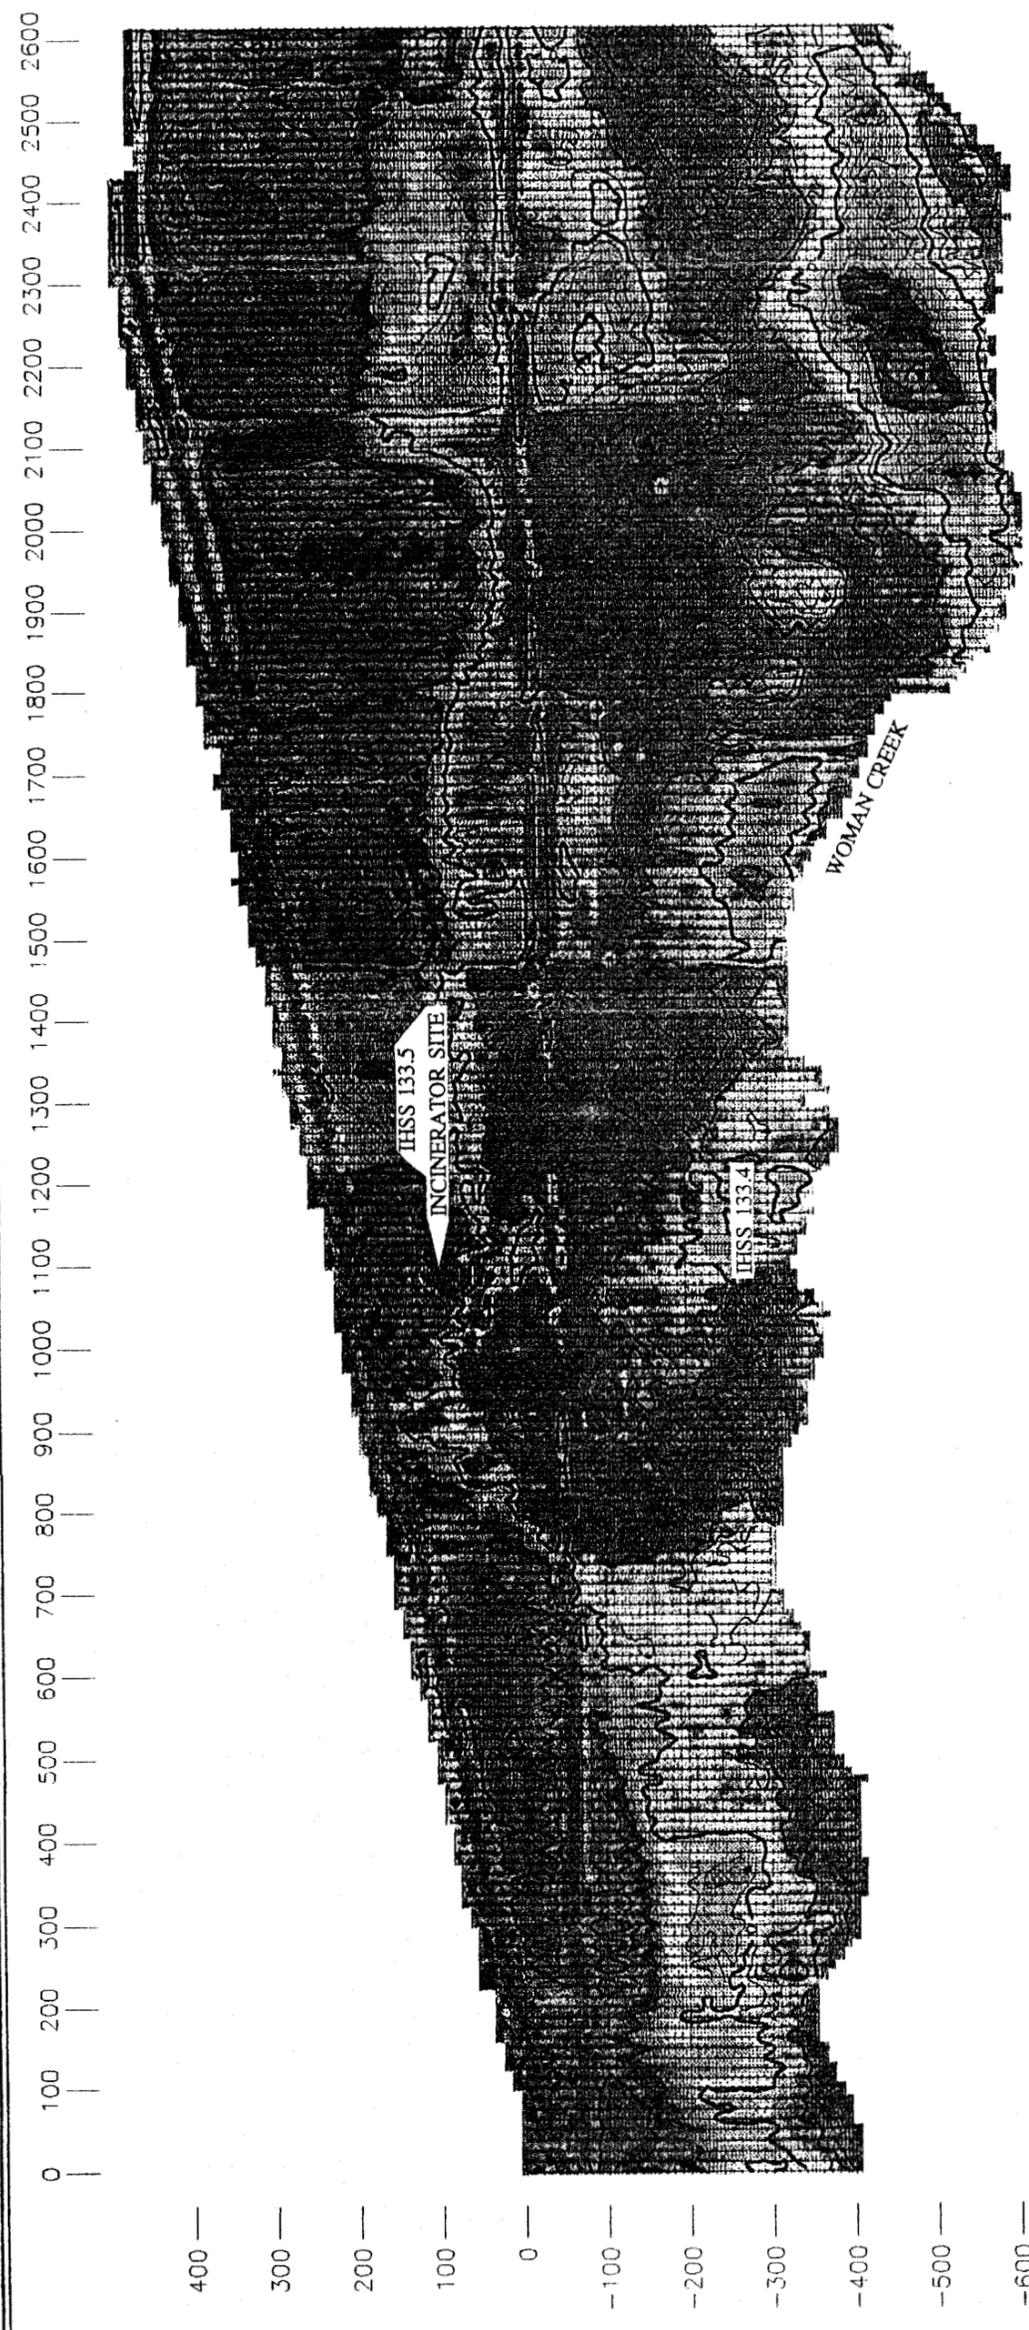
IHS 133	
EM31 IN PHASE CONTOUR MAP ( VERTICAL DIPOLE )	
TBT - SOIL BORING SAMPLING PLAN	
008 PHASE I RFI/RI IMPLEMENTATION	
	8208.15.01.17
	FIGURE 7
FEBRUARY 98

and 7) coincide with the plotted location of the incinerator and therefore indicate that the foundation and floor were left in place when the incinerator was demolished. The magnetometer data did not fully delineate the site, but contained some weak anomalies that may correspond to the buried foundation.

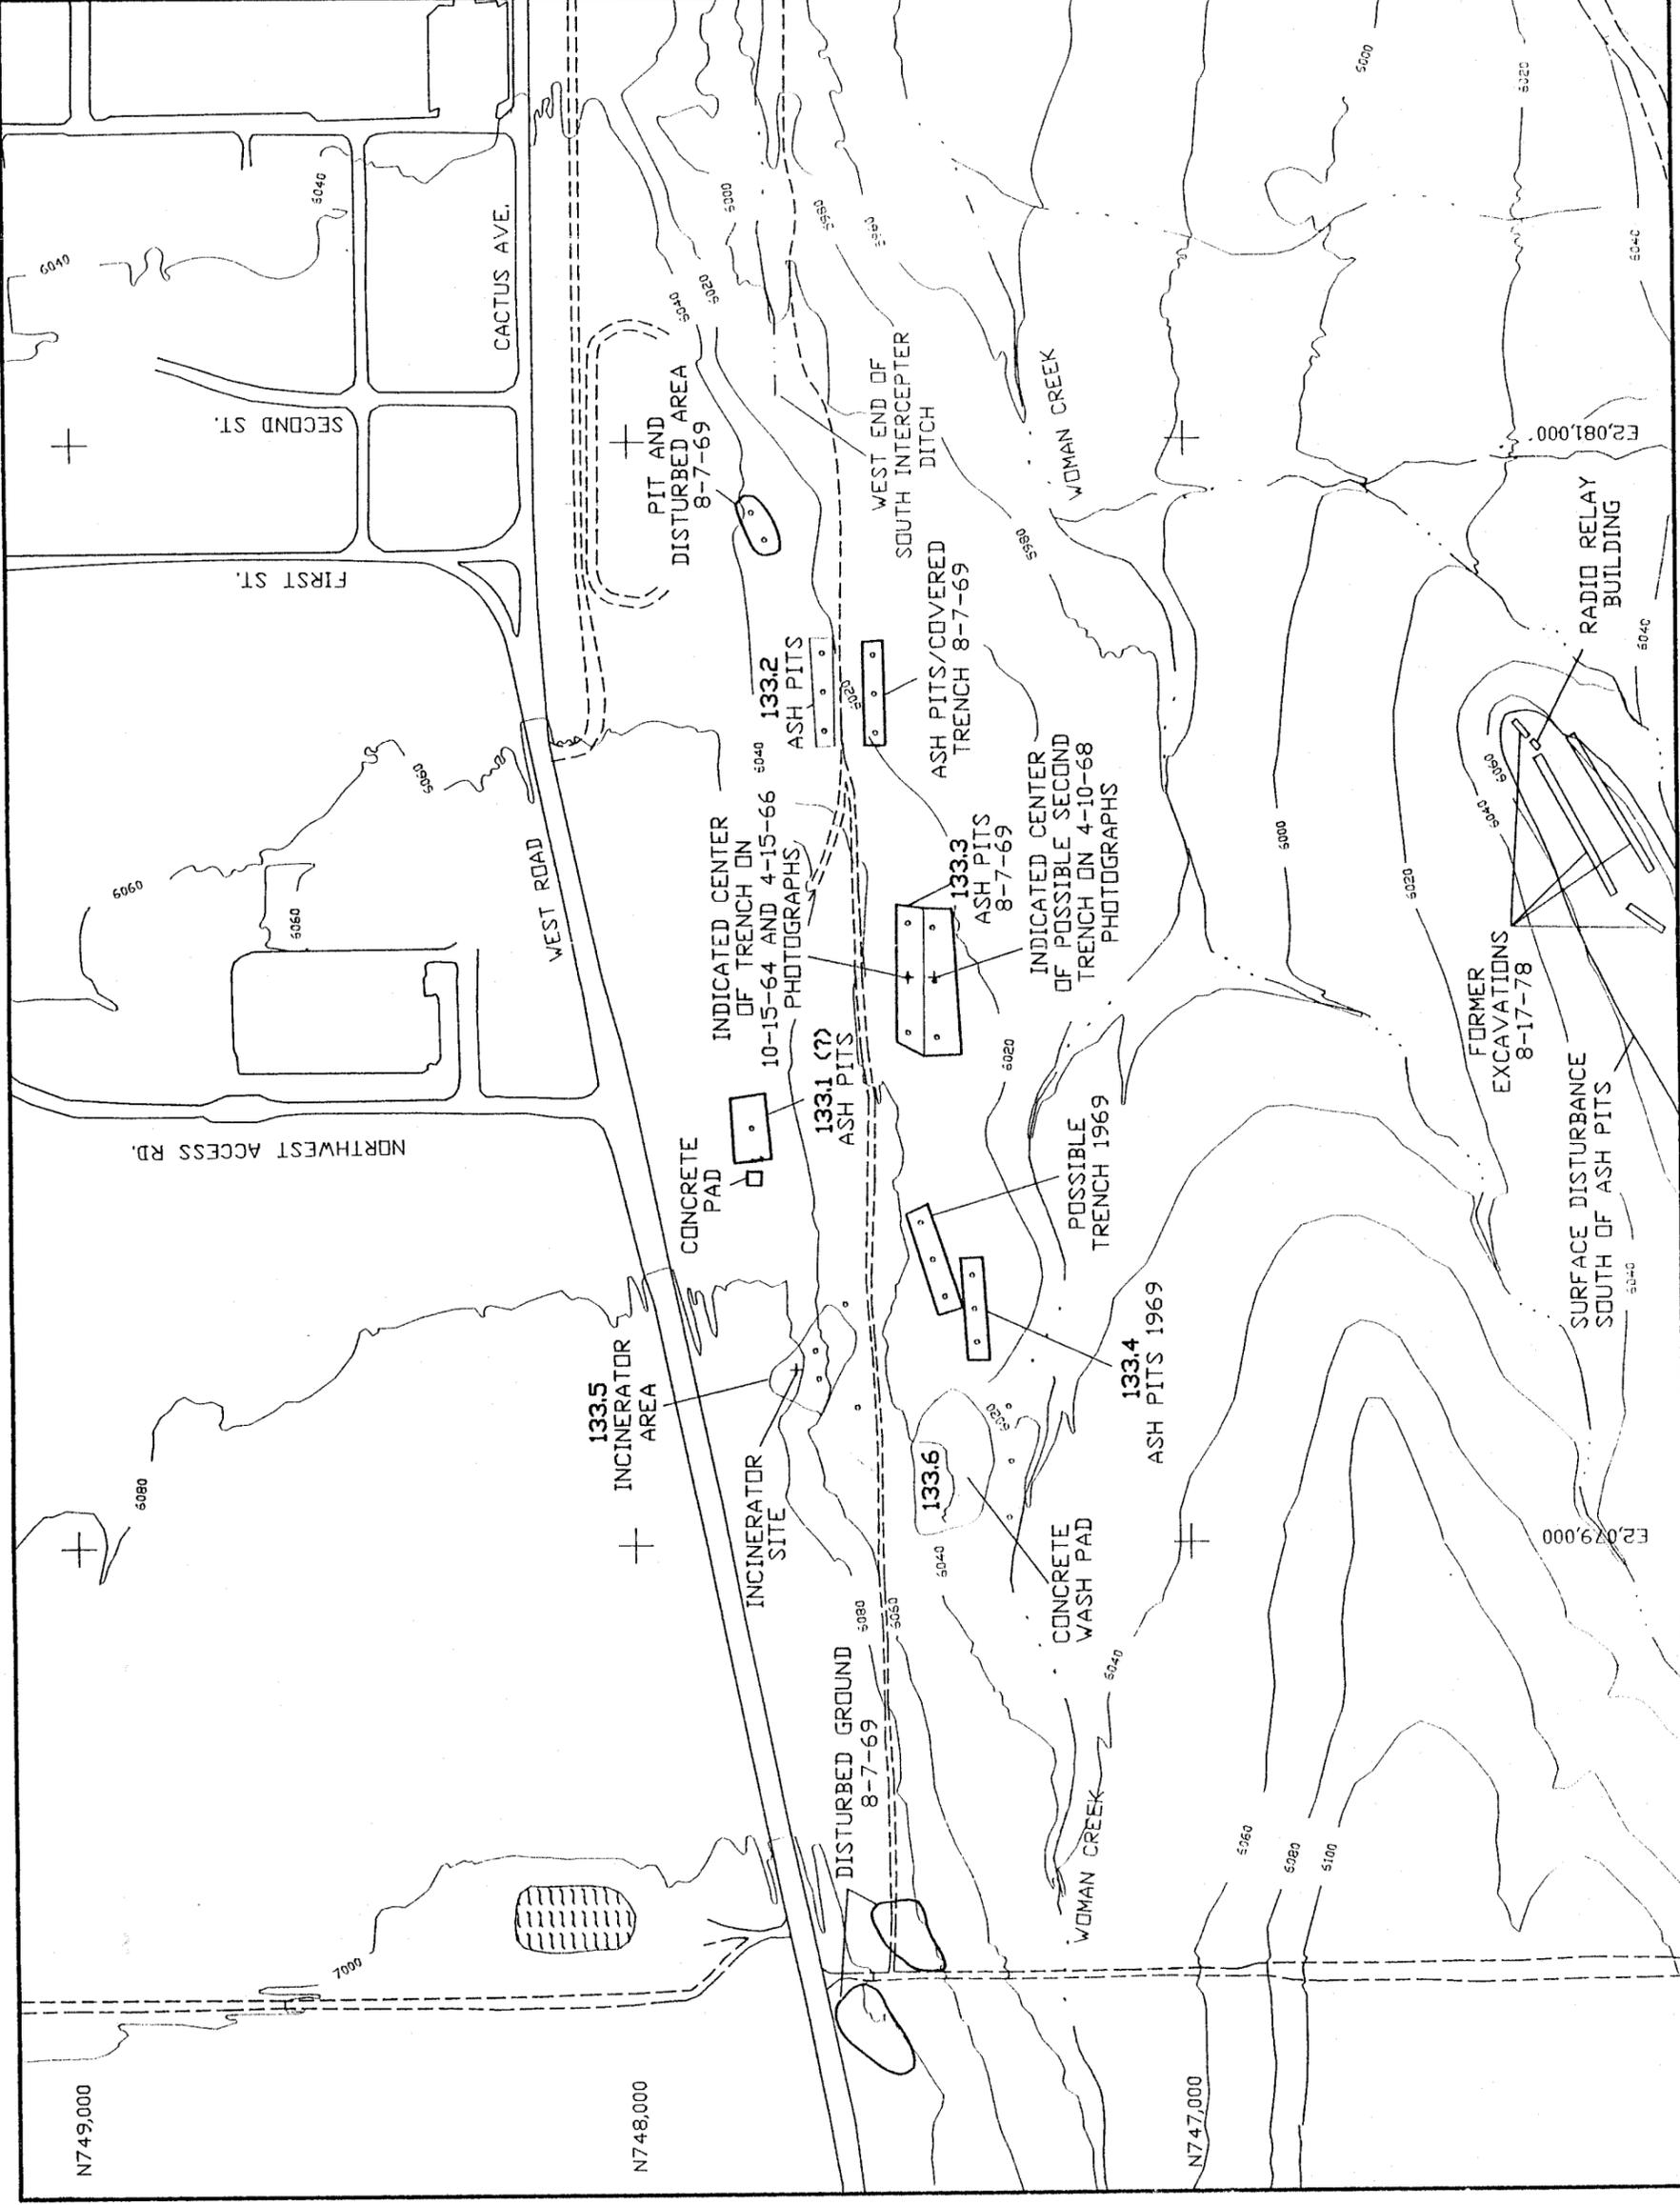
Figure 8 shows the proposed soil boring locations. The drilling and soil sampling techniques that will be implemented during this drilling program are described in detail in the following sections.
