**DRAFT ENVIRONMENTAL RESTORATION  
RFCA STANDARD OPERATING PROTOCOL  
FOR ROUTINE SOIL REMEDIATION  
FY03 NOTIFICATION #03-09  
IHSS 133.5 - INCINERATOR**

**June 2003**

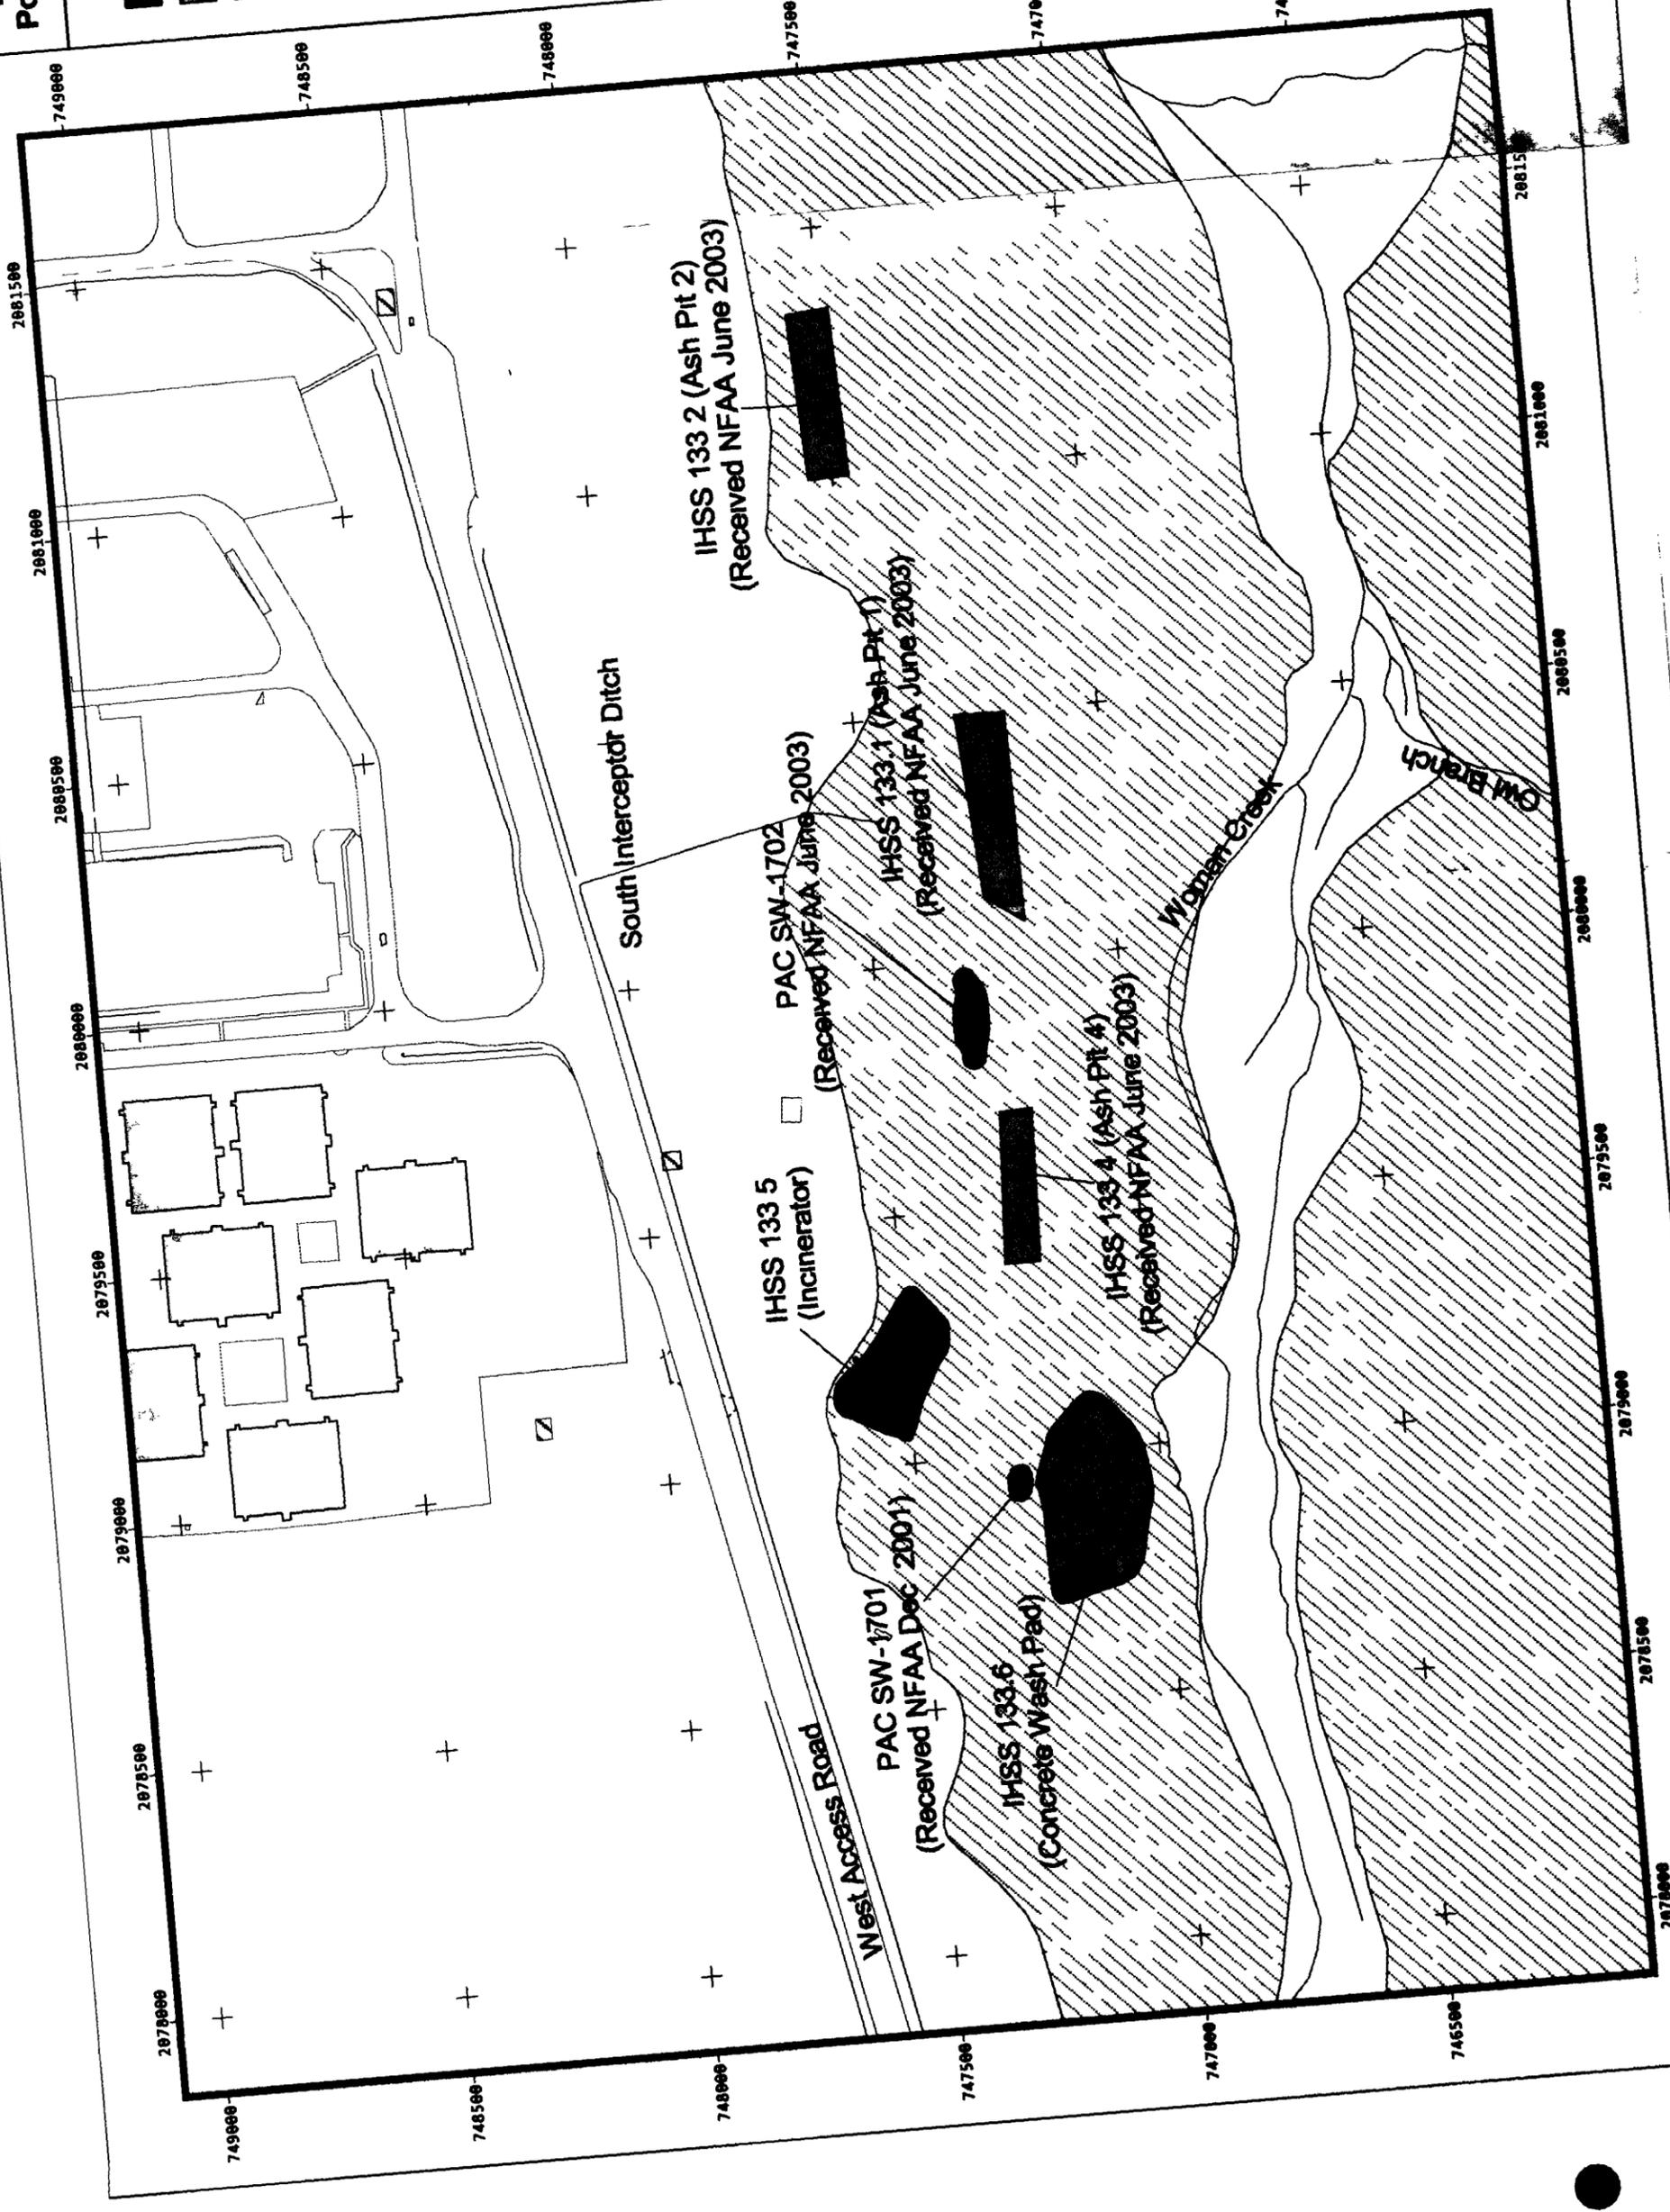
**Figure 2**  
**IHSS 133 5 - Incinerator**  
**Potential Remediation Area**

It is anticipated that after remediation there may be areas with concentrations of radionuclides, metals, VOCs and dioxins/furans greater than background or method detection limit, but less than RFCA ALs. The potential remediation area is shown on Figure 2.

Based on the PCOCs (Table 1 and Section 2 1) and the ER RSOP (DOE 2002a), it is anticipated that contamination above the RFCA WRW ALs or as indicated through the SSRS will be remediated. Figure 2 shows the potential remediation area. Additional remediation to below RFCA WRW ALs or as indicated through the SSRS is not required by RFCA, but will be evaluated using the consultative process during project execution.

IHSS 133 5 is located in the RFETS Southwest BZ. The nearest IHSS or PAC is IHSS 133 4, Ash Pit 4 located approximately 200 feet to the southeast and PAC SW-1701, Recently Identified Ash Pit located approximately 200 feet to the southwest. IHSSs 133 1, 133 2 and 133 4 and PACs SW-1701 and SW-1702 received NFAA and are located downgradient, and as such, these sites do not have the potential to adversely impact IHSS 133 5. See Figure 2 for the locations of these IHSSs and PAC.

High-volume air samplers may be used at the remediation area consistent with work controls to determine airborne radioactivity concentrations. Potential air sampling locations are shown on Figure 2.
