Second Five-Year Review Report for the Rocky Flats Site Jefferson and Boulder Counties, Colorado

Five-Year Review Report

**Prepared by
U.S. Department of Energy
Office of Legacy Management
Grand Junction, Colorado**

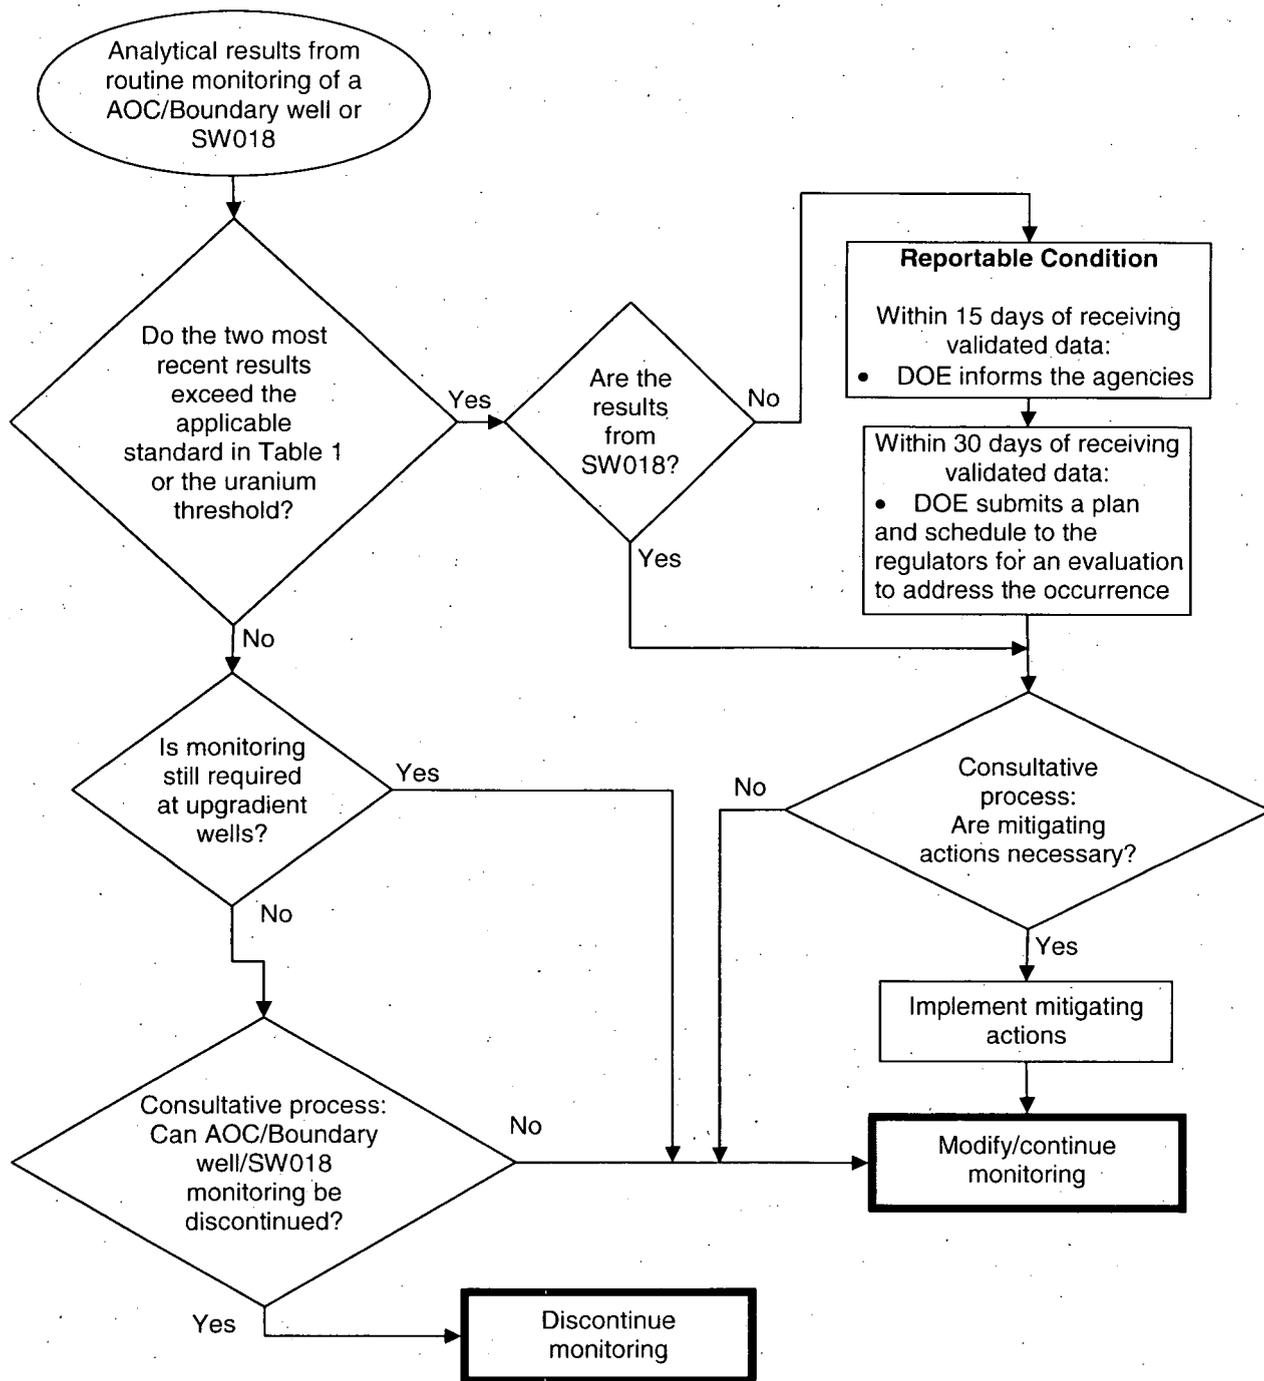
Figure 7. Area of Concern Wells, Boundary Wells, and SW018

- AOC wells and location SW018 are sampled twice each year; see Table 2.
- Boundary wells are sampled once each year; see Table 2. These wells are not part of the remedy, but are a component of operational monitoring.
- Decisions related to uranium in ground water are based upon a 16 ug/L threshold for Boundary wells (basis: the 11 pCi/L standard) and a 120 ug/L threshold for AOC wells (basis: a grand mean of results from Site-wide high-resolution uranium analyses performed in the late 1990s through mid-2000s), rather than the standard in Table 1.

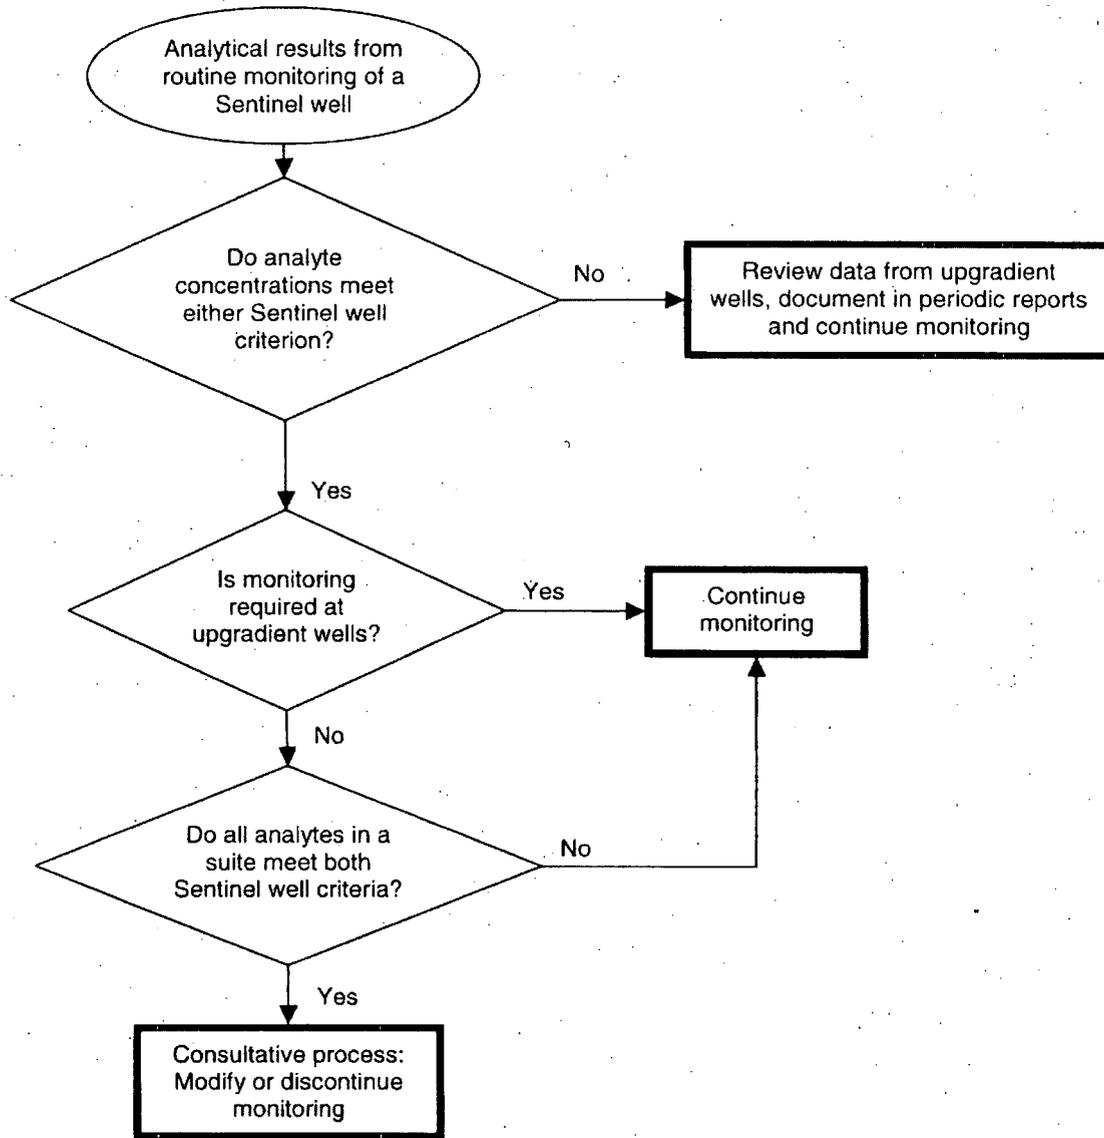
Figure 8. Sentinel Wells

- Sentinel wells are sampled twice each year; see Table 2.
- Decisions related to uranium are based upon a 120 ug/L threshold for AOC wells (basis: a grand mean of results from Site-wide high-resolution uranium analyses performed in the late 1990s through mid-2000s), rather than the standard in Table 1.

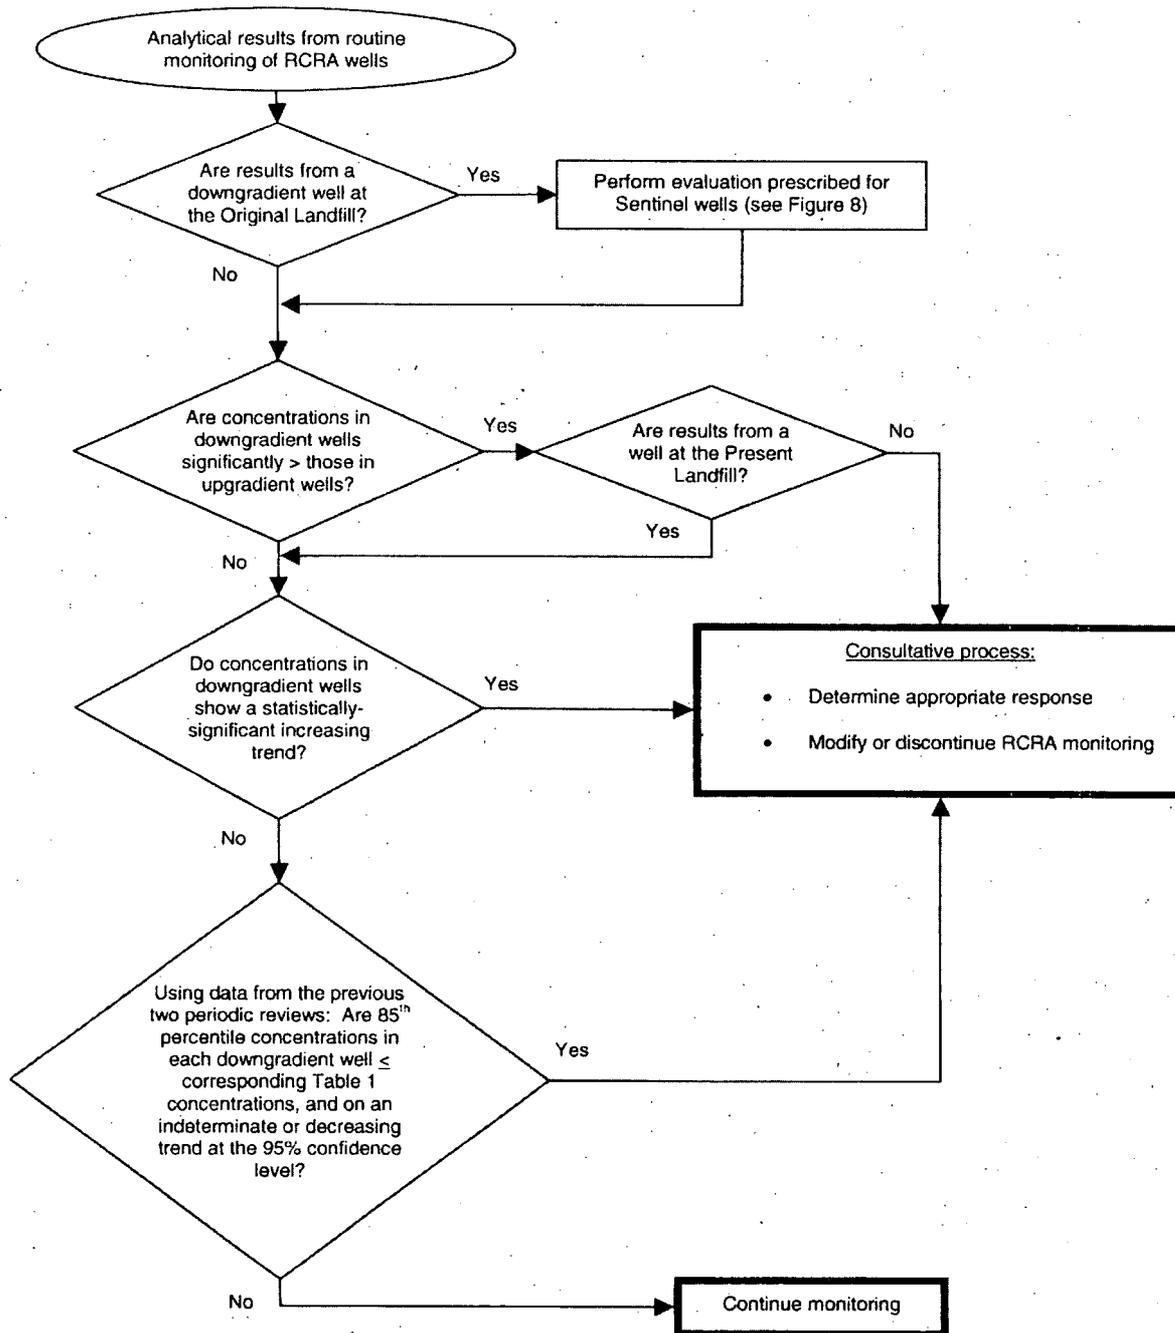
Figure 10. RCRA Wells

Notes: see Fig. 1 and Tables 1 and 2 for locations, standards, and sampling criteria. RCRA wells are sampled quarterly; see Table 2.

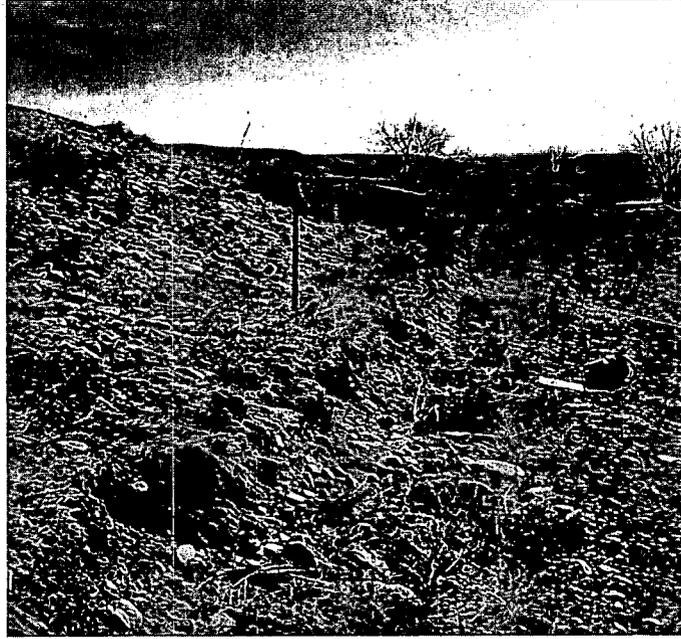
Photograph B1. Erosion on north side of former gravel road, above Woman Creek, west of Original Landfill, looking east. Typical of minor erosion along edge of former gravel road in this area.

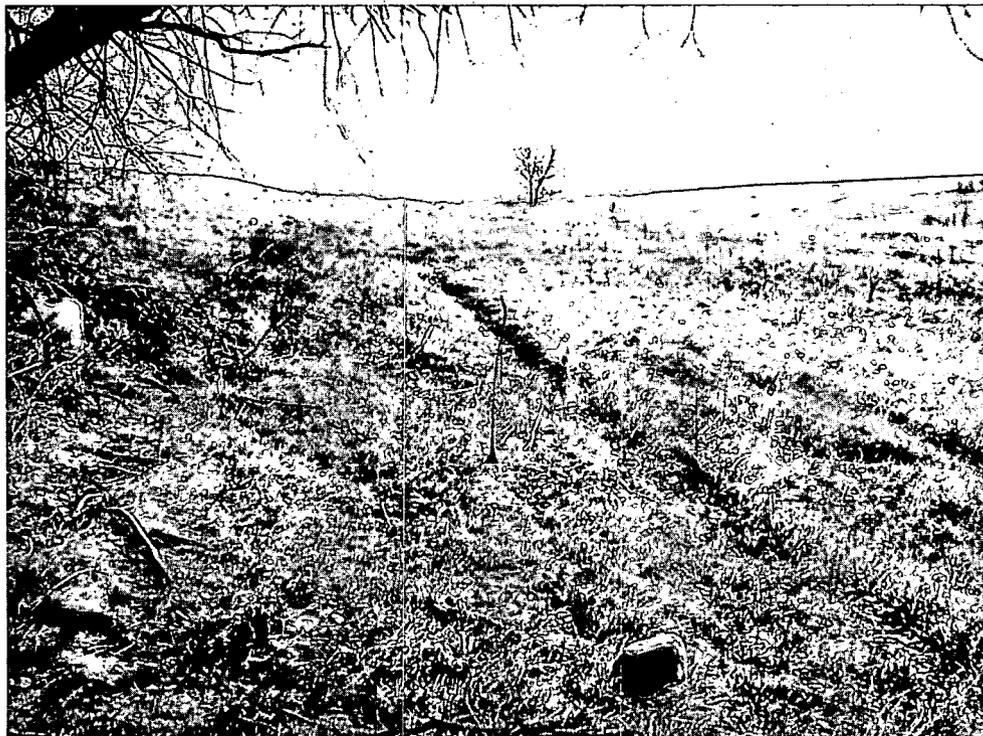
Photograph B4. Deep tire depressions along an approximately 100-foot stretch of former road, with some deposition.

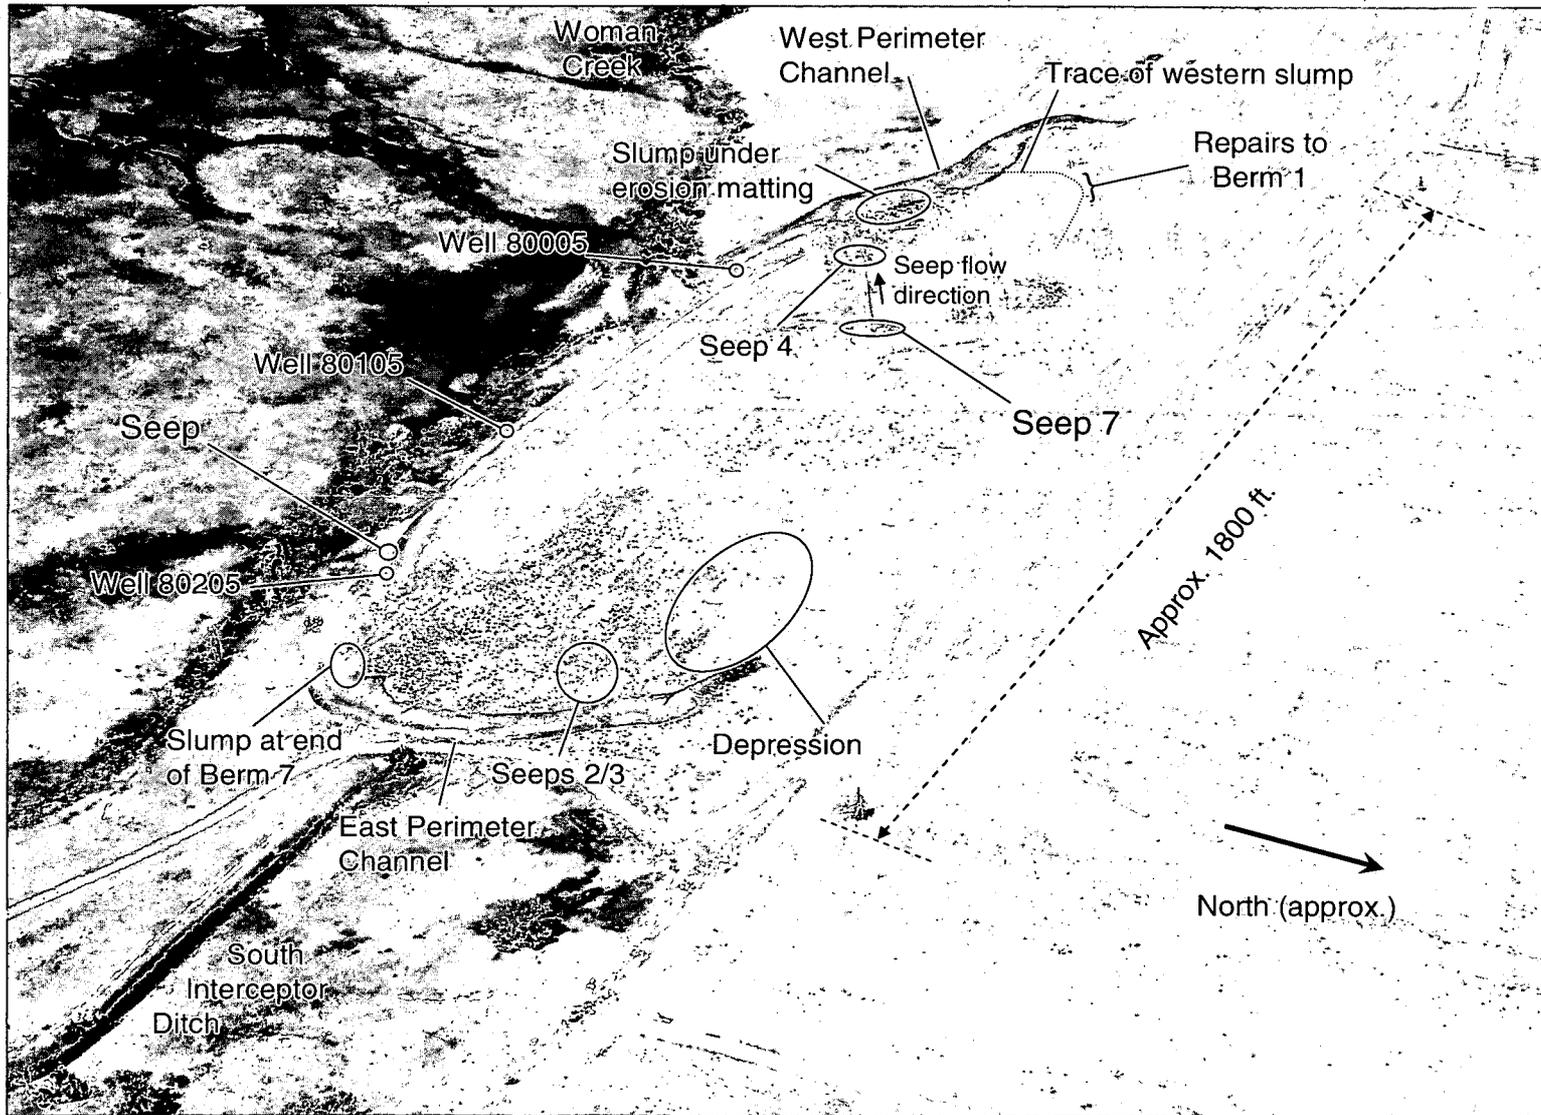
Issue: Routine inspections have identified historical seeps and small areas of slumps and slides on the OLF cover that need to be addressed and repaired as necessary to continue to meet cover design criteria.

Figure C1. Aerial photo taken June 2007 of Original Landfill. Approximate locations of main slumps and seeps are noted.

Recommendation: Continue to inspect the OLF cover in accordance with RFLMA requirements. Cover repairs should be made in accordance with the OLF Monitoring and Maintenance (M&M) Plan so that design criteria continue to be met. An engineering evaluation to identify possible causes as well as approaches to address the causes should be completed.
