Rocky Flats Site, Colorado

**Quarterly Report of Site Surveillance
and Maintenance Activities
Second Quarter Calendar Year 2011**

**Rocky Flats Site, Colorado
Quarterly Report of Site Surveillance and Maintenance Activities**

Second Quarter Calendar Year 2011

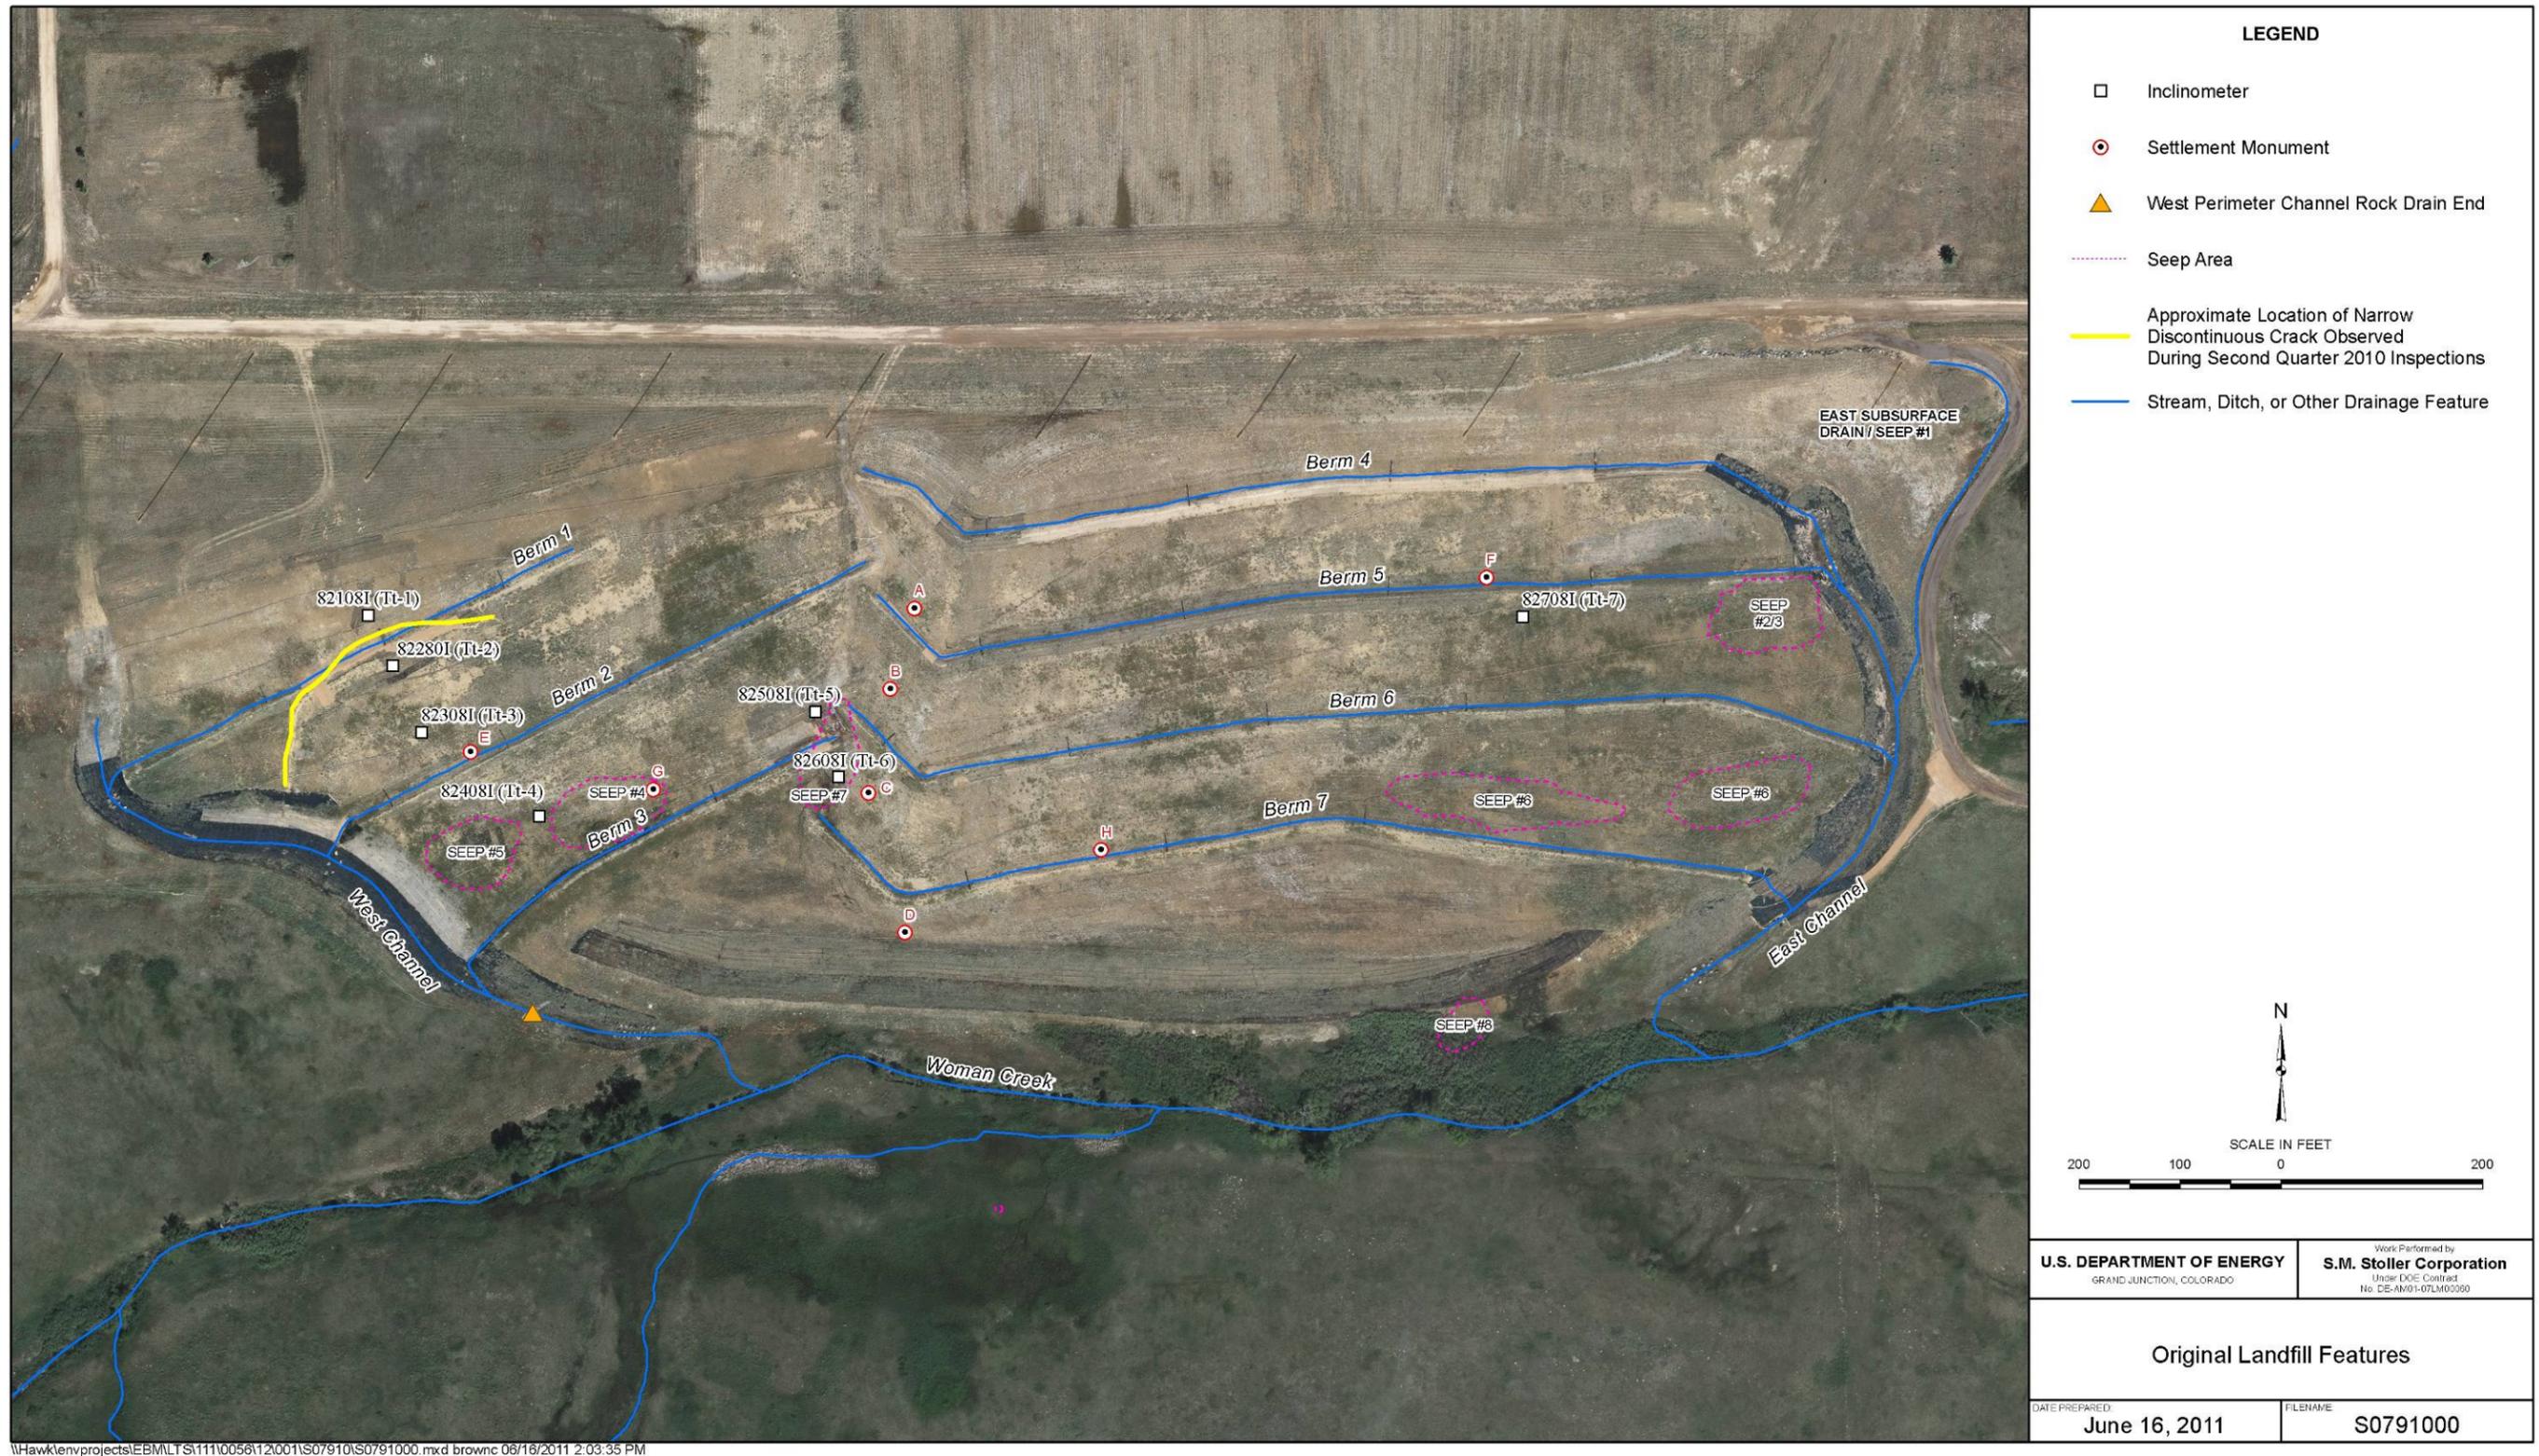
Figure 1. Original Landfill Observed Surface Cracking Location and Inclinometer Locations

As discussed in the quarterly report for the first quarter of CY 2010 (DOE 2010c), areas where the landfill cover is pushed up or rolling are noticeable on the western end of the OLF between Berms 2 and 3; however, no new slumps were observed during the second quarter of 2011.

No new cracking was observed in the Berm 1 area during the second quarter of CY 2011. Staff continued to perform routine and nonroutine inspections of the Berm 1 area to monitor this location for any changes.

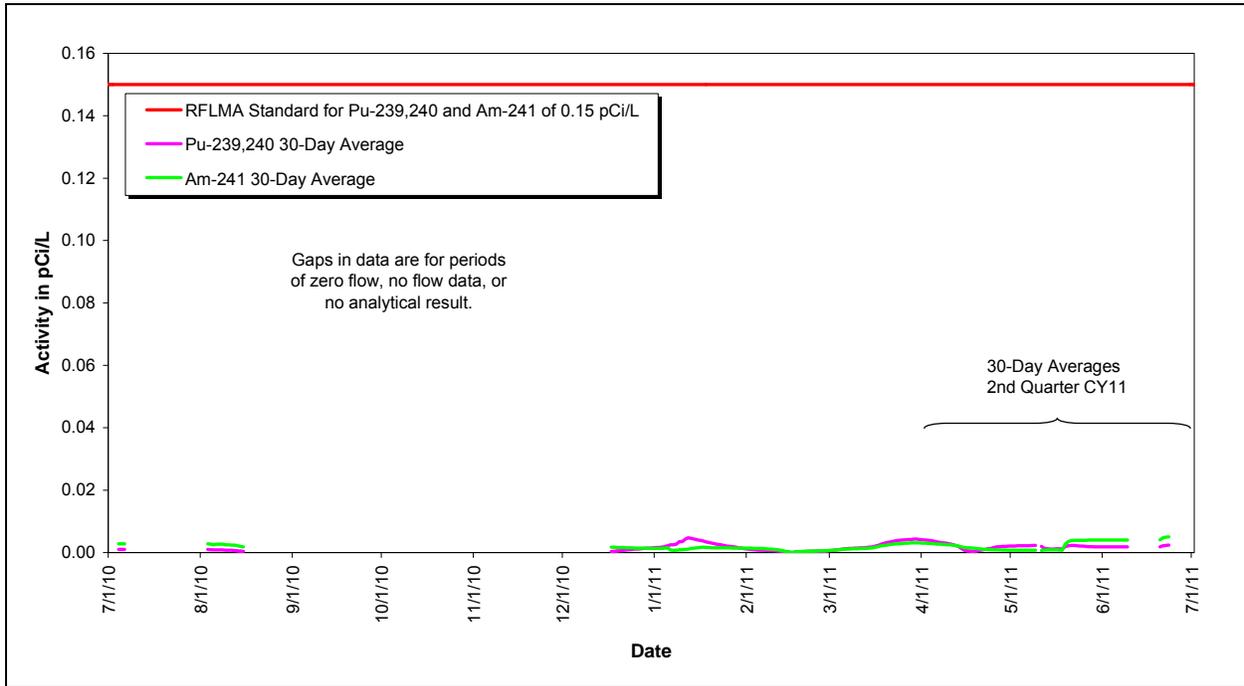
Figure 2. Volume-Weighted 30-Day Average Plutonium and Americium Activities at GS01: Calendar Year Ending Second Quarter CY 2011

Monitoring location GS01 is on Woman Creek at Indiana Street. Figure 2 and Figure 4 show no occurrences of reportable 30-day averages for the quarter. Figure 3 and Figure 5 show sampling data from 2005 through the second quarter of CY 2011.

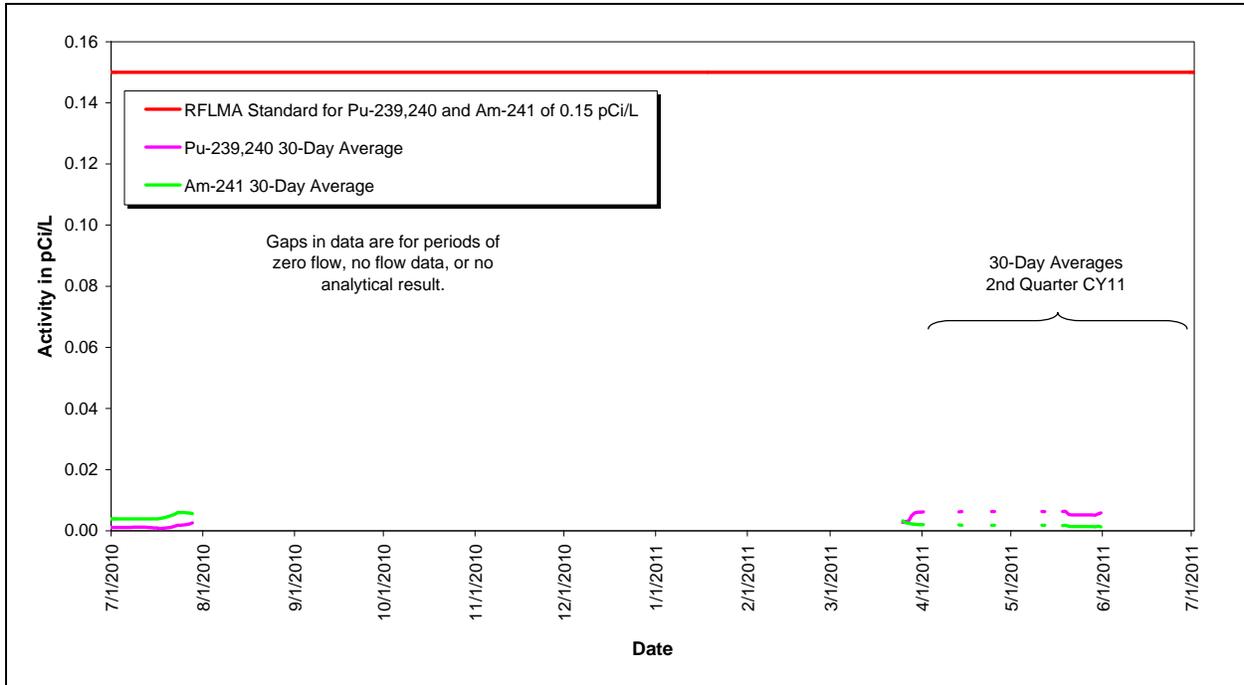
Figure 6. Volume-Weighted 30-Day Average Plutonium and Americium Activities at GS03: Calendar Year Ending Second Quarter CY 2011

Monitoring location GS03 is on Walnut Creek at Indiana Street. Figure 6, Figure 8, and Figure 10 show no occurrences of reportable water quality for the quarter. Figure 7, Figure 9, and Figure 11 show sampling data from 2005 through the second quarter of CY 2011.

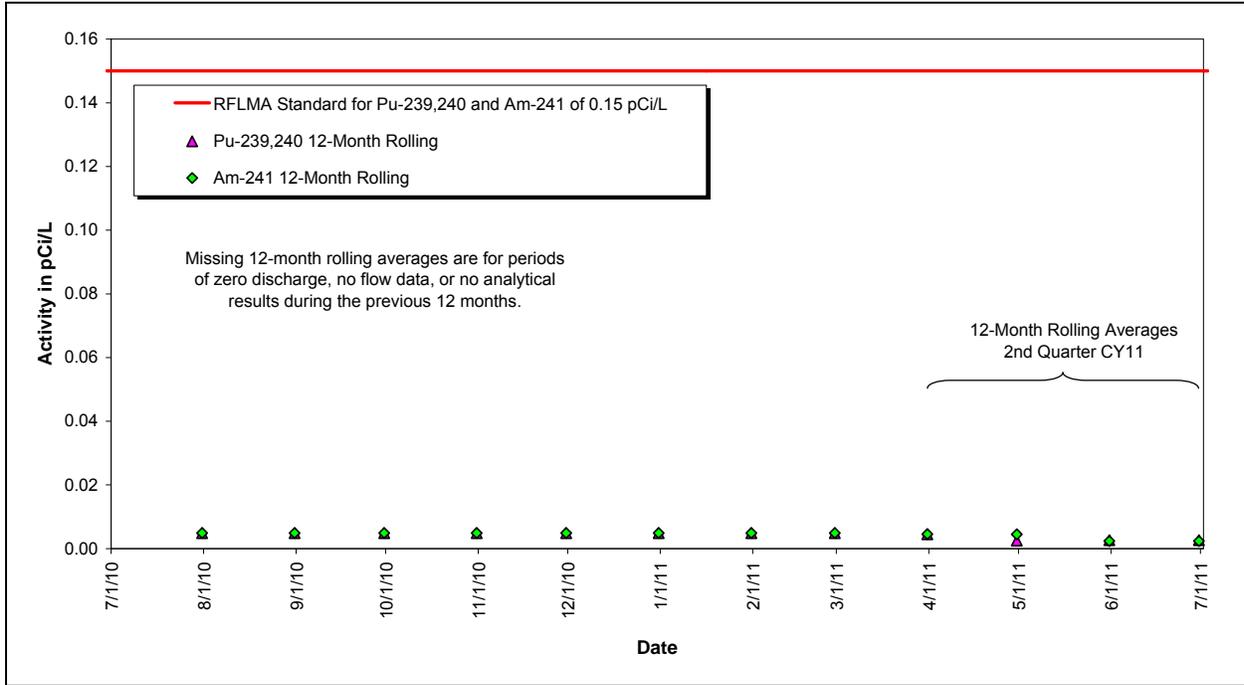
Figure 12. Volume-Weighted 12-Month Rolling Average Plutonium and Americium Activities at GS08: Calendar Year Ending Second Quarter CY 2011

Monitoring location GS08 is on South Walnut Creek at the outlet of Pond B-5. Figure 12, Figure 14, and Figure 16 show no occurrences of reportable 12-month rolling averages for the quarter. Figure 13, Figure 15, and Figure 17 show sampling data from 2005 through the second quarter of CY 2011.

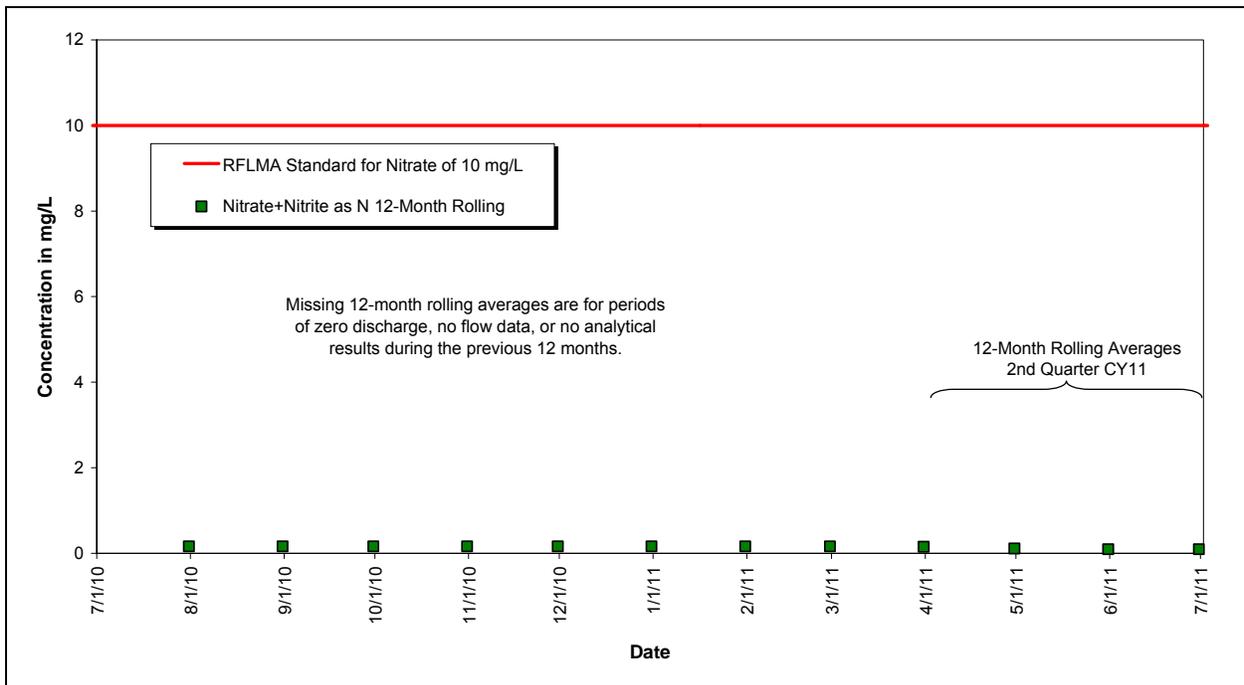
Figure 16. Volume-Weighted 12-Month Rolling Average Nitrate + Nitrite as Nitrogen Concentrations at GS08: Calendar Year Ending Second Quarter CY 2011

Note: Nitrate + nitrite as nitrogen 12-month averages are conservatively compared to the nitrate standard only.
mg/L = milligrams per liter

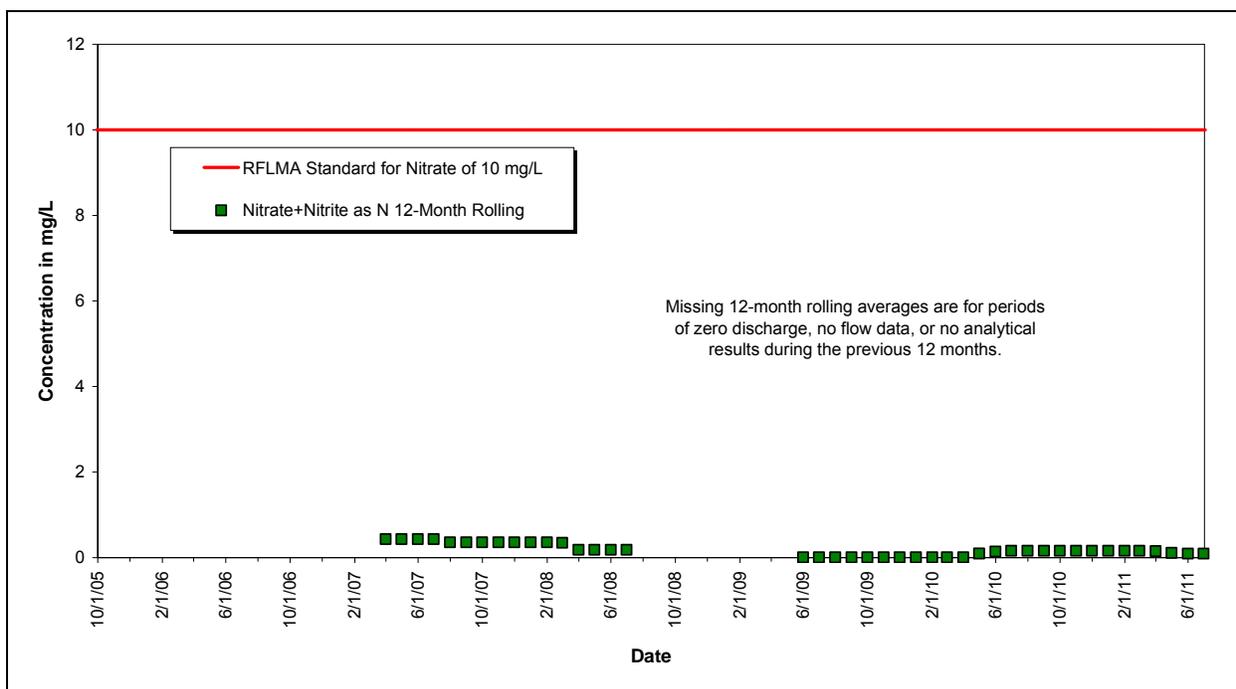
Figure 17. Volume-Weighted 12-Month Rolling Average Nitrate + Nitrite as Nitrogen Concentrations at GS08: Post-Closure Period Ending Second Quarter CY 2011

Note: Nitrate + nitrite as nitrogen 12-month averages are conservatively compared to the nitrate standard only.
 mg/L = milligrams per liter

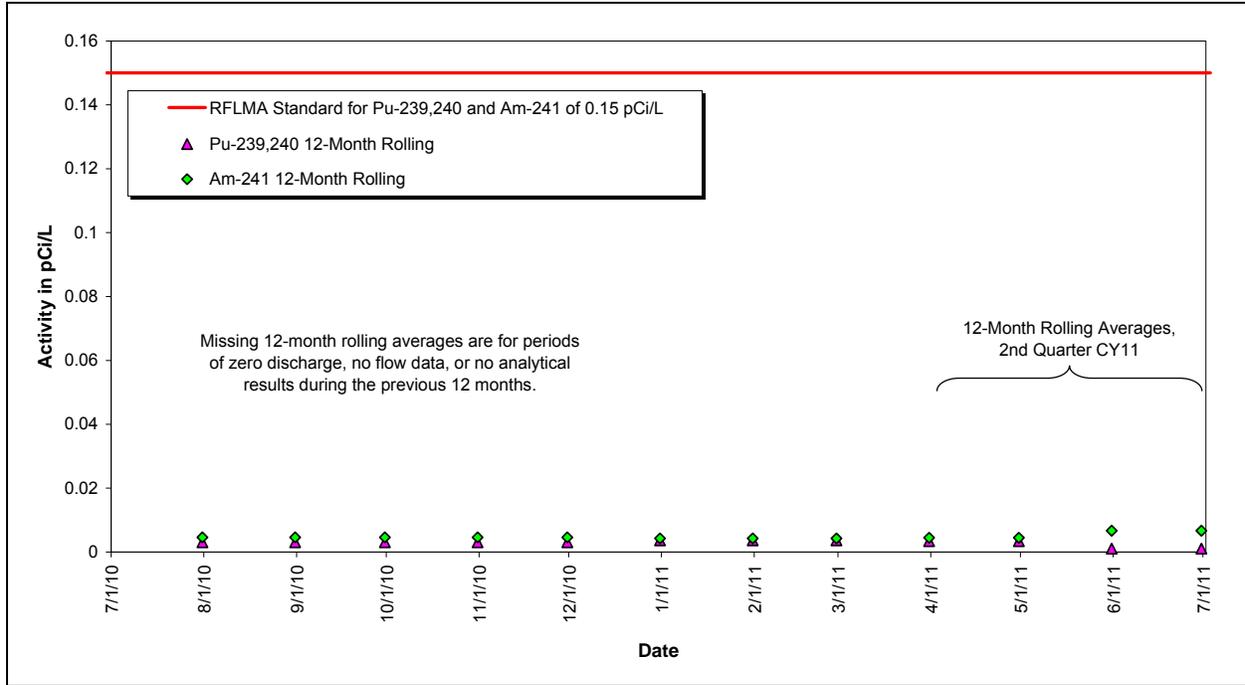
Figure 18. Volume-Weighted 12-Month Rolling Average Plutonium and Americium Activities at GS11: Calendar Year Ending Second Quarter CY 2011

Monitoring location GS11 is on North Walnut Creek at the outlet of Pond A-4. Figure 18, Figure 20, and Figure 22 show no occurrences of reportable 12-month rolling averages for the quarter. Figure 19, Figure 21, and Figure 23 show sampling data from 2005 through the second quarter of CY 2011.

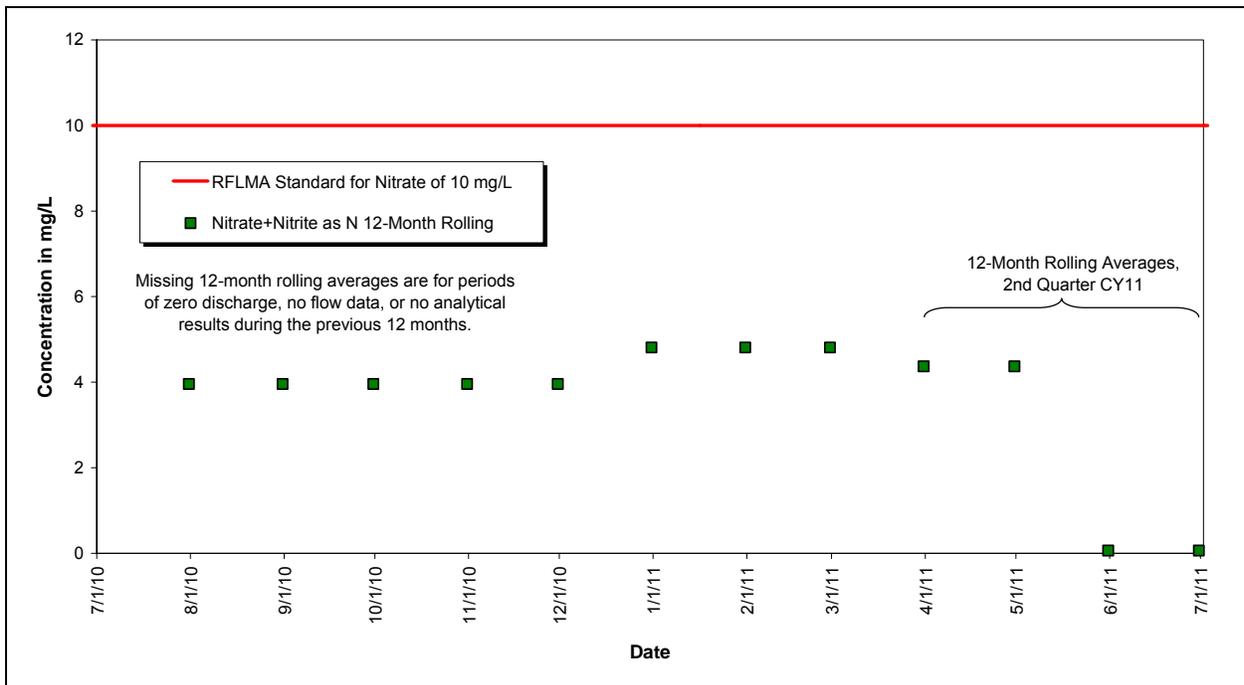
Figure 22. Volume-Weighted 12-Month Rolling Average Nitrate + Nitrite as Nitrogen Concentrations at GS11: Calendar Year Ending Second Quarter CY 2011

Note: Nitrate + nitrite as nitrogen 12-month averages are conservatively compared to the nitrate standard only.
mg/L = milligrams per liter

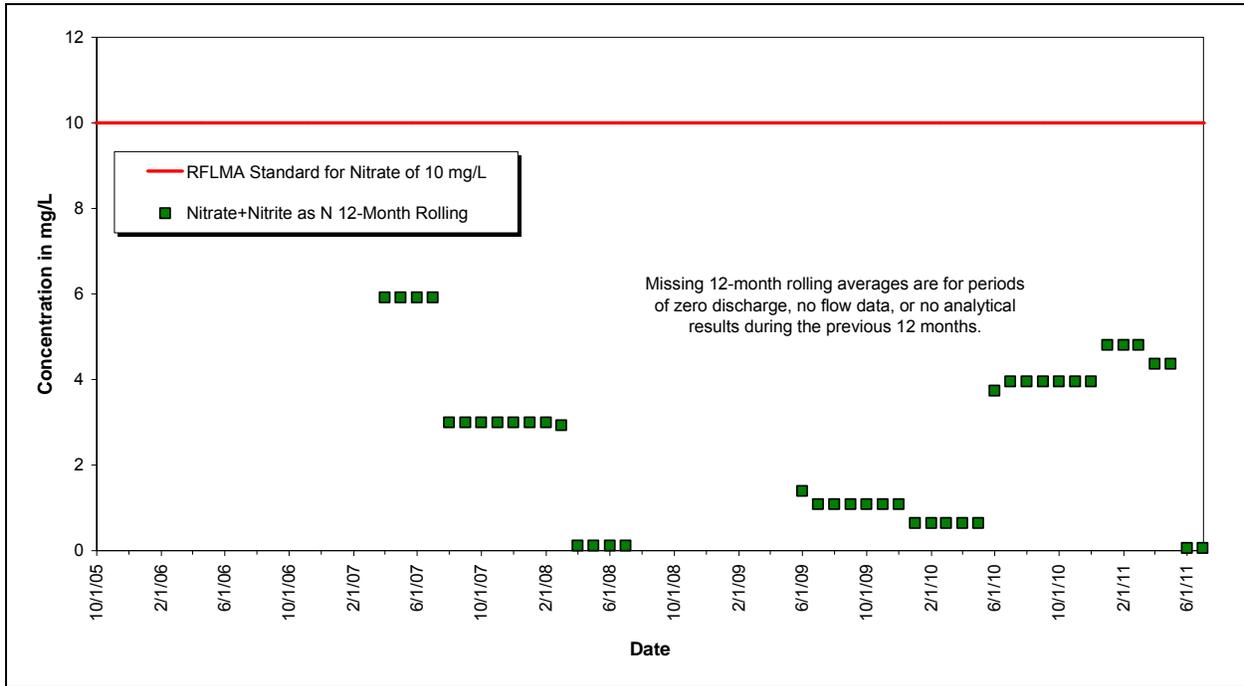
Figure 23. Volume-Weighted 12-Month Rolling Average Nitrate + Nitrite as Nitrogen Concentrations at GS11: Post-Closure Period Ending Second Quarter CY 2011

Note: Nitrate + nitrite as nitrogen 12-month averages are conservatively compared to the nitrate standard only. mg/L = milligrams per liter

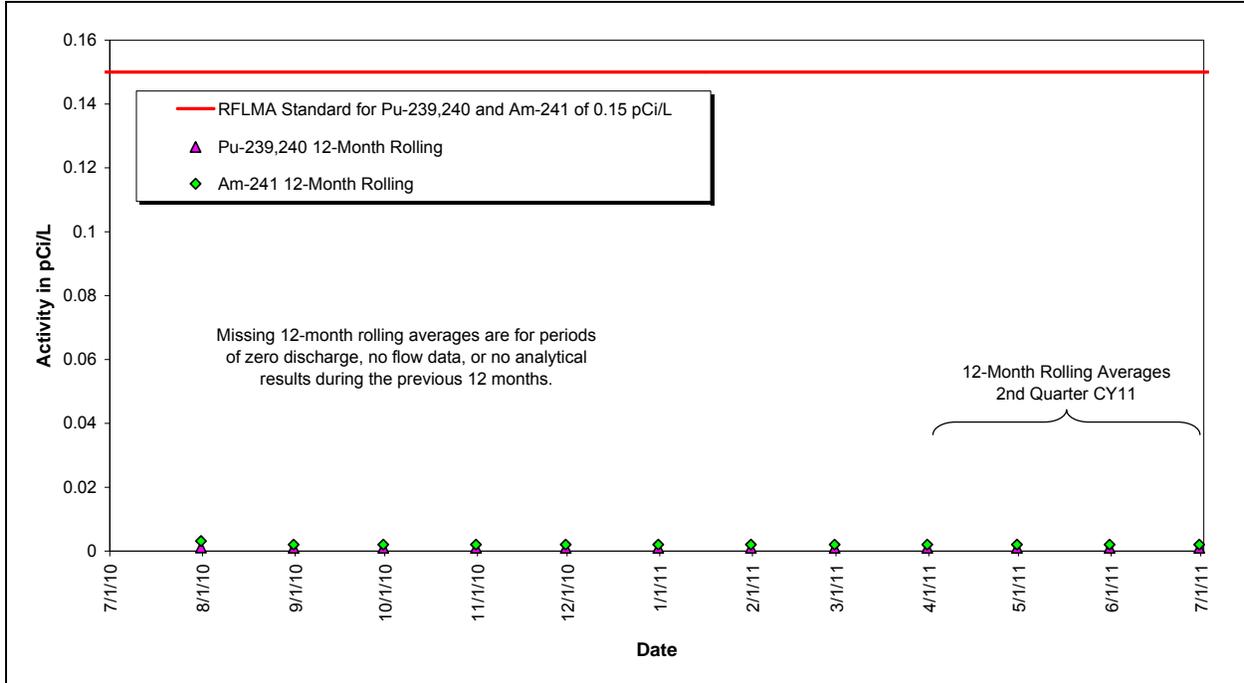
Figure 24. Volume-Weighted 12-Month Rolling Average Plutonium and Americium Activities at GS31: Calendar Year Ending Second Quarter CY 2011

Monitoring location GS31 is on Woman Creek at the outlet of Pond C-2. Figure 24 and Figure 26 show no occurrences of reportable 12-month rolling averages for the quarter. Figure 25 and Figure 27 show sampling data from 2005 through the second quarter of CY 2011.

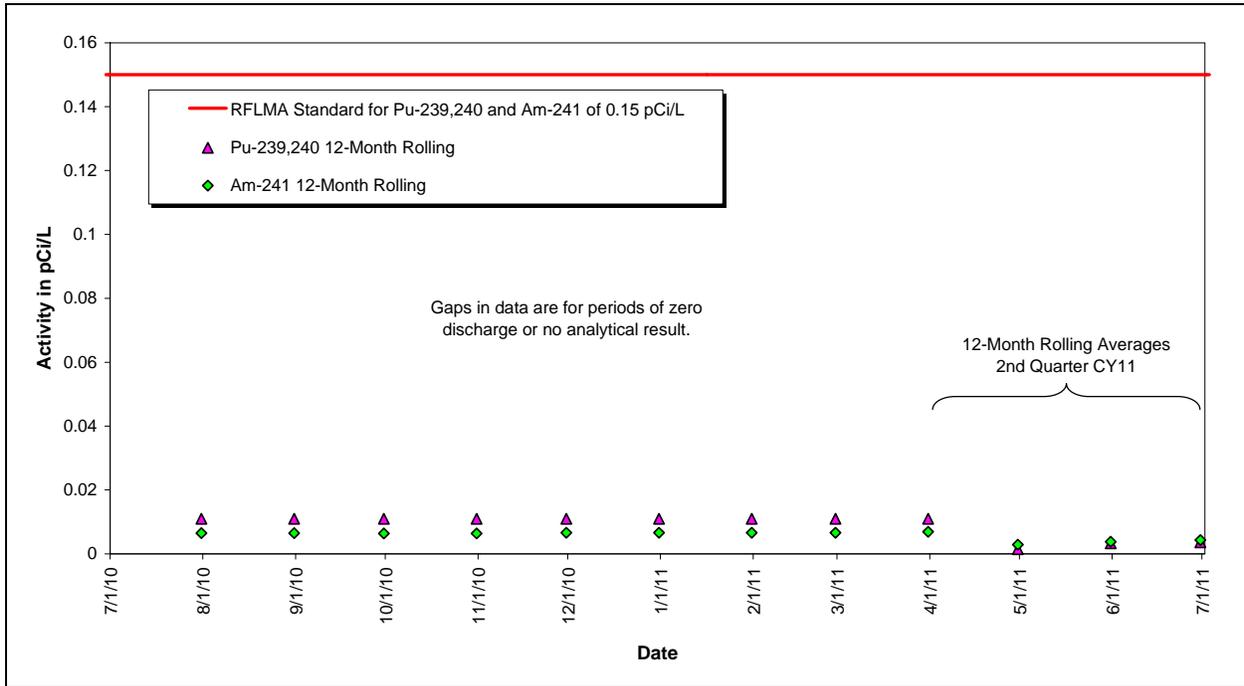
Figure 28. Volume-Weighted 12-Month Rolling Average Plutonium and Americium Activities at GS10: Calendar Year Ending Second Quarter CY 2011

Monitoring location GS10 is on South Walnut Creek just upstream of the B-Series ponds. Figure 28 and Figure 30 show the 12-month rolling averages for plutonium, americium, and total uranium values during the quarter. Figure 29 and Figure 31 show sampling data from 2005 through the second quarter of CY 2011.

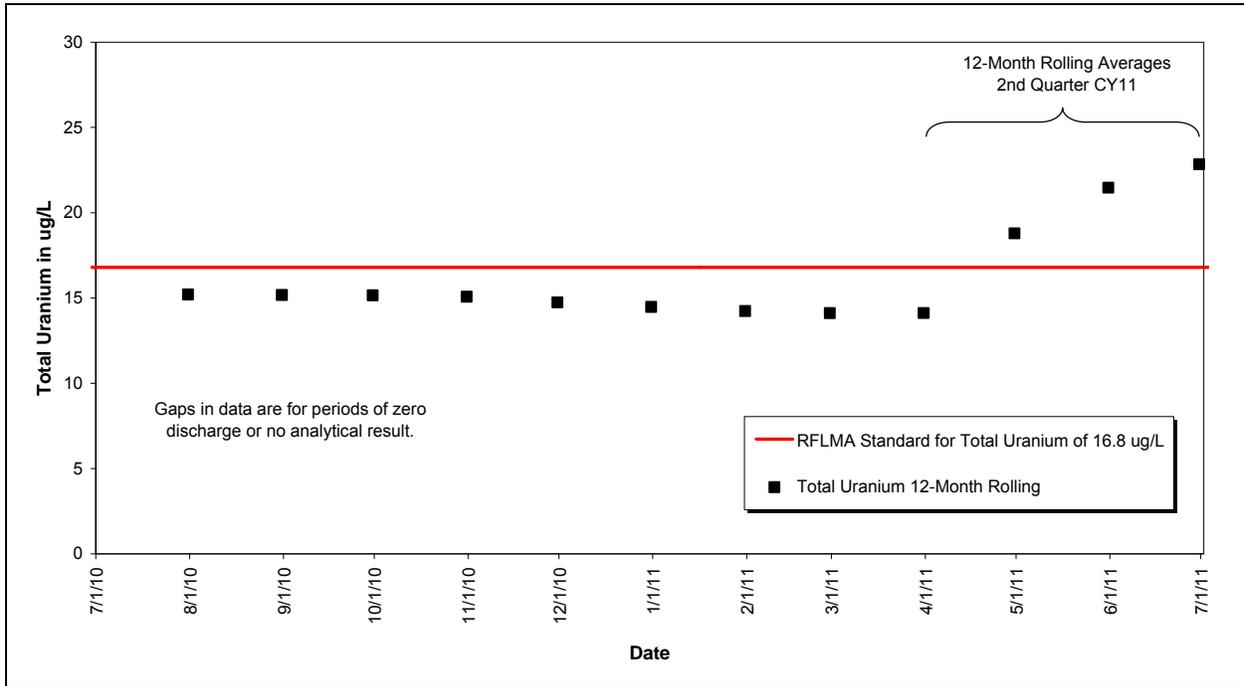
Figure 30. Volume-Weighted 12-Month Rolling Average Total Uranium Concentrations at GS10: Calendar Year Ending Second Quarter CY 2011

Figure 30 shows that the 12-month rolling average for uranium exceeds the RFLMA standard of 16.8 micrograms per liter (µg/L). The composite sampling results for uranium at GS10 collected during CY 2011 are given in Table 1. All other analytes were not reportable during the second quarter of CY 2011.

The GS10 evaluation was performed in accordance with RFLMA Attachment 2, Figure 6, “Points of Evaluation,” which resulted in a calculated 12-month rolling average concentration for uranium on April 30, 2011, of 18.8 µg/L. This amount exceeds the RFLMA applicable Table 1 standard of 16.8 µg/L. Validated results were received on June 14, 2011, and notification to the regulatory agencies and the public, in accordance with RFLMA Attachment 2, Figure 6, was made by e-mail on June 16, 2011. RFLMA Contact Record 2011-04, “Reportable Condition for Uranium at Point of Evaluation GS10,” provides a discussion of the monitoring results and recaps the outcome of the RFLMA Parties consultation regarding the evaluation steps to be taken. Contact Record 2011-04 is available on the Rocky Flats website, http://www.lm.doe.gov/Rocky_Flats/ContactRecords.aspx.

- The uranium concentrations are expected to vary due to the natural variability in environmental conditions such as the amounts of precipitation over time. Elevated uranium concentrations at GS10 above the then-effective 10 pCi/L RFLMA standard previously occurred for the period from April 30, 2006, to March 31, 2009, with the 12-month rolling averages in the range of 10.2 to 15.8 pCi/L. The RFLMA uranium standard was subsequently revised from an activity-based radionuclide parameter of 10 pCi/L to a concentration based metal parameter of 16.8 µg/L, which equates to approximately 11.3 pCi/L. Thus, the ranges in activity summarized above for 2006 to 2009 equate to approximately 15.2 to 23.5 µg/L. Levels returned to below the RFLMA standard after March 31, 2009, when precipitation increased.

The RFLMA Parties agreed that no mitigating actions are necessary while the condition is being evaluated, for the following reasons:

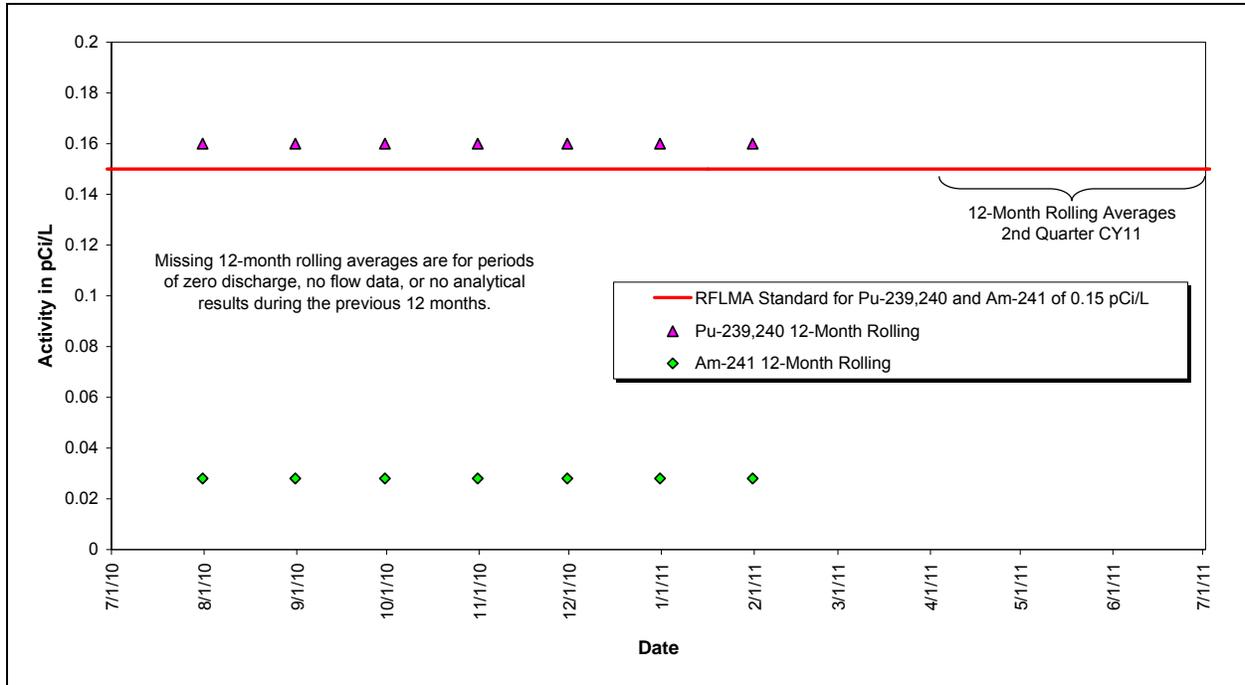
Figure 32. Volume-Weighted 12-Month Rolling Average Plutonium and Americium Activities at SW027: Calendar Year Ending Second Quarter CY 2011

Monitoring location SW027 is at the end of the South Interceptor Ditch (SID) at the inlet to Pond C-2. Figure 32 and Figure 34 show the 12-month rolling averages for plutonium, americium, and total uranium during the quarter. Figure 33 and Figure 35 show sampling data from 2005 through the second quarter of CY 2011.

Figure 32 shows that the 12-month rolling average for plutonium exceeds the RFLMA standard of 0.15 picocuries per liter (pCi/L). The composite sampling results for plutonium at SW027 collected during 2010 and 2011 are given in Table 2. All other analytes were not reportable during the second quarter of CY 2011.

Note: The composite sample started on February 17, 2011, was still in progress at the time of publication, so those results for this composite sample were not available for this report.
pCi/L = picocuries per liter

August 31, 2010. This report provides data evaluation and an update on the steps taken in accordance with Contact Record 2010-06. Recommendations beyond the actions already taken and discussed in the Contact Record are also provided. The August 31, 2010, report on the status of actions related to evaluation of the conditions is also available on the Rocky Flats website, http://www.lm.doe.gov/Rocky_Flats/ContactRecords.aspx.

The recommendations in the evaluation included installing additional erosion control wattles in locations along the hillside north of the SID, installing permanent erosion blankets, and reseeded three areas in the SID. This work was successfully completed on December 20, 2010. Approximately 2,560 linear feet of Filtrexx wattles and 8,452 square feet of permanent erosion matting were installed.

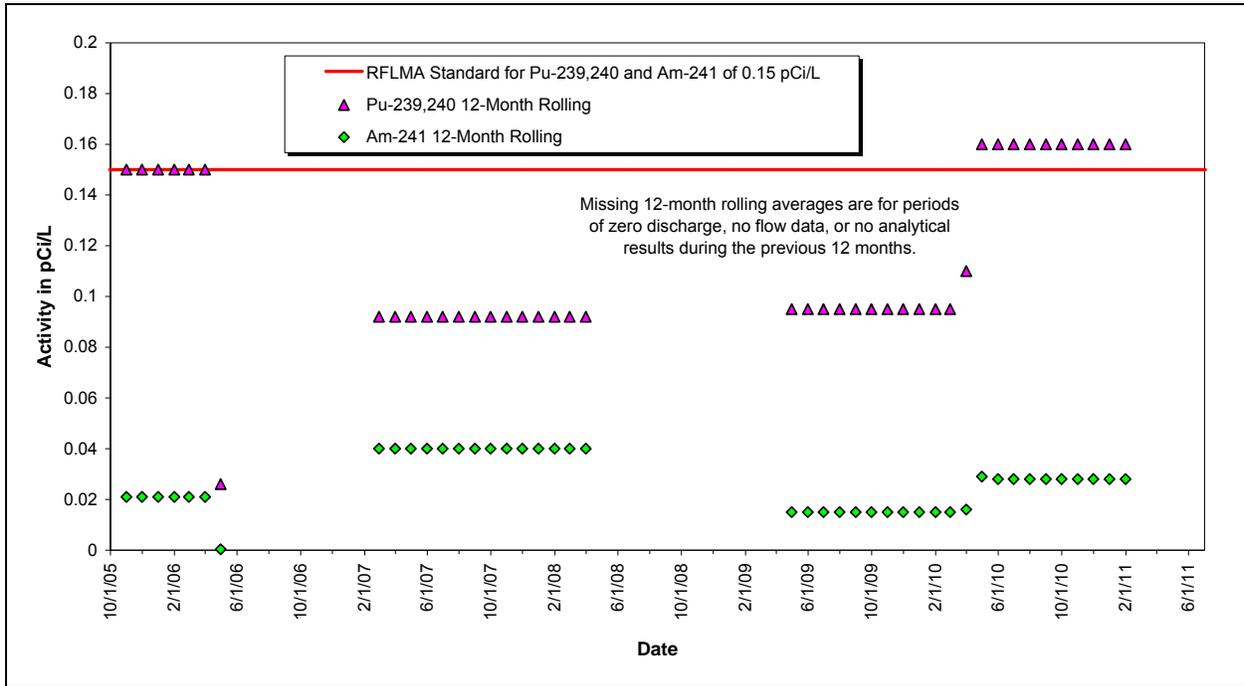
Figure 33. Volume-Weighted 12-Month Rolling Average Plutonium and Americium Activities at SW027: Post-Closure Period Ending Second Quarter CY 2011

Note: The composite sample started on February 17, 2011, was still in progress at the time of publication, so those results for this composite sample were not available for this report.
pCi/L = picocuries per liter

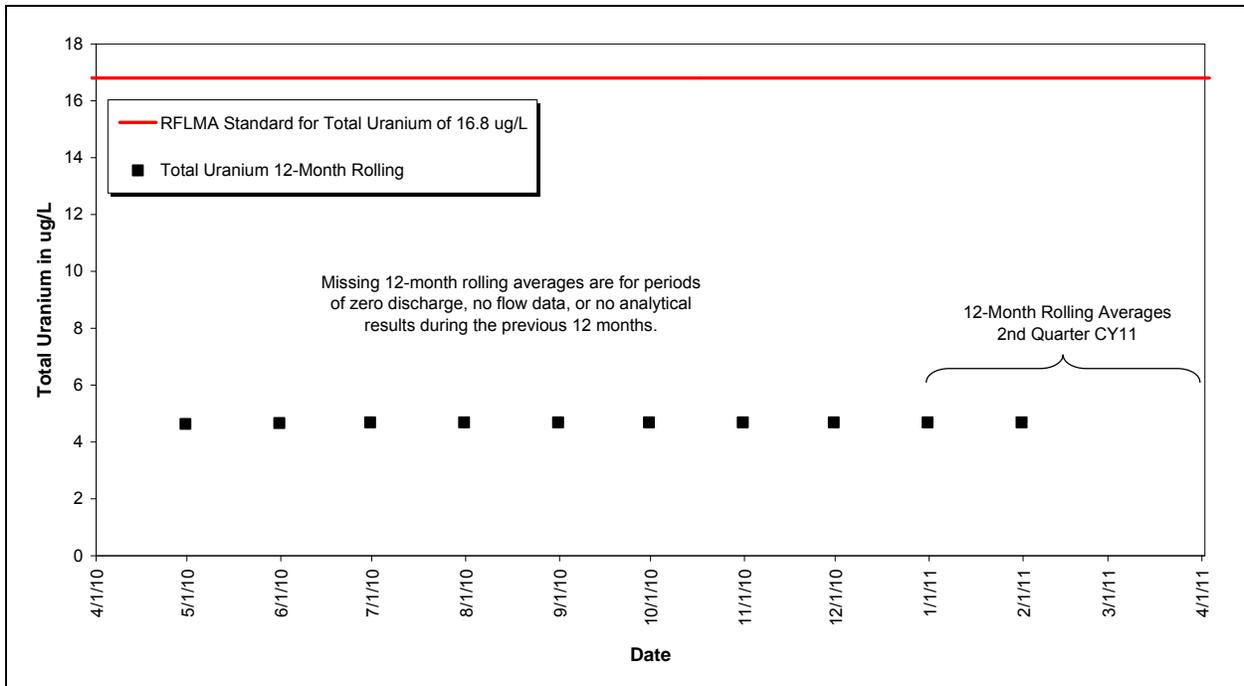
Figure 34. Volume-Weighted 12-Month Rolling Average Total Uranium Concentrations at SW027: Calendar Year Ending Second Quarter CY 2011

Note: The composite sample started on February 17, 2011, was still in progress at the time of publication, so those results for this composite sample were not available for this report.
µg/L = micrograms per liter

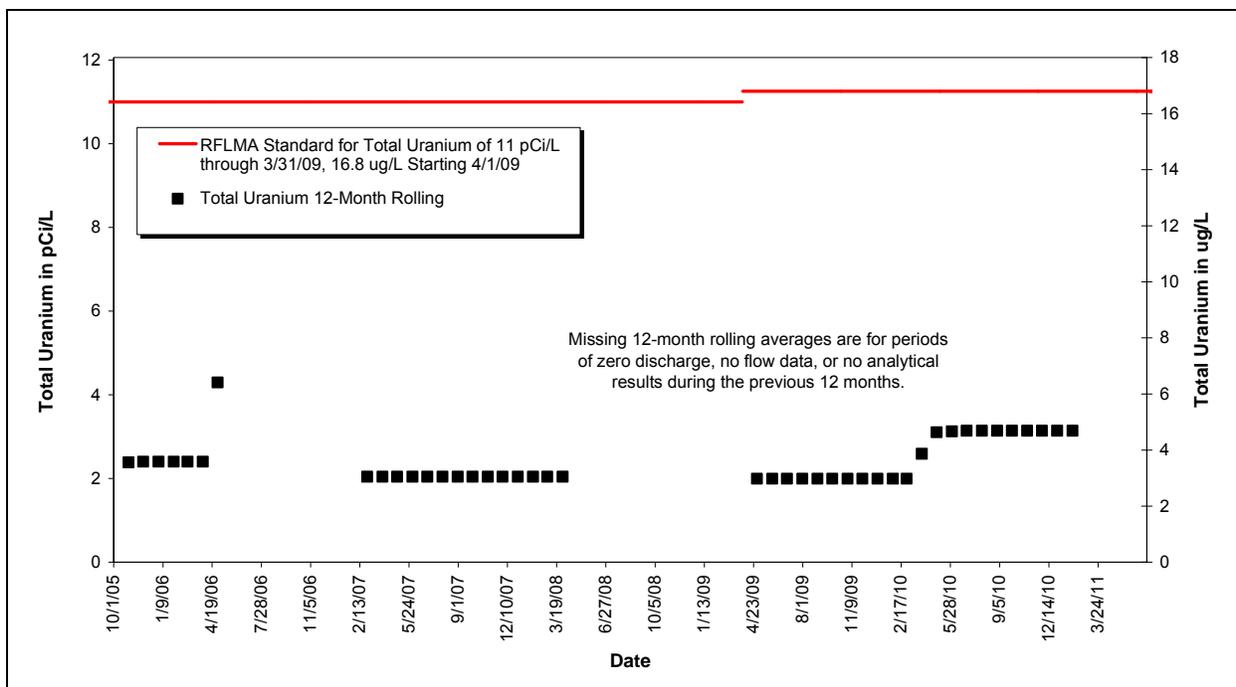
Figure 35. Volume-Weighted 12-Month Rolling Average Total Uranium Concentrations at SW027: Post-Closure Period Ending Second Quarter CY 2011

Note: The composite sample started on February 17, 2011, was still in progress at the time of publication, so those results for this composite sample were not available for this report.
 µg/L = micrograms per liter; pCi/L = picocuries per liter

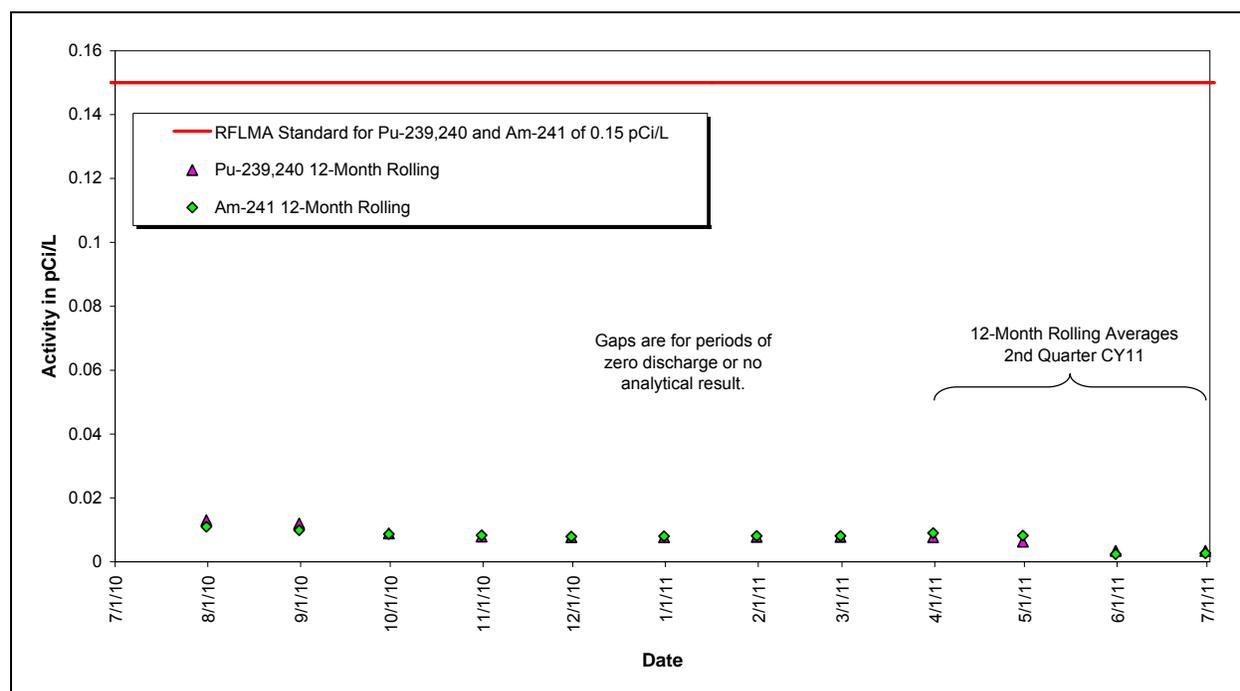
Figure 36. Volume-Weighted 12-Month Rolling Average Plutonium and Americium Activities at SW093: Calendar Year Ending Second Quarter CY 2011

Monitoring location SW093 is on North Walnut Creek 1,300 feet upstream of the A-Series ponds. Figure 36 and Figure 38 show no reportable plutonium, americium, or total uranium values during the quarter. Figure 37 and Figure 39 show sampling data from 2005 through the second quarter of CY 2011. None of the 85th-percentile 30-day average metals concentrations were reportable for the quarter.
