**Draft Closeout Report  
for SW056 Pipeline**

October 2005

This Closeout Report summarizes accelerated action activities conducted at surface water station SW056, located at the Rocky Flats Environmental Technology Site (RFETS or Site), Golden, Colorado. Activities were planned and executed in accordance with the Environmental Restoration (ER) Rocky Flats Cleanup Agreement (RFCA) Standard Operating Protocol (RSOP) for Routine Soil Remediation (ER RSOP) Modification 1. Notification of the planned characterization and removal activities was provided in ER RSOP Notification #05-09.

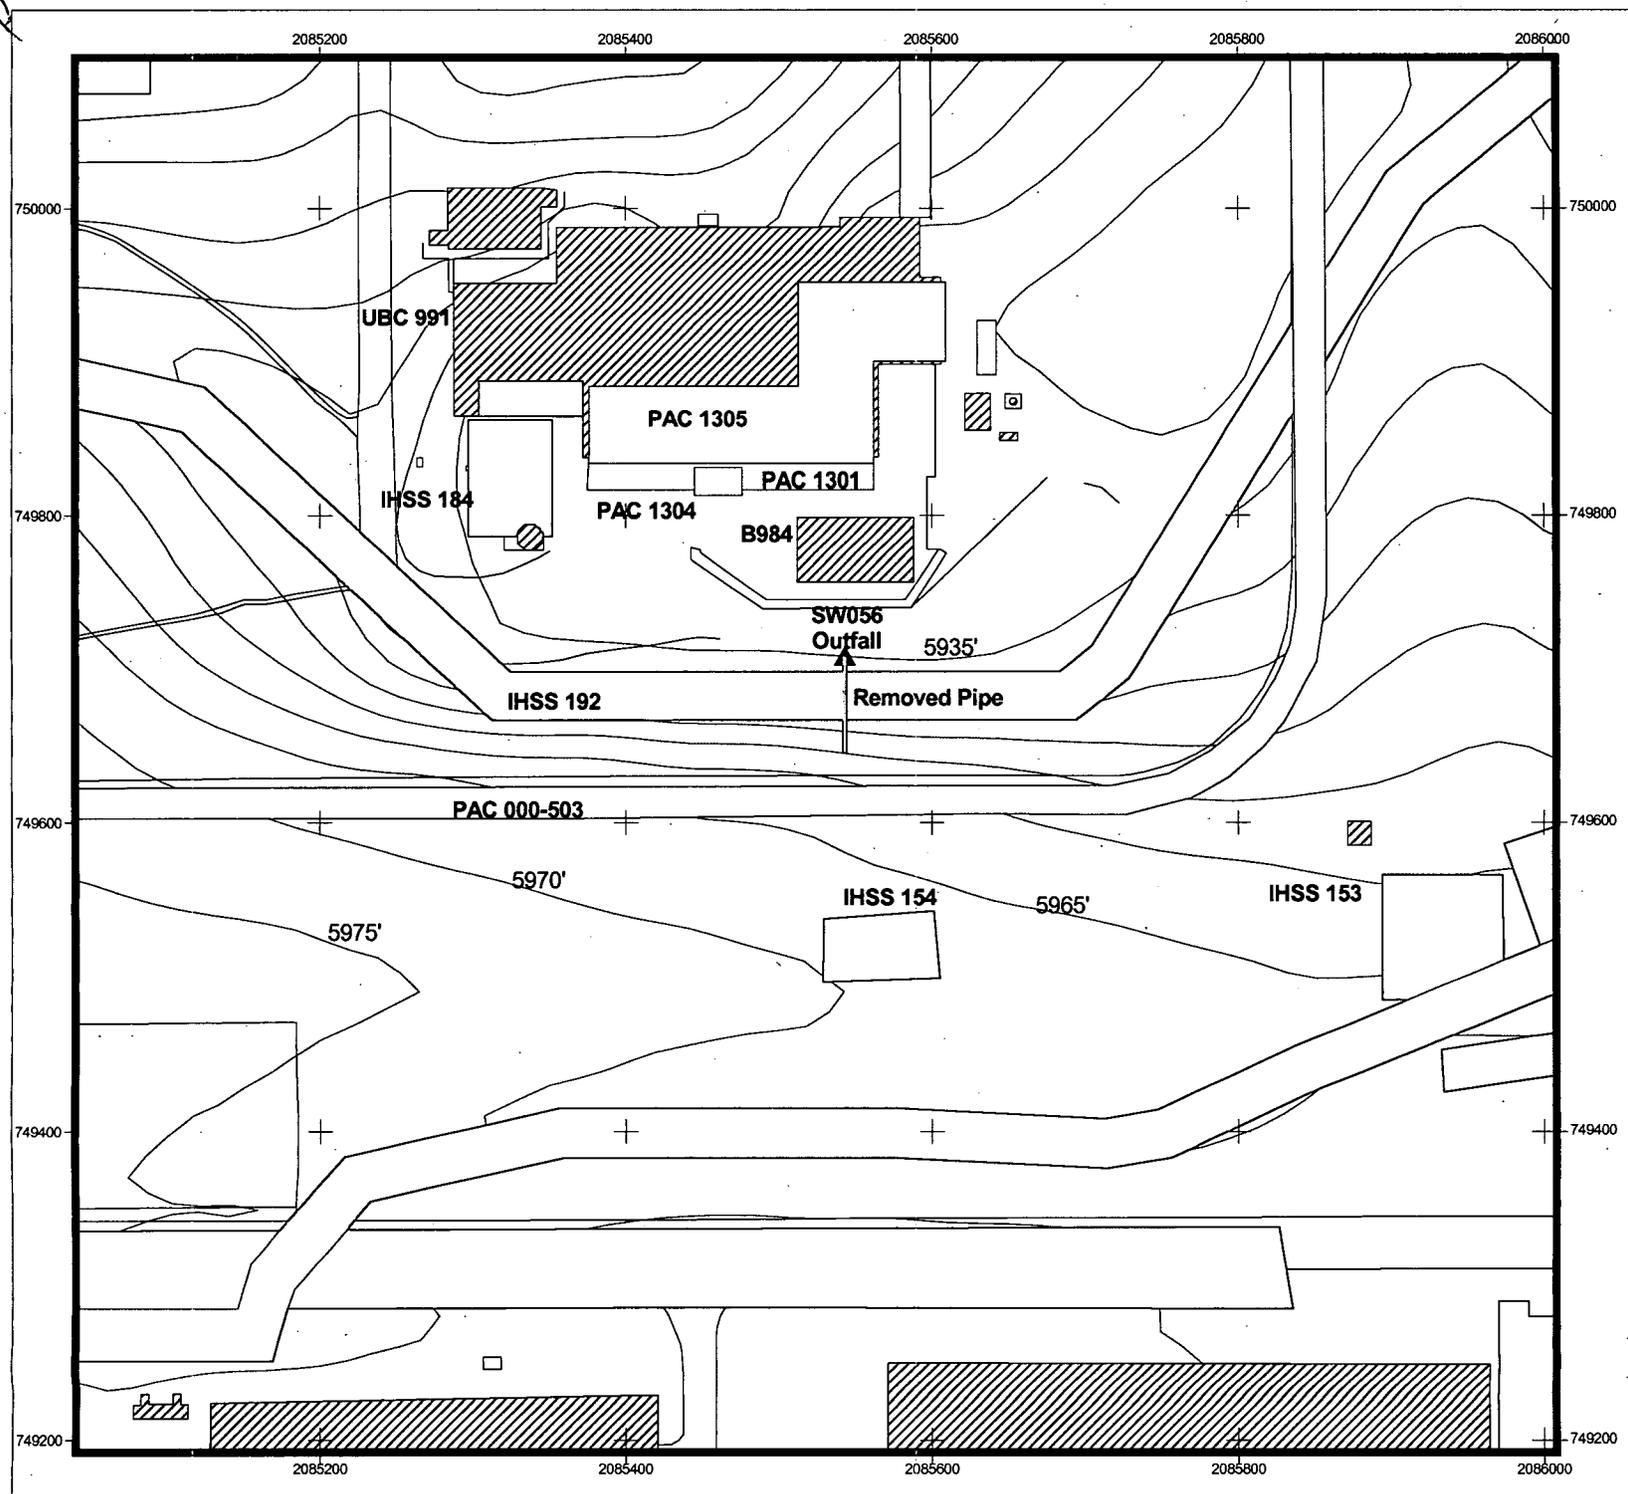
Figure 1  
SW056  
Location Map

SW056 was a surface water monitoring location at the perforated pipe outfall from a french drain installed to drain the area of the former protected area fence (Figure 1). The flow rate was visually estimated at approximately 2-3 gallons per minute (gpm). Flow was reported to be relatively constant although no measurements were ever taken. The water source was a gravel pack also installed to dewater the area of the former protected area fence. The perforated pipe was thought to be connected to another length of pipe that ran east-west along the former patrol road.

Accelerated action activities were conducted between September 27, 2005 and September 30, 2005. Starting and ending dates of significant activities are listed in Table 2. Features removed and remaining are shown on Figure 1.

All accelerated action objectives were met. The french drain was removed. HRC was added to the excavation and the excavation was backfilled and regraded. A monitoring well was installed. Removed and remaining structures are shown on Figure 1.

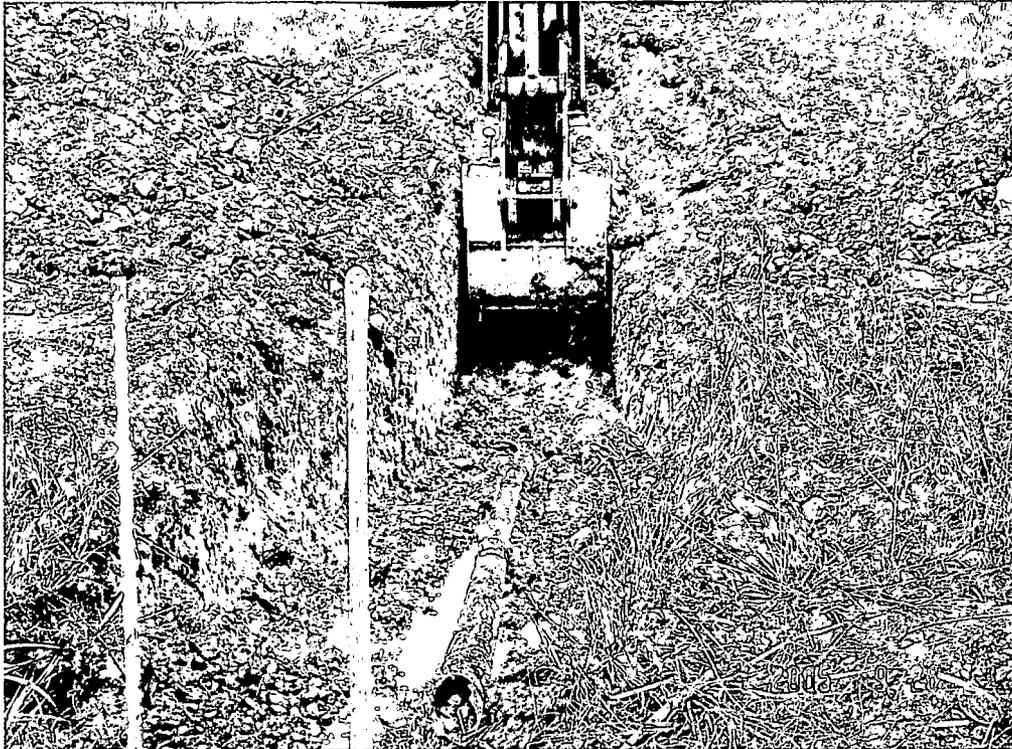
1. Excavation proceeding from the outfall of SW056. Red stake marks northern extent of pipe prior to excavation.

Work was initiated on September 27, 2005. The outfall was excavated sufficiently to expose the perforated pipe and determine the trend of the pipe. Then, the location of the suspected elbow

On September 28th, excavation resumed at the SW056 outfall to determine the source of the water by excavating from the north towards the water source and into the hill. The perforated pipe lay within an approximately 1 foot square gravel filled trench. The lowermost portion of the gravel and the pipe contained water. As the excavation proceeded to the south, the pipe and associated gravel were removed and the pipe was disposed as sanitary waste. The open excavation to the north was backfilled as the excavation proceeded to provide a stable working platform. As a result, water flow was contained within the excavation boundaries.

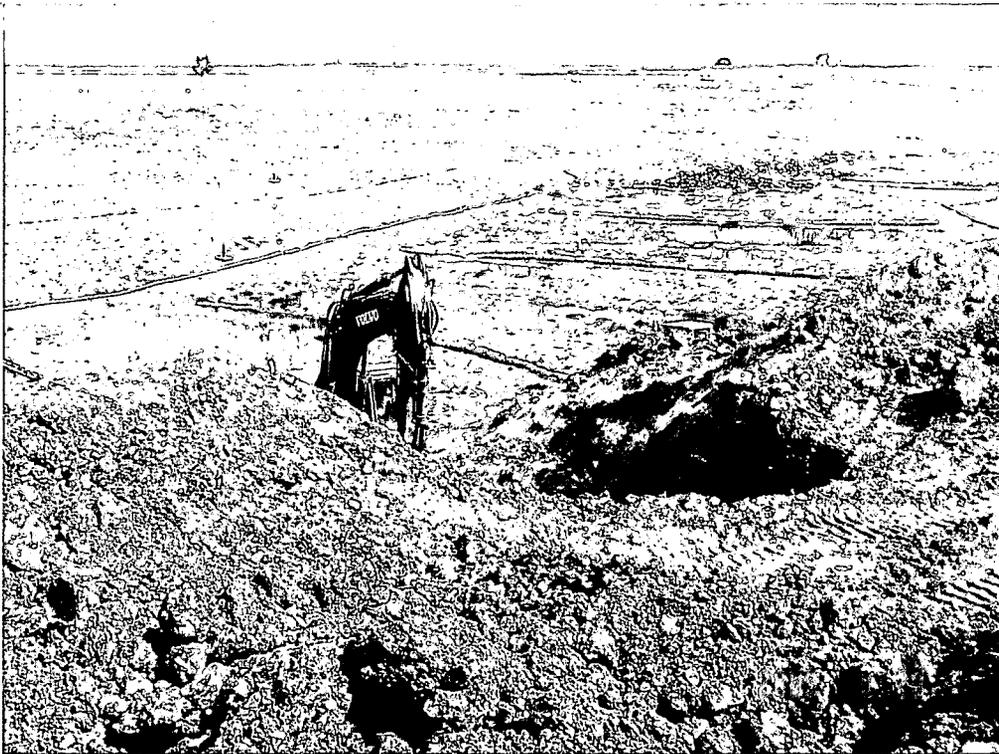
5. Excavation proceeding from the north.
