Nevada Offsites

Gasbuggy, New Mexico, Site

This fact sheet provides information about the Gasbuggy, New Mexico, Site. This site is managed by the U.S. Department of Energy Office of Legacy Management.

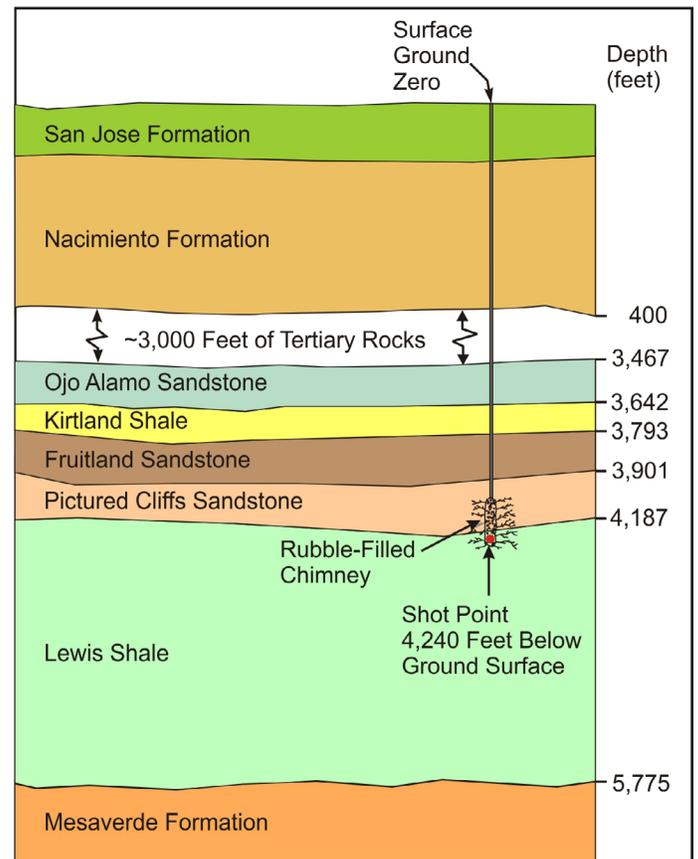
Cross section of the Gasbuggy, New Mexico, Site

The blast created a cavity and a chimney of rubble above and within it. The purpose of the detonation was to stimulate flow of natural gas through the fractures created by the blast and use the chimney as a collection chamber. No radiation was released at the surface at the time of the blast. The molten rock in the cavity encapsulated most of the radionuclides from the detonation.
