MOUND PLANT

Potential Release Site Package

PRS # 320/321/322/323/324/325

MOUND PLANT POTENTIAL RELEASE SITE PACKAGE

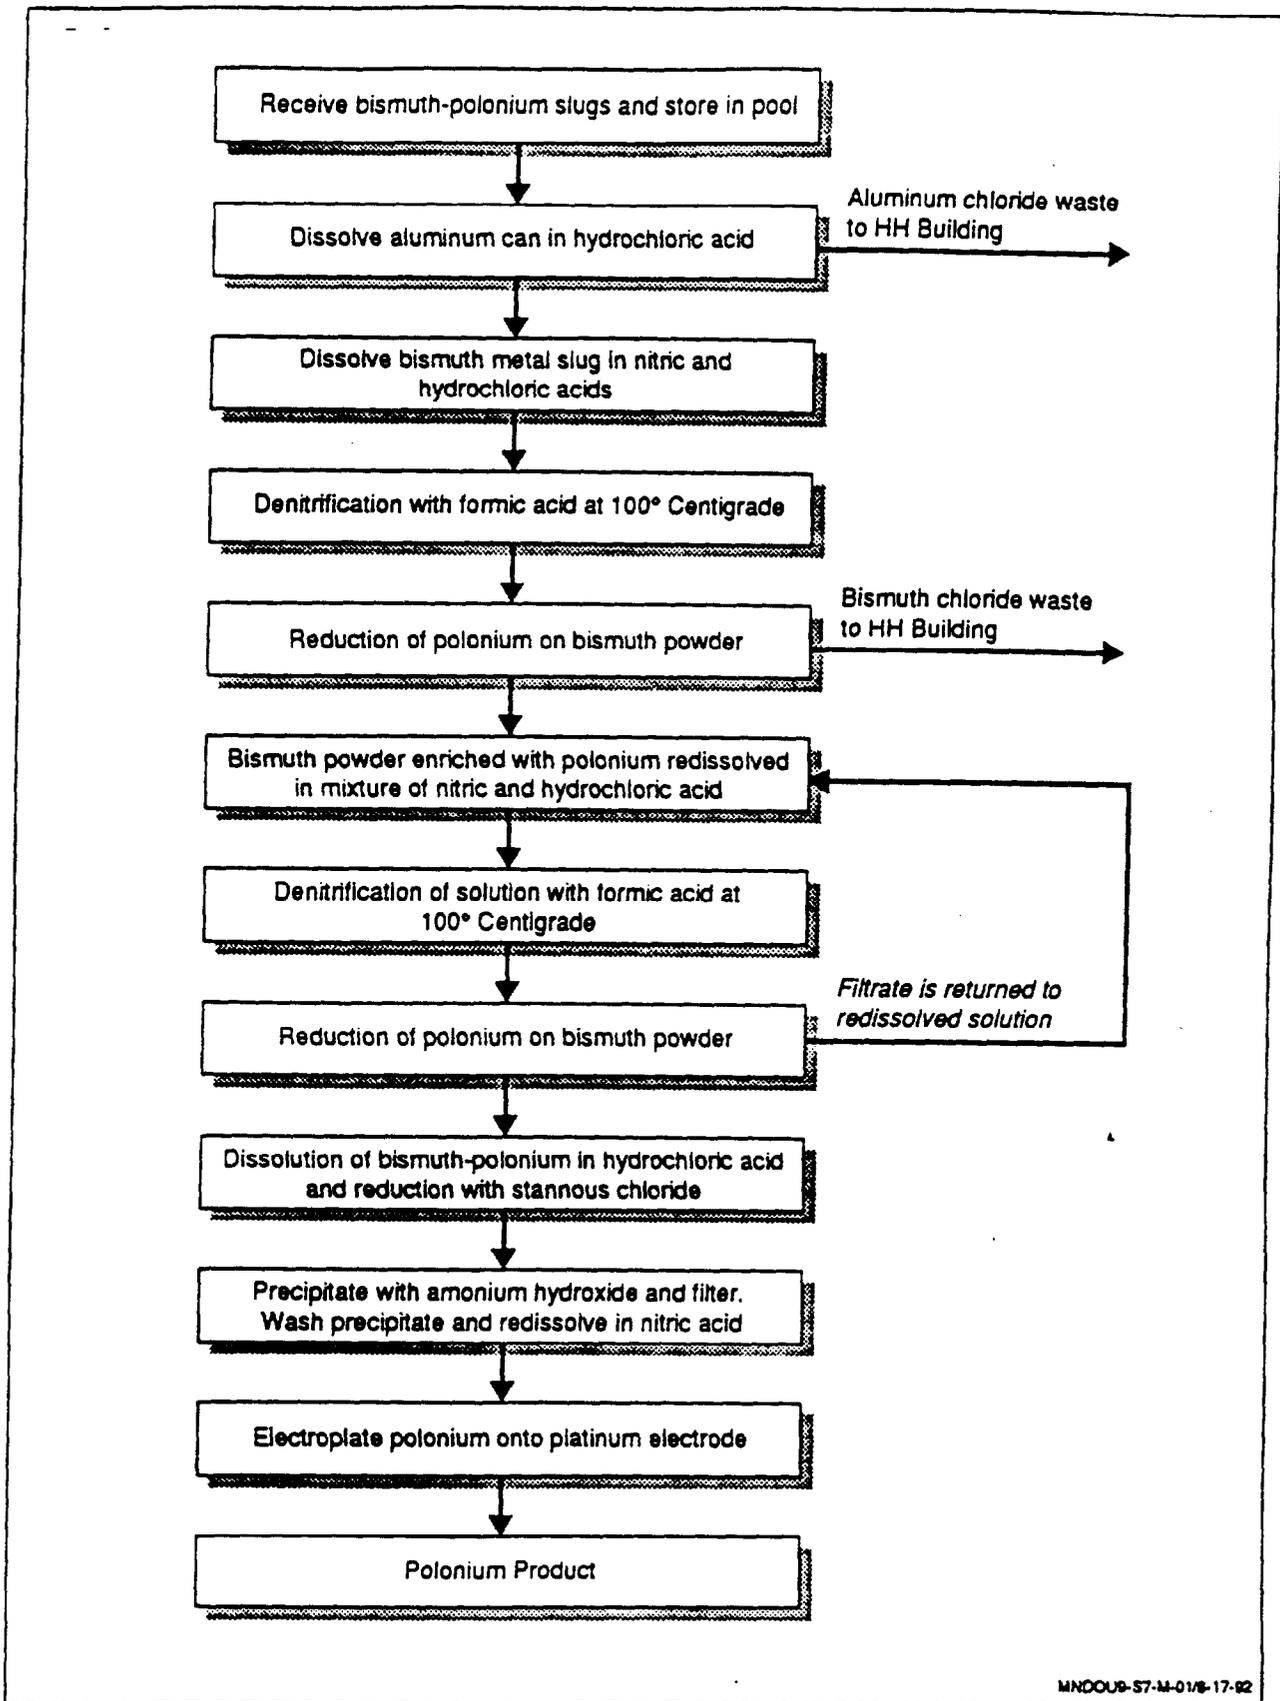
Figure 2.2. Bismuth-polonium separation process.

The separation of polonium-210 from bismuth took place on the second floor of the T Building. This chemical separation process is shown in Figure 2.2. The process is generally described by Huddleston et al. (1963). The process began with the dissolution of the bismuth metal slug in a mixture of nitric and hydrochloric acids (Lonadier and Huddleston 1964). During this step, gaseous nitric acid, nitrogen dioxide, and hydrogen gas were generated. These gases were passed through a caustic scrubber, and the acidic components were neutralized before being exhausted through the high efficiency particulate air (HEPA) filter bank to the building's stack. After the bismuth slug was completely dissolved, the resulting solution was denitrated by the addition of formic acid and heating the solution to 100°C.

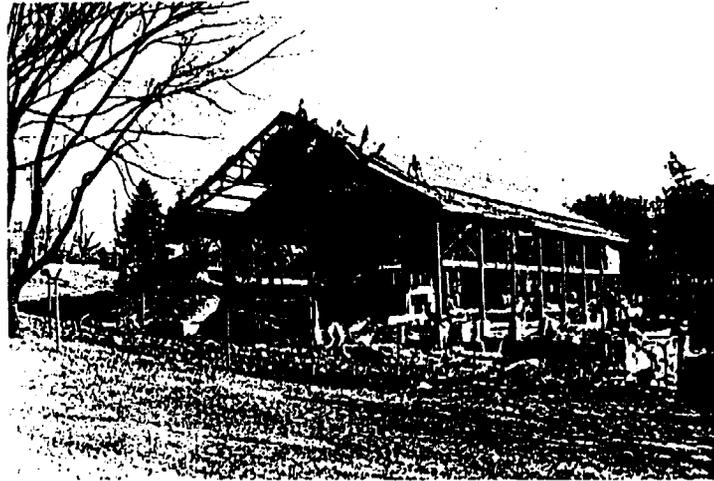
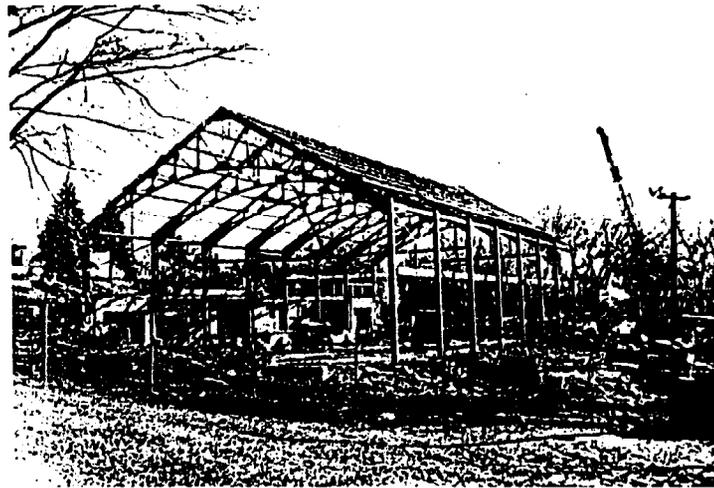
Views of southwest corner of Unit IV during dismantling operations in 1950.

It was decided that it would be both less expensive and safer to dismantle the Unit IV location than to restore it to its original condition. Surveys made after the transfer of operations to Mound Laboratory showed that the interior of the playhouse was highly contaminated. Demolition was started in February 1950 and completed later the same year. The remains were moved to Mound Laboratory by truck and stored. The excavation was filled with dirt, covered with sod, and returned to the original owners.

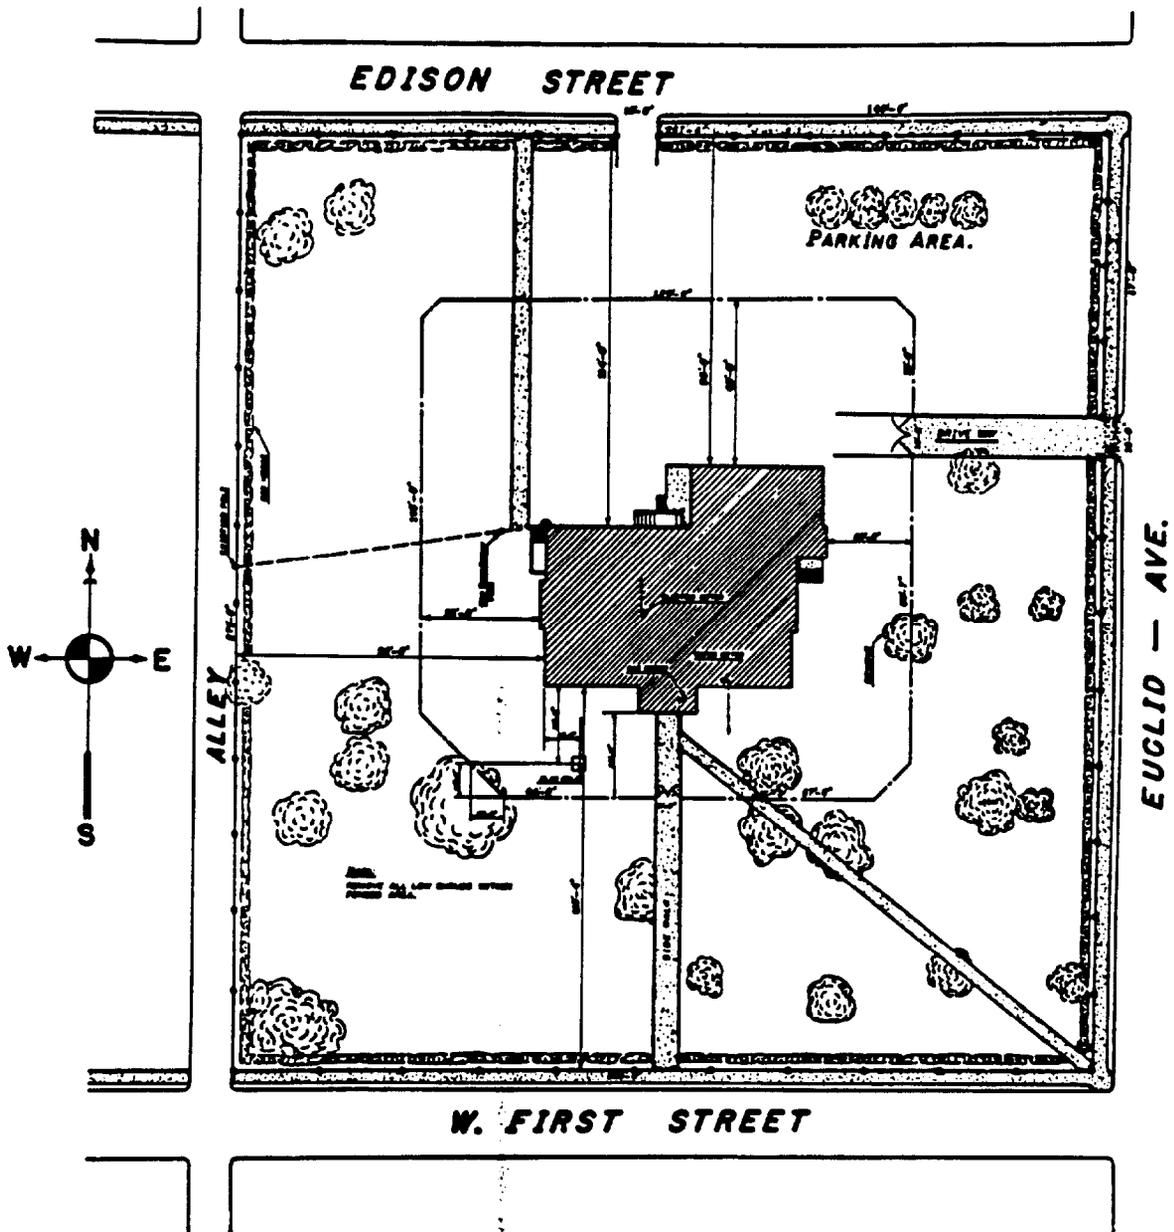
PLOT PLAN UNIT 3 PRIOR TO OCCUPANCY SEPTEMBER 1943

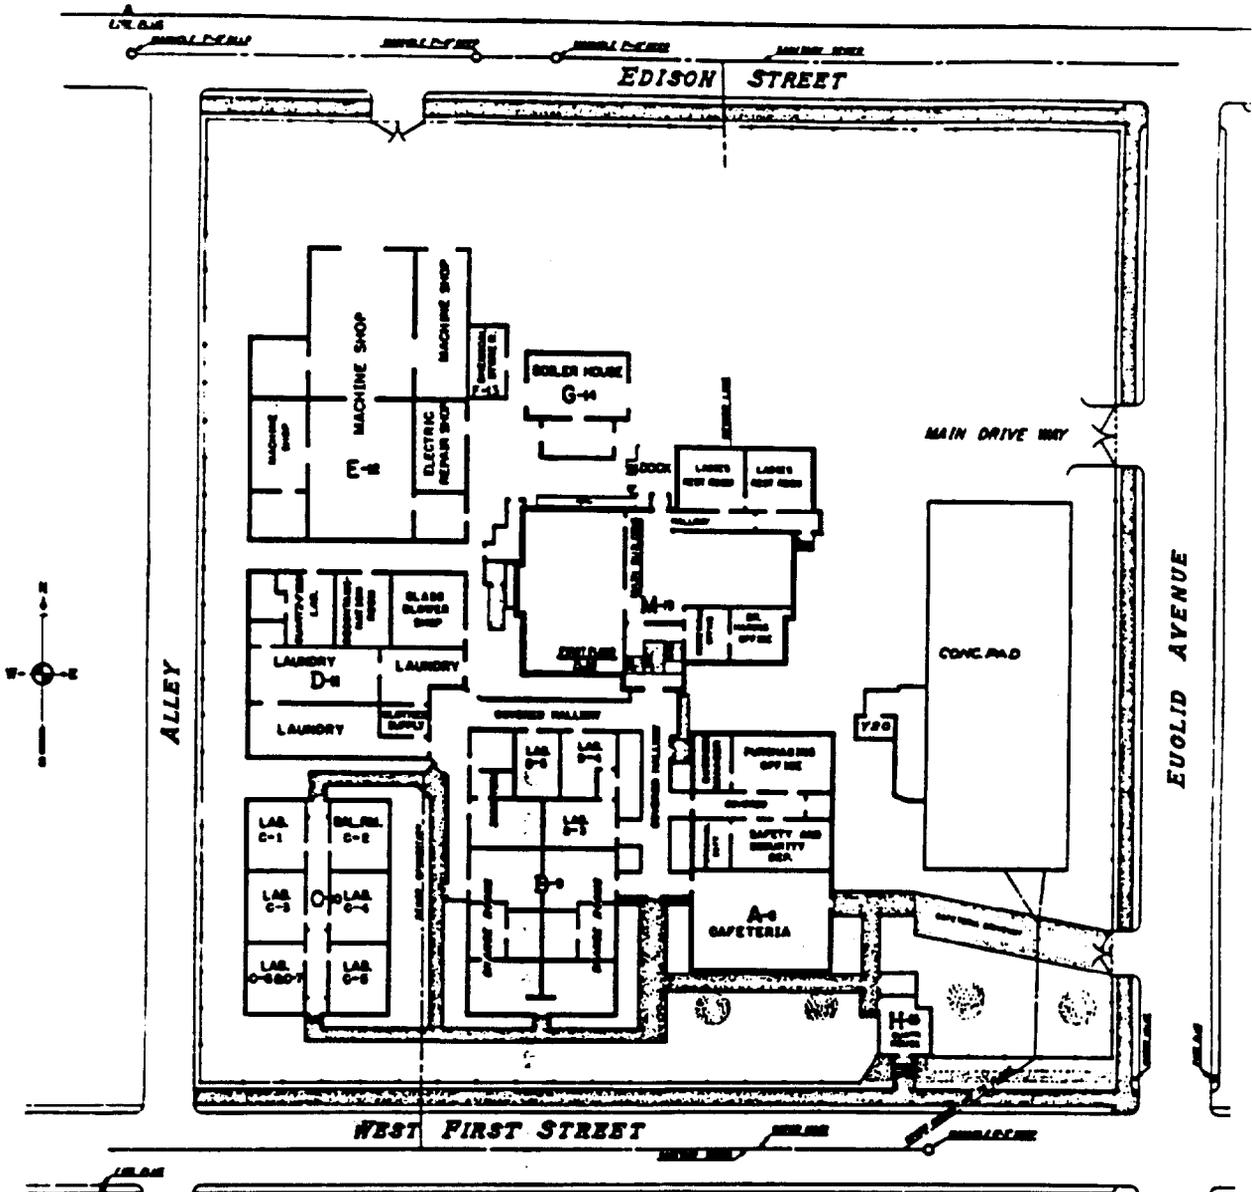
PLOT PLAN UNIT 3 AREA OCTOBER 1949

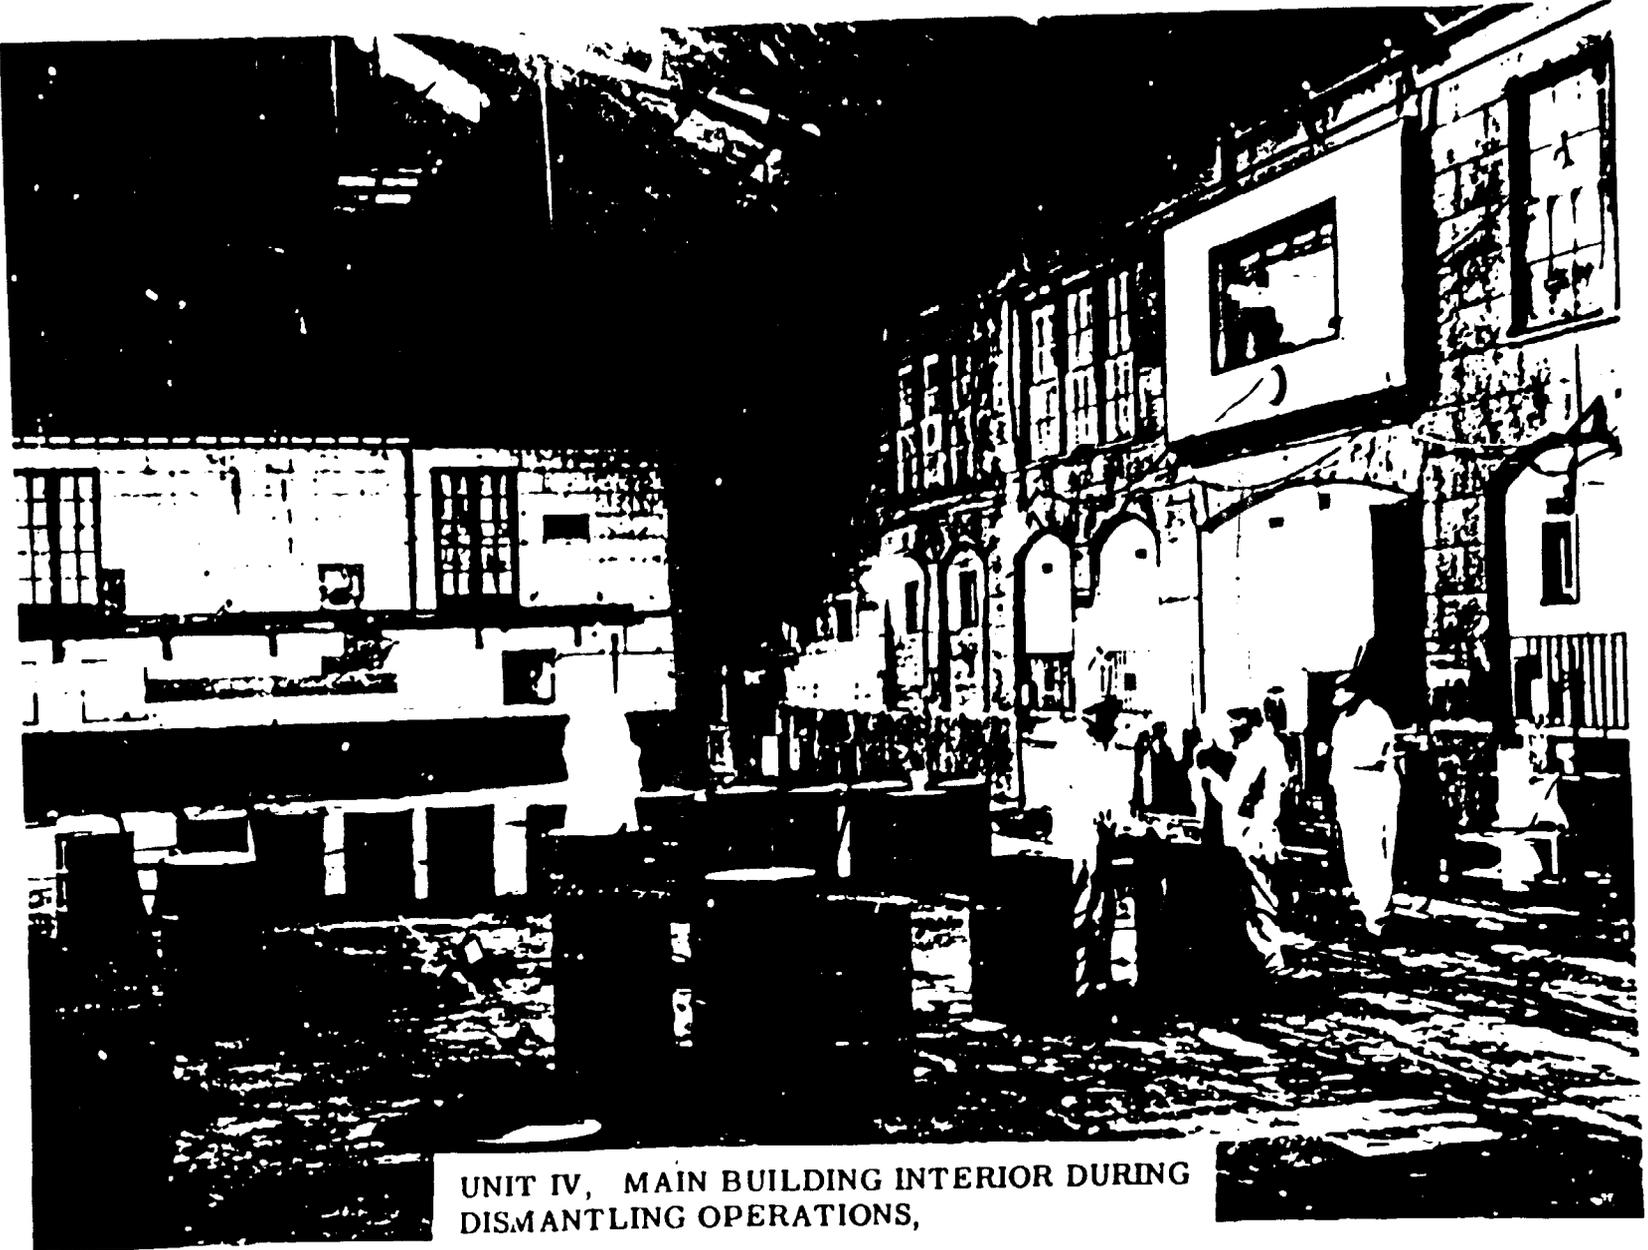
UNIT IV, MAIN BUILDING INTERIOR DURING
DISMANTLING OPERATIONS,

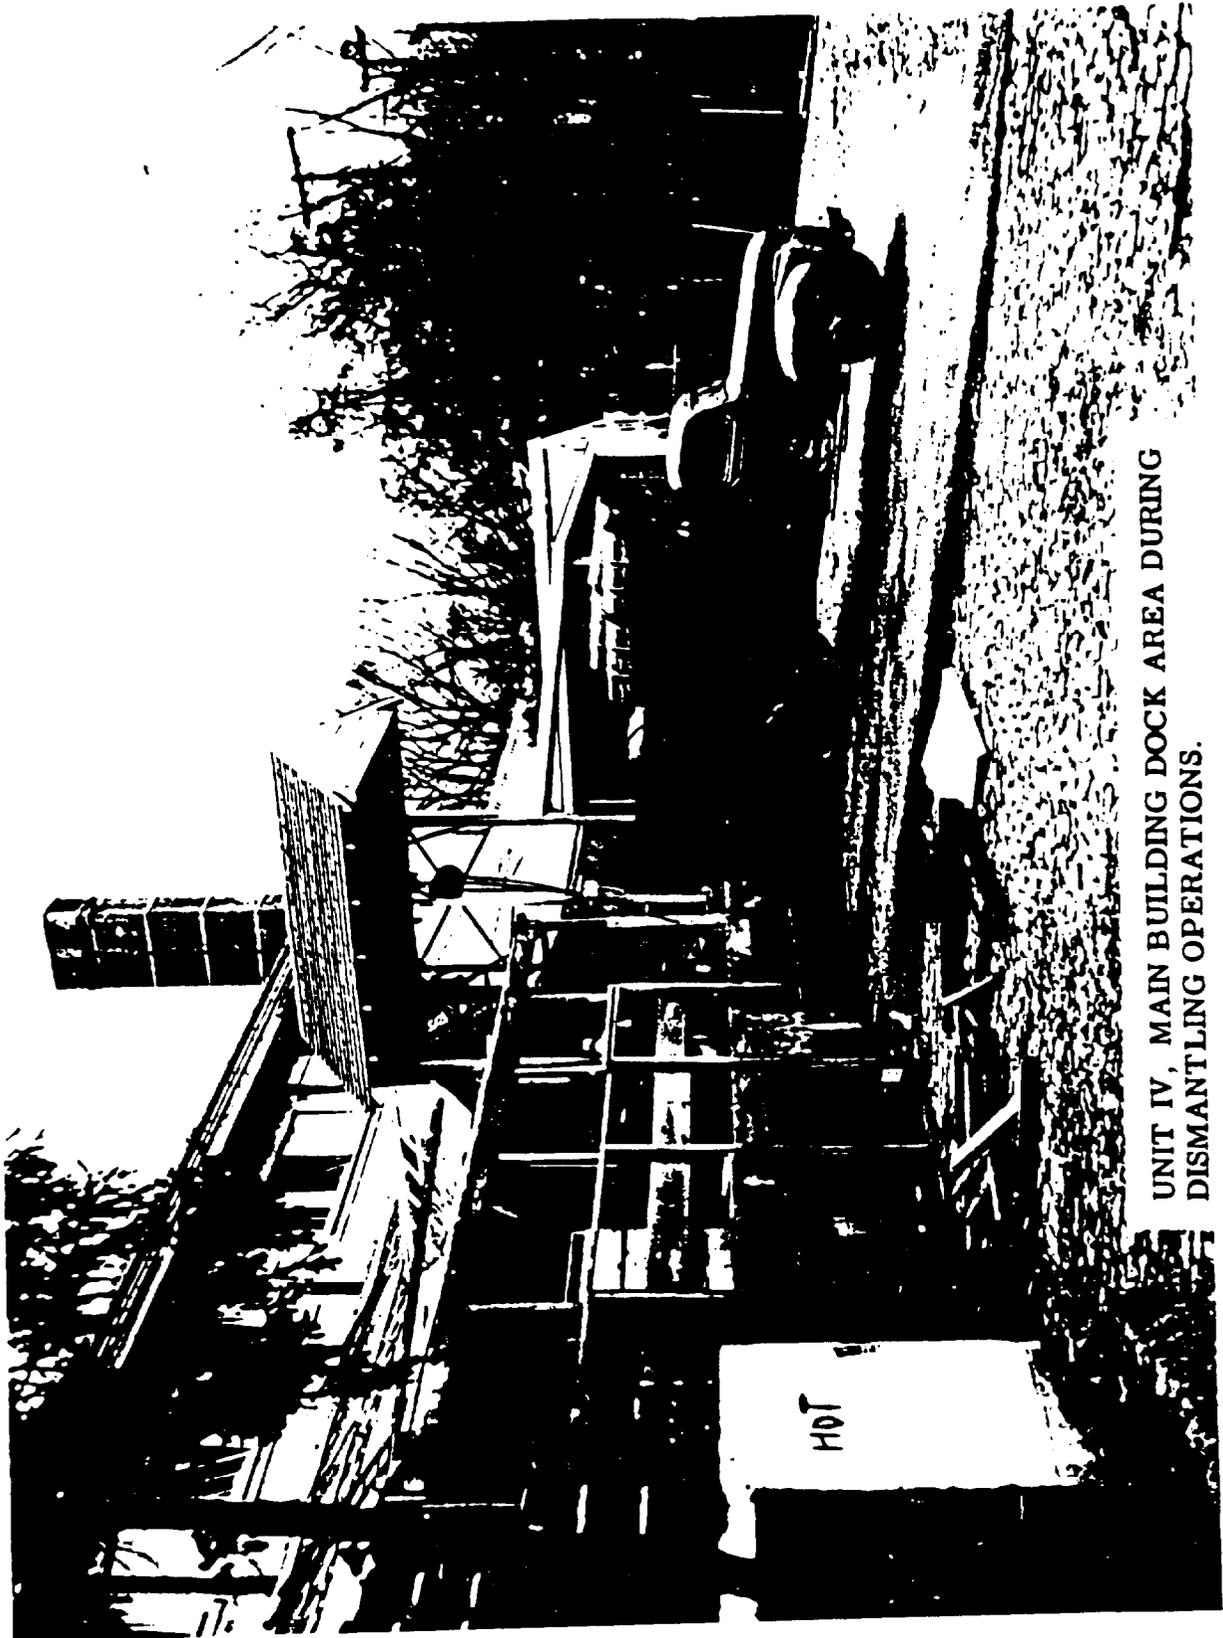
UNIT IV, MAIN BUILDING DOCK AREA DURING
DISMANTLING OPERATIONS.

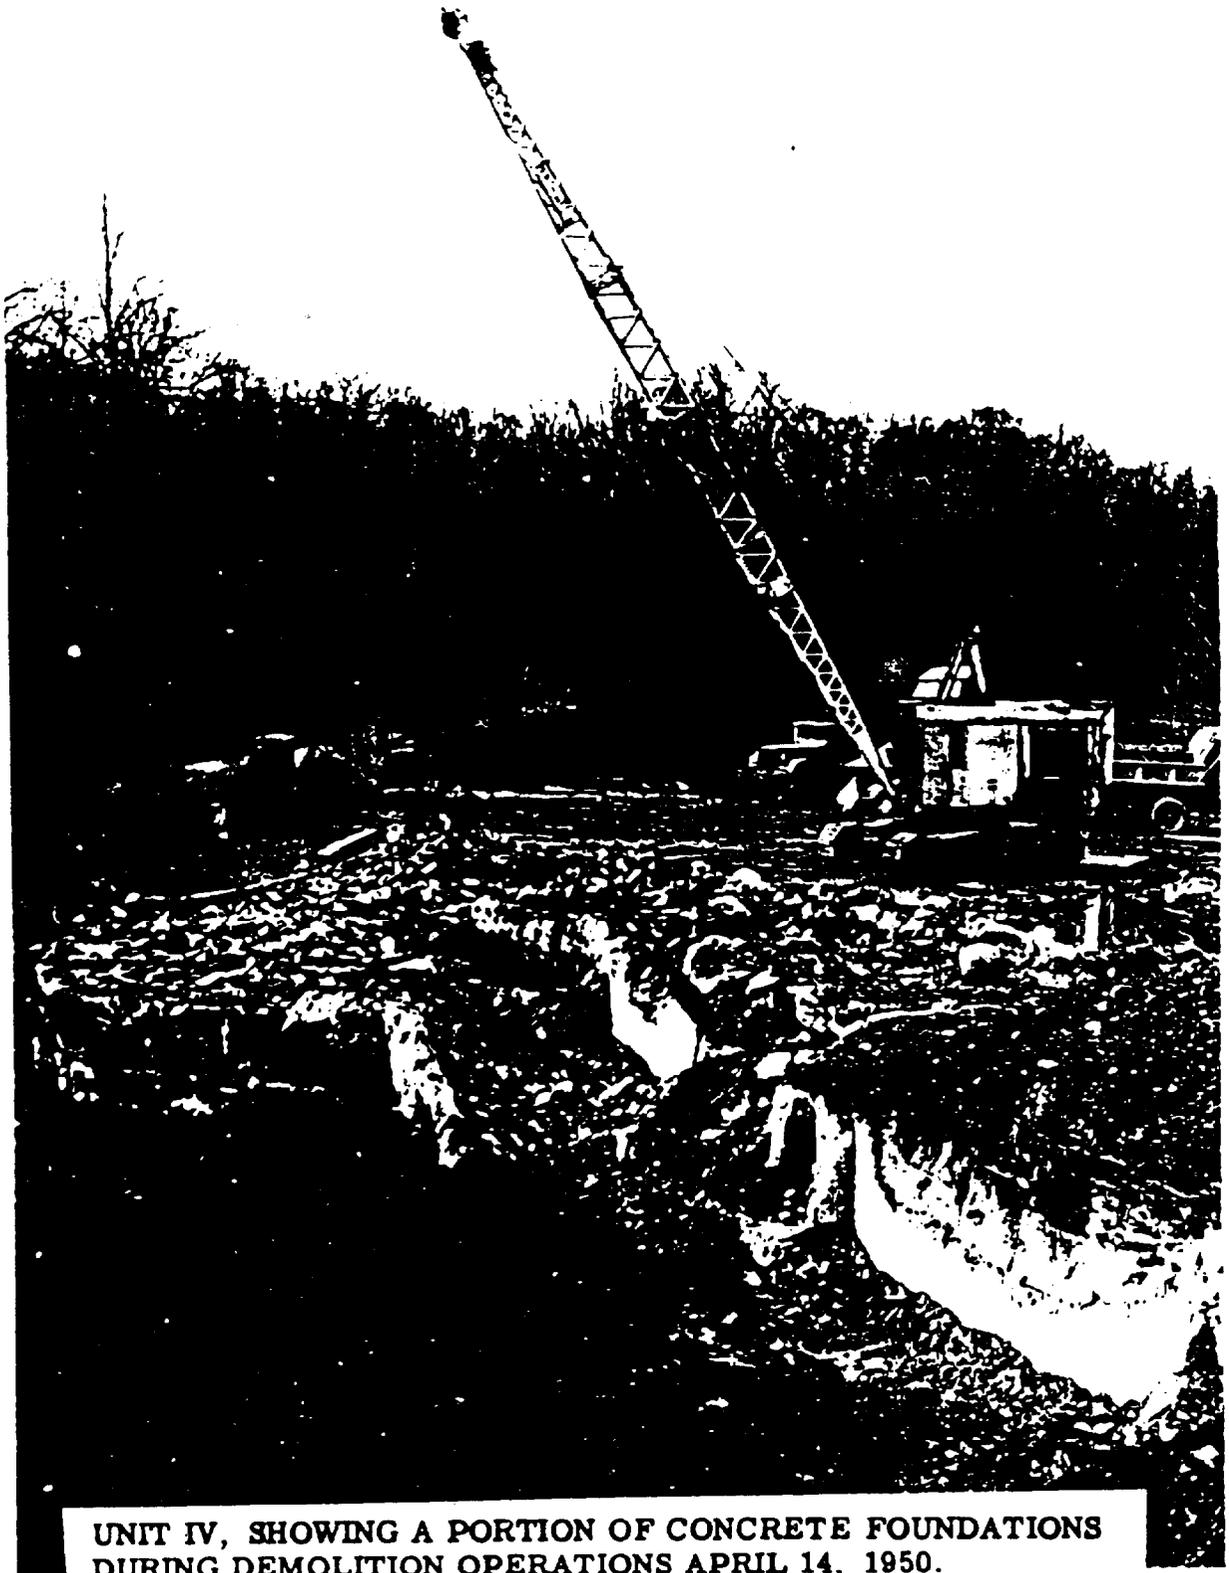
UNIT IV, SHOWING A PORTION OF CONCRETE FOUNDATIONS
DURING DEMOLITION OPERATIONS APRIL 14, 1950.
