DOE/NV--694-rev 1

Closure Report
for Corrective Action Unit 407:
Roller Coaster RADSAFE Area,
Tonopah Test Range, Nevada

December 2001

Environmental Restoration
Division

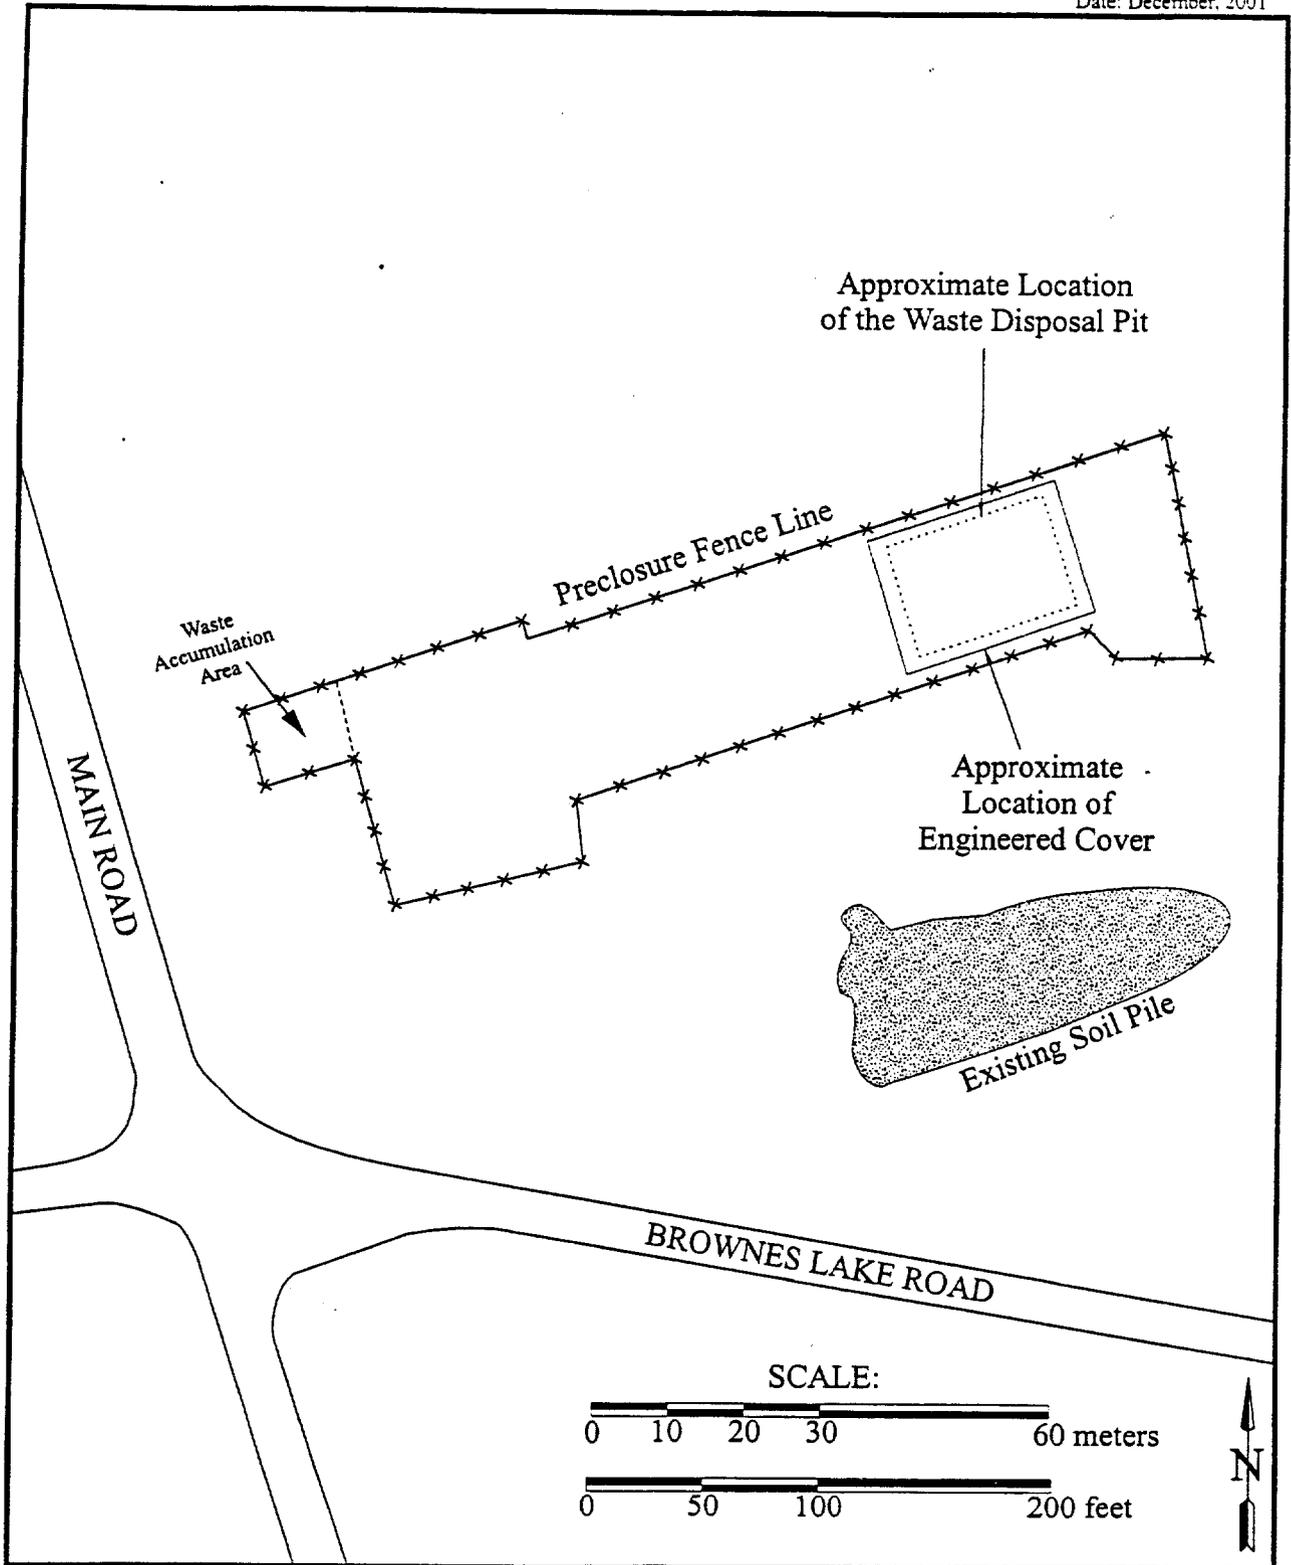
FIGURE 2
CAU 407 SITE VICINITY MAP

The cover design was a 0.6-meters (m) (2-feet [ft]) thick monolayer of clean fill which was placed over the historic waste pit (Figure 2). The main purpose of this layer was to provide an additional level of protection to the hypothetical future land user from subsurface radionuclides which remain. As-built drawings of the engineered cover are located in Appendix A. Photos of cover construction are included in Appendix B.

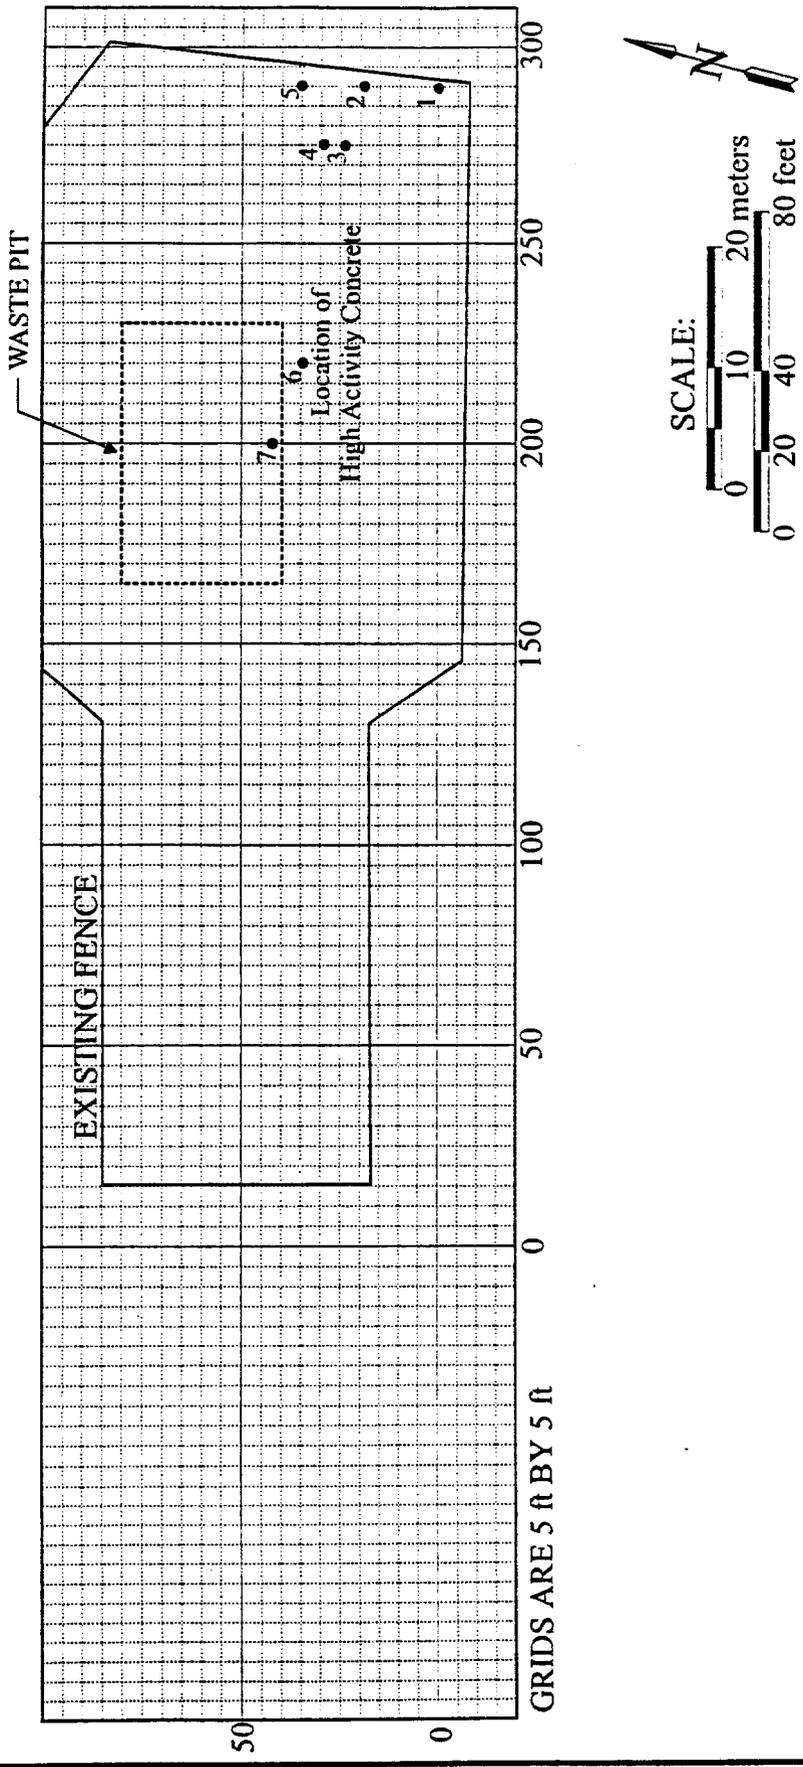
FIGURE 3
LOCATIONS OF HOT SPOTS REMOVED FROM CAU 407

Soil was removed from the "hot spot" locations until the criterion of less than three times background was met. The locations of the soil removals are shown in Figure 3. FIDLER readings taken after "hot spot" removal confirmed that no surface soil activity remained that was greater than the three times background criterion. Excavated soil was managed as LLW. Impacted soil was placed into a 55-gallon (gal) drum following Bechtel Nevada (BN) Procedure OP-2151.304, "Radioactive Waste Tracking, Handling, and Management at the NTS," (BN, 1999) and stored temporarily in a waste management area prior to disposal at the Area 5 RWMS on the NTS. Excavations were backfilled with clean fill from a borrow source near the site.

Background = 3,500 counts per minute using a FIDLER detector.

Location Number	Initial Reading (cpm x 1000)	Reading after Removal (cpm x 1000)
1	64	10
2	16	9
3	12	8.5
4	12	9
5	13	9.4
6	47	10
7	30	8.4

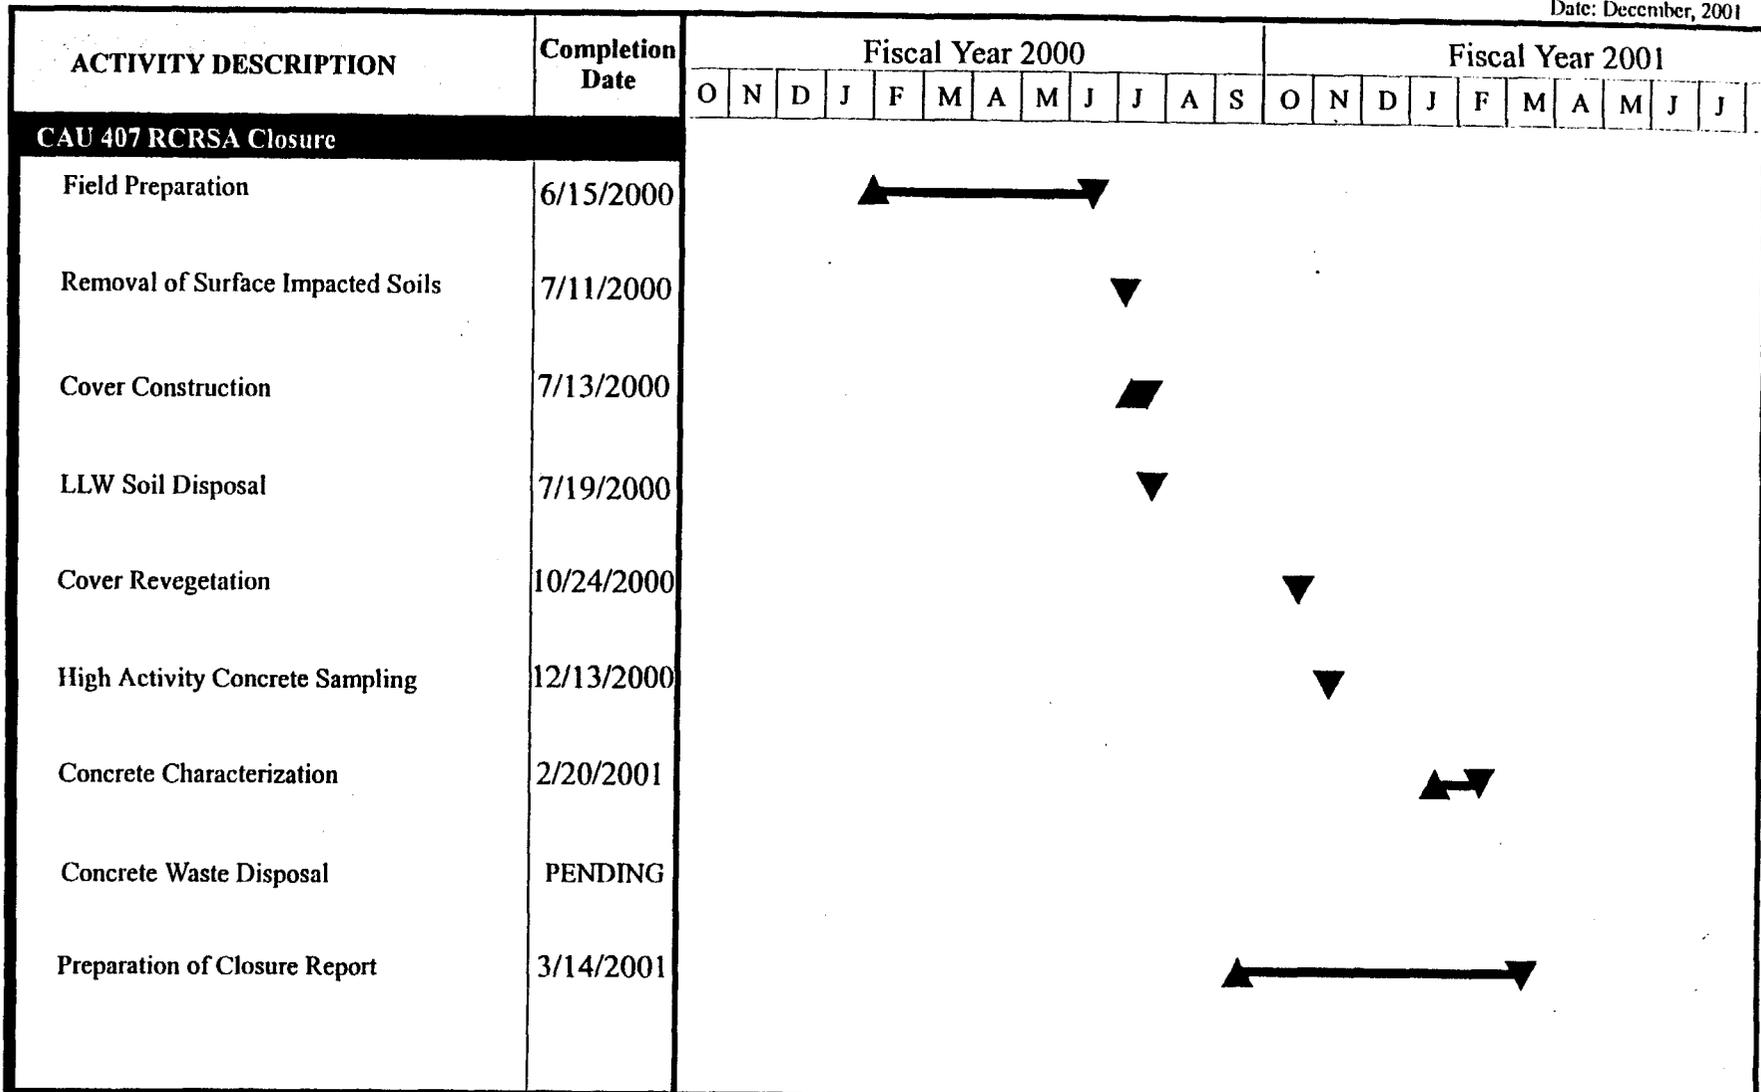
FIGURE 4
 CAU 407 SCHEDULE AS COMPLETED

The corrective action began on July 10, 2000. Hot spots removal and cover construction were completed on July 13, 2000. Impacted surface soils were shipped to the Area 5 RWMS for disposal on July 18, 2000. Cover revegetation was completed on October 24, 2000. The concrete pieces were shipped to the Area 5 TRU pad for storage on March 6, 2001. Figure 4 provides a detailed schedule of closure activities as completed.

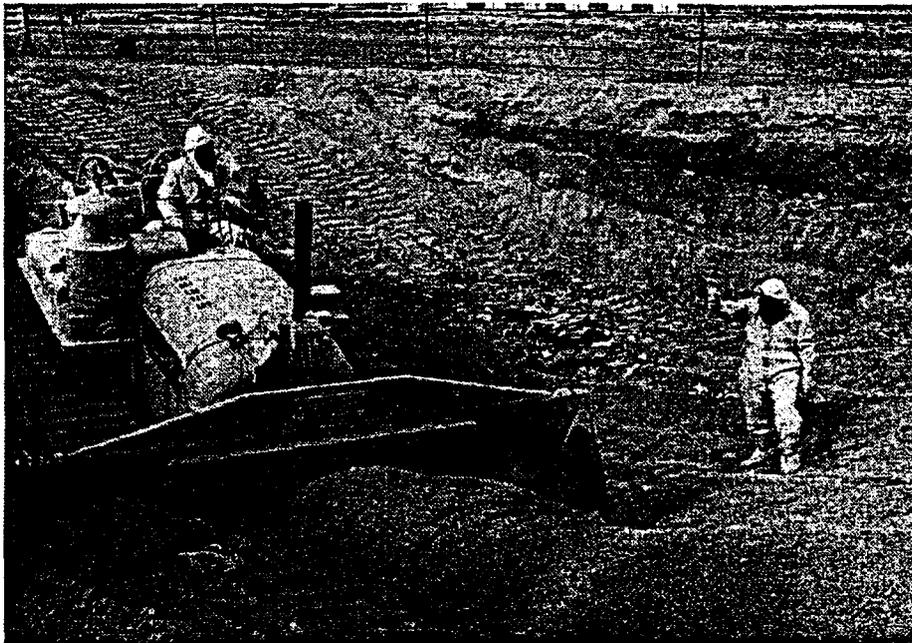
Photo 175-03-TTR-63 shows Radiological Control Technicians during the Roller Coaster Followup Operation directing a bulldozer operator during digging for buried debris at the Rad Safe Waste Pit at Tonopah

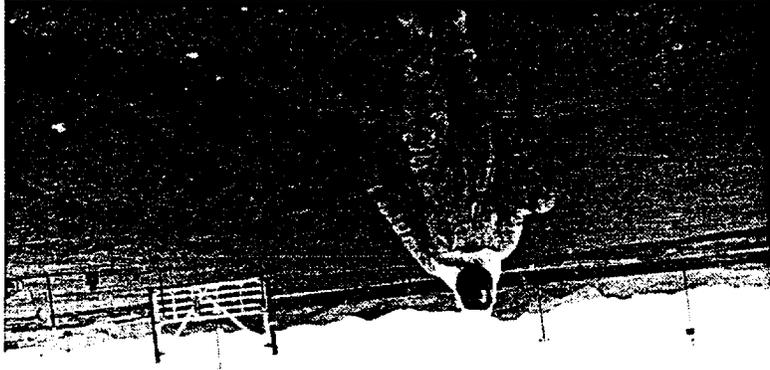
Photo 175-05-TTR-63 shows a Radiological Control Technician carrying debris from the Rad Safe Waste Pit at Tonopah

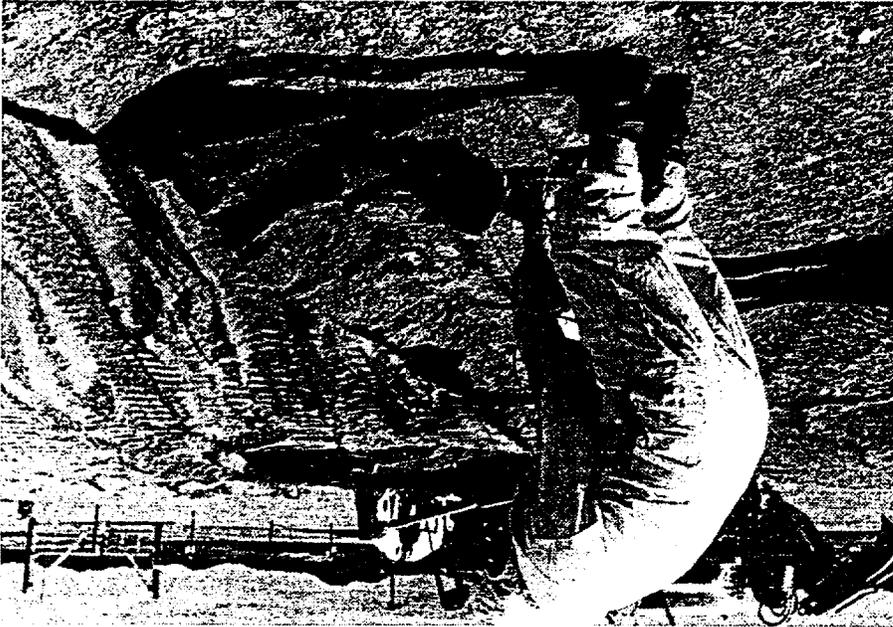
Photo 175-04-TTR-63 shows a Radiological Control Technician during the Roller Coaster Followup Operation using rope to handle contaminated debris at the Rad Safe Waste Pit at Tonopah

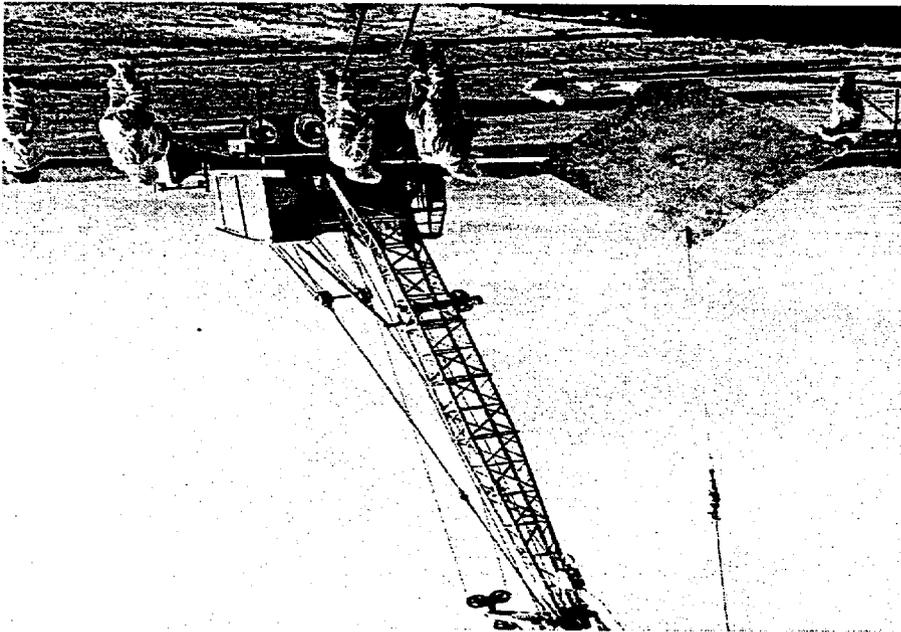
Photo 175-12-TR-63 shows the crane lifting the 8 x 8 ft Double Tracks Steel Base Plate from the Rad Safe Waste Pit at Tonopah during the Roller Coaster Followup Operation

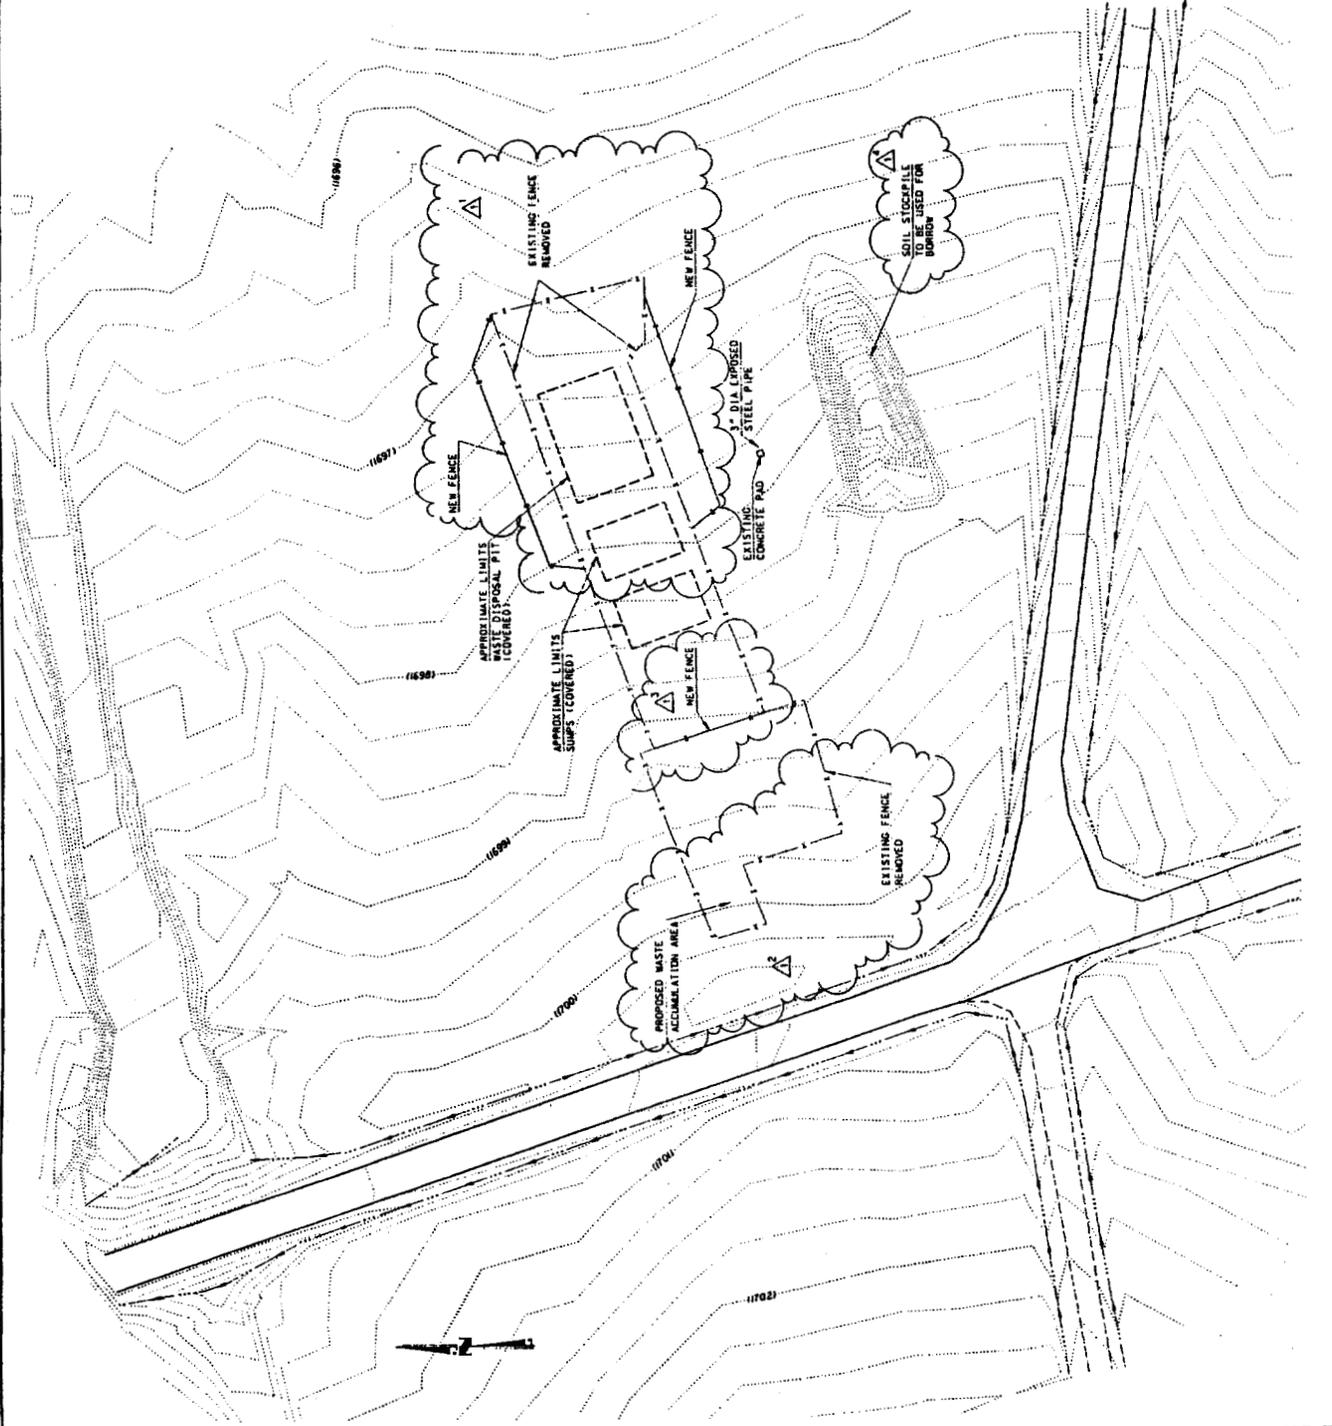
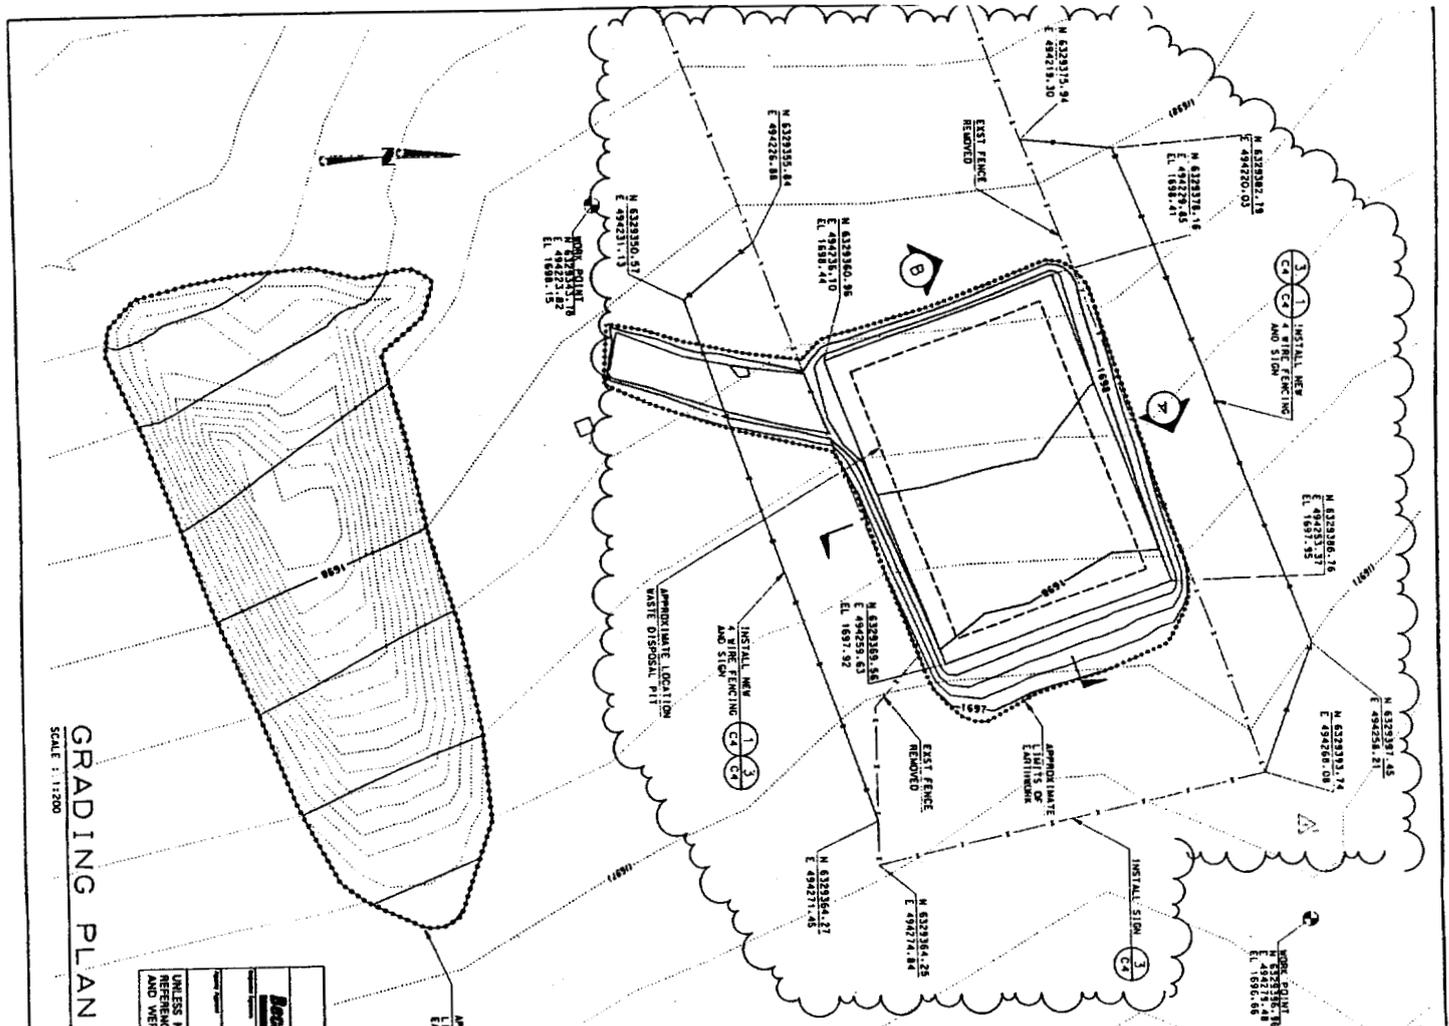
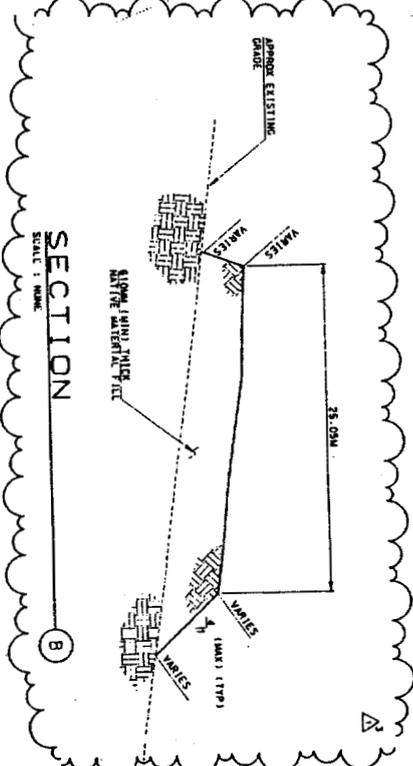
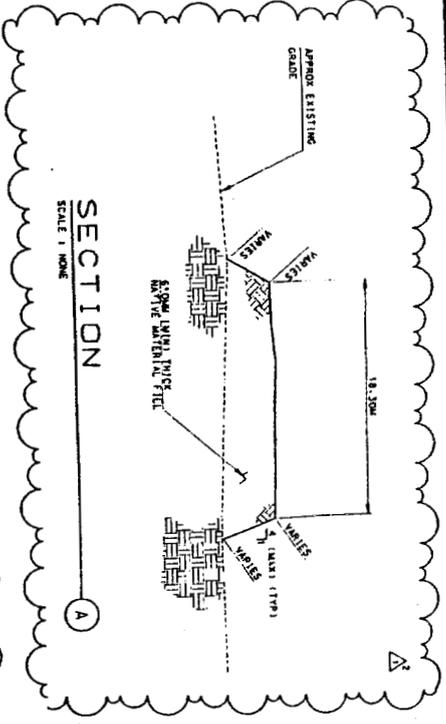
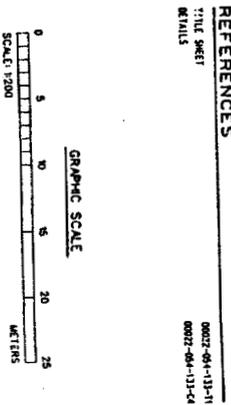
GRADING PLAN
SCALE: 1:1200

DESCRIPTION	QUANTITY	UNIT
NATIVE FILL	455	CUBIC YARDS

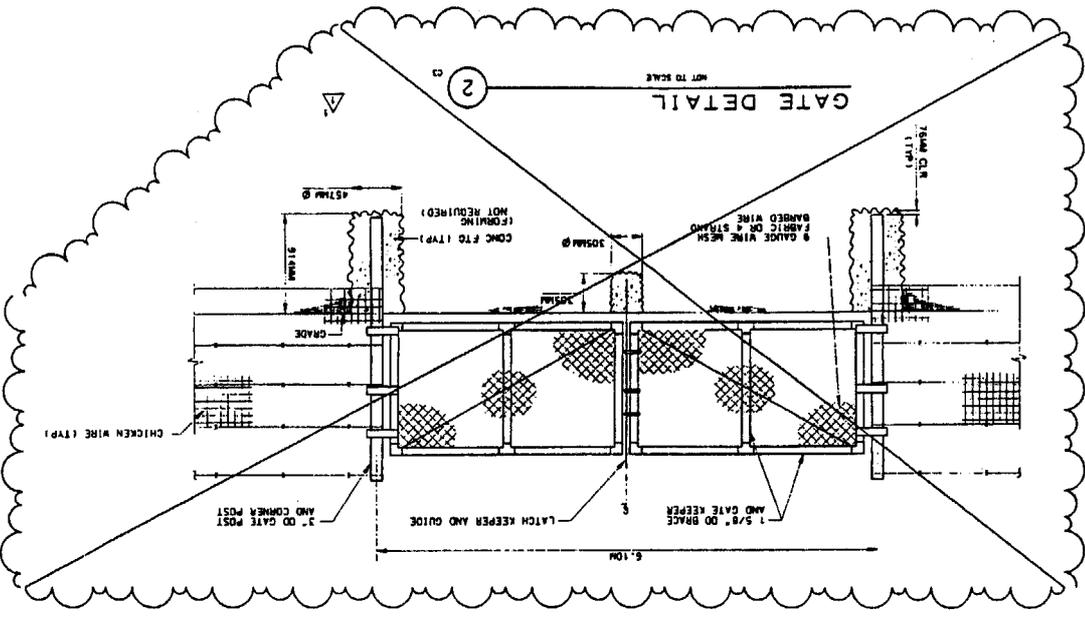
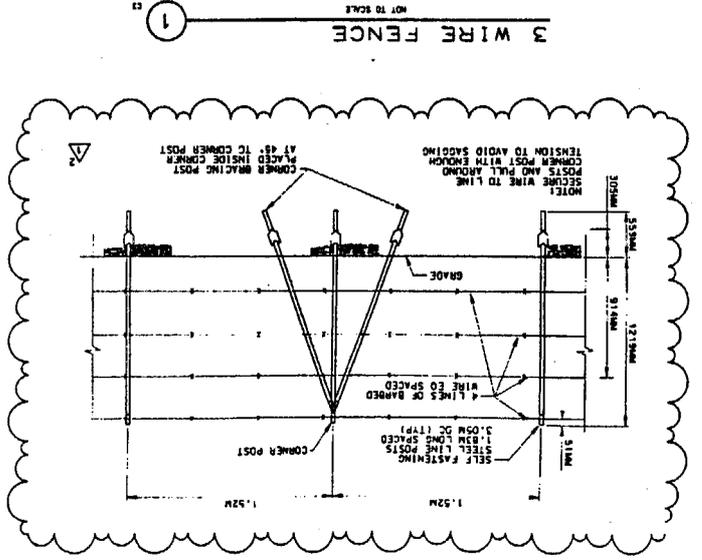
- SIGN NOTES**
1. THIS DETAIL APPLIES TO SIGNS ON FENCE ONLY.
 2. SIGN SHALL BE YELLOW WITH BLACK LETTERING AND RADIATION WARNING SYMBOL.
 3. MINIMUM LETTER/WORD HEIGHT SHALL BE CONTACT TEXT = 32MM WARNING TEXT = 19MM CONTACT TEXT = 19MM
 4. SIGN STOCK THICKNESS SHALL BE 16 GAGE/0.0635 ON ONE SIDE.
 5. SIGNS SHALL BE LOCATED CENTERED ON ALL SIDES OF FENCE AND GATE.
- FENCE NOTES**
1. FENCING SHALL MEET THE REQUIREMENTS OF SPECIFICATION SECTION 02831.
 2. ALL FENCING COMPONENT DIMENSIONS SHOWN ARE NOMINAL. SEE NOTE 1.

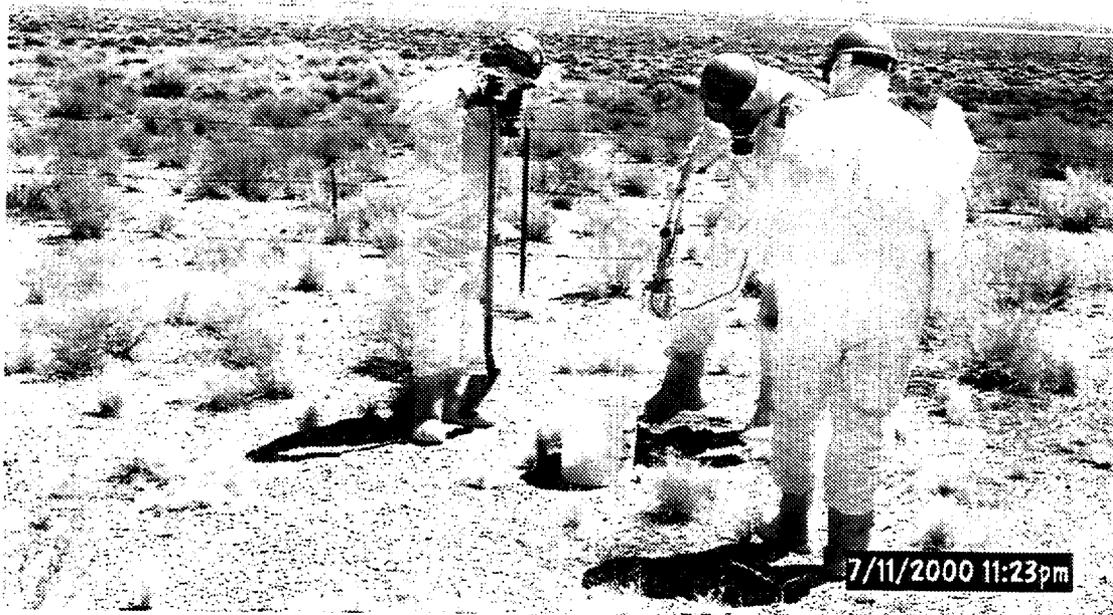
HOT SPOT REMOVAL

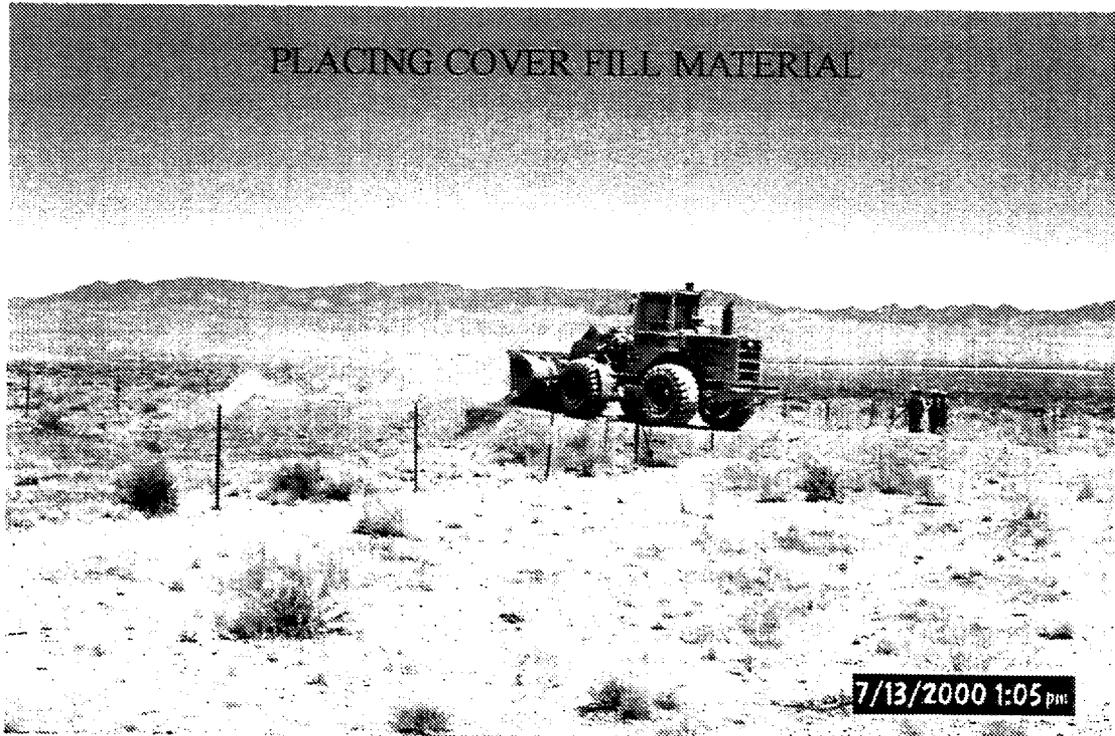
PLACING COVER FILL MATERIAL

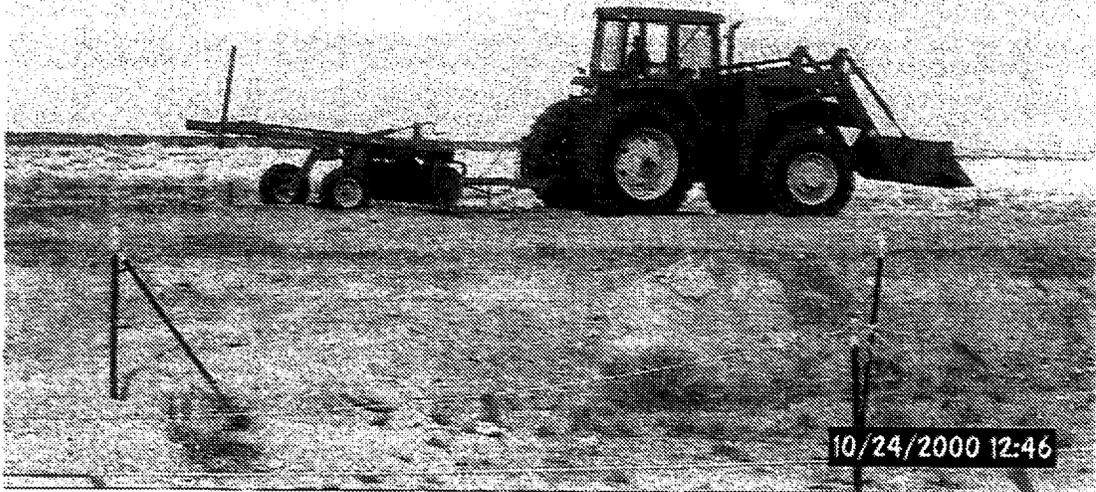
DISCING THE COVER SURFACE

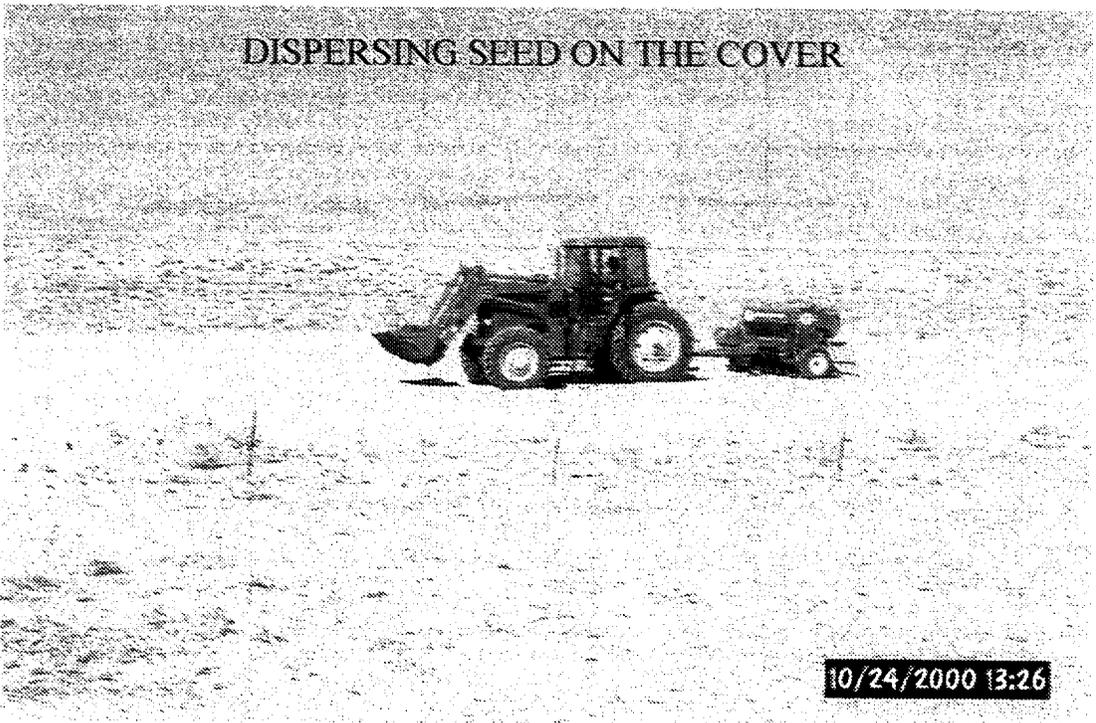
DISPERSING SEED ON THE COVER

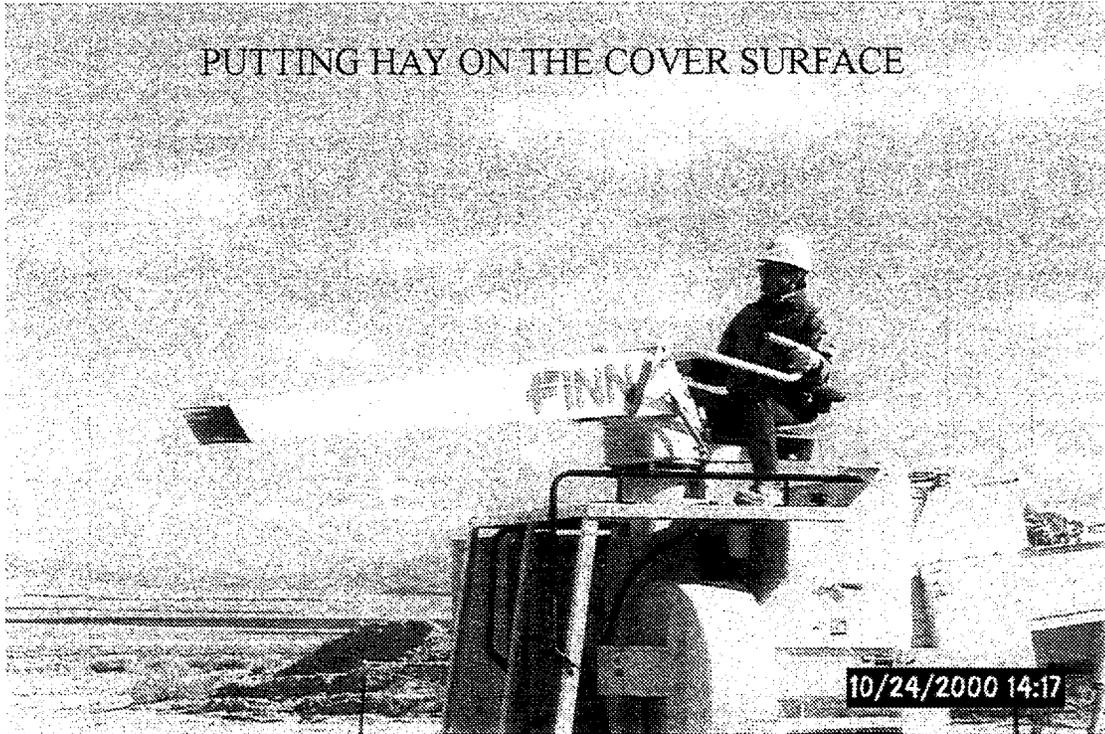
PUTTING HAY ON THE COVER SURFACE

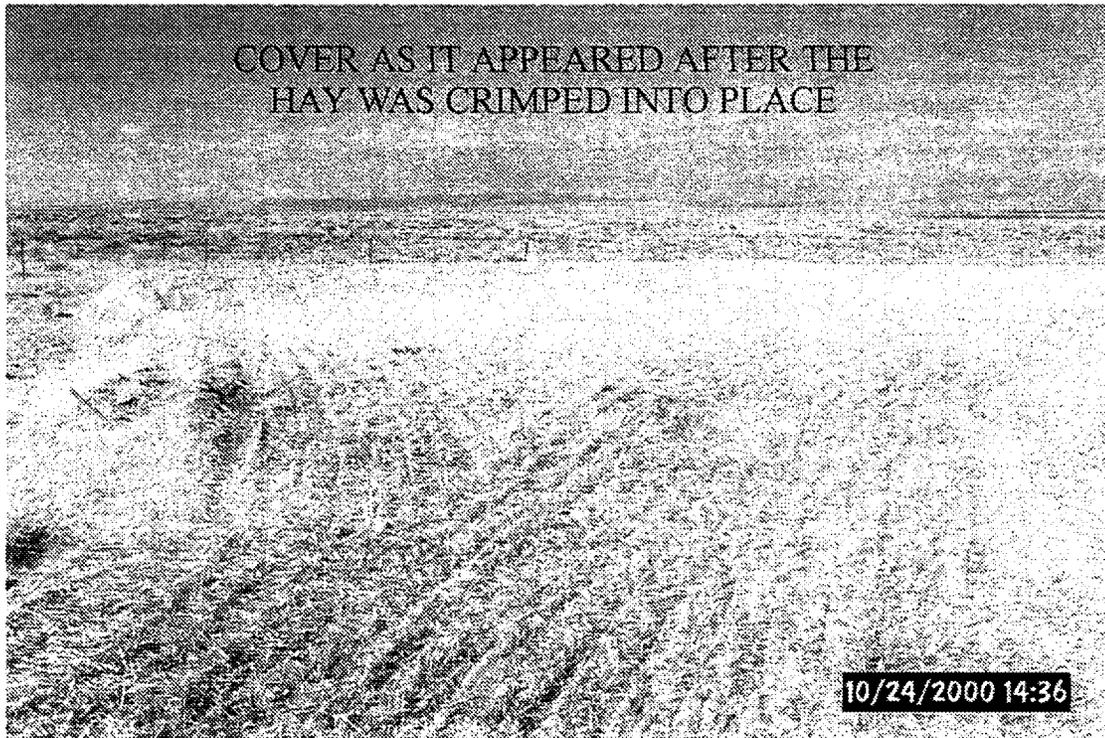
COVER AS IT APPEARED AFTER THE
HAY WAS CRIMPED INTO PLACE
