Subject: Annual Assessment of the Effectiveness of Site Wide Institutional Controls Applied to the Former Mound Site Property, June 2007

**Annual Assessment of the Effectiveness of
Site-Wide Institutional Controls
Applied to the Former
DOE Mound Site Property**

June 2007

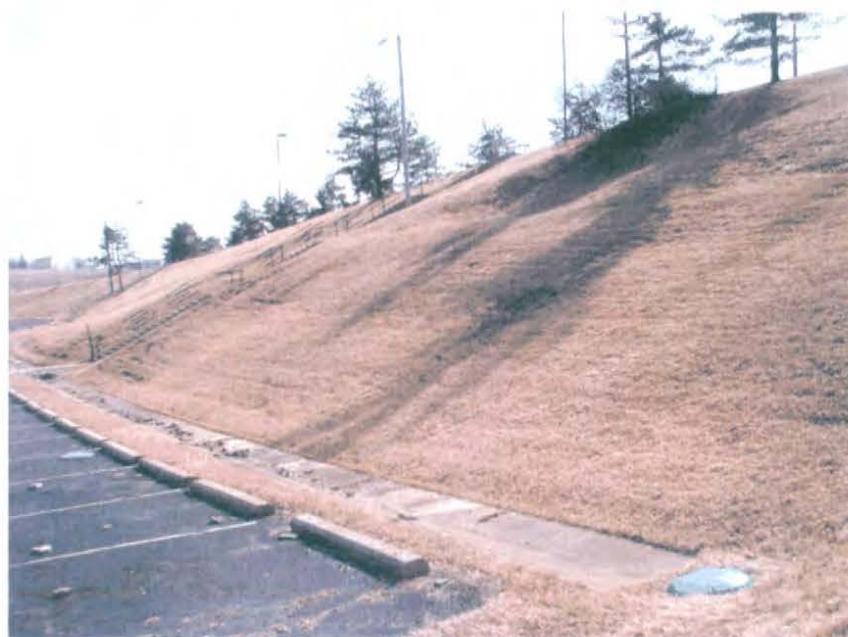
Figure 4. Parcel H March 2007 Sleds at bottom of Northeast Hillside

Three plastic sleds were seen abandoned at the bottom of the hill in the northeast corner of Parcel H. There was no evidence of continuous recreational use such as worn paths or constructed structures (Figure 4).

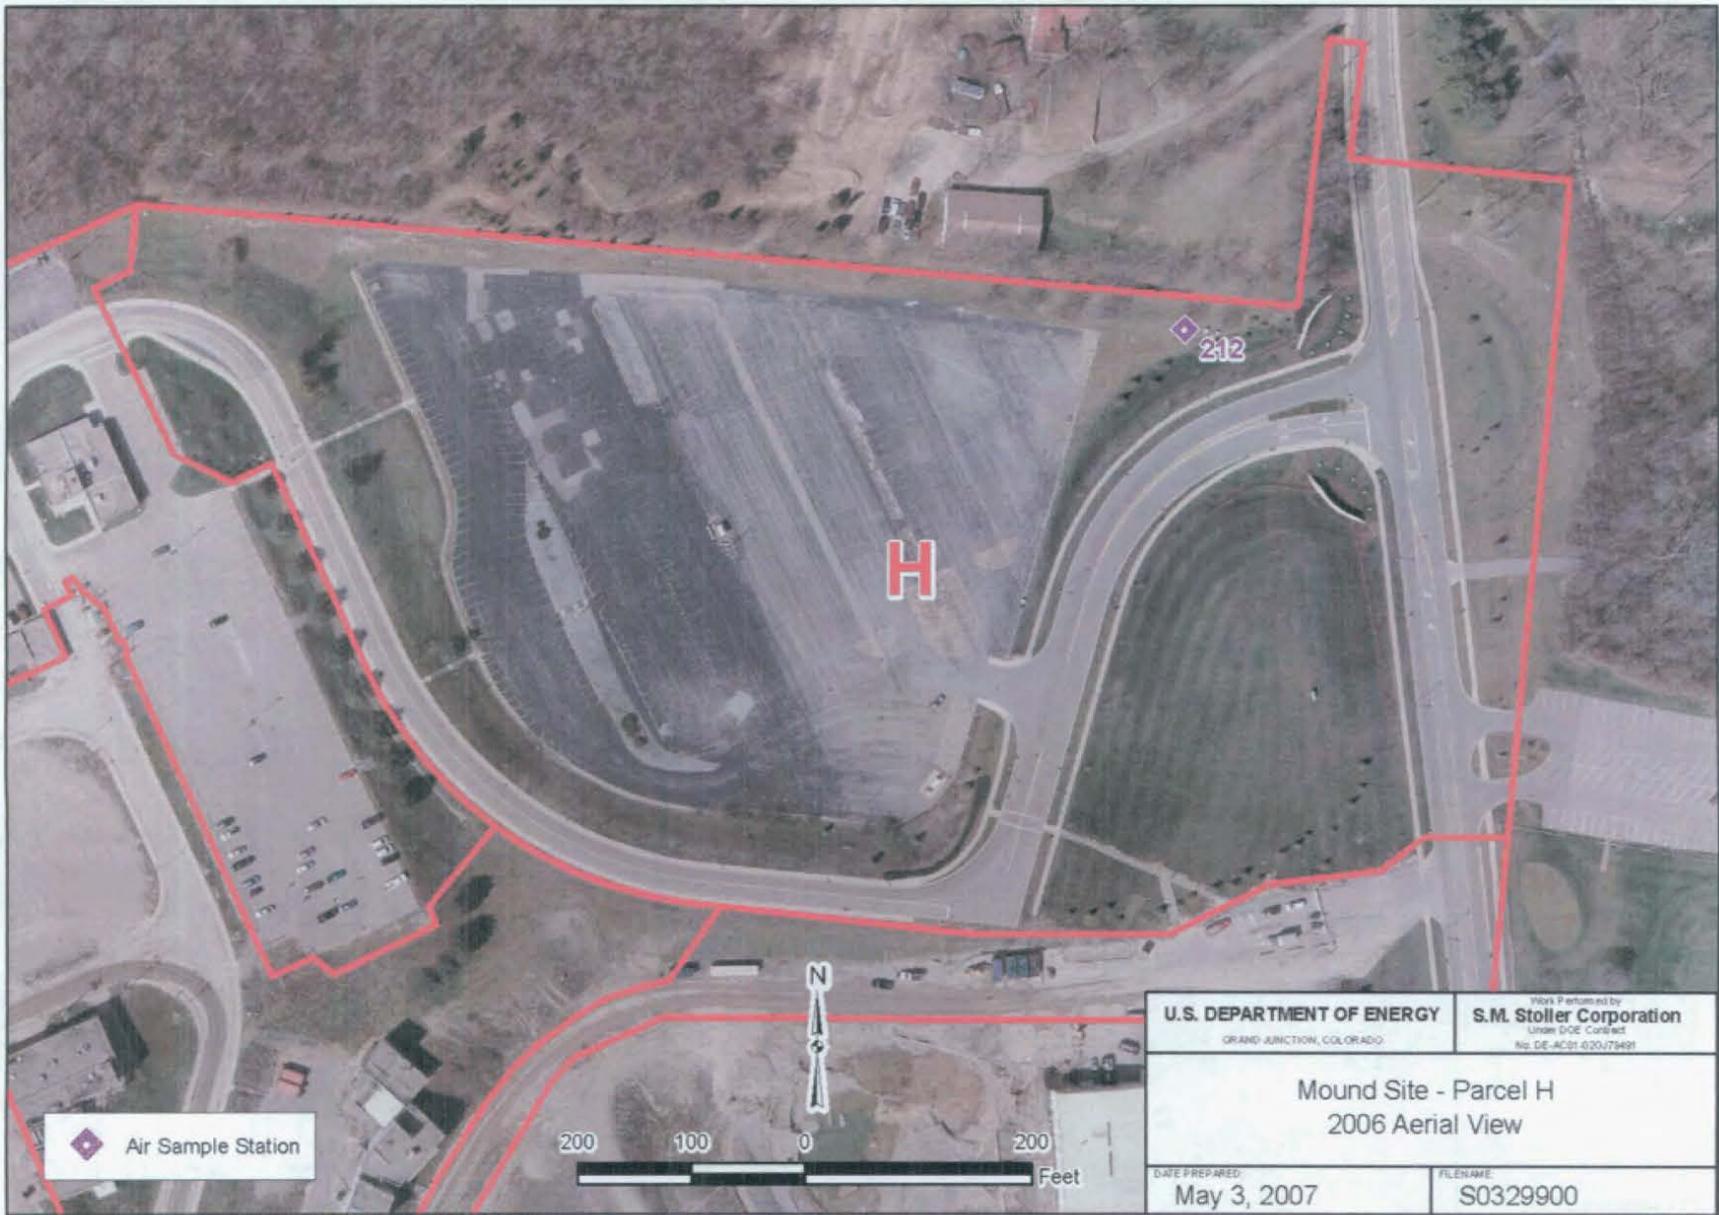
Figure 5. Parcel H 2006 Aerial View

In Parcel H, there were no observations of non-compliance with the ICs, including no evidence of unauthorized well installation or soil removal from the original boundaries of the DOE Mound Site Property (Figure 5).

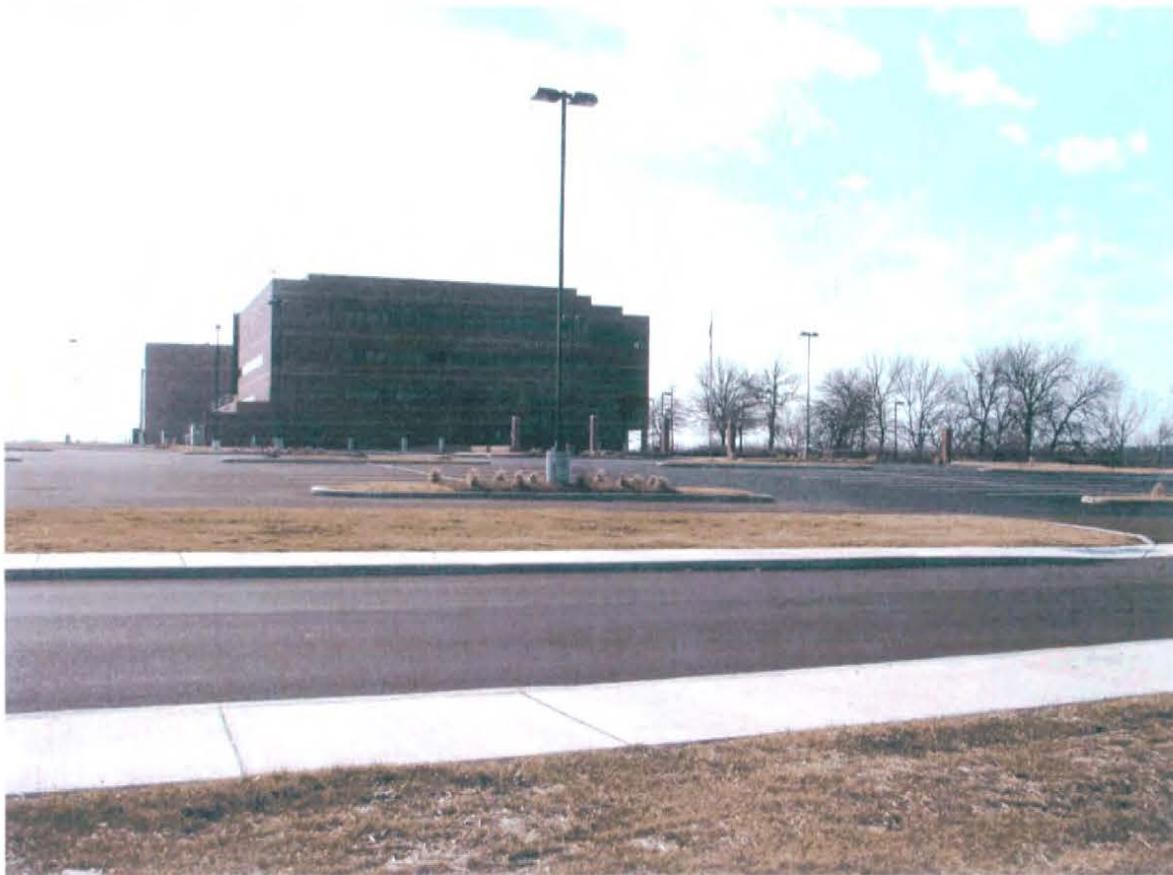
Figure 6. Parcel 3 New Parking Lot and Landscaping Replace Building GP-1

Major changes had occurred in the Parcel since the last assessment. MMCIC has demolished GP-1 Building and replaced it with parking and landscaping (Figure 6).

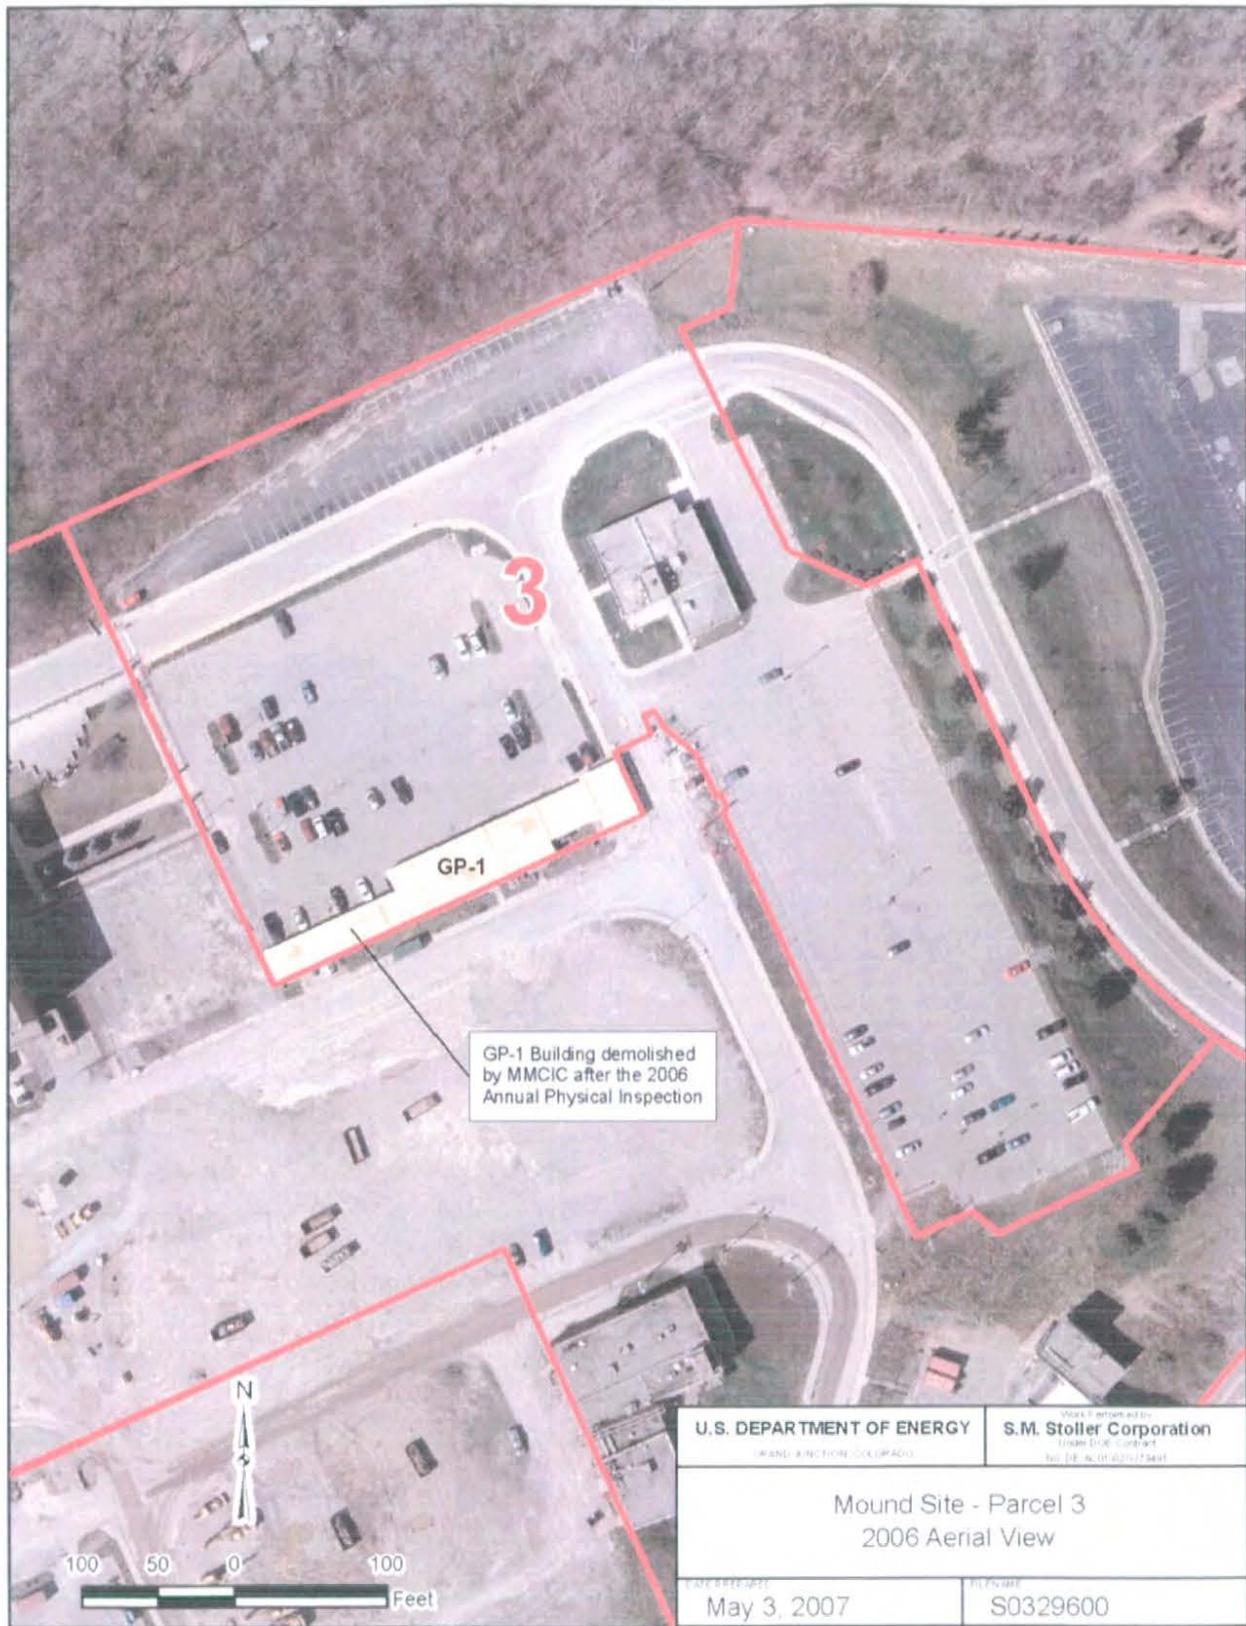
Figure 7. Parcel 3 2006 Aerial View

In Parcel 3, there were no observations of non-compliance with the ICs, including no evidence of unauthorized well installation or soil removal from the original boundaries of the DOE Mound Site Property (Figure 7). There are no groundwater monitoring wells located on Parcel 3.

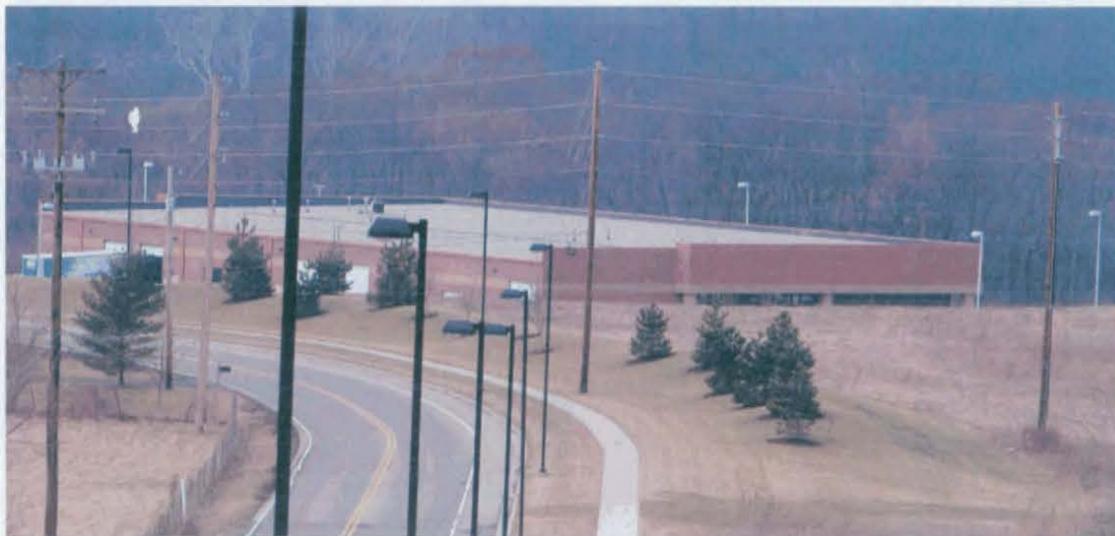
Figure 8. Parcel 4 MMCIC Flex Building in southwest corner of Parcel 4 (near Benner Road and Old 25)

The three year old "Flex" building in the southwest corner of Parcel 4 is leased to a single tenant. The tenant's line of business is consistent with the City of Miamisburg's I-2 General Industrial District Zoning ordinance (Figure 8).

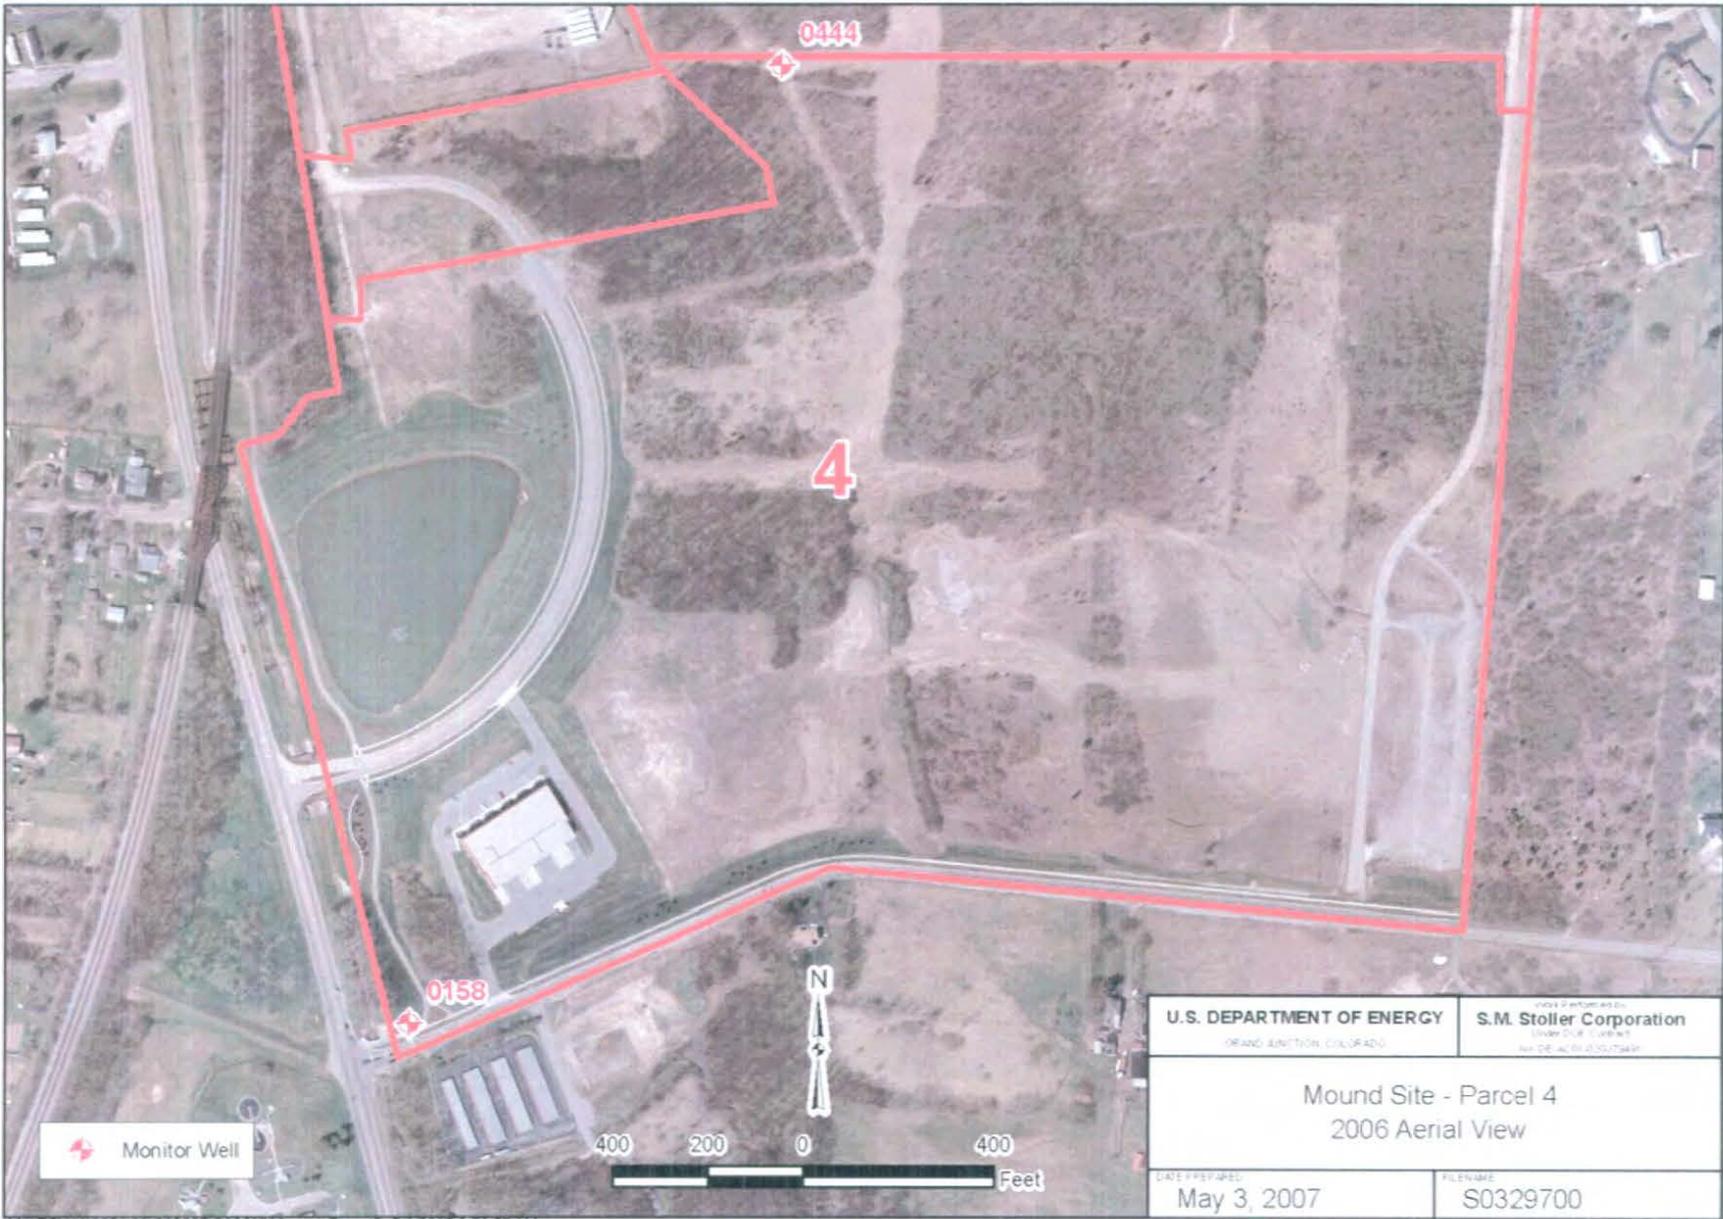
Figure 9. Parcel 4 2006 Aerial View

In Parcel 4, (Figure 9) there were no observations of non-compliance with the ICs including no evidence of unauthorized well installation or soil removal from the original boundaries of the DOE Mound Site Property.

There is one abandoned well, Well 0354, located near the northern boundary of Parcel 4. Well 0158, located near the intersection of Benner Road and Old State Route 25, is still functional but not currently part of a groundwater monitoring plan. It was locked and in good repair.

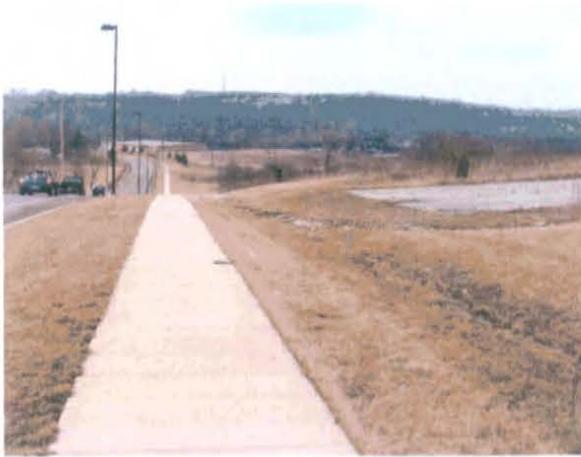
Figure 10. Parcel 4 Entry to old construction road on Benner Road

Unauthorized vehicular access to the old southeast construction road is still prohibited by a sidewalk installed along Benner Road. The northern entrance to this road is blocked by fencing and a locked gate. (Figure 10 Figure 11)

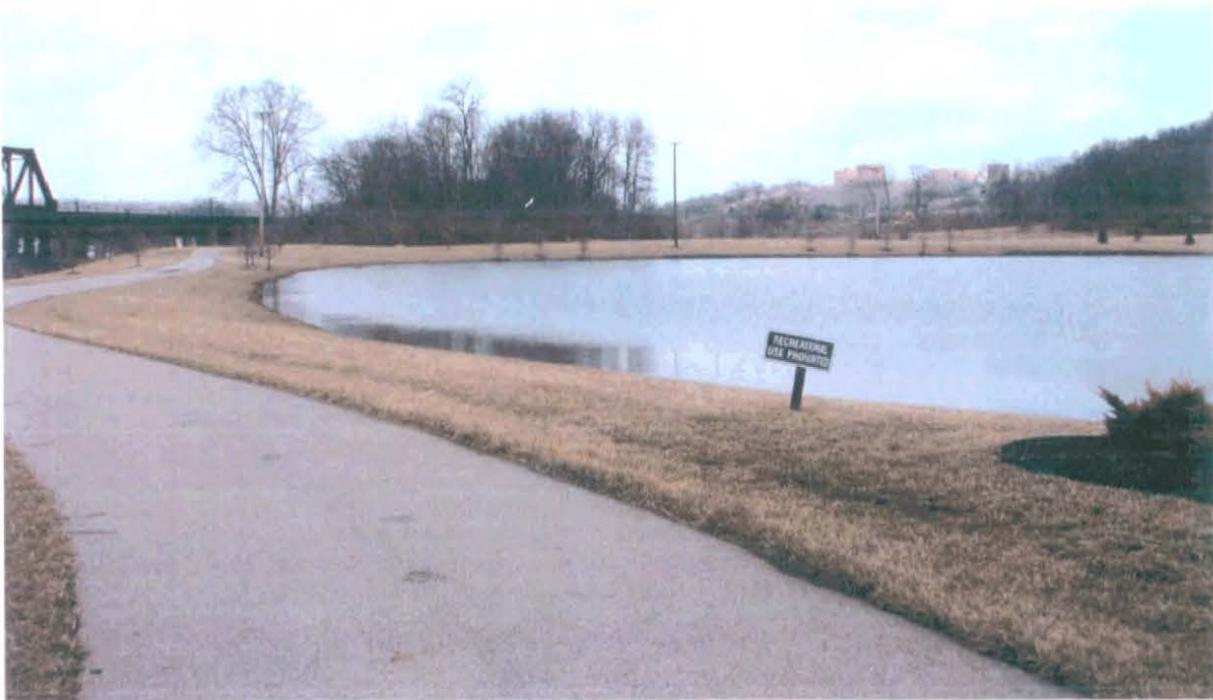
Figure 12. Parcel 4 MMCIC Retention Pond with signage in foreground. Bike path between pond and Old Route 25

There is a storm water run-off retention/detention pond located on Parcel 4 (Figure 12). This pond is posted with four signs stating, "Recreational Use Prohibited." The signs were placed around the pond after people were observed fishing in the pond during June 2004 and in 2005. There are no indications of fishing during this year's physical inspection.

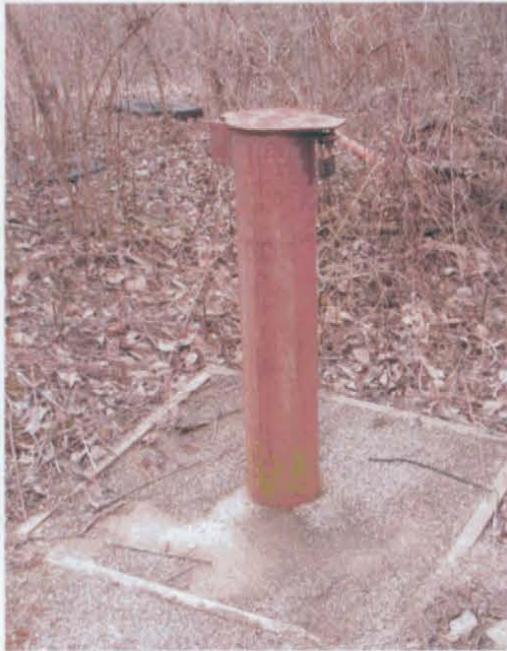
Figure 13. Parcel 4 Well 0444 Locked and in Good Repair

Well 0444, the only active groundwater monitoring well on Parcel 4, is located on the northern boundary of Parcel 4, near the boundary of the Phase I land parcel. Well 0444 was padlocked and in good repair, but it is not identified by an external monument. (Figure 13)

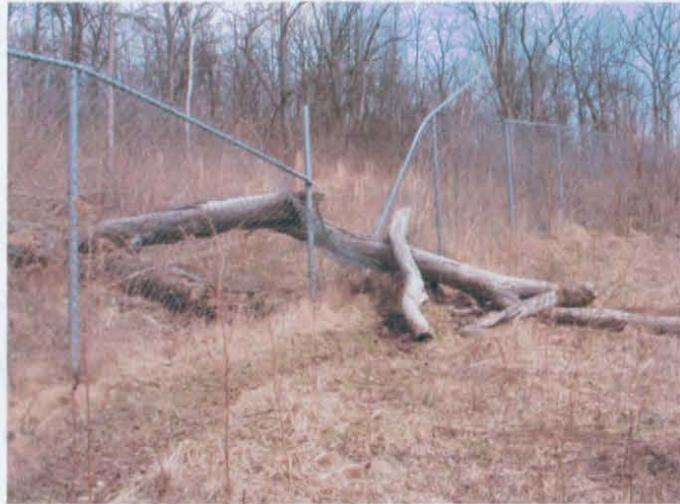
Figure 14. Parcel 4 Fallen log across fence

There was a log across a damaged fence along the northern boundary of Parcel 4 near well 0444. The fencing is not part of the institutional control for that parcel. (Figure 14)

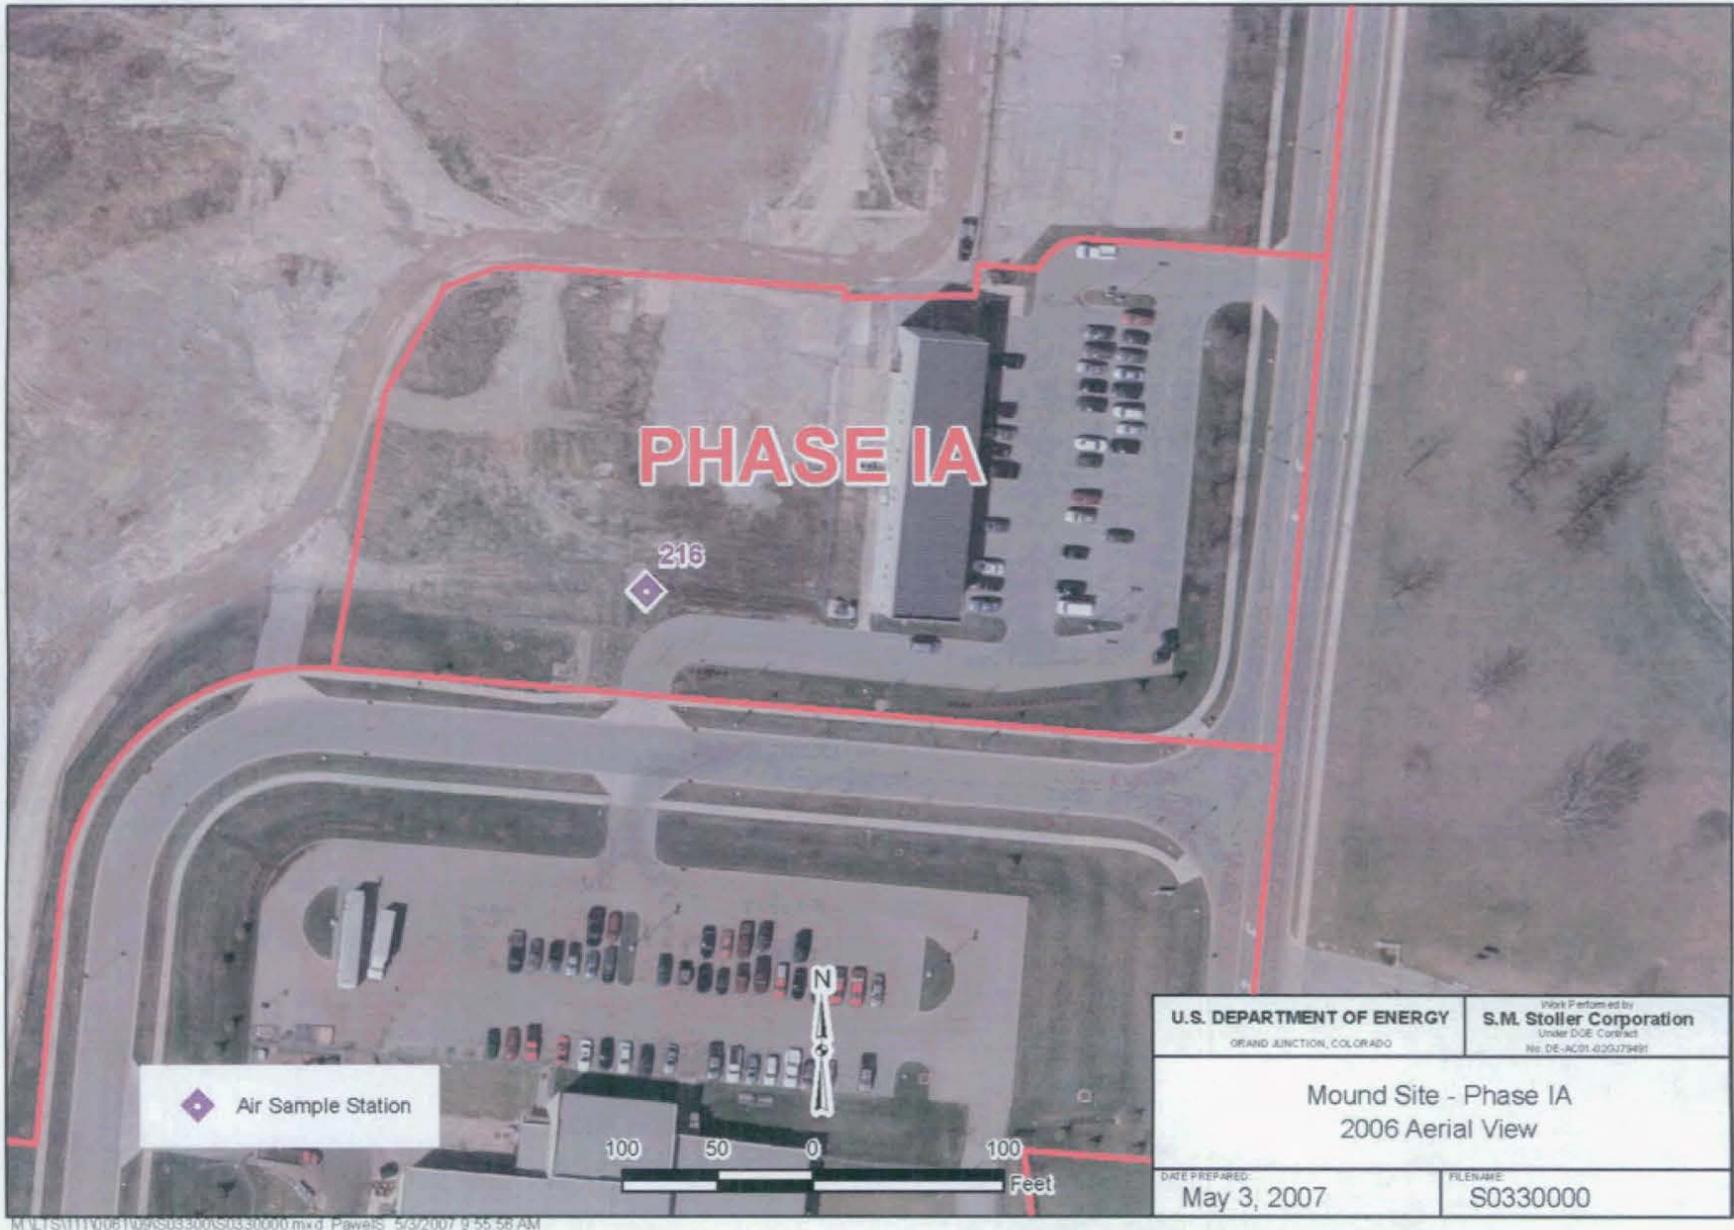
Figure 15. Parcel Phase IA 2006 Aerial View

Phase I land parcel consists of three, noncontiguous sub-parcels A, B and C, which have not transferred to the MMCIC (Figure 15, Figure 16, and Figure 17). The Phase I land parcel includes both an IC Remedy and a Monitored Natural Attenuation (MNA) Remedy.

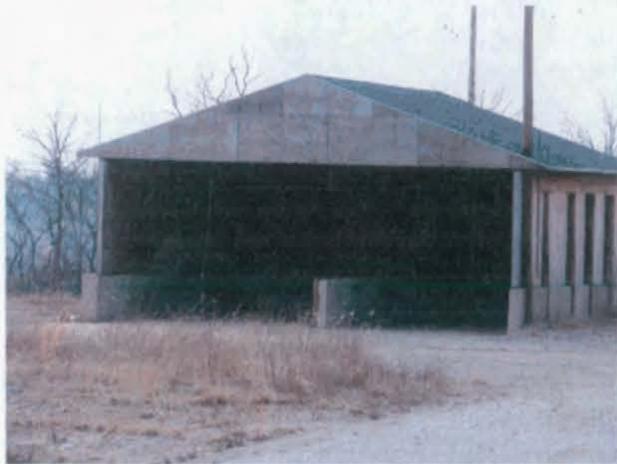
Figure 18. Phase IB Empty salt storage shed

The salt storage shed and concrete pad in Parcel 1B are empty as shown in Figure 18 and Figure 19.

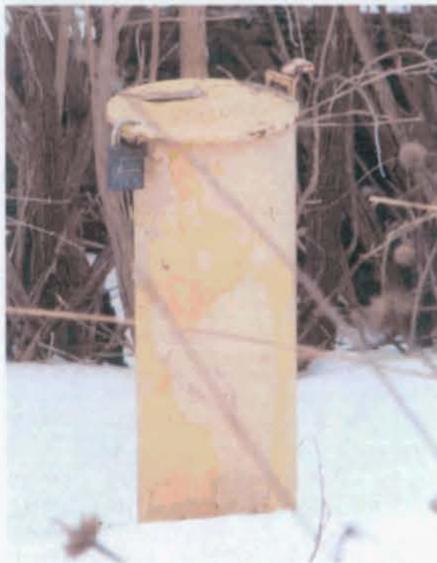
Figure 20. Phase IB Well 0411 locked and in good repair

Wells 0411, 0442 and 0443 were locked and in good repair. Seep 0617 was in good condition. (Figure 20, Figure 21, Figure 22, and Figure 23)

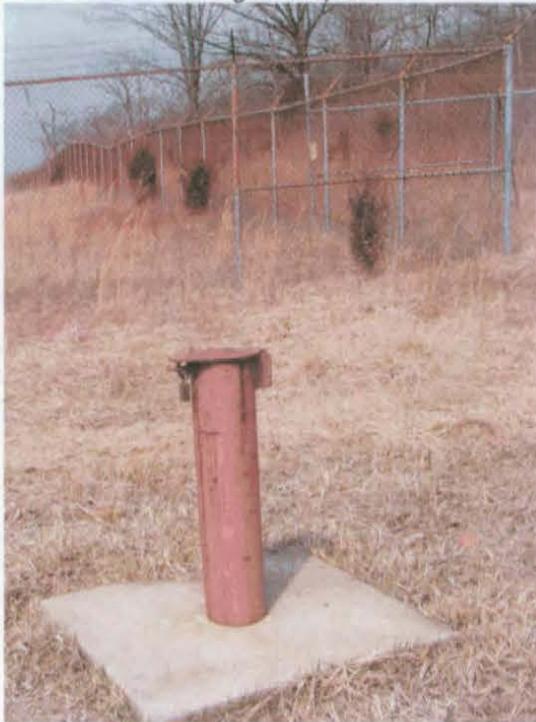
Figure 24. Parcel IC Well 0445 locked and in good repair

The 2006 Annual Assessment Report recommended that well 0445 in Phase IC be abandoned. Due to low flow, this downgradient well is never flushed and, therefore, is not effective. This recommendation was not directly related to the ICs.

Well 0445 was locked and in good repair. (Figure 24)

Last year's recommendation to abandon well 0445 located in Phase IC will be included in a site wide well closure effort after the final groundwater monitoring plan is developed. This planning will occur after OU-1 excavation work is completed.

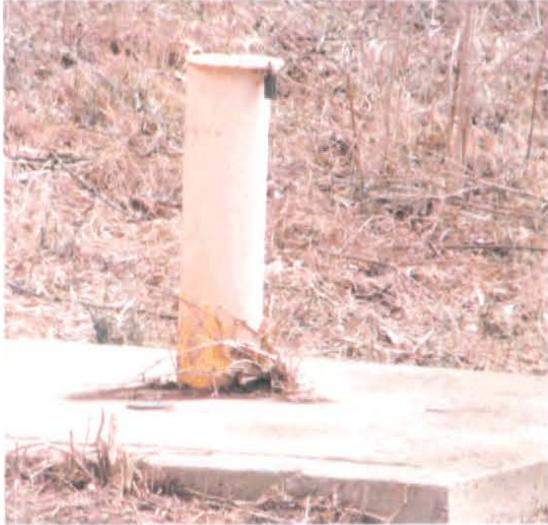
Figure 25. Parcel IC Well 0400 locked and in good repair. Weeds growing between casing and concrete pad.

Wells 0400, P033, and 0319 were locked and in good repair. Well 0400 had some vegetation growing between the casing and the concrete pad. (Figure 25, Figure 26, and Figure 28)

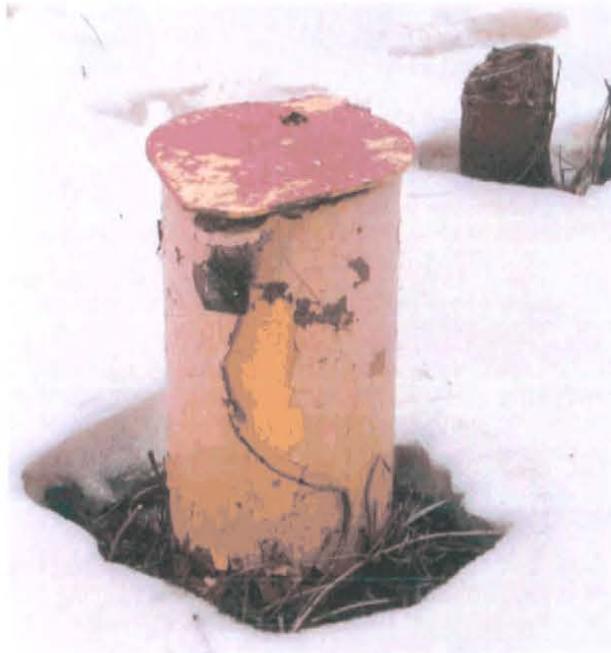
Figure 27. Parcel IC Well 0344, locked and in good repair

Well 0344 was locked and in good repair, but is not part of any current monitoring program. (Figure 27)
