TYPE 1 RECONNAISSANCE LEVEL CHARACTERIZATION REPORT (RLCR)

SEWAGE TREATMENT PLANT CHLORINE CONTACT BASINS CLOSURE PROJECT (995-CCC-1 and 995-CCC-2)

REVISION 0

December 20, 2004

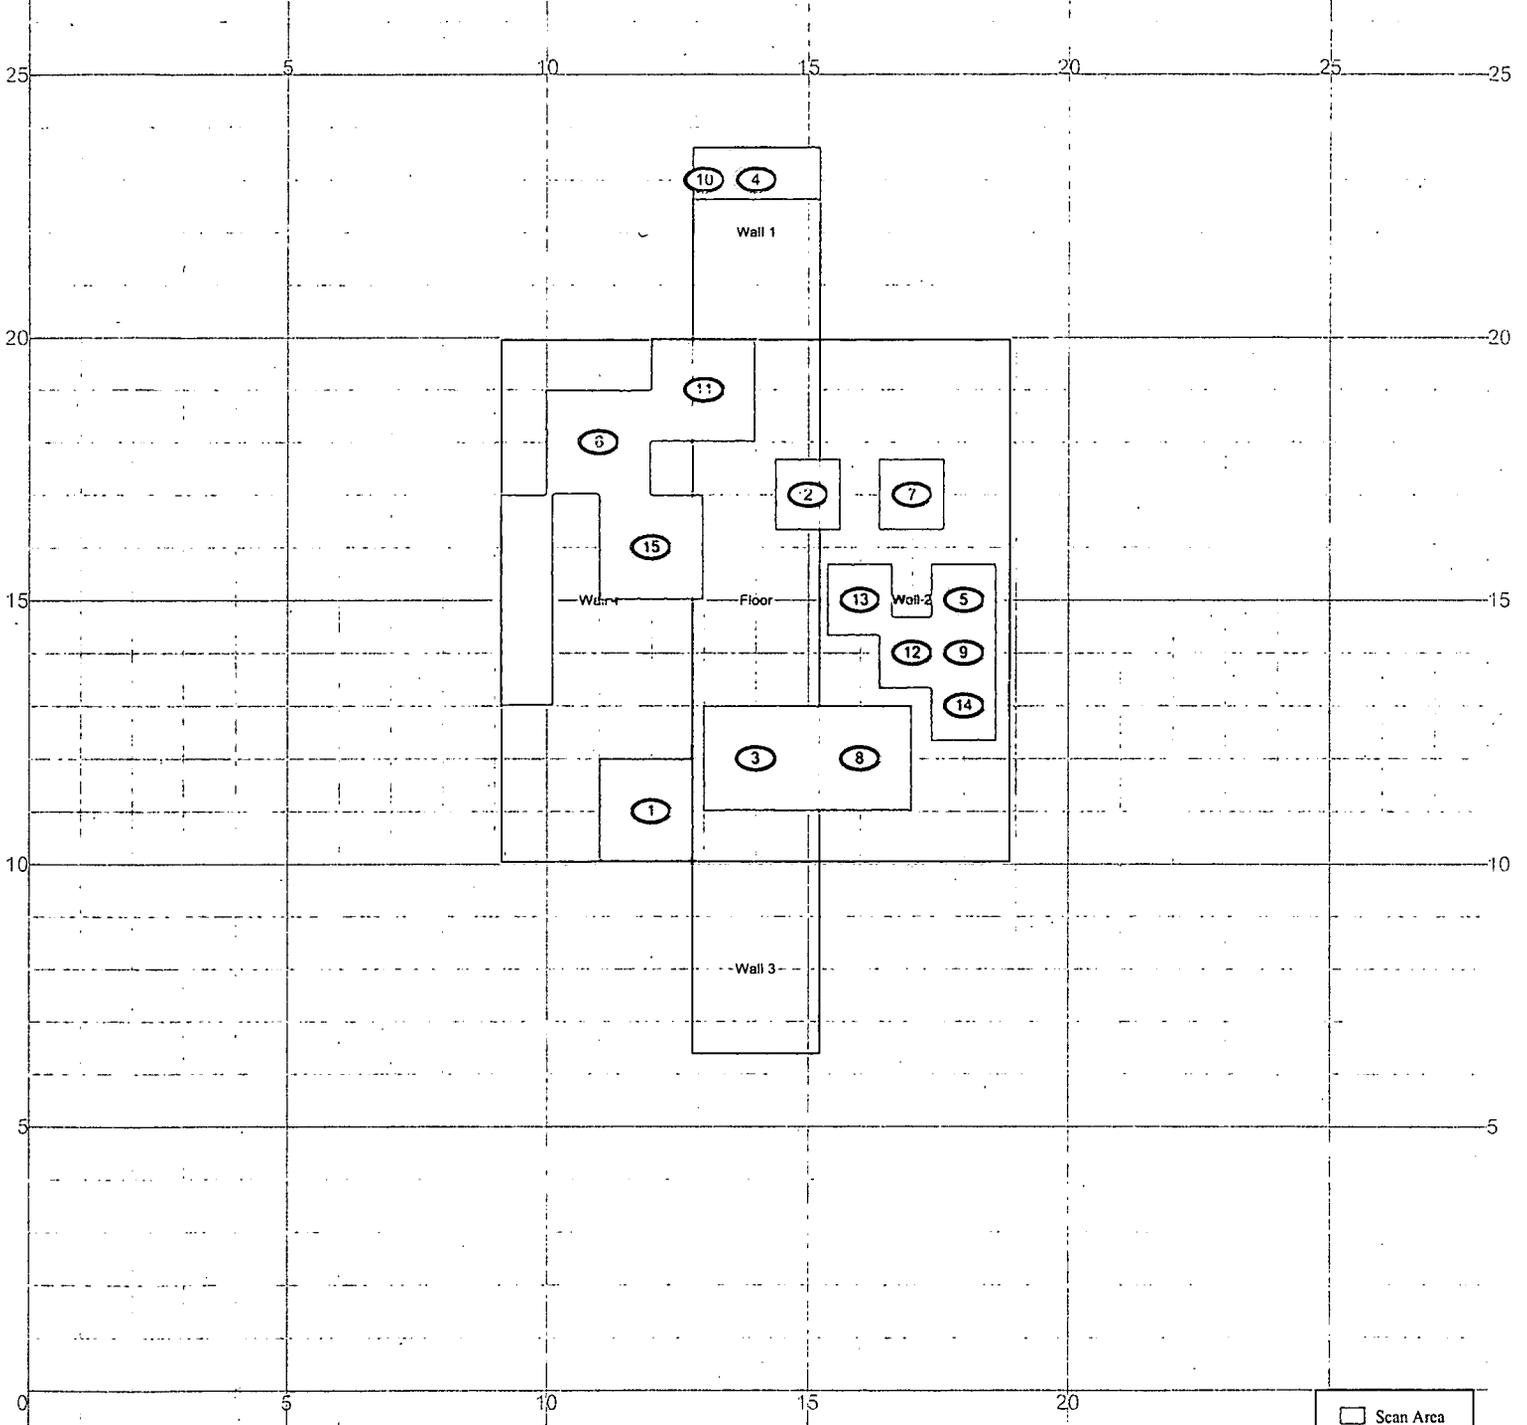
Survey Area: 5 Survey Unit: 995CC1 Classification: 3
 Building: 995-CCC-1
 Survey Unit Description: B995-CCC-1 Chlorine Contact Basin (All Surfaces)
 Total Area: 114 sq. m. Total Floor Area: 24 sq. m.

Seventeen (17) TSA measurements (15 random and 2 QC) and fifteen (15) RSA measurements (15 random) were performed; and a minimum of 20% of the facility surfaces were scanned on all surfaces of each facility. The RLC data confirmed that these facilities do not contain radiological contamination above the surface contamination guidelines provided in the PDSP. Radiological survey data, statistical analysis results, and survey locations are presented in Attachment C, *Radiological Data Summary and Survey Maps*. The radiological survey unit packages are maintained in the RISS Characterization Project files. Level 2 Isolation Control postings are displayed on the facilities to ensure no radioactive materials are inadvertently introduced.

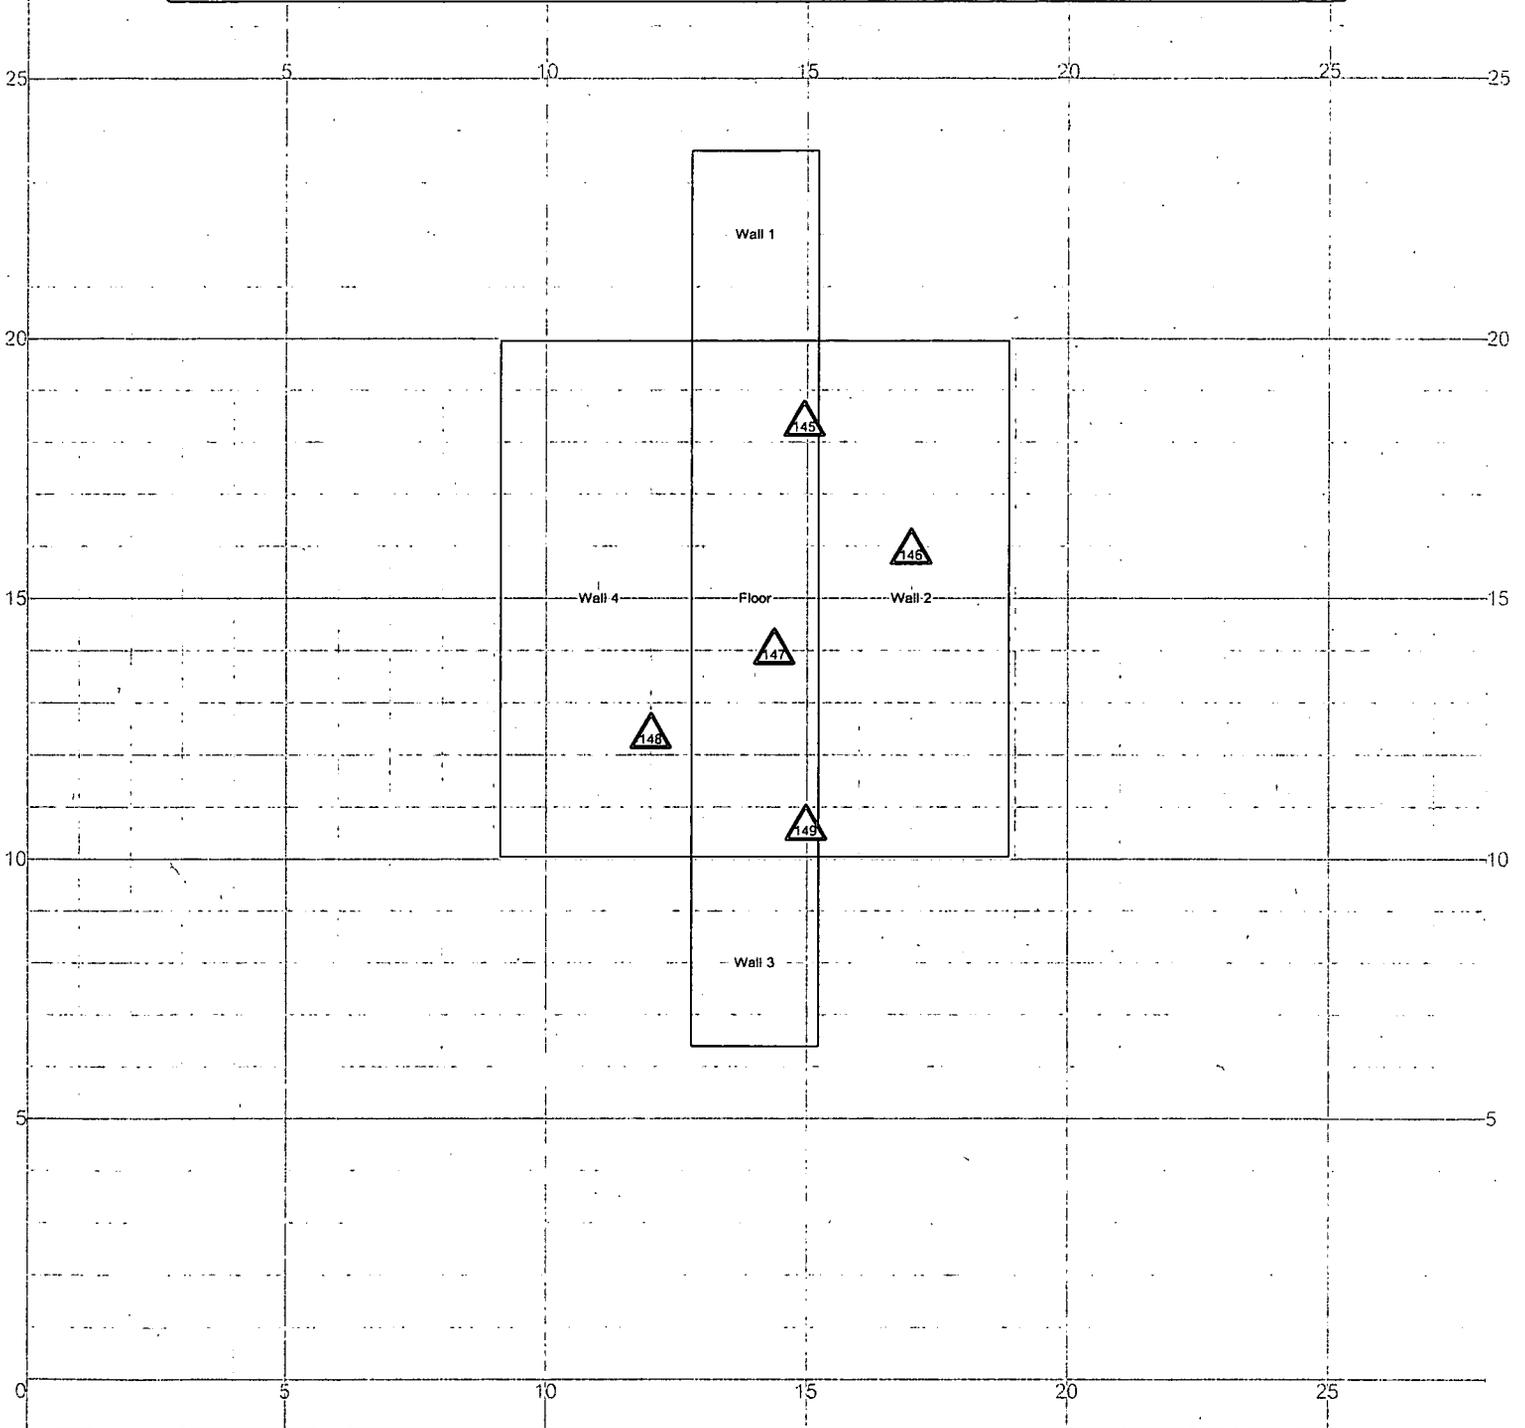
Chlorine Contact Basin 995-CCC-1 Beryllium

All beryllium smear sample results were less than $0.1 \mu\text{g}/100\text{cm}^2$ and meet the unrestricted release limits. Beryllium laboratory sample data and location maps are contained in Attachment D, *Chemical Data Summaries and Sample Maps*.
