TRANSMITTAL OF THE DRAFT ENVIRONMENTAL RESTORATION RFCA  
STANDARD OPERATING PROTOCOL FOR ROUTINE SOIL REMEDIATION  
NOTIFICATION #02-10 - JLB-052-02

**DRAFT ENVIRONMENTAL RESTORATION  
RFCA STANDARD OPERATING PROTOCOL  
FOR ROUTINE SOIL REMEDIATION  
FY02 NOTIFICATION #02-10  
IHSS GROUP 300-1**

**September 2002**

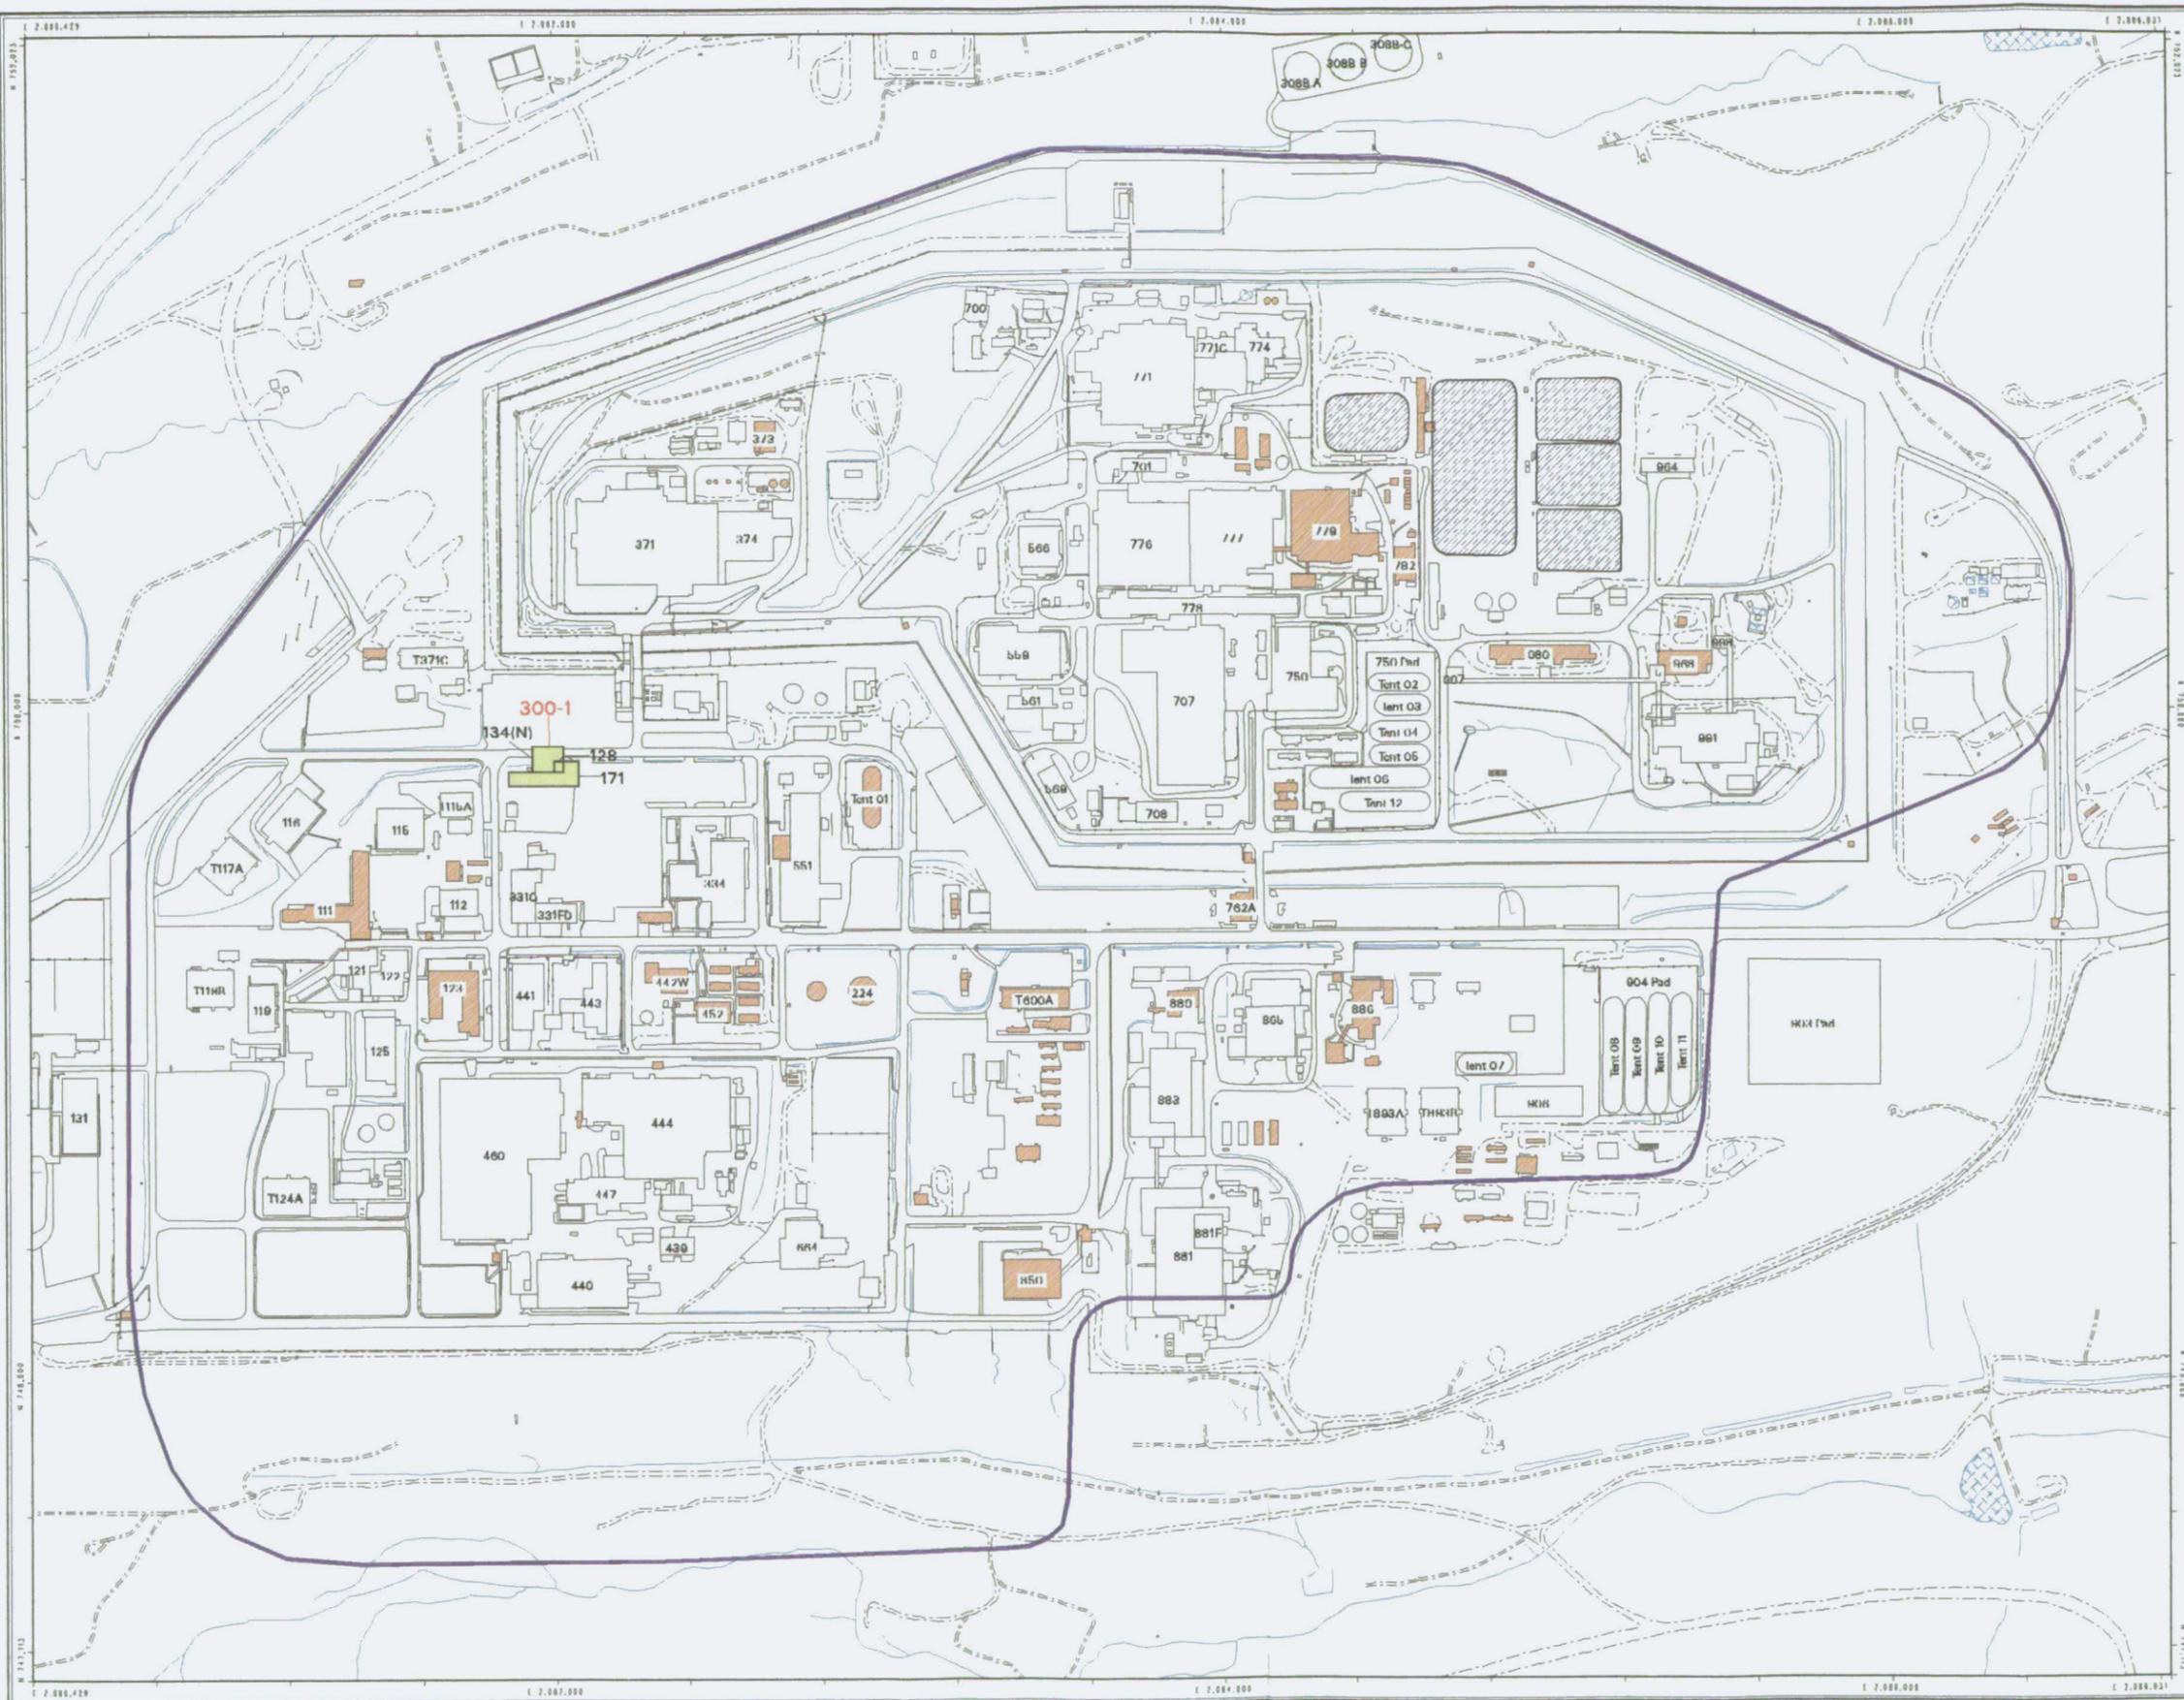
IHSS Group 300-1 includes IHSS 300-128, Oil Burn Pit #1; IHSS 300-134(N), Lithium Metal Site; and IHSS 300-171, Solvent Burning Grounds. The IHSS locations are shown on Figure 2.

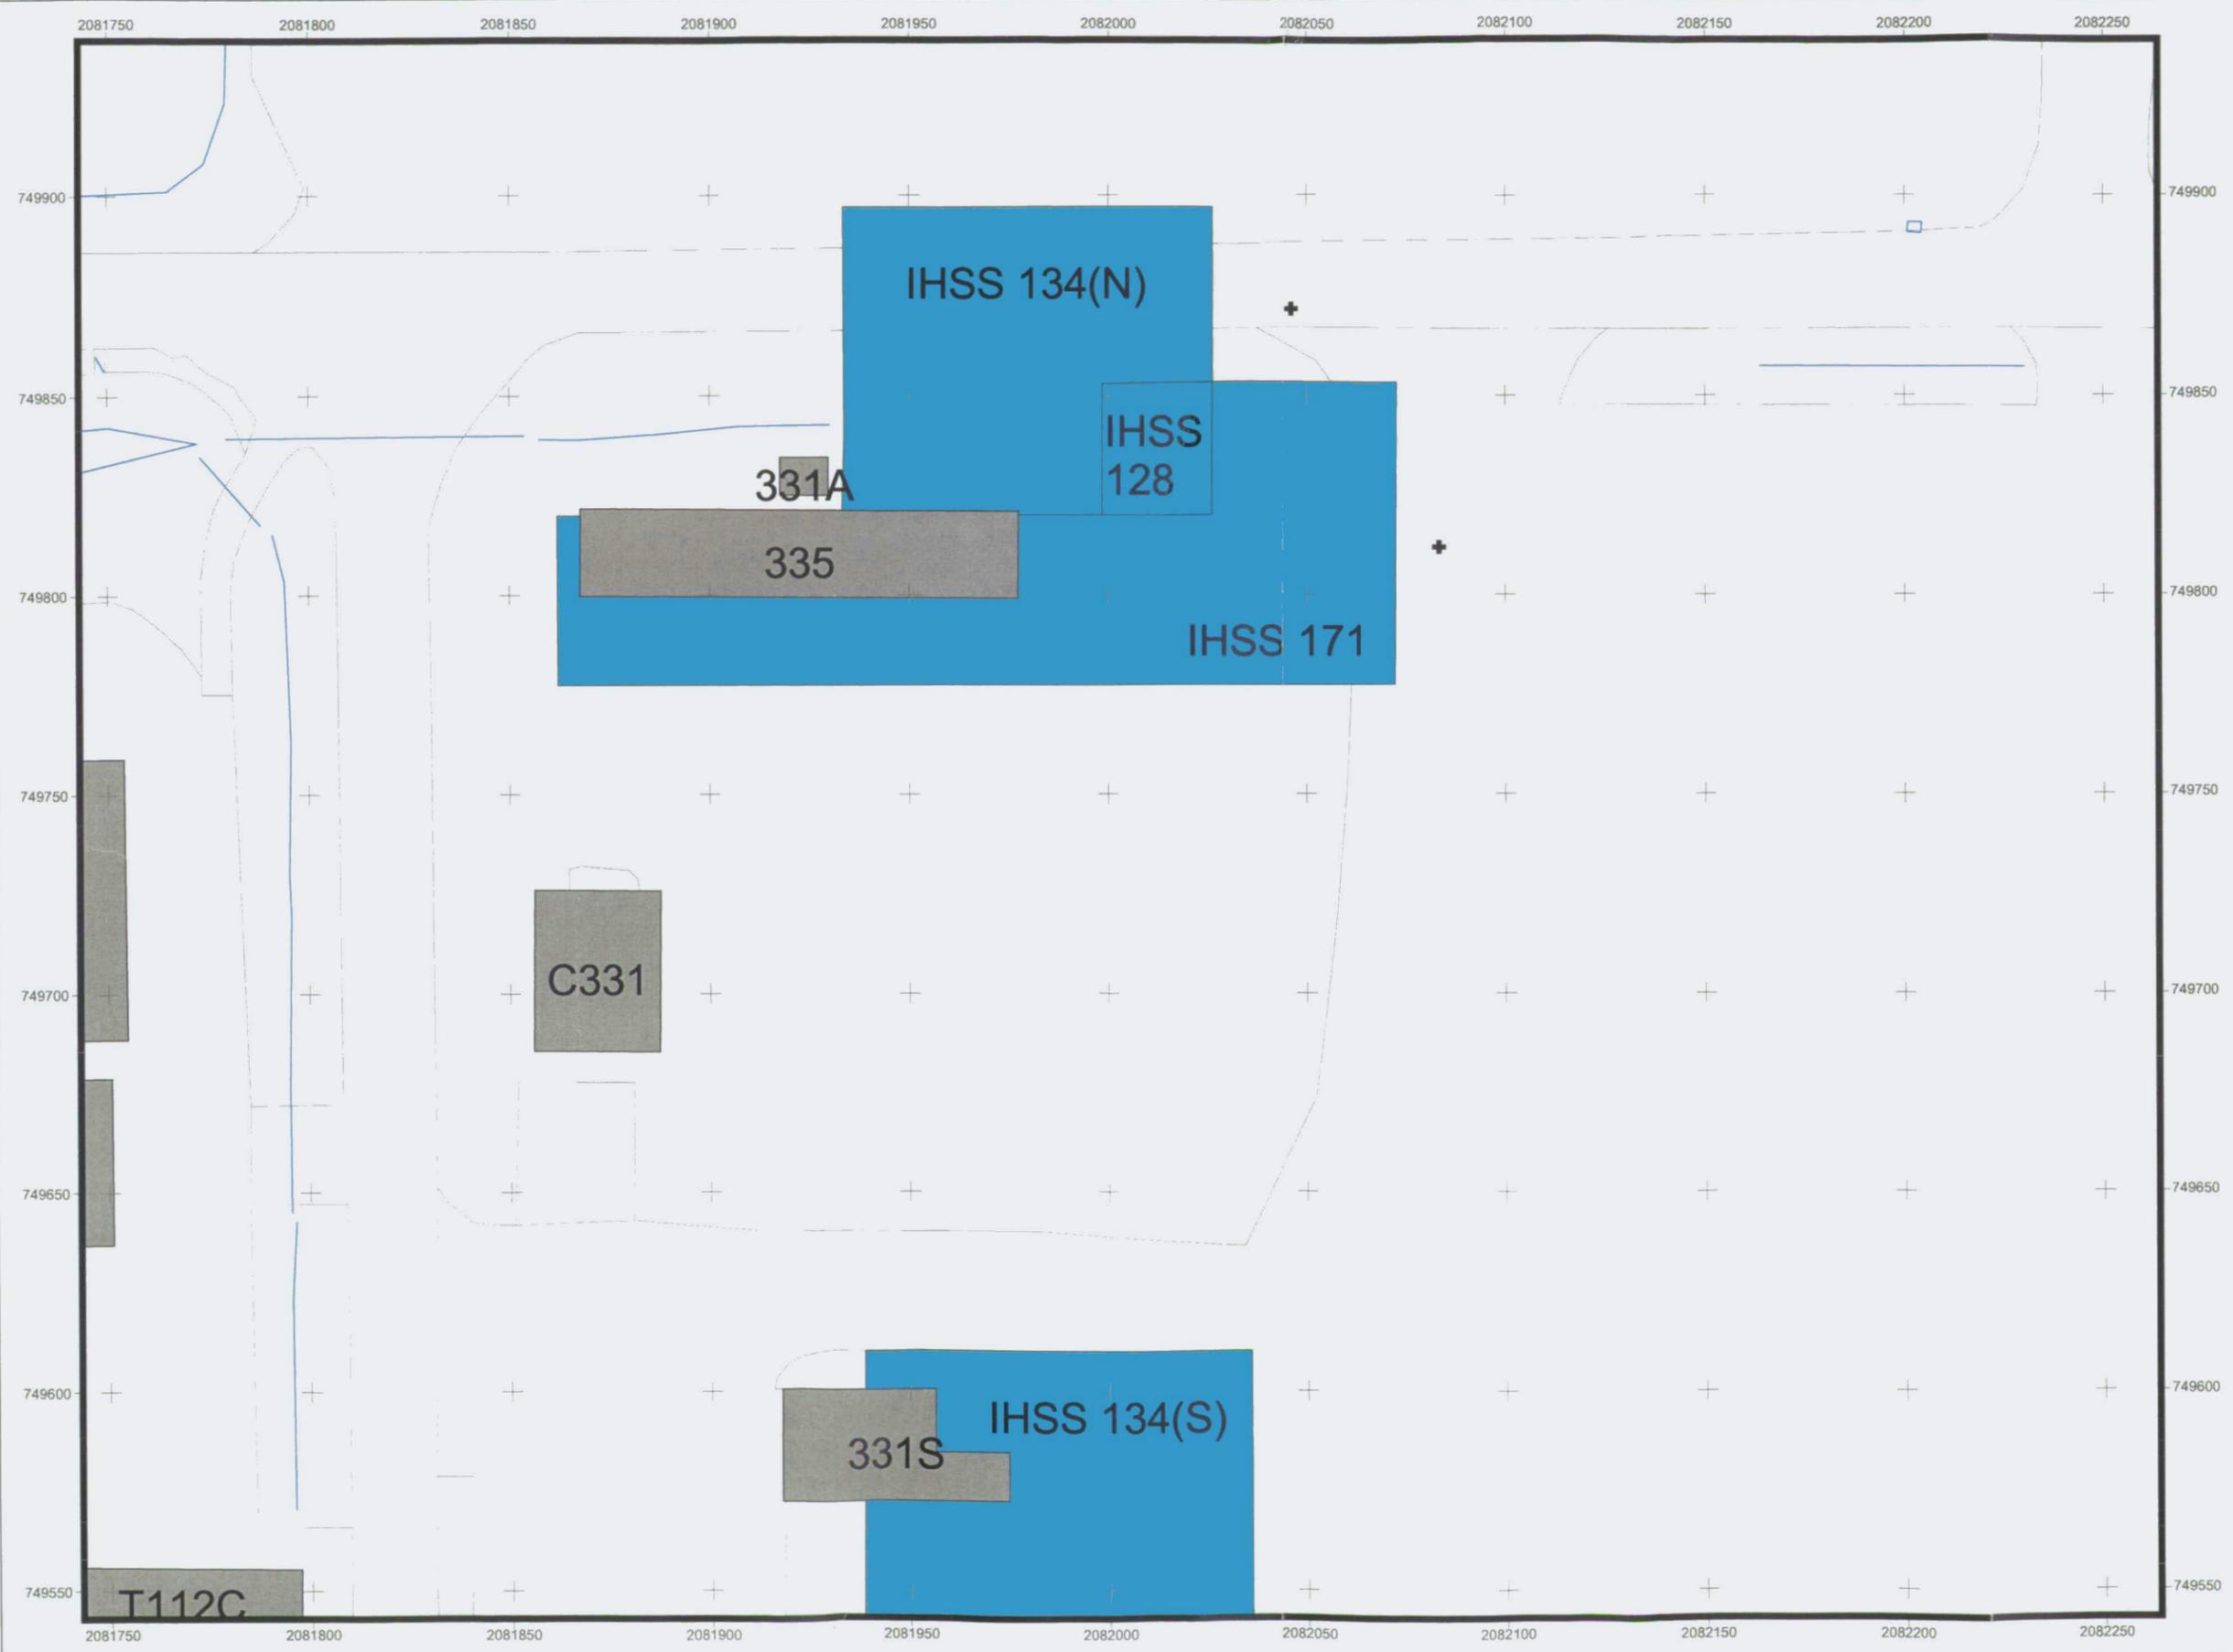
Figure 2  
Potential Remediation Area  
IHSS Group 300-1

Based on the PCOCs (Table 1 and Section 2.1) and the ER RSOP (DOE 2002), it is anticipated that all contamination above RFCA Tier I ALs will be remediated. Figure 2 shows the potential remediation area. Additional remediation to below Tier I ALs is not required by RFCA but will be evaluated using the consultative process.

IHSS Group 300-1 is in the RFETS IA. It is not located near other potential contaminant sources. The nearest IHSS, PAC or UBC is IHSS 134(S), which is located 170 feet to the south (refer to Figure 2). Therefore, other contaminant sources do not affect stewardship considerations at IHSS Group 300-1.

High-volume air samplers may be used at the remediation area consistent with work controls to determine airborne radioactivity concentrations. Approximate locations of air samplers are shown on Figure 2.
