ASBESTOS CHARACTERIZATION REPORT

BUILDINGS 776 & 777

ROCKY FLATS ENVIRONMENTAL TECHNOLOGY SITE

Foothills Environmental, Inc.
2801 Youngfield St., Ste. 300
Golden, CO 80401

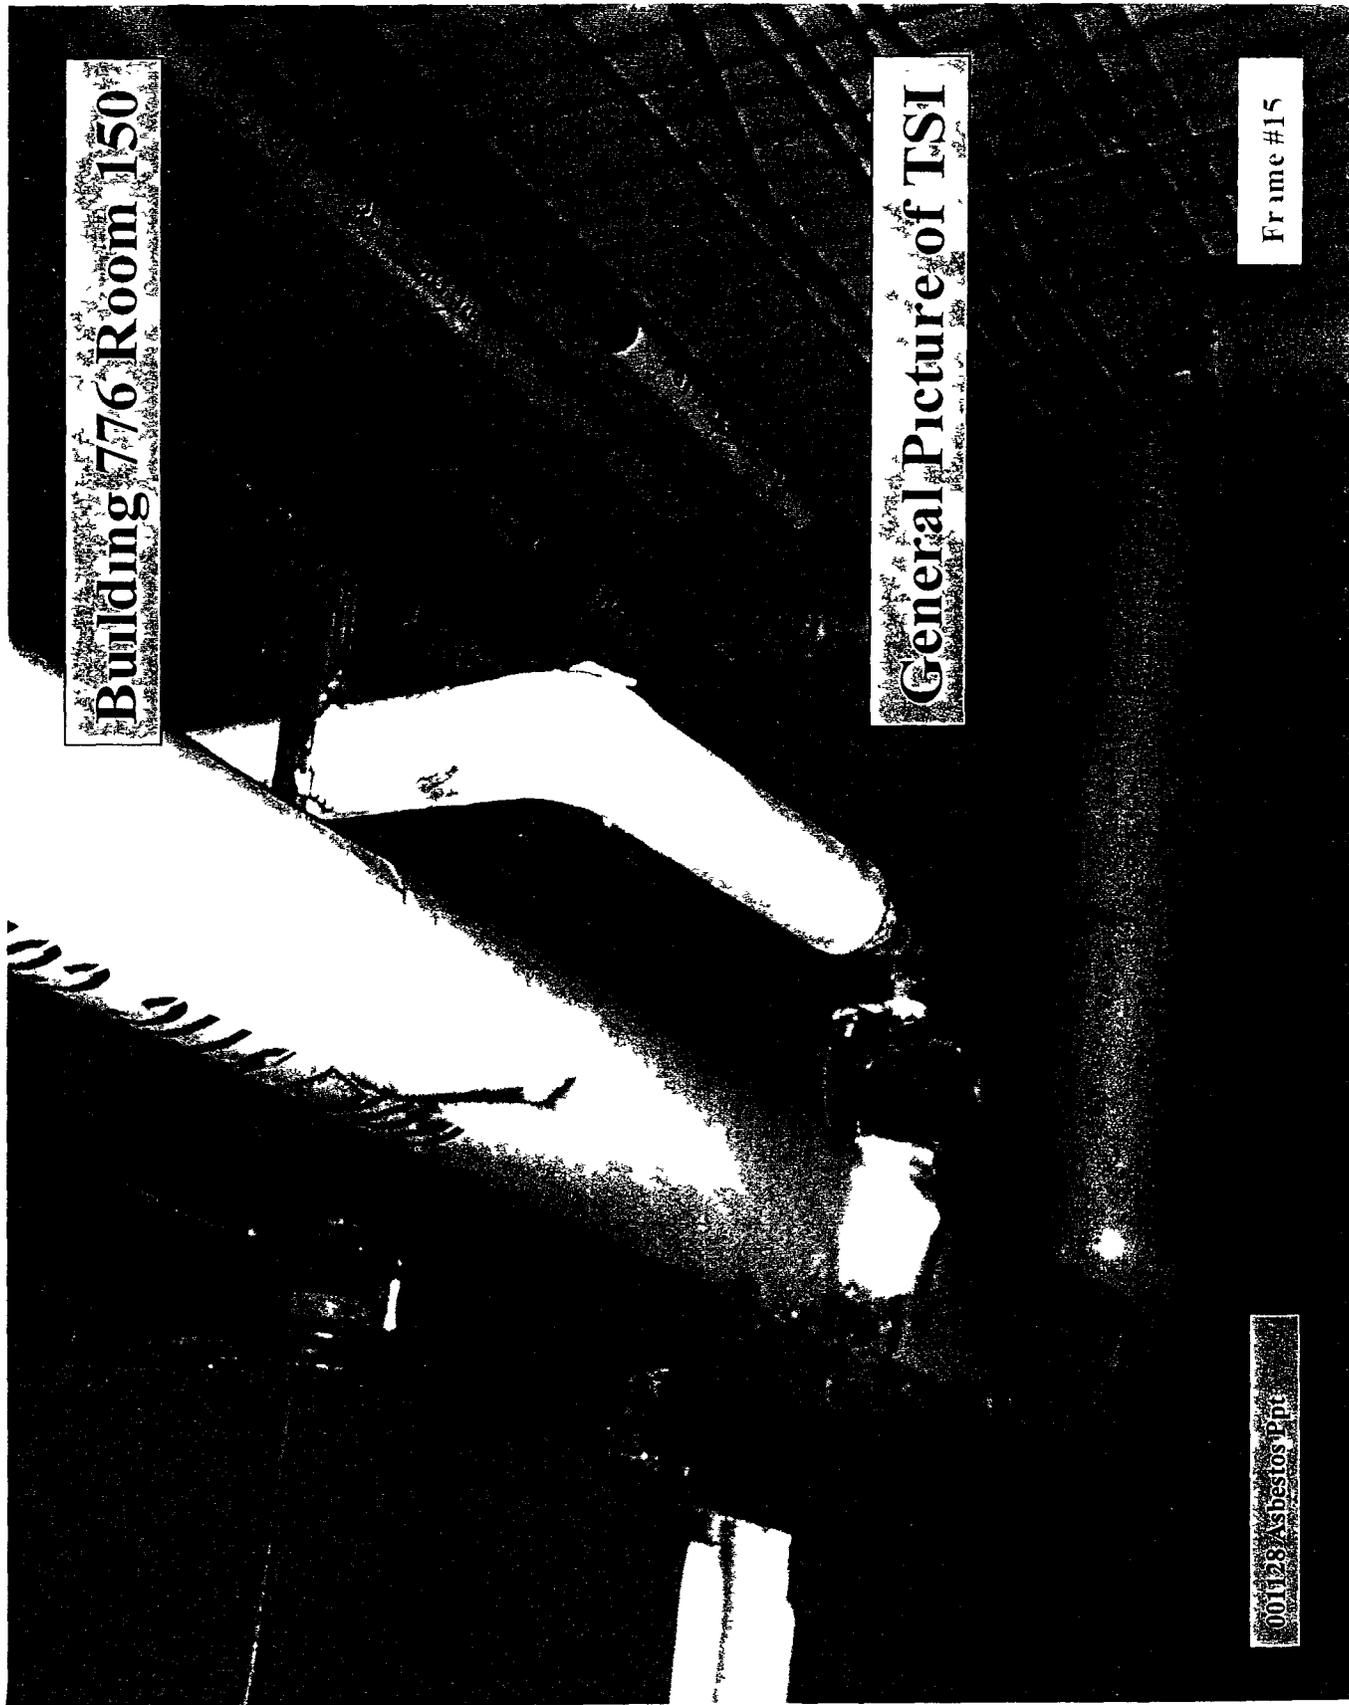
776-09292000-05-004

Building 776 Room 150

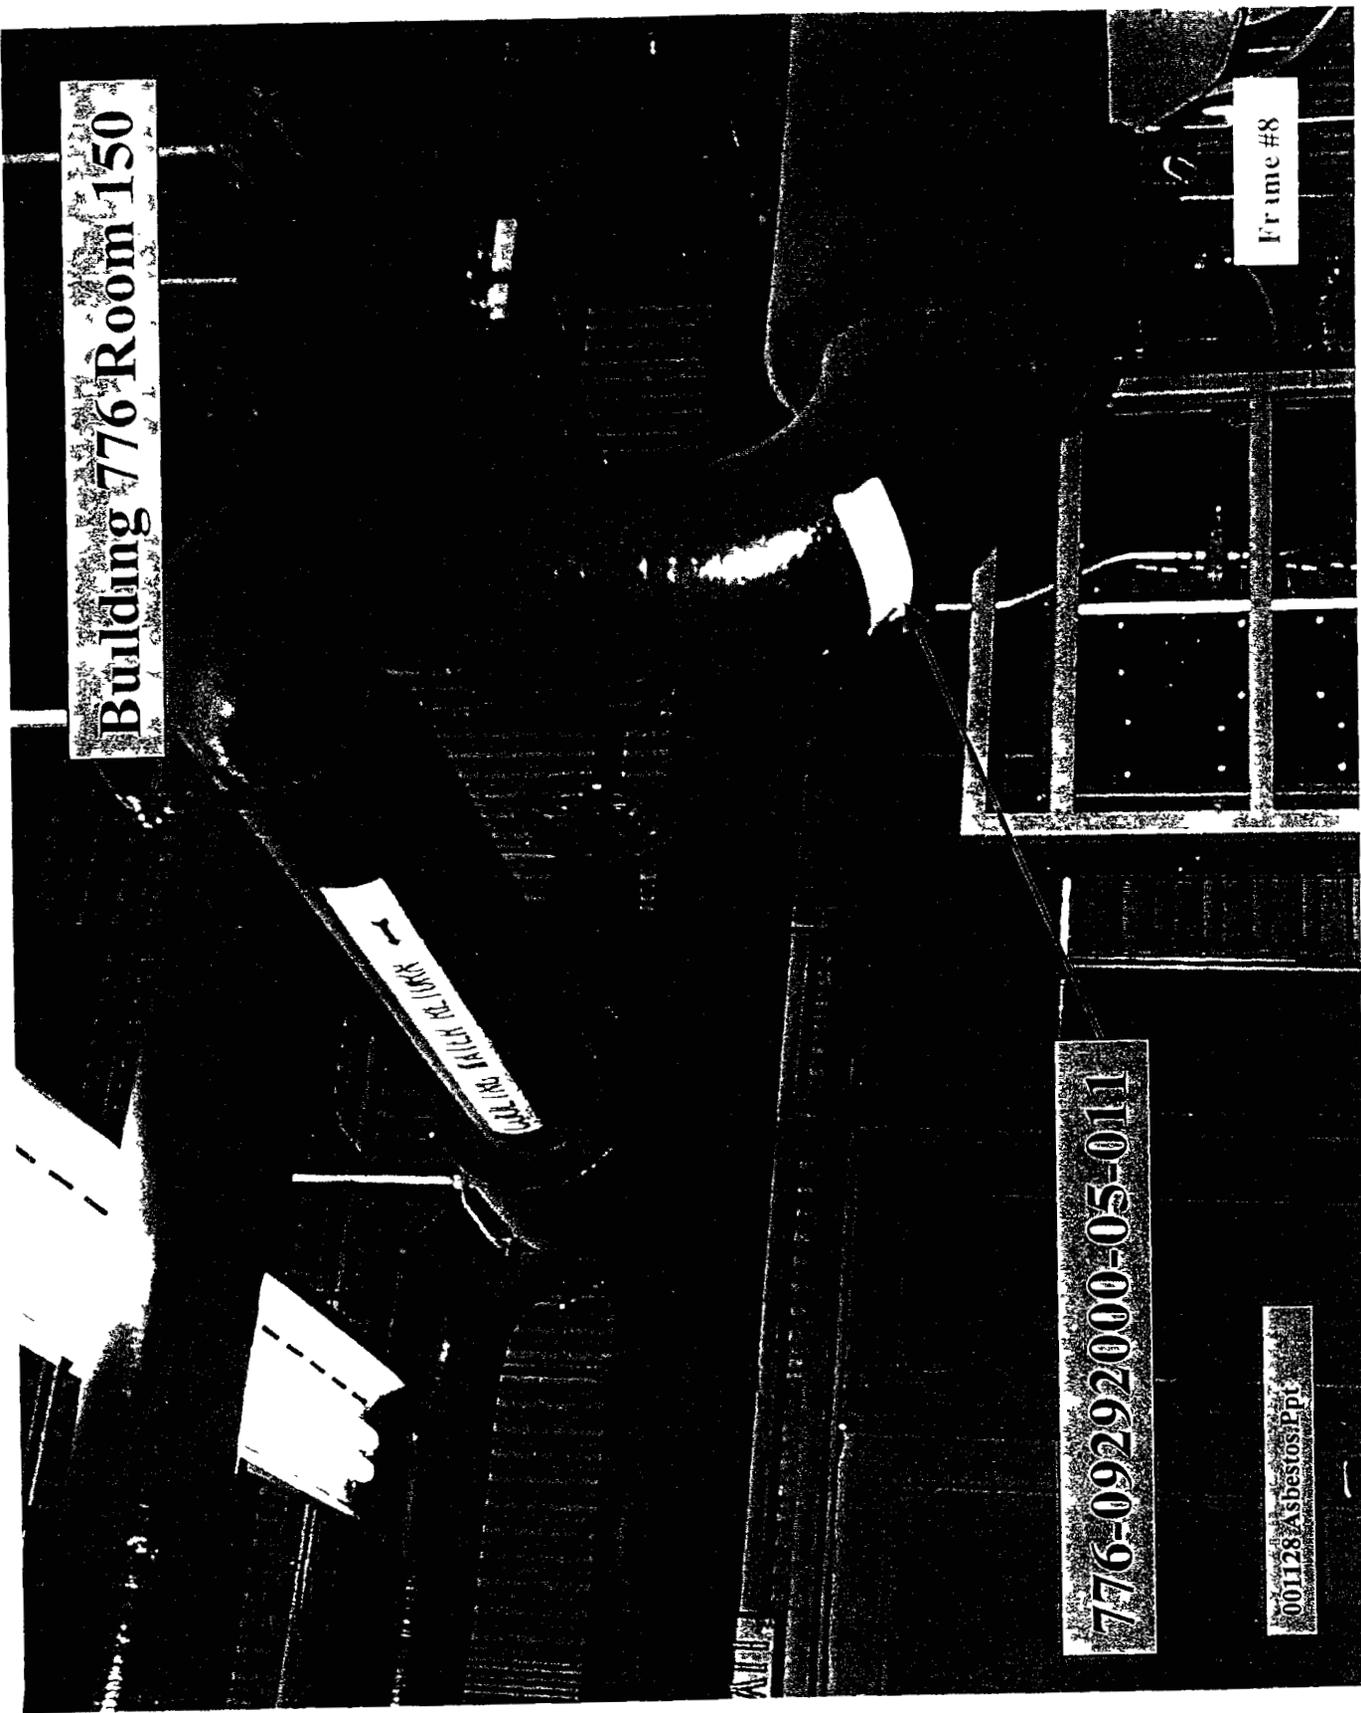
776-09292000-05-010

Building 776 Room 150

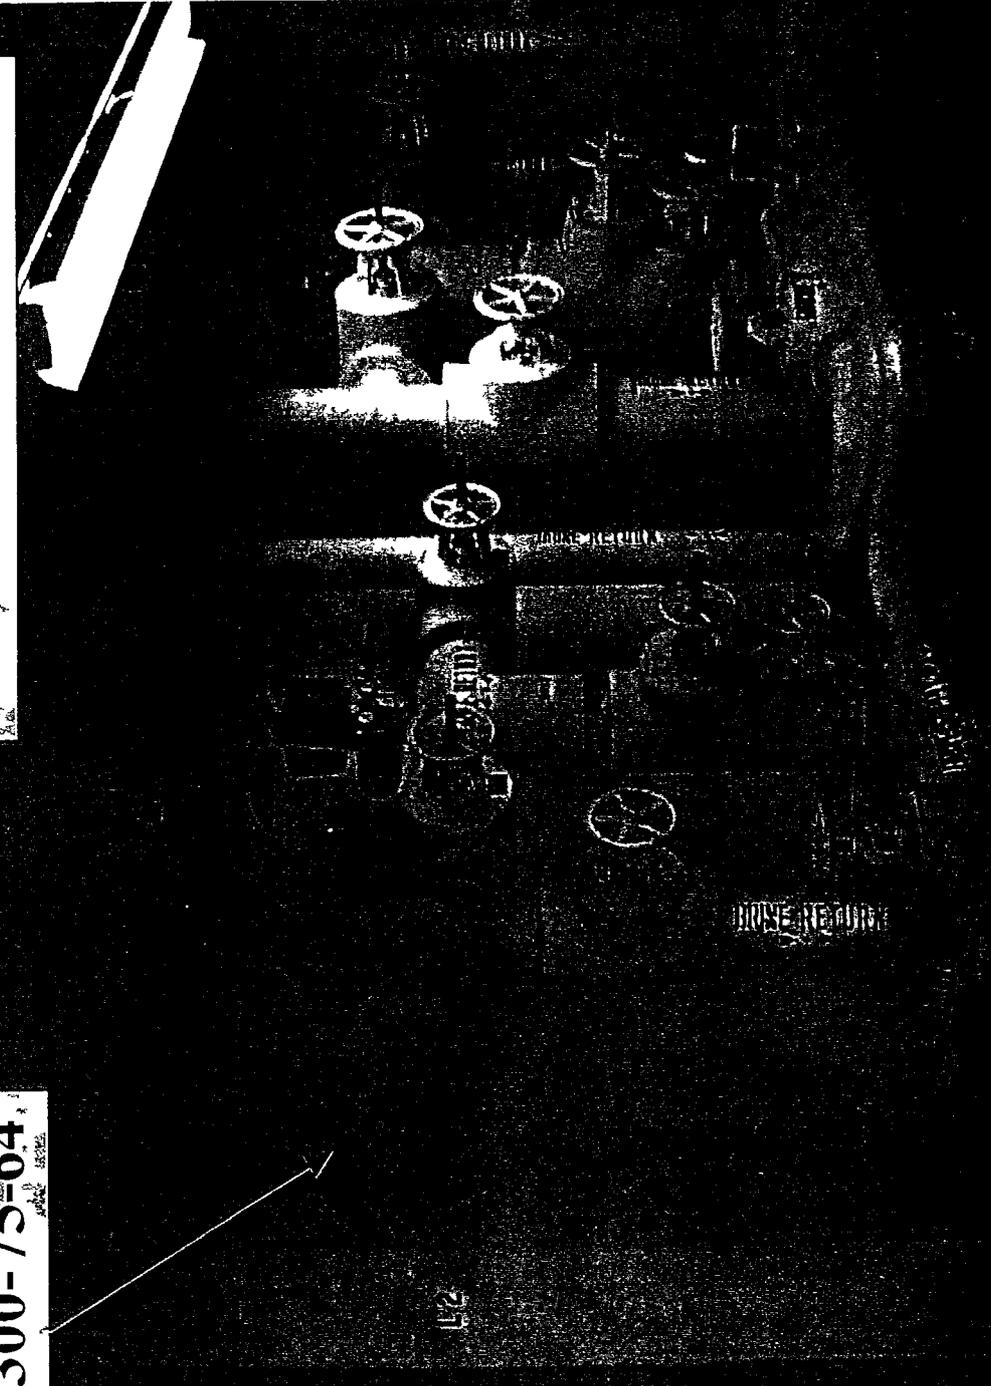
Building 776 Room 208
Pillar J-16

776-092300-75-73
L. M. KANESEK, JR.
