Amchitka Mud Pit Caps 2016 Post-Closure Monitoring and Inspection Report Amchitka Island, Alaska

November 2016

U.S. DEPARTMENT OF
ENERGY

Legacy
Management

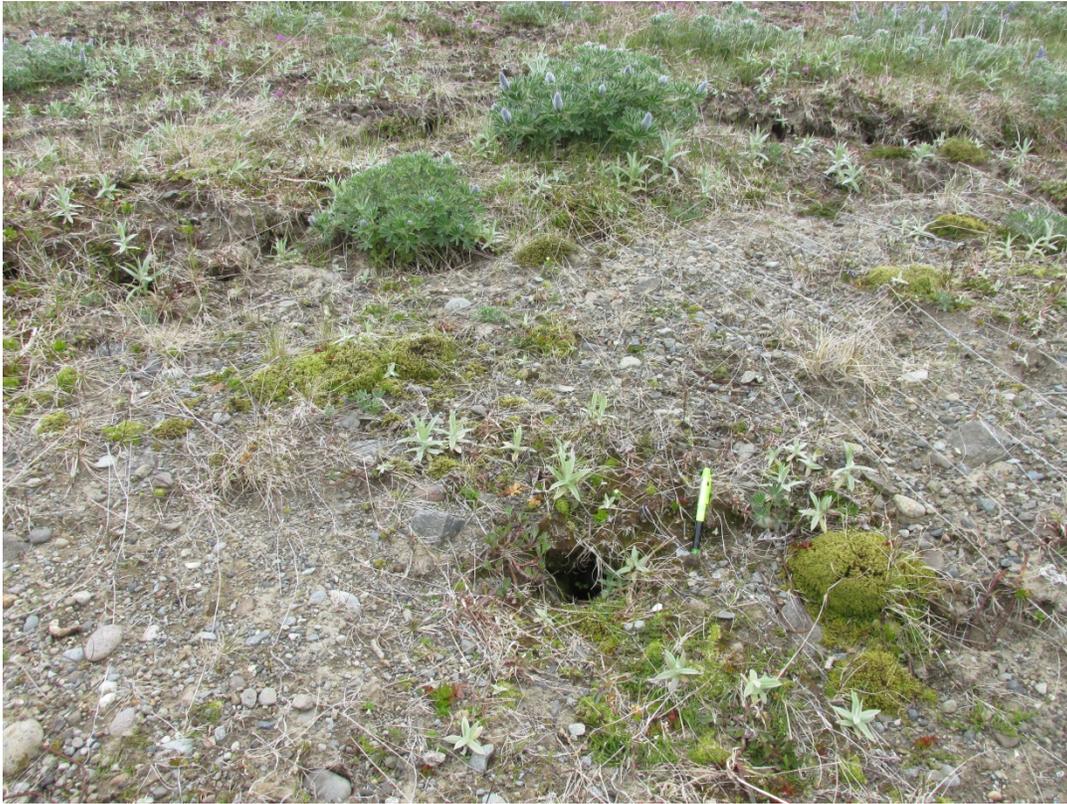
IMG_0794 – View W of small hole near E base of mud pit cap, Long Shot

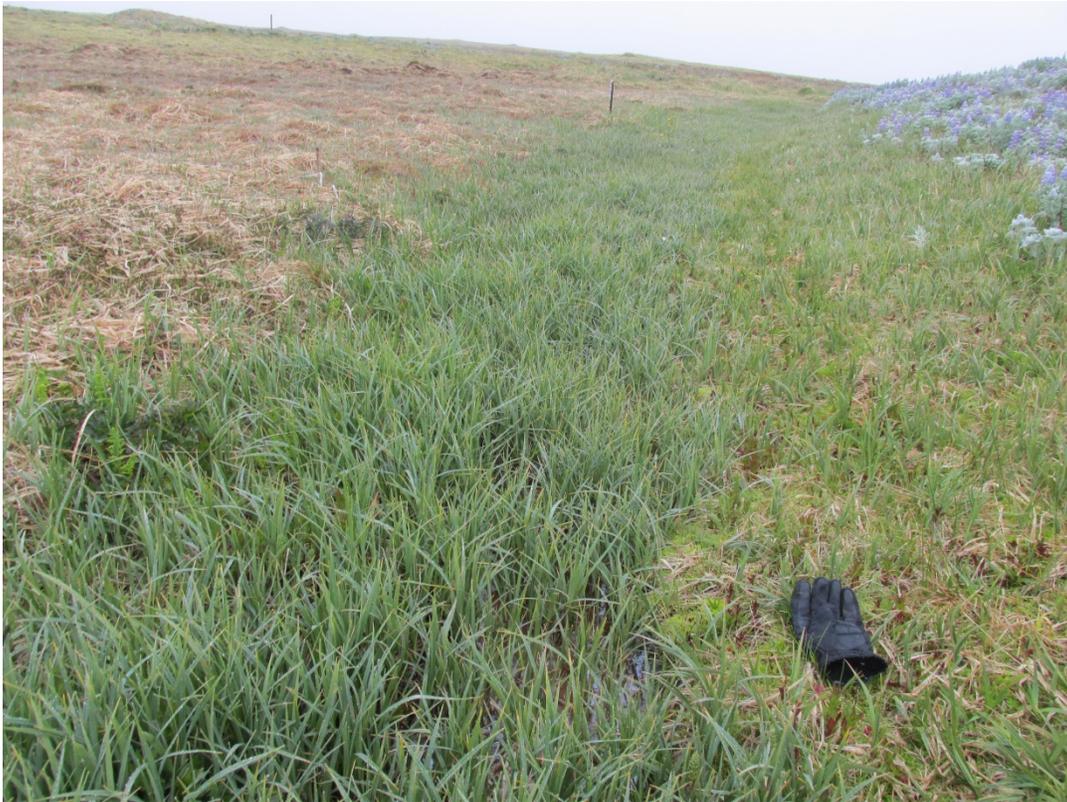
IMG_0796 – View S showing drain just E of the mud pit cap that contains reddish-brown water, Long Shot

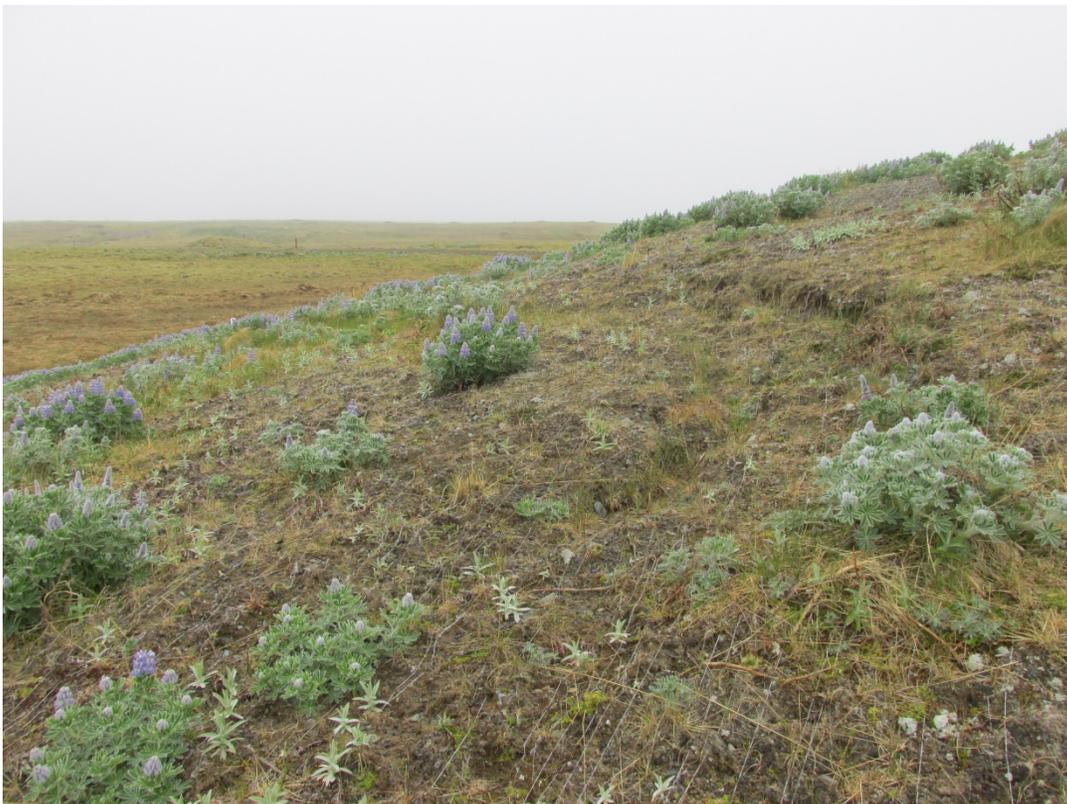
IMG_0797 – View SSE showing arcuate slump scarp (~1 ft) in NE corner of mud pit cap, Long Shot

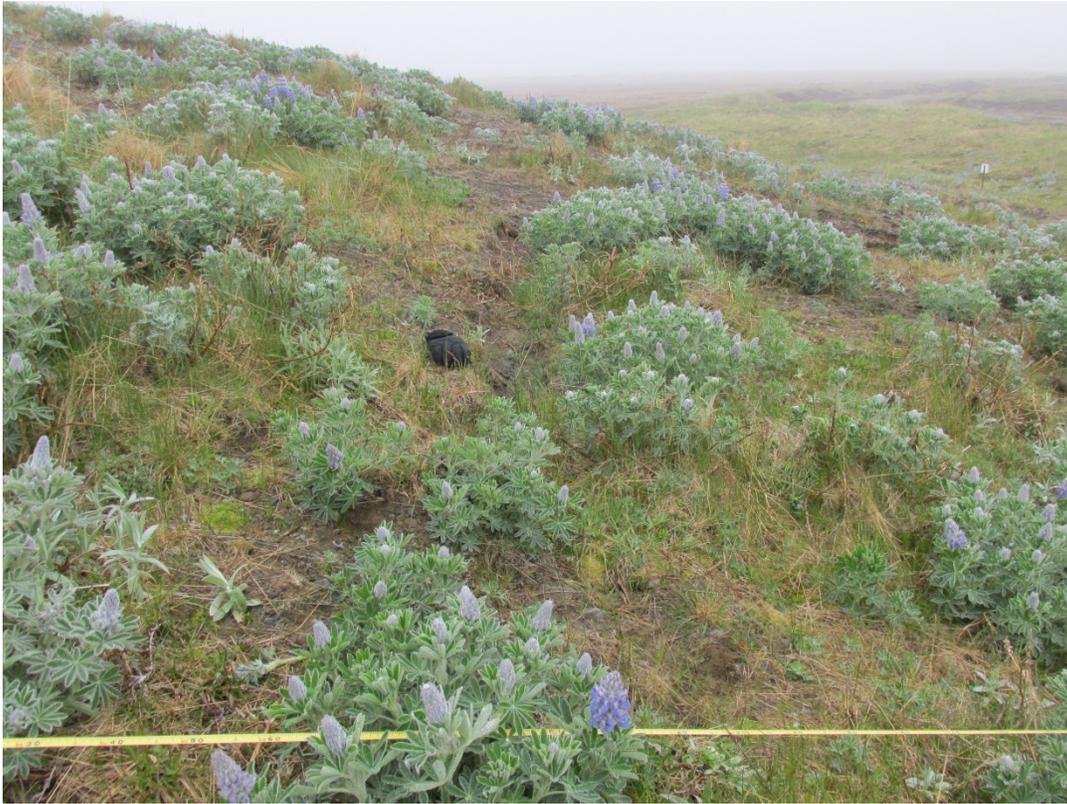
IMG_0798 – View W showing arcuate slump scarp (~9 in.) along N side slope of mud pit cap, Long Shot

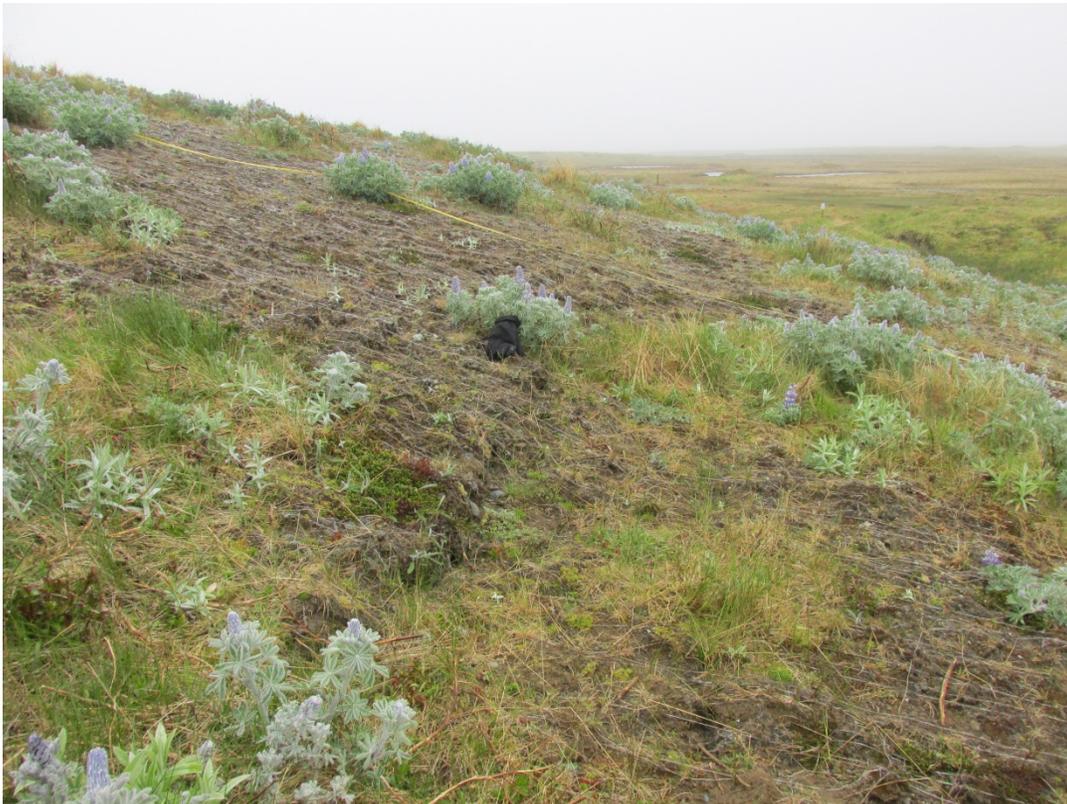
IMG_0799 – View W showing straight slump scarp (~9 in.) along N side slope of mud pit cap, Long Shot

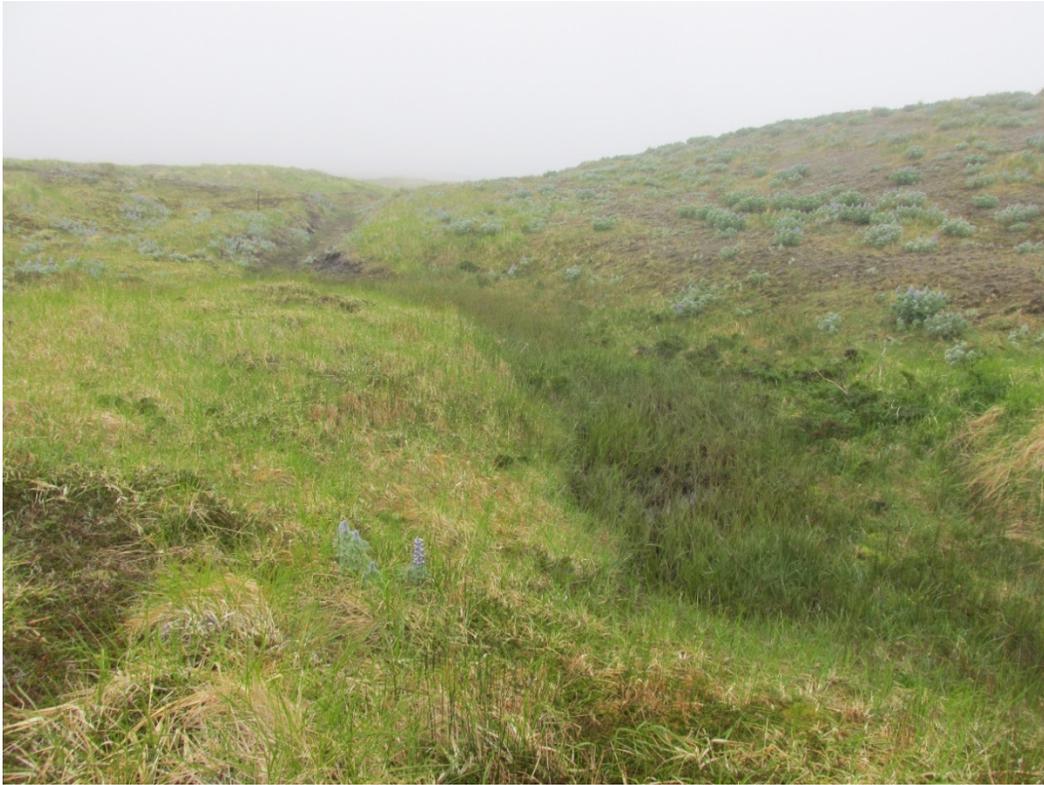
IMG_0800 – View E showing drain just N of the mud pit cap that contains reddish-brown water, Long Shot

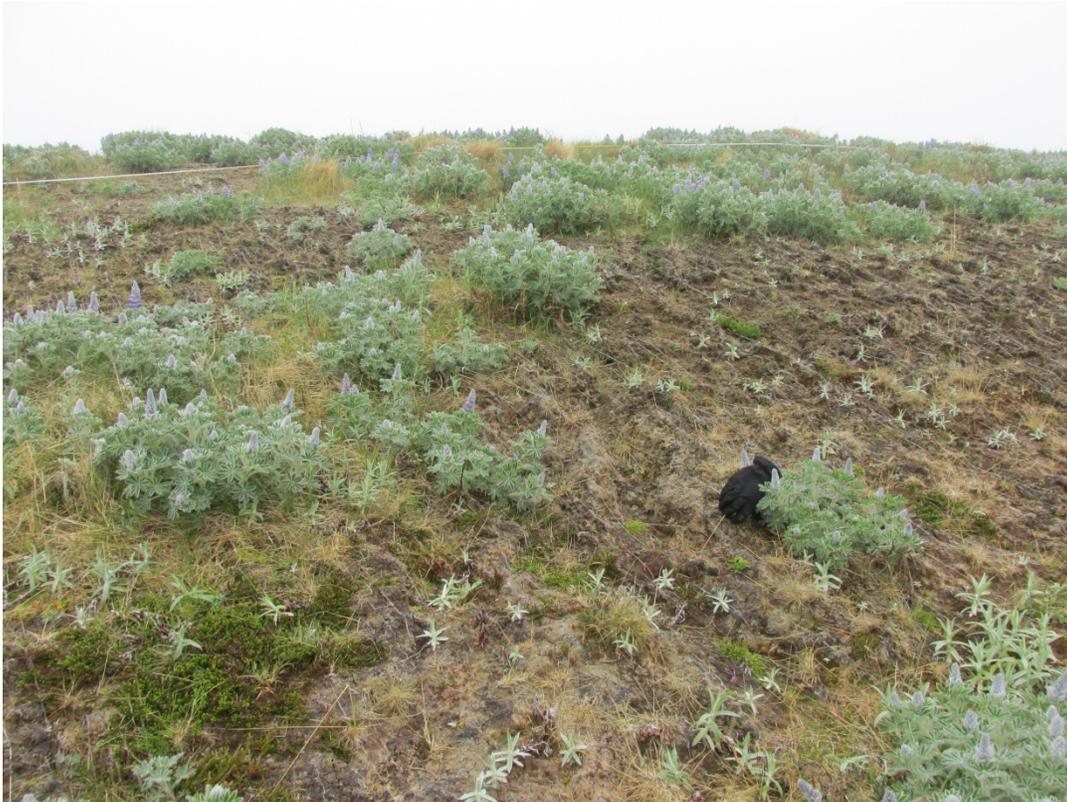
IMG_0803 – View SW of rills on steep slope in NE corner of mud pit cap, Long Shot

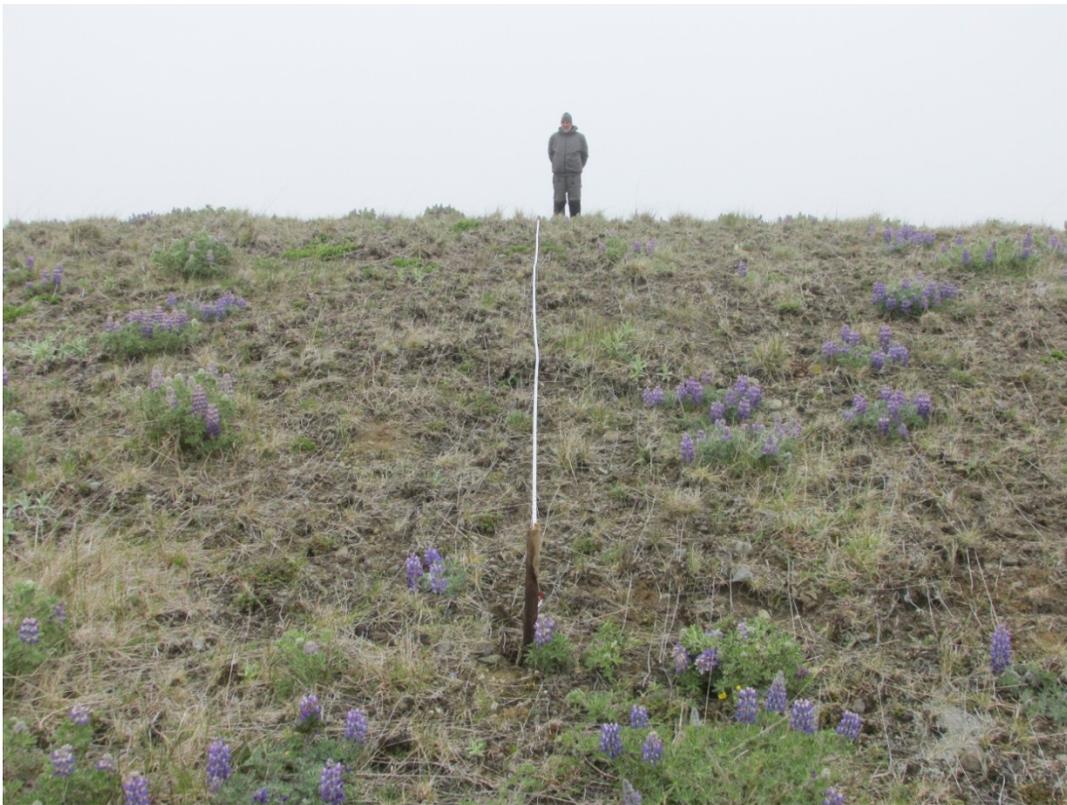
IMG_0766 – View NNW at Transect CS-2S, P. Darr, Cannikin South

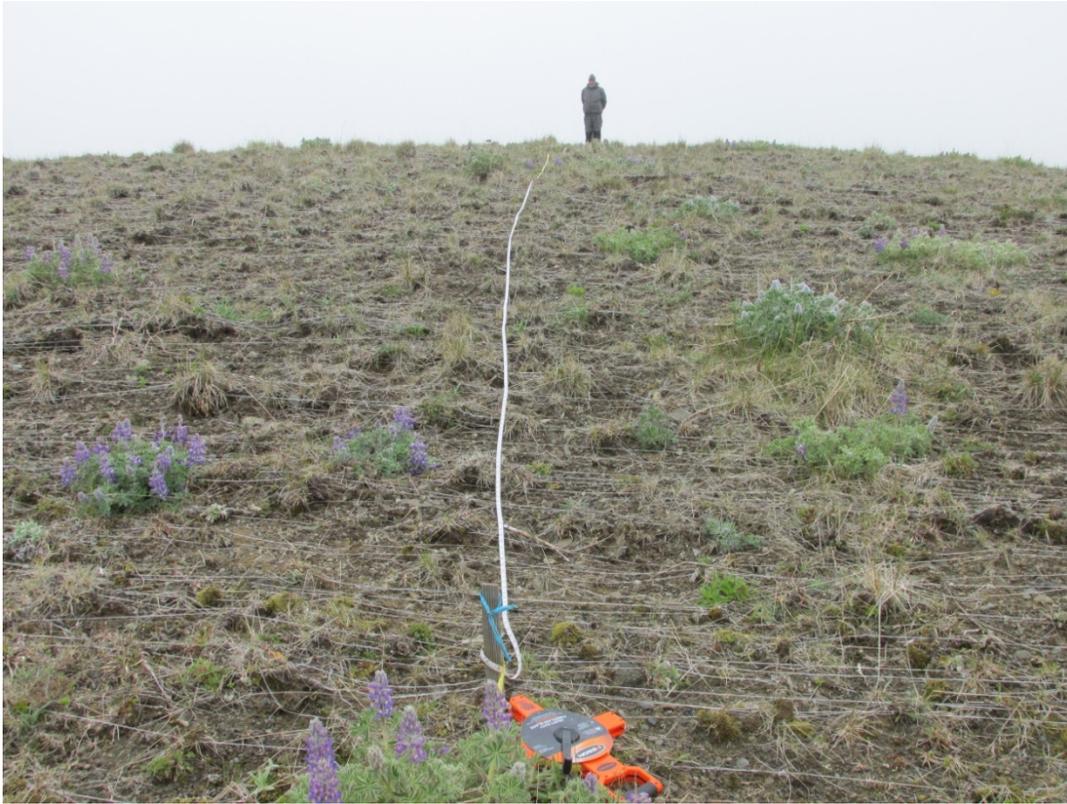
IMG_0767 – View WSW at Transect CS-1E, P. Darr, Cannikin South

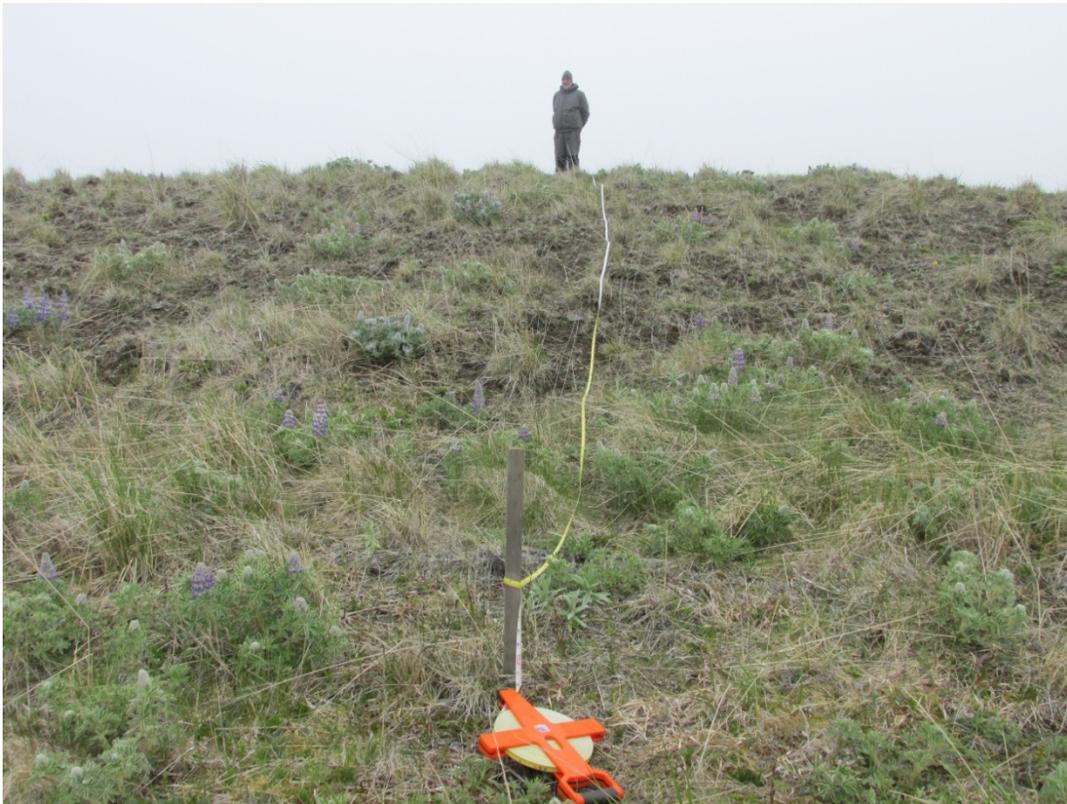
IMG_0768 – View SSE at Transect CS-2N, P. Darr, Cannikin South

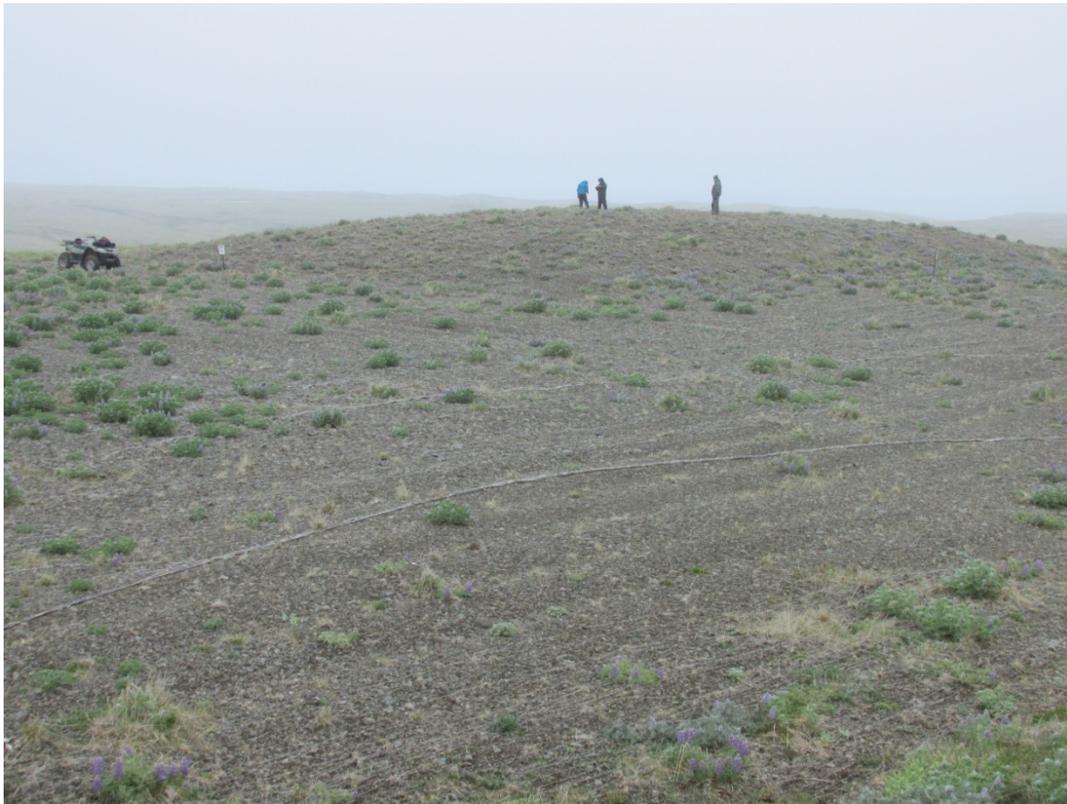
IMG_0769 – View NE across graded area to Cannikin South Mud Pit Cap

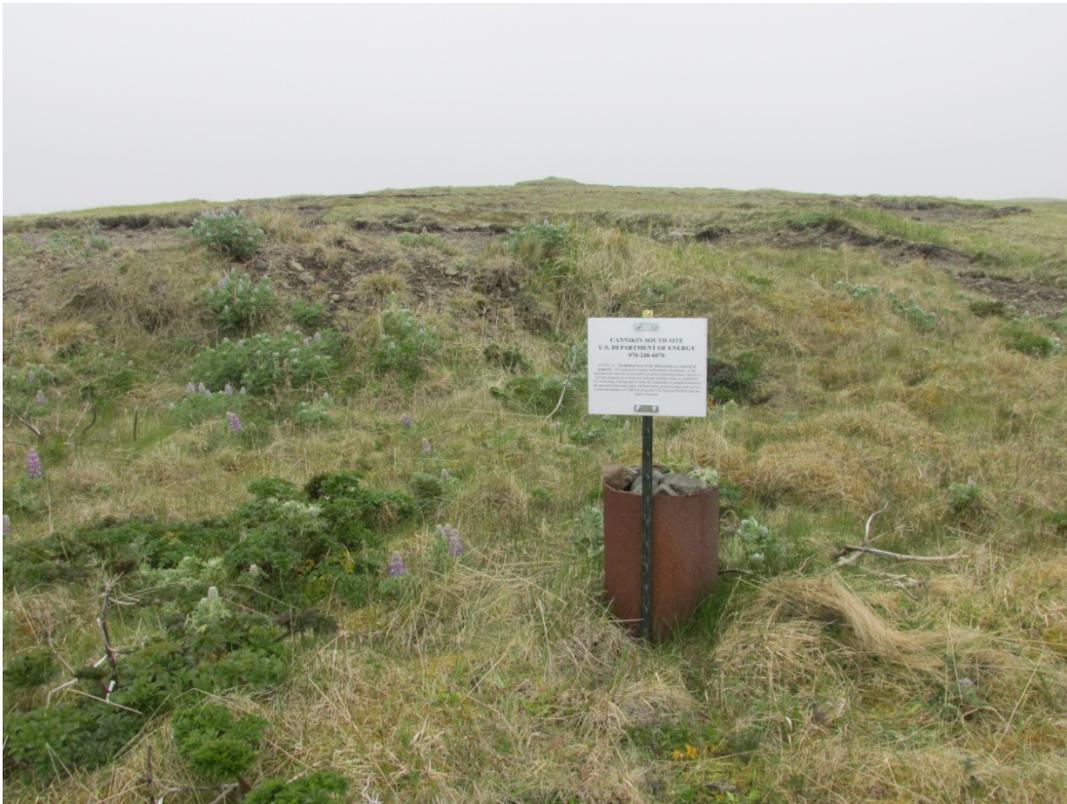
IMG_0770 – View SW of USFWS Monument and new sign, Cannikin South

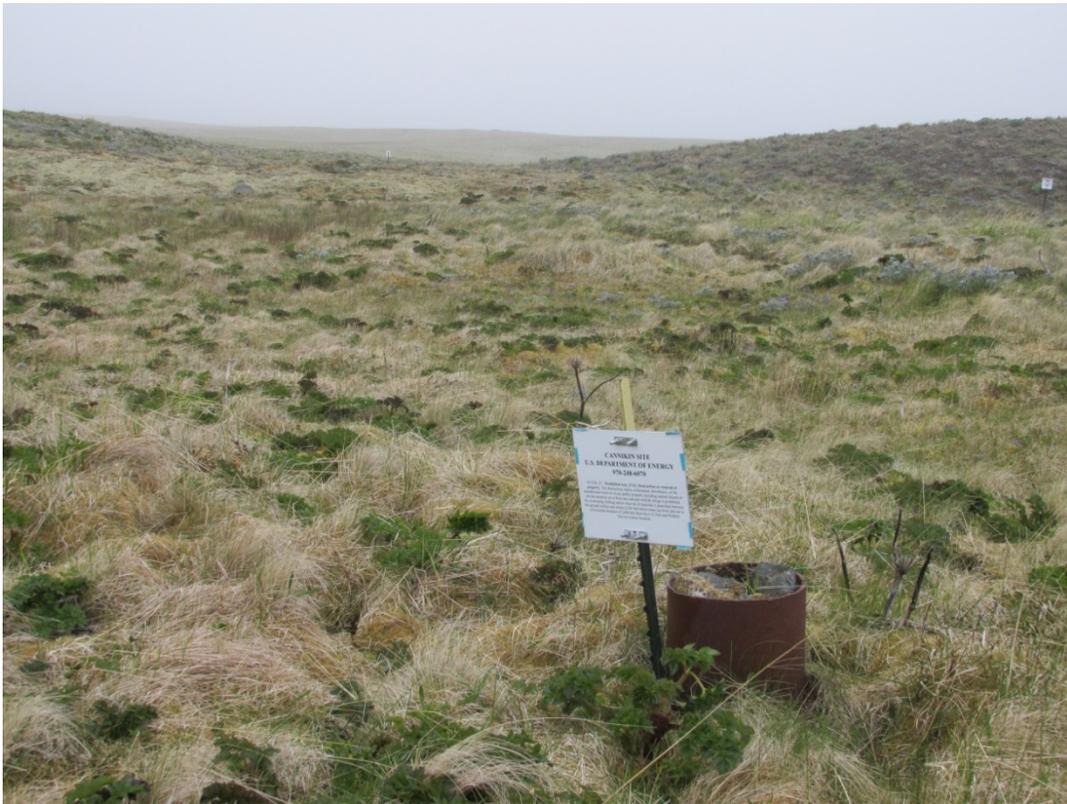
IMG_748 – View W of USFWS Monument and new sign, Cannikin Ground Zero

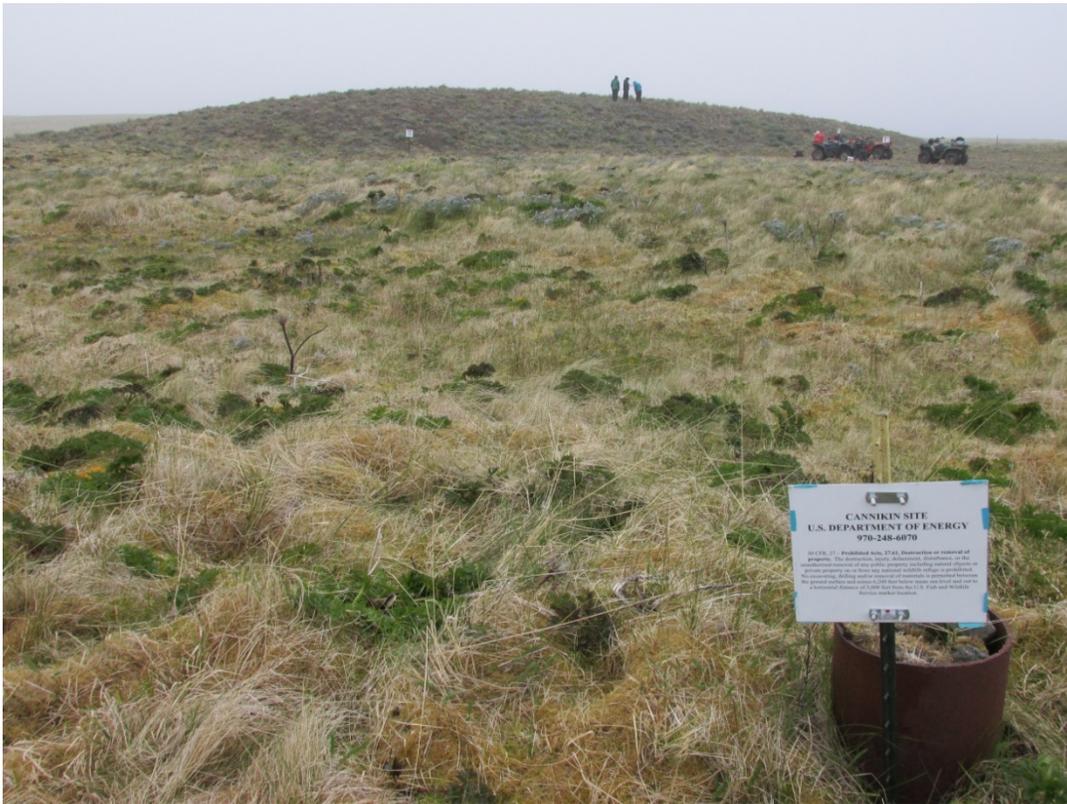
IMG_750 – View N of Cannikin Ground Zero Mud Pit Cap from USFWS Monument and new sign

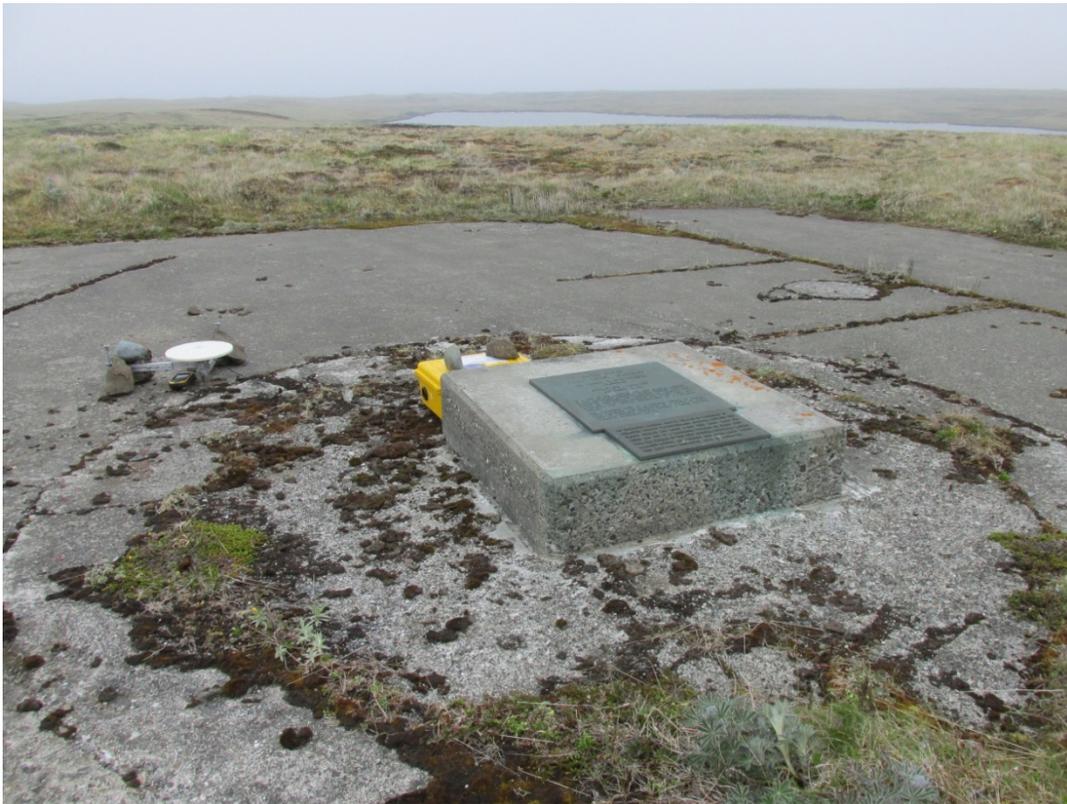
IMG_763 – View NE of Cannikin Ground Zero Monument Plaque and Cannikin Lake in BG

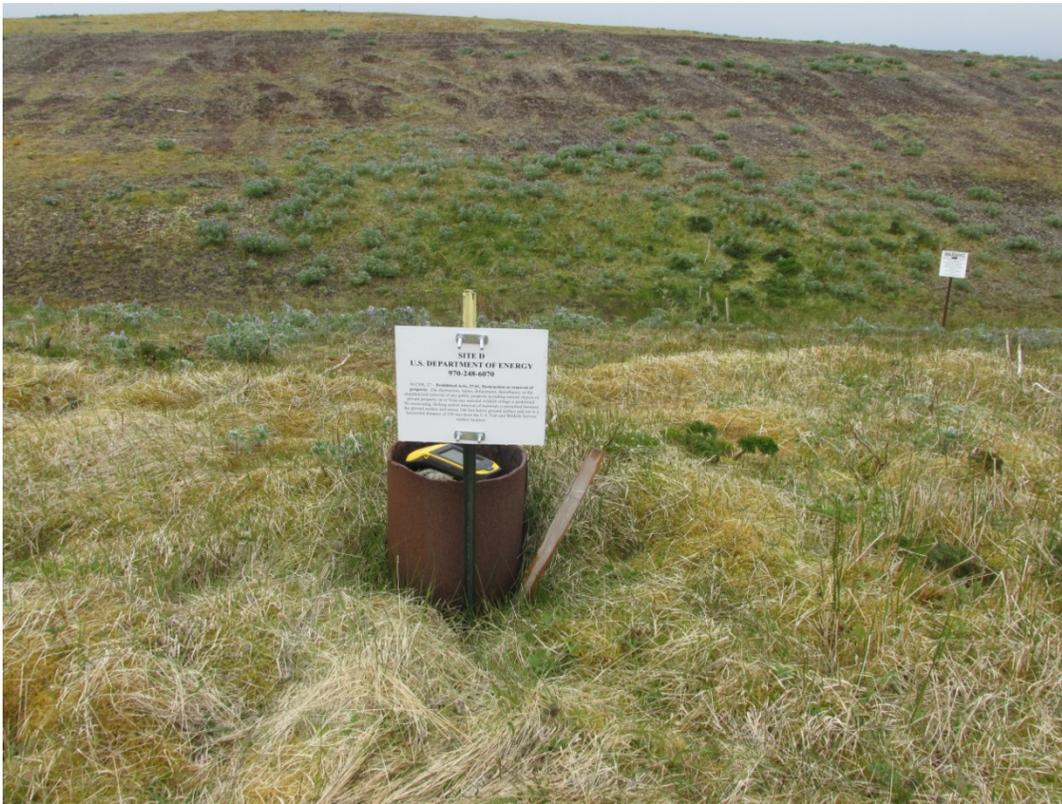
IMG_0733 – View SW of USFWS Monument and new sign, Site D

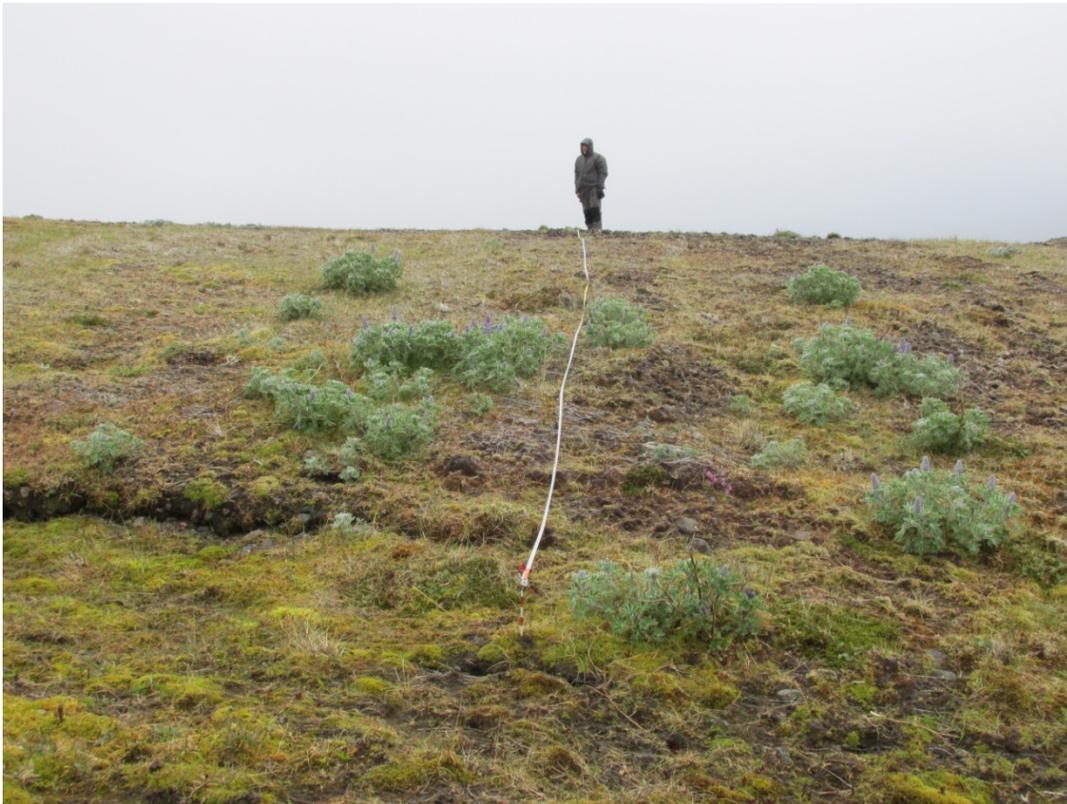
IMG_0715 – View NE at Transect D-9SW, small scarp, P. Darr, Site D

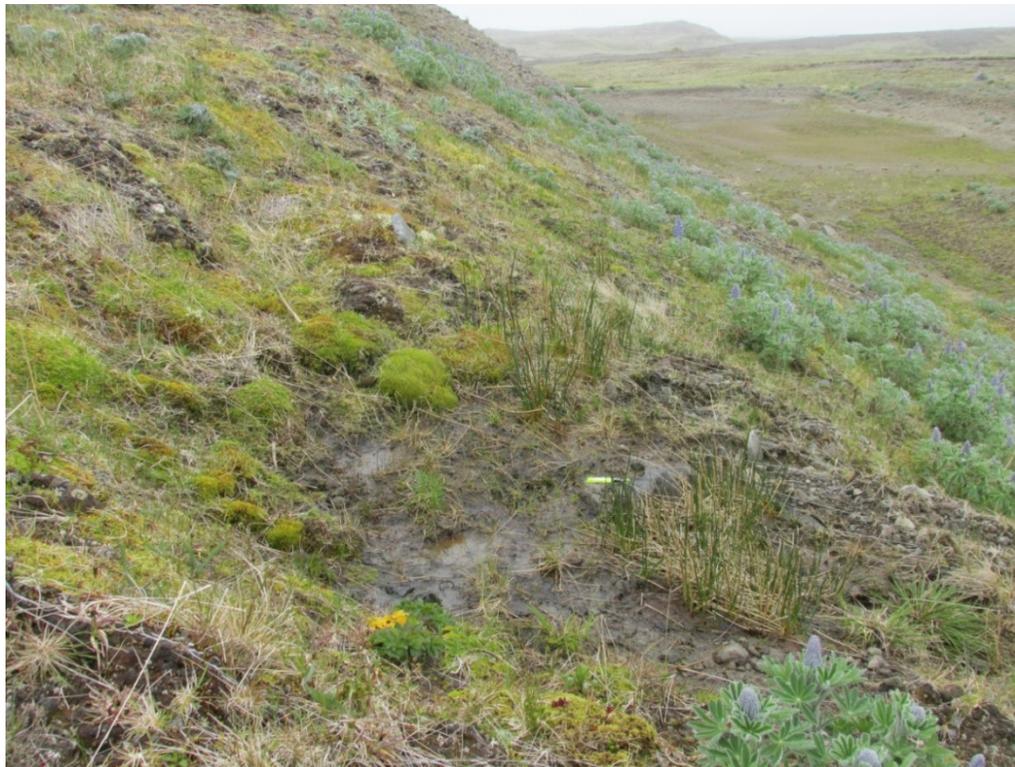
IMG_0735 – View SE of Sediment Trap D-1 and its dam, and steep slope on SW side of West Mud Pit Cap, Site D

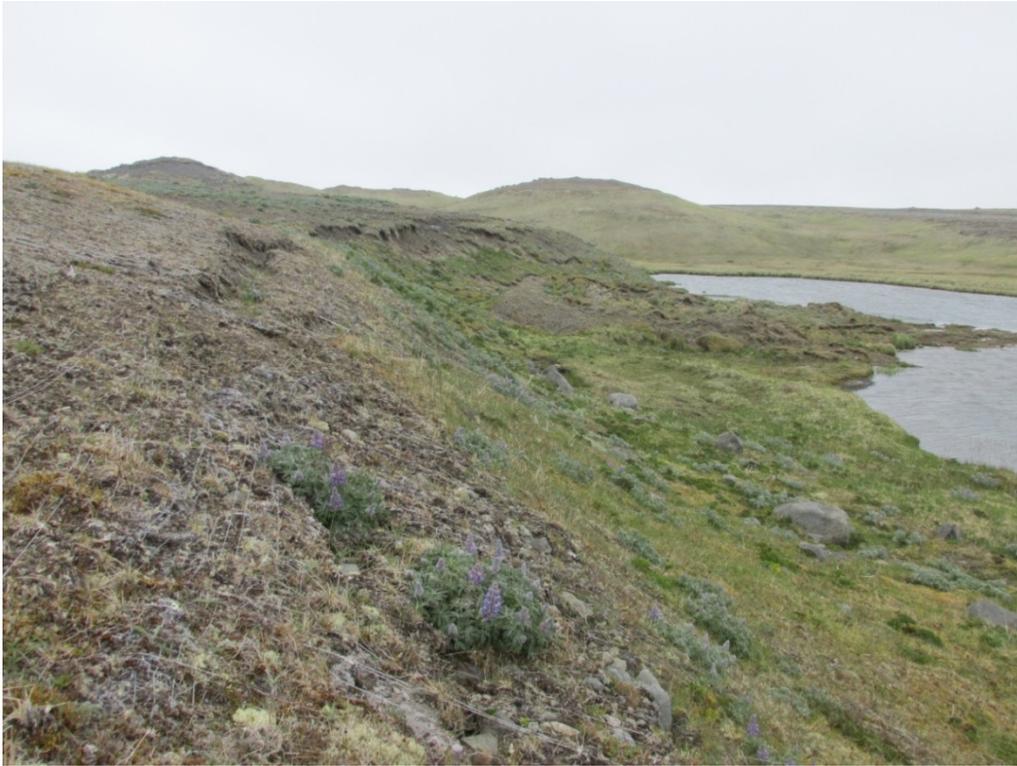
IMG_0736 – View SE of small slump and seep of oily water just SE of D-2SW on SW side of West Mud Pit Cap, Site D

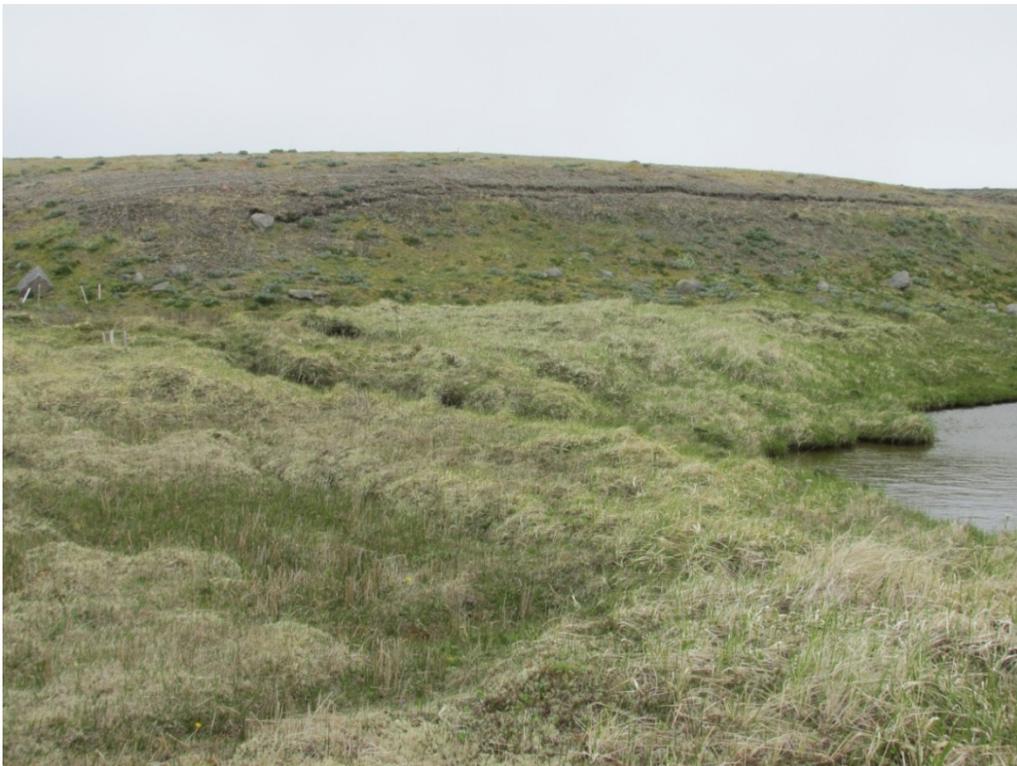
IMG_0738 – View E from D-1SE showing slump (~1 ft) along S end of West Mud Pit Cap and the larger slump at S end of East Mud Pit Cap, Site D

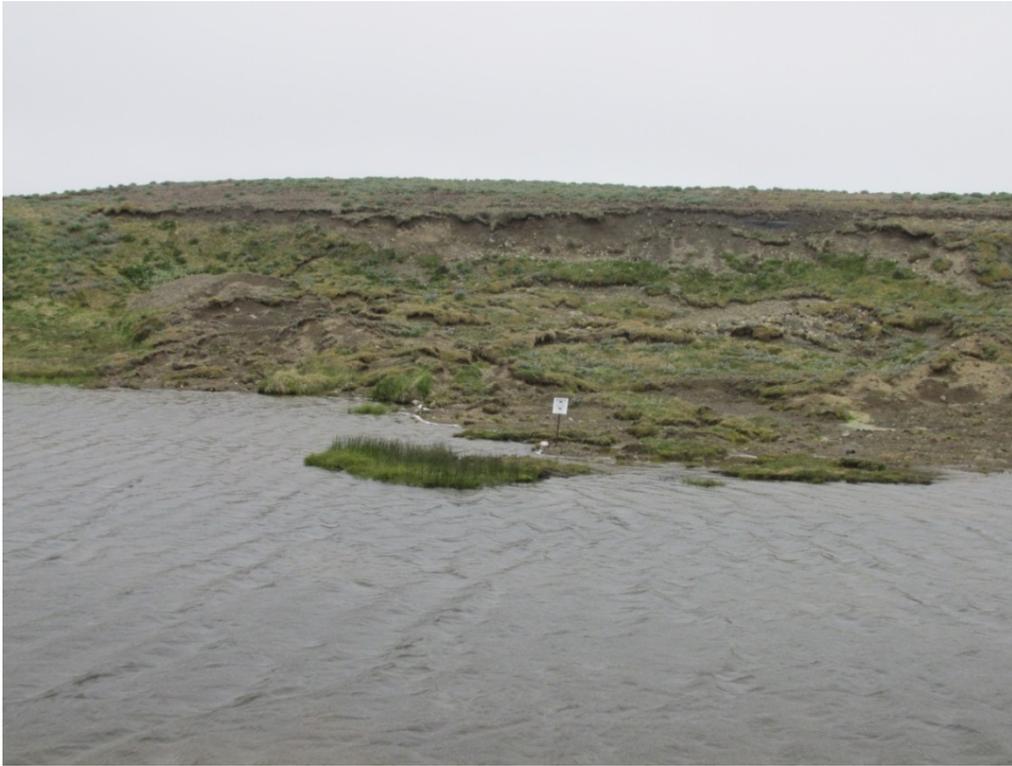
IMG_0739 – View N showing slump scarp along S end of West Mud Pit Cap, Site D

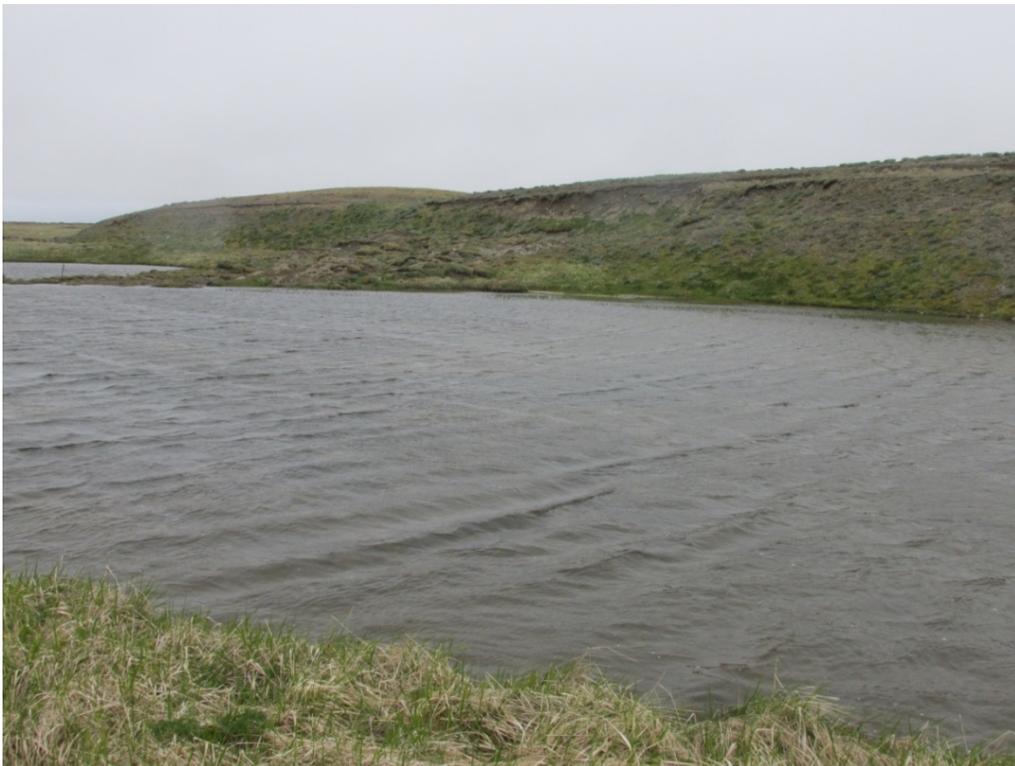
IMG_0740 – View N showing large slump along S end of East Mud Pit Cap and exposed black liner, Site D

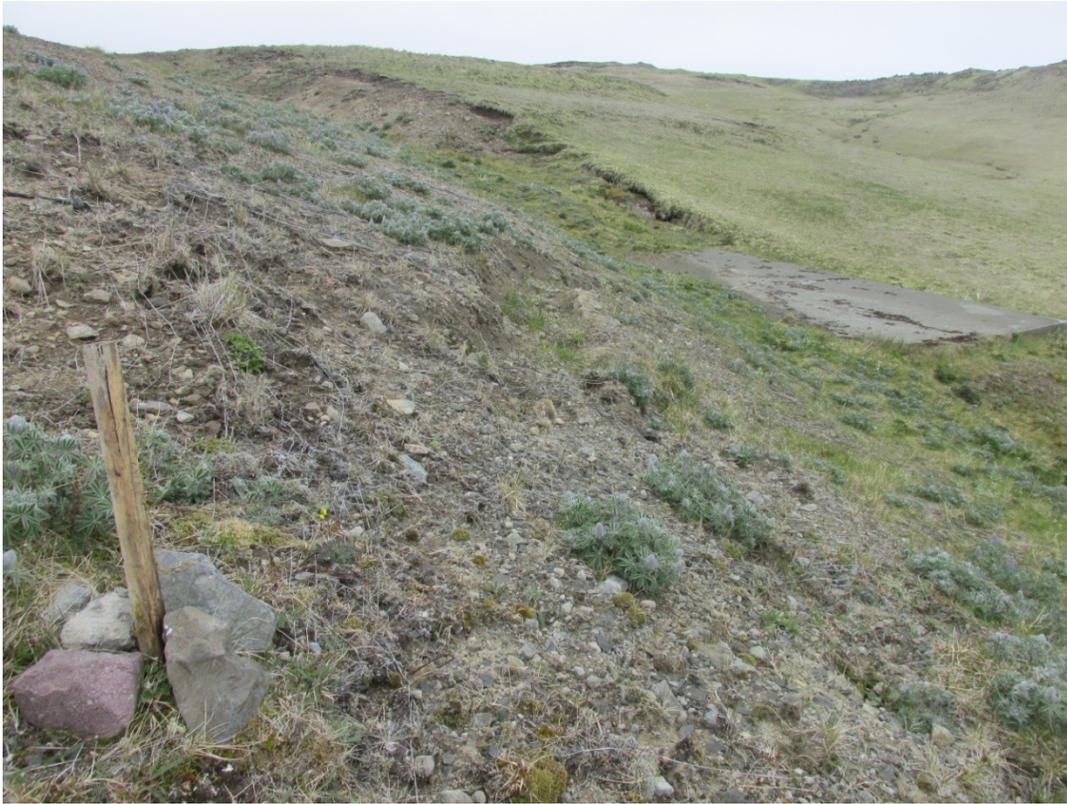
IMG_0741 – View NW showing slump scarps along S ends of West and East Mud Pit Caps, Site D

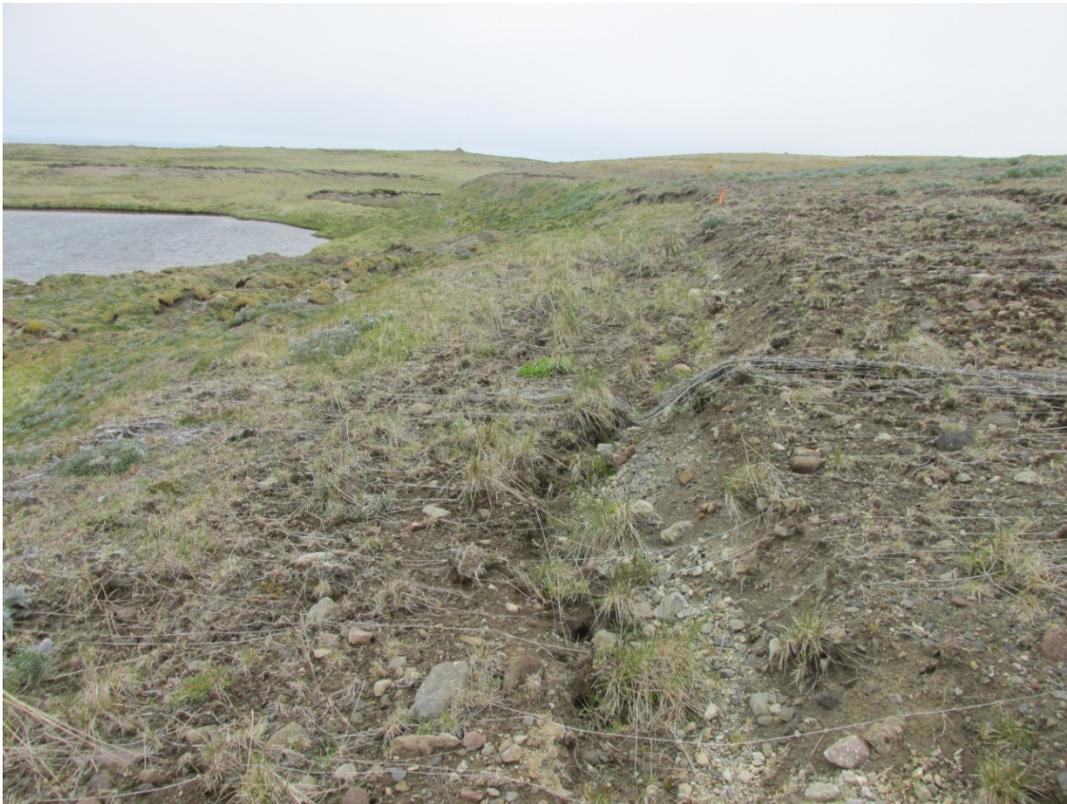
IMG_0742 – View N from D-5SE of small slump along SE end of East Mud Pit Cap, Site D

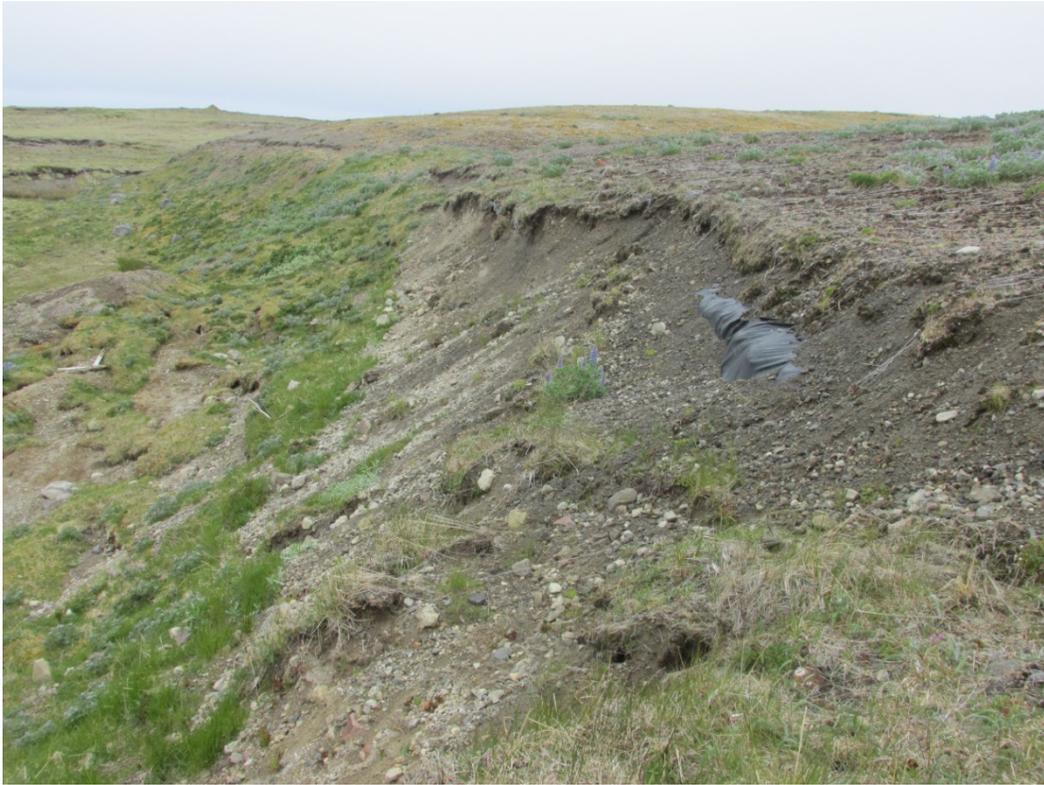
IMG_0743 – View W of small slump along E part of S end of East Mud Pit Cap, Site D

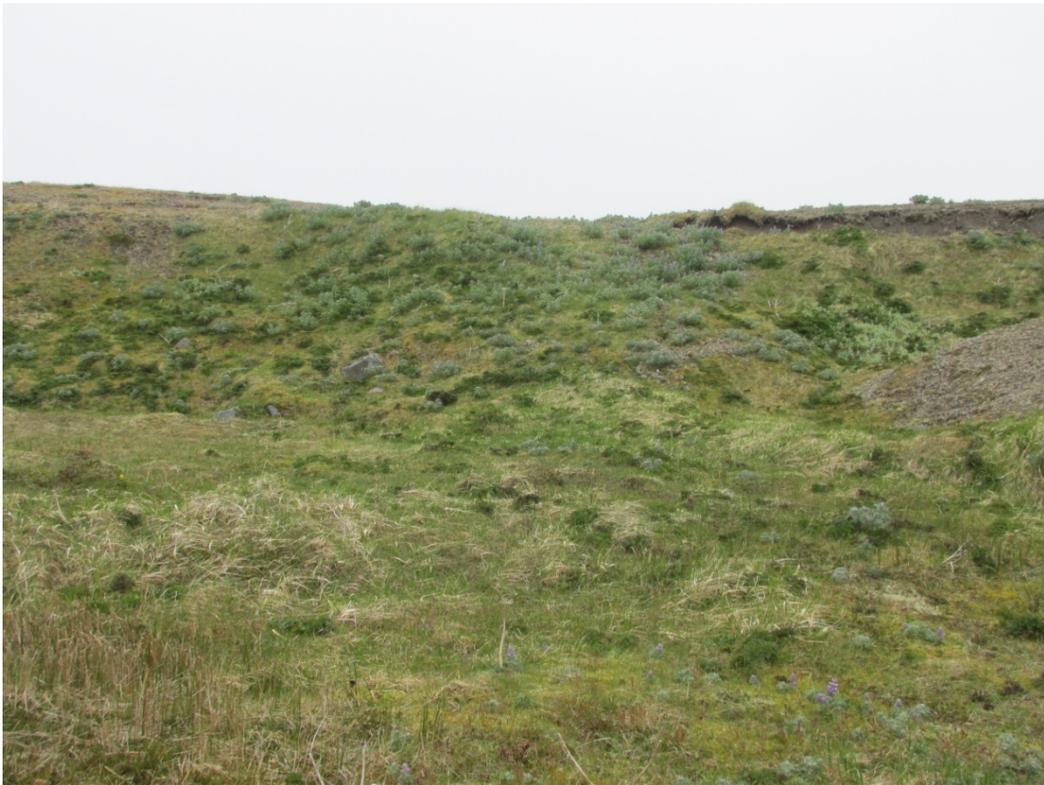
IMG_0744 – View W of exposed black liner in large slump in W part of S end of East Mud Pit Cap, Site D

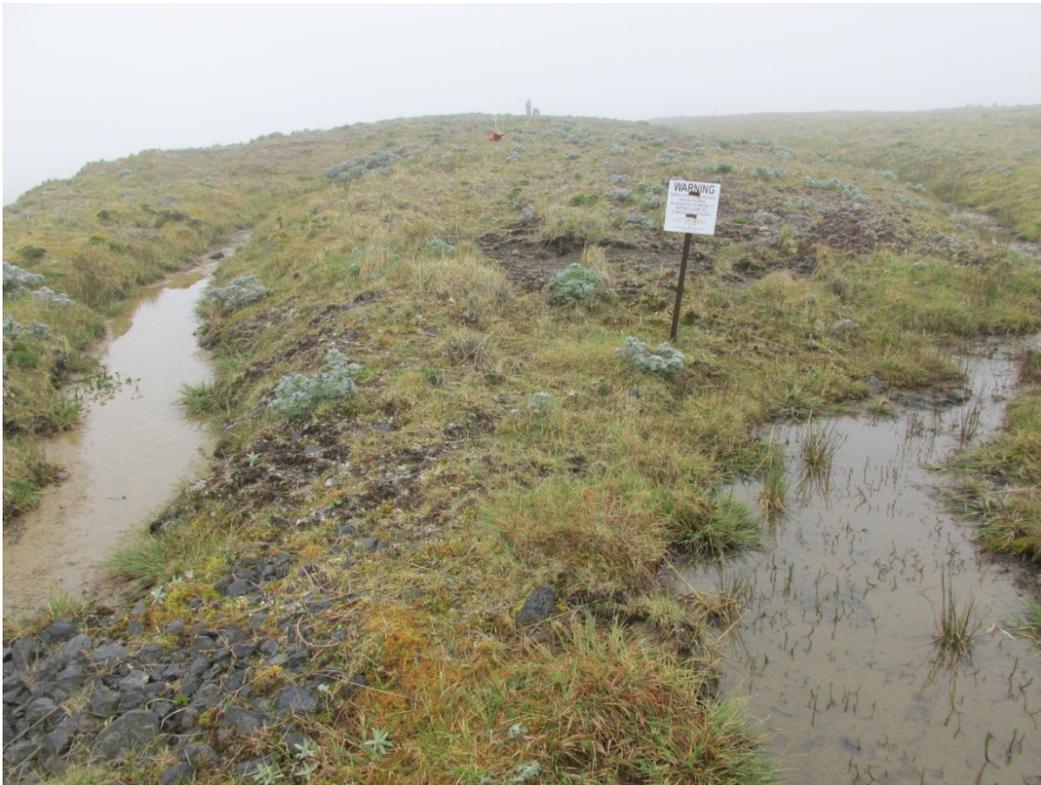
c. Evidence of erosion (wind or water)?		X	Ponded water in Channel F1 at the E end of the mud pit cap noted in this and past inspections could lead to future erosion

IMG_0702 – View W of rock, sign, Channel F1 at right, and E end of mud pit cap, Site F
