Amchitka Mud Pit Caps 2016 Post-Closure Monitoring and Inspection Report Amchitka Island, Alaska

November 2016

U.S. DEPARTMENT OF
ENERGY

Legacy
Management

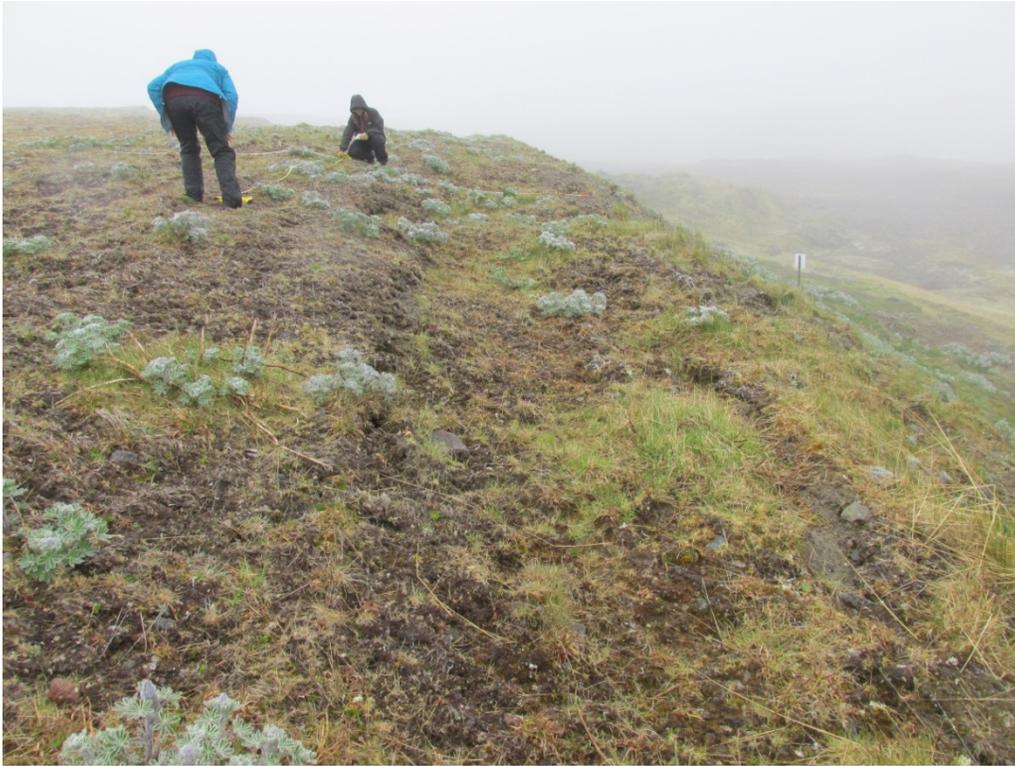
b. Evidence of cracking?	X		A long crack and associated slump from the 2014 earthquake are along the S edge of the mud pit cap. Another long crack is NE of the mud pit cap.

IMG_0705 – View E along slumped area toward F-3 Transect, L. Sheader and D. Marshall, Site F

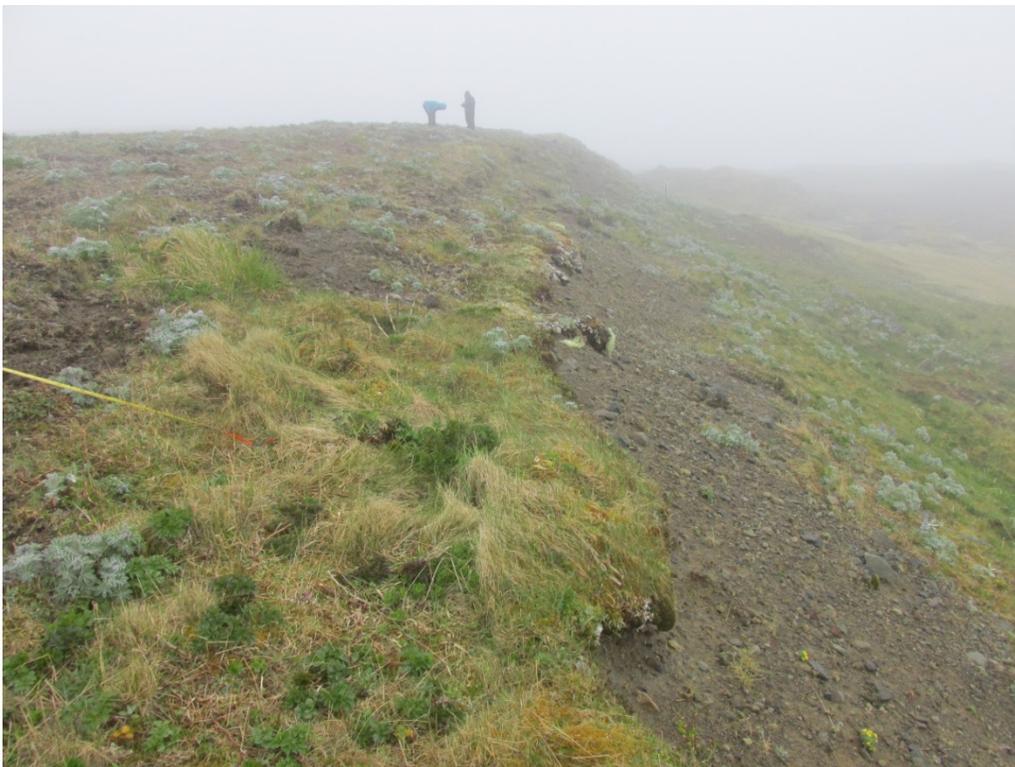
6. Rationale for field conclusions: Conclusions were based on walkover visual inspections and plant counts. A long, semi-continuous crack and associated slump block extends along the south edge of the mud pit cap. This feature formed as a result of the June 2014 7.9-magnitude earthquake and several strong aftershocks. It was documented in August 2014 by an inspection team soon after the quake. The mostly continuous crack defines a scarp for a slump block 4 to 6 ft wide that shows about 1 ft of displacement to the S (photos 0705 and 0706). Soil is exposed in the steep slope in a bank about 150 ft long just below the S edge of the slump block (photos 0701, 0706, and 0707). This slump block and the exposed soil band should be monitored during future inspections for erosion on the steep slope.

IMG_0706 – View E from near S end of F-2 Transect showing slumps along S side of mud pit cap, Site F

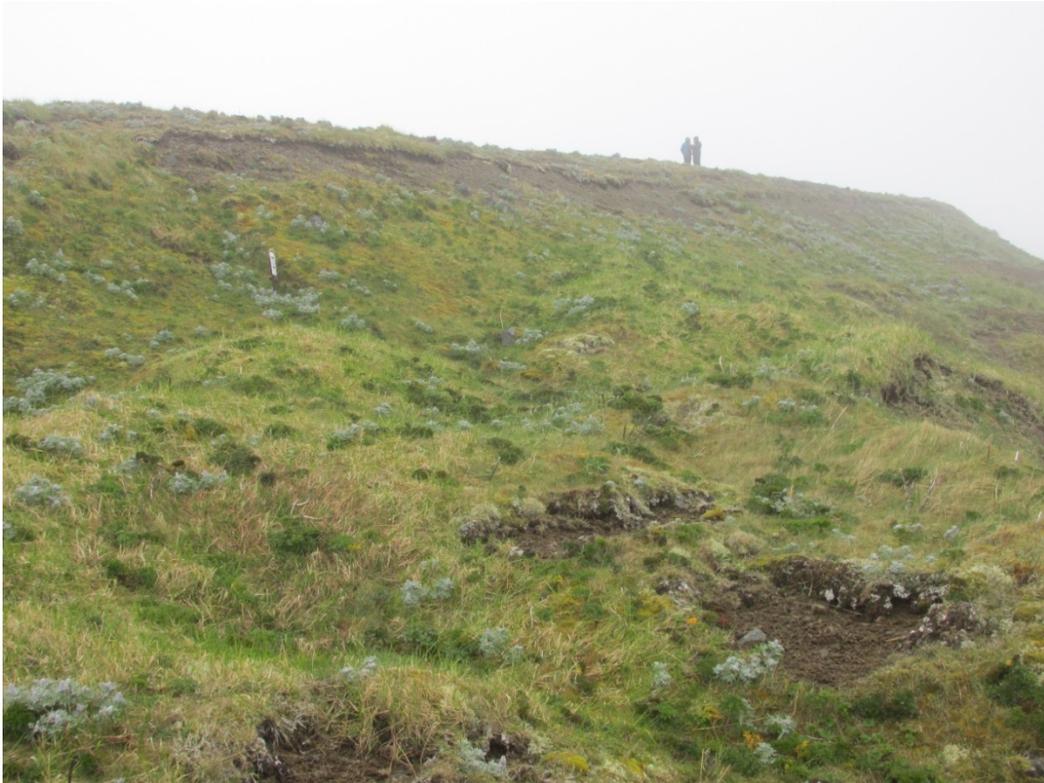
IMG_0707 – View NE of slumping along S side of mud pit cap, Site F

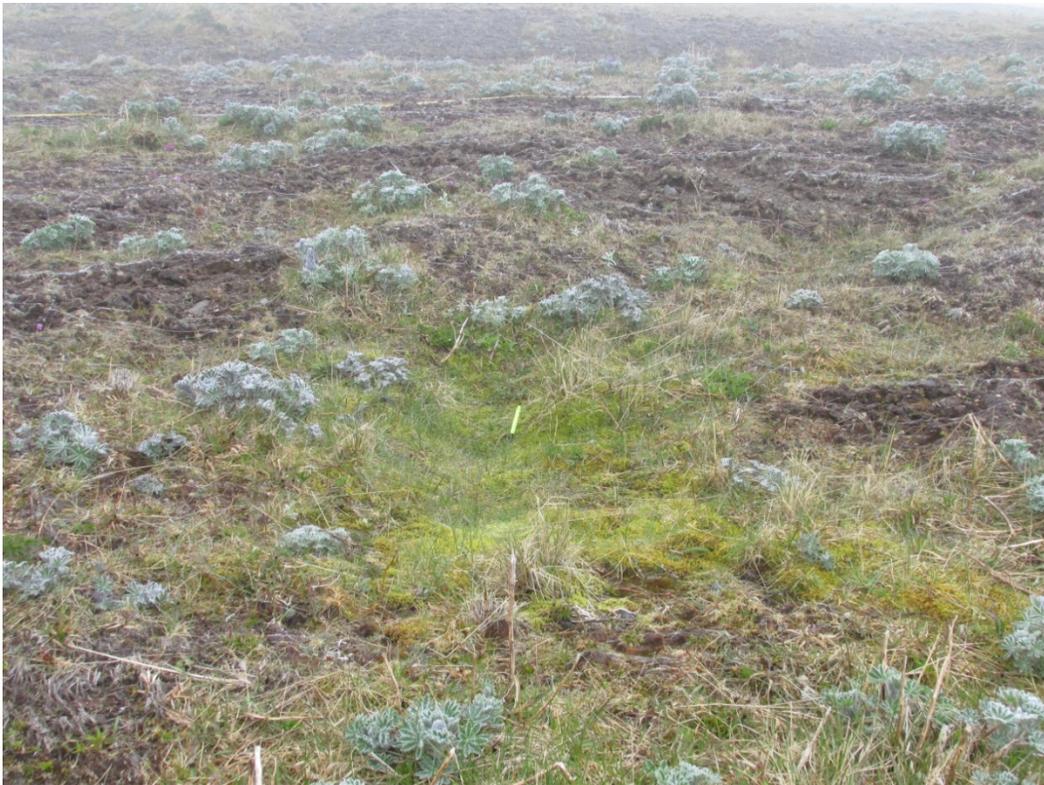
b. Signs damaged or removed?		X	New signs installed at USFWS Monument. Other signs are in good condition.
3. Cap			
a. Evidence of subsidence?	X		Vegetation continues to cover the small area of subsidence seen in the 2006 inspection

The small depression or subsidence noted since 2006 is covered by vegetation (moss) and has not changed since the 2011 inspection (photo 0708). Overall, vegetation appears to have increased slightly on the mud pit cap since the 2011 inspection.

IMG_0708 – View N of small depression in SW part of mud pit cap, Site F

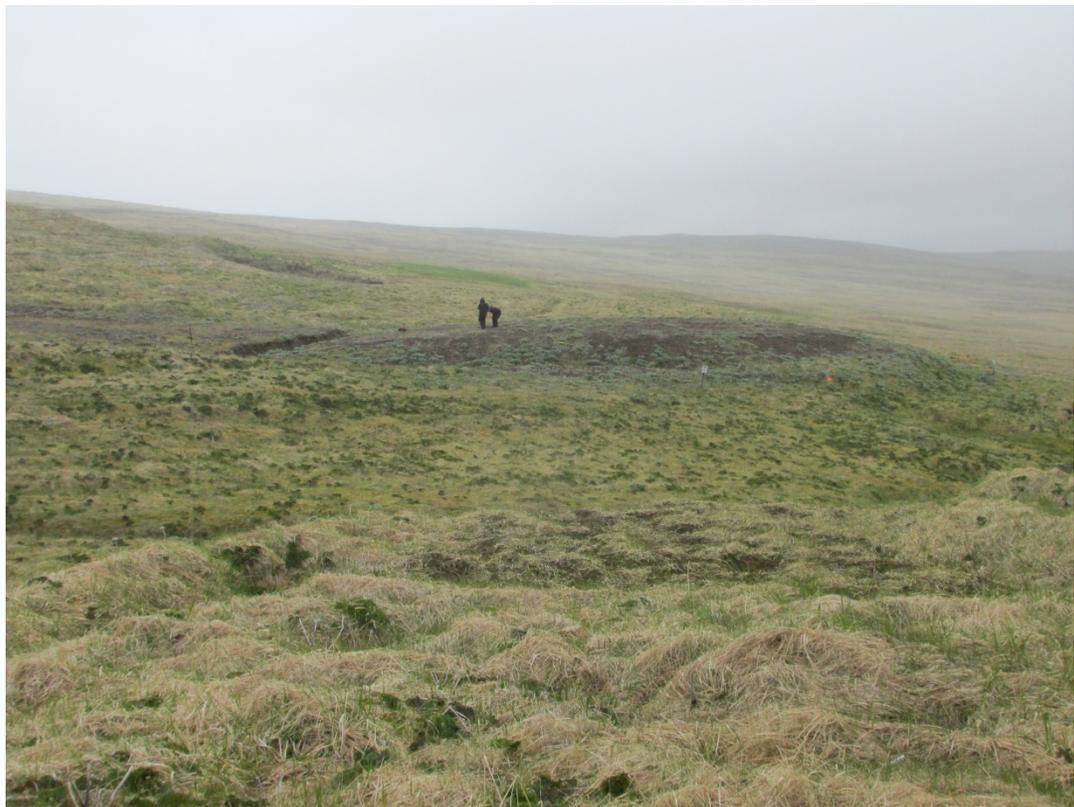
IMG_0684 – View ESE of mud pit cap from about 200 ft, Site E

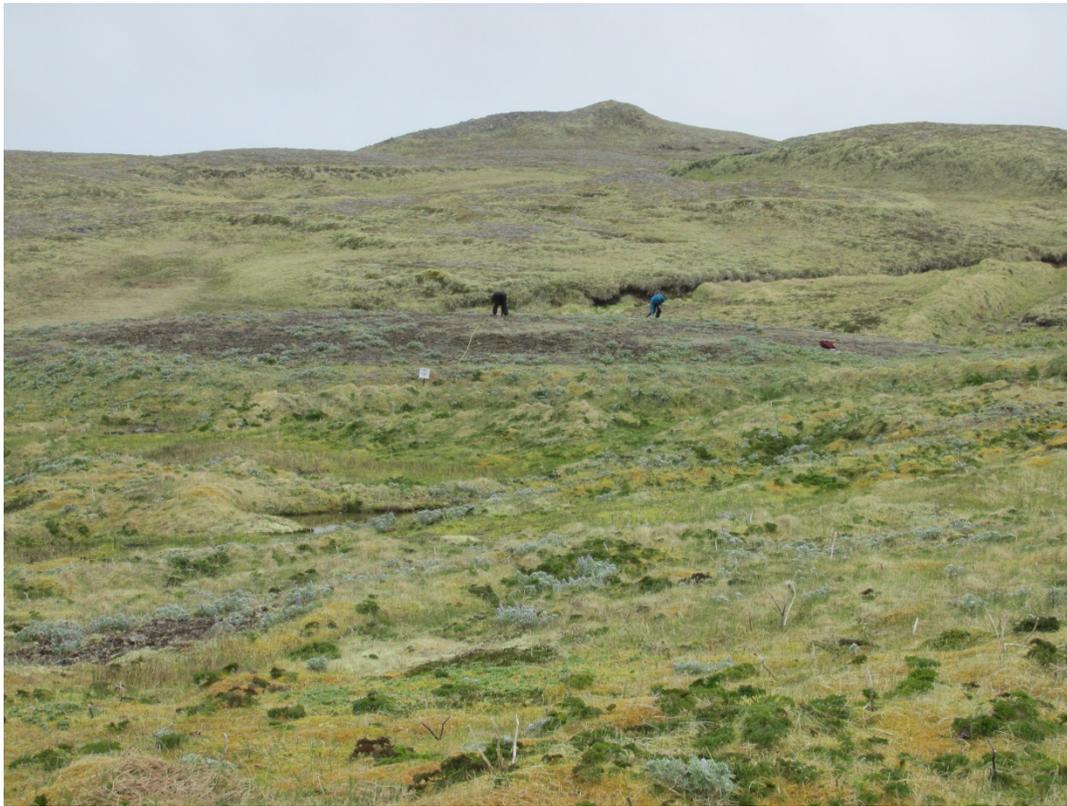
IMG_0690 – View WSW of mud pit cap from about 200 ft, Site E

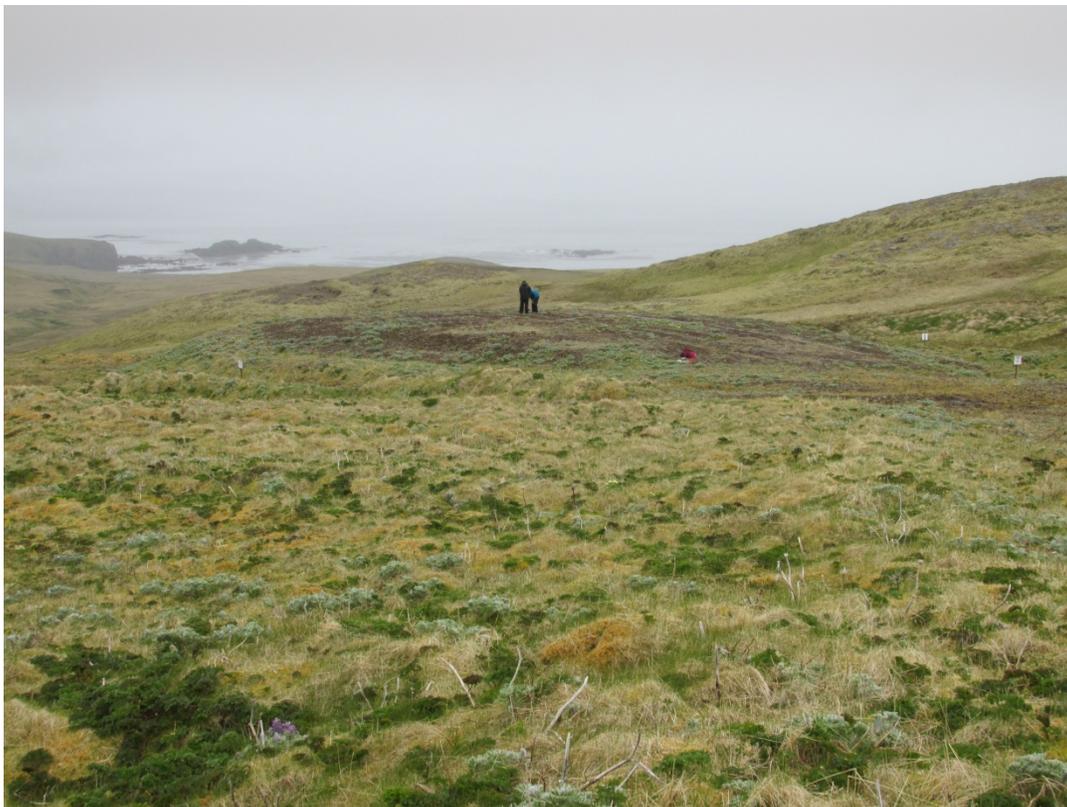
IMG_0691 – View SW of mud pit cap from about 200 ft and Pacific, Site E

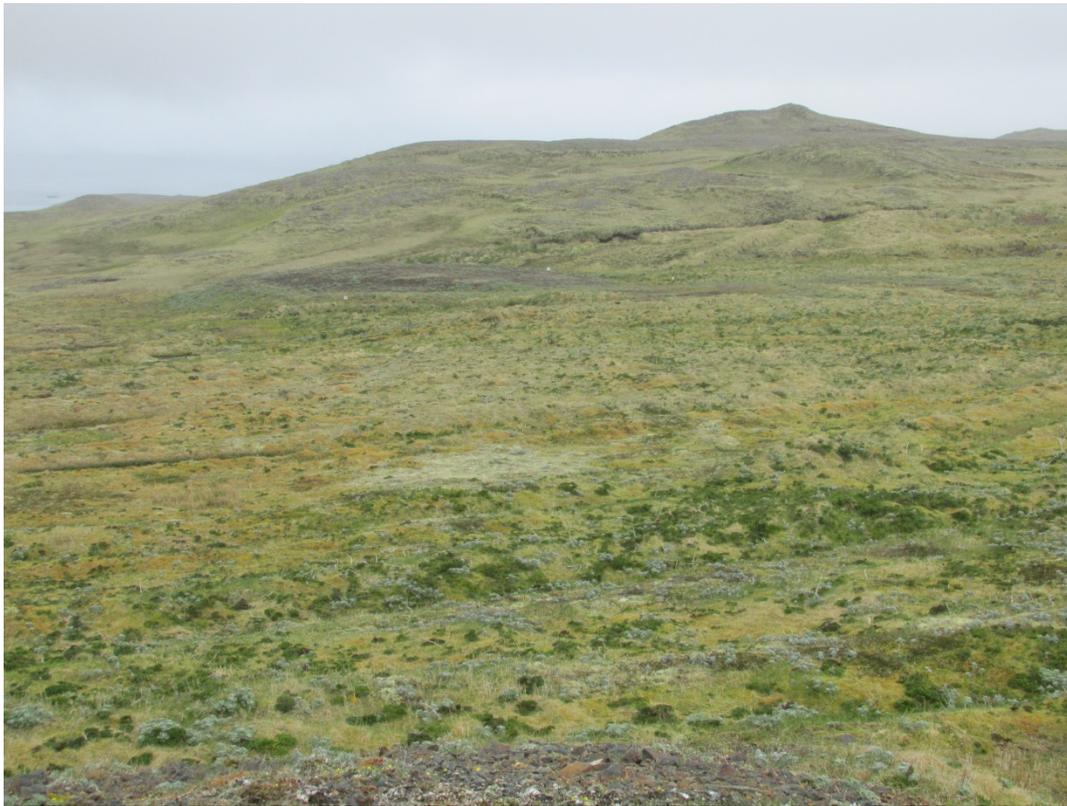
IMG_0692 – View SW of mud pit cap from pad for well UAE-7, Site E
