Amchitka Annual Site Inspection Trip Report Amchitka, Alaska, Site

August 2017

U.S. DEPARTMENT OF
ENERGY

Legacy
Management

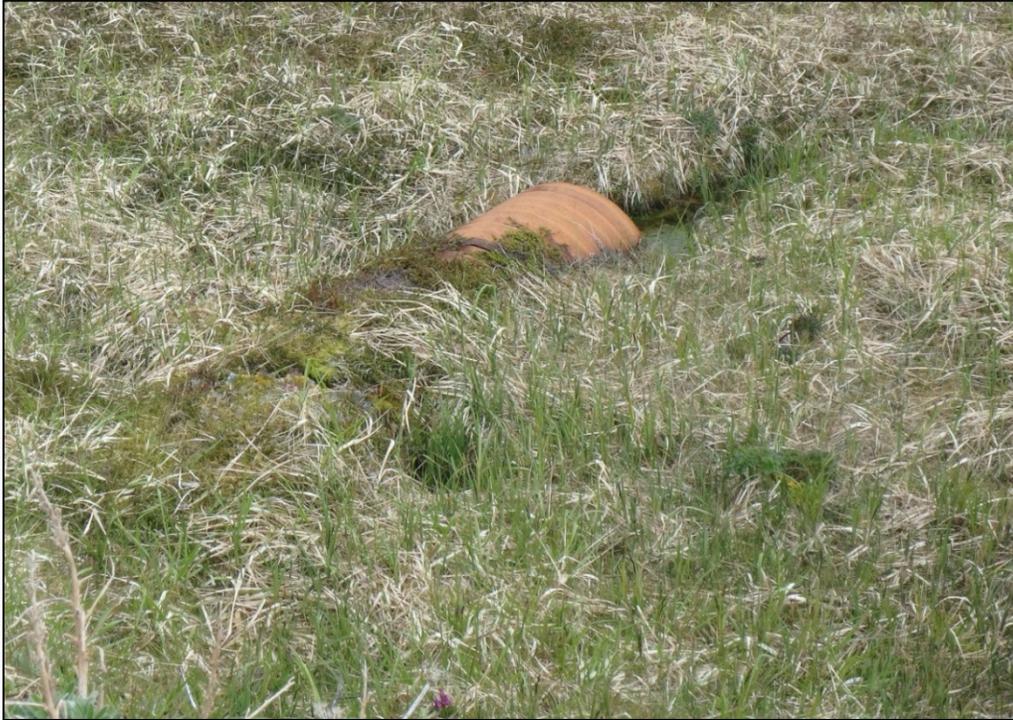
PL-CR011. 24-inch-diameter CMP approximately 700 yards from north end, east side

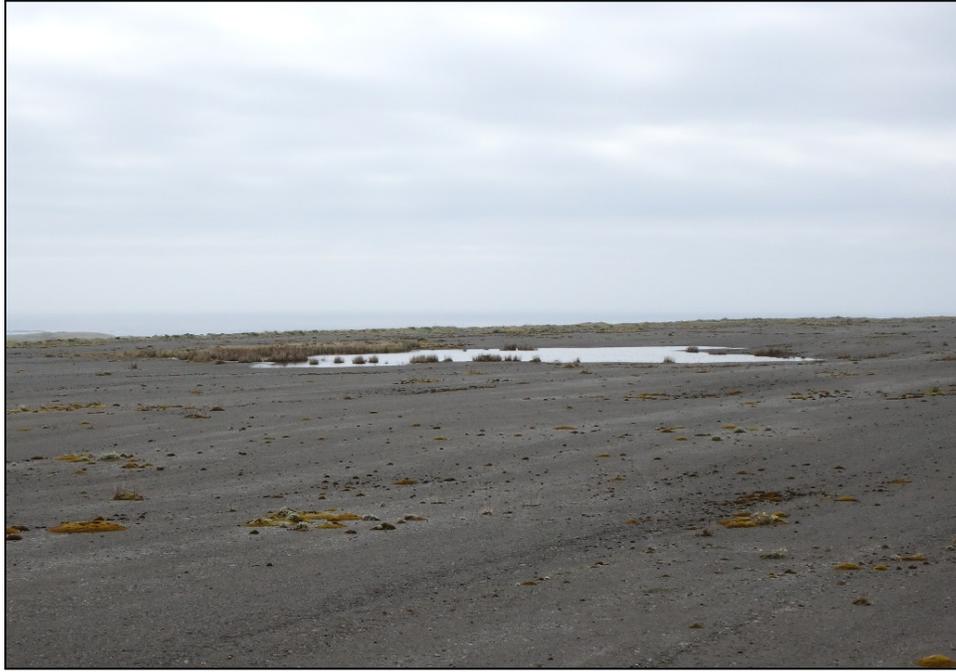
PL-CR021. Depression/ponding area approximately 80 ft by 92 ft, 3 inches deep

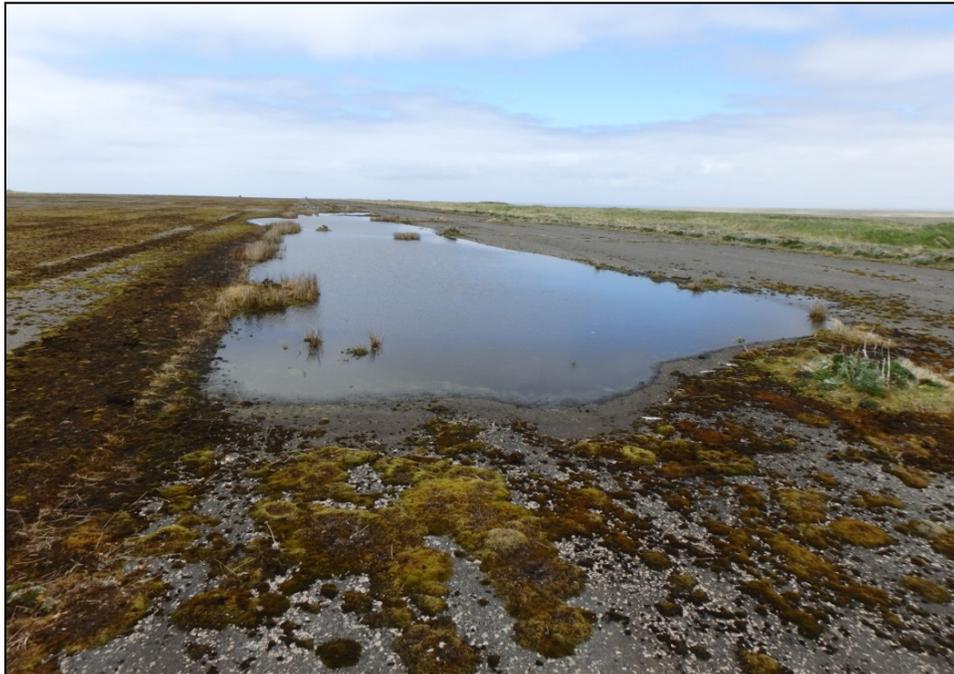
PL-BR05. Pond on runway (slightly east of middle of runway)

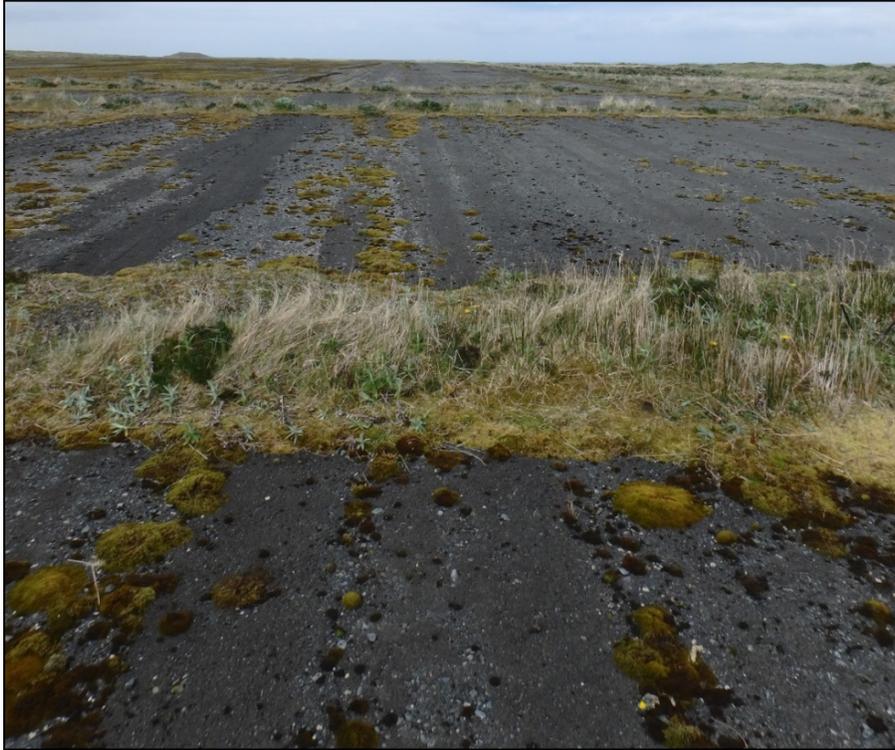
PL-BR06. Vegetation rows on old lights (perpendicular to runway)

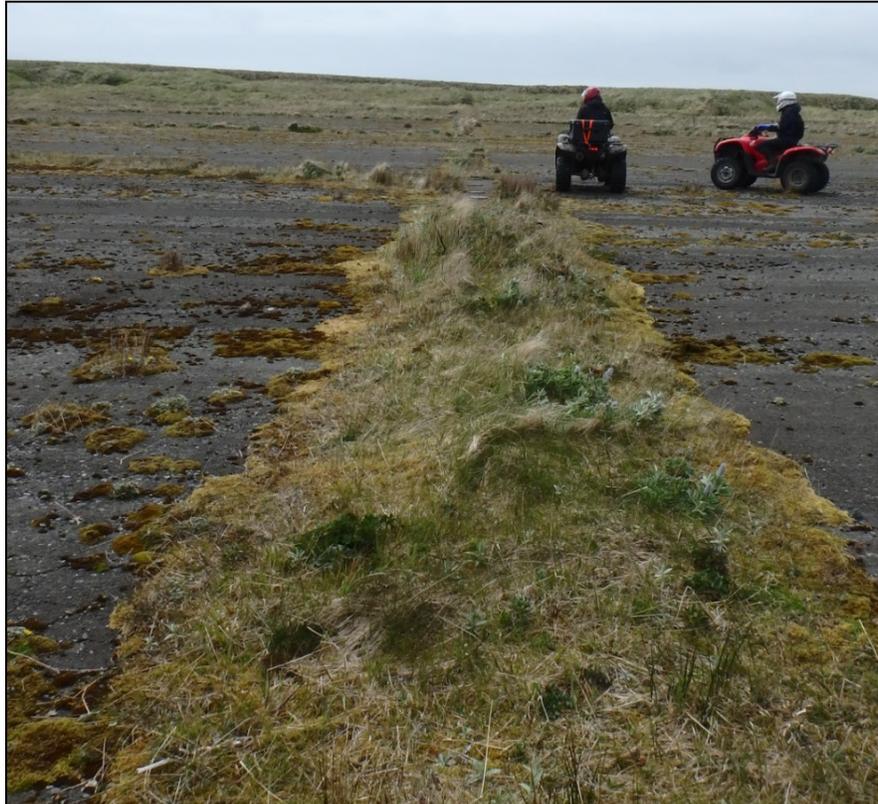
PL-BR07. Looking down vegetation on old lights, east end

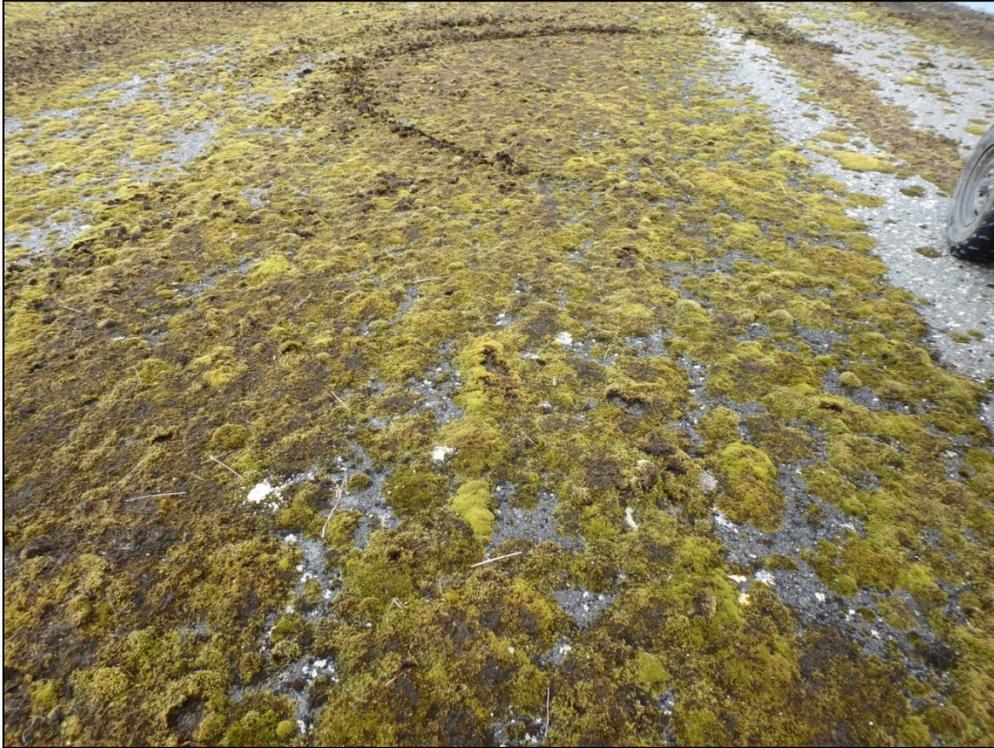
PL-BR010. Vegetation on runway

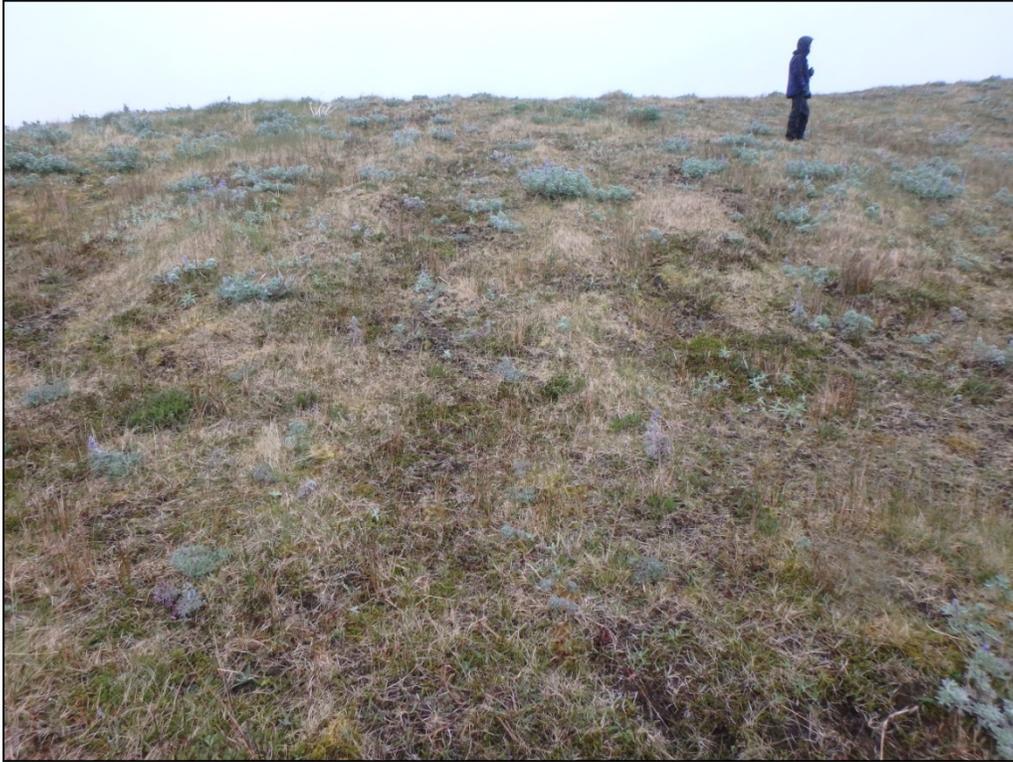
PL-LS02. Rills along east, southeast side

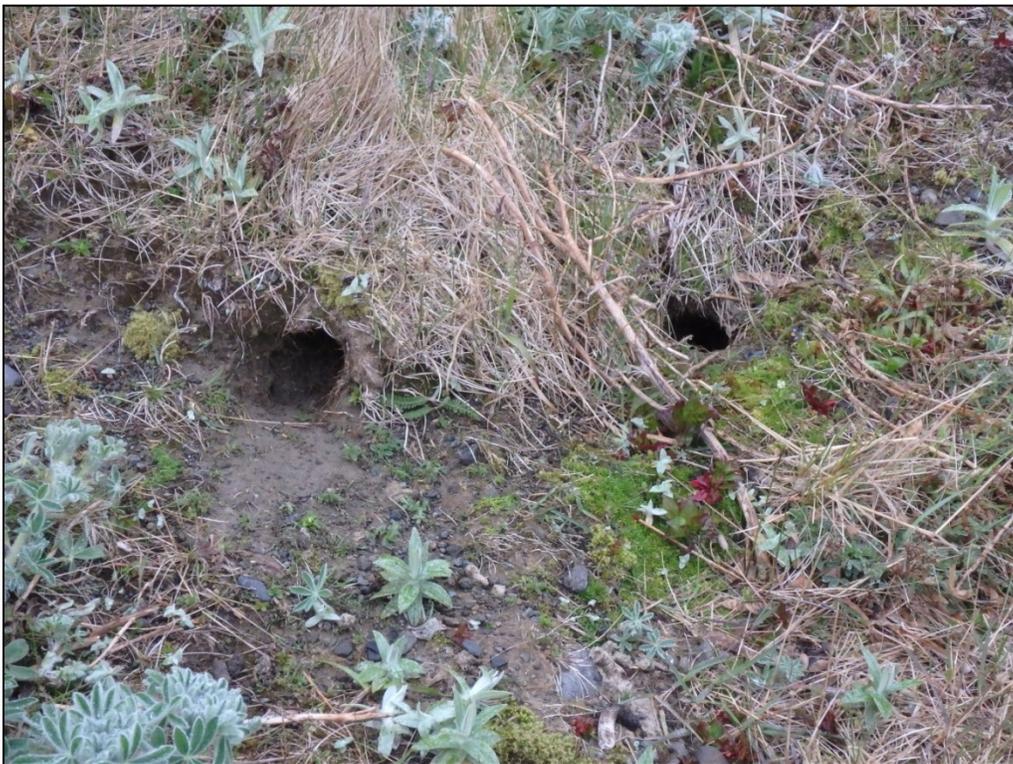
PL-LS03. Small holes near east base (IMG_794 from 2016 report)

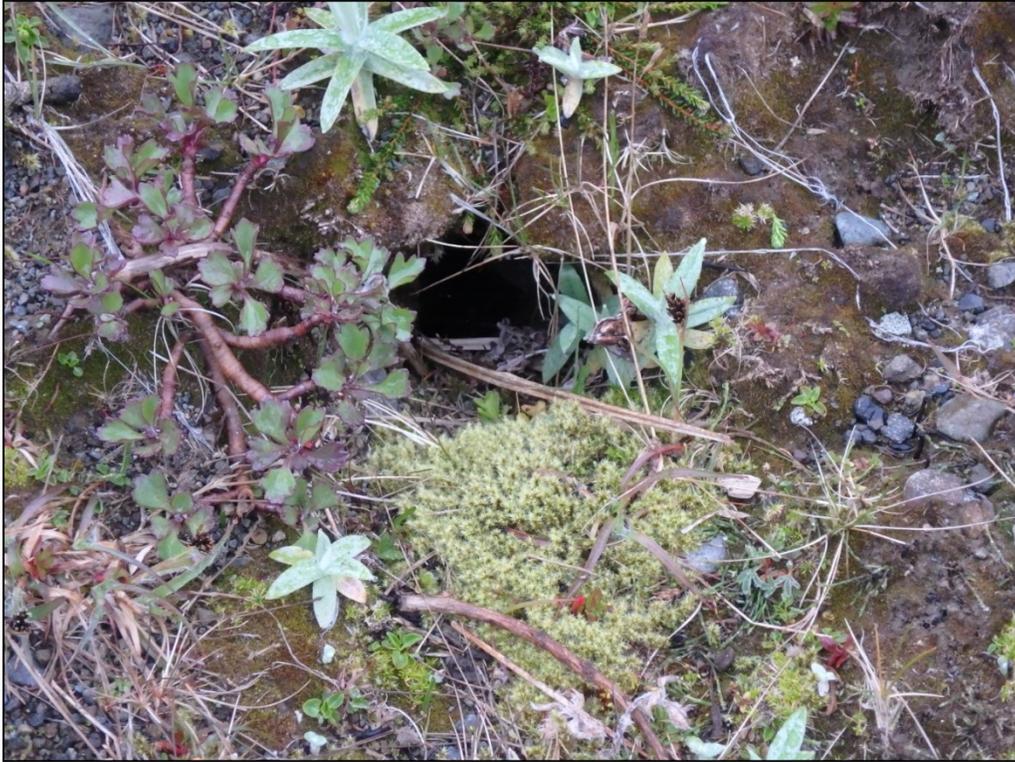
PL-LS04. Small hole near east base (IMG_794 from 2016 report)

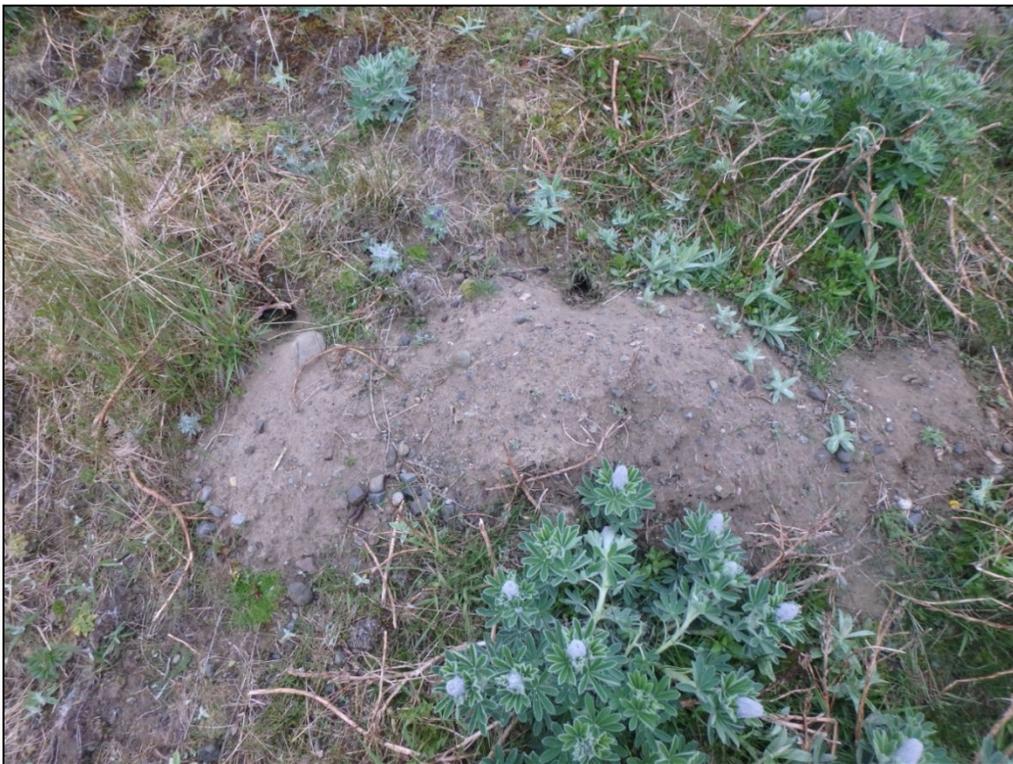
other holes were found on the cap. These holes were filled in and compacted by stomping on them by foot in 2016. Now three to five holes are visible on the east side in the same area and approximately nine new holes are visible on the north face. The south face has visible undulation across the entire side. It is unknown if this is left over from the original construction or if settlement is occurring. The new features collected are areas that may not have been observed in previous inspection due to being covered by vegetation (see Appendix A, Figure 2). See Appendix B for photos and the inspection checklist.

PL-LS 011. Small holes (new) along northeast side of cap, approximately 3 inches diameter, approximately 9 holes counted

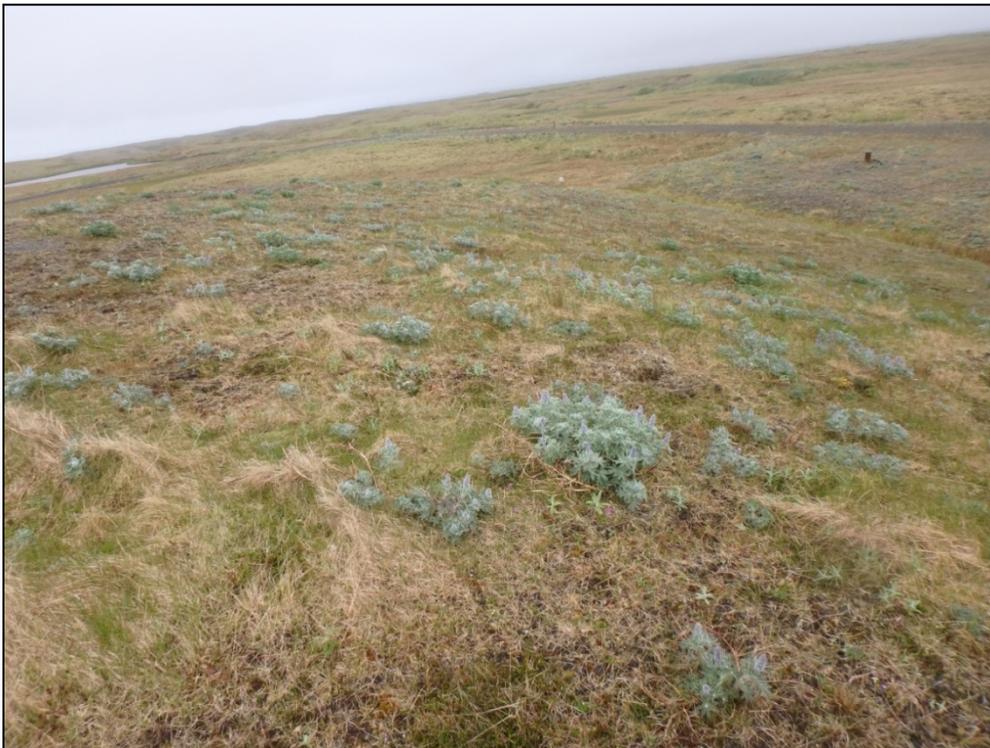
PL-LS013. Undulating surface along entire south side, photo taken from approximately middle of cap looking east

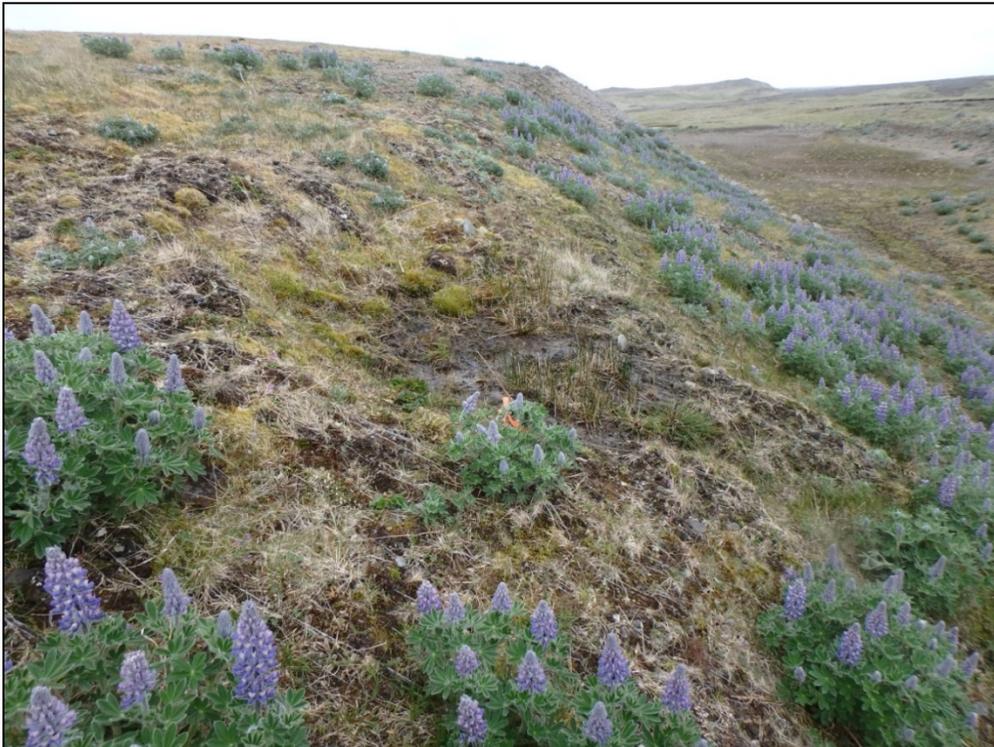
PL-D08. Depression/ponding area southwest side of west cap, duplicate of IMG_736 from 2016 report

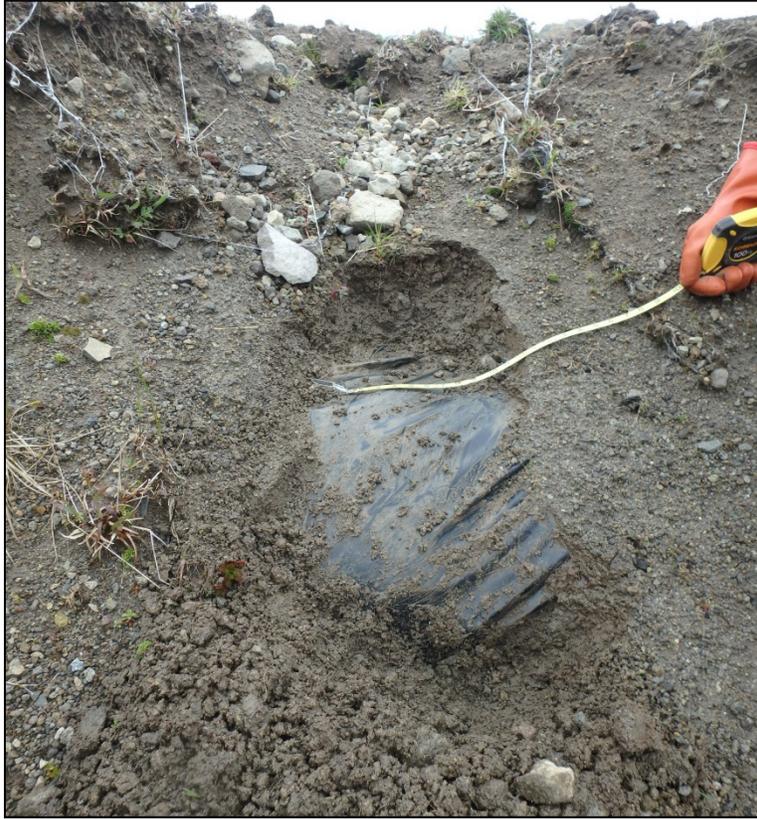
PL-D012. Exposed liner on south side of cap, approximately 12 inches wide, 24 inches vertical uncovered (west exposed section)

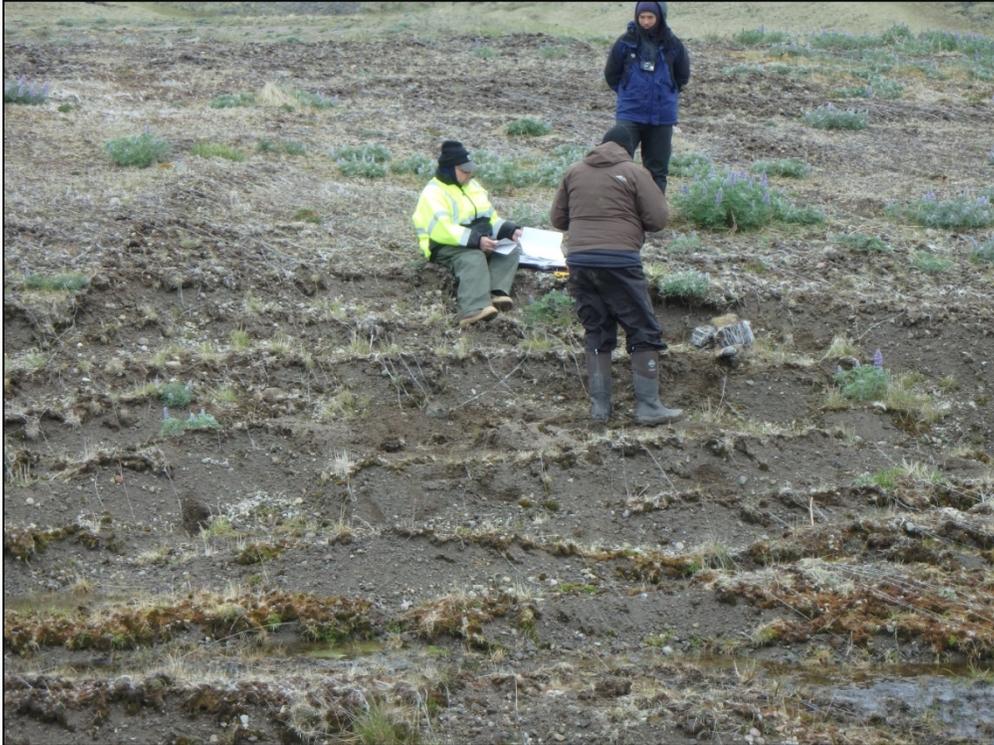
PL-D019. Final condition hole from D018 after filling it in

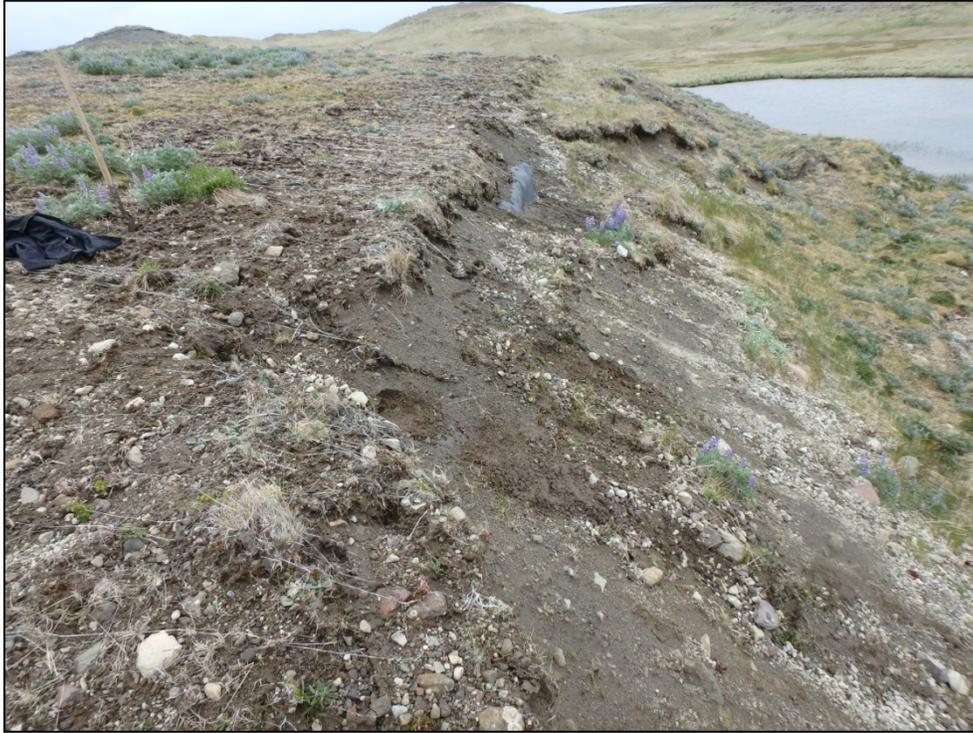
*PL-D022. Standing on west side of exposed liner looking east,
duplicate of IMG_744 from 2016 report*

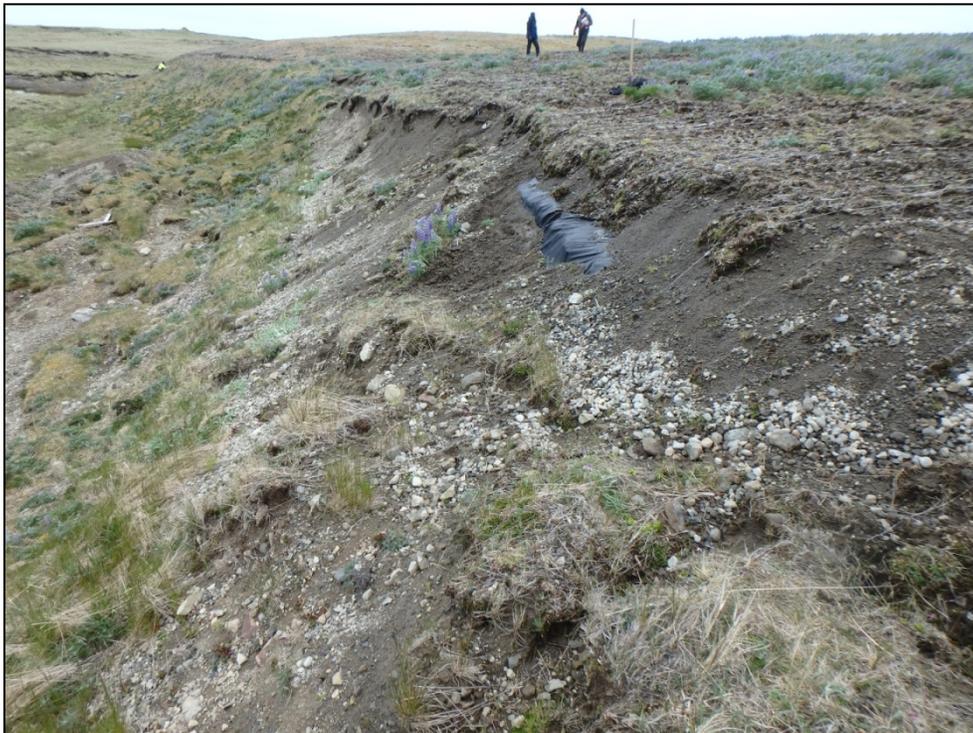
*PL-D023. Standing on east side of exposed liner looking west,
duplicate of IMG_744 from 2016 report*

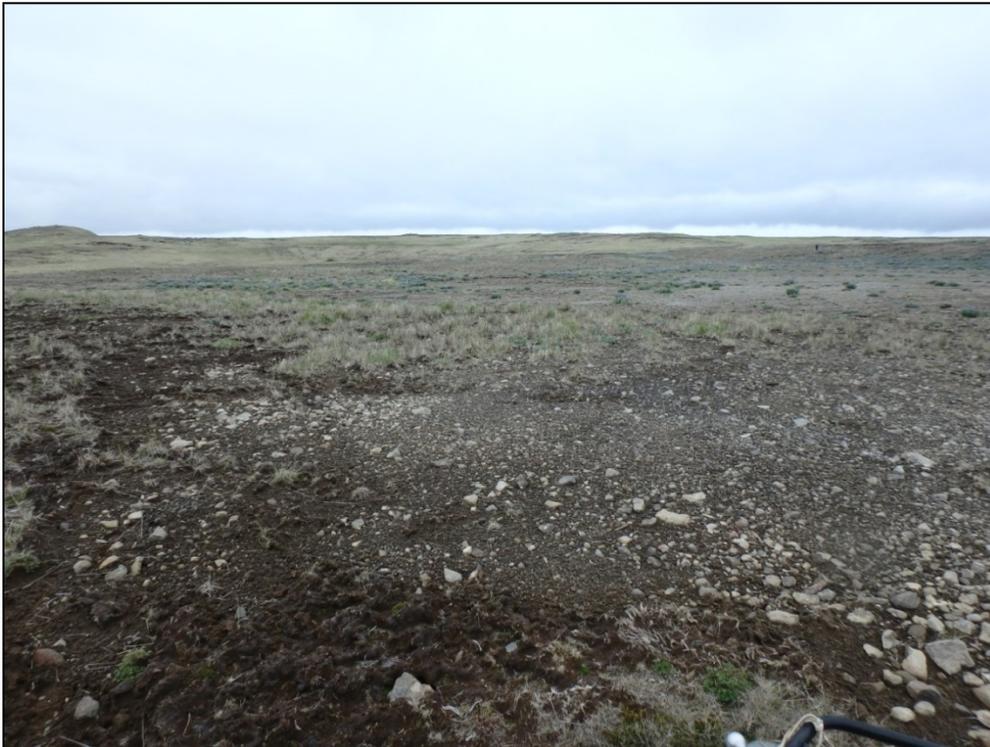
PL-D038. Standing west of west cap looking north across proposed area for new combined Site E and Site F mud pit

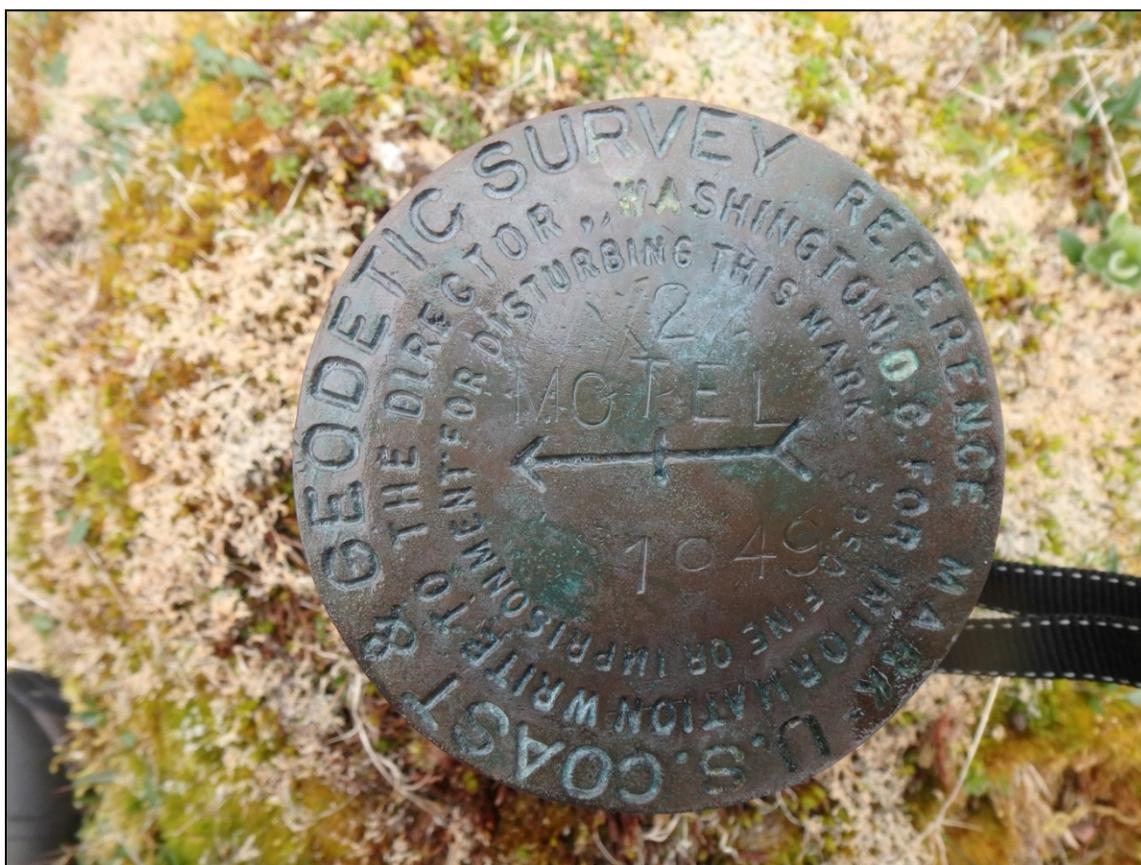
PL-F01. Brass cap on bent steel pipe marked U.S. Coast & Geodetic Survey Reference Mark, 2 MOTEL, 1949

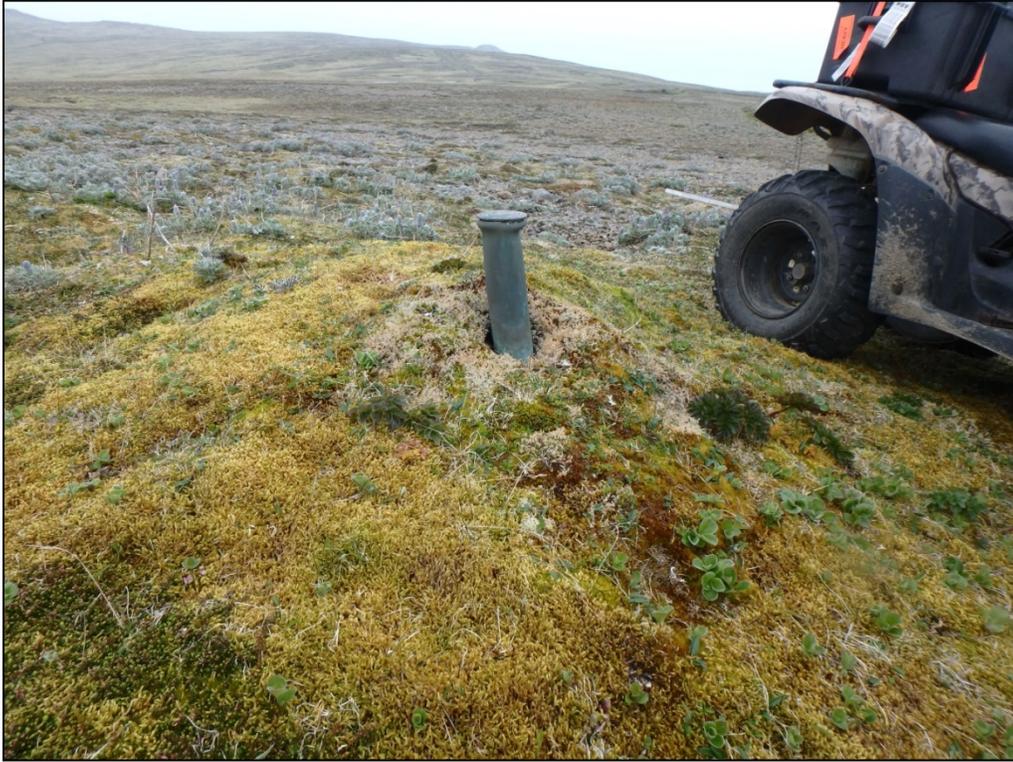
PL-F02. Slightly bent pipe with survey marker, 2 MOTEL, 1949

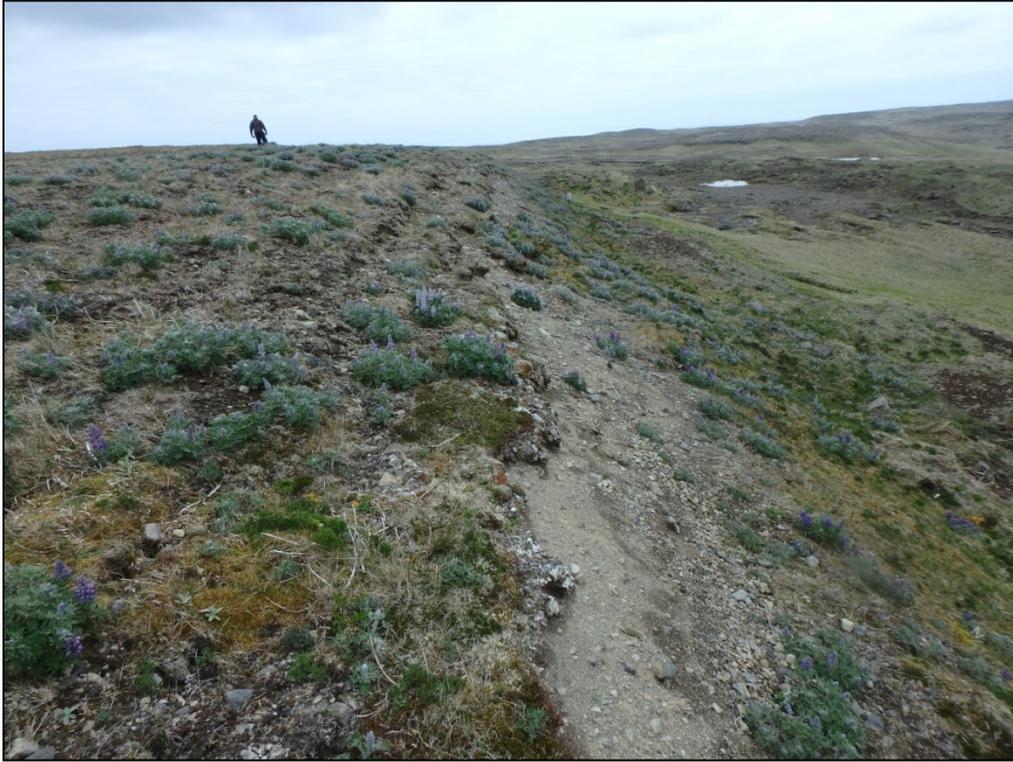
PL-F06. South side of cap looking east

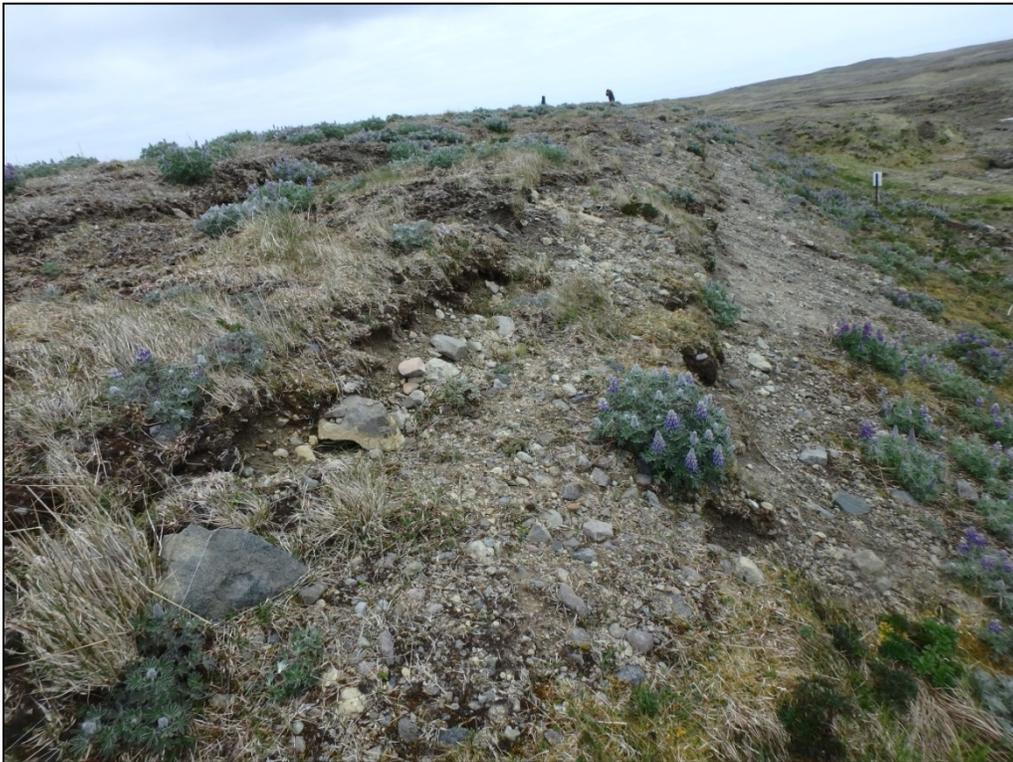
b. Evidence of cracking?	X		A long crack and associated slump from the 2014 earthquake are along the S edge of the mud pit cap (outside the cap boundary). Another long crack/scarp is NE of the mud pit cap (outside the cap boundary).

PL-F07. South side of cap looking E approximately from cap midpoint, three terraces of scarp (Upper approximately 6 to 12 inches deep, middle 6 to 18 inches deep, lower 6 to 18 inches deep)

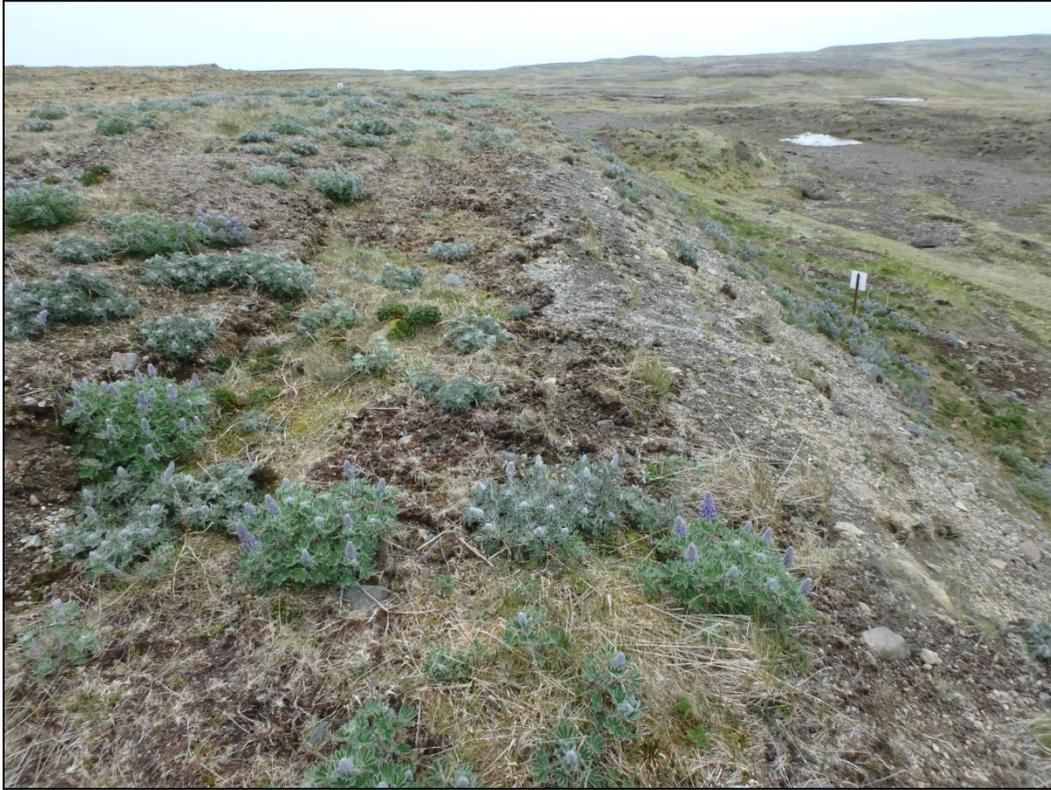
PL-F08. South side of cap looking east, duplicate of IMG_705 from 2016 report

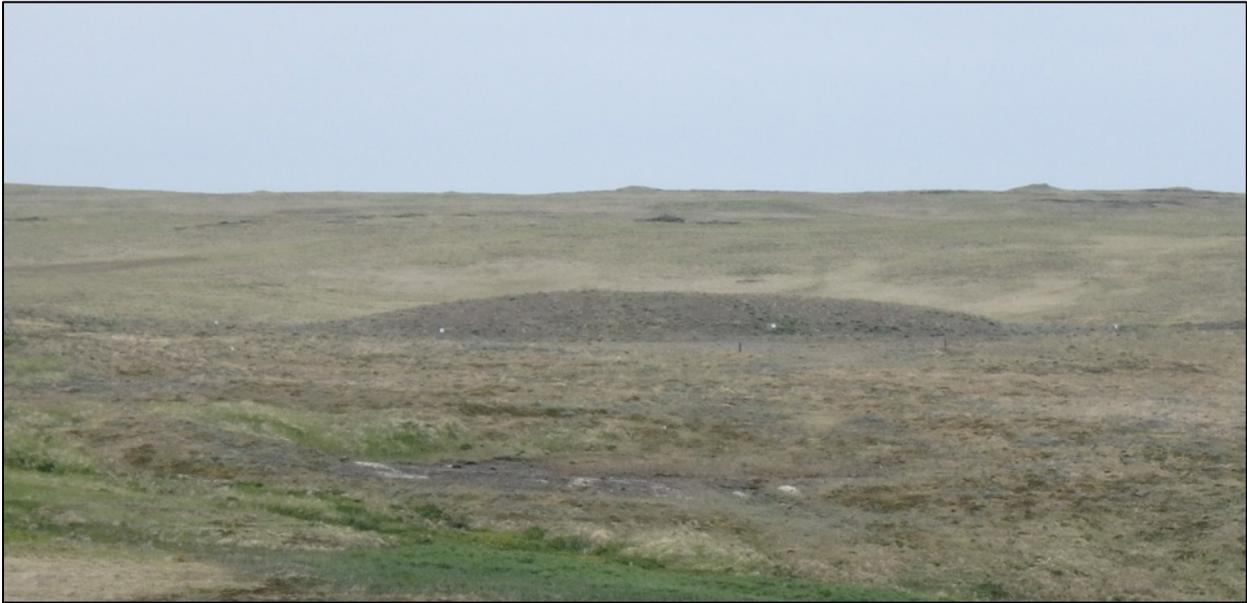
View east of Cannikin ground zero

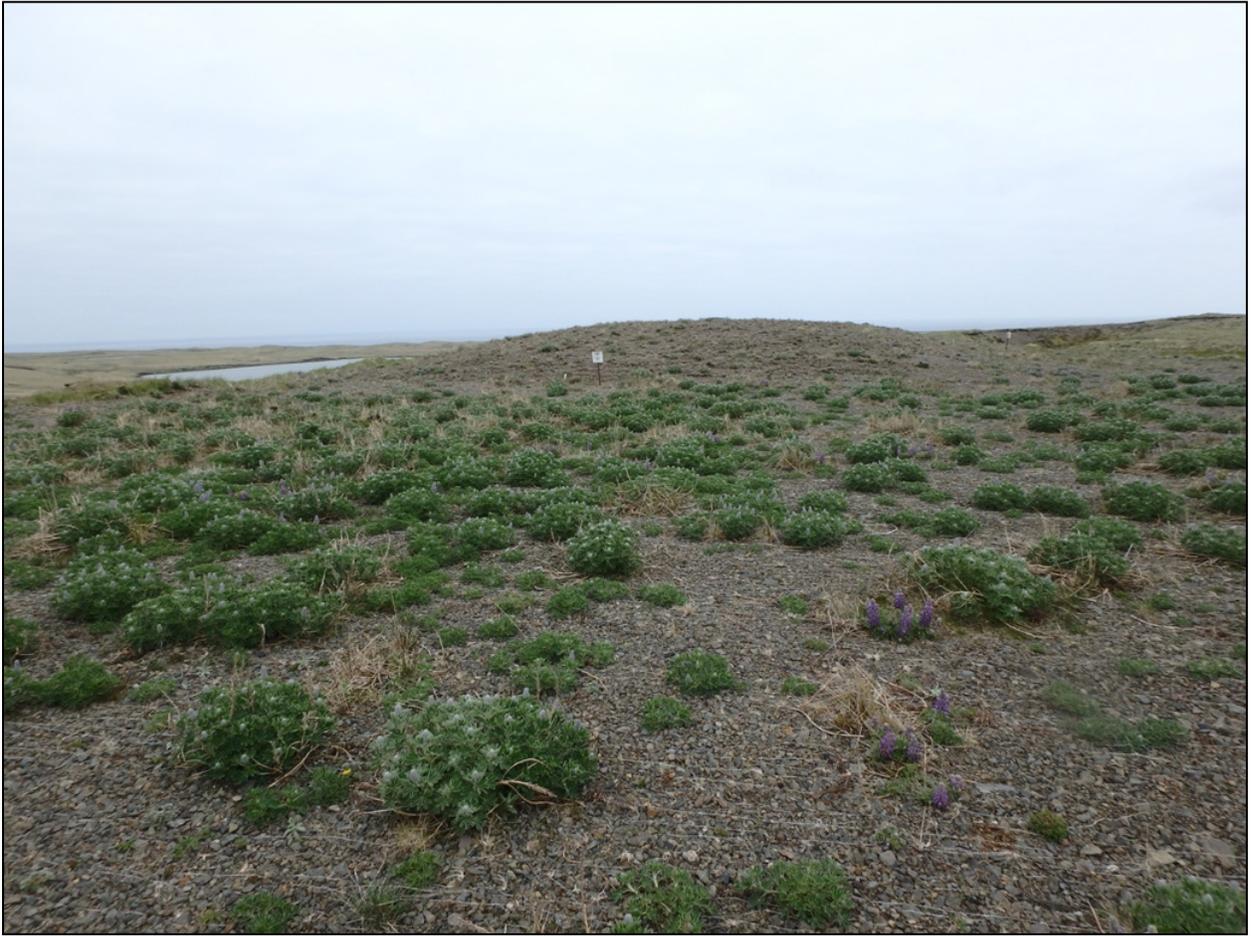
View northwest of Cannikin south mud pit cap with Cannikin Lake in background

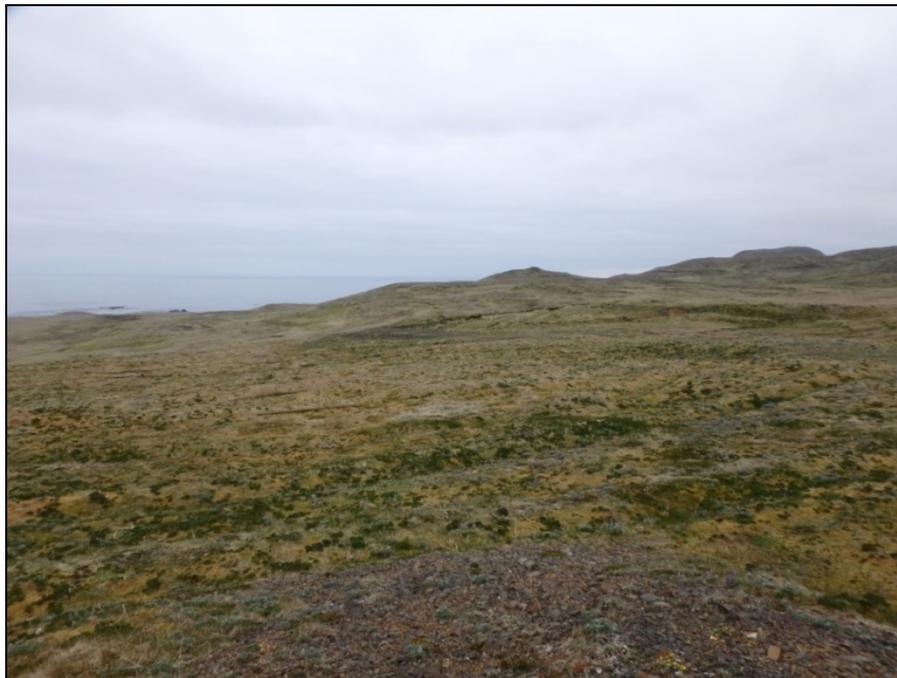
PL-E01. Photo from well/parking area, duplicate of IMG_692 from 2016 report

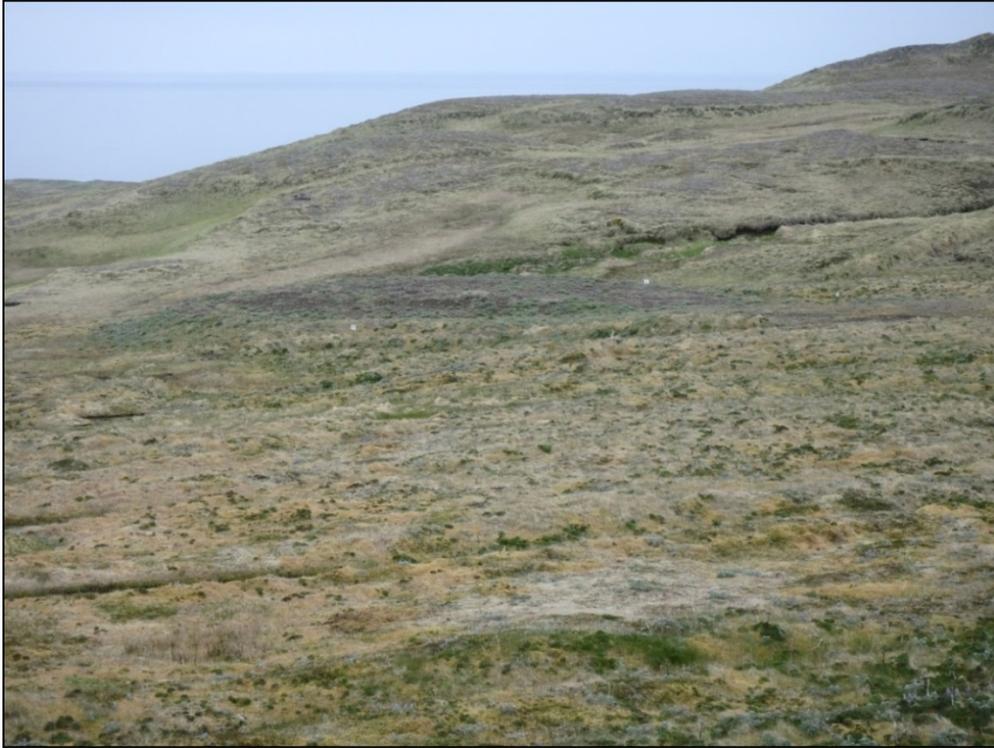
PL-E02. Zoomed photo from well/parking area, similar to IMG_691 from 2016 report

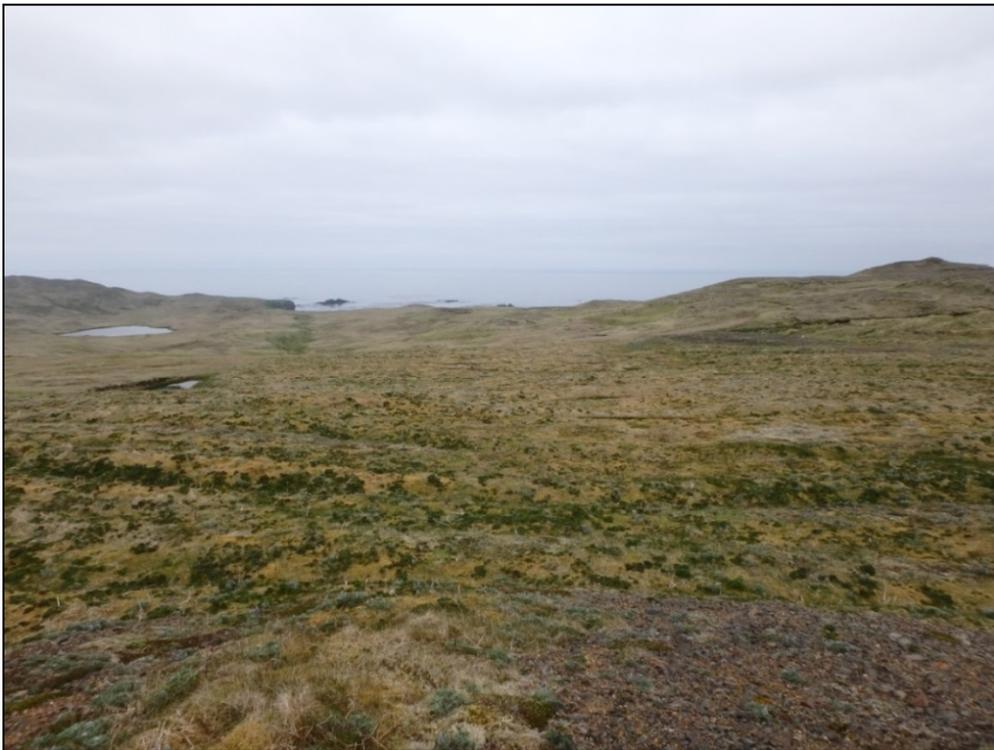
PL-E03. Photo from well/parking area that captures the drainage going to Pacific Ocean

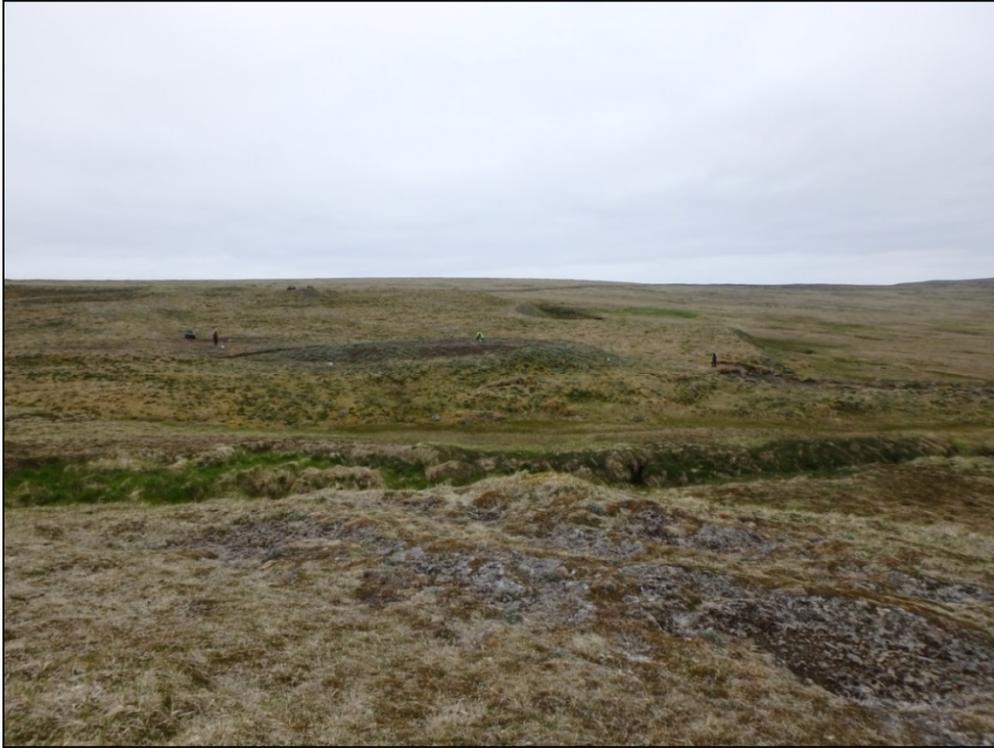
PL-E04. Photo from west looking east from approximately 75 yards away

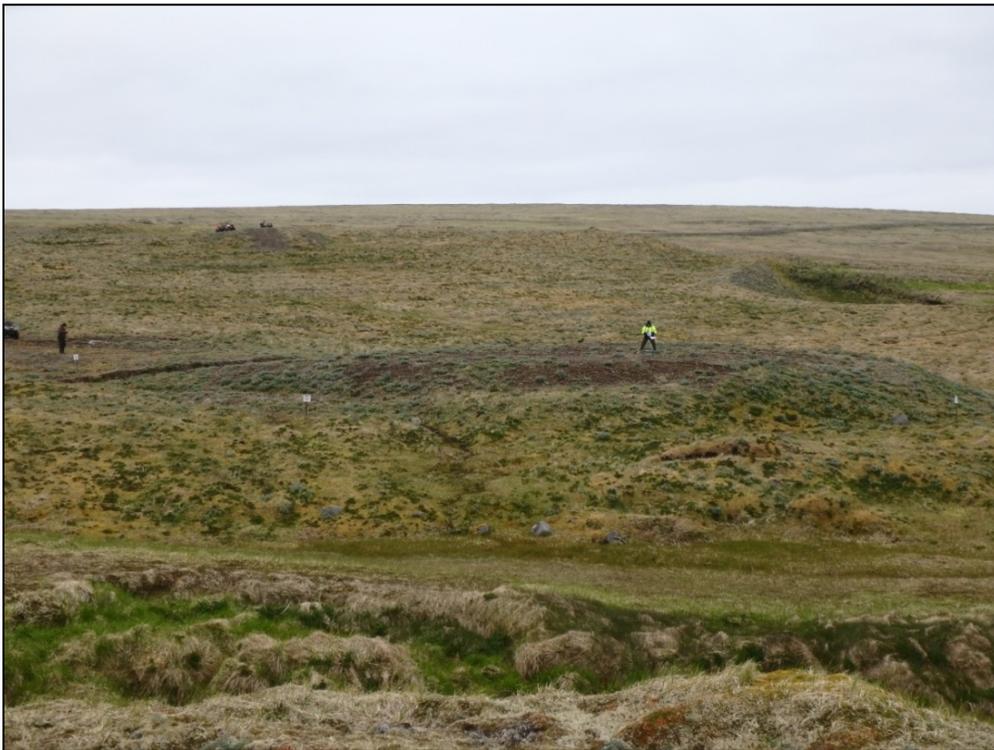
PL-E05. Photo from west looking east from approximately 200 ft away, duplicate of IMG_684 from 2006 report
