Amchitka Annual Site Inspection Trip Report Amchitka, Alaska, Site

August 2017

U.S. DEPARTMENT OF
ENERGY

Legacy
Management

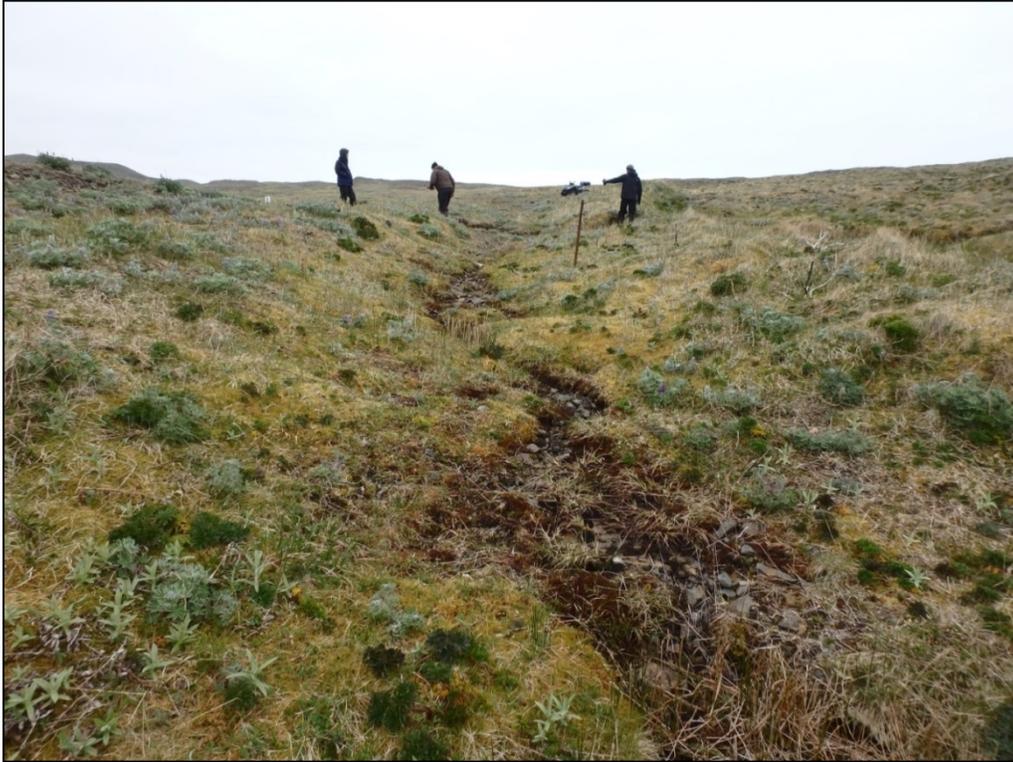
PL-E06. East drainage channel

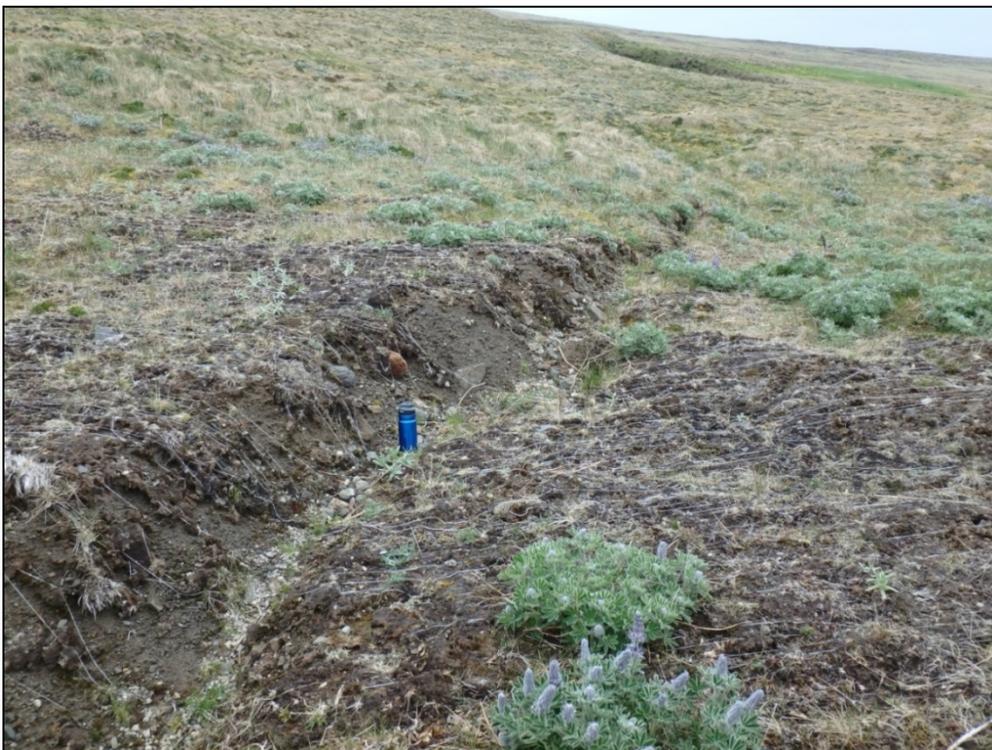
PL-E09. North scarp at approximately mid cap looking east, approximately 2.0 ft exposed

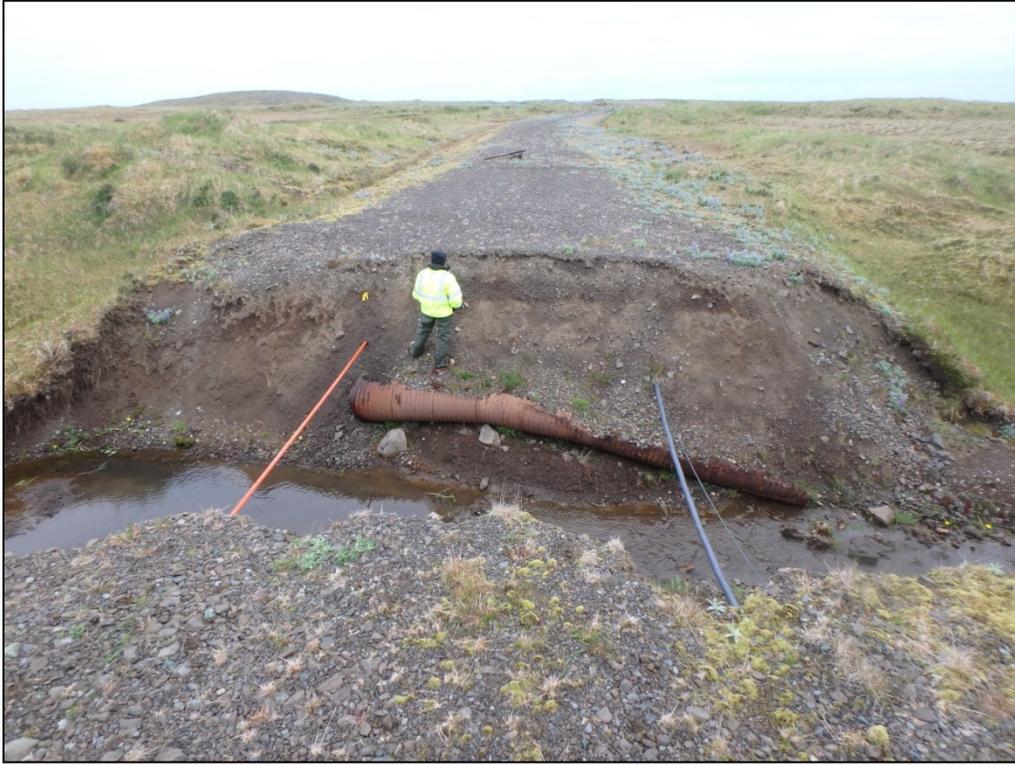
PL-MM4_02. Looking north

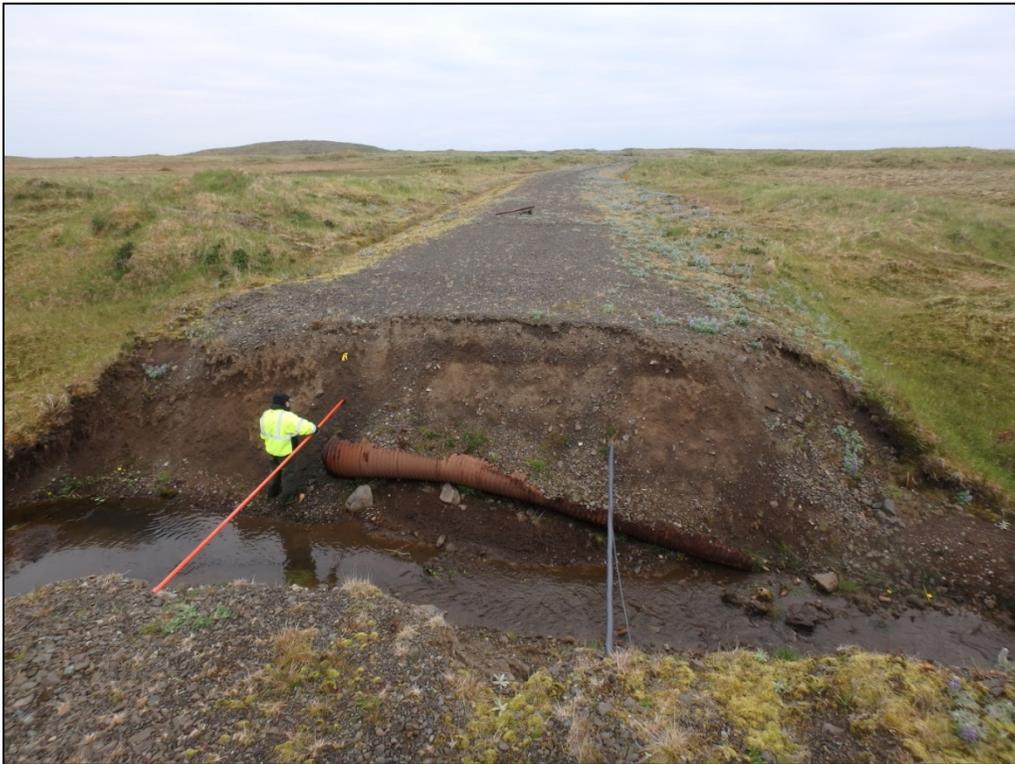
PL-MM4_03. Looking north

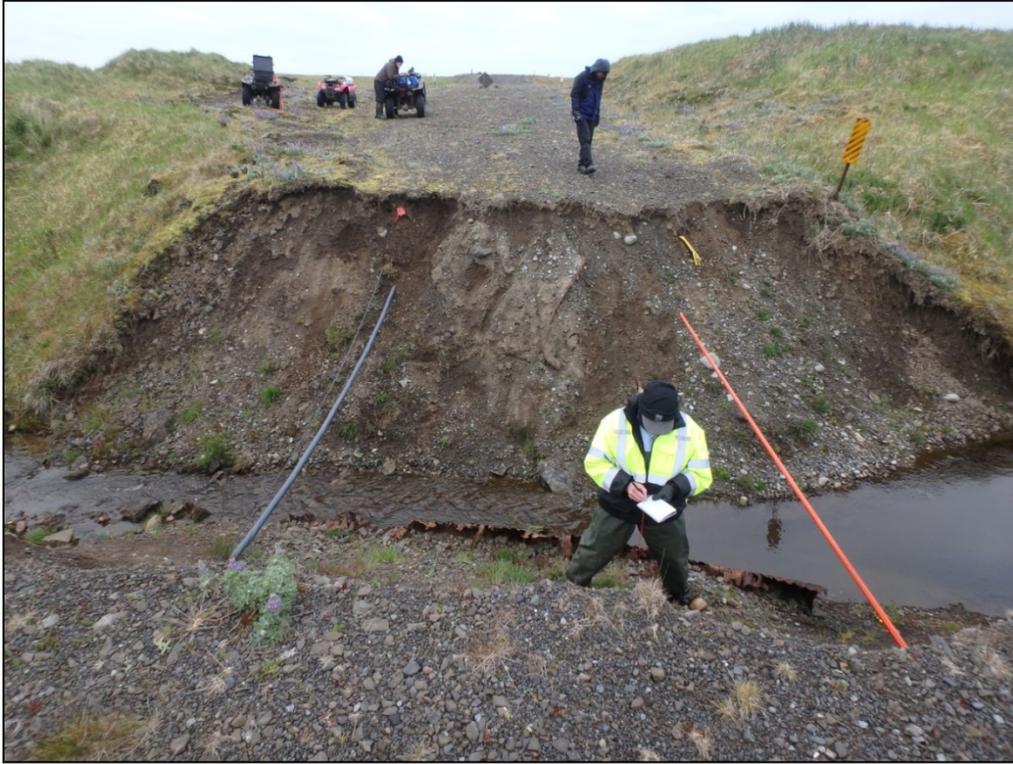
PL-MM4_04. Looking south

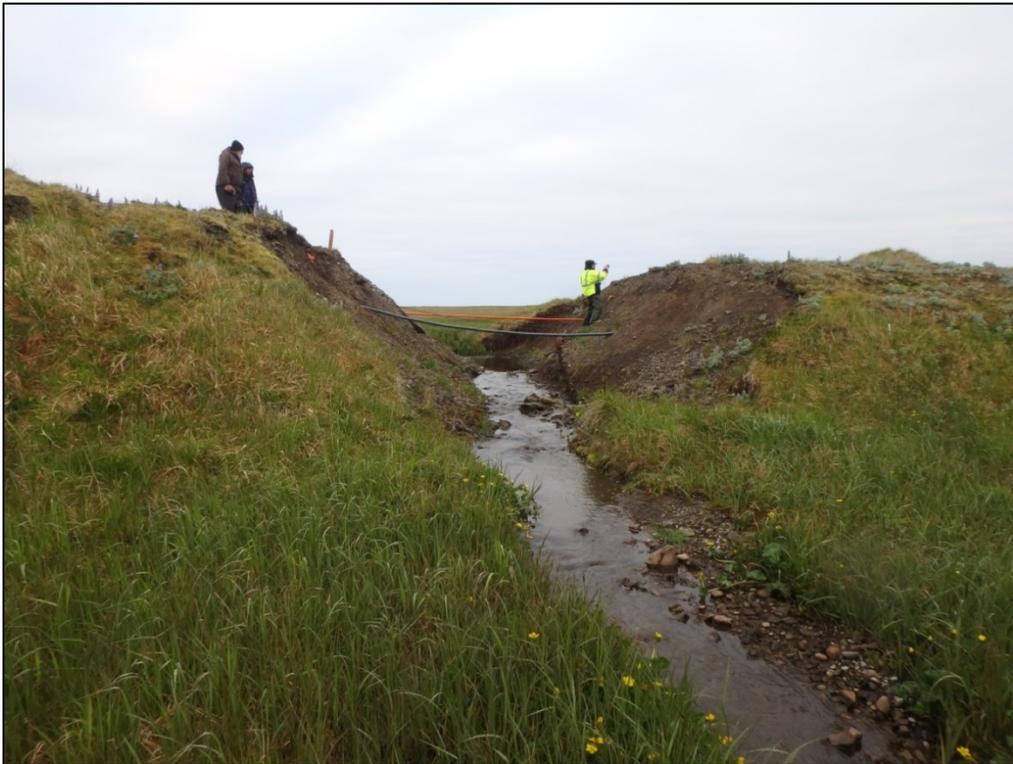
PL-MM4_05 Looking west from approximately 75 ft downstream

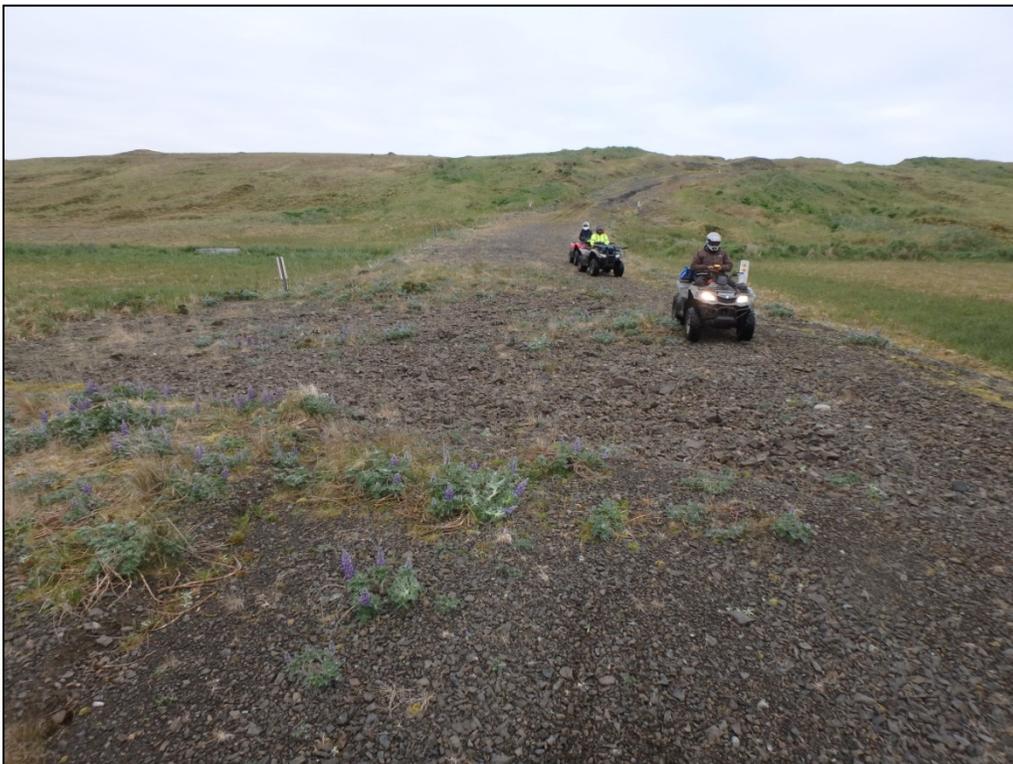
PL-MM5_07. Drainage channel flow line crossing road (low spot) looking south

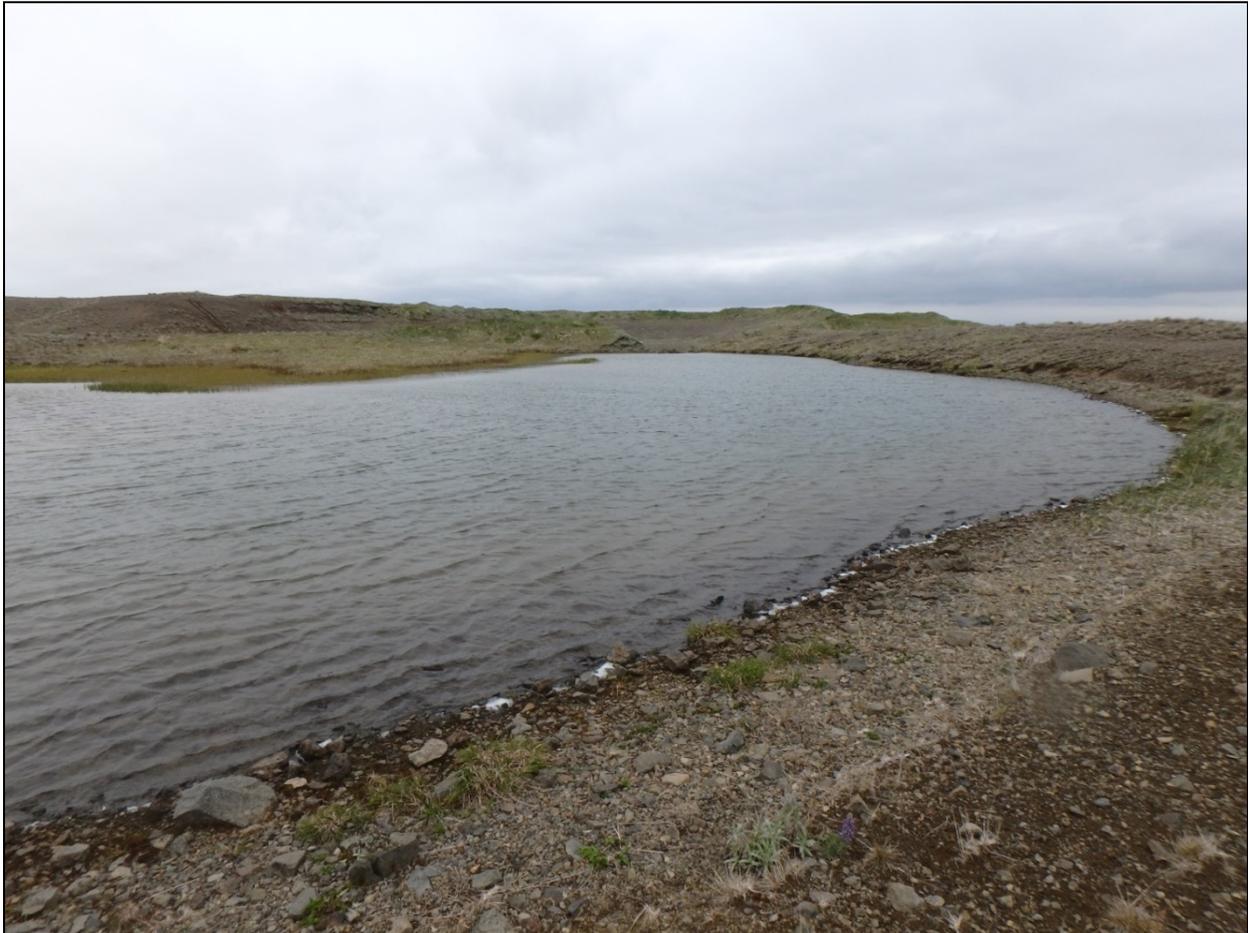
PL-MM8 B_01. Southwest corner of pond looking north, northwest to main borrow area

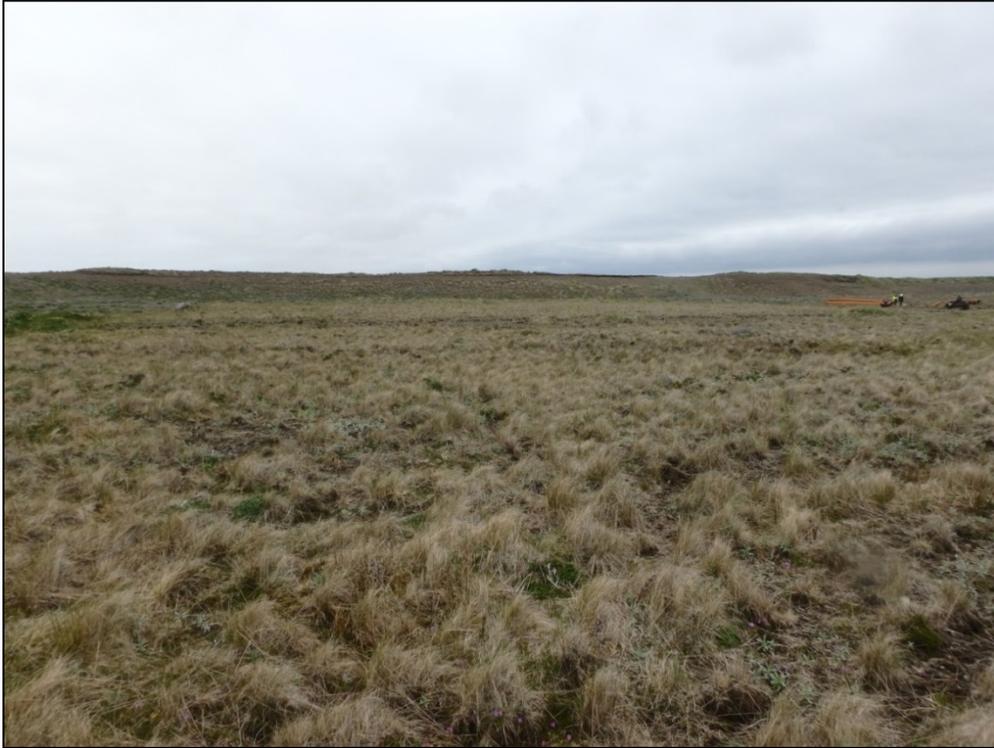
PL- MM8 B_02. Southwest corner of pond looking north toward south end of existing borrow area

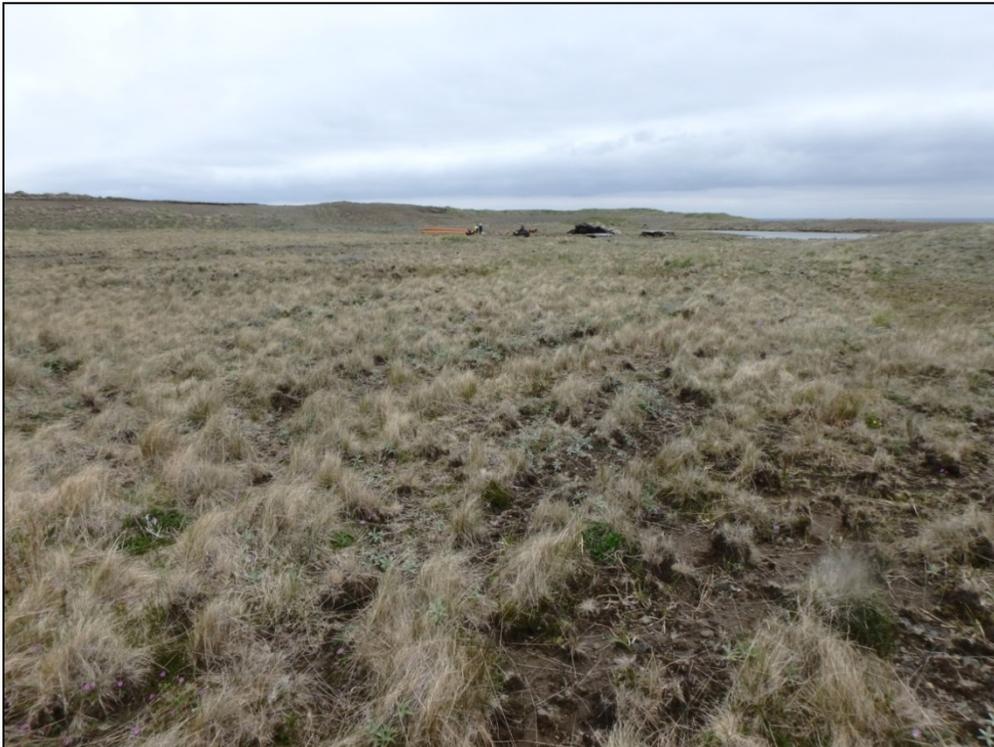
PL-MM8 B_03. Possible new borrow material southeast corner of new area looking northwest

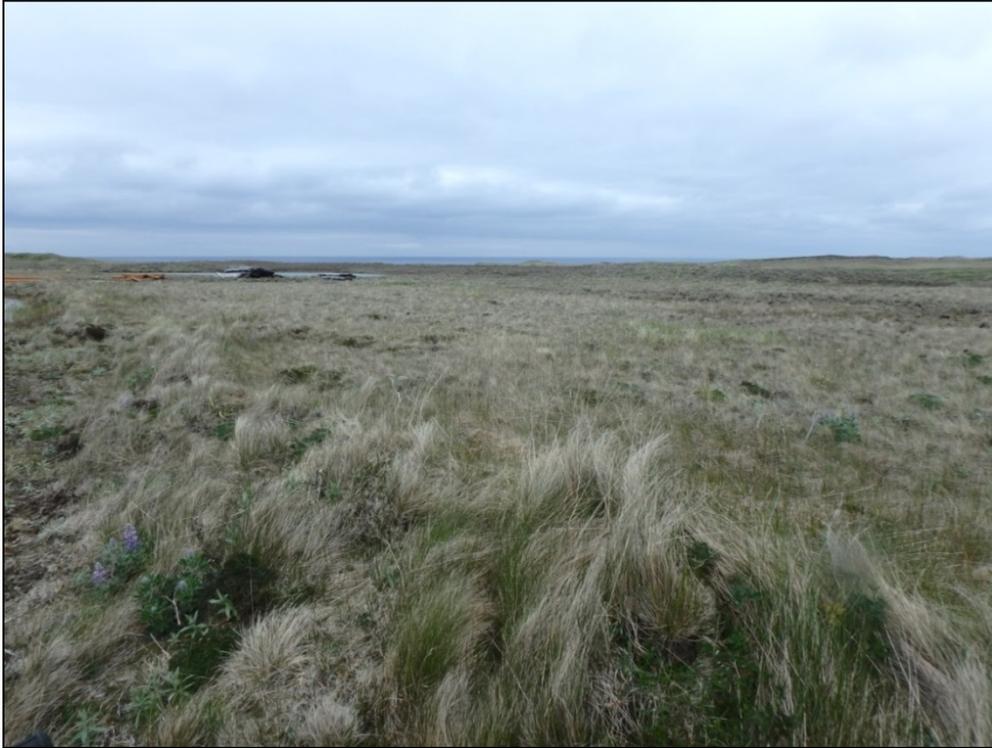
PL-MM8 B_04. Southwest corner of possible new borrow material area looking north, northeast toward the south end of the existing borrow area

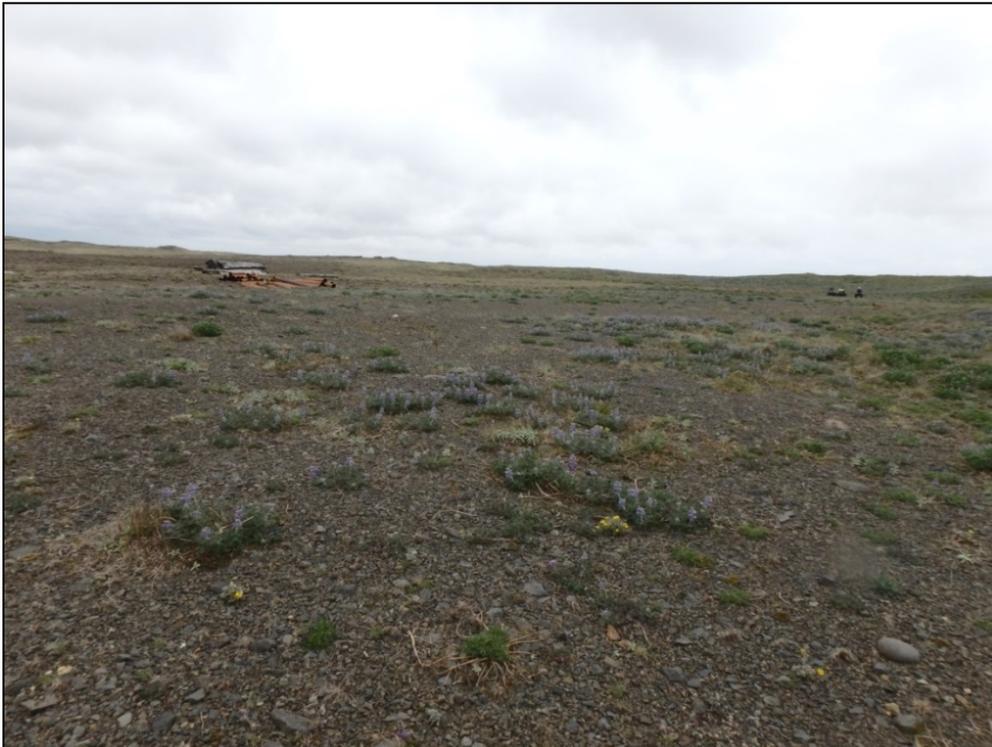
PL-MM8 B_05. Northwest corner of possible new borrow material area looking east, southeast

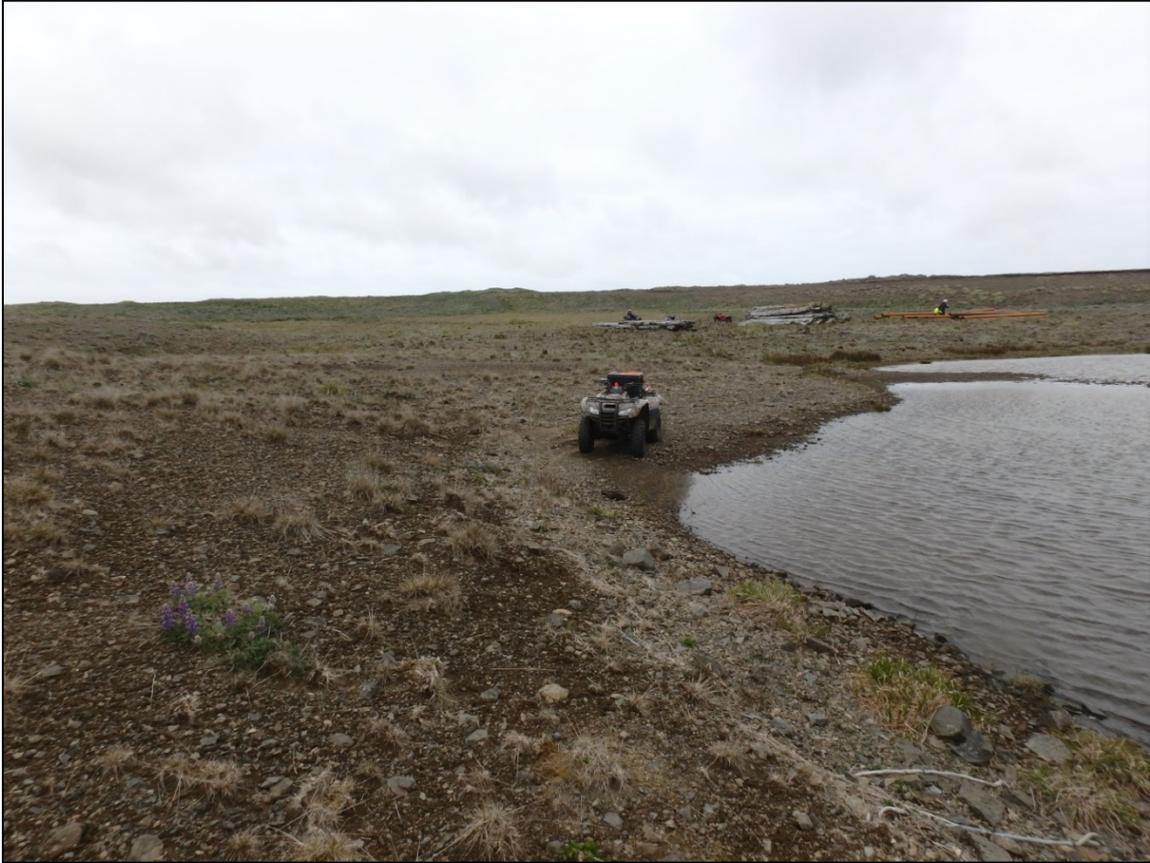
PL-MM8 B_06. Northeast corner of possible new borrow material area looking east
